Stranding and loss of the fishing vessel *Coelleira* (OB 93) Ve Skerries, Shetland 4 August 2019

SUMMARY

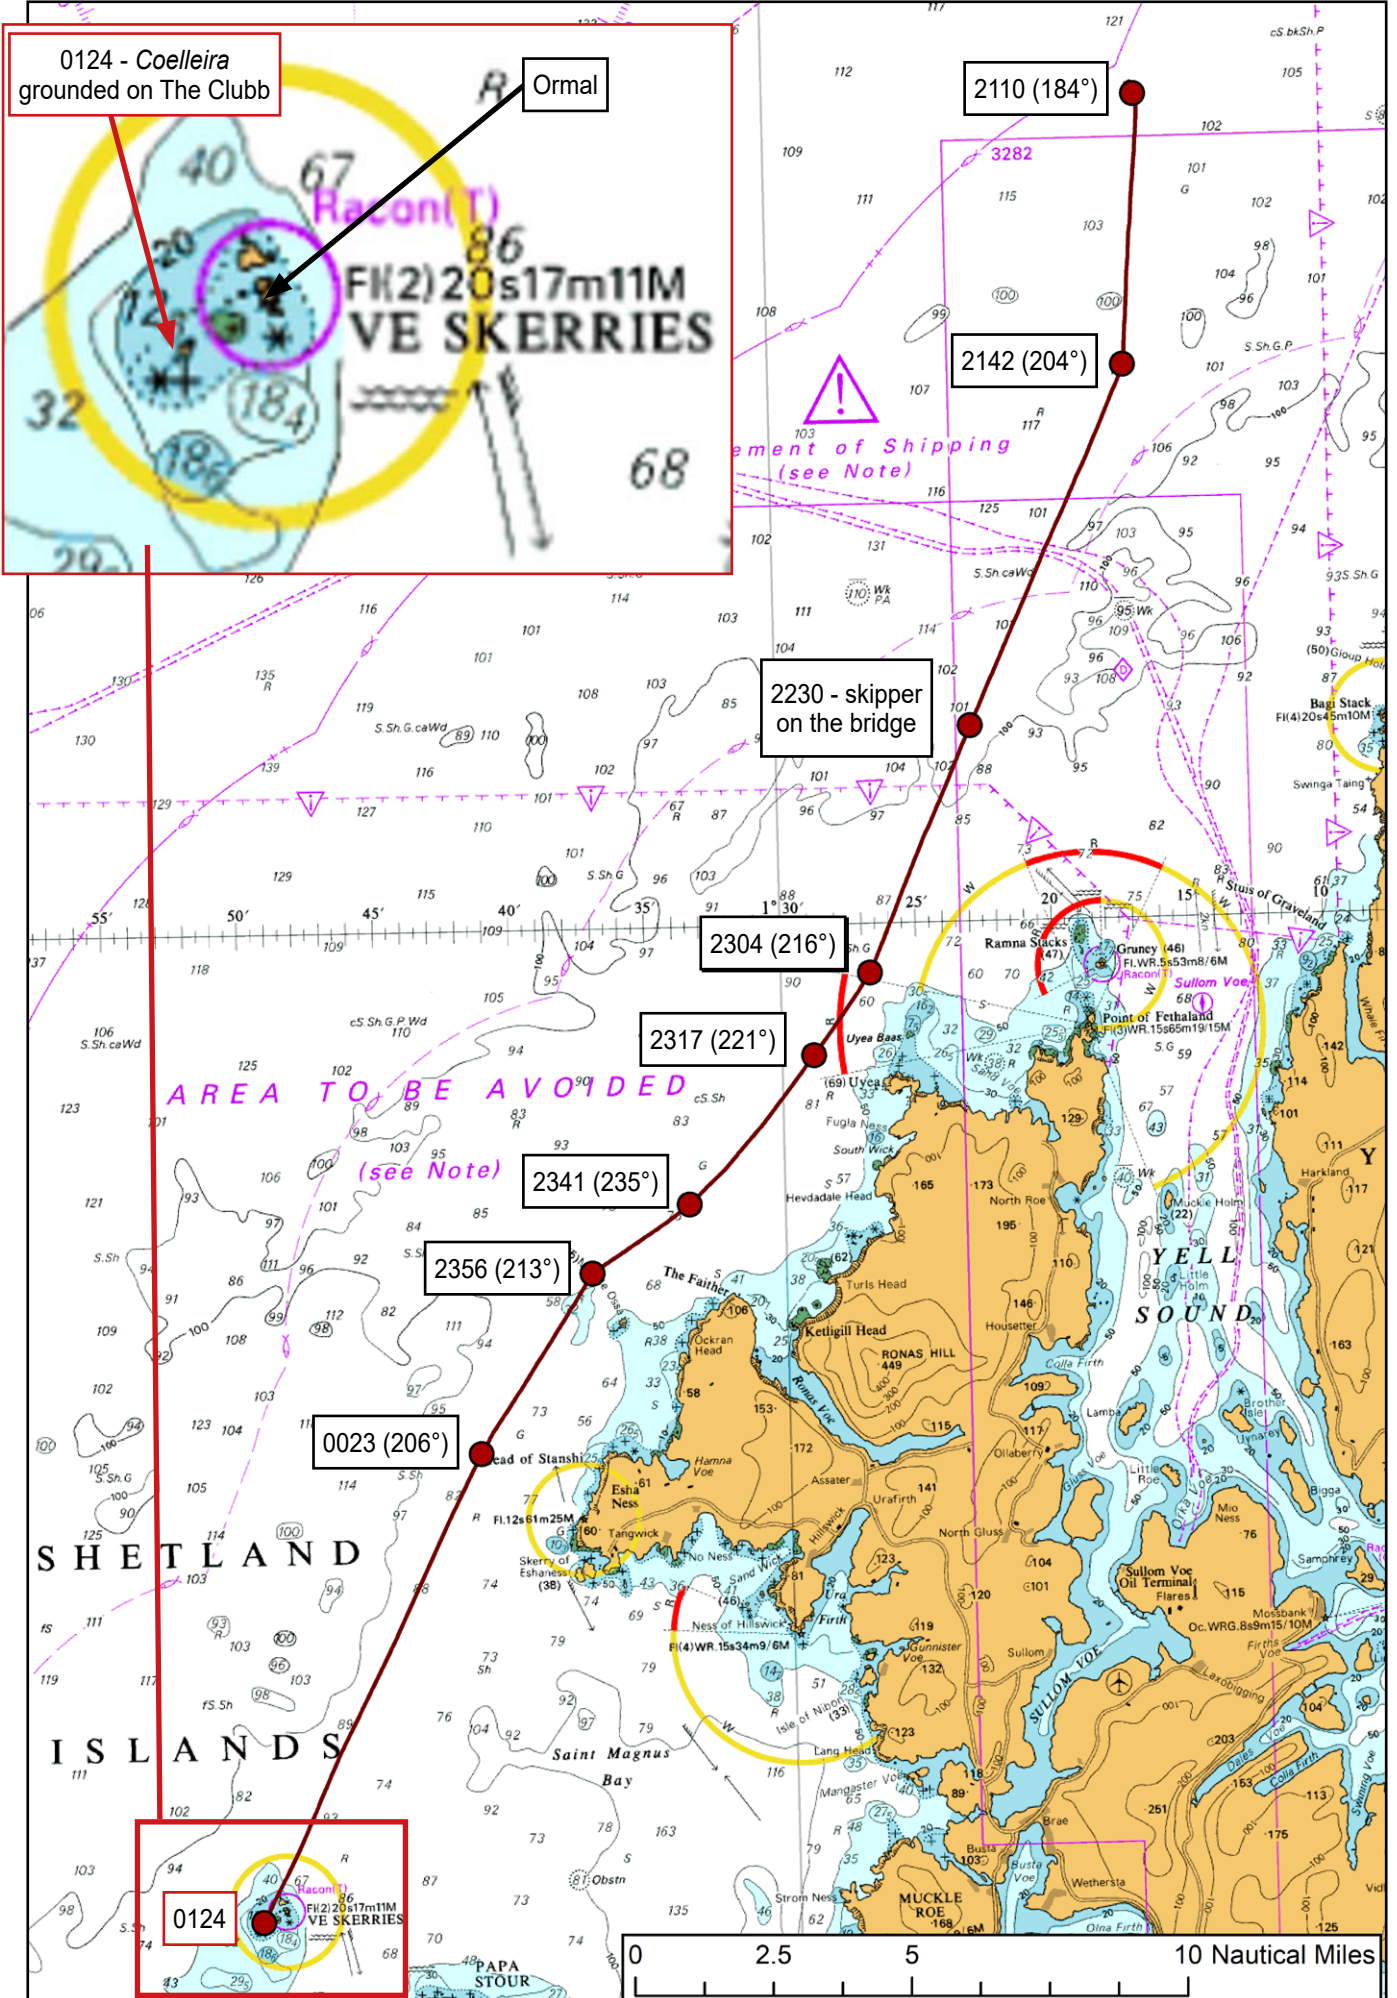
Figure 1: Coelleira's AIS track (inset: detail showing Ve Skerries)

Sometime later, the skipper left the wheelhouse. He did not specifically check the vessel's position before he left, nor did he note anything of concern or notice the lighthouse light ahead. The skipper was returning to the wheelhouse when, at 0124, *Coelleira* grounded on The Clubb, Ve Skerries (**Figure 1 inset**) at a speed of 10kts. The skipper was confused by the vessel's position.

Coelleira was heading directly towards Ve Skerries as soon as the vessel's heading was adjusted at 0023 (**Figure 1**). During the following hour, in which the vessel made good a course of 206° at a speed of 9-10kts, the skipper did not recognise the impending danger ahead. Although he saw a light off the vessel's port bow during the transit, he did not associate it with the lighthouse on Ormal. The skipper also did not see the racon from the lighthouse or returns from the low-lying reefs on the radar display, Ve Skerries ahead of the vessel on the chart plotter, or, the lighthouse light as he left the wheelhouse. Such omissions reflect a combination of an absence of passage planning, ineffective lookout and position monitoring, and possibly inaccurate or incomplete electronic chart data.

Coelleira's passage plan from the fishing grounds to Scrabster was based on following the Shetland coast (**Figure 1**) rather than a plotted route. The skipper relied on his limited knowledge of the area and adjusted the vessel's heading to remain between 1.25nm and 2nm clear of charted dangers. The five course alterations between 2304 and 0023 indicate that the skipper was monitoring *Coelleira*'s position and was using the radar and/or the chart plotter to monitor distances. They also suggest that the skipper's navigation was reactive rather than planned. The skipper's aim was to arrive in Scrabster as soon as possible, but he chose to follow the coast rather than a more direct and marginally shorter route that was clear of many navigational dangers (**Figure 5**). This decision might have been made because the vessel did not carry a sufficiently small-scale chart.

When *Coelleira*'s heading was adjusted to 206° at 0023, which was an alteration of only 7°, the skipper did not realise he was turning *Coelleira* directly towards Ve Skerries. Ve Skerries were 10nm ahead and therefore would not have been displayed on the radar at the 3nm range scale. Whether or not the reefs were displayed on the chart plotter would have depended on the scale selected and the quality of the electronic chart, and at a range of 10nm the light on Ormal also might not have been readily apparent due to its geographical range (11nm) together with its characteristics (flashing twice every 20 seconds). Although the adjustment of heading was small, and was possibly made in an attempt to save time, the absence of any reference to a small-scale chart and a planned route on either paper charts or in the chart plotter, along with not periodically adjusting the range on the radar display and chart plotter, denied the skipper opportunities to identify the presence of the reefs ahead.

- The route from the fishing grounds to Scrabster was not drawn on the paper charts or entered into the electronic chart plotter.
- The vessel's heading was adjusted to follow the coastline using information from the radar and chart plotter. Due to ineffective lookout and position monitoring, the skipper was not aware that the vessel was heading directly towards Ve Skerries following an adjustment of heading at 0023.

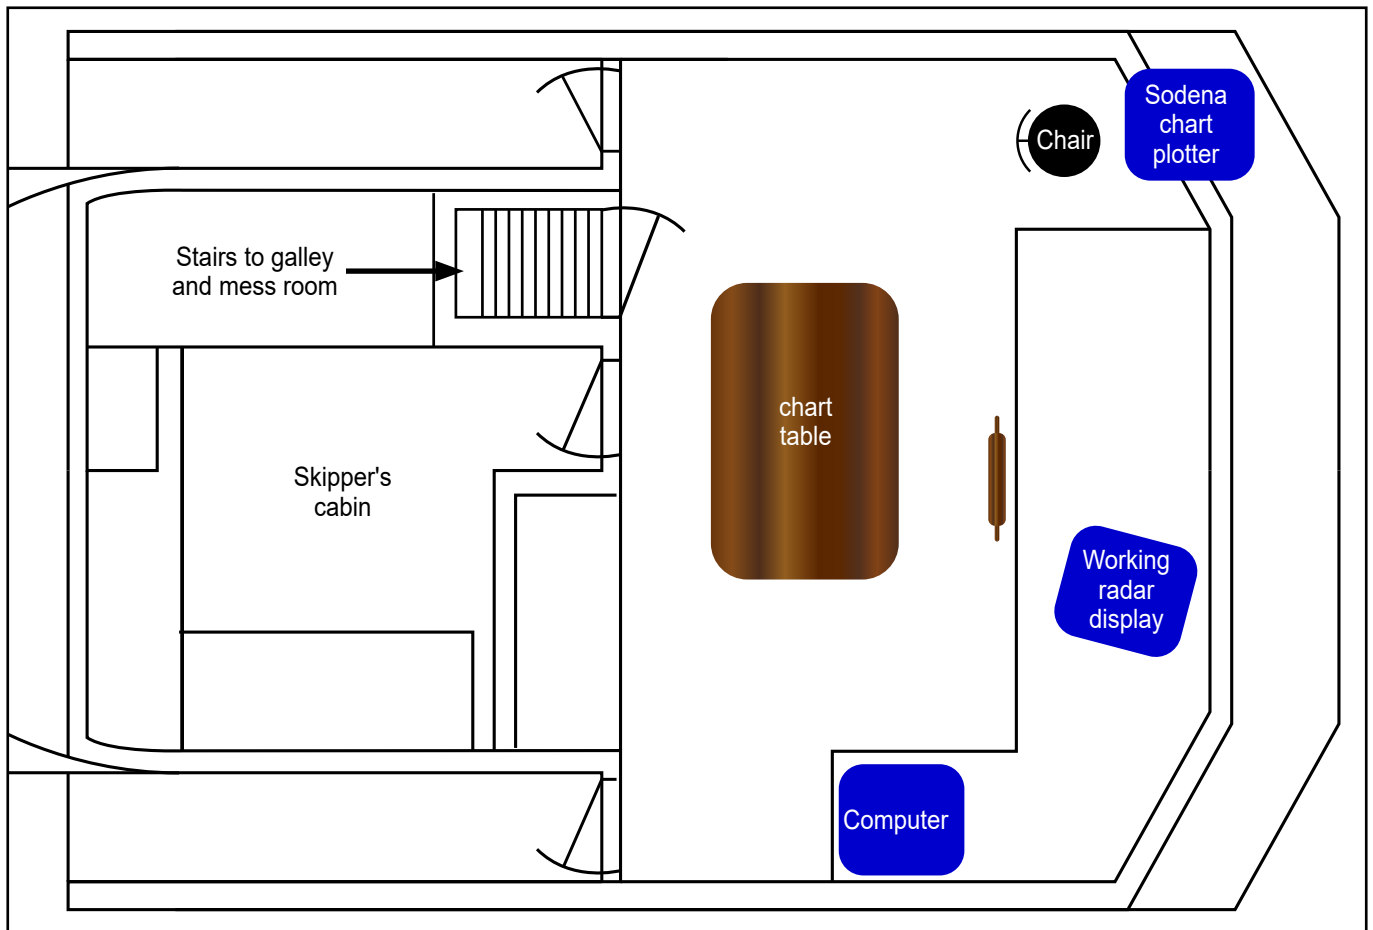
Figure 2: Bridge layout

The navigation equipment fitted in *Coelleira*'s wheelhouse (**Figure 2**) included a Robertson autopilot, a chart table, a global positioning system receiver, Maxsea and Sodena Turbowin electronic chart plotters, and two radar displays. One of the radars was not working because its scanner had been damaged when struck by the rescue boat davit arm. The working radar was usually kept on the 6nm range scale when fishing and on the 3nm range scale when on passage. The vessel also carried an automatic identification system (AIS) transceiver on which the vessel status was set to '*engaged in fishing*'.

Coelleira's primary means of navigation was paper charts. The vessel's chart plotters had been fitted in 2007 to support its fishing operations. However, the Maxsea chart plotter no longer worked and was not used. The Sodena chart plotter used C-Map electronic charts, but no records were available to indicate either which charts were installed or whether those installed had been updated. It was reported that the hydrographic information displayed on the chart plotter was not as detailed as that shown on the paper charts. The intended passage from the fishing grounds to Scrabster was not drawn on paper charts or input into the Sodena chart plotter.

In this case, the skipper had been alone in the wheelhouse during darkness after taking over the watch and was not in the wheelhouse when the vessel grounded. The passage had not been planned and checked either on paper charts or on the chart plotter. Therefore an accurate assessment of the likely proximity of navigational hazards had not been made, and the vessel's position was not plotted and verified on the paper chart. Furthermore, one of the vessel's radars and the Maxsea chart plotter were not working, and the reported lack of detail of the information on the Sodena plotter and the absence of any records to show that its C-Map charts had been updated since 2007, both indicate that this plotter, although reported as working, was not sufficiently accurate to be used for navigation.

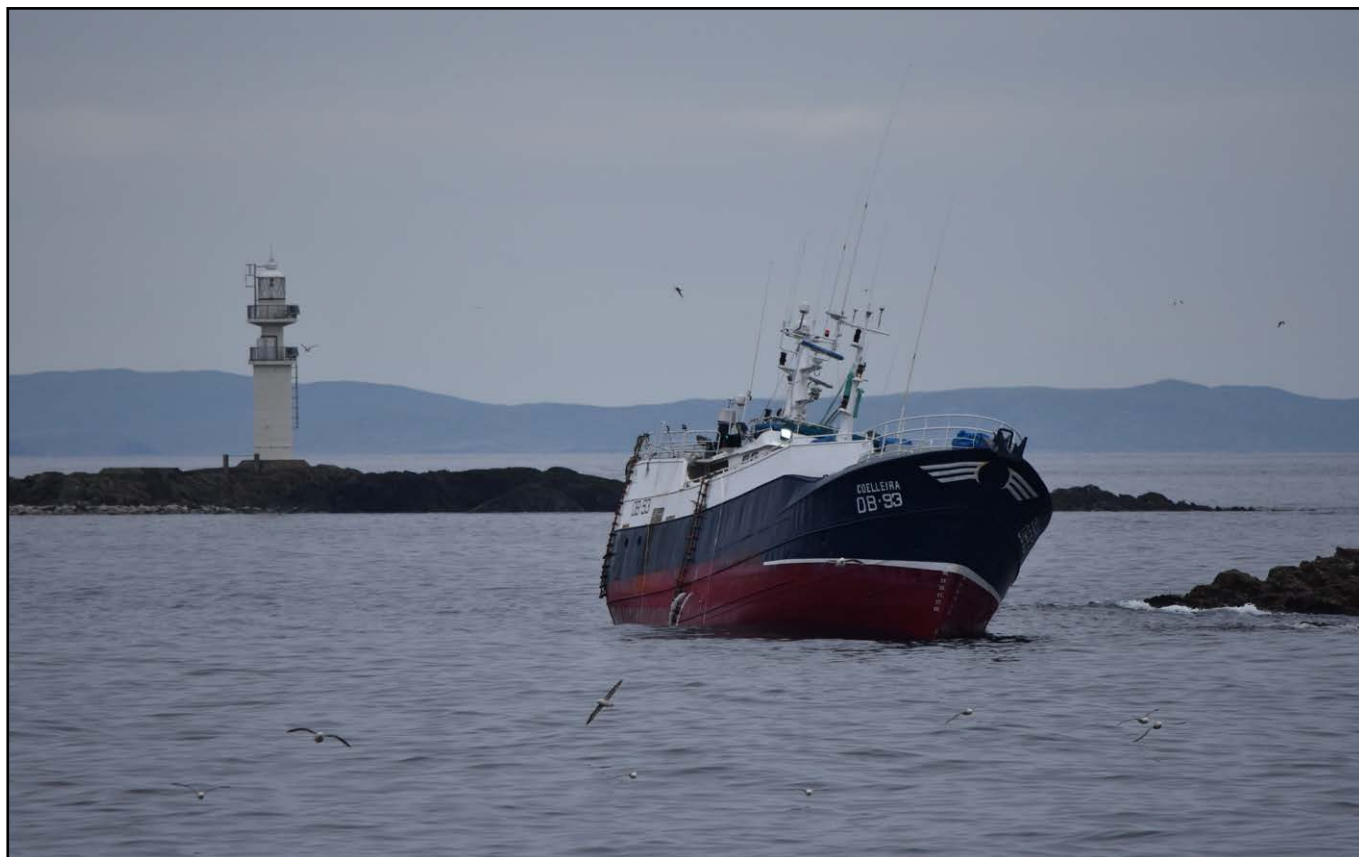
Figure 3: Coelleira aground

During 4 August, *Coelleira* remained hard aground with its generator still running, and diesel oil mixed with the generator's water discharge (**Figure 3**) was spreading around and downwind of the vessel. The Maritime and Coastguard Agency (MCA) Deputy Counter Pollution and Salvage Officer (DCPSO) and the Deputy to the SOSREP⁴ liaised with *Coelleira's* owners, insurers, the Scottish Standing Environment Group and the Shetland Islands Council to assess the vessel's position, condition and the possibility of re-floating. *Coelleira's* owners and insurers contracted *Tystie*, a 56t bollard pull tug operated by the Sullom Voe Harbour Authority in Shetland, to assist. The owner and the vessel's agent also travelled from Spain to Shetland. *Coelleira* was carrying approximately 15 tonnes of fish and 15 tonnes of diesel oil and had a draught of about 4m.

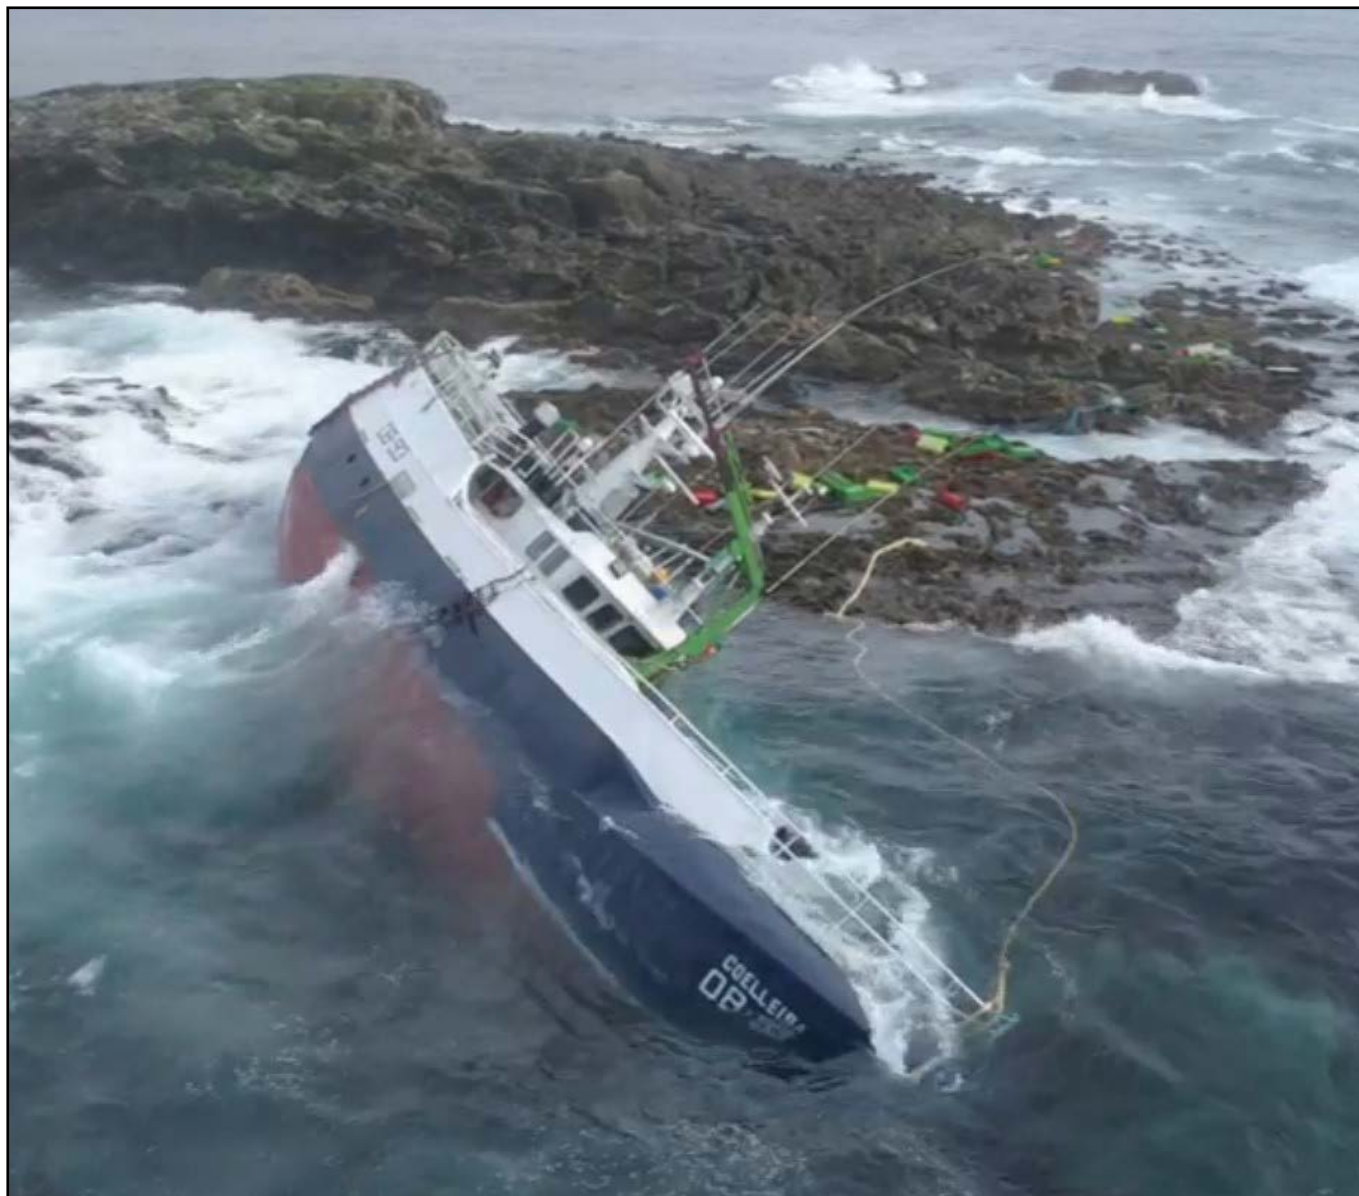
Figure 4: *Coelleira* post-salvage attempt

Between 5 and 6 August, a further onboard inspection was conducted by a surveyor appointed by *Coelleira*'s owner. The owner also appointed salvors, and the SOSREP established a 500m exclusion zone around the vessel. At high water on 7 August, an attempt by *Ievoli Black* to tow *Coelleira* off the rocks was unsuccessful and the fishing vessel developed a 55° list to port (**Figure 4**). The following day, a survey identified a 30cm wide crack extending between 4m and 5m along *Coelleira*'s starboard side. Consequently, with worsening weather and sea conditions forecast, the vessel was declared unsalvageable. MV *Constructor*, a dive vessel, was contracted to act as a guardship, recover debris and remove oil if the weather conditions allowed. However, *Coelleira* soon began to break up and eventually slid off the rocks into deeper water and sank.
