# **MARINE ACCIDENT INVESTIGATION BRANCH**

## **Summary of Investigations No 1/91**

# INDEX

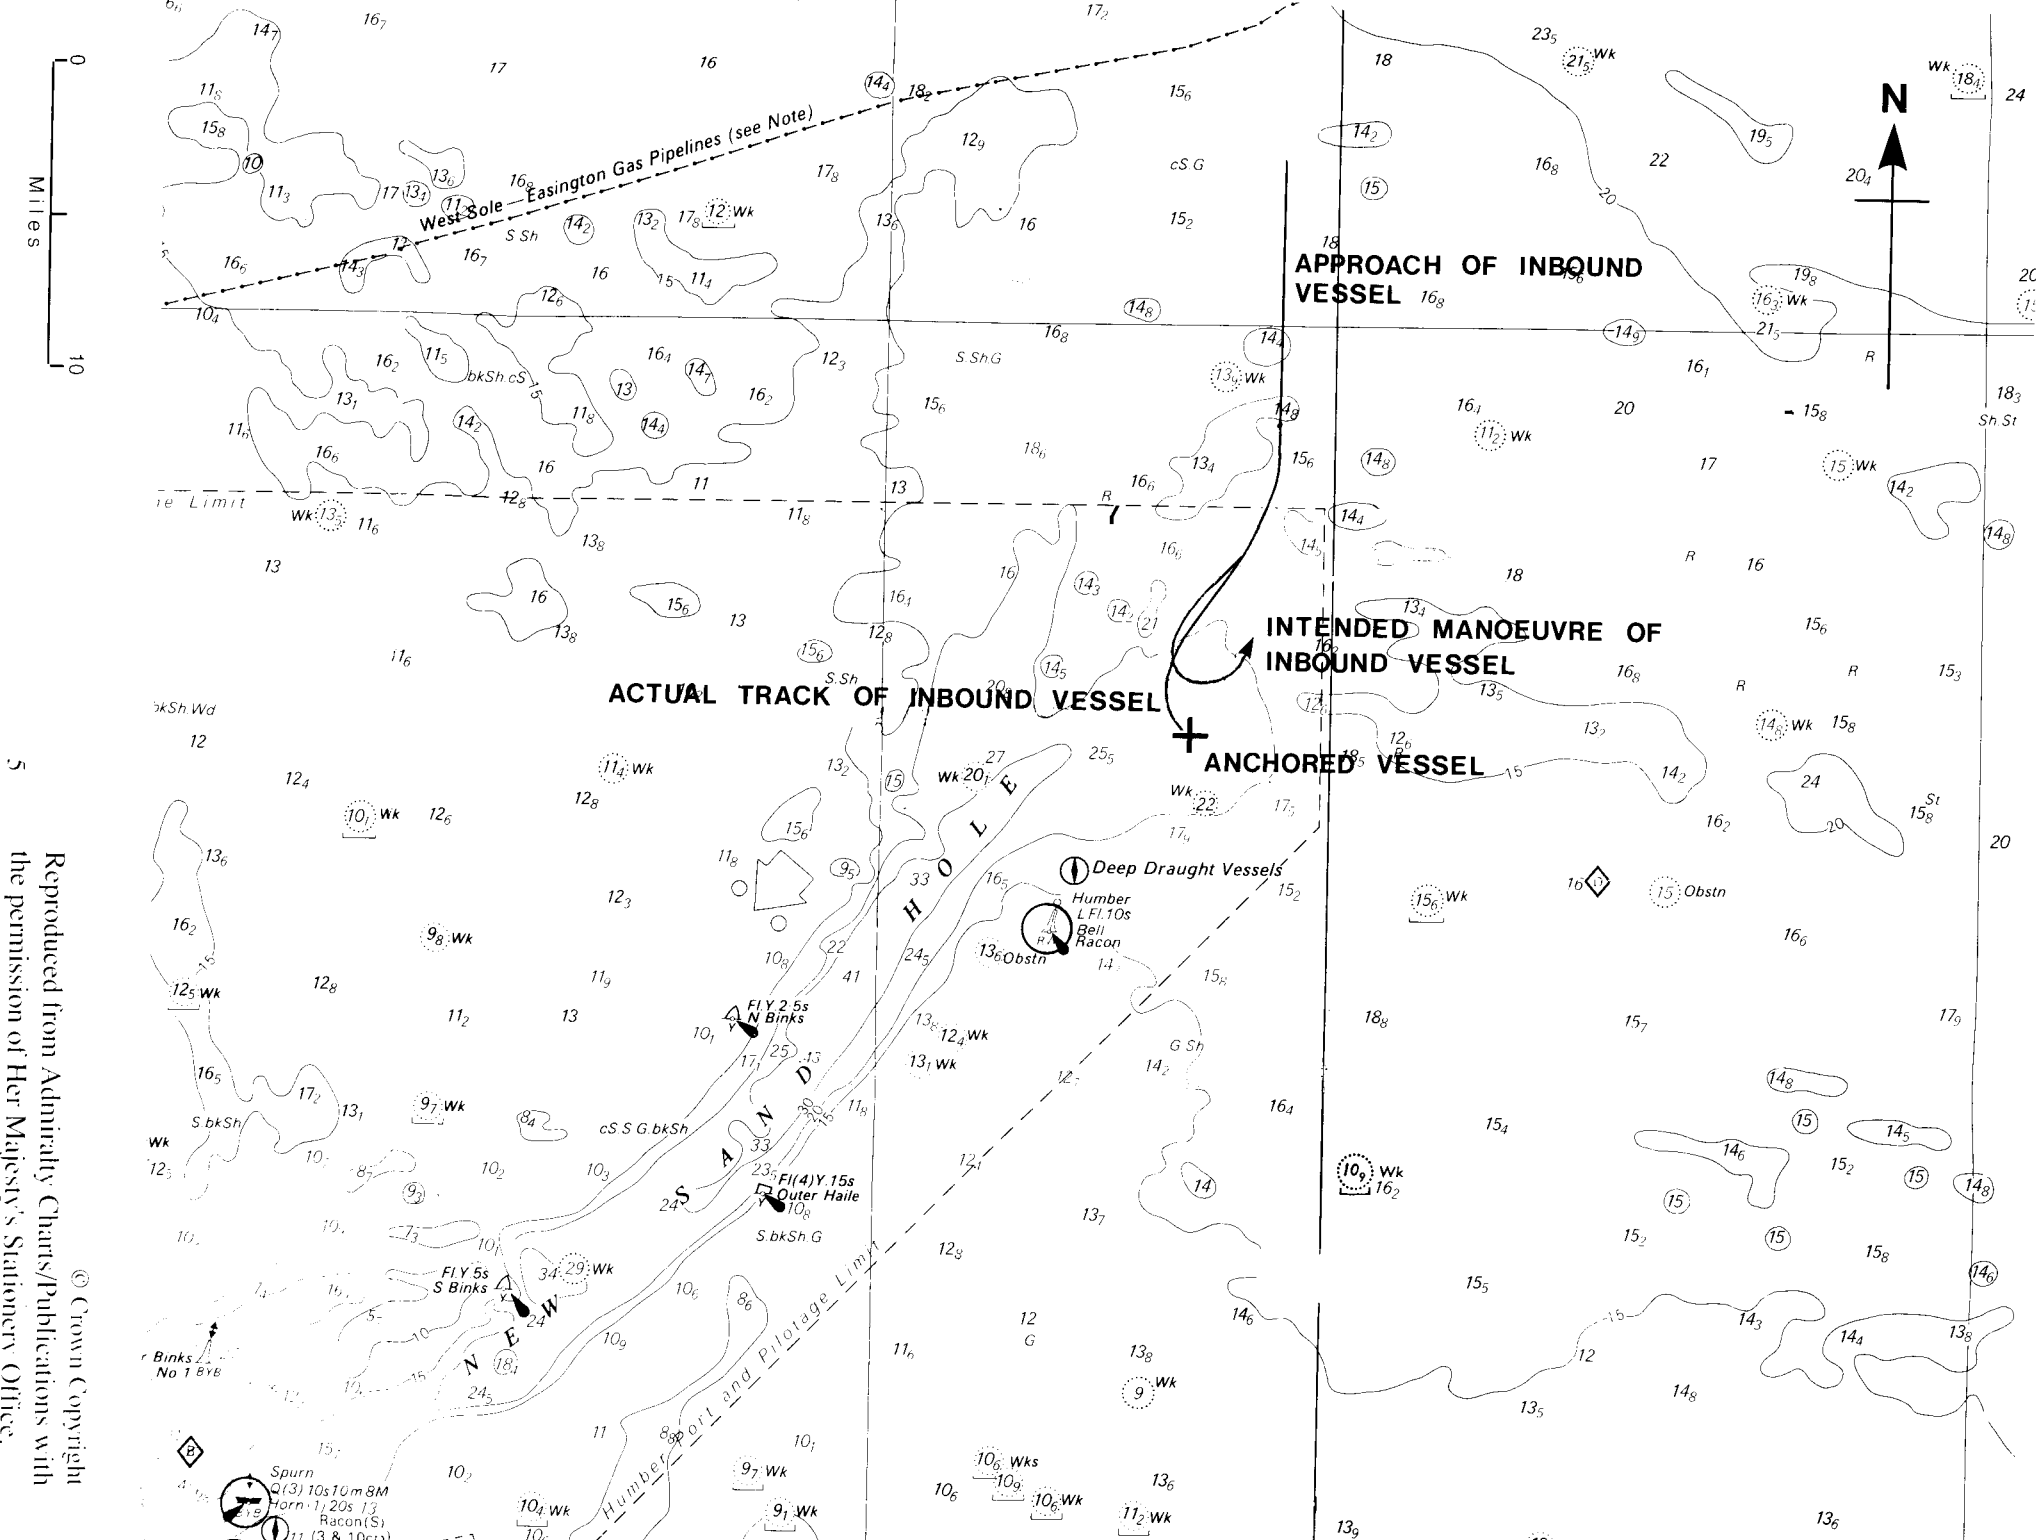
Figure 1

A tanker of 26,974 gross registered tonnage (grt) was bound for the River Humber with a cargo of some 52,000 tonnes of crude oil. As her berth was not immediately available it was decided to anchor north of the Humber Light-Float; this is a common anchorage for vessels awaiting entry to the River. Among ships already there, was another tanker, of 28,709 grt laden with some 46,500 tonnes of fuel oil. The Master of the in-bound ship decided to anchor about a mile to the north of this vessel. (See Figure 1).

In order to stem the tide it was necessary to turn through about 180° before anchoring. The manoeuvre was commenced, by altering course to starboard, when the anchored vessel was some 14 cables distant. Once the anchored vessel was well on the port bow the helm was put hard aport, the object being to complete the swing ahead - therefore up-tide - of that vessel. Unfortunately, insufficient allowance had been made for the tide and the ship set down on to the vessel at anchor so that collision occurred.

The impact ruptured the in-bound vessel's slop tank, and the heat which was generated as a result set oil escaping from that tank on fire. The fire spread to both vessels; that on the ship at anchor was extinguished by her crew, but the fire on the other ship became extensive and was only put out with the aid of fire-fighting tugs from the Humber and two off-shore support vessels which were in the vicinity. Despite this, no serious personal injury resulted from the accident. There was some oil pollution but it was quickly dealt with.

1. This collision would not have taken place if the in-bound vessel's approach to the anchorage had been properly planned and carefully monitored.
2. The collision might have been avoided if the bridge team had been better organised so that full use was made of the Chief Officer and the Officer of the Watch.
