# **MARINE ACCIDENT INVESTIGATION BRANCH**

## **Summary of Investigations No 1/90**

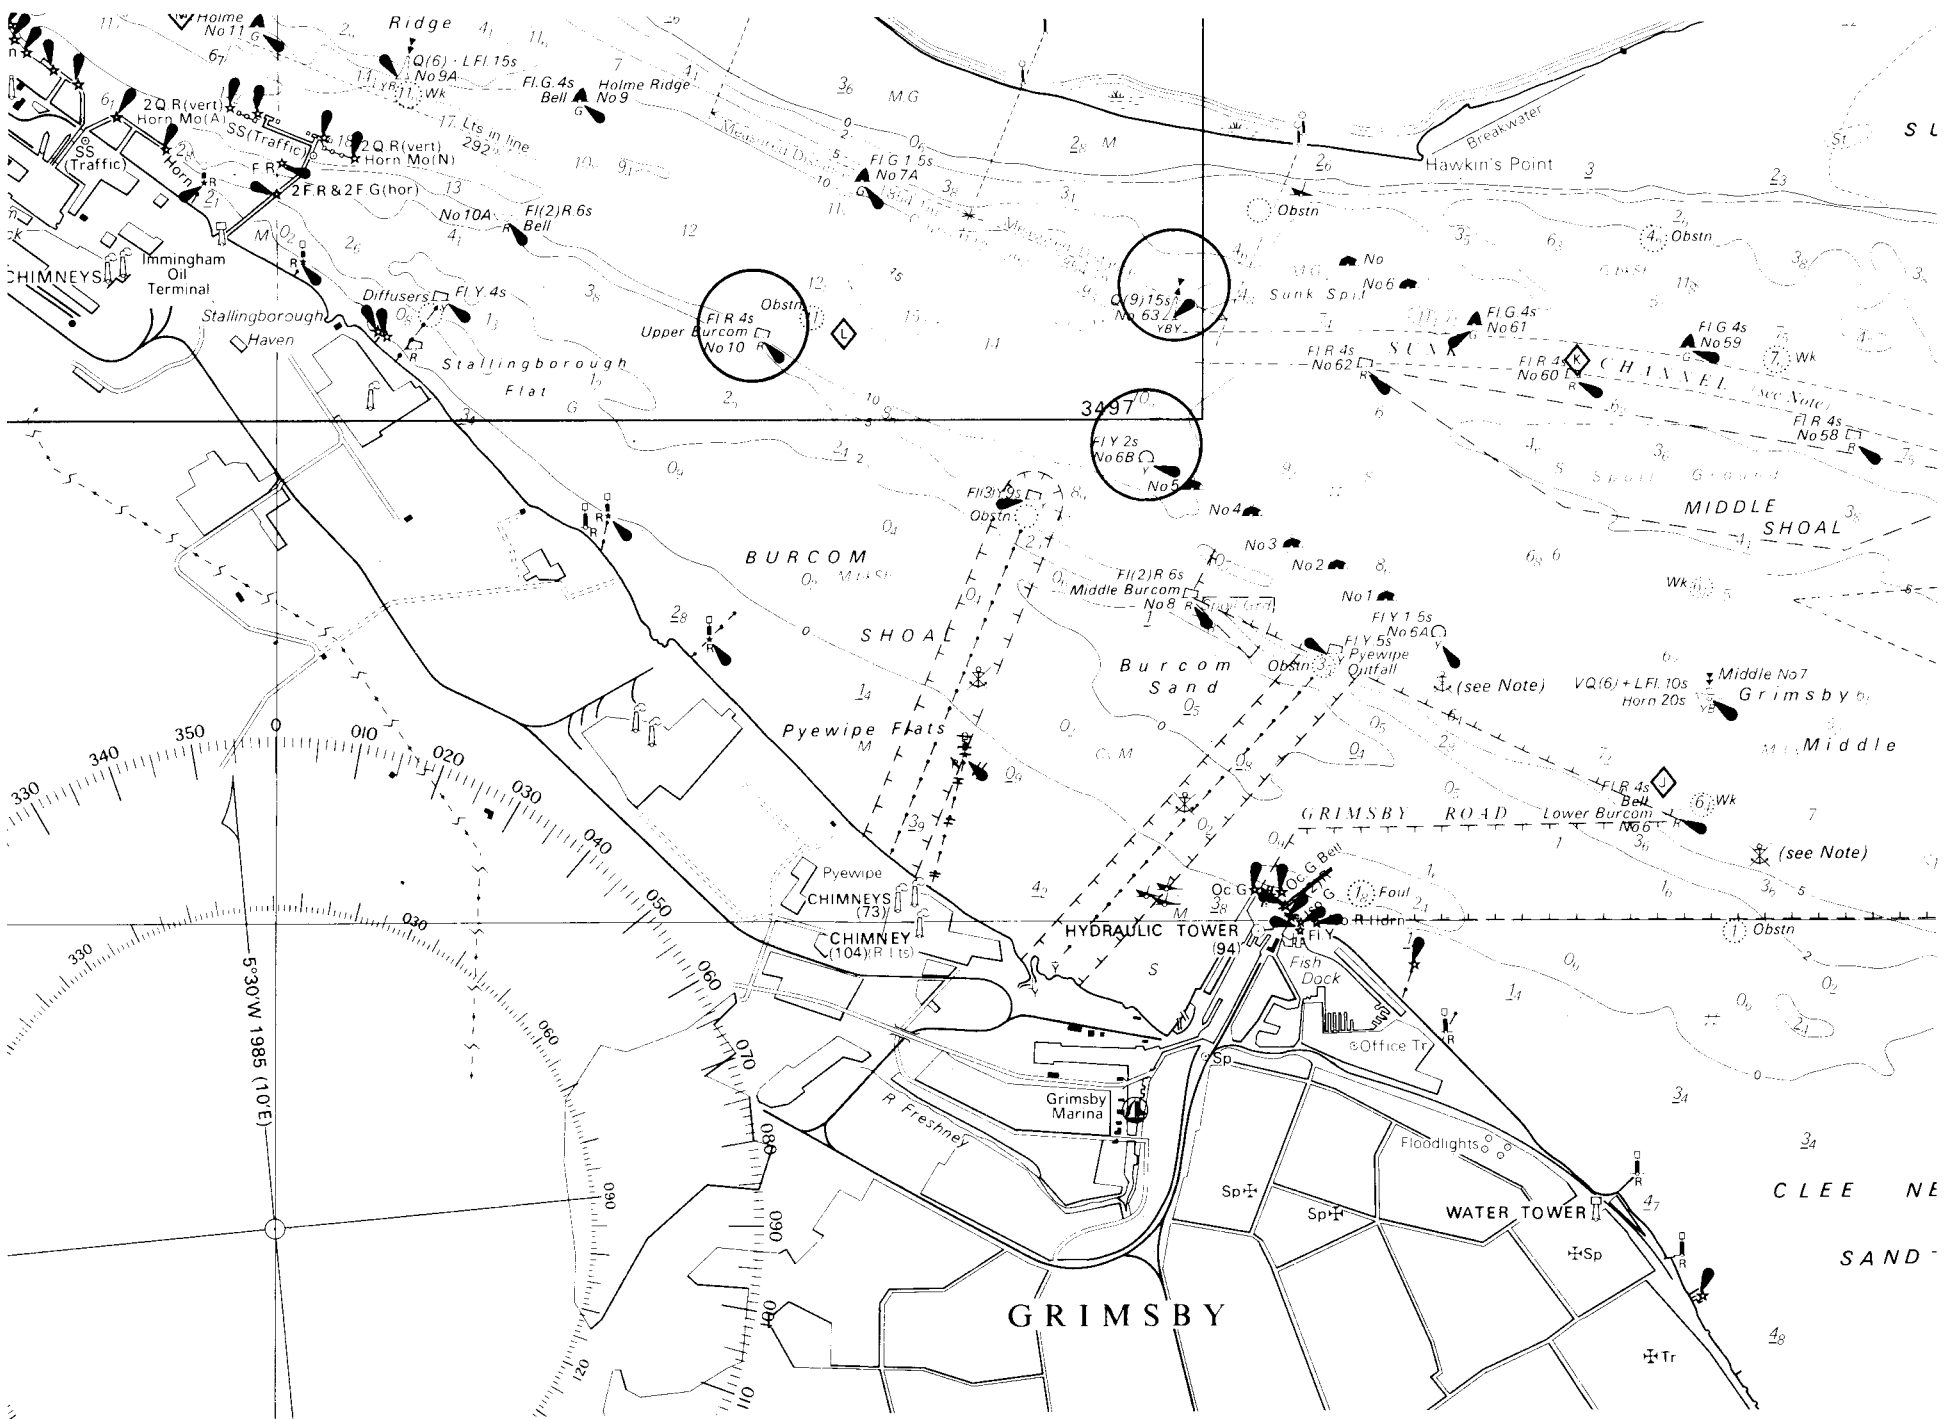
The collision occurred within one cable of a position 0.22 miles, 030 degrees (T) from No 10 Buoy. There was dense fog at the time, and the tide was flooding at rather more than 2 knots. A copy of the relevant chart is at Figure 1.

1. Both vessels were properly manned, with the Master on the Bridge accompanied by an experienced pilot who was conning.
2. As they approached each other, the vessels were closing, in dense fog, at a combined speed of some 20 knots. Neither was proceeding at a safe speed, as required by the Collision Regulations.
3. The chemical tanker was not on her own starboard side of the channel (the proper side under the Collision Regulations). The ro-ro ship was on her own starboard side, but not so far over as she would have been had she not just overtaken the small tanker; it would have been better not to overtake until clear of No 10 Buoy.

4. The chemical tanker was not regularly sounding the proper fog signals on her whistle.
5. When the chemical tanker appreciated that a close quarters situation was developing, and at about the same time heard the ro-ro ship's whistle, she did not reduce speed to the minimum as required by the Collision Regulations, but instead INCREASED to half ahead. The ro-ro ship did not, it appears, recognise danger until almost immediately before the collision occurred.

6. With a hazardous cargo of Propylene Oxide and No 2 cargo tank breached, the potential existed for this accident to have very grave consequences indeed. The Master and crew are to be commended for the prompt and efficient way in which they tackled the fire which broke out at once after collision, which did much to reduce the immediate danger; the emergency services are also to be much commended for their action, which brought the situation under control and eventually restored safety. The Emergency Plan HESMEP underwent a severe test and came through it well. However, it is noted that one of the two fire-fighting tugs stationed on the Humber was locked in at Immingham docks, and it was only fortuitous that the other was outside the locks and immediately able to assist. There is a strong case for one of these tugs to be stationed outside the docks, so as to be readily available at all times.

7. The Port Authority subsequently imposed restrictions on the movement of vessels with hazardous cargoes in restricted visibility.

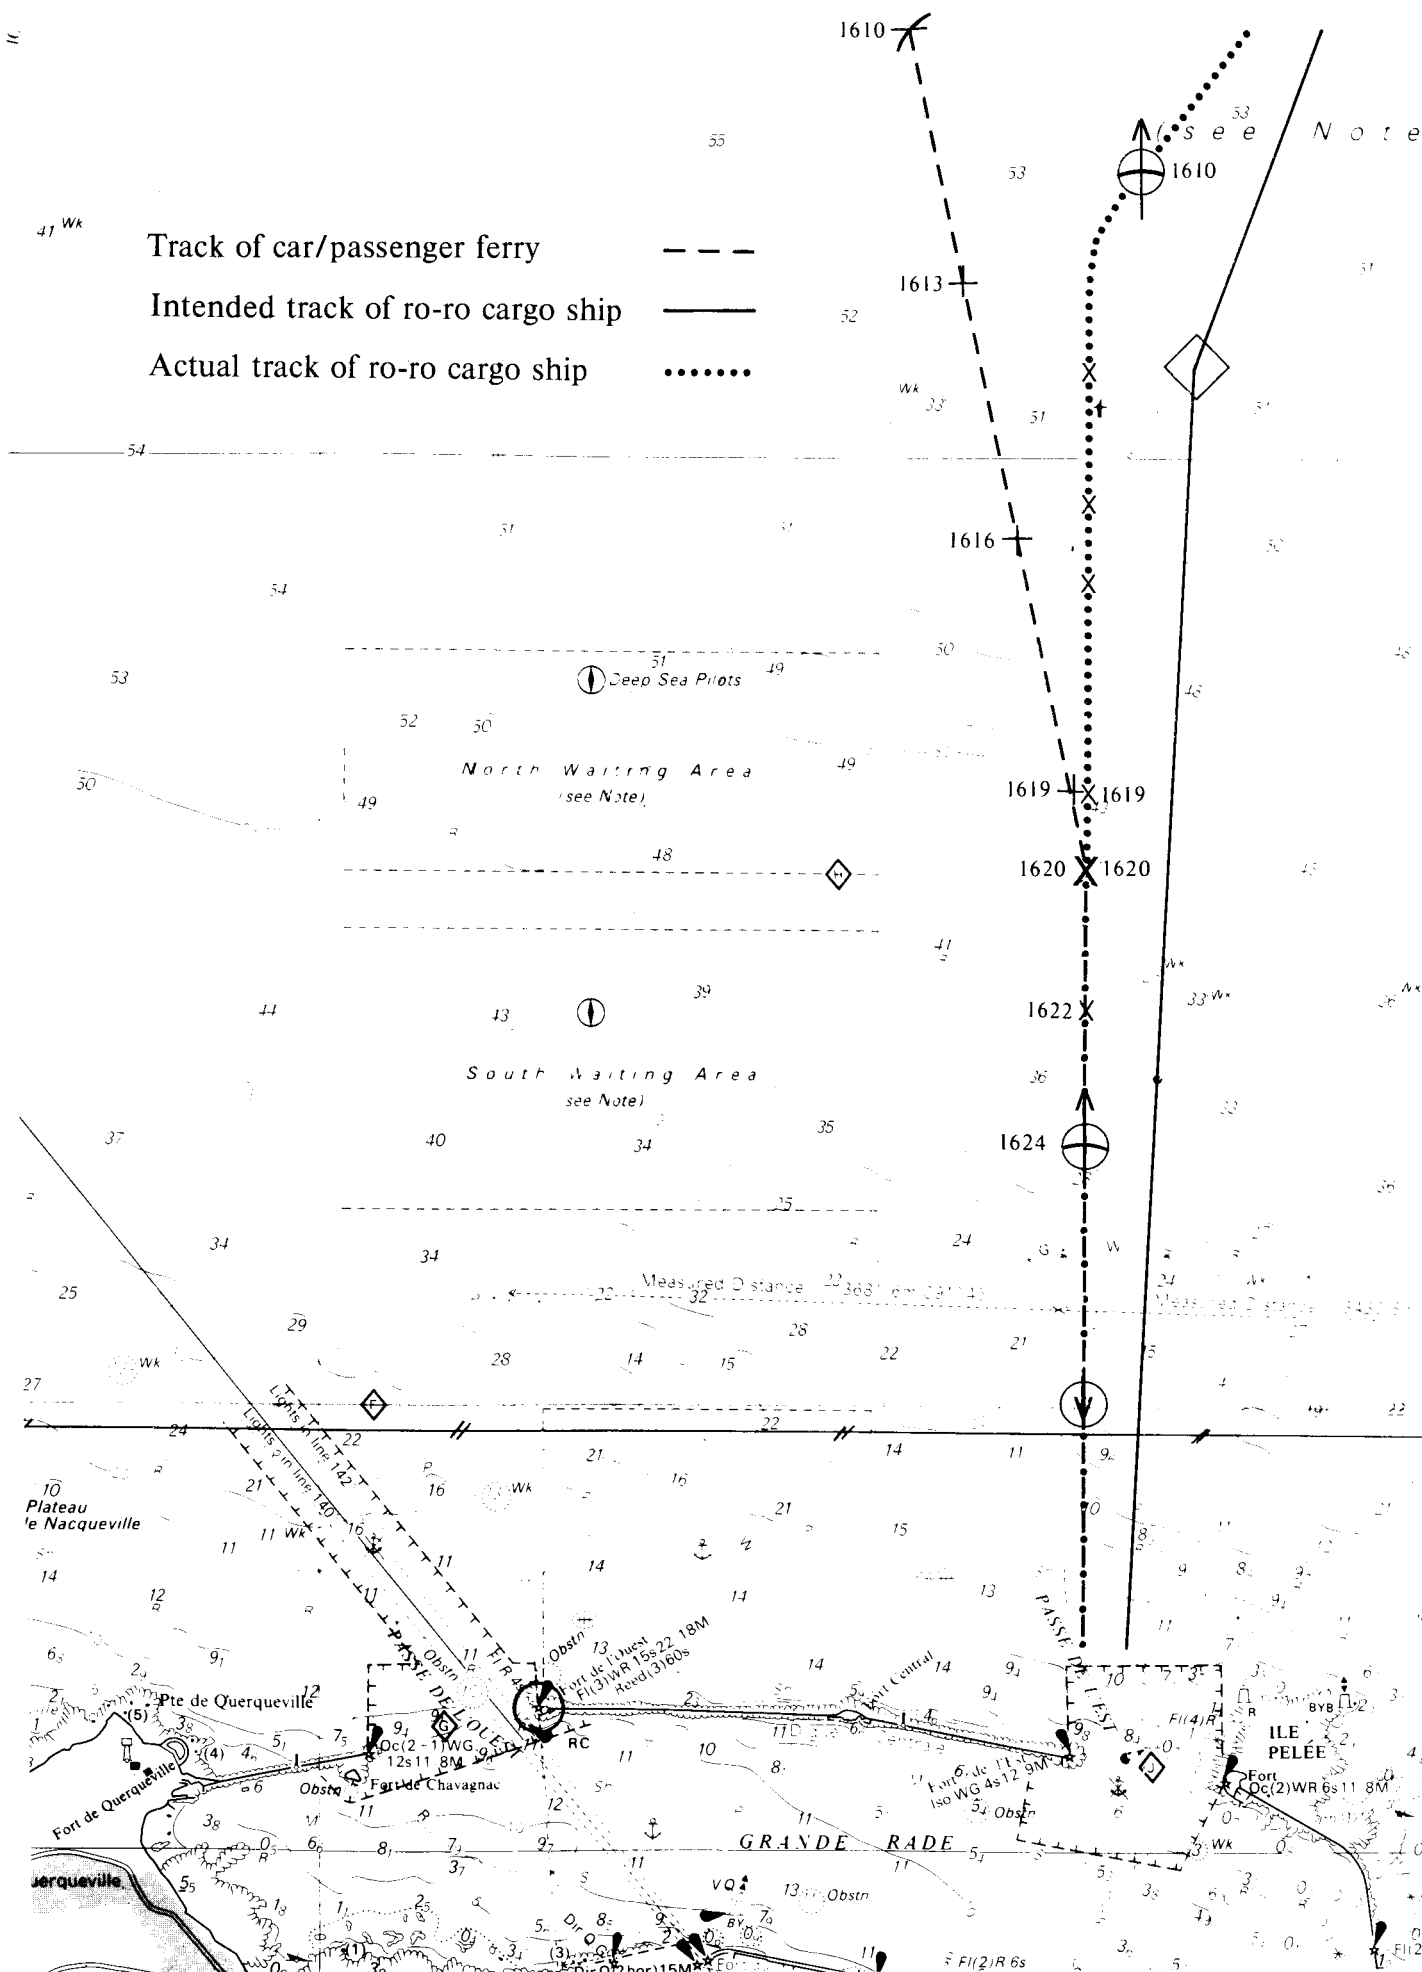
A car/passenger ferry and a ro-ro cargo ship nearly collided when both vessels were making their approach to Cherbourg Eastern harbour entrance. The sea state was slight; it was daylight with clear visibility and a westerly tidal stream was being encountered by both ships. A copy of the relevant chart is at Figure 2.

1. The fundamental cause of the near miss was that the car ferry, being the overtaking vessel, did not "keep out of the way of the vessel being overtaken" by Rule 13(a) of the International Regulations for Preventing Collision at Sea 1983.

2. The car ferry approached and passed the ro-ro ship at far too close a distance. Both ships were travelling at rates which were imprudent for approaching a harbour entrance and a dangerous shoal. The car ferry also made a dangerous alteration of course to port across the bows of the ro-ro ship "before finally past and clear" (Rule 13 (d)) and thus aggravated an already dangerous situation to a point where both ships nearly collided.

3. The ro-ro ship was also at fault in that those responsible for the navigation did not show their doubt of the intentions or actions of the car ferry's approach by sight or by sound (Rule 34(d) of the Collision Regulations). When it became apparent that the car ferry was not taking appropriate action in compliance with the Collision Regulations, the ro-ro ship did not take action to avoid collision by her manoeuvre alone (Rule 17 (a)(ii)).

4. Both vessels were travelling at imprudent speeds when approaching a dangerous reef and a harbour entrance, thus allowing themselves no margins of safety in which to escape any dangerous situations.

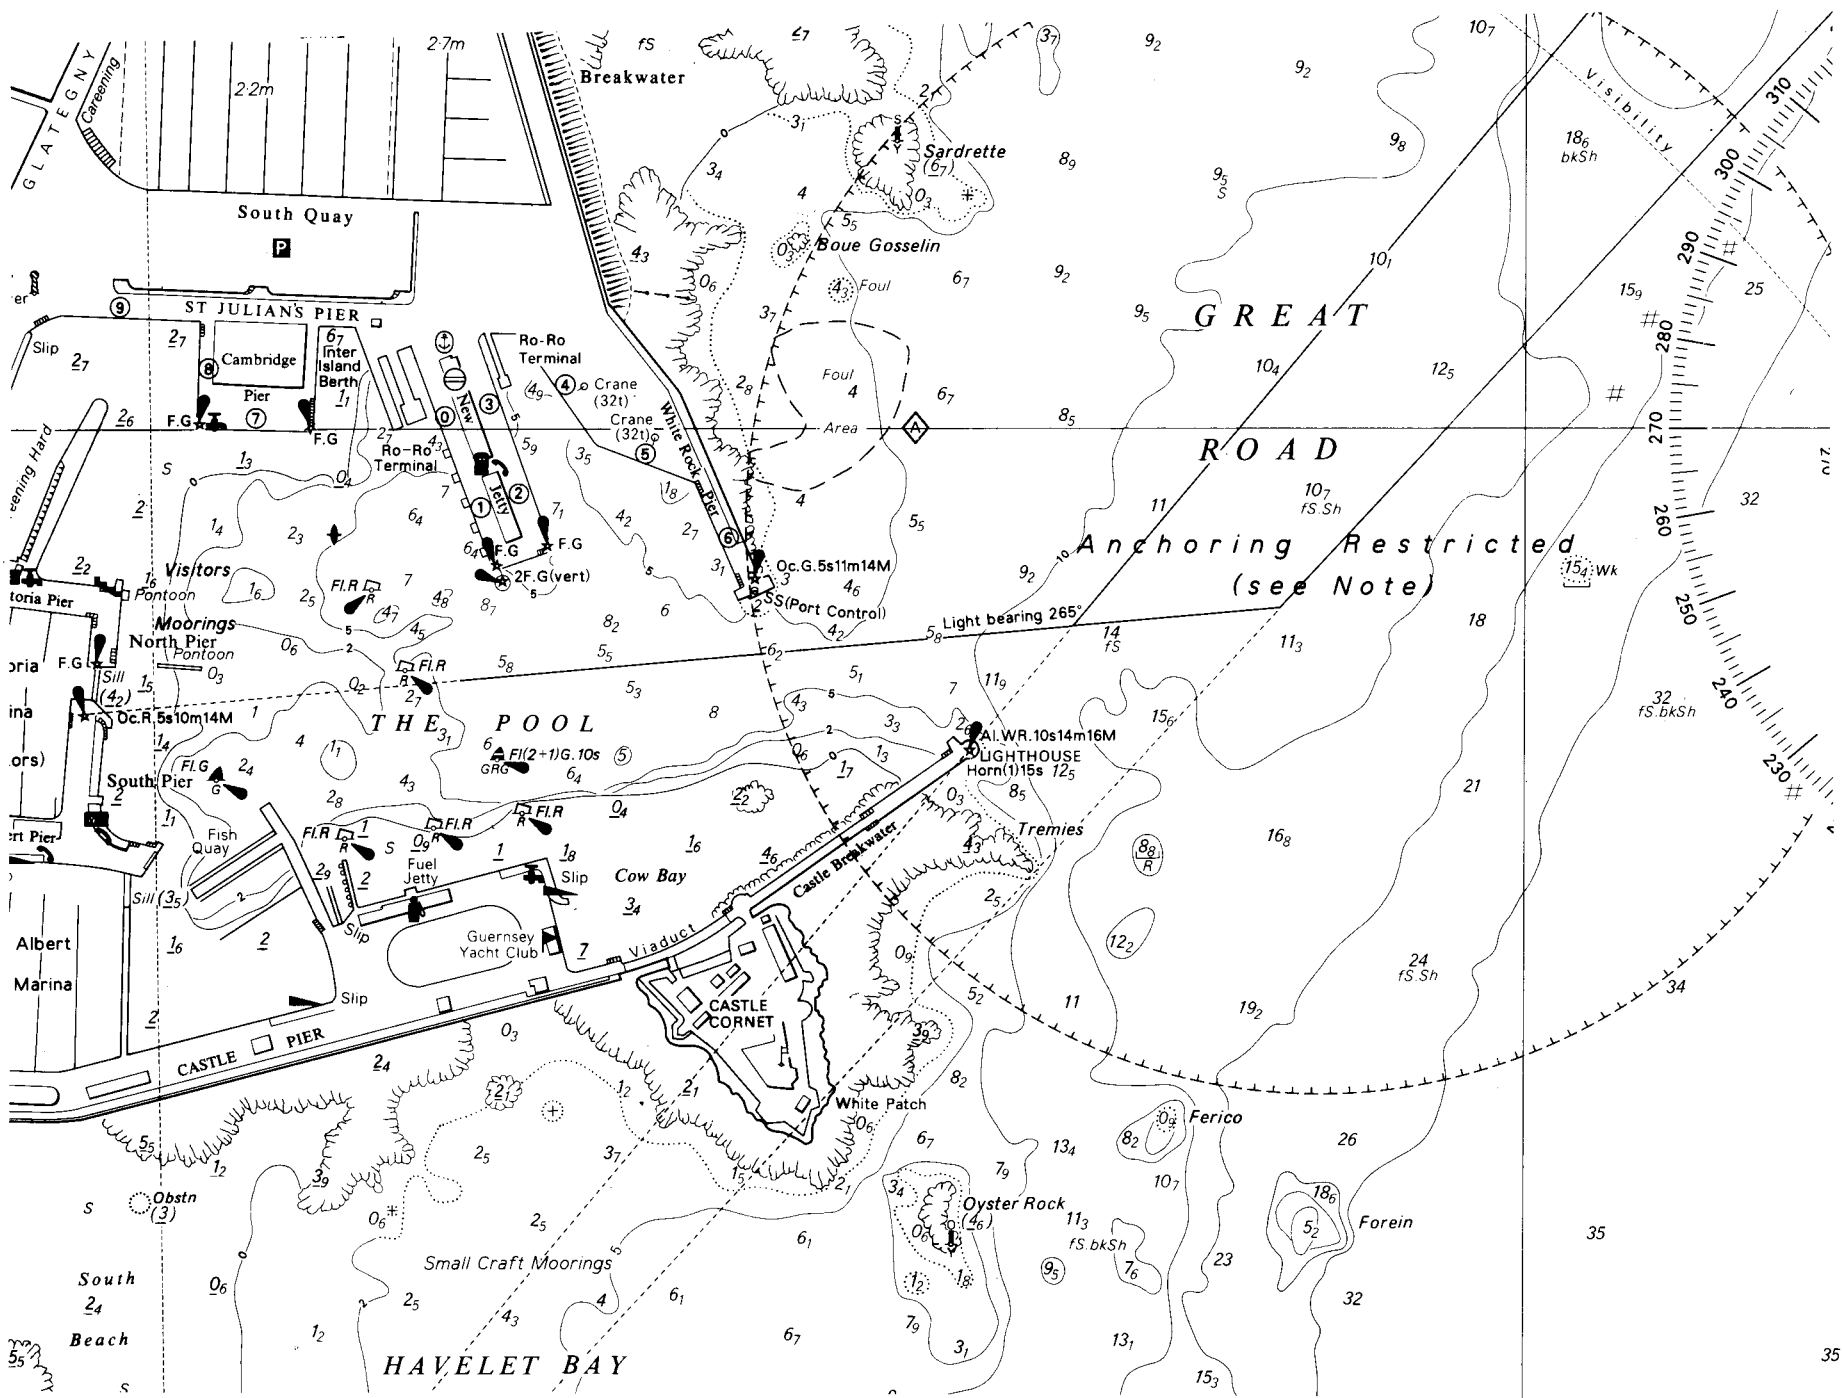
Figure 3

6. When it was appreciated that the vessel was to the south of her normal position, (ie when the port bridge wing was abeam of the end of the south breakwater) no corrective action was taken by the Chief Officer. Also the Master failed to take over control of the vessel or to offer any advice to the Chief Officer, who was in control at the time.

5. The vessel concerned had a bow thruster; the accident emphasized the advantage of a stern thruster also being provided in vessels which are required to manoeuvre in very restricted waters.

6. The practice of allowing a Chief Officer to handle and berth the ship is to be encouraged, but Masters must exercise close supervision and must not hesitate to take control if the manoeuvre is not going according to plan.
