MARINE ACCIDENT INVESTIGATION BRANCH

Summary of Investigations No 1/92

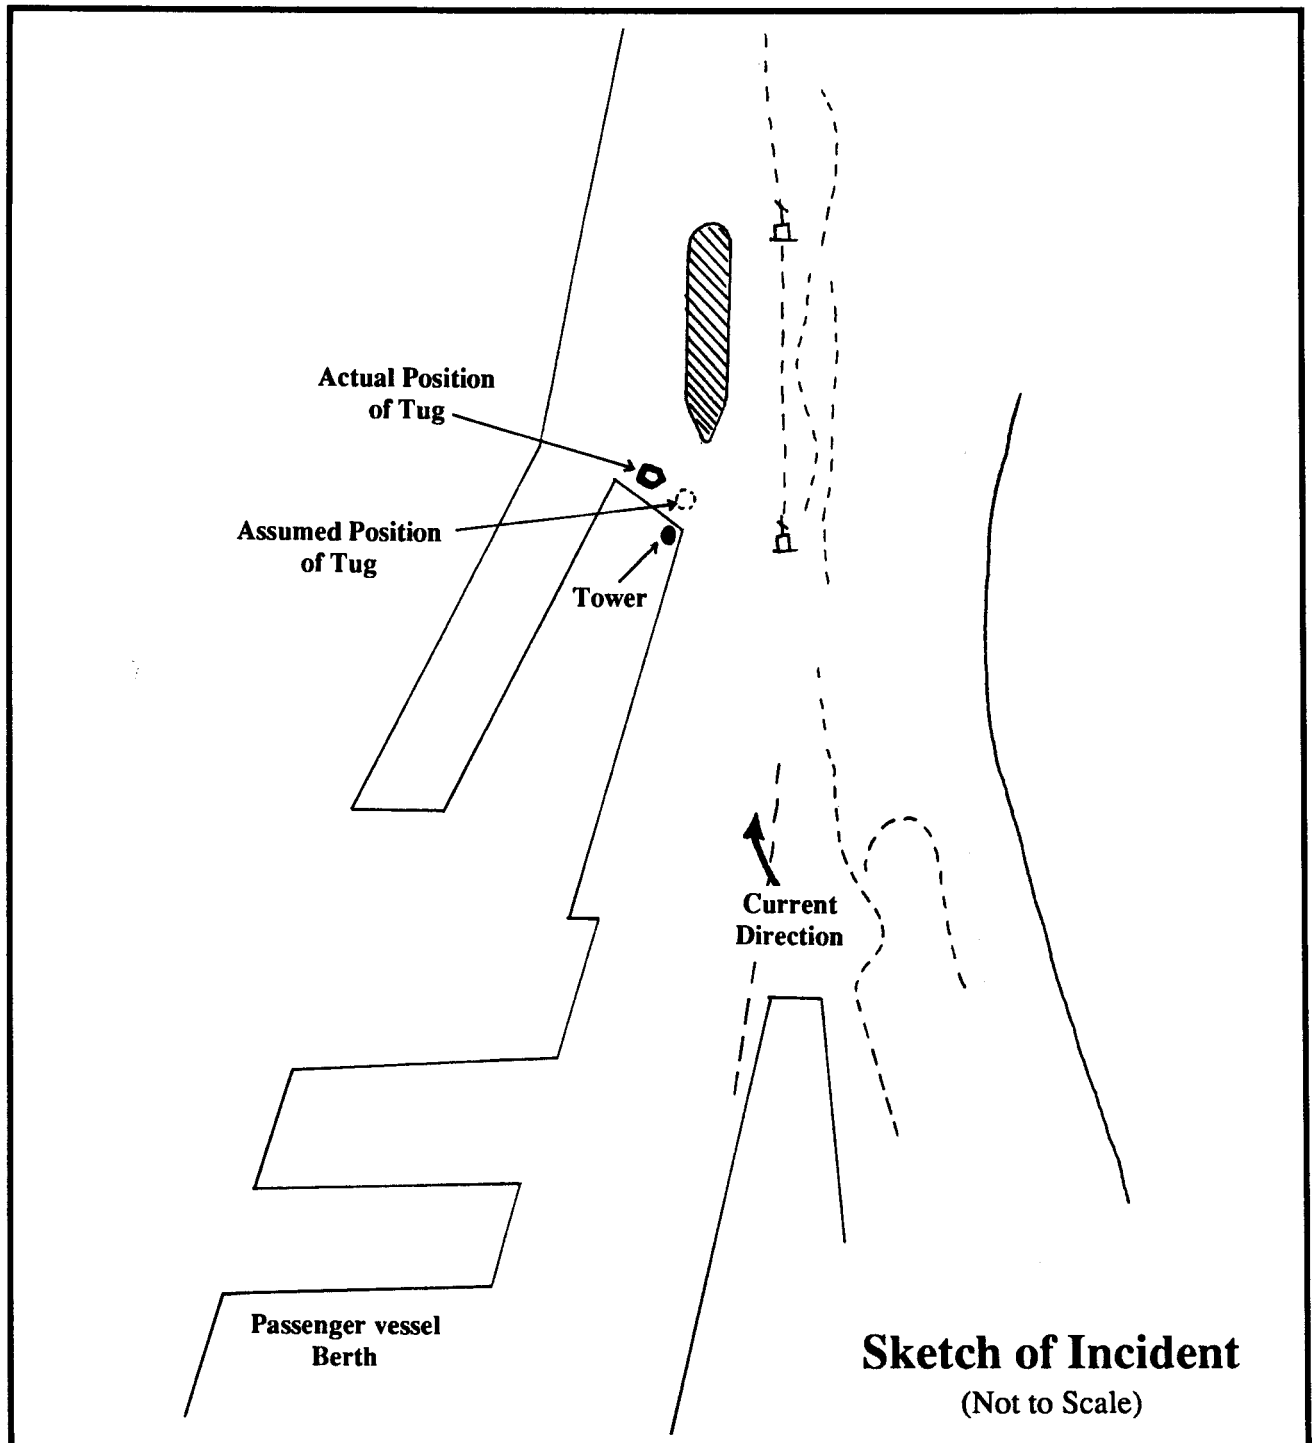
The pilot who had the con was navigating by radar and he spoke to one of the waiting tugs by VHF radio. The pilot, who had seen the tug visually, asked if she was standing by off the corner of an angled jetty, which the passenger vessel would pass on her way to the berth. The tug replied in the affirmative. The pilot then asked the Skipper of the tug to remain in that position, his intention being to pass the tug and the jetty on the starboard hand (see sketch).

Despite rapid and full power manoeuvres the passenger vessel contacted the outer knuckle of the jetty, sustaining hull damage. Before the contact, the tug which the pilot had spoken to earlier was seen by the inner knuckle and going full astern to increase her distance from the approaching passenger vessel.

1. The pilot had thought that the tug was off the outer knuckle when in fact it was off the inner knuckle. Consequently the course which the pilot then steered did not clear the north east corner of the jetty. The strong river current set the passenger vessel on to the outer knuckle. Fortunately the damage was above the waterline and there were no injuries.
2. The bridge manning of the passenger vessel included two experienced senior officers, a navigator and the two pilots.

1. This incident highlights the need for caution when using inter-ship communications in restricted visibility.

2. The ship's bridge staff should maintain an accurate check of the vessel's position and movement, whether or not the pilot has the con, and the intentions of the pilot should be fully understood. This advice is given in Merchant Shipping Notice No M.854.
3. The jetty would have presented a clear return on the radar and 'parallel indexing', as recommended in Merchant Shipping Notice No M.1158, could have avoided the accident.
