MARINE ACCIDENT INVESTIGATION BRANCH

Summary of Investigations No 1/93

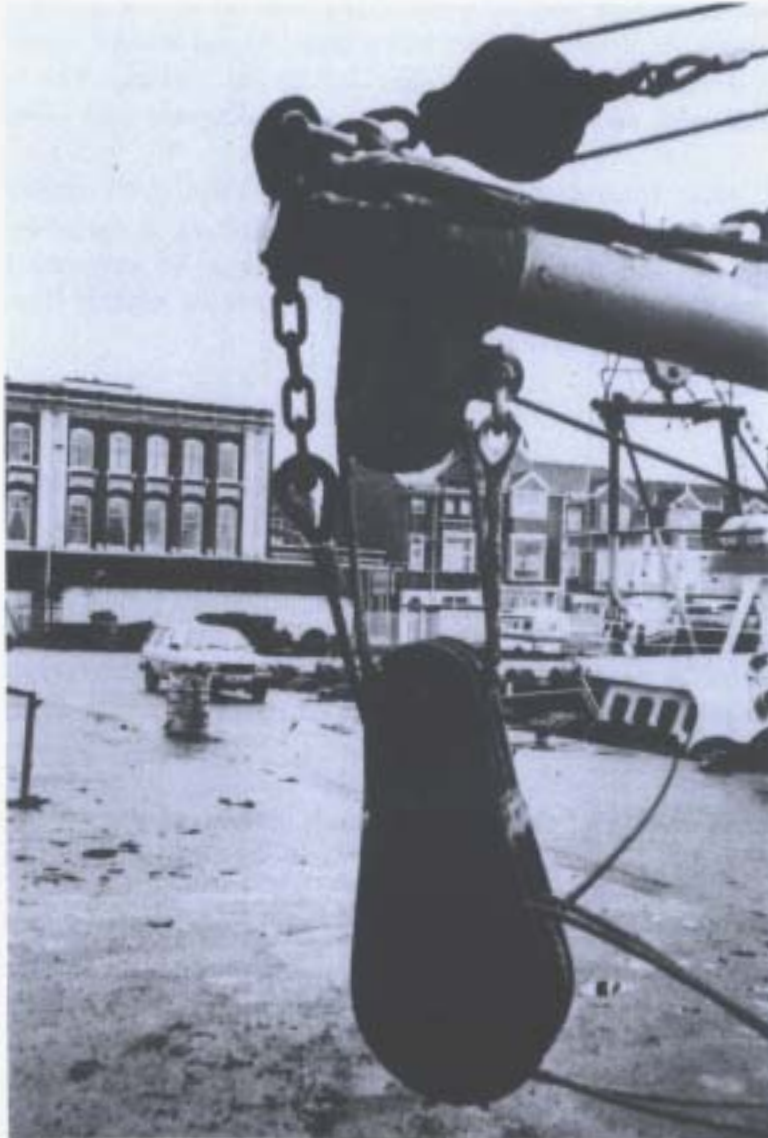
2. Inspection of the wire showed that it had broken near the ferrule splice at the eye by which it was shackled to the derrick. In the region of the break there was severe local corrosion and a number of broken wire strands.

3. The probable causes of the corrosion and damage to the wire are, firstly that when fishing is in progress and the derrick in the operating position, the quick-release gear is in the "splash zone" and therefore very susceptible to accelerated corrosion; secondly, in the course of operation the blocks can come close up to one another. In this situation, the aluminium ferrule securing the thimble eye may cause the wire to be bent rather than led into the sheave, which can result in kinking and possibly lead to strand fracture.

1. The combined effects of corrosion and damage to the wire seriously reduced its tensile strength, so that an applied load normally within its capability caused overloading and fracture.

View of double purchase block in normal position with new quick release wire fitted. Note: the ferrule has been replaced by a "traditional" splice.

2. The particularly severe environment to which beam trawling gear is subject indicates that frequent examination and regular maintenance is especially necessary. A record of such work is helpful in ensuring that **no** items are overlooked.
3. In such a rig **as** described here, a "traditional" splice has the advantage of greater flexibility when compared with one finished with a ferrule.

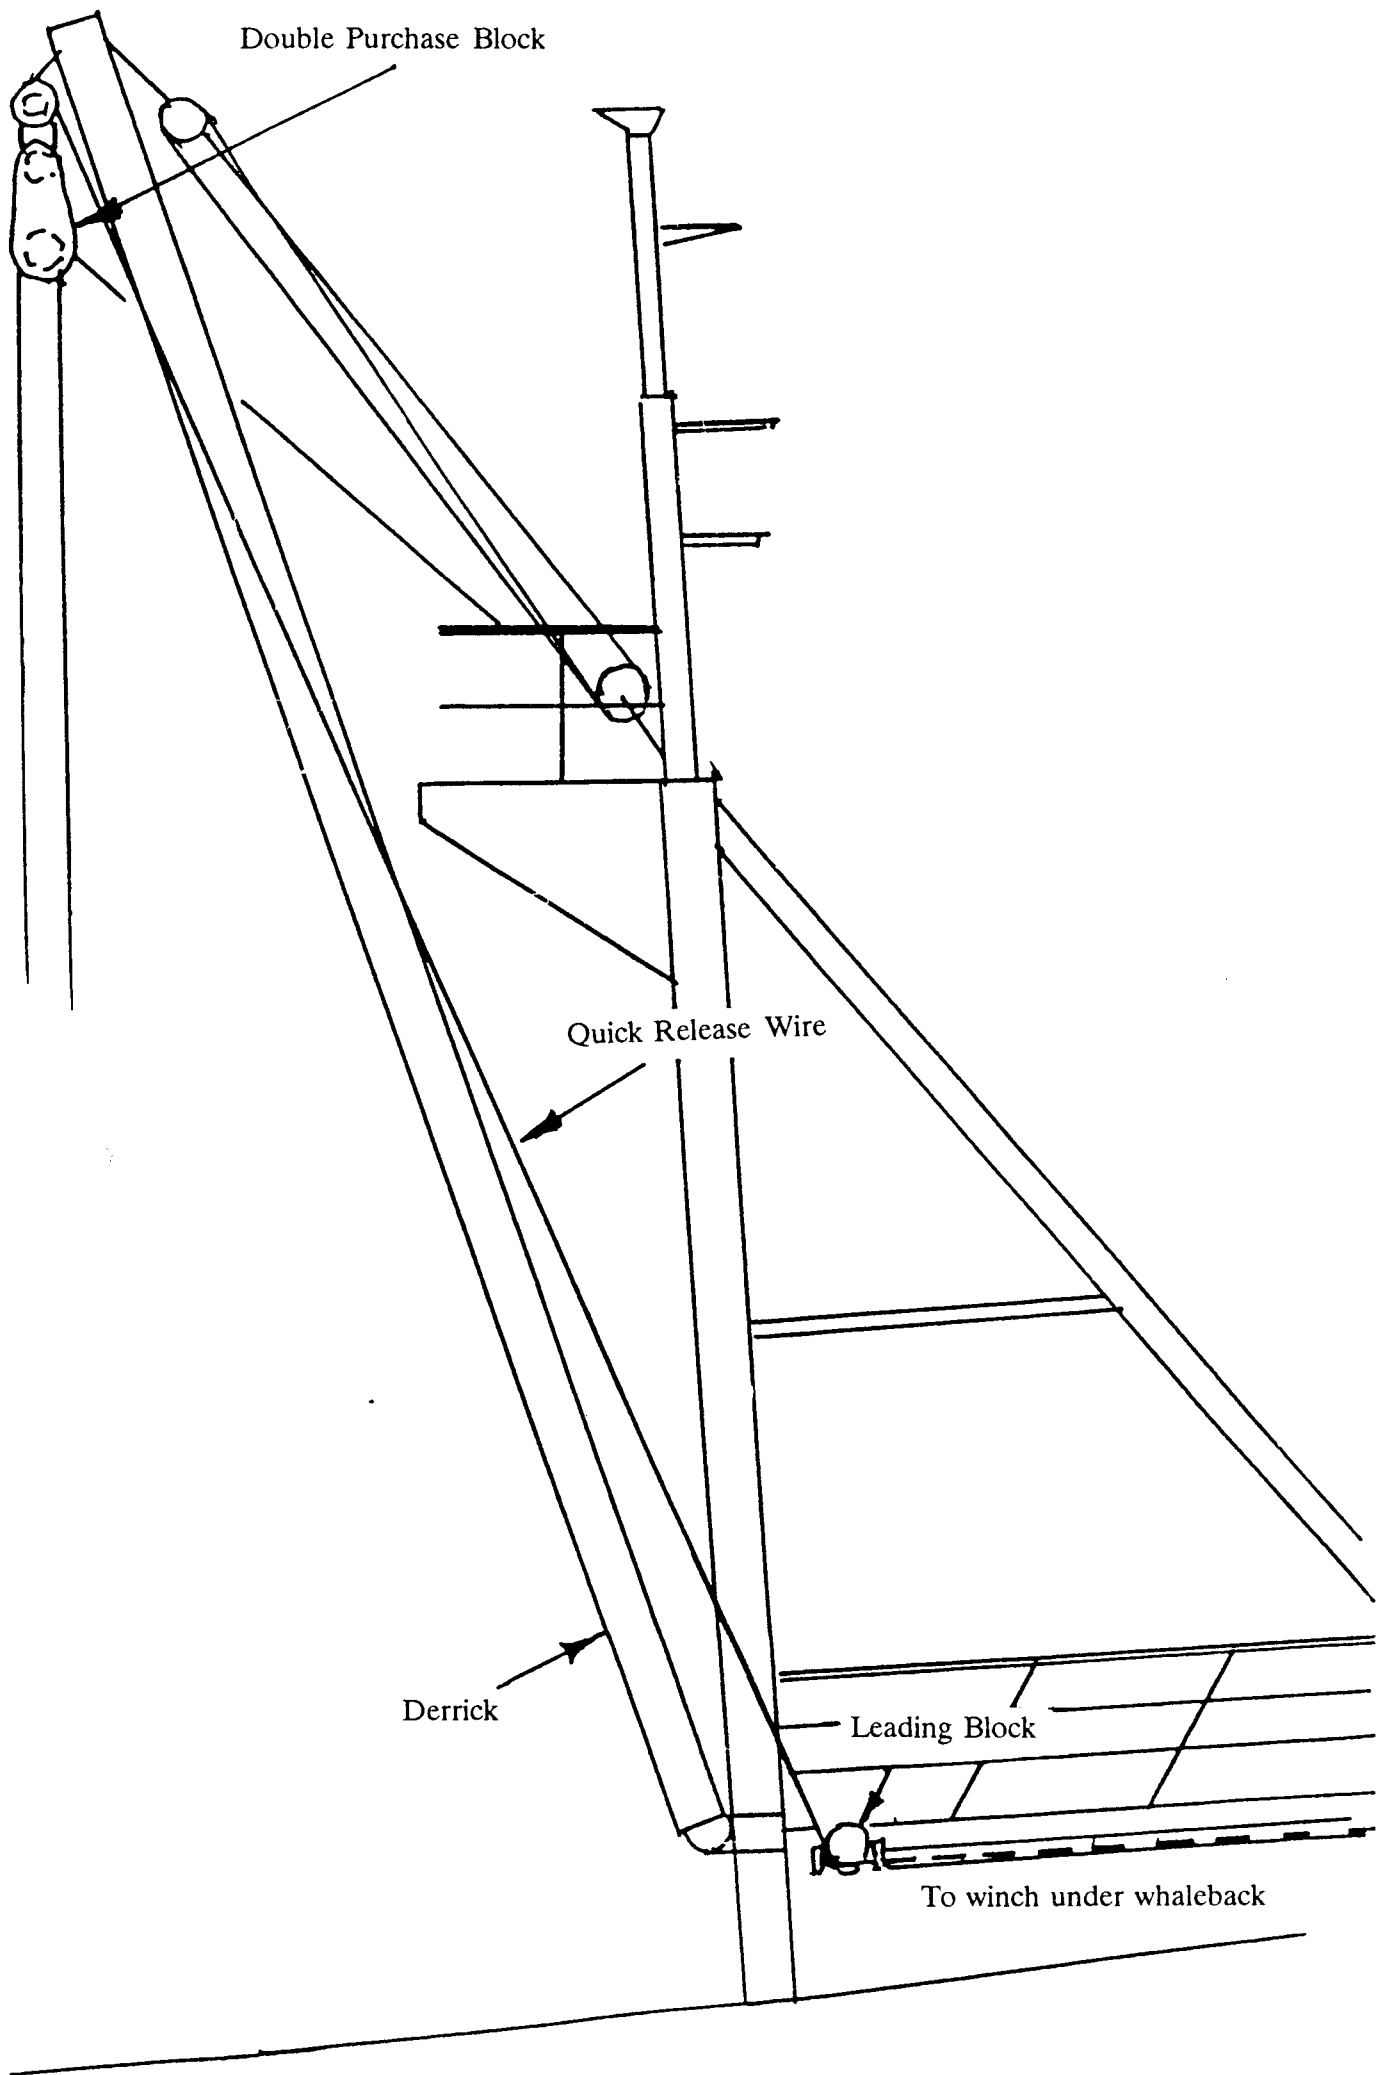
DIAGRAM OF STARBOARD DERRICK

A 35 metre beam trawler working in the North Sea was hauling her gear. It was observed that the gear on the starboard side was fouled by a small anchor and some rope caught round one of the chain bridles by which the warp is joined to the beam. To clear this, the derrick was topped, the beam was brought alongside, and some weight was put on the warp so that it would be kept taut while the work was being carried out. The warp was rove through the lower sheaves of a 10 tonne double-purchase block which in turn was secured to the derrick by the quick-release tackle; this was rove through the upper sheaves and a block at the derrick head, with one end of the wire led to a winch and the other shackled to the derrick. The hard eye at the shackle was spliced with an aluminium ferrule, (see diagram and photograph).
