MARINE ACCIDENT INVESTIGATION BRANCH

Summary of Investigations No 3/93

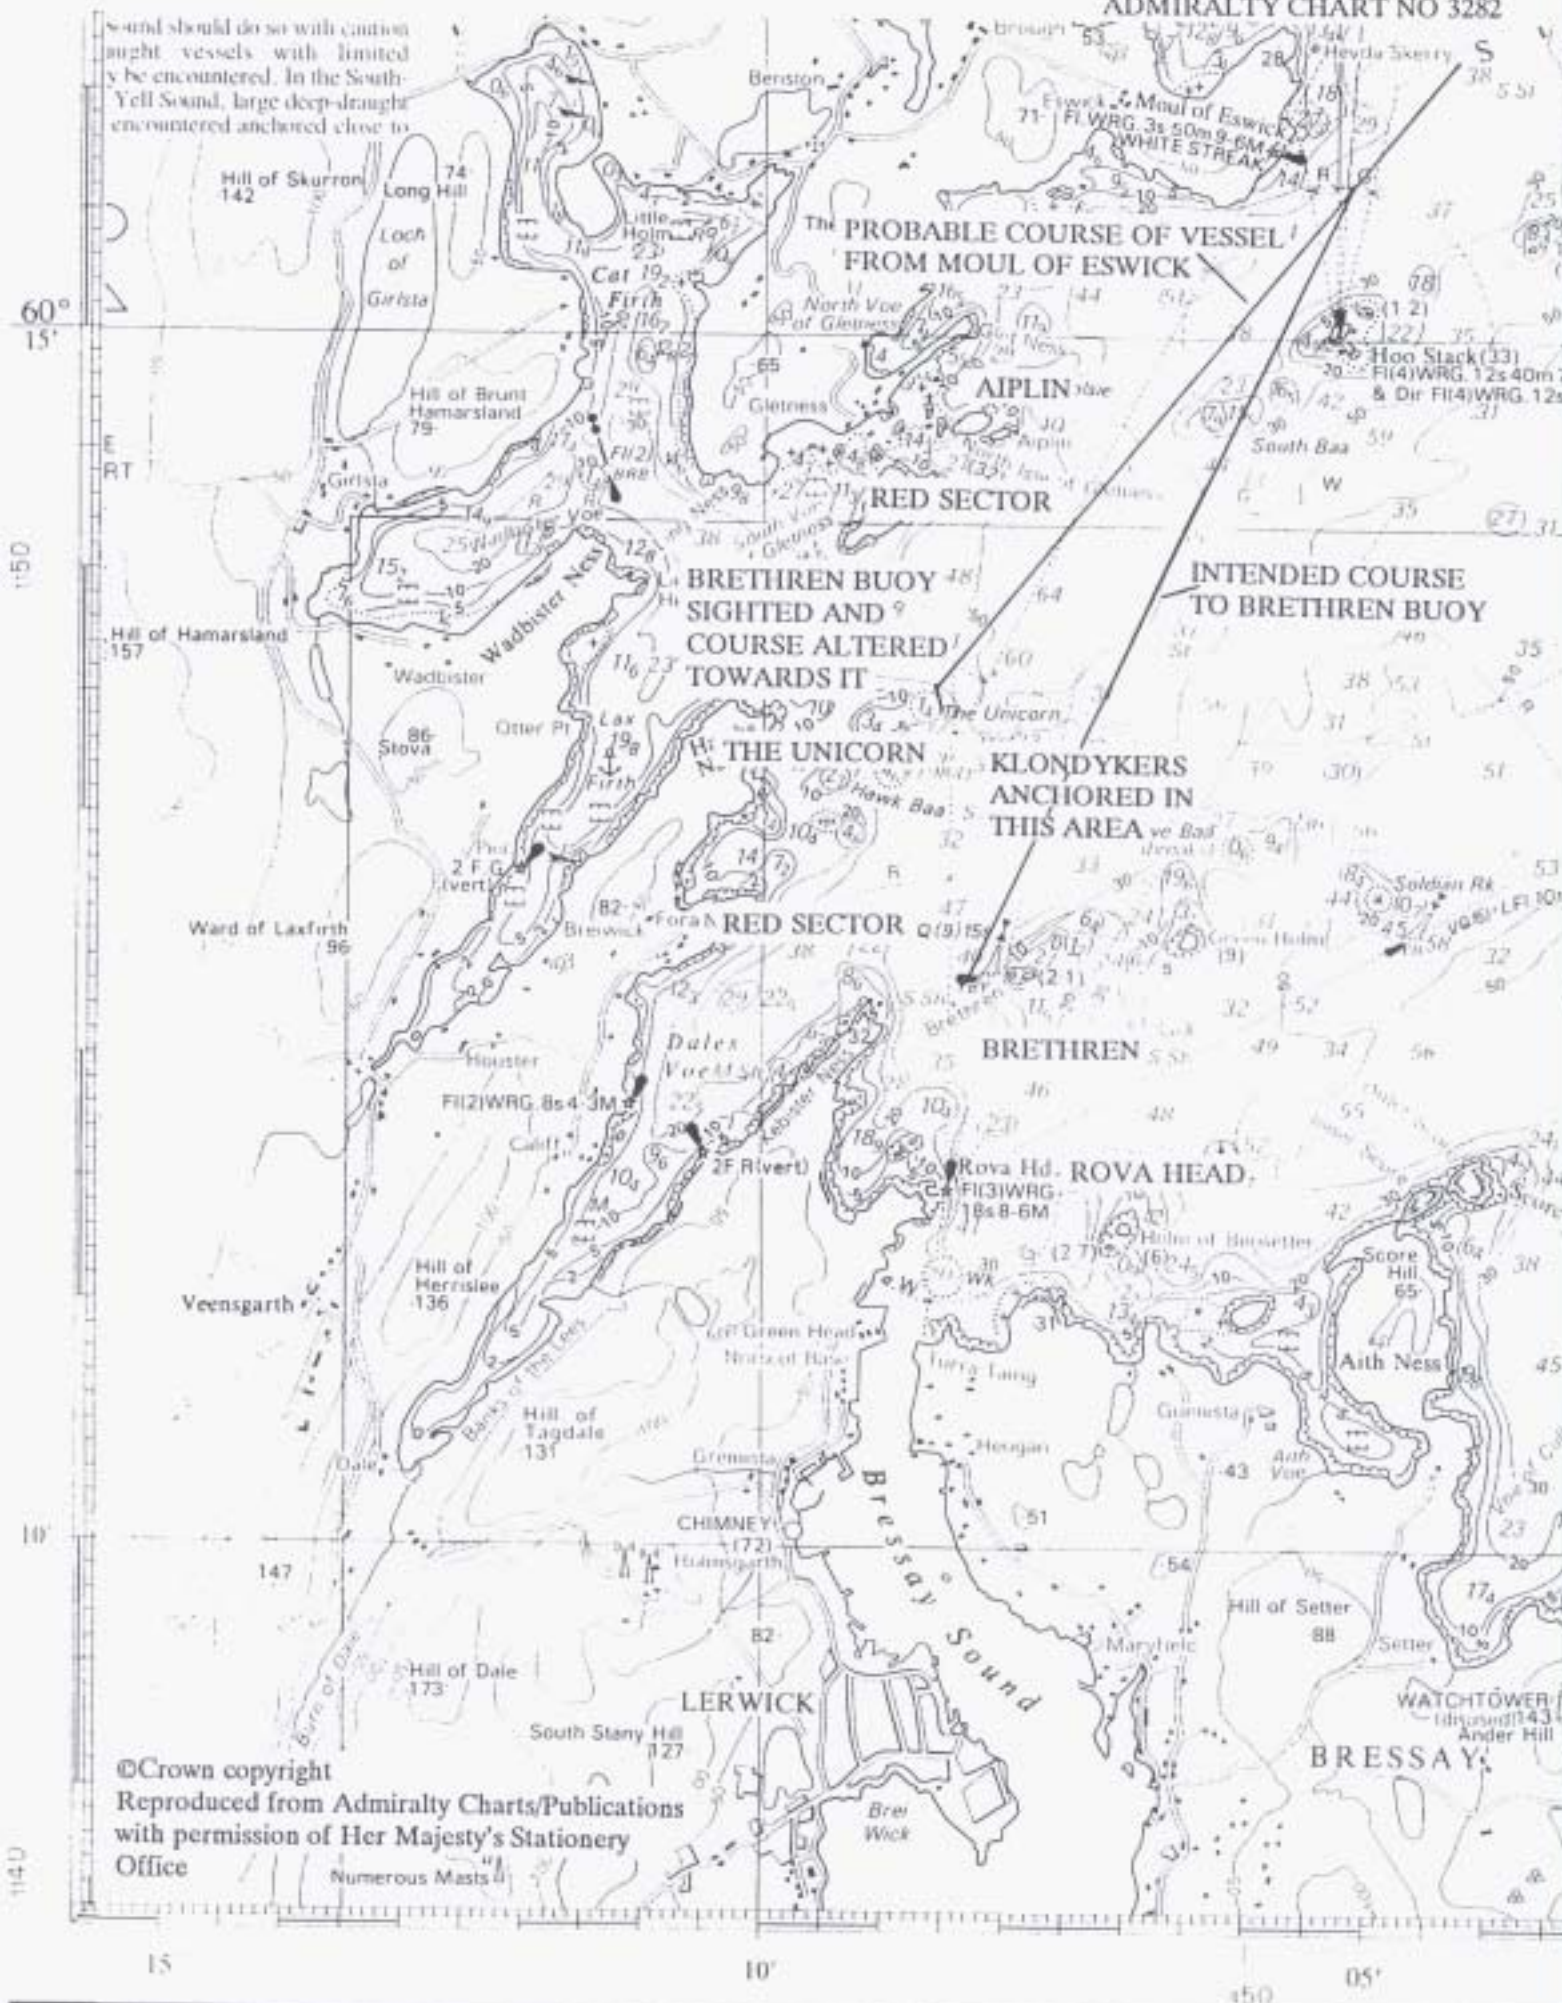
There were no injuries and no pollution. The vessel suffered damage to her starboard bilge keel and bottom plating with penetration of the forward freshwater and fore peak tanks, the estimated cost of repairs being £80,000.

1. The fishing vessel was fitted with two operational radars and both terrestrial and satellite navigation systems.
2. The Mate was very familiar with the local area.
3. Unicorn Shoal has a least depth of 1.4 metres over it and is covered by the red sectors of two lighthouses, Rova Head and Moul of Eswick.

1. The cause of the grounding was reliance on eventually sighting the Brethren buoy and failure to use other navigation marks that could actually be seen. The red sector of Moul of Eswick light covered the Unicorn Shoal but concentrating on trying to locate the buoy the Mate failed to see that the vessel, which was proceeding at reduced speed, was being set into this sector.

3. Where the buoy and other lights were obscured, use could have been made of the radars, either for radar bearings or parallel indexing. Merchant Shipping Notice No M.1158 provides information on the use of parallel indexing techniques as an aid to navigation.

4. The Mate should not have been on watch alone. It is recommended in Merchant Shipping Notice No M.1190 that casualties could be avoided if a two-man watch system is employed when the vessel is close to land. Attention is also drawn to Merchant Shipping Notice No M.1020, which sets out the IMO "Basic Principles to be Observed in Keeping a Navigational Watch on board Fishing Vessels" including making full use of all navigational aids and keeping a continual check on position. These principles had not been followed on this occasion.
