MARINE ACCIDENT INVESTIGATION BRANCH

Summary of Investigations No 1/94

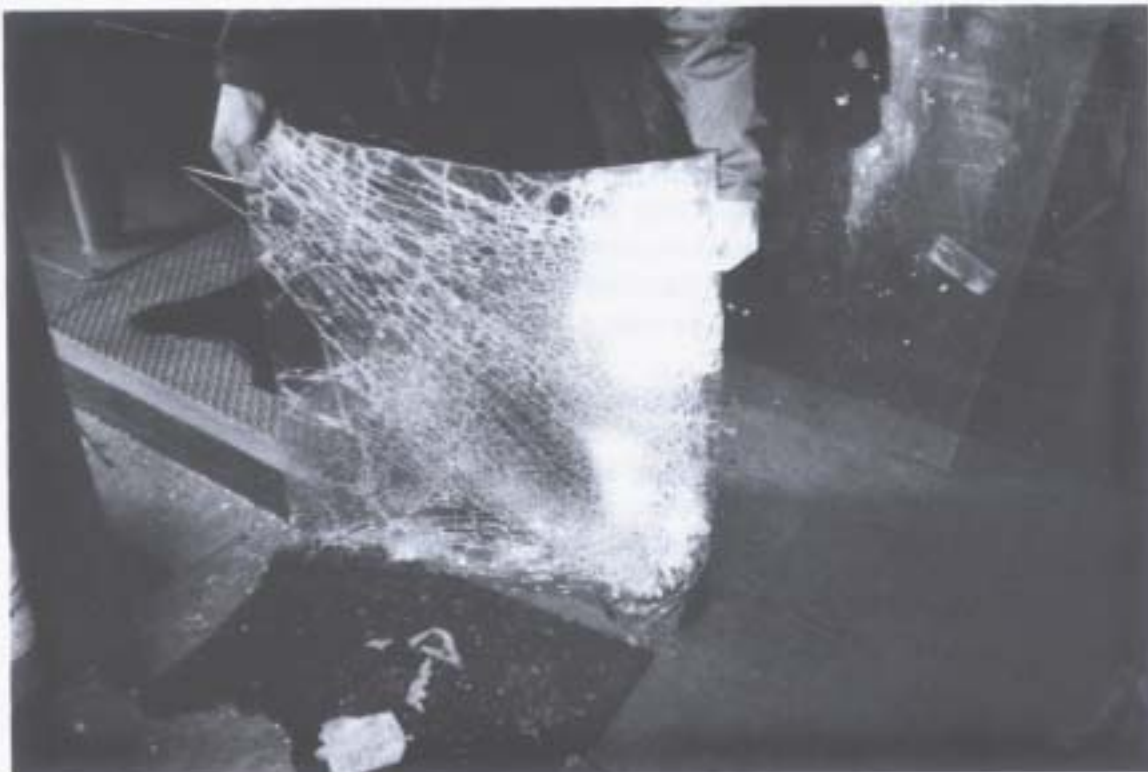
1. The weather in each case, although severe, was thought to be well within the capabilities of the vessels. The vessels were being handled in a manner appropriate to the prevailing conditions, and up until the actual incident they were experiencing little difficulty.
2. Although the ships were of completely different size they all had bridge structures situated within about 10% of the ship's length of the bow.
3. The vessel in Case 3 was built 20 years ago to work in the Gulf of Mexico and was typical of such vessels. She was fitted with 6mm thick laminated glass wheelhouse windows. The photograph shows the damaged laminated glass panel still in one piece after being pushed out of its seal. It indicates the importance of having laminated toughened glass to prevent splintering. Splinters of glass can be extremely dangerous to crew members in these circumstances.

1. These cases illustrate the particular vulnerability of wheelhouse windows to damage on those ships with bridge structures which are located near the bow. Designers and builders should pay particular regard to the construction of both the windows and the surrounding structure when dealing with vessels with such characteristics.
2. Owners of such vessels should have the windows inspected for compliance with BS MA 25 including measuring the glass thickness with a gauge. This is particularly important when a vessel, built to operate in a region of generally less severe weather, is transferred to an area such as the North Sea when bad weather is frequent. Also see Merchant Shipping Notice No M.712, Shattering of Windows in Heavy Weather.
3. These cases also illustrate the value of having back-up equipment (such as portable VHF sets) stored separately from the main communications equipment.
