# **MARINE ACCIDENT INVESTIGATION BRANCH**

**Summary of Investigations No 2/92**

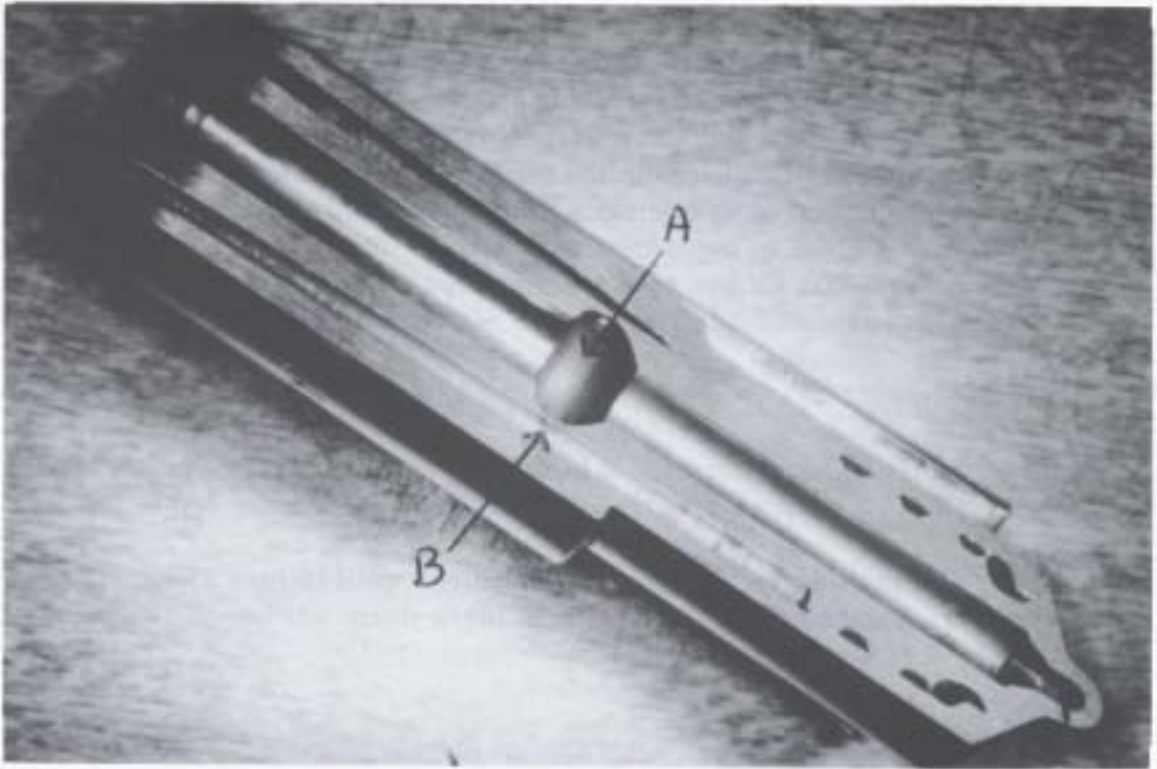
2. Although the new water cooled nozzles were stated to have been manufactured to the required specifications, when sectioned longitudinally through the middle, it was seen that incorrect drilling of the water passages had produced a very thin wall thickness between the high pressure fuel oil side and the low pressure water side. Subsequent usage of the injector in the engine with its normal cyclic hydraulic pressure stresses, caused a fatigue failure in the separation wall and contamination of the water cooling system. This manufacturing defect would not be detectable by normal testing procedures and illustrates the importance of quality control during the manufacturing process. Furthermore, in as much as the choice was dictated by spare part delivery times, it demonstrates the importance of good forward planning and advisability of using only genuine manufacturers items.

Longitudinal section of fuel valve nozzle showing central fuel chamber "A" and outer cooling water space "B"

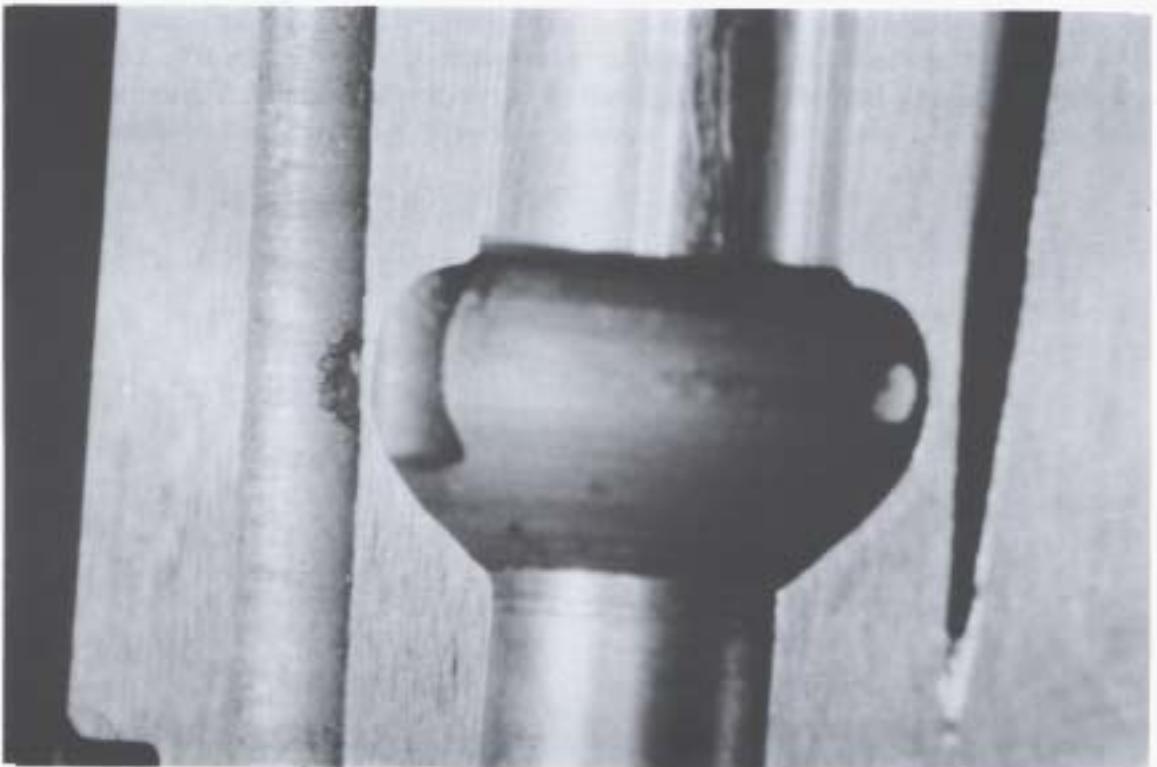
Close-up view of perforation into water cooling space at side "B"

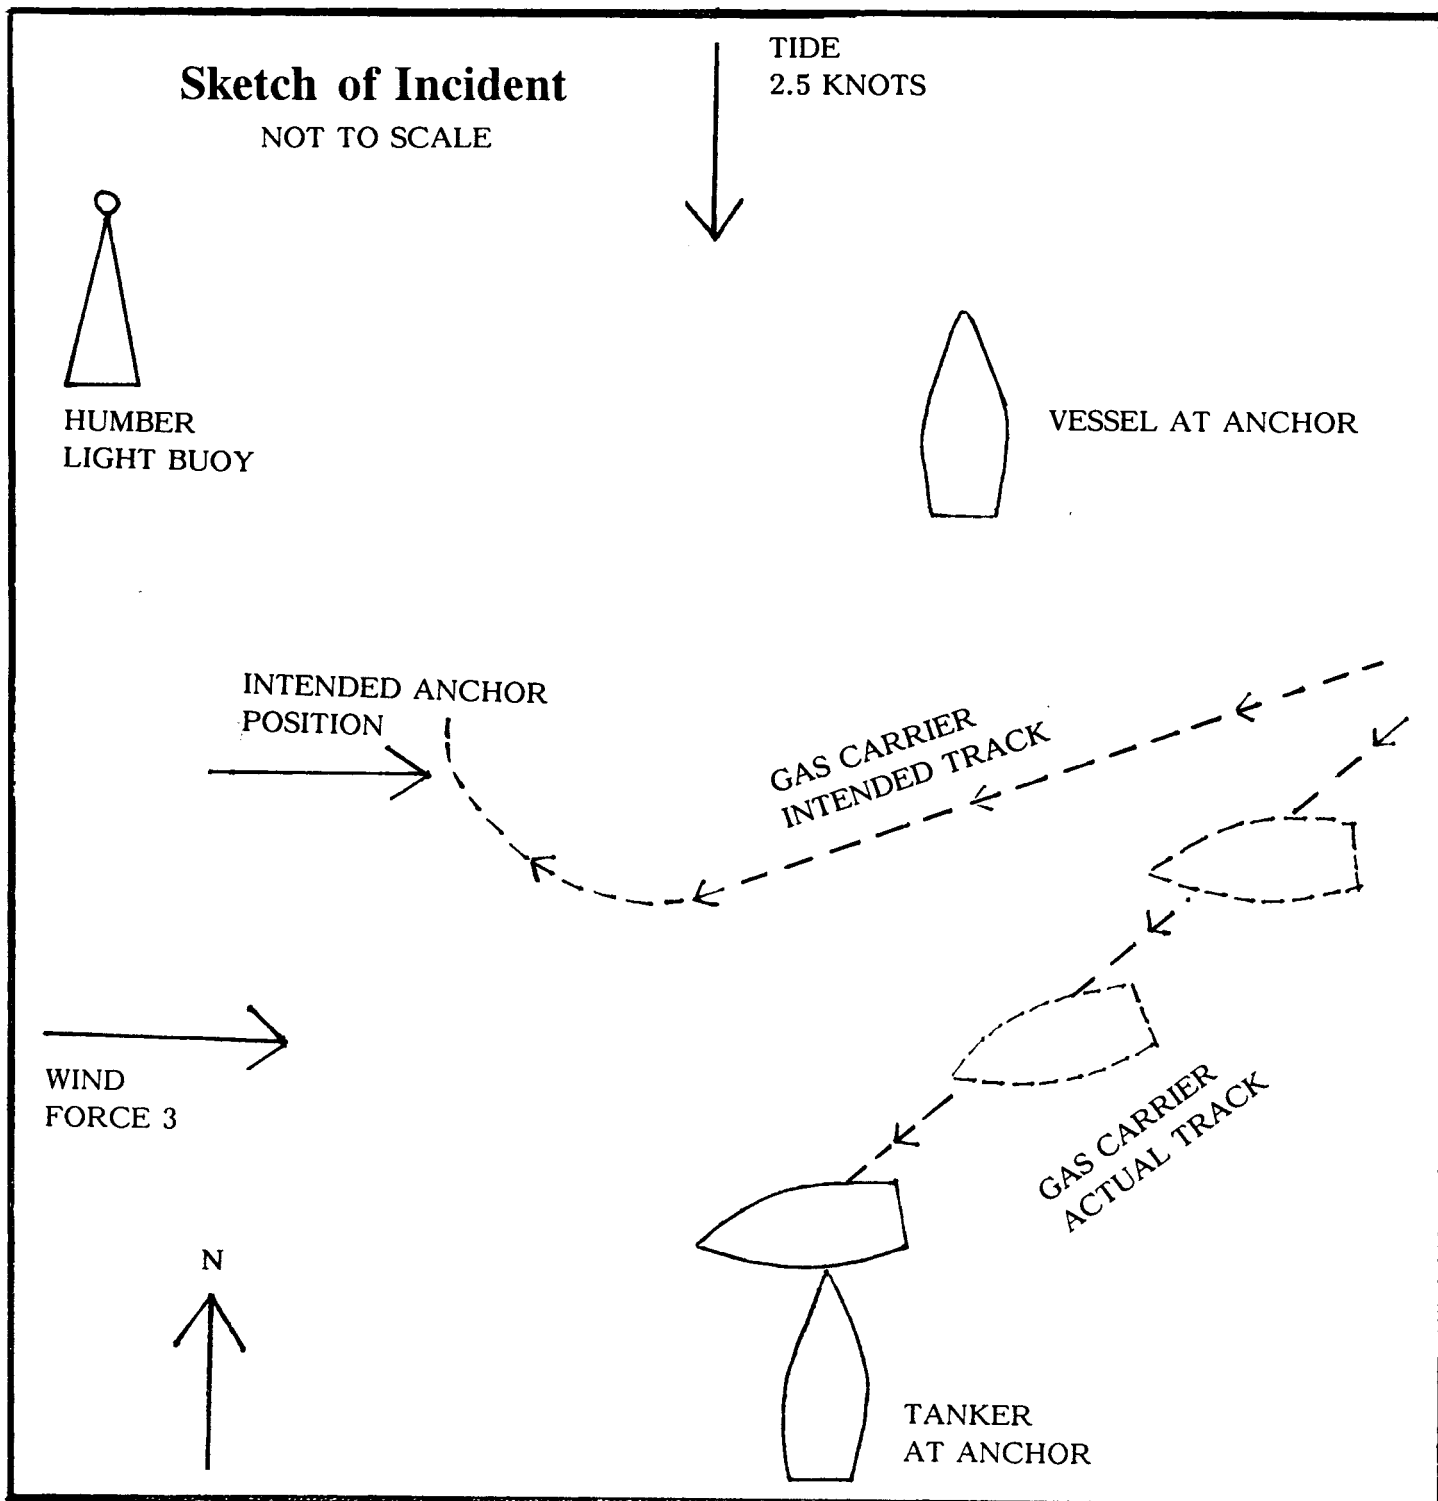
The Master of the gas carrier was able to see two vessels at anchor; the oil tanker to the south-east of the Humber Light float, and another vessel to the east. They were approximately 4 cables apart. He decided to pass between these vessels and turn to starboard in order to stem the tide before anchoring (see sketch).

At a distance of approximately 1.5 miles from the anchorage, the Master sent the Chief Officer forward to anchor stations leaving the Master and the helmsman on the bridge. The speed of the vessel had been reduced and she was moving very slowly through the water. As the approach continued, the Master became aware that the vessel was drifting to the south. He went into the chartroom to check the course on the satellite navigator. When he returned to the wheelhouse, he could see that collision with the oil tanker was imminent. His initial action was to turn to starboard and then hard to port. His actions were unsuccessful, and his vessel's port quarter contacted the starboard bow of the anchored vessel. Minor damage was sustained by both vessels. No pollution occurred.
