# **MARINE ACCIDENT INVESTIGATION BRANCH**

## **Summary of Investigations No 3/94**

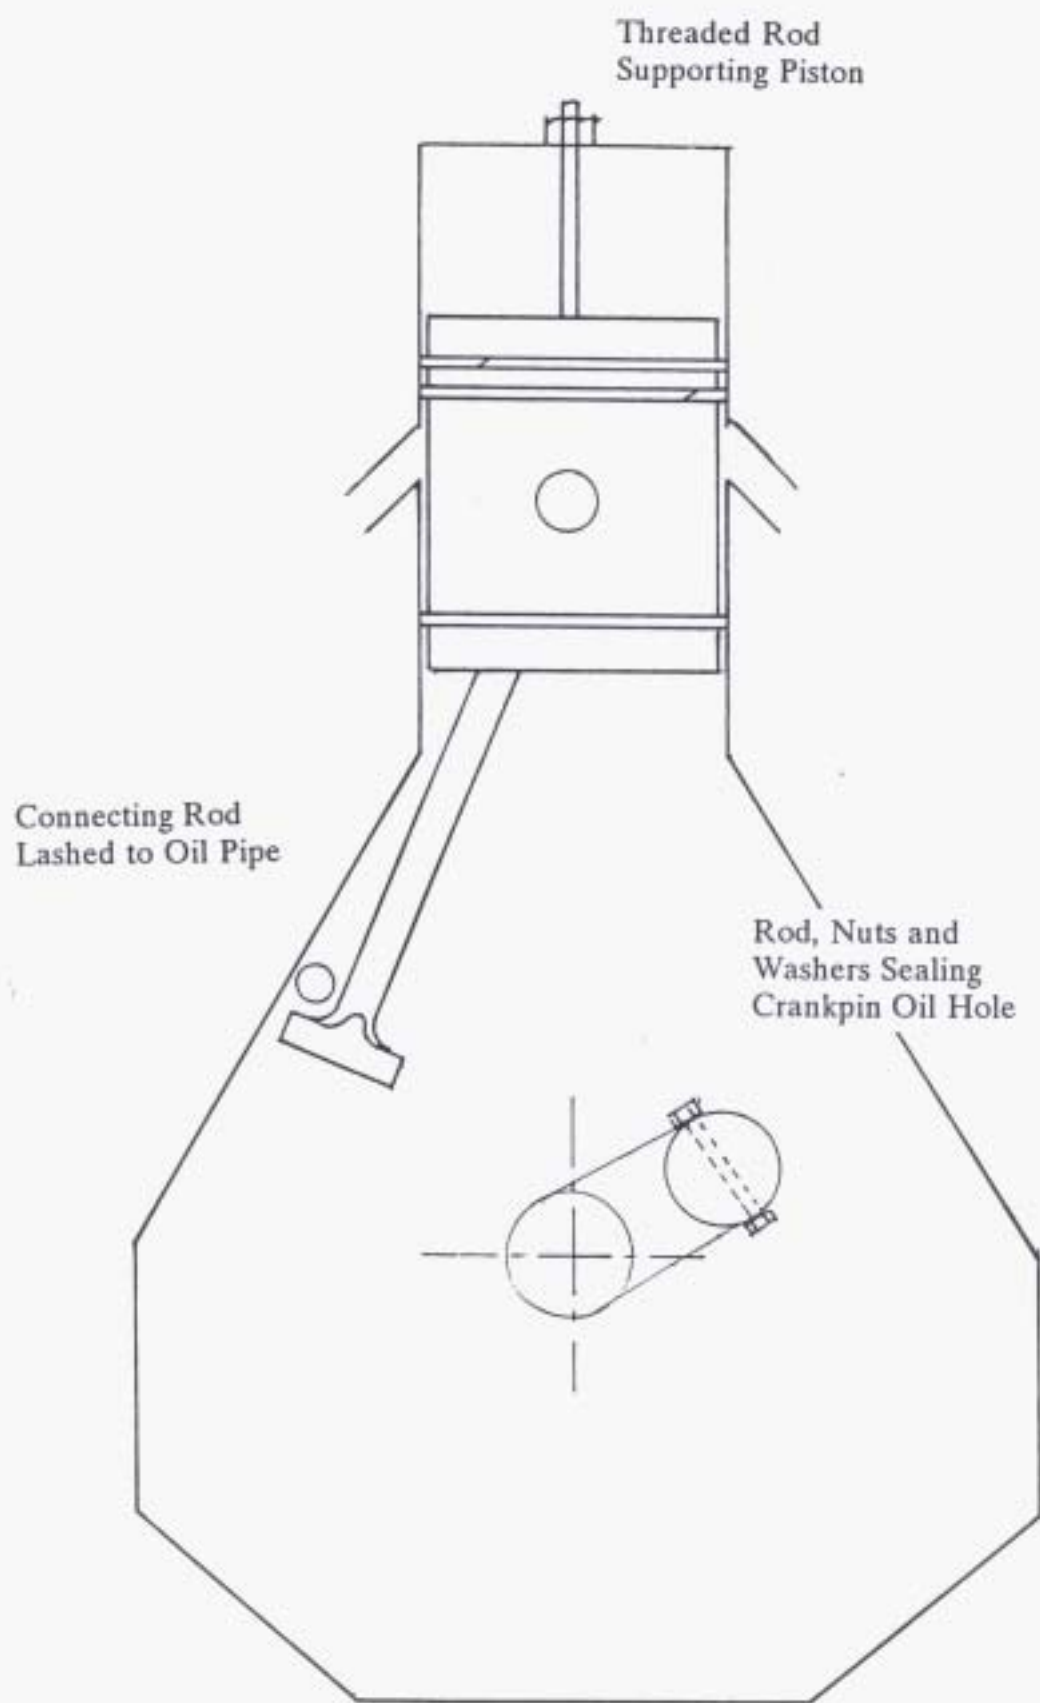
DIAGRAMMATIC SECTION THROUGH NO 5 UNIT AFTER TEMPORARY REPAIR

Whilst in this situation another large sea broke over the stern above gantry height. The main engine exhausted from the top of the gantry. Sea water passed down this exhaust and, as the engine was a port controlled two stroke, into one cylinder of the engine. Consequential damage consisted of a smashed piston and liner forcing the crew to stop the engine. Due to the appalling weather, and the vessel's position, there was little hope of receiving assistance in less than a few days. The vessel's Chief Engineer thus decided to attempt a repair.

The damaged components were removed and the spare liner and piston installed. However, due to the bottom end bearing being damaged and having no serviceable spare on board, the piston was hung within the liner by a stud passing through the fuel valve orifice in the cylinder head with the piston being positioned so as to blank off the air and exhaust ports. The connecting rod was lashed to an oil pipe in the crankcase in order to be clear of the crankshaft. Also the oil supply drilling in the crank pin was blanked off with a length of studding, passed through the pin, with washers and nuts on each end. (See diagram opposite)

After repeated attempts to achieve water and gas tight joints on the cylinder head the engine was started and ran on the five remaining cylinders. The vessel arrived in Iceland about two days later. The temporary repair took some 50 hours of work on the part of the Chief and Second Engineers.
