MARINE ACCIDENT INVESTIGATION BRANCH

Summary of Investigations No 2/94

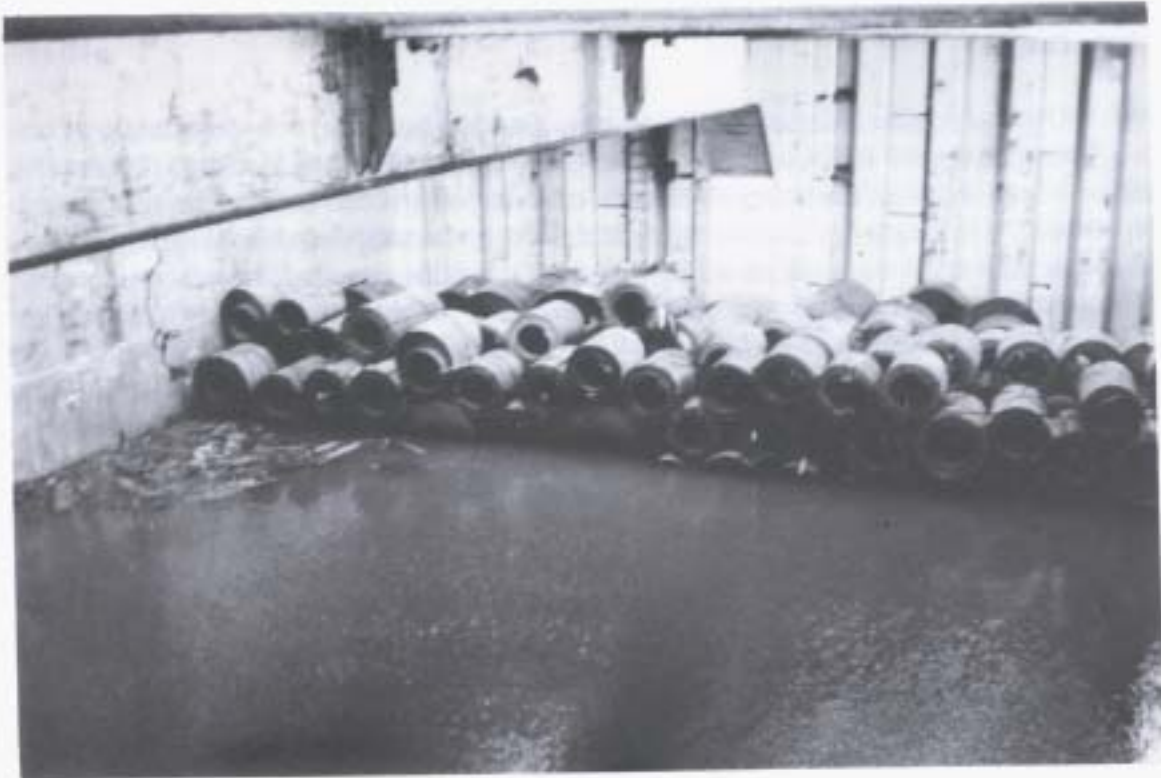
1. The loading and securing of the steel coils was poorly carried out.
2. The flooding of No 4 hold and the starboard list were caused by a shifting of the coils, one of which penetrated No 4 port side tank allowing over 600 tonnes of water from that tank to flood into the hold causing a starboard transfer of water and a starboard list of about 12°.
3. Ship's officers did not initially sound around all tanks and spaces but stopped when they came to the water in No 4 hold. No 4 side tank was not sounded therefore it was not suspected that its contents were leaking into No 4 hold.

1. Stowage and securing of the steel coils in the loading port was plainly of a very poor standard. Steel and especially steel coils need a careful stow, and particularly so when there are large void spaces in the hold and there is little over-stowing, as was the case here.
2. The 1992 IMO Code of Safe Practice for Cargo Stowage and Securing provides recommendations on the safe stowage and securing of coiled sheet steel in Annex 6.
3. The actions taken by the pilot and the emergency services with regard to the beaching and rescue of personnel from the vessel were carried out professionally and efficiently.

Photograph A
Poorly secured coils in flooded hold

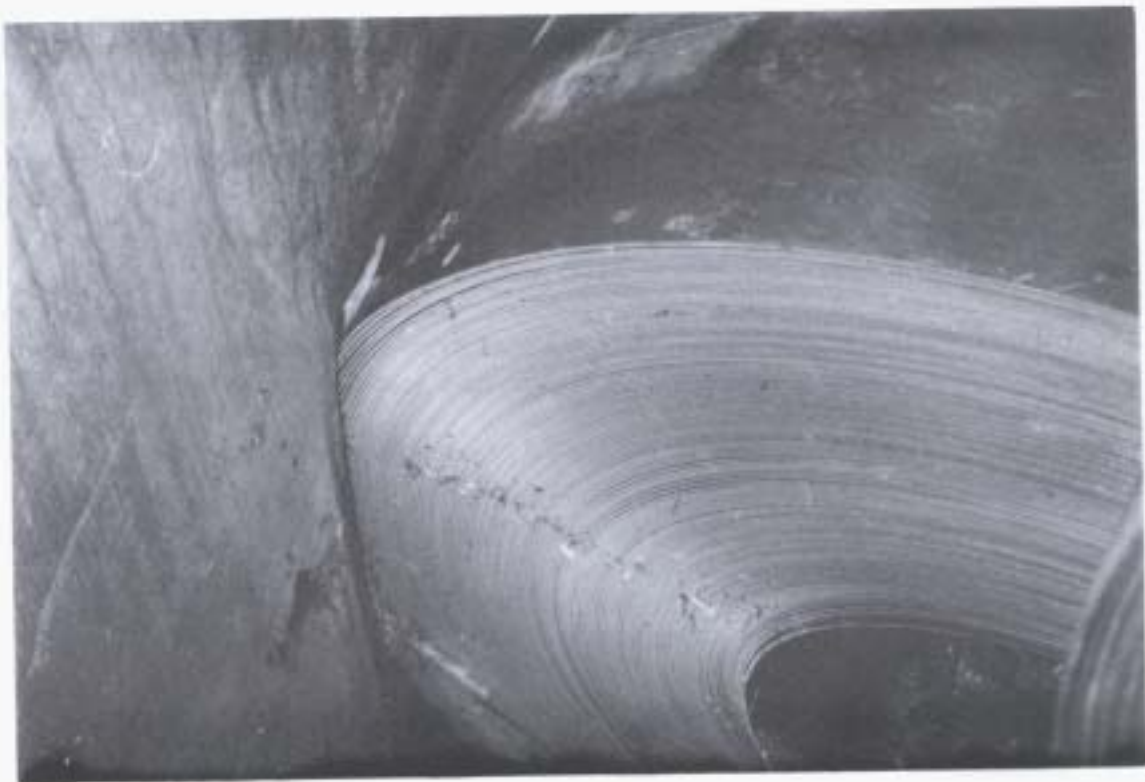
Photograph B
Steel coil penetrating tank bulkhead

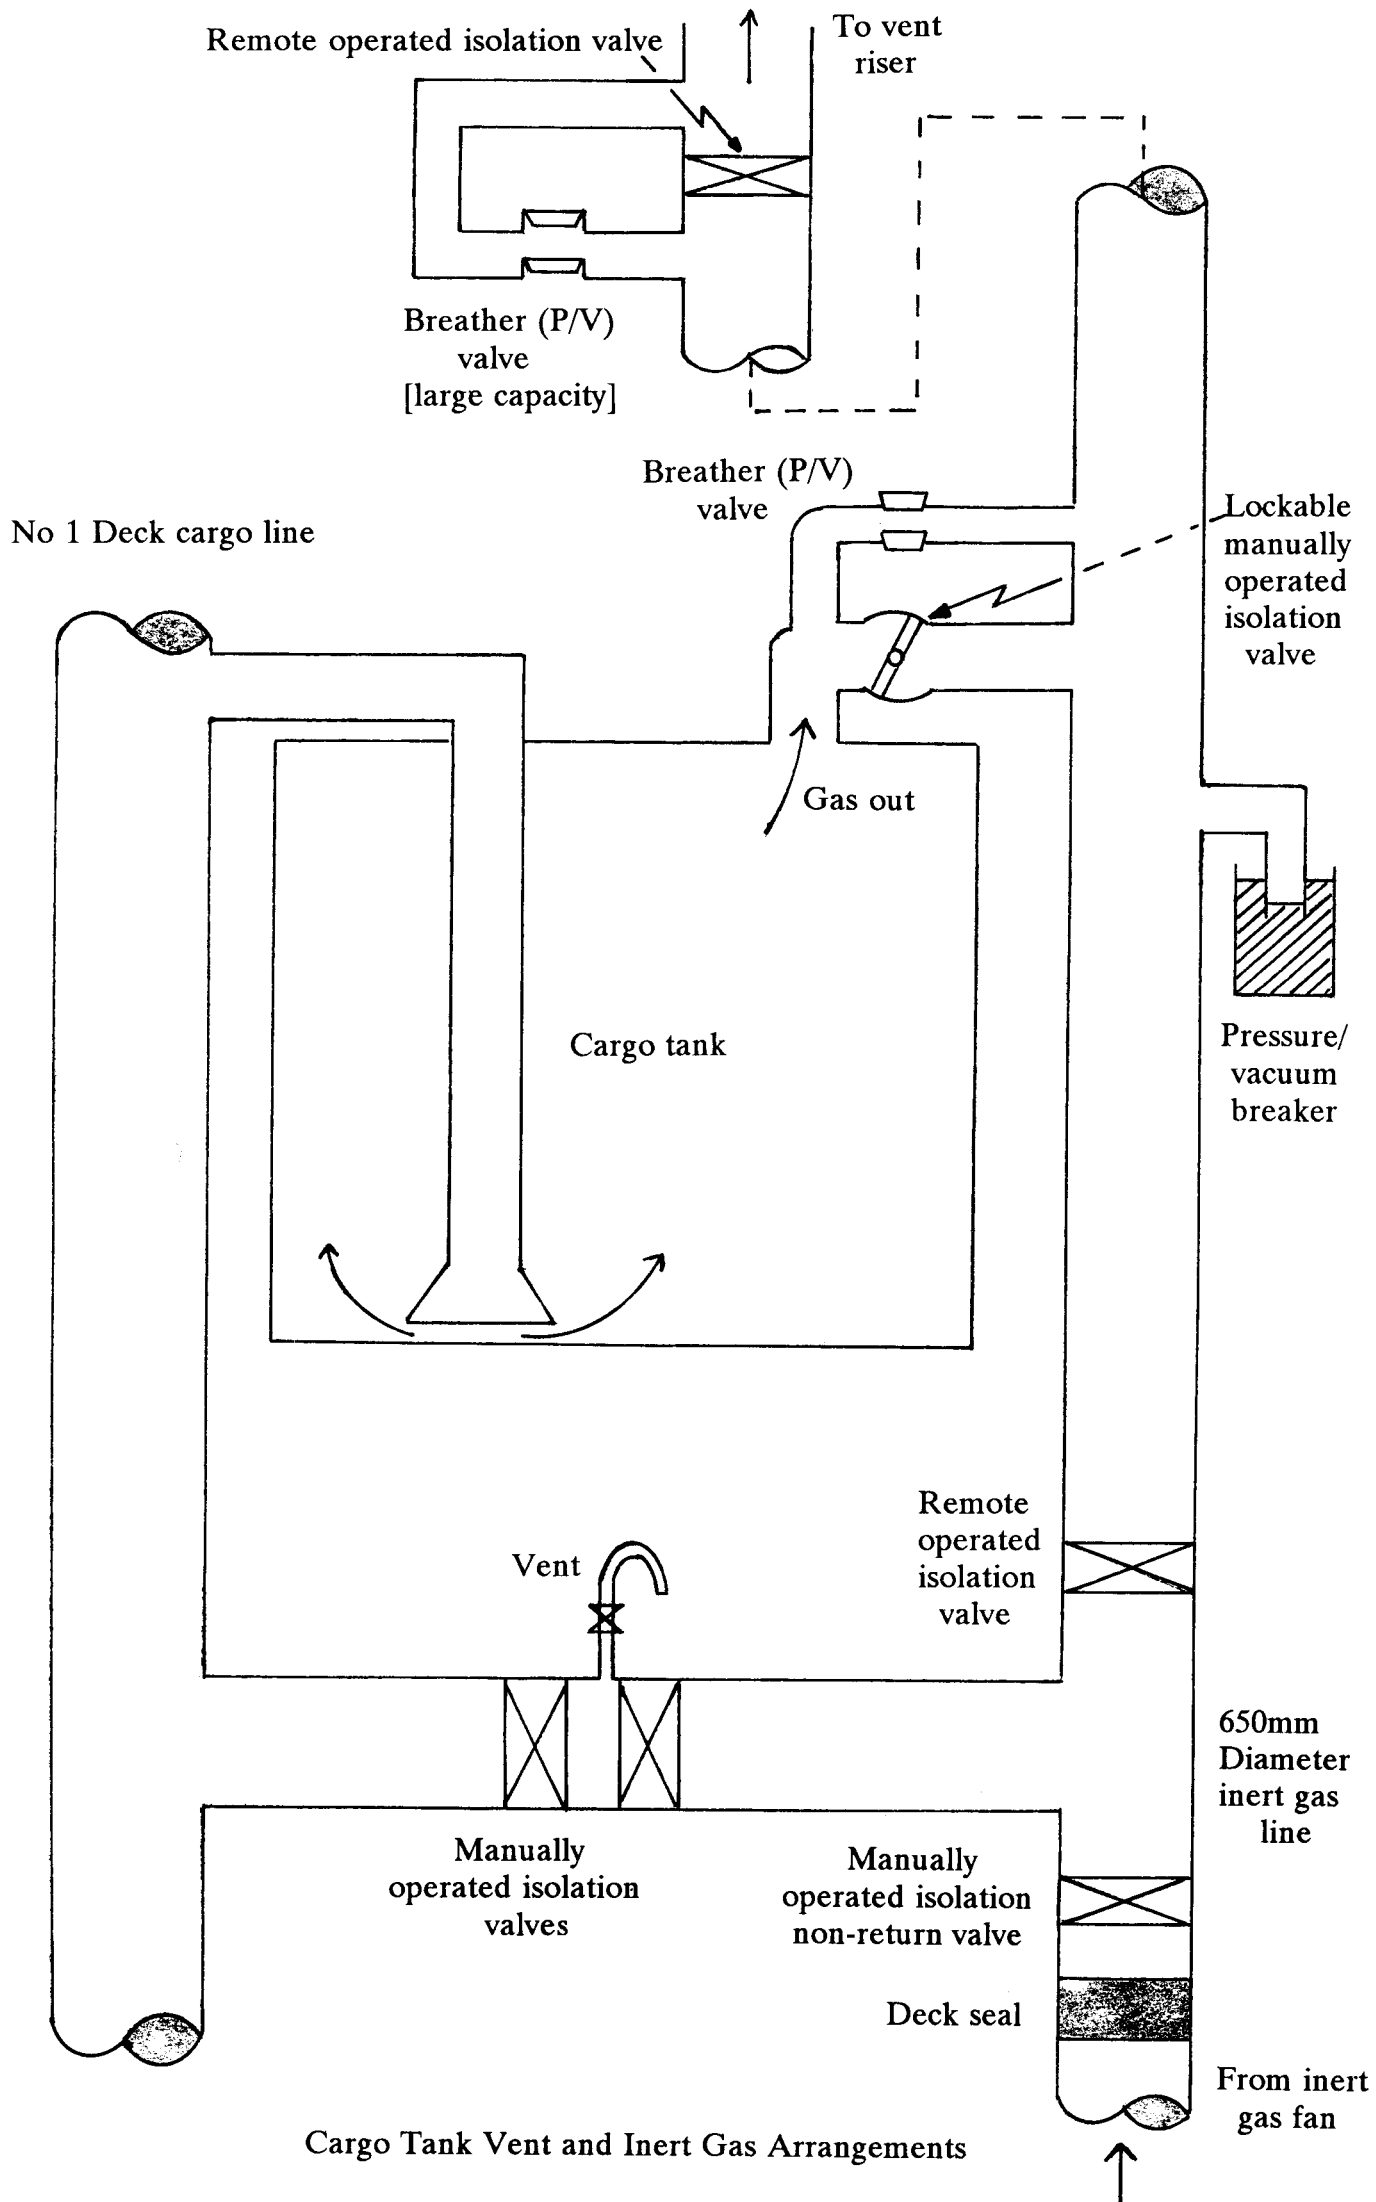
Cargo Tank Vent and Inert Gas Arrangements

Because of the circumstances of the closure of the cargo tank vent isolating valve, together with non-realisation by crew members that over-pressurisation of the tank was taking place, rupture of the tank was inevitable. No reason has been given as to why the isolating valve was shut, but a number of operational factors indicate human error as a probable cause.

2. The investigation highlighted the need for consideration to be given to the design of tank venting systems, so that pressure relief devices fitted to prevent over-pressurisation of cargo and ballast tanks cannot be isolated from individual tanks. Closure of the vent isolating valve rendered safe pressure relief of No 4 centre tank impossible. This situation was identical to that found on the MOBIL PETREL¹ when this vessel suffered a similar incident in November 1989. The need to install a pressure relief device direct to the tank without an intermediate isolating valve is, in engineering terms, analogous to that of a boiler. A cargo and ballast tank, like a boiler, is a pressure vessel. A boiler however has its safety valve attached direct to the shell. The fitting of an isolating valve between the safety valve and shell is unacceptable.

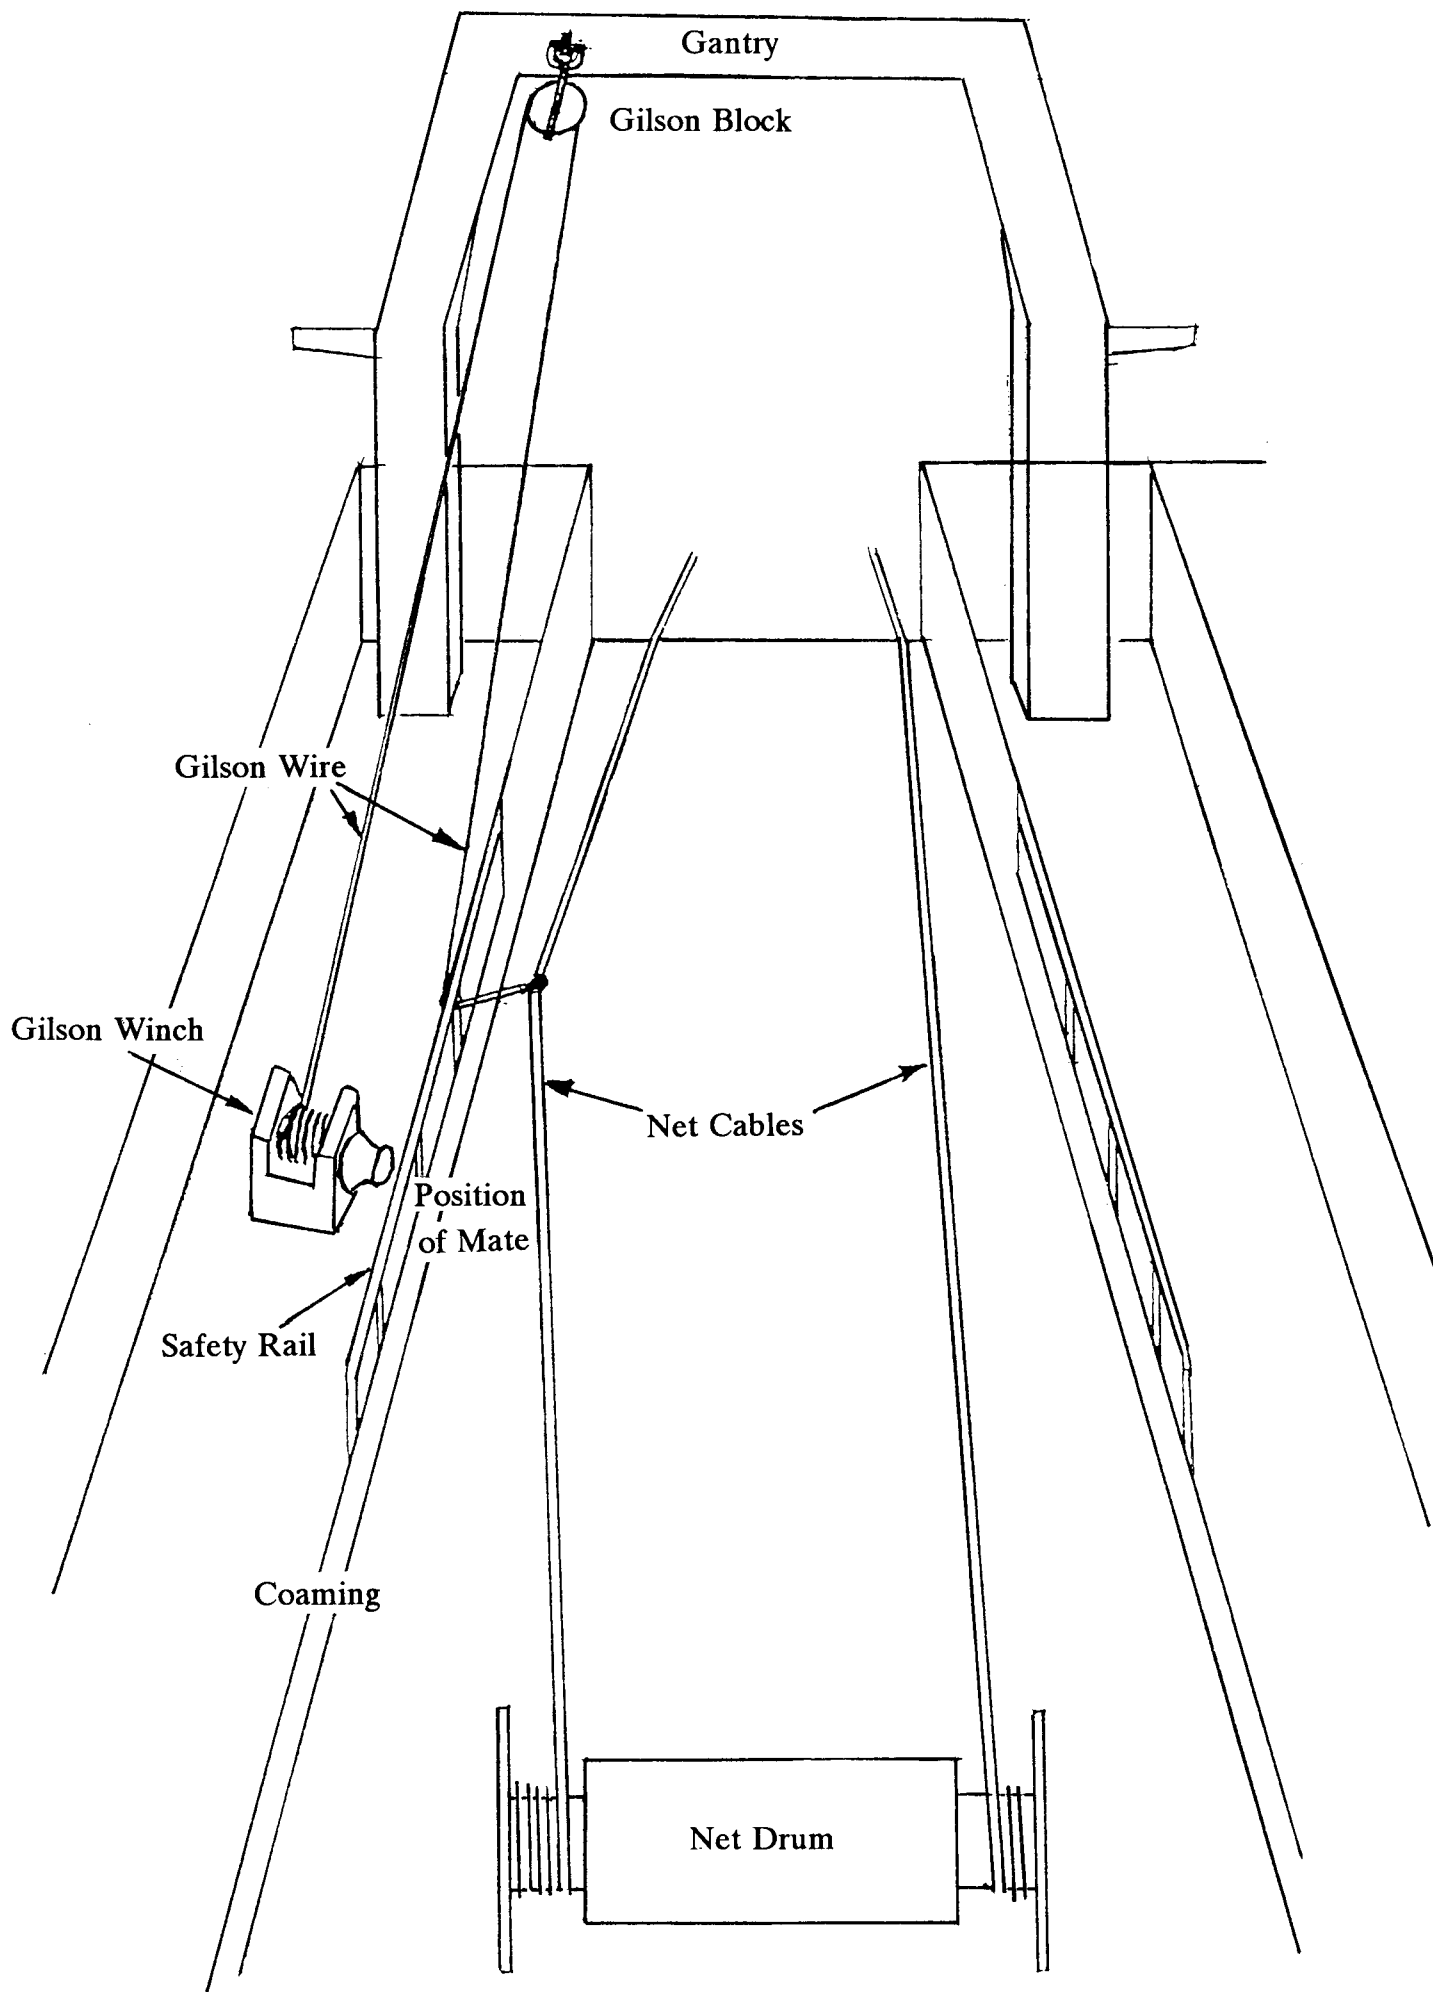
GILSON/NET WINCH ARRANGEMENT

1. This type of operation had been performed many times before on this vessel; wear patterns on the under sides of the safety rails, caused by rubbing of the loaded gilson wires, being clear evidence of this.
2. The only person inboard of the port and starboard safety rails was the Mate, all others were outside of the net handling area.
3. The net winch had no mechanical brake fitted; any change of load on its drum would have caused it to move.
4. Both the net winch and the gilson winch were in simultaneous operation on the net chain.

1. The gilson and net winches were, by being coupled, operated in such a fashion as to act in opposition, so causing an overload and hence failure of the gilson wire.
2. The safety rails were being used as part of a loaded system without having been tested or designed as load bearing components.
3. Causing the gilson wire to rub on the under surface of the safety rail, rather than using a block, risked a significant reduction in the working life of the wire due to abrasion and bending.

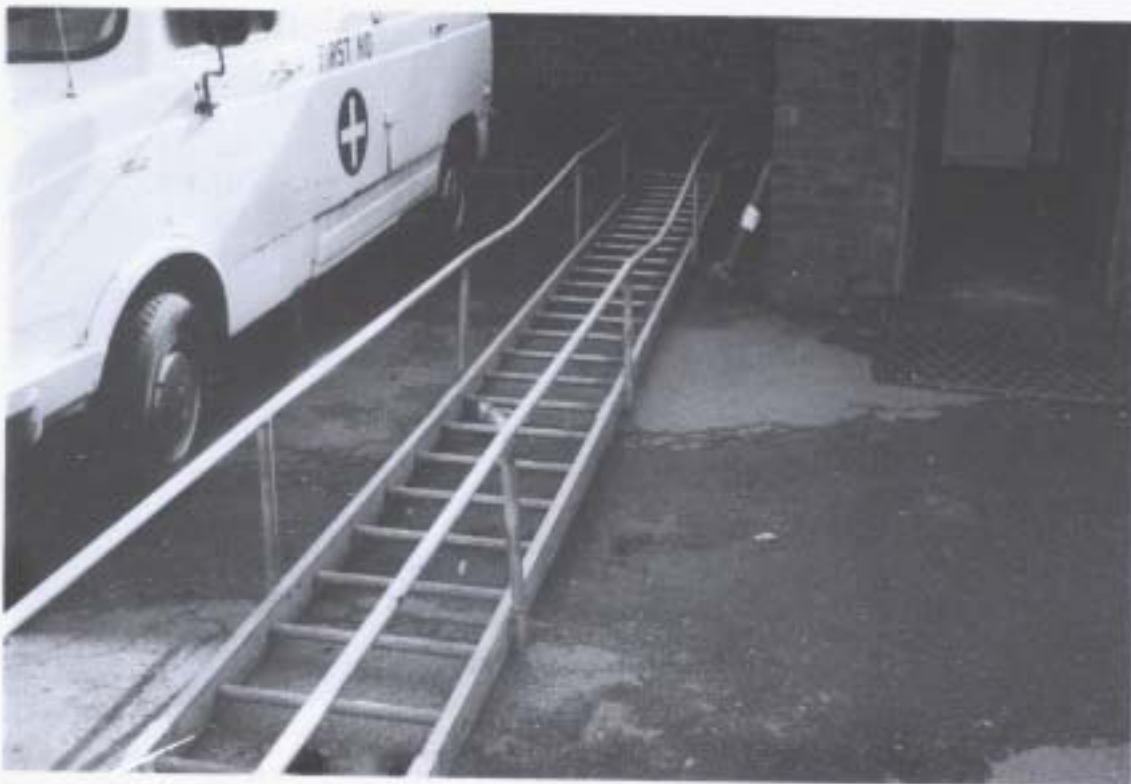
Photograph 1
Aluminium Safety Ladder

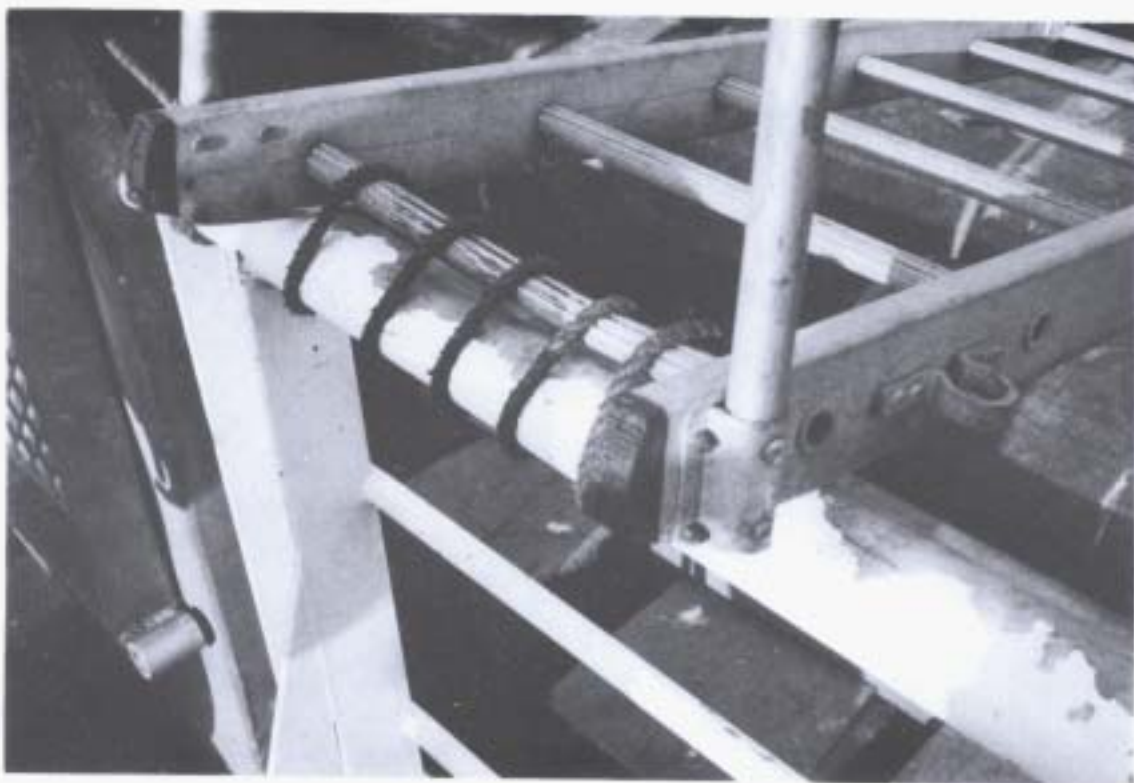
Photograph 2
Ladder lashed to the side rails of the vessel

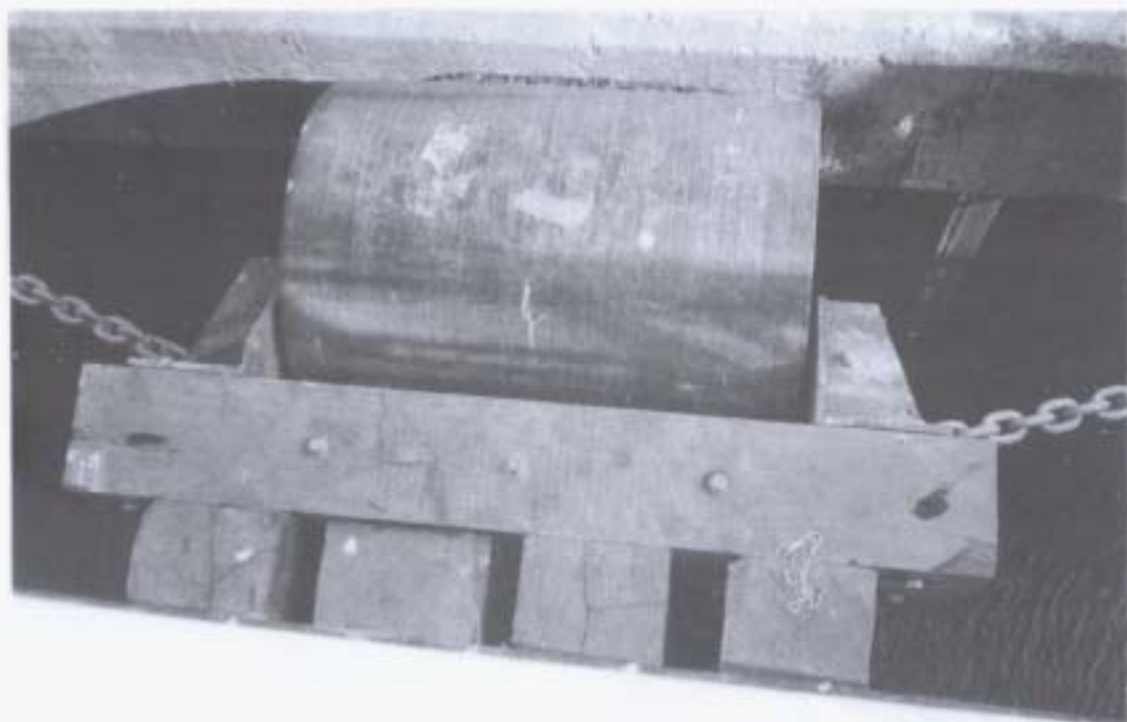
1. The trawler had her own gangway, but it was not used because the leg support under the top platform might have fouled the top of the pile below it at low water.
2. The ladder belonged to the harbour authority. It was usually used for access to small vessels when the deck level was below the level of the quay.
3. The lashing at the head of the ladder had become insecure. This probably happened when the tide was falling and the foot of the ladder became caught in one of the crane tracks on the quay, stressing the lashing. (See photograph 4).

Photograph 3
Quay pile with fender

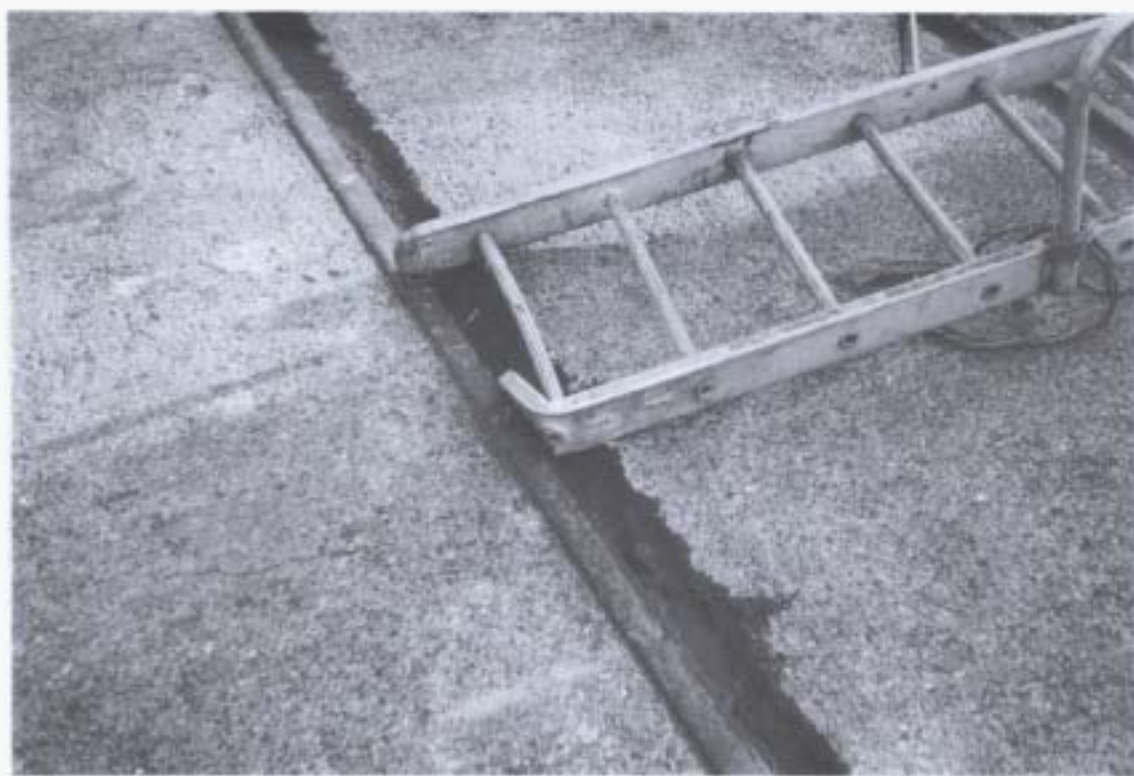
Photograph 4
Damaged foot of the ladder
