# Safety Digest 3/2003

## **Marine Accident Investigation Branch**

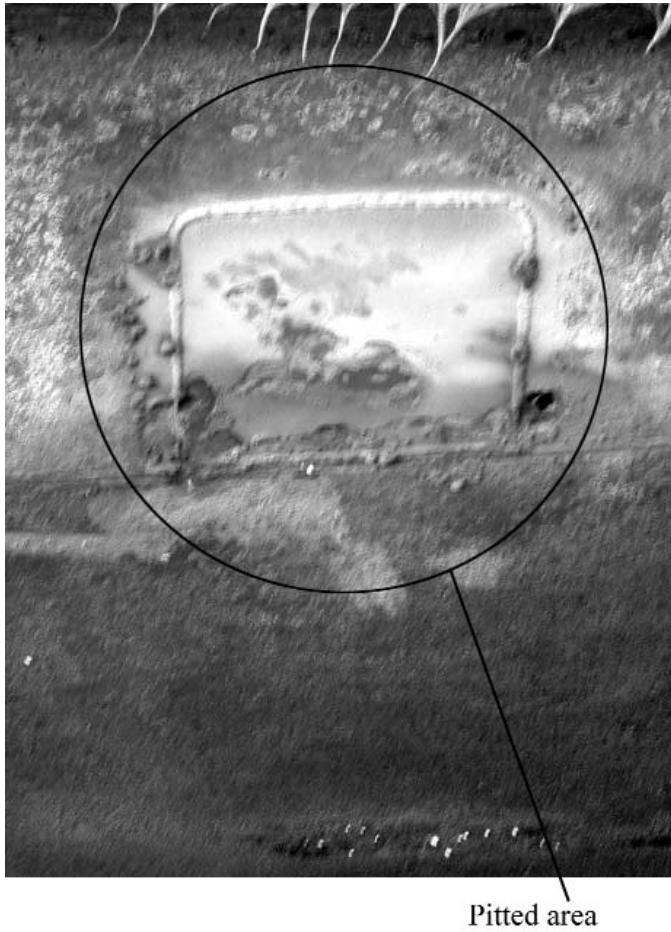
The vessel was taken to a nearby slipway and hauled from the water. A hole, about 4cm diameter, was found in the hull plating about 50cm below the normal waterline (see figure). This was the cause of the flooding.

The owners concluded that stray electrical currents between the steel pier and the vessel's hull in the lay-up berth had contributed to accelerated wastage of the anodes. In turn, corrosion rates of the hull then became significant and resulted in the perforation and flooding.

**Close up of pitted area on the hull of the vessel**

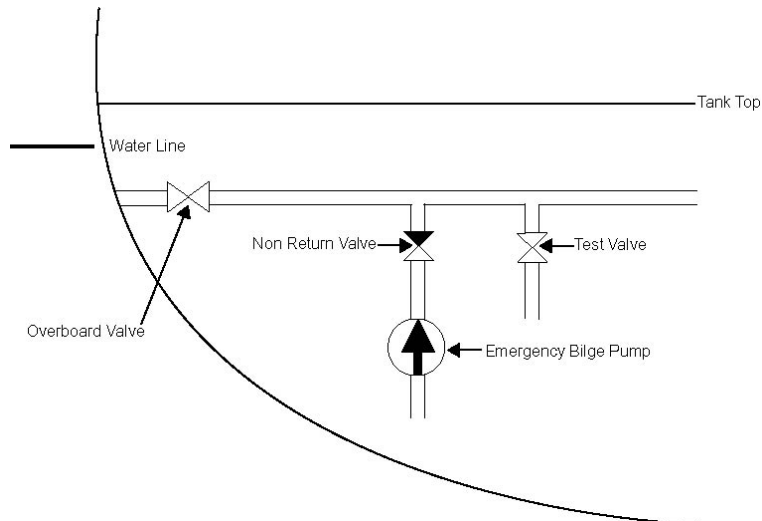
#### Diagram of valves

Investigations found that the recently installed test valve on the emergency bilge pump discharge line had been left open after a previous test, despite the posting of warning notices giving instructions in the correct procedures. They also revealed that the overboard discharge valve did not have a non-return capability, adding to the risk of flooding.

An overboard non-return valve has since been fitted to this ship. However, the crew must close the test valve when not being used for test purposes. Failure to do so will result in future flooding.

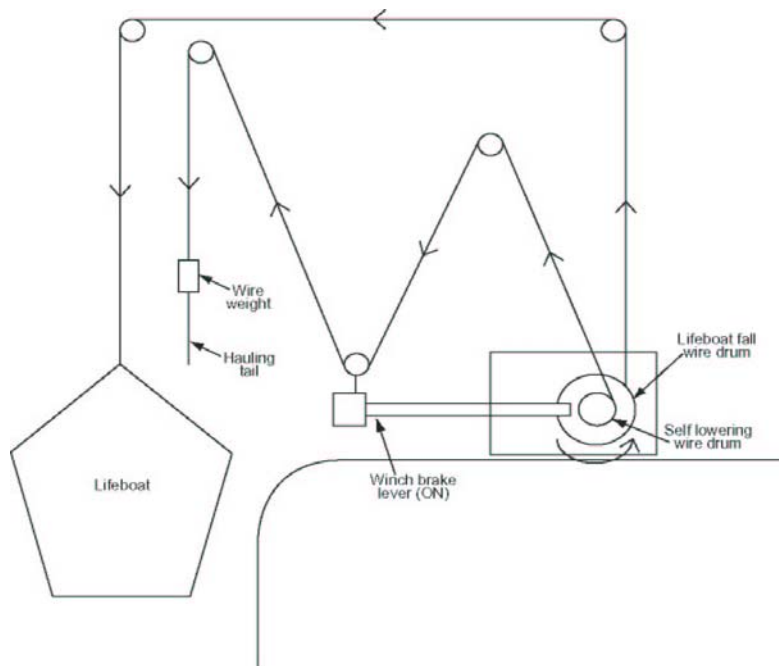
**Figure 1: Schematic - Lifeboat lowering system, showing the normal direction of wires when lowering**

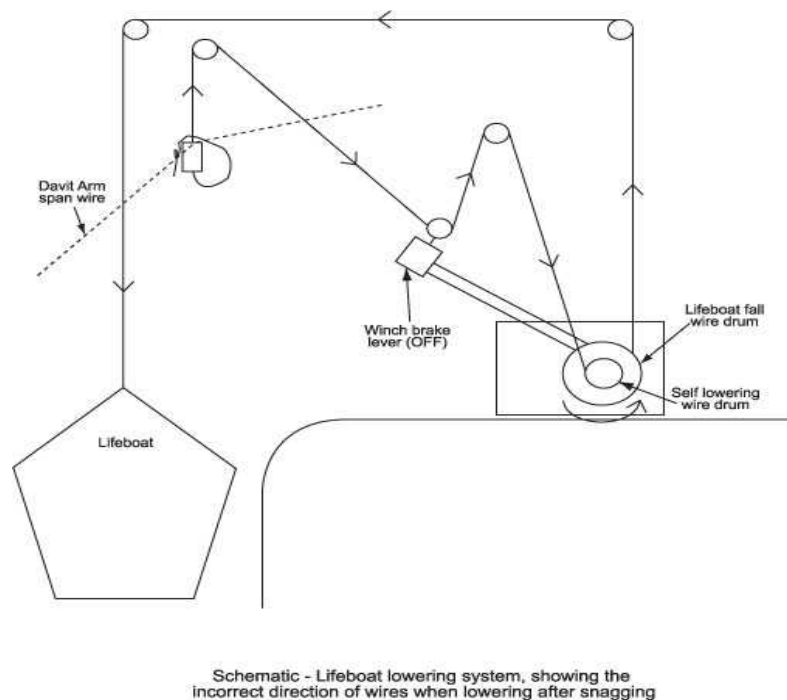
In this case, an officer on a passenger vessel was engaged in lowering the vessel's tenders, under power from the deck, to the sea, shortly after the vessel arrived at her anchorage. The boat crew were in the boat for the operation. When the boat had been lowered about halfway down to the sea, the paying-out self-lowering wire jumped from its drum and caught on the opposite side of the drum, so that it began hauling back in. This resulted in the weight attached to the wire rising. It then became fouled around the davit arm span wire, which resulted in the brake arm being lifted, releasing the brake.

**Figure 2: Schematic - Lifeboat lowering system, showing the incorrect direction of wires when lowering after snagging**

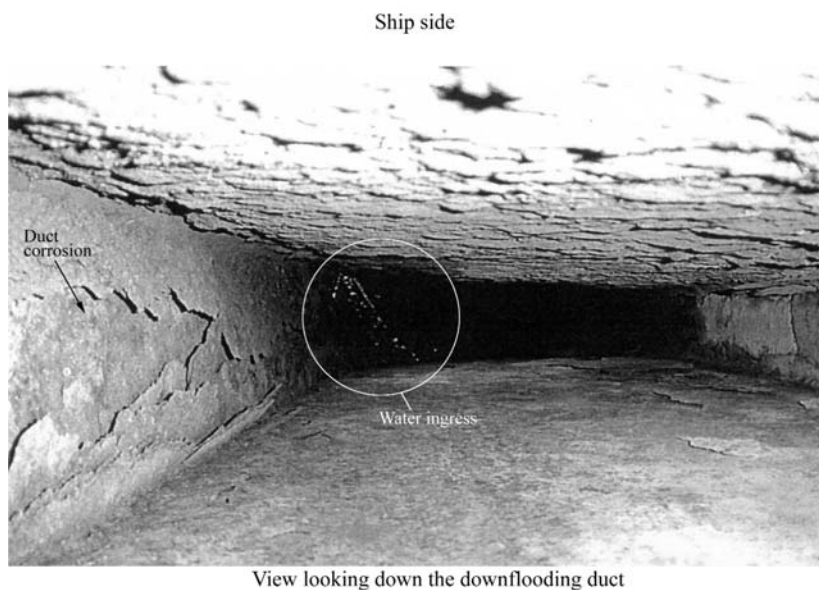
Inspection of all the ducts on board revealed that four of the ten ducts were badly corroded (see photograph) in the vicinity of the crew's galley. The corroded ducts passed through the high temperature compartments of the galley and bakery and, owing to the temperature difference between the hull and the inboard duct plate, the water vapour in the air condensed on to the colder ship's side plate, which caused the corrosion.

View looking down the downflooding duct

To make the ship operational, it was necessary to replace two 8 metre vertical lengths of shall plating in way of the corroded ducts.

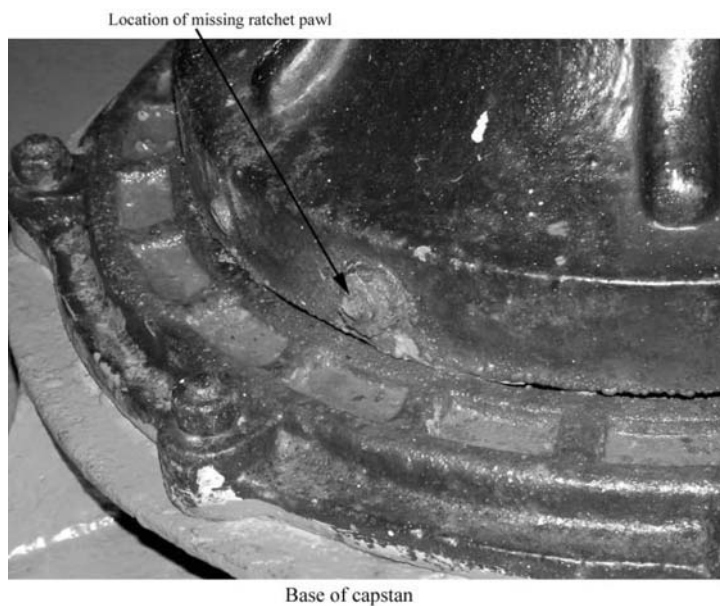
The capstan was a basic design: the operating handle was removable and was attached to drive shafts on the capstan. An internal gear ratio of 13:1 enabled one person to tension the mooring line adequately. To prevent reverse rotation, external ratchet pawls at the base of the capstan fitted into slots at the circumference. Three pawls were in use, the fourth having failed some time in the past.

### Base of capstan showing location of missing ratchet pawl

Because the vessel was surging along the berth, an additional load had been placed on the aft mooring line. The combined load caused the ratchet pawls to fail simultaneously, resulting in the capstan drum rotating in the opposite direction. The internal gearing spun the capstan handle out of the AB's hands and struck him on the head. The blow was fatal.

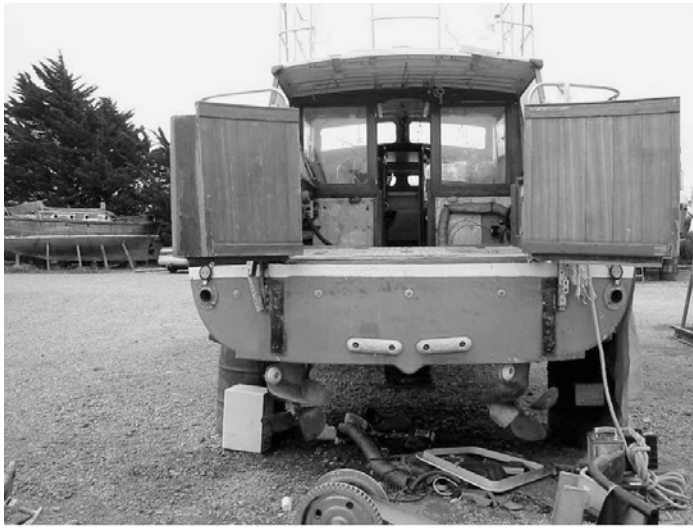
### The transom doors
