SAFETY DIGEST

Lessons from Marine Accident Reports 3/2005

MAIB

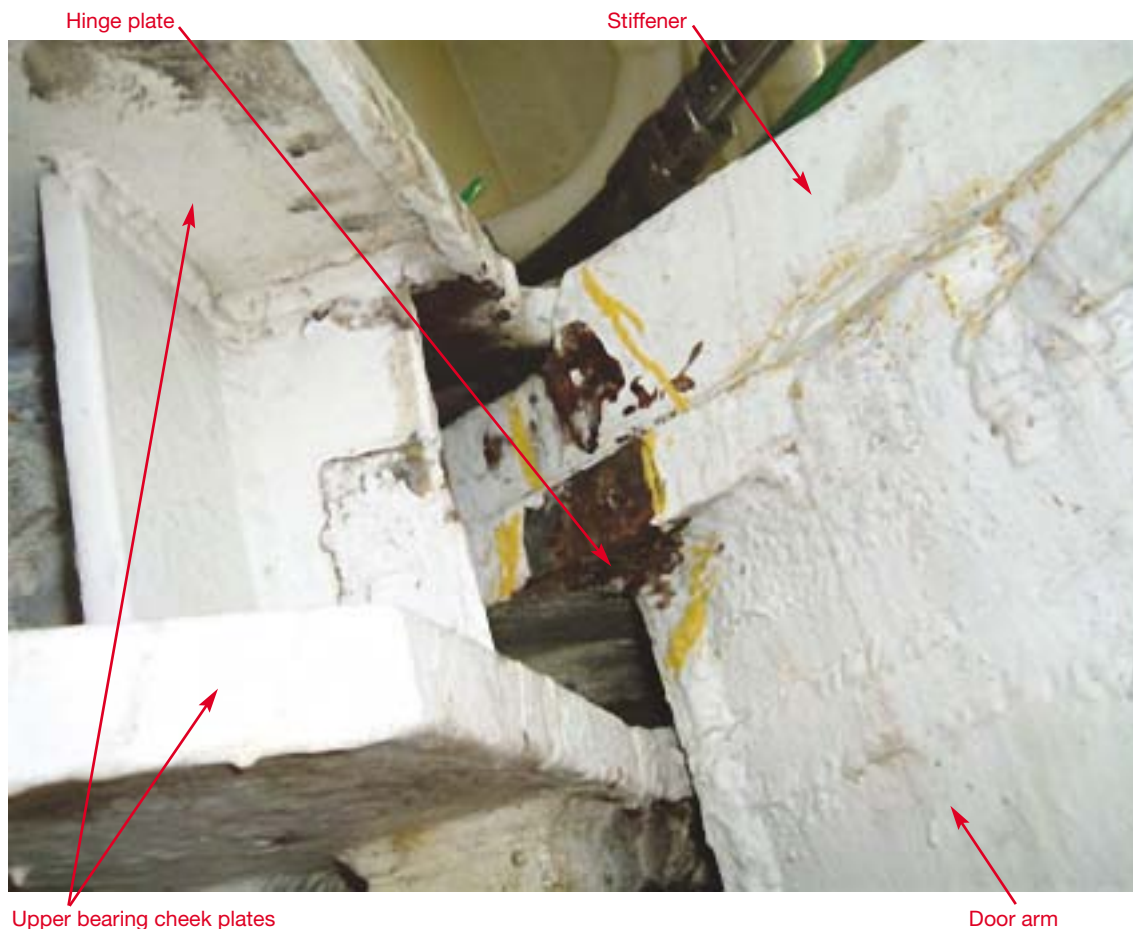
During a routine inspection of the bow door space of a ro-ro passenger ferry, by ship's staff, cracks were found in the upper hinge assembly of the starboard bow door (Figures 1a and 1b). The company, classification society and flag administration were informed. The following day, a classification society surveyor inspected the cracks to determine a suitable and safe course of action.

Figure 1a: Starboard door upper bearing arrangement

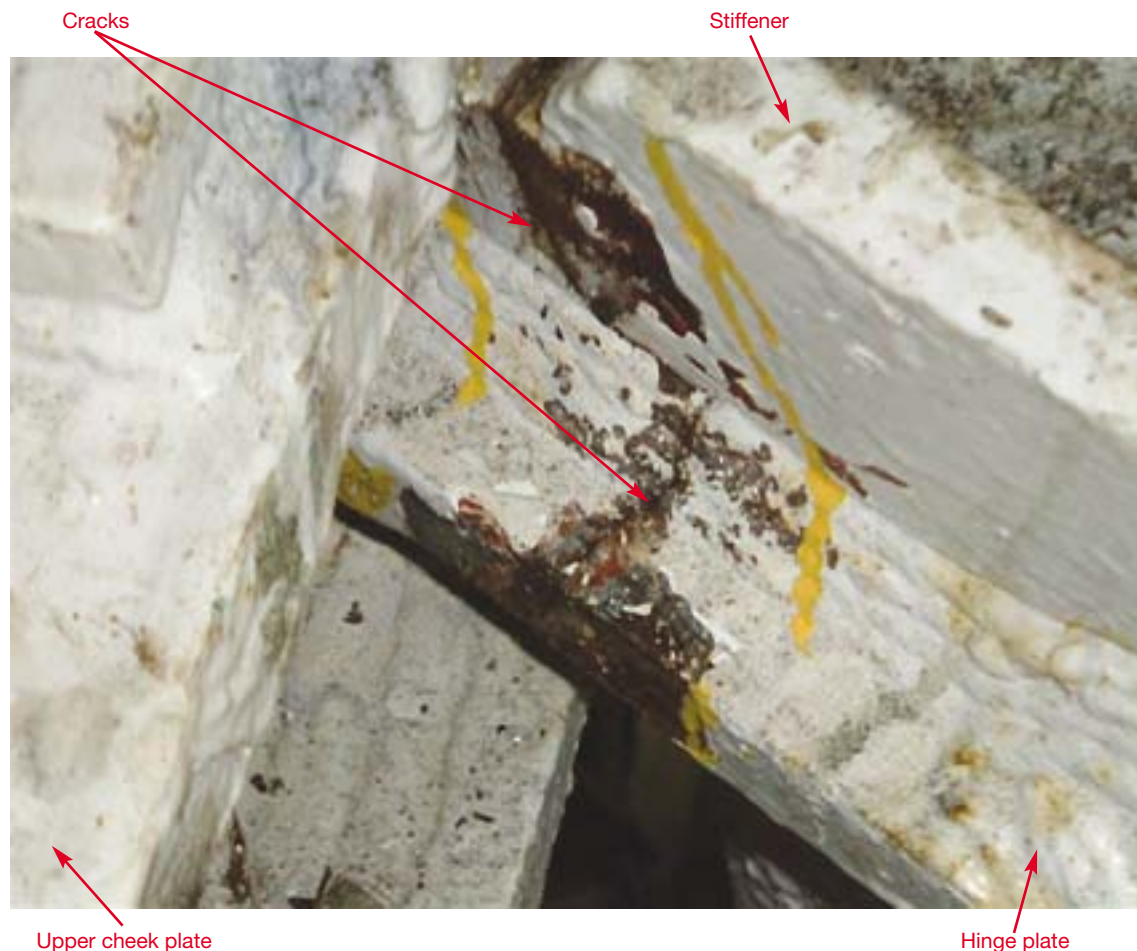
Figure 1b: Starboard door upper bearing hinge in detail showing crack

The investigation found that the contact between the door and the cowcatcher caused the operating cylinder to overload the door operating equipment and supporting structure, which led to the cracking.

3. Had a suitable method of Non-Destructive Testing (such as Magnetic Particle Inspection) been carried out on the door hinge components, after the cracks were discovered, it might have been possible to determine the depth and extent of the cracks. This, in turn, might have provided the surveyor with valuable information on which to base his decision. Consider all the options available to assist in diagnosing a fault condition rather than relying purely on the Mk I eyeball.

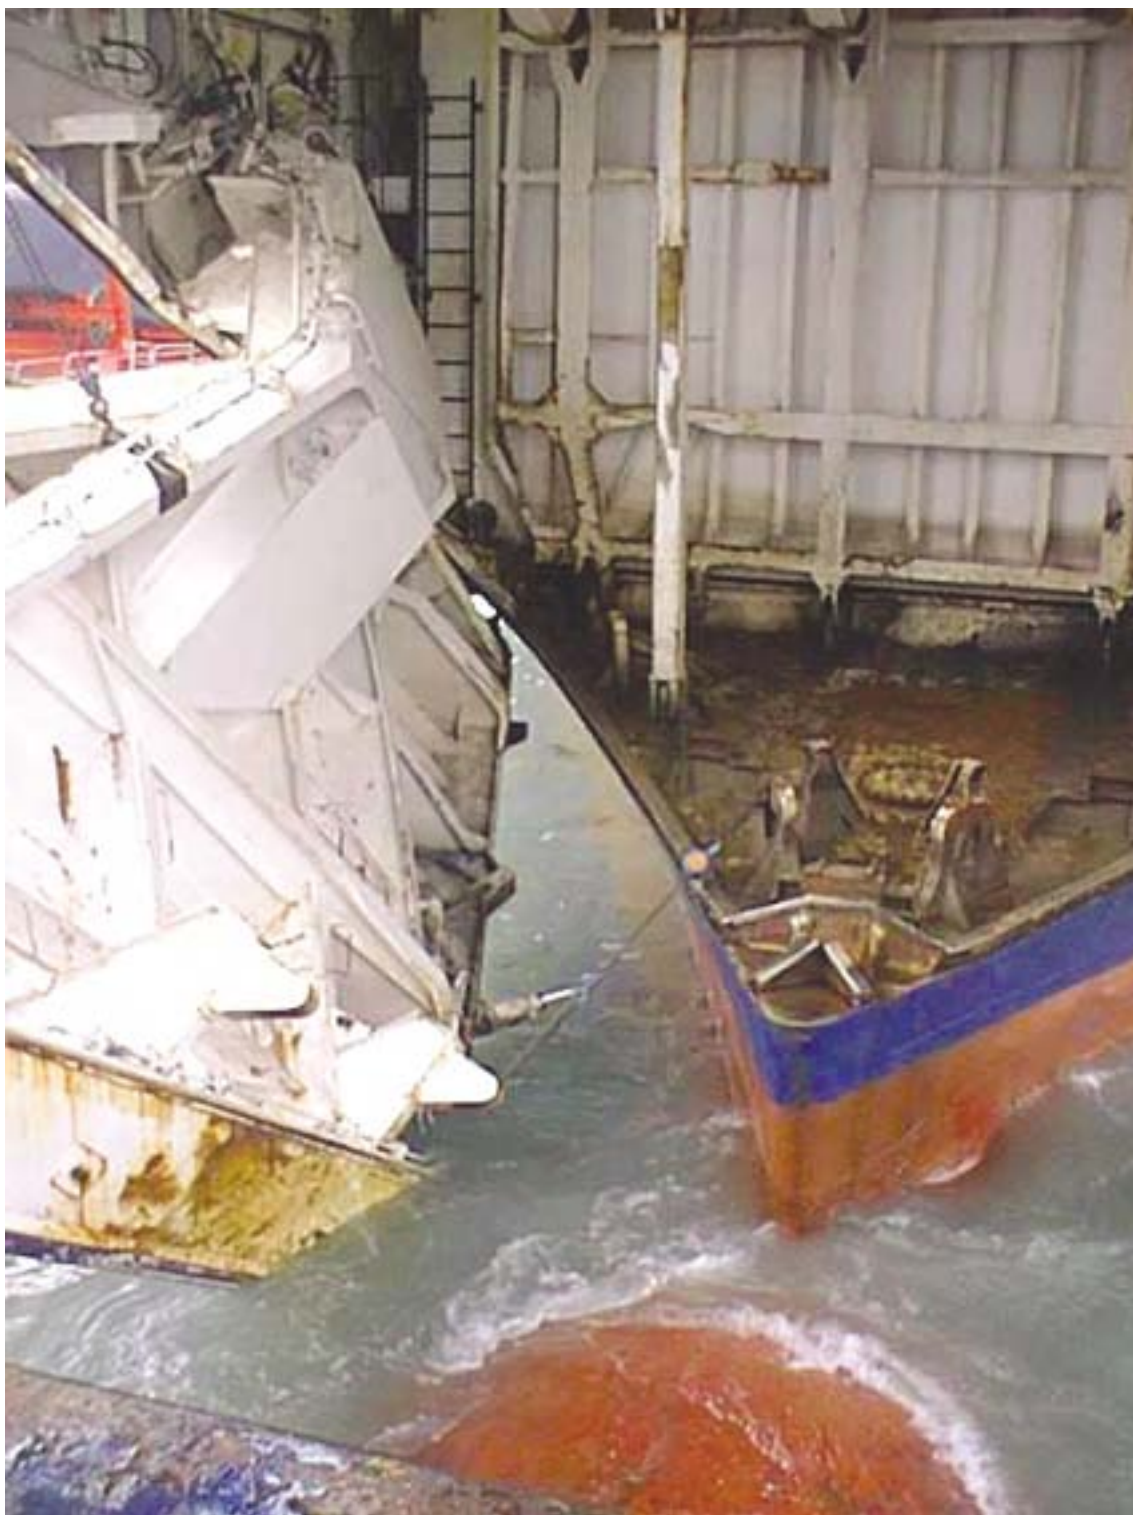
At a European port 5 days later, the vessel had completed discharge and loading, and was preparing for departure when the upper hinge of the starboard "clamshell" type bow door failed. As soon as the operating lever for the bow door's hydraulic operating cylinders was moved to the "door close" position, a bang was heard and the door was seen to drop. The 20 tonne weight of the door came to bear on the hydraulic cylinder and the lower hinge assembly. The door came to rest partially supported by the cowcatcher (an external structure attached to the bow, which enabled the vessel to connect to the linkspan), with the lower part of the door submerged about a metre in the water (Figure 2).

Figure 2: View of damaged starboard bow door

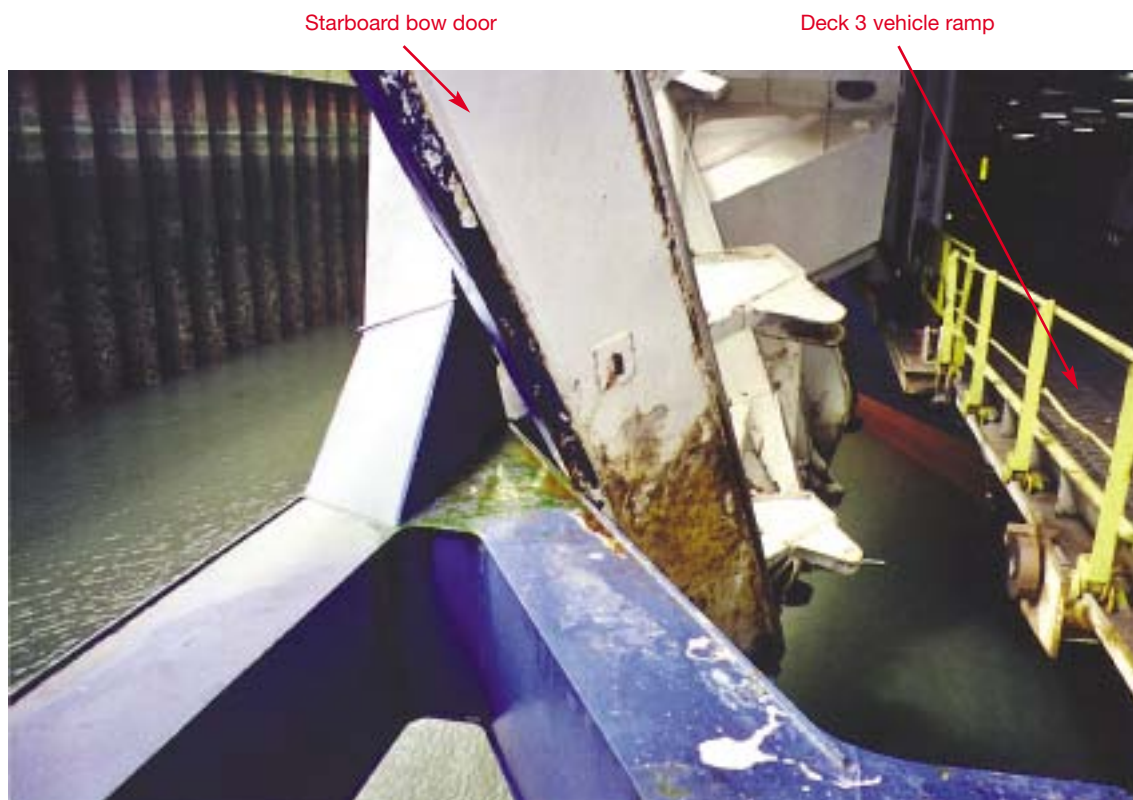
Figure 3b: Starboard door in contact with 'cowcatcher'

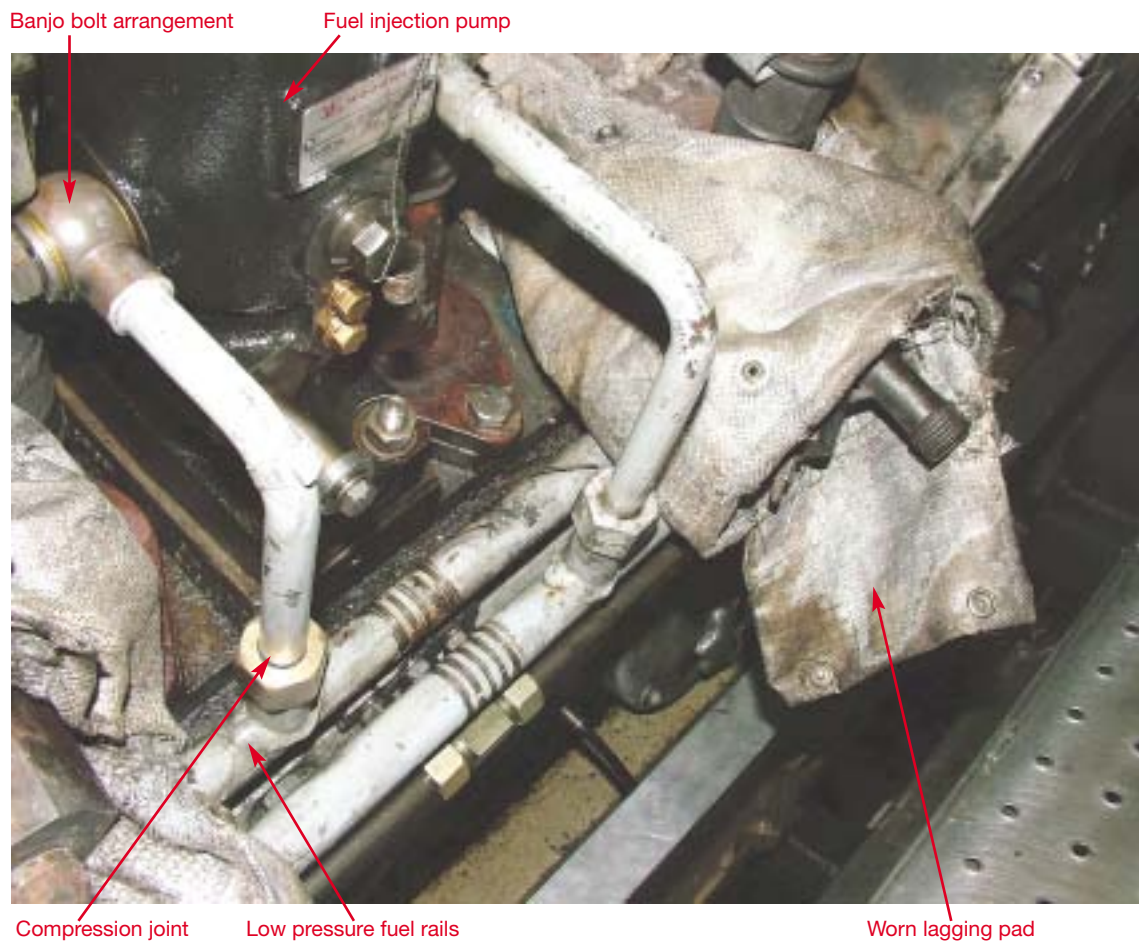
Figure 1: Low pressure fuel pipe arrangement

On investigation, it was found that one of the low pressure fuel pipes, supplying a cylinder fuel injection pump, had failed. The steel pipe (Figure 1) had a banjo fitting at the pump connection, and a steel ferrule compression fitting at the low pressure fuel rail. The pipe had suffered circumferential cracking adjacent to the banjo connection braze (Figure 2), which allowed fuel to escape at pressures up to 2.2 bar. The fuel vapour was then ignited by the hot test cock situated adjacent to the leak. The test cock lagging pads were worn, and the vapour barrier in some cases was no longer intact.

1. Diesel engine low and high-pressure fuel systems are subject to high-level pressure pulses. This, coupled with engine vibration and the often frequent dismantling and re-assembly of the systems for maintenance purposes, makes them vulnerable to leakage. It is, therefore, essential that piping system connections are correctly aligned before

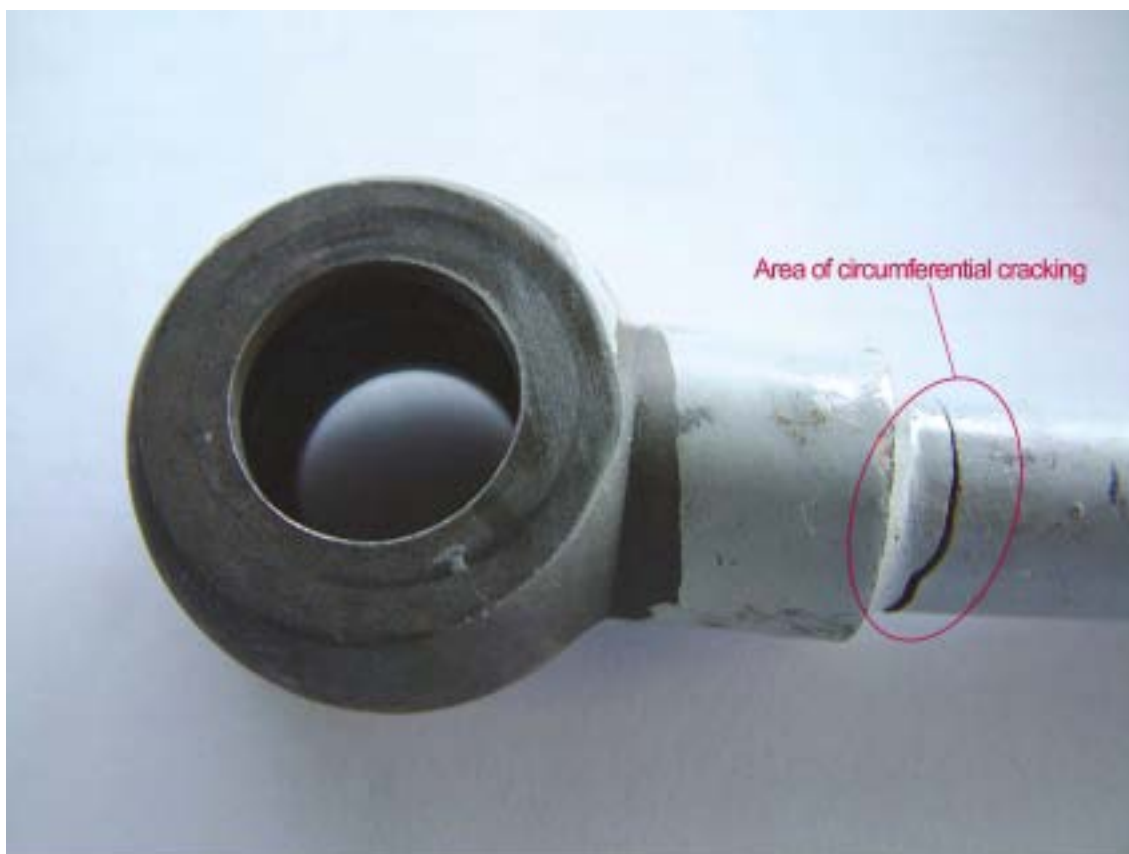
Figure 2: Failed low pressure fuel pipe

It was discovered that a minor fuel weep had resulted in the pipe being replaced just 2 days before the fire. Unfortunately, the pipe, which was slightly over length, had been fitted

incorrectly. This caused stressing in the area of the banjo connection, and this, coupled with the engine vibration, resulted in eventual failure.

final tightening. This will reduce stresses that could lead to pipe or connection failures. Do not assume that those involved in maintenance are aware of alignment procedures.

2. It is good engineering practice to uniquely identify matching pipes to injection pumps, by etching or banding. This will ensure that pipes are refitted to their original position, reducing the risk of stressing that could lead to failure.
3. Any damaged insulation may act as a wick. This can soak up fuel and increase the risk of fire. Damaged lagging pads should be replaced without delay and should, where possible, be secured away from fuel lines.
4. It is essential that fuel leaks are investigated *immediately*. The cause must then be identified and measures implemented to prevent re-occurrence, wherever possible. Never accept fuel leakage on any system: a minor weep may originate from a small crack, which can propagate very quickly under vibration and engine loading conditions.

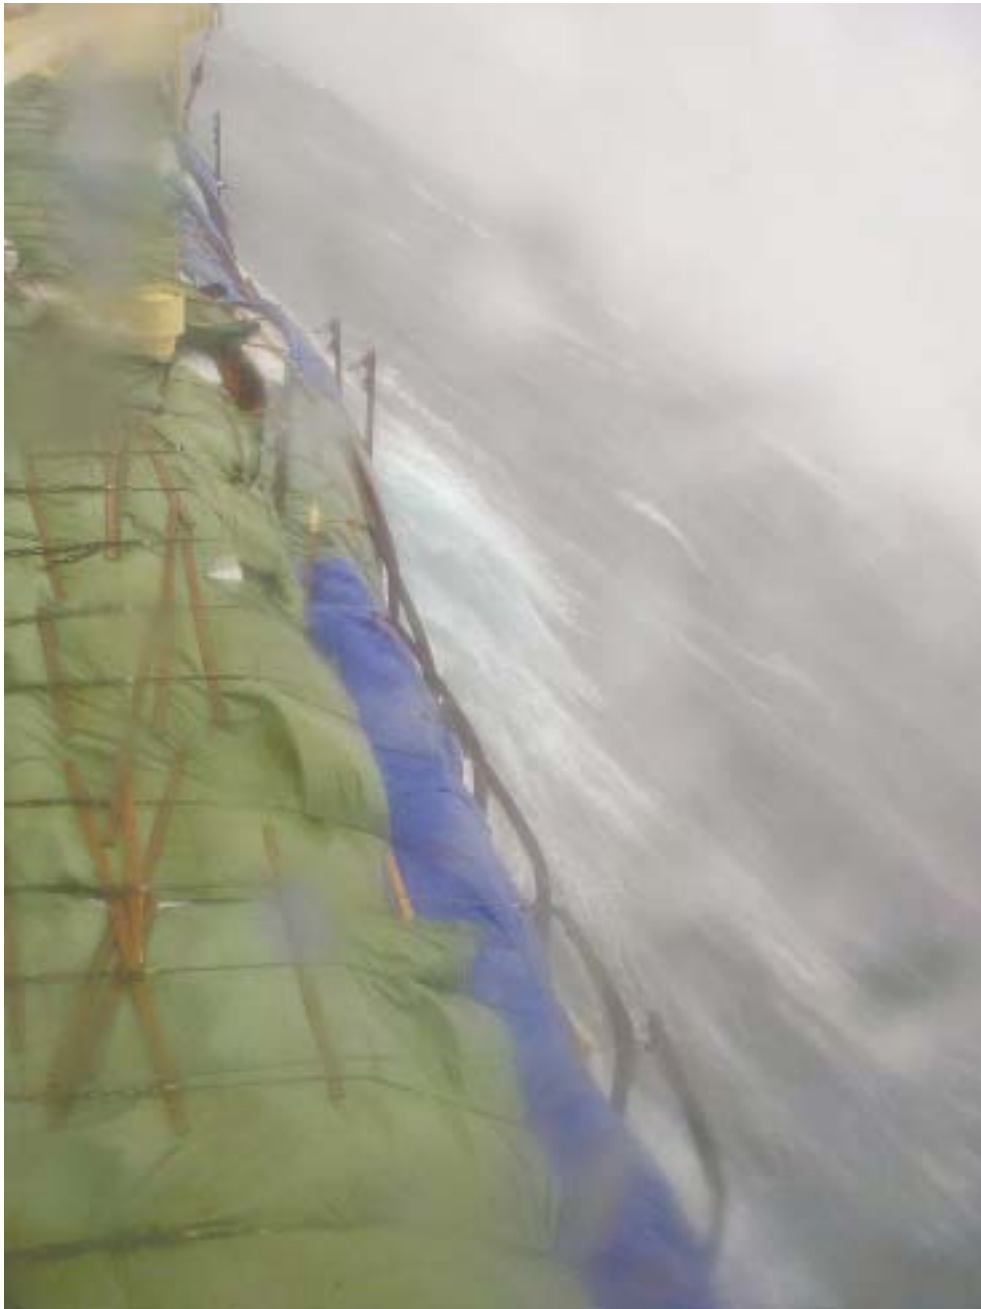
Figure 1

Just after midday, a combination of sea and swell waves caused the vessel to roll to port by 30–40°. This shifted the deck cargo, which led to an angle of port list of about 30°. The vessel continued to roll, reaching alarming angles to port (Figure 1).

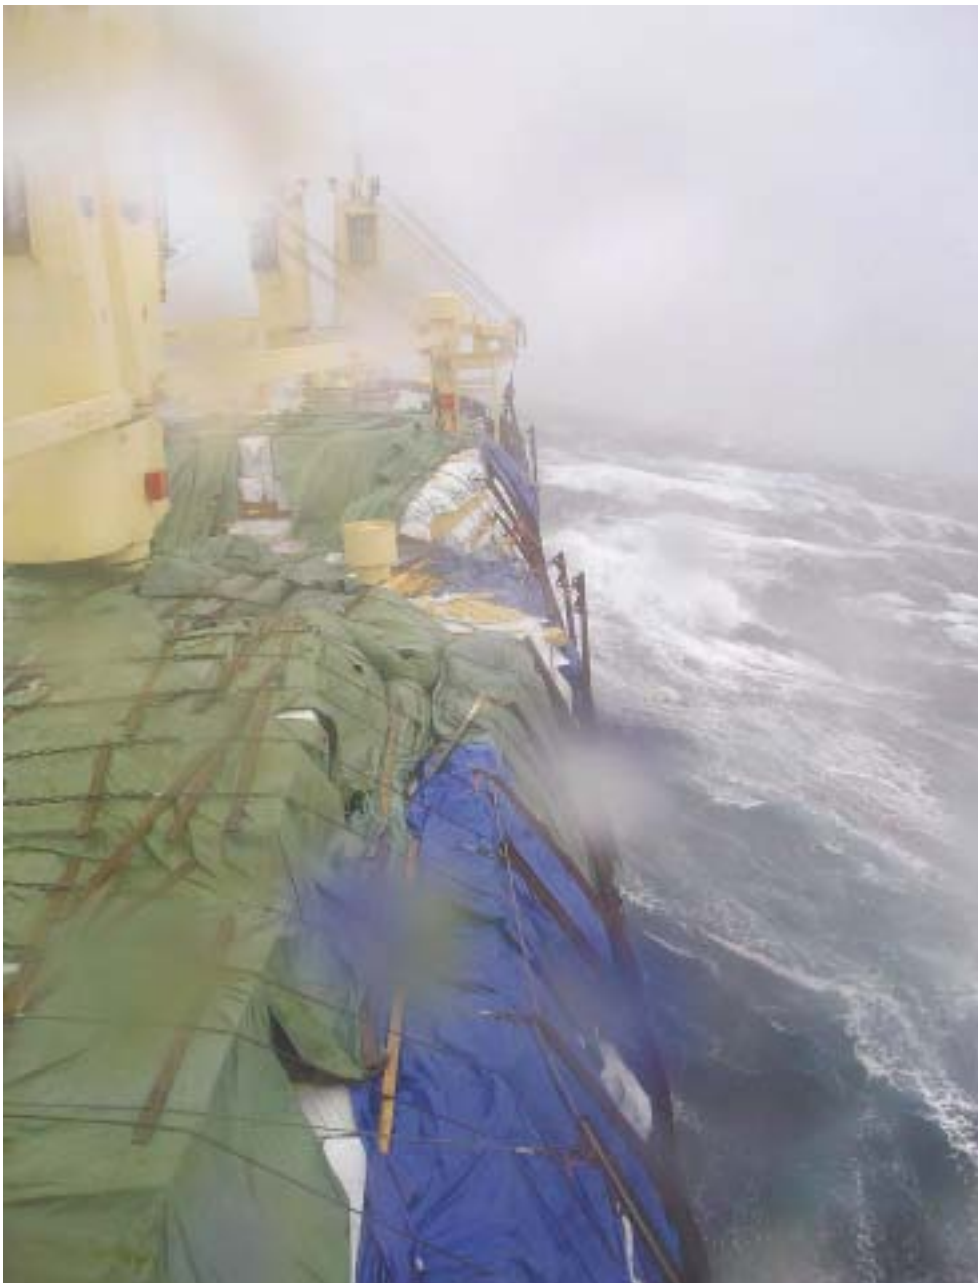
Figure 2

comparative safety of the accommodation. The master then turned the ship so that the weather was on her starboard beam. In this situation, the remaining lashings parted and a large quantity of timber packages slid over the side (Figures 2 and 3).

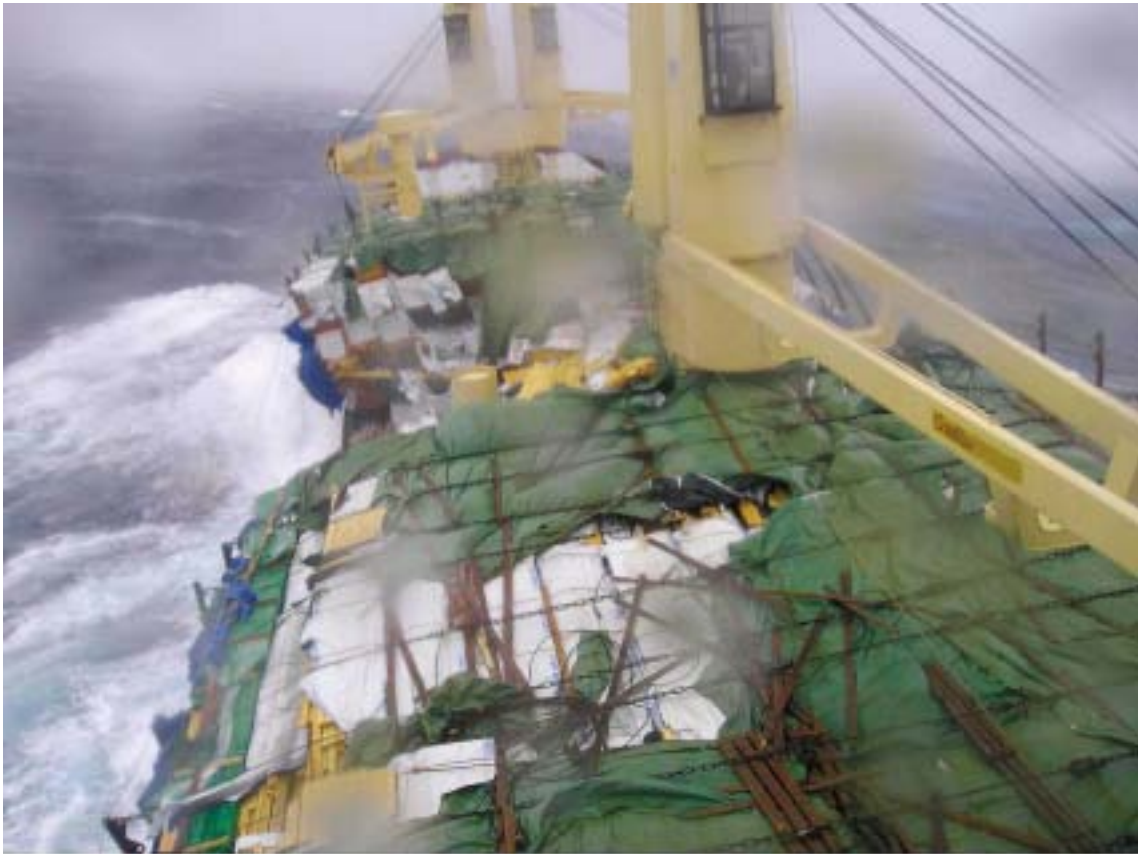
Figure 3: Lashings parted

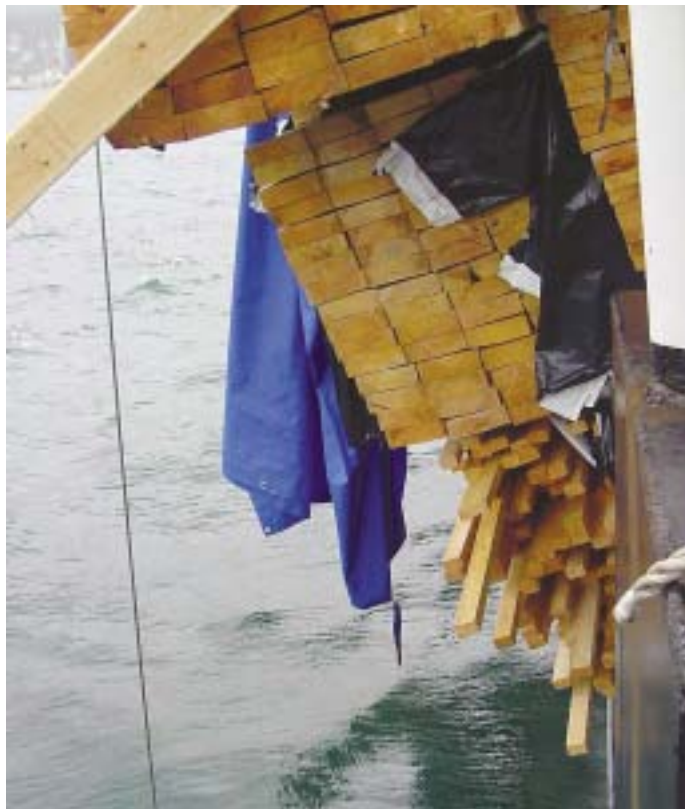
Figure 4: Timber packages sliding over the side

There was a substantial overhang of packages on the port side (Figure 4), but the ship arrived safely (Figure 5) having sustained only minor damage and no injuries to any crew members.

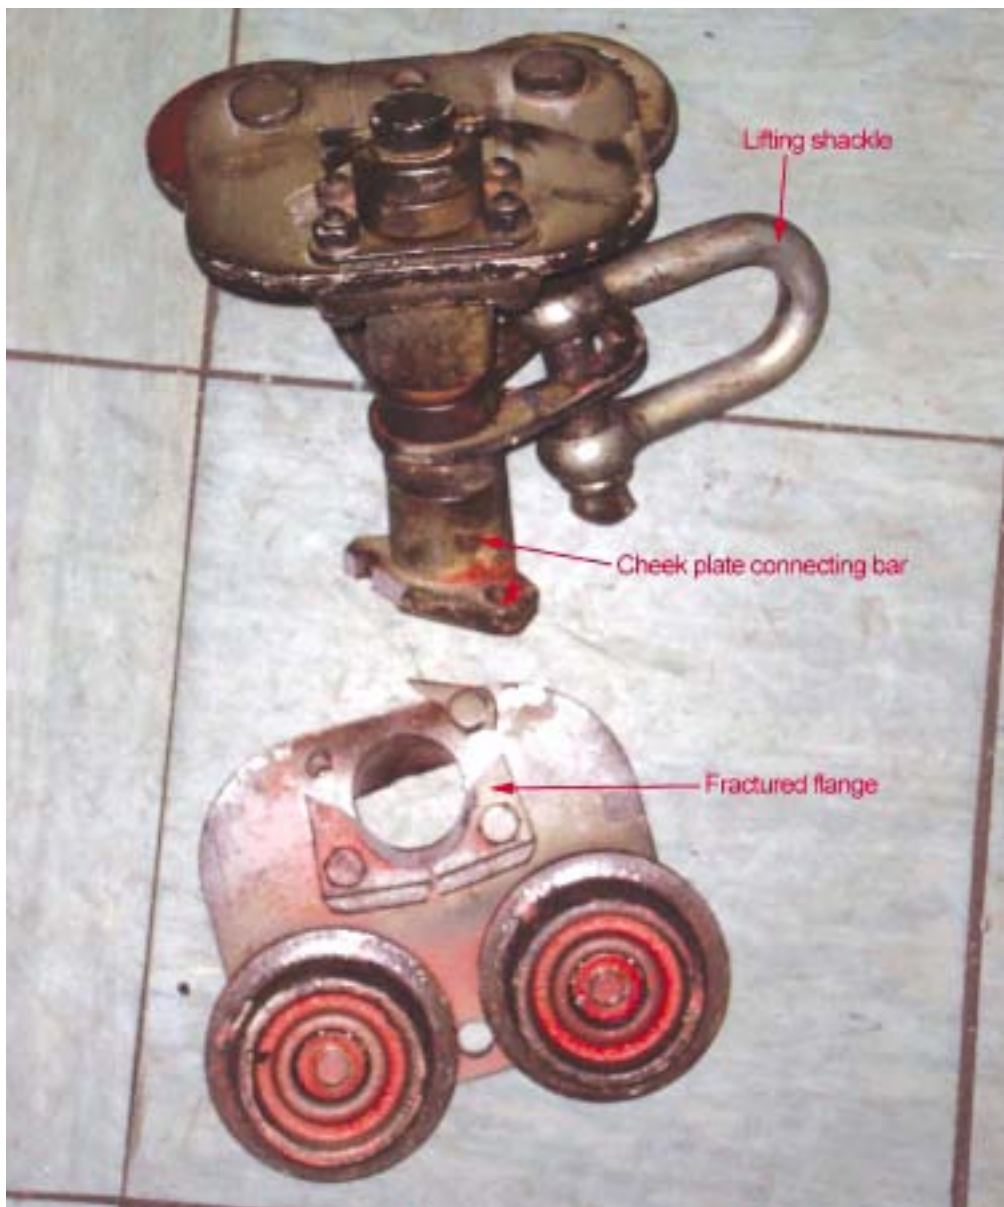
While the third engineer was applying tension on the chain block, the flange and one bolt on the trolley cheek plate connecting bar fractured, causing the chain block and trolley to fall from the “H” beam.

Figure 1: Four wheel trolley

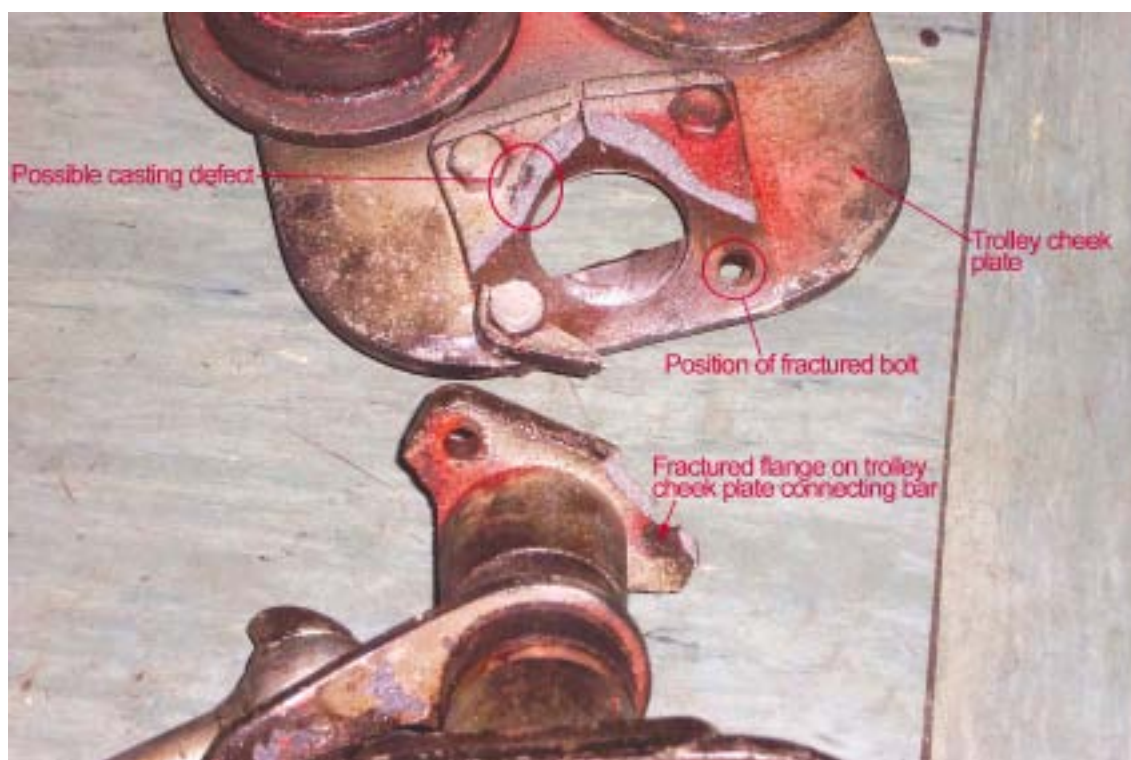
Figure 2: Detail of fractured components

On investigation, it was found that the flange had suffered brittle fracture. It is possible that the flange bolts were not fully fastened, causing the flange to flex and fail while the trolley was under tension. There was indication of a possible casting defect, close to

one of the flange fastening bolts (Figure 2). This could have weakened the casting and caused the catastrophic failure.

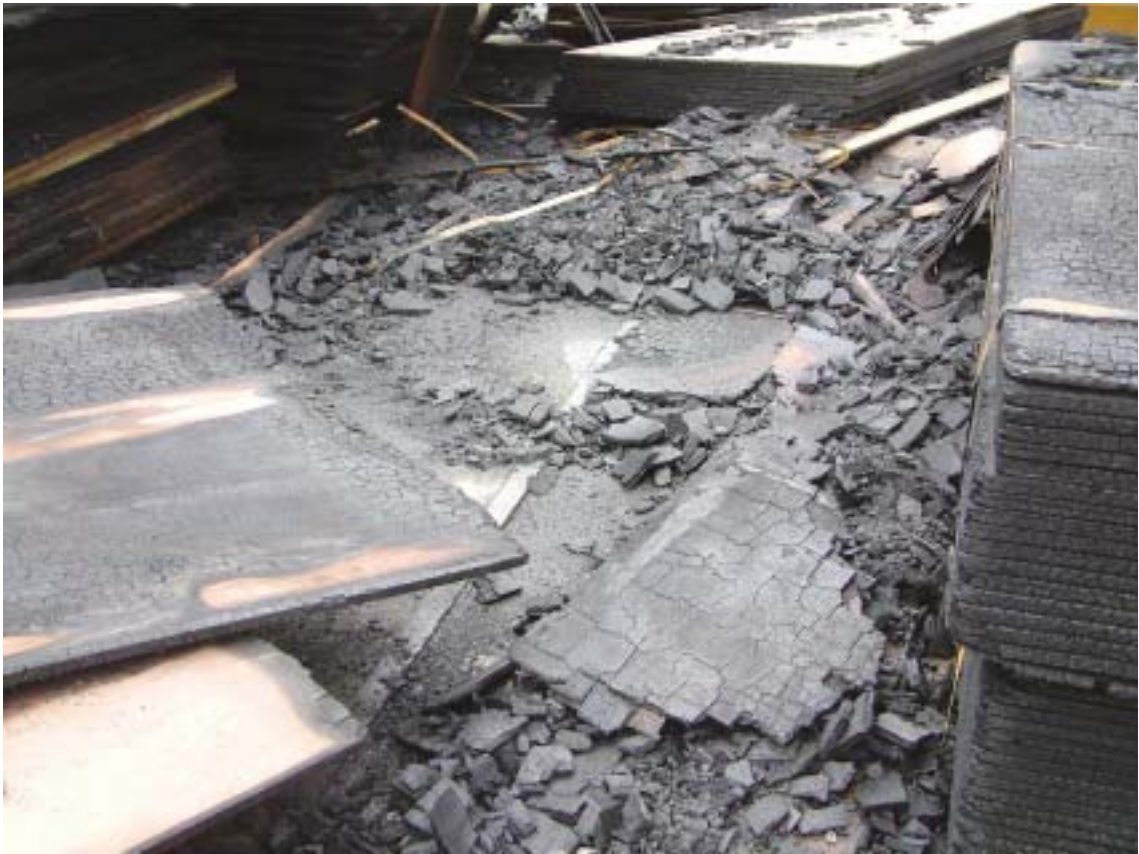
Plywood fire damage on jetty

As burning progressed, molten steel fell into the hold and ignited the plywood stowed immediately under the box section. At about 1500, the fitter noticed smoke issuing from the (now open) box section. He poured the bucket of water into the hold and ran to inform the bosun, who was working in No 1 hold. The bosun hurried to the bridge to collect the fire locker key and to inform the OOW. Meanwhile, the deck crew set up hoses for boundary cooling.

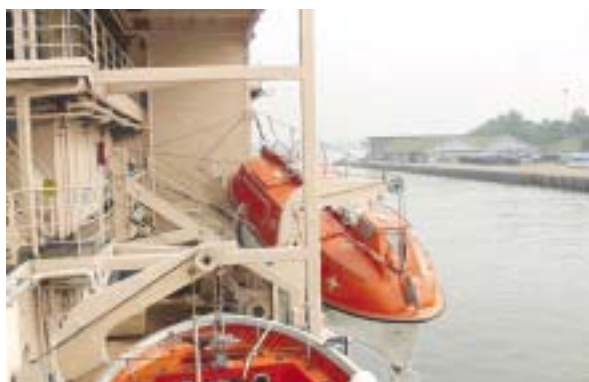
Photograph showing the lifeboat at its position of rest, with the forward gripe trapped and the aft davit arm moved to the lower position. The twisting action wedged the boat as shown

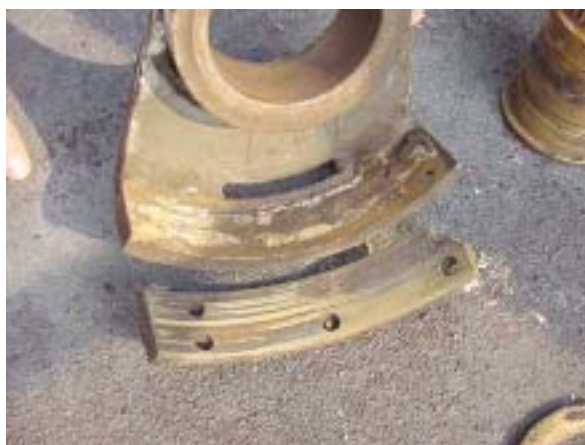
Once the brake mechanism was dismantled for inspection, the immediate reason for the boat's uncontrolled lowering became apparent. The brake pad had become detached from the brake shoe. It was found that during the recent overhaul, the pad had been secured to the shoe with glue and two rivets, contrary to the manufacturer's instructions and guidance. The pads should have been secured by six rivets.

Securing of the pad had been carried out by the use of adhesive over the full face and two rivets at one end

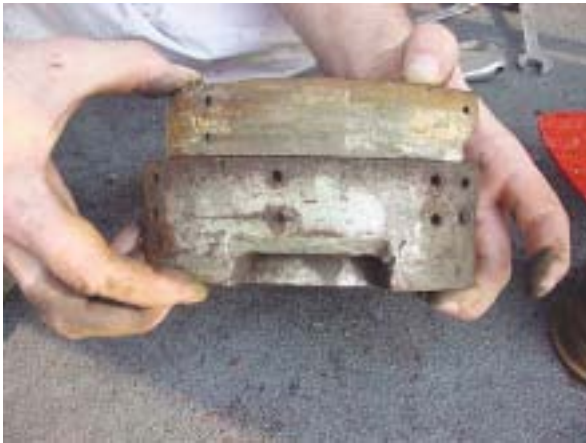
This picture shows the pad and shoe – note the misalignment of the rivet holes

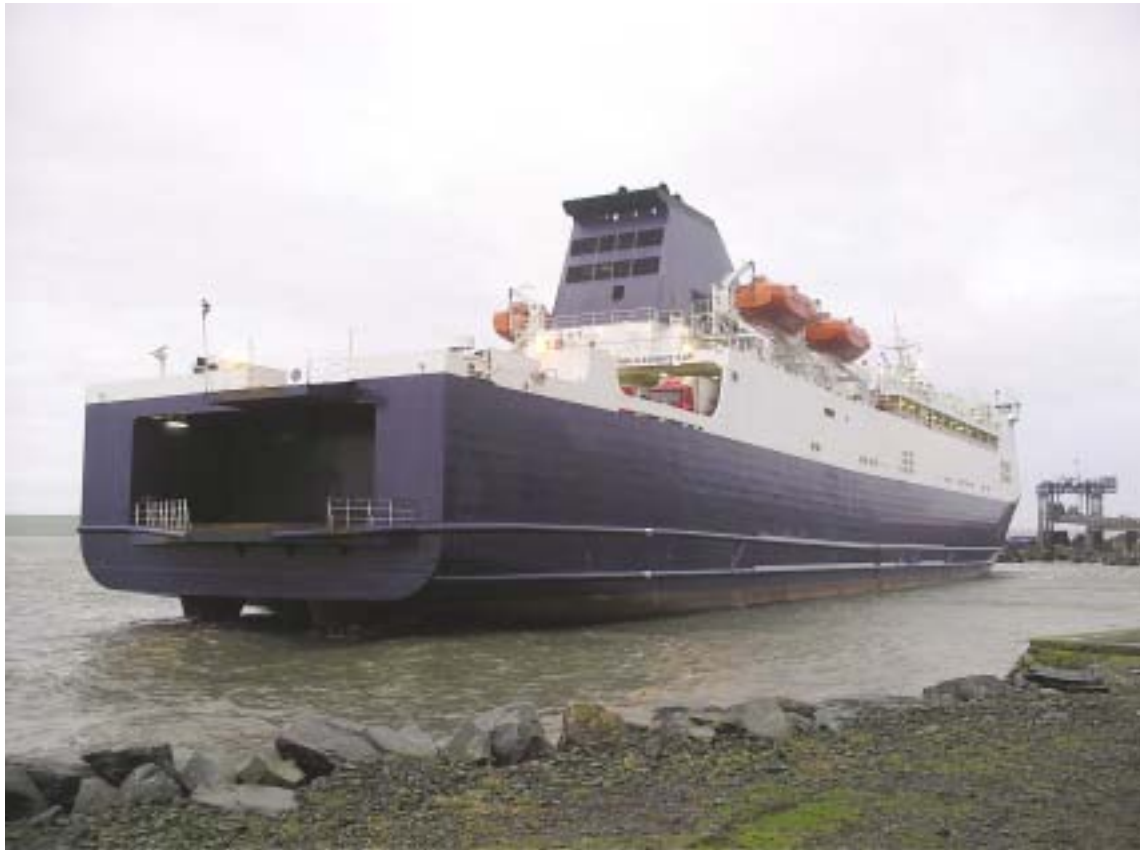
The vessel aground close to her berth

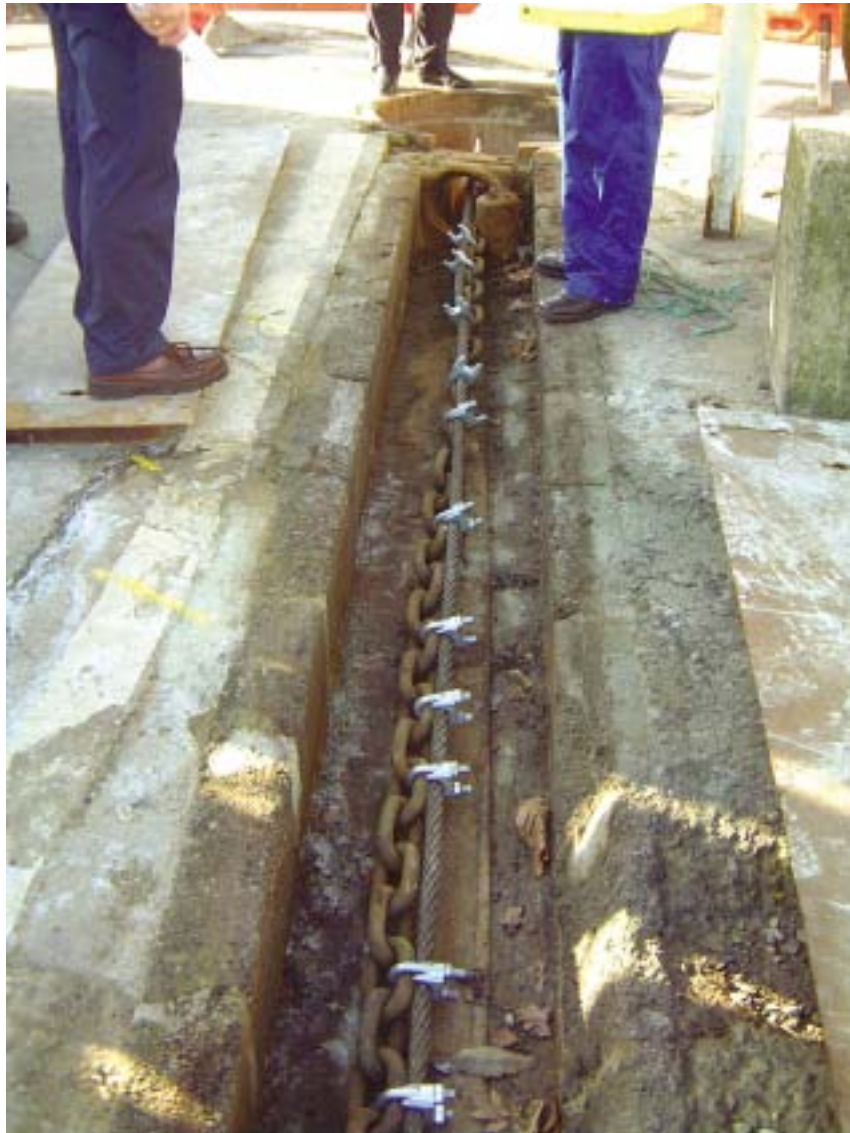
Figure 1 – Before the incident the wire was attached to chain using bulldog clips

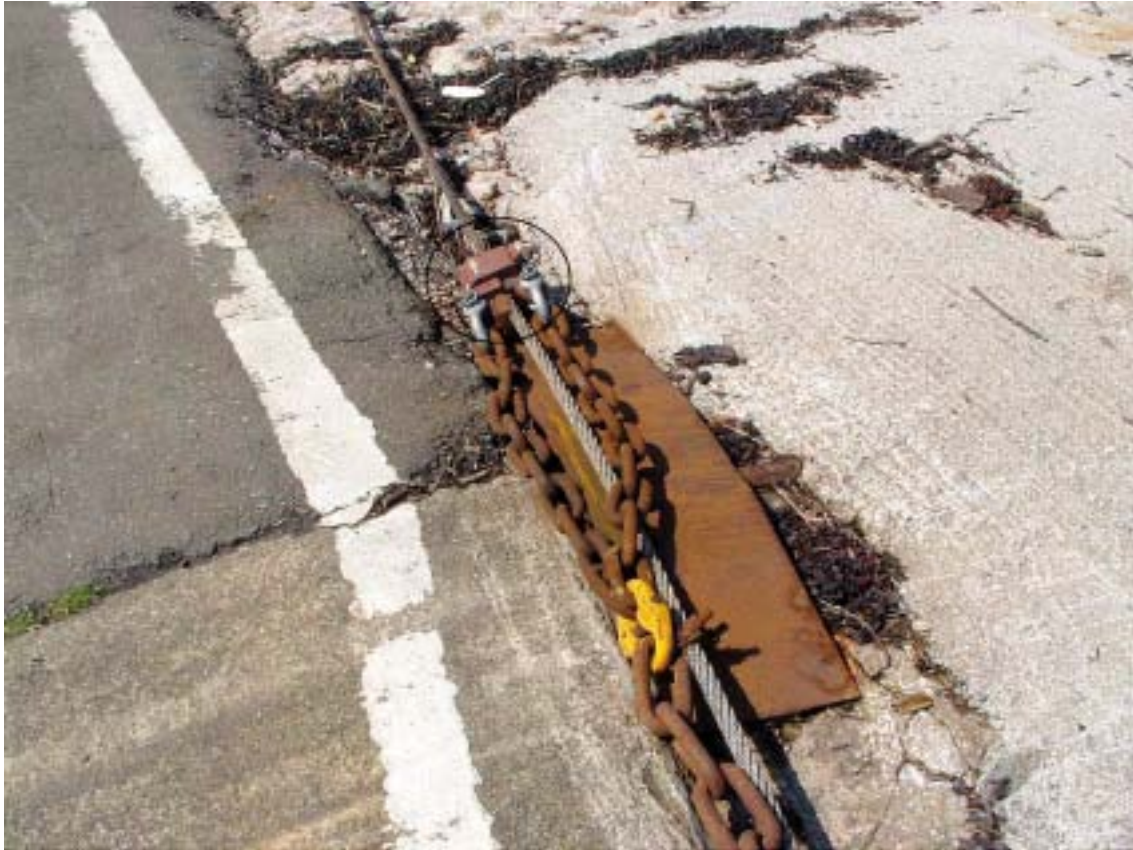
Figure 2 – Wire now attached to chain using carpenter's stopper

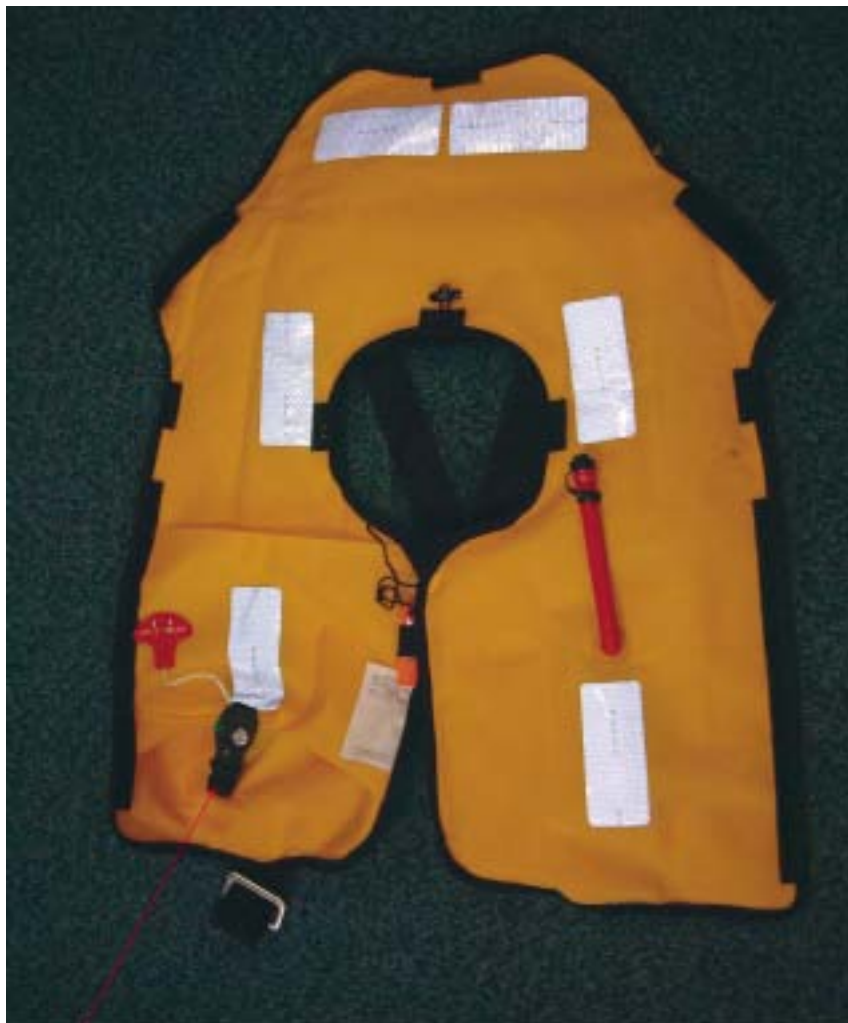
CO₂ bottle missing

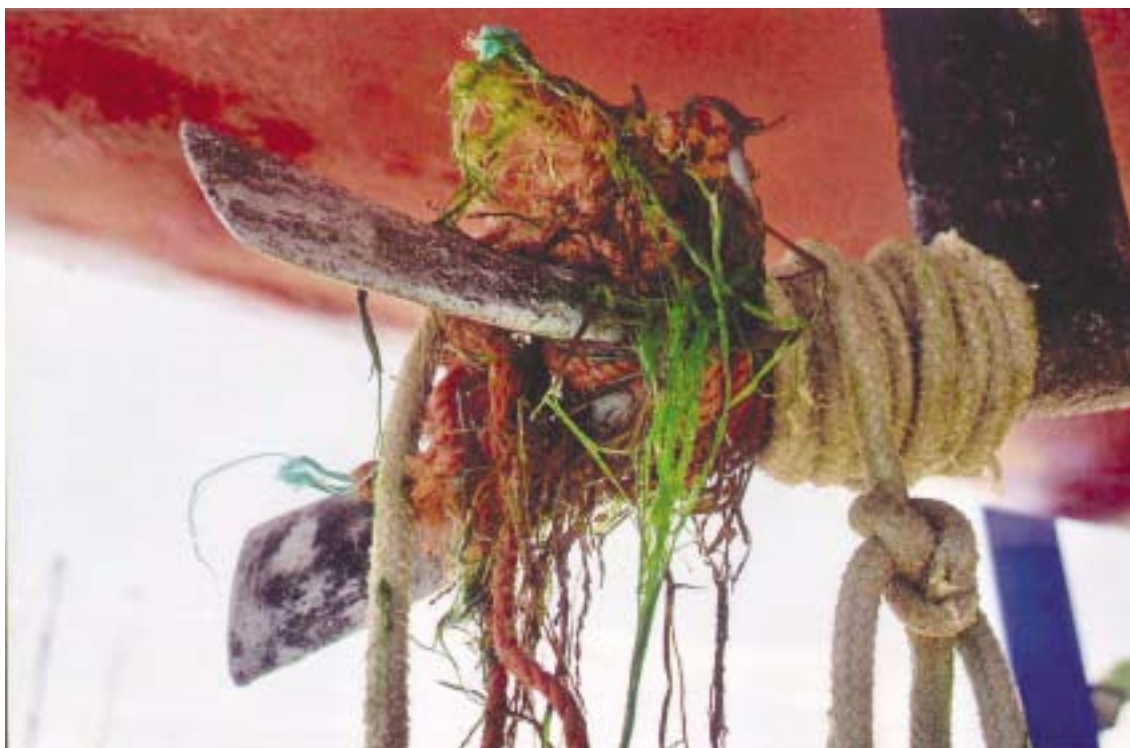
Folding prop with entangled rope

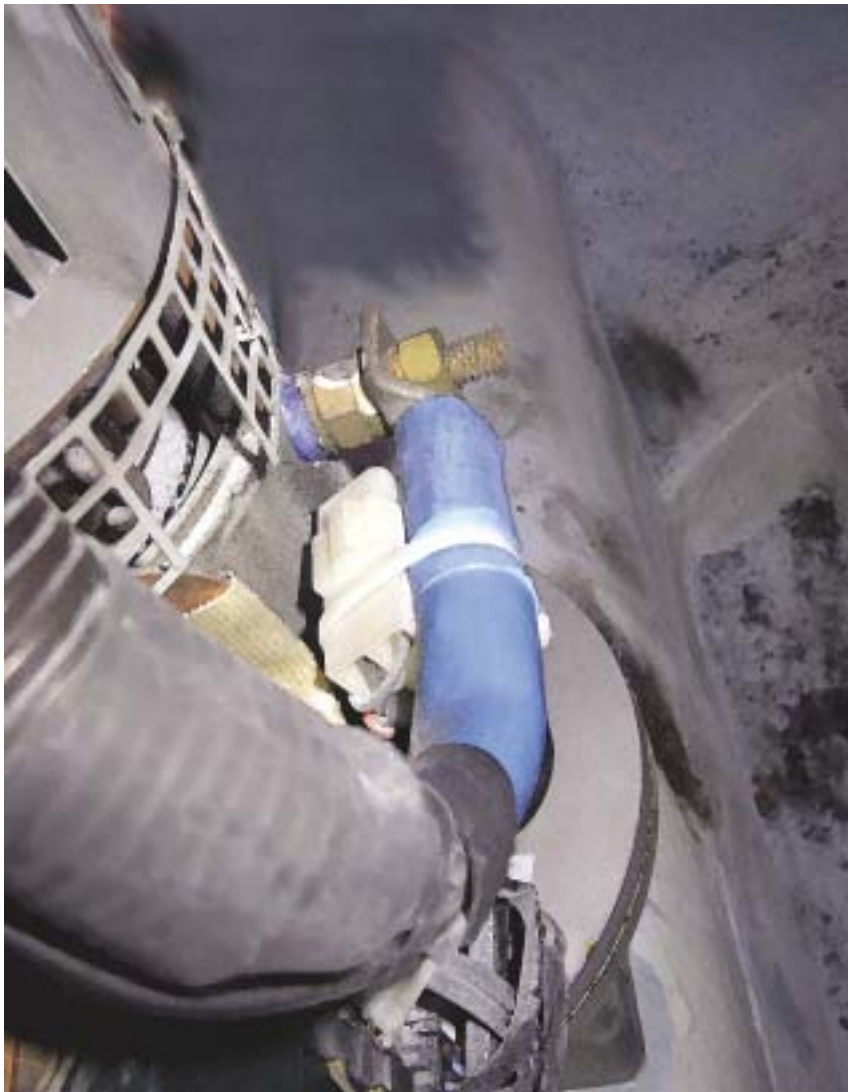
A closer examination found that a metal cover to the brush gear of the bow thruster's motor had been displaced. The cover had then made contact with a terminal on one of the motor's power cables, causing arcing (Figure 1). This sparking had ignited a sail bag.

Figure 1: Bow thruster showing exposed power cables and fire damage

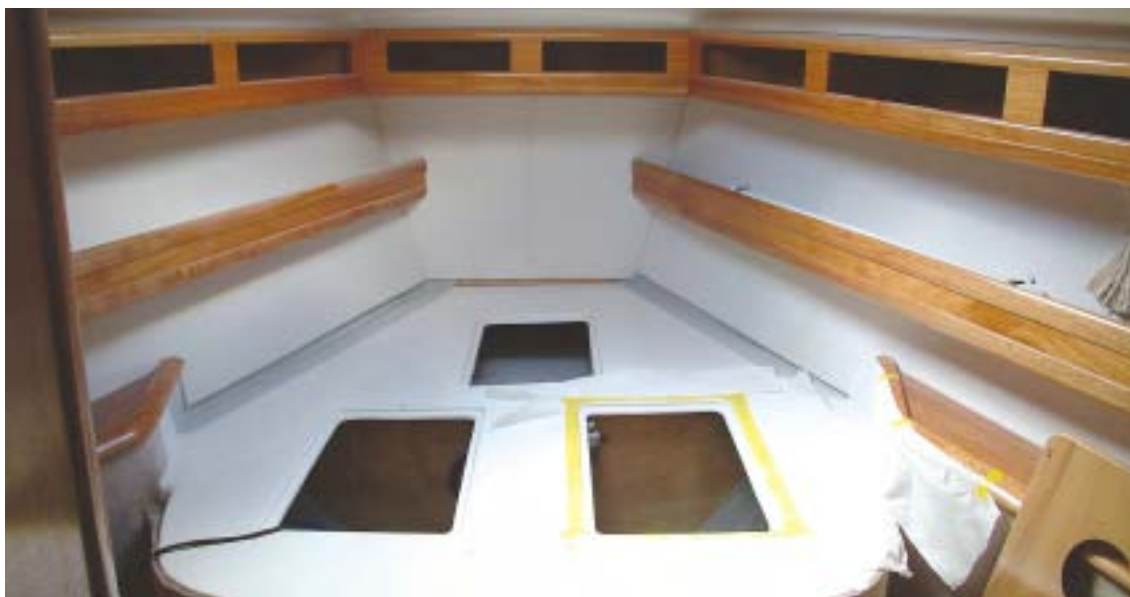
Figure 2: Machinery space with no visible warnings can be easily mistaken for a storage locker
