MARINE ACCIDENT
INVESTIGATION BRANCH

SAFETY DIGEST

Lessons from Marine Accident Reports 1/2005

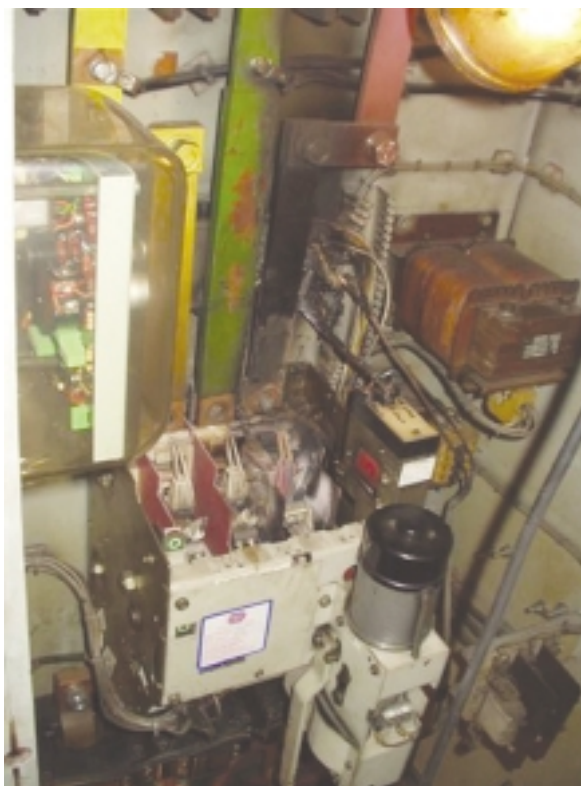
The damage was limited to the area immediately surrounding the contactors of one of the auxiliary generators, the operating mechanism of which had suffered a mechanical failure leading to the fire. The vessel was inspected by the MCA and was allowed to sail with certain restrictions until the affected breaker was replaced. Having loaded, the vessel sailed 5 hours later.

Photograph showing breaker

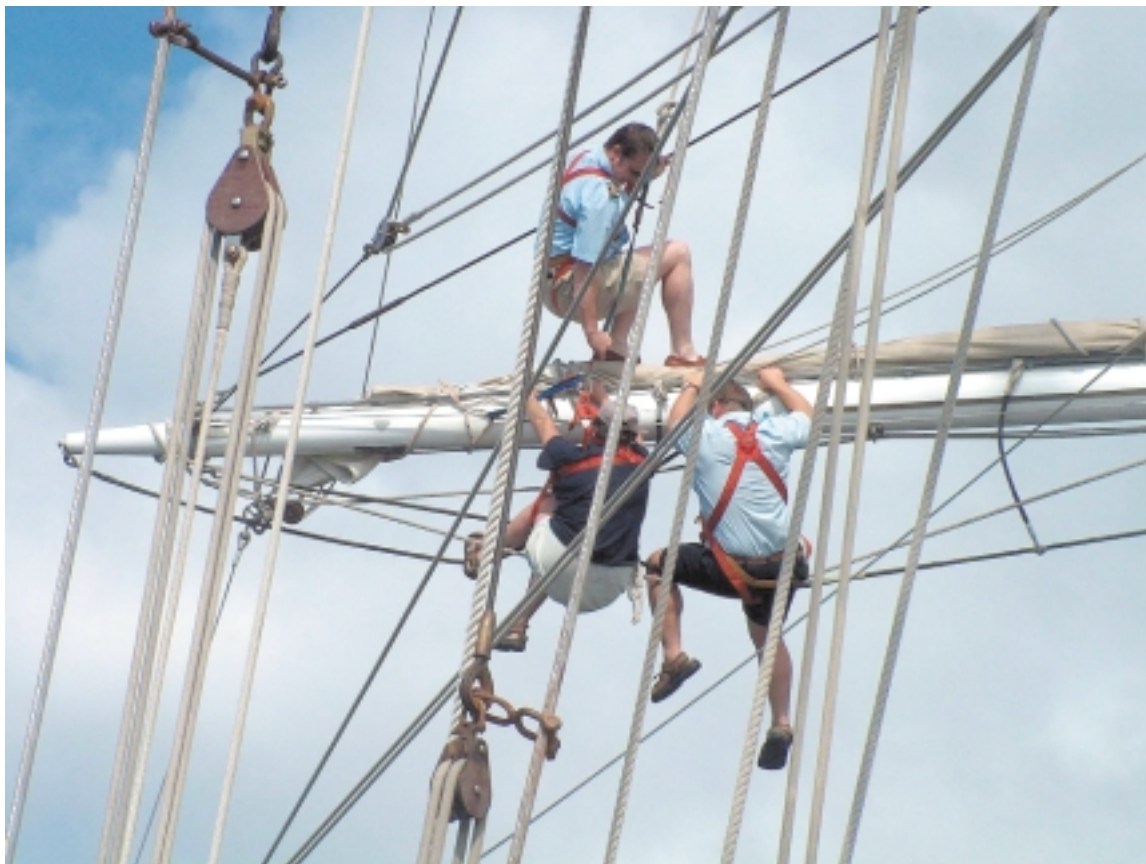
without the strength to return to the upright position. In this position, the thigh straps of the safety harness had slipped down his legs to knee level, allowing the back plate of the harness to ride up to neck level. The unfortunate crew member could not regain position on the yardarm, and his safety harness no longer offered effective protection from falling. The crew member's efforts to regain position allowed the harness to slip yet further. With his shoulders being drawn forward by his body weight, the crew member could have slipped backwards out of the harness and fallen.

Photograph showing the displaced safety harness

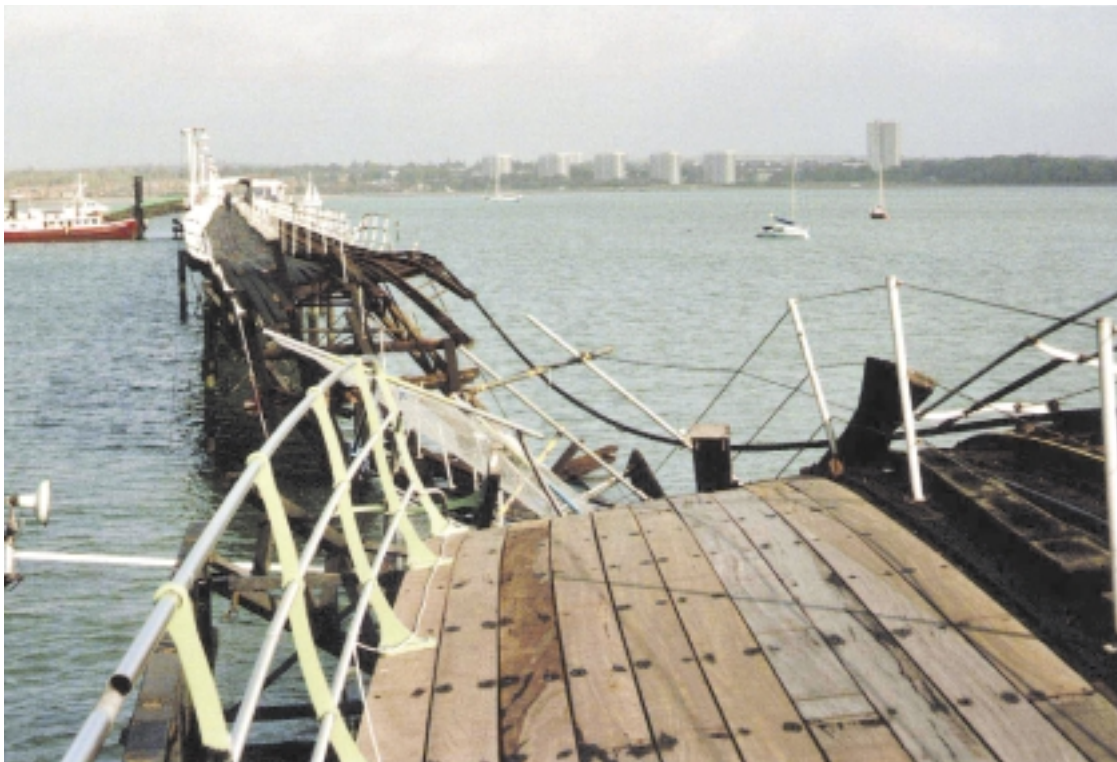
Damage to the pier

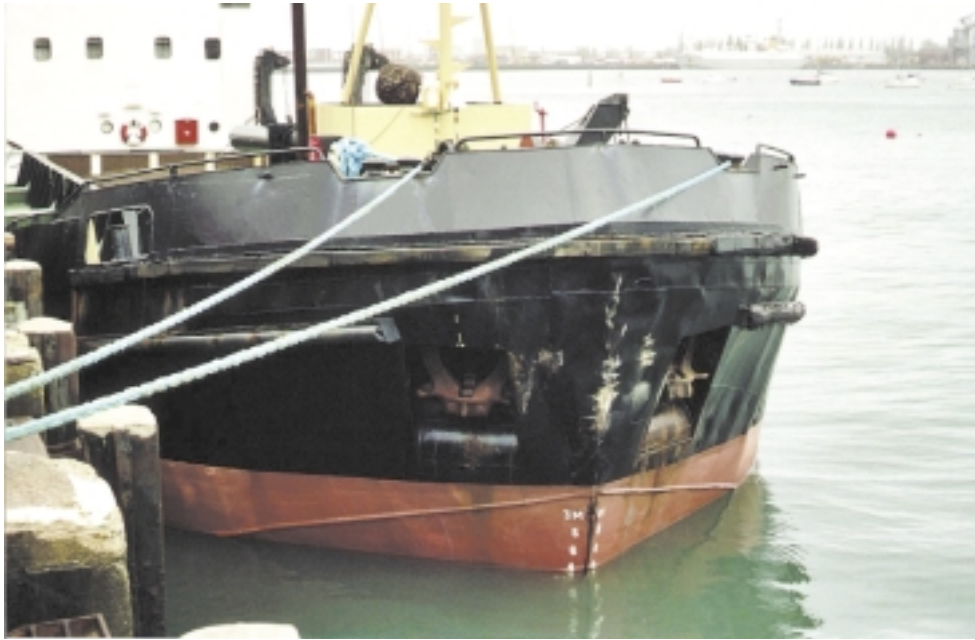
Damage to vessel

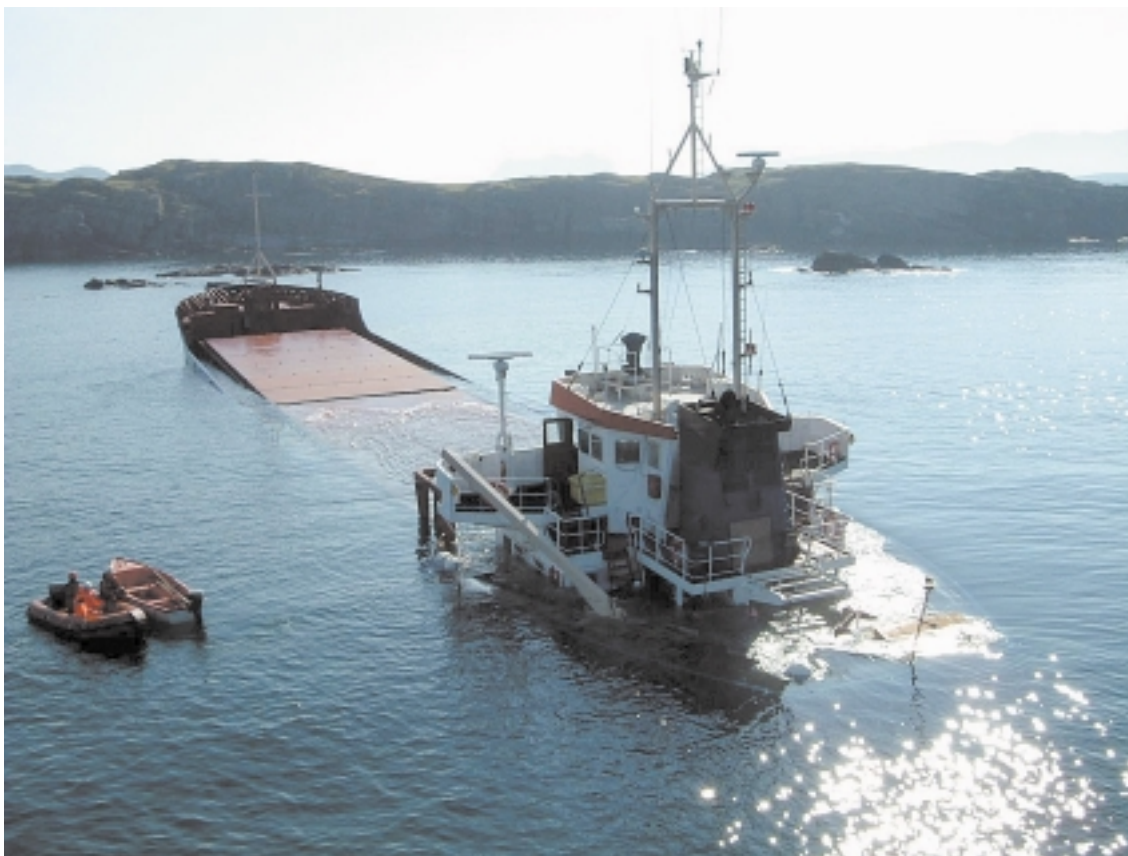
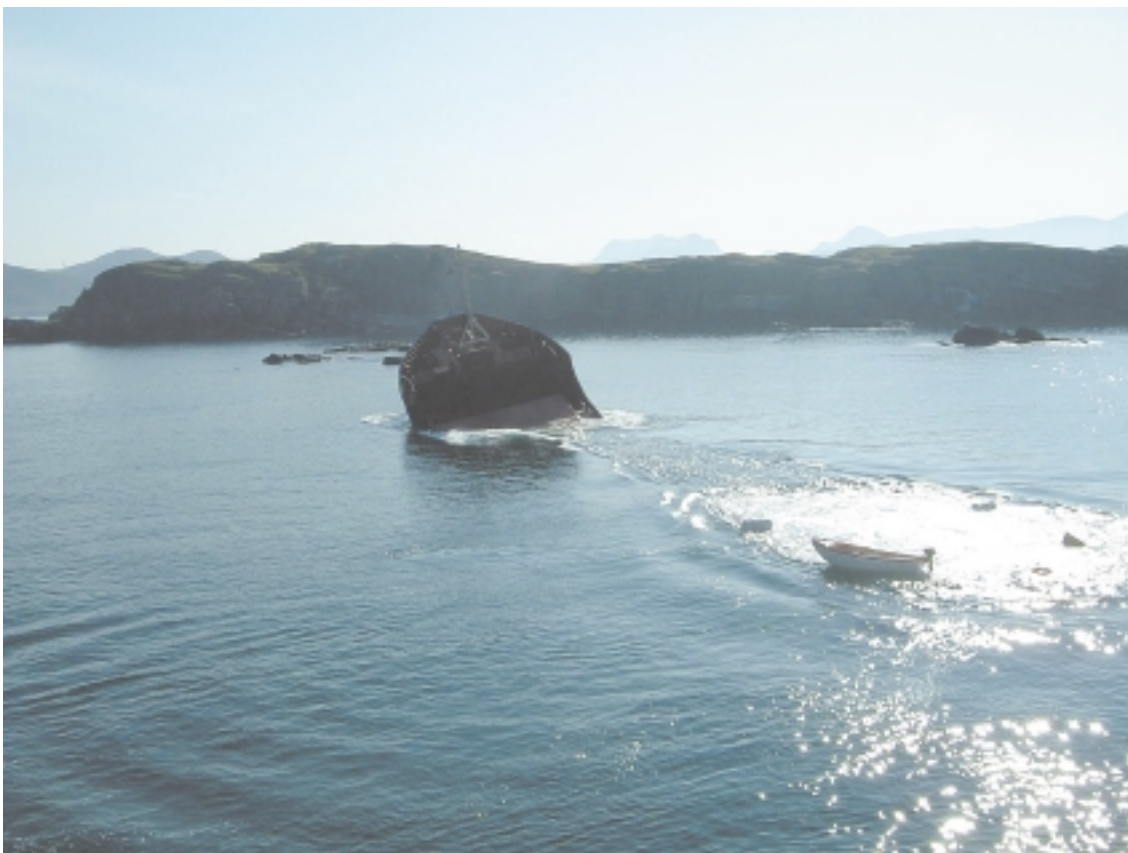
The chief officer fell asleep while alone on the bridge, missing an intended change of course. He was awoken, standing at the engine controls, by the impact of the vessel grounding. The sea was calm, there was no swell and the visibility was good. It was daylight, although the sun was yet to rise. The vessel was stationary aground.

Photographs showing the vessel aground

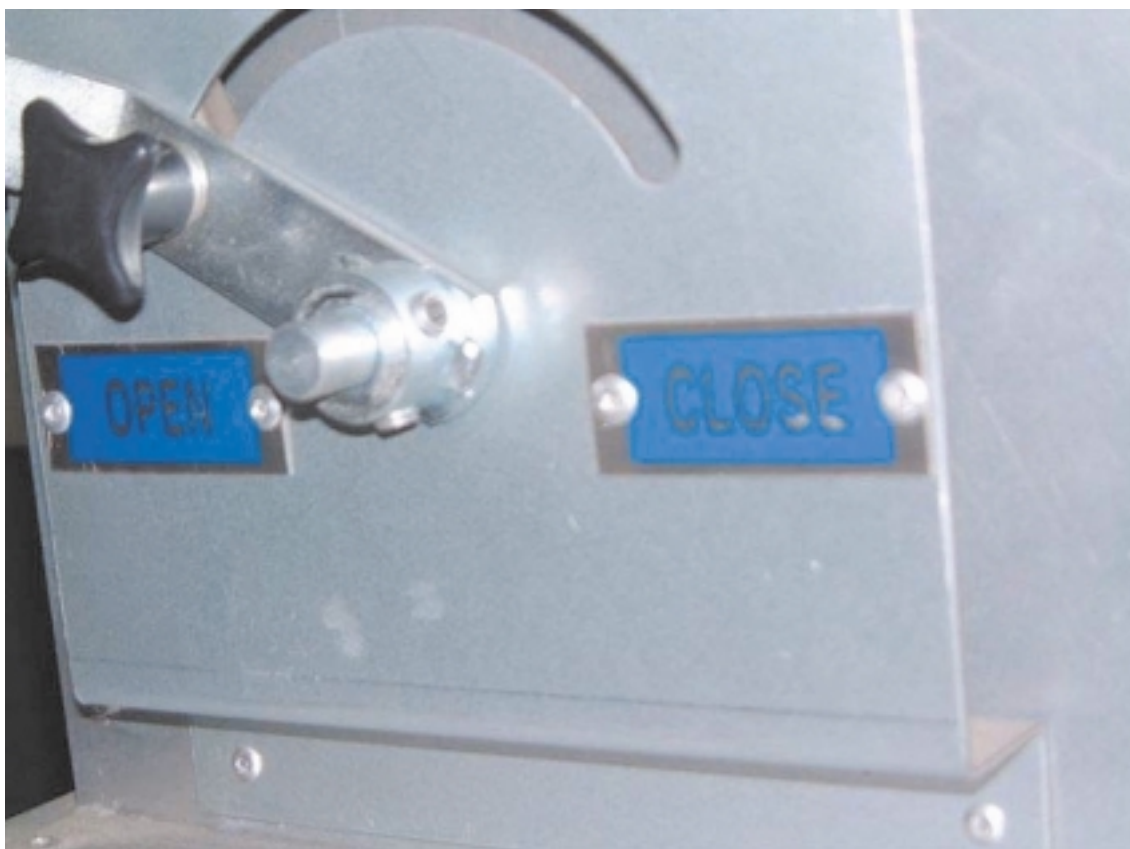
the locking screws on the vent flap handle were slack (**Figure 1**). Both fans supplied a common air delivery duct, and the airflow from the running fan caused the fan on number 1 to rotate in the reverse direction soon after it stopped.

Figure 1: Accommodation fan unit – delivery flap handle

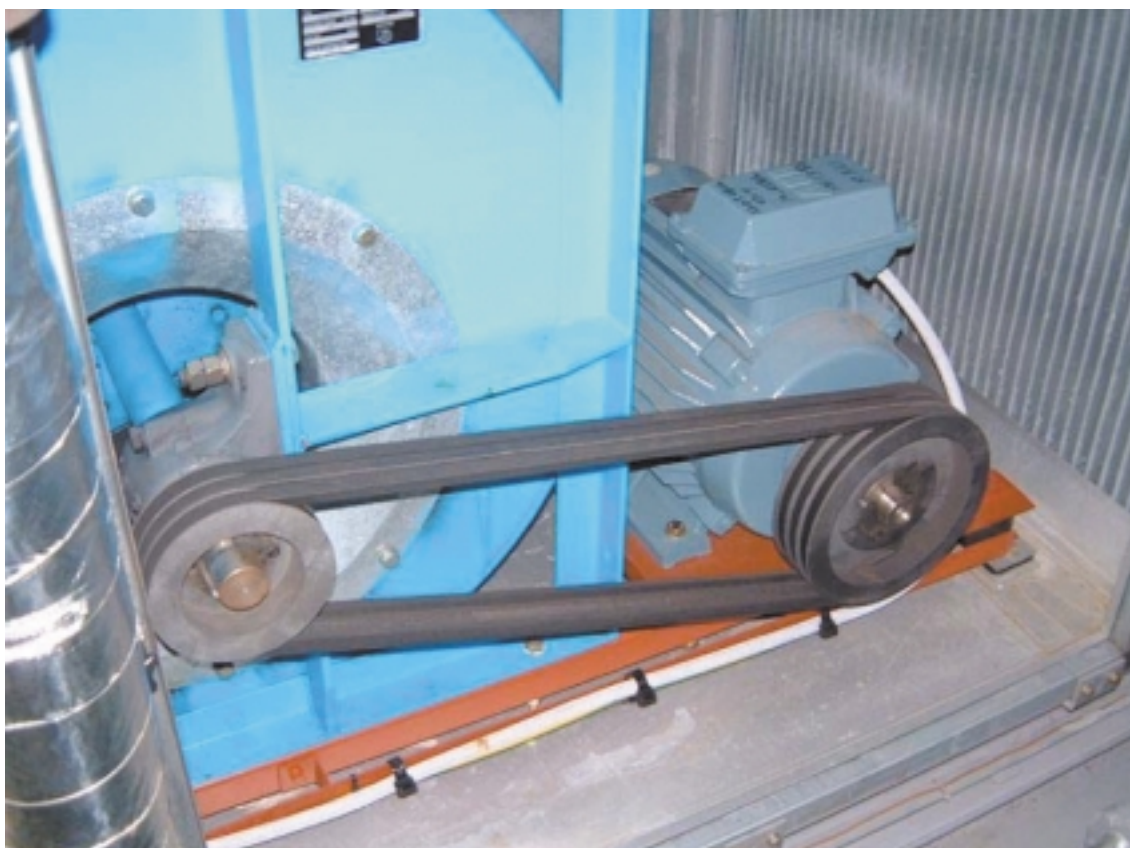
Figure 2: Motor fan unit and vee belts

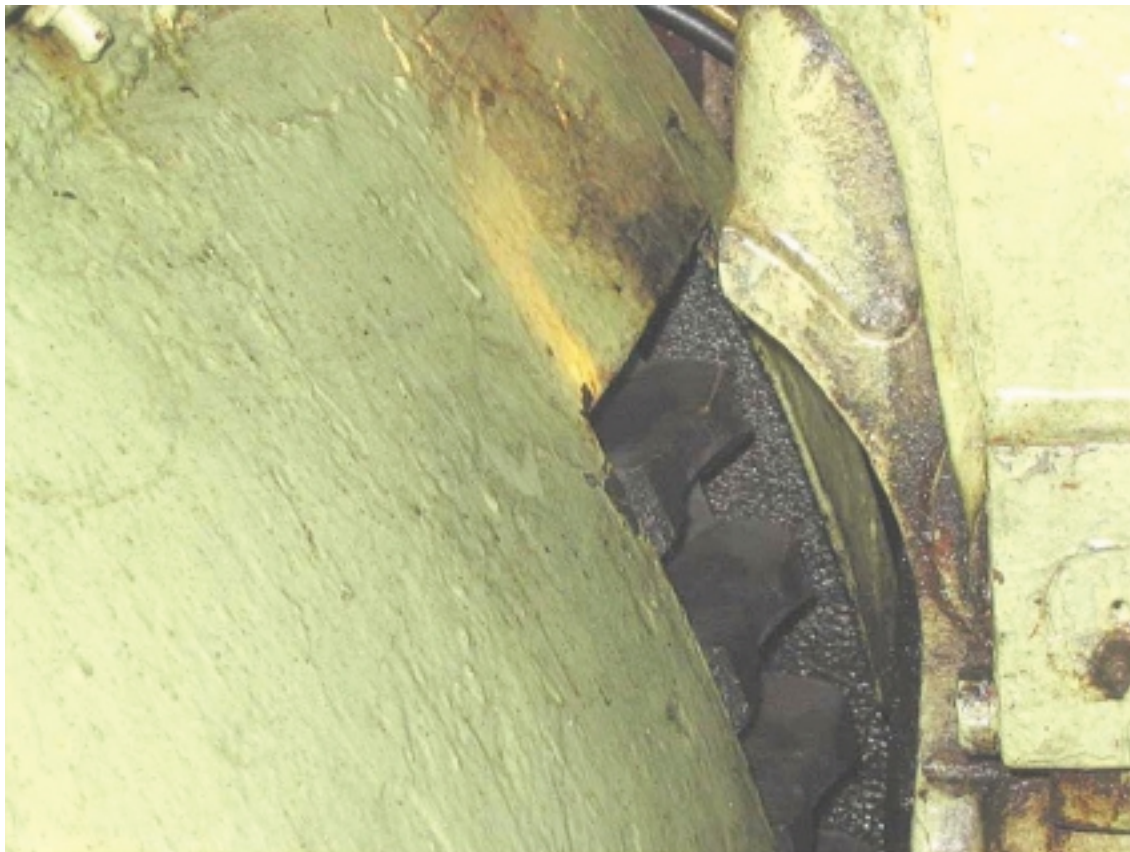
He decided this mess needed cleaning up. In attempting to wipe the area, his hand became trapped in the gap between the turning gear's worm and the flywheel. As the engine was running, his hand suffered severe lacerations.

The gap between the turning gear's worm and the flywheel

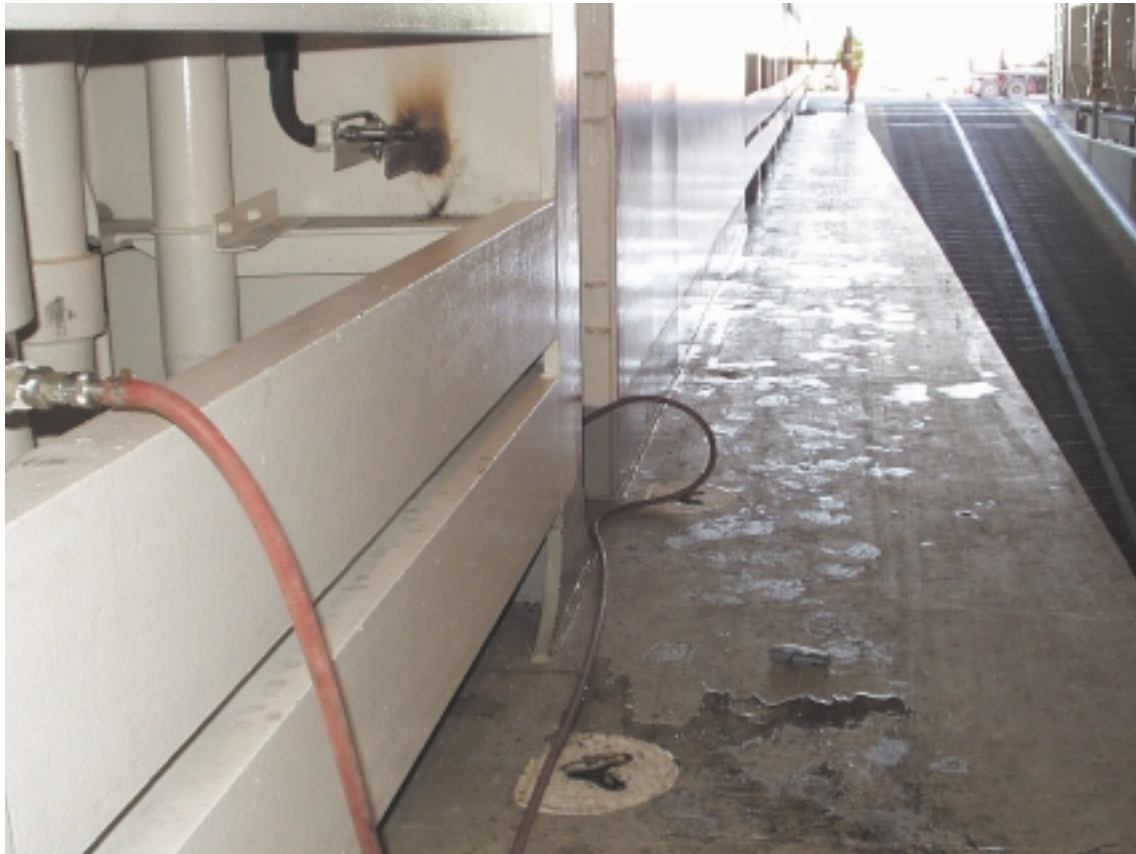
Figure 2: Photograph of the main deck platform showing the hose connected to the water supply

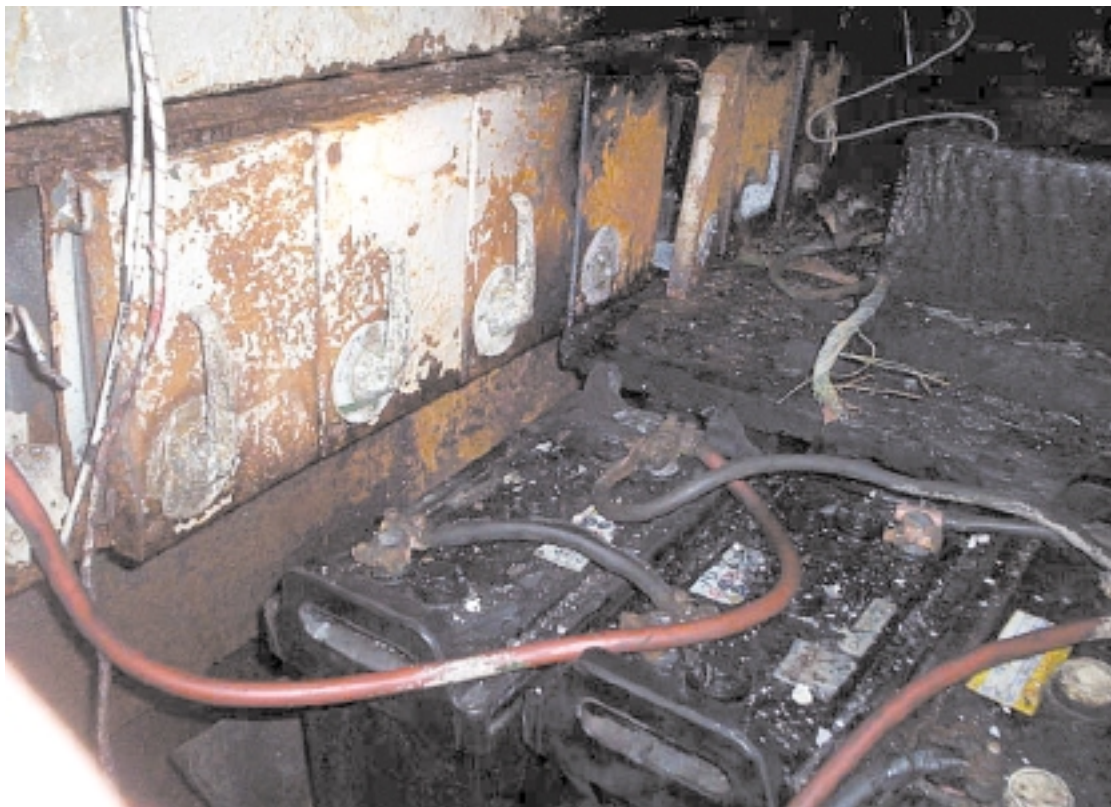
The casualty was towed to a nearby port where the fire brigade attended. They entered the engine room and found no signs of fire, although there were still significant amounts of heat. Damage appeared to be confined to a group of electrical switchboxes just above the battery bank. It was presumed that an electrical fault started the fire.

Damaged area above batteries

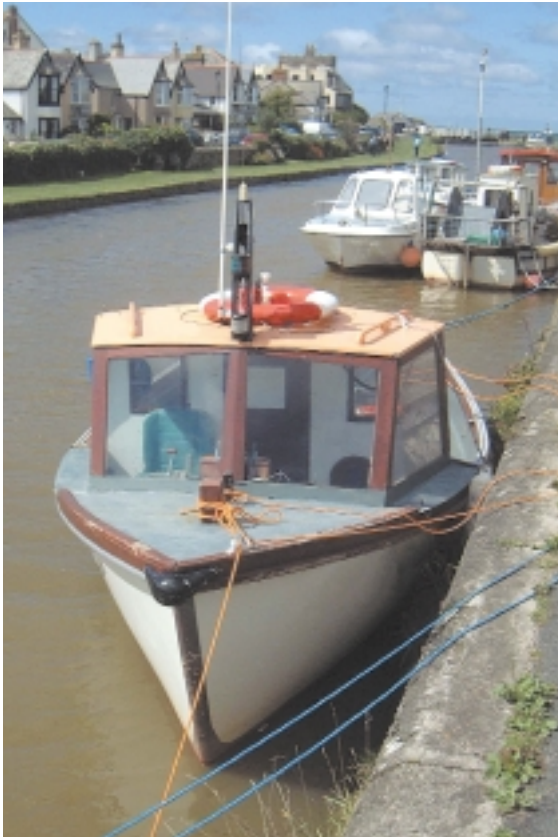
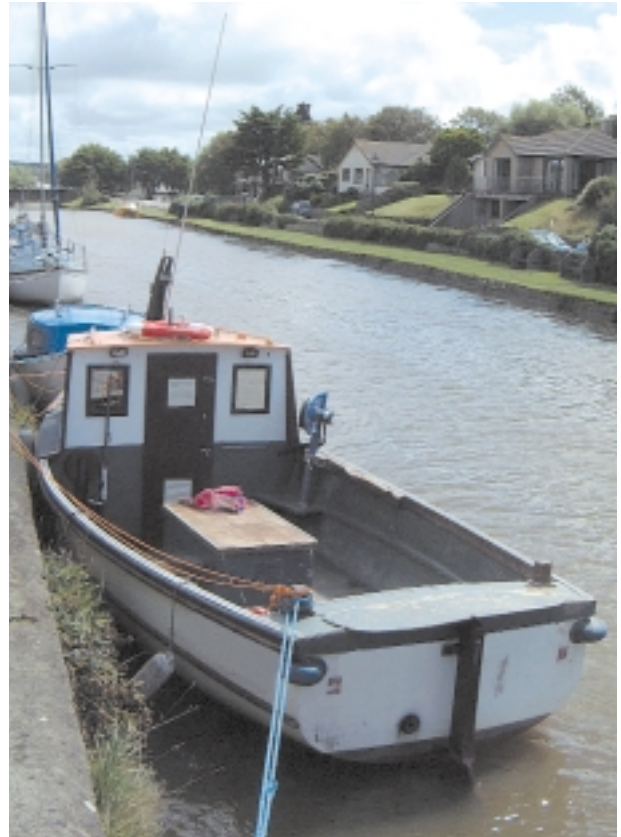
General views of the vessel

The skipper/owner had bought the vessel about 3 months before the accident. The vessel had been fitted with a shooting table, which prevented the back rope coming into contact with the crew when the gear was shot. However, for ease of single-handed operation, the skipper had removed it: a fatal decision.

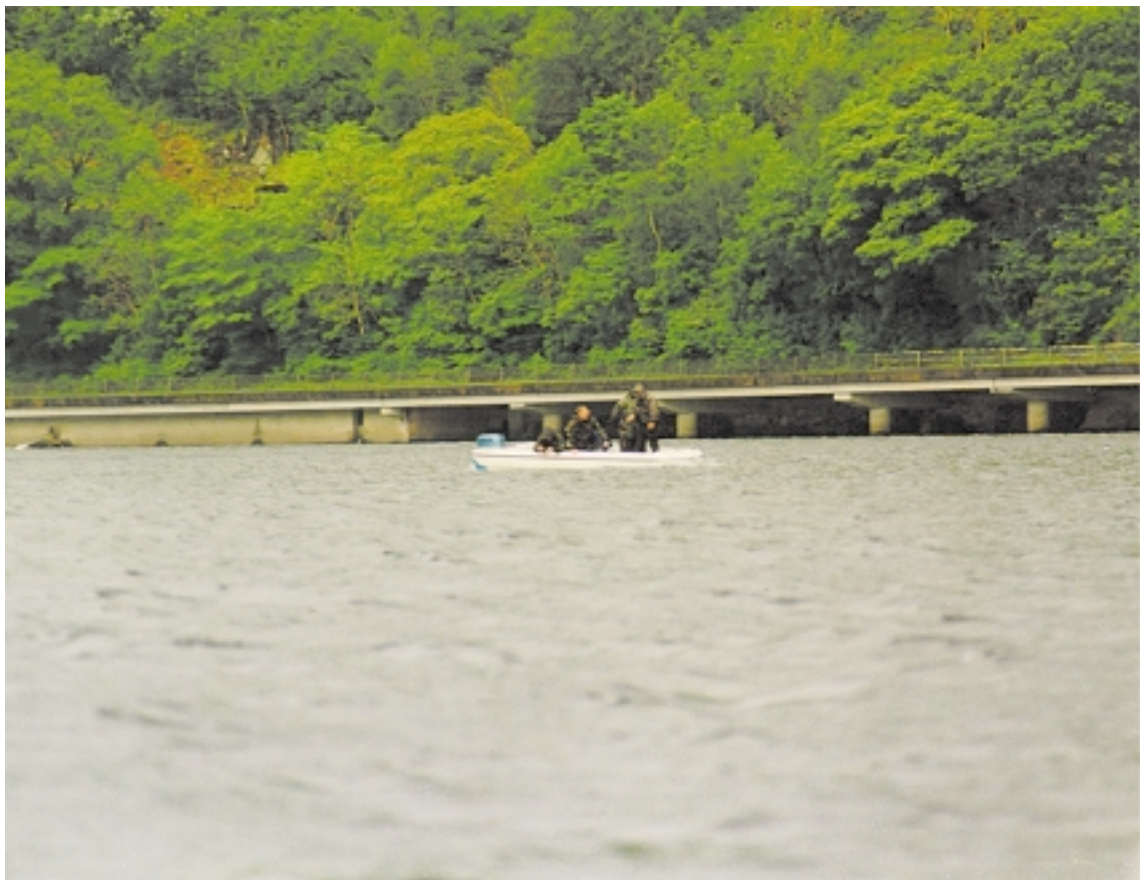
Later inspection and loading trials (see **photograph overleaf**) showed that water had accumulated over a period of time, without anyone's knowledge, and had penetrated the void between the main hull and the deck. This had two serious effects: it caused the boat to sit lower in the water (see **photograph below**), making her more prone to swamping, and the sloshing of the trapped water reduced her stability. The situation was made worse because the dory was overloaded; it was designed to seat four, but on the day of the accident was carrying six people.

Photograph highlighting low freeboard

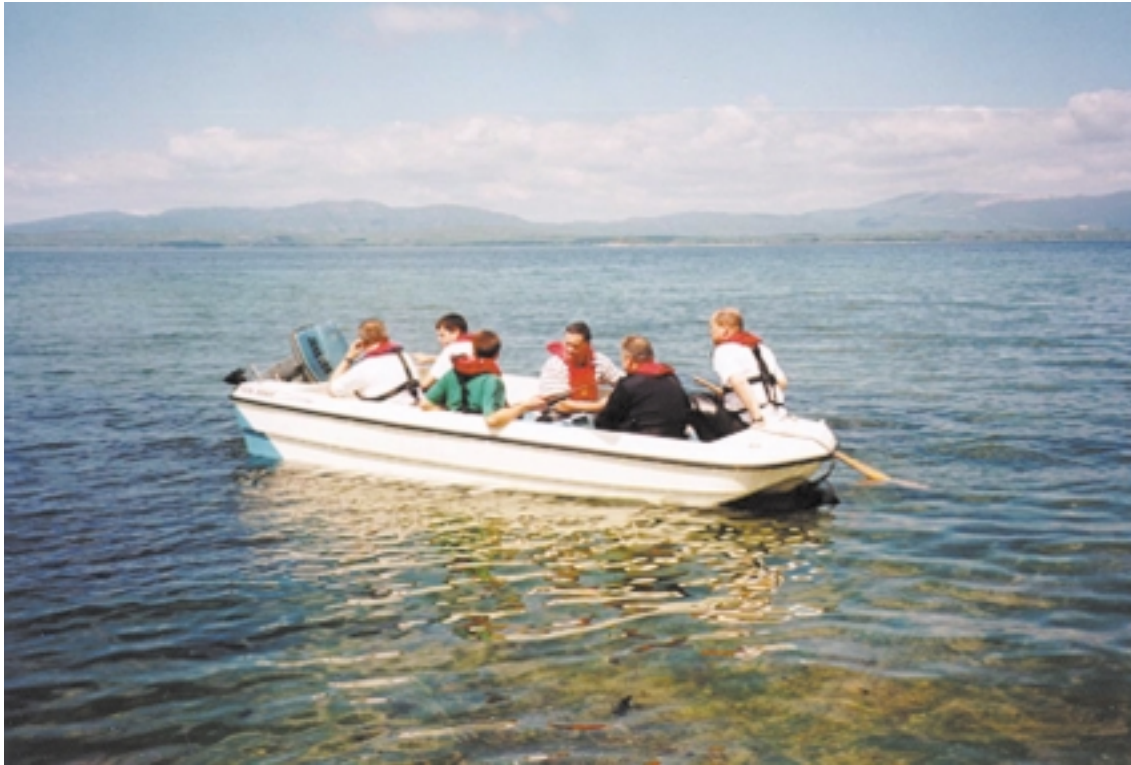
Photograph taken during loading trials to assess the freeboard

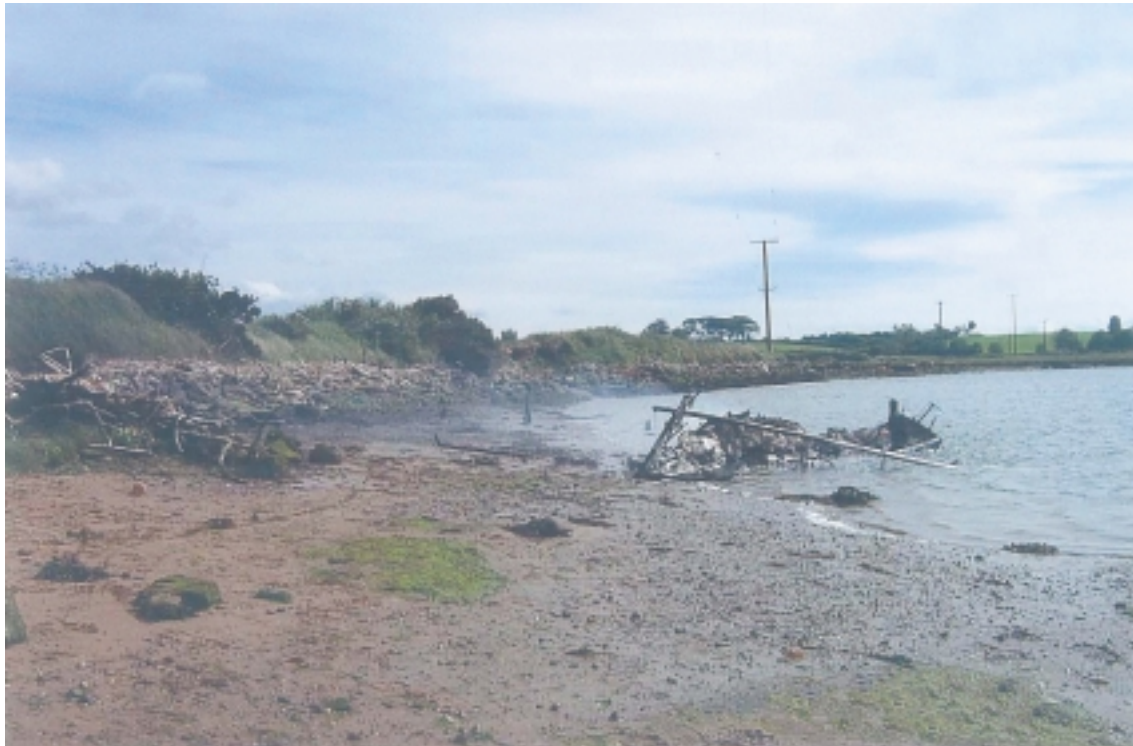
The yacht was totally destroyed by the fire.

1. It is vitally important to know the height of your masthead above the waterline, and the existence and height of any hazards you are likely to encounter. Heights above MHWS of cables and other overhead obstructions such as bridges will normally be found on charts, but this stretch of river was uncharted. Warning signs and other information have been distributed since this accident.
2. The course of the river had almost certainly undercut on the outside of the bend, slowly bringing the deep water closer to the line of the cable over time. All concerned, but particularly electricity supply companies, and other organisations responsible for overhead works close to or crossing waterways, should ensure that such effects are closely monitored. Since this accident, the height of these cables has been raised.
