**MARINE ACCIDENT
INVESTIGATION BRANCH**

SAFETY DIGEST

**Lessons from Marine
Accident Reports
3/2006**

No 3/2006

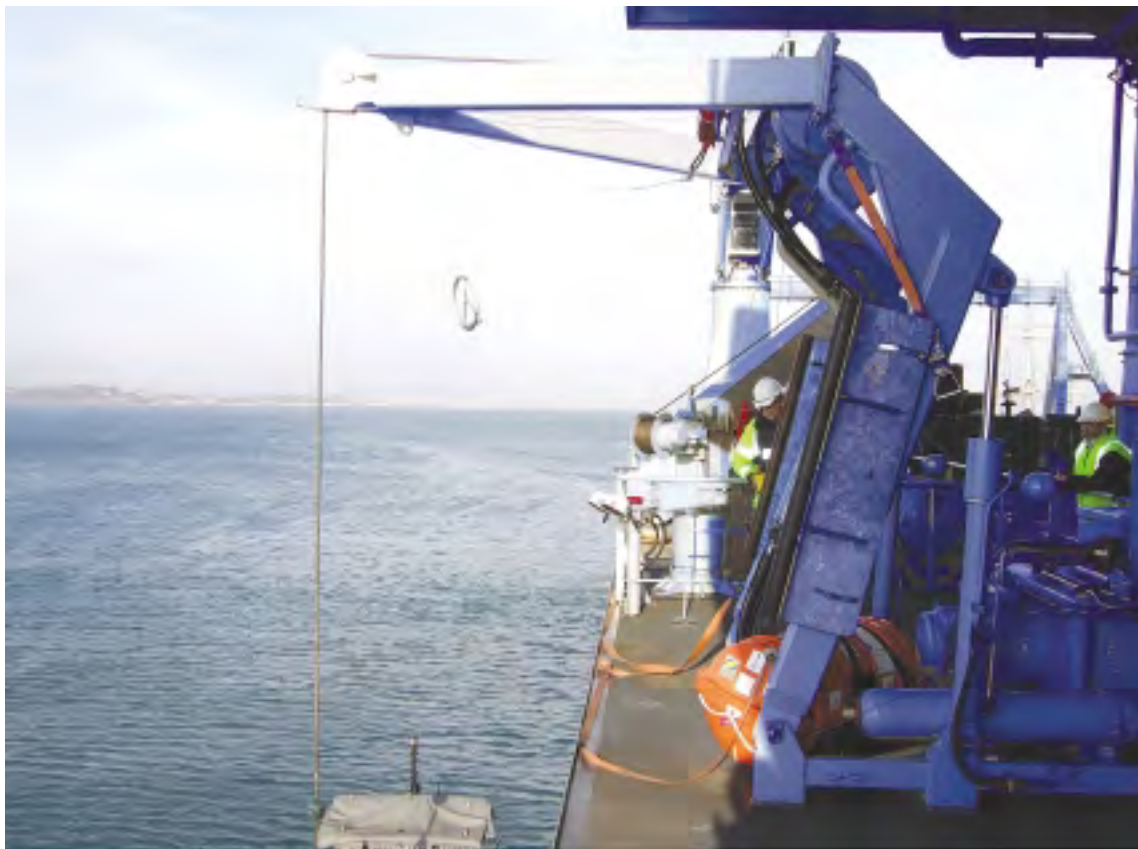
Figure 1 – FRC davit

The FRC, a 7 metre long rigid hulled inflatable boat, was stowed in a dedicated davit and launched using a single wire arrangement (Figure 1). The boat was connected to the wire via a quick release hook (Figure 2), which operated in the "off-load" mode, such that when the boat was lowered into the water, the hook automatically released once the weight of the boat on the hook was reduced to below 12kgs.

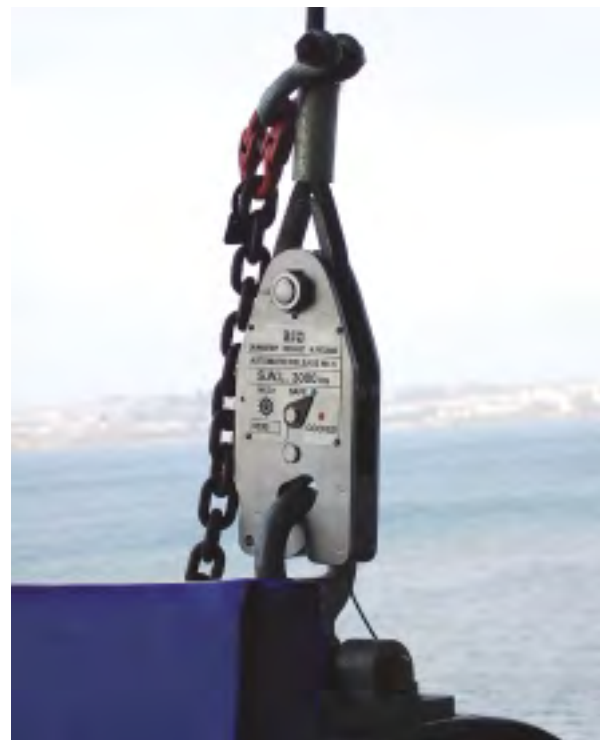
Figure 2 – Quick release hook

Once ready, the crew indicated to the winch operator that the FRC could be lowered into the water. The boat then started to lower and almost immediately stopped, at which point the quick release hook opened and the boat fell just under a metre into the water. The crew were shaken but unharmed by this accident. Following an examination of the davit and the fitting of a replacement hook, as a precaution, the FRC was safely recovered.

Investigation into the cause of the accident revealed that, as the hook released the davit was observed to judder. Subsequent tests showed that when the winch motor was stopped (button released) from the fast lower (fully depressed) position, the davit assembly juddered considerably, and it is thought that this movement in the davit arm could have

been sufficient to cause the off-load release hook to open, allowing the boat to drop into the water.

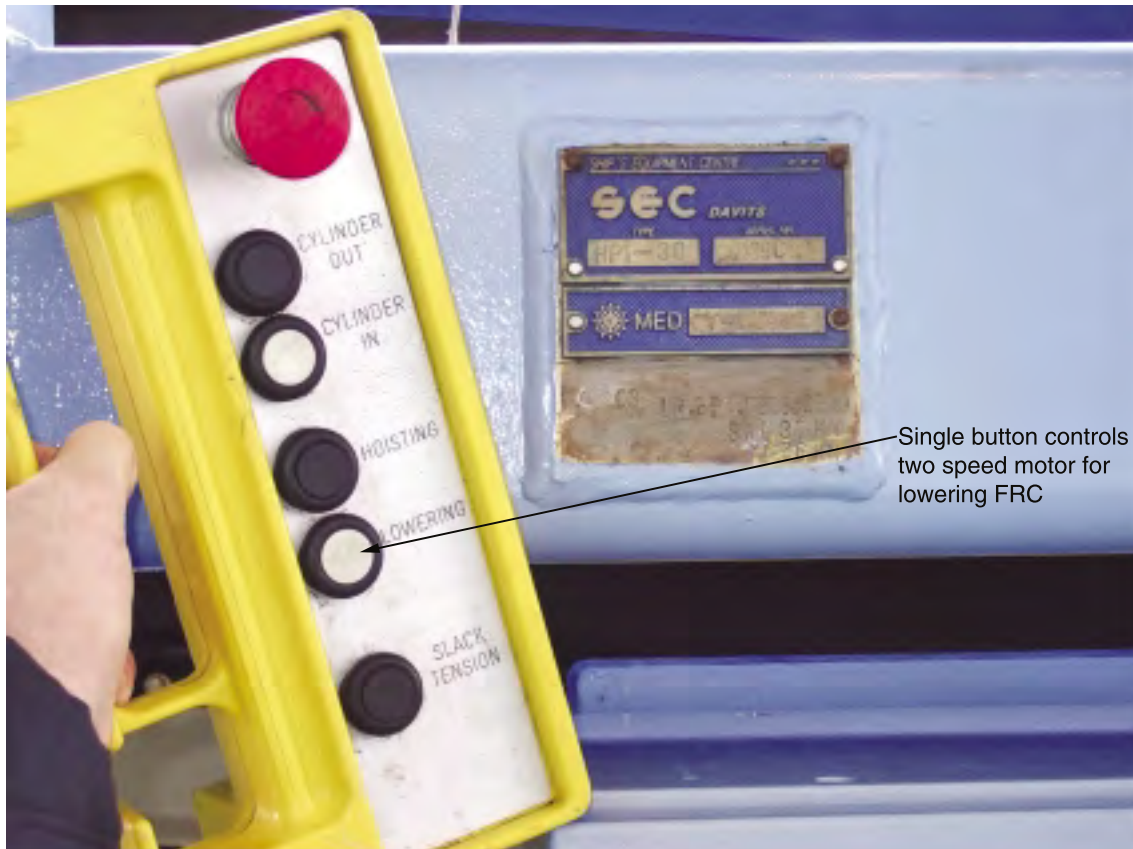
Figure 3 – FRC davit controller

The davit itself was hydraulically operated and was controlled by a winch operator using a control unit on a wandering lead. This unit was fitted with push-buttons which controlled the position of the davit arm and the hoist and lower speed of the winch motor (Figure 3). The hoist/lower winch was controlled via a two speed motor, operated on single button controls such that the operator pushed the button partially in to obtain slow speed operation (0.6 m/s) and fully in to obtain the fastest speed (1.3m/s).

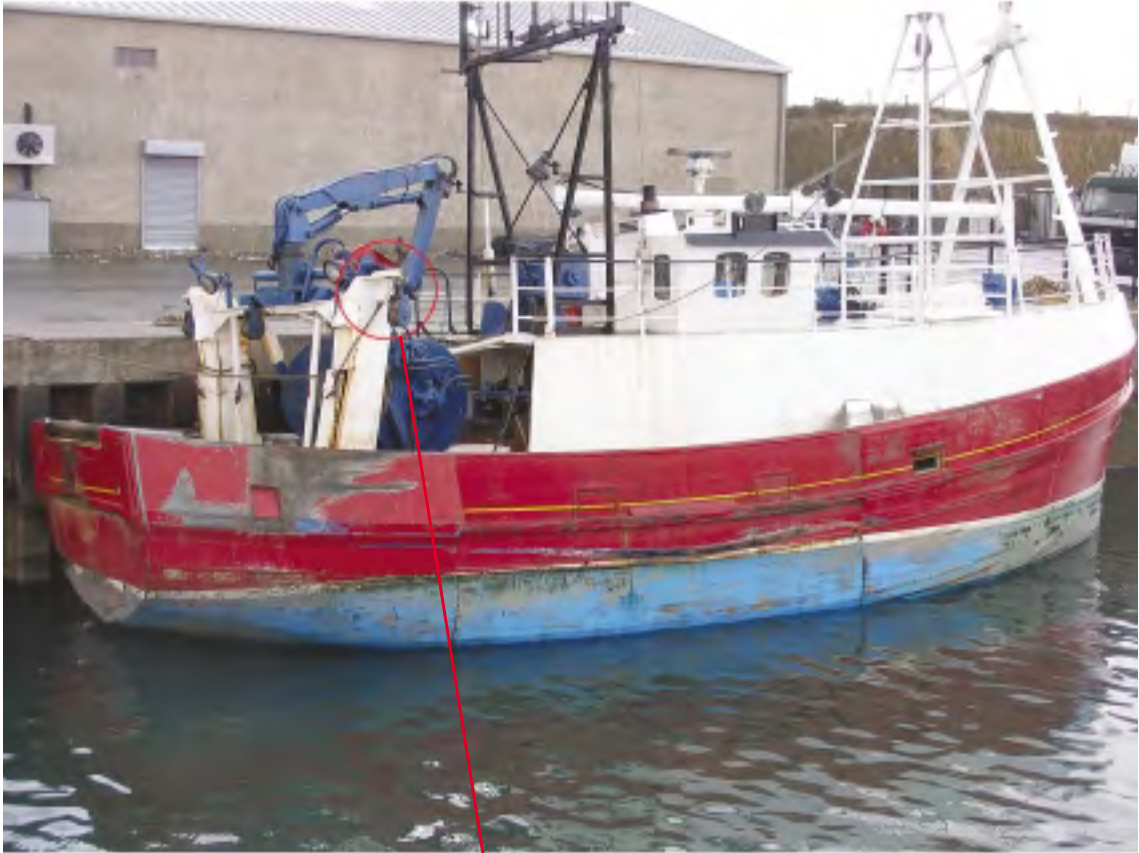
Photograph highlighting initial contact point, and showing scrape marks to starboard side

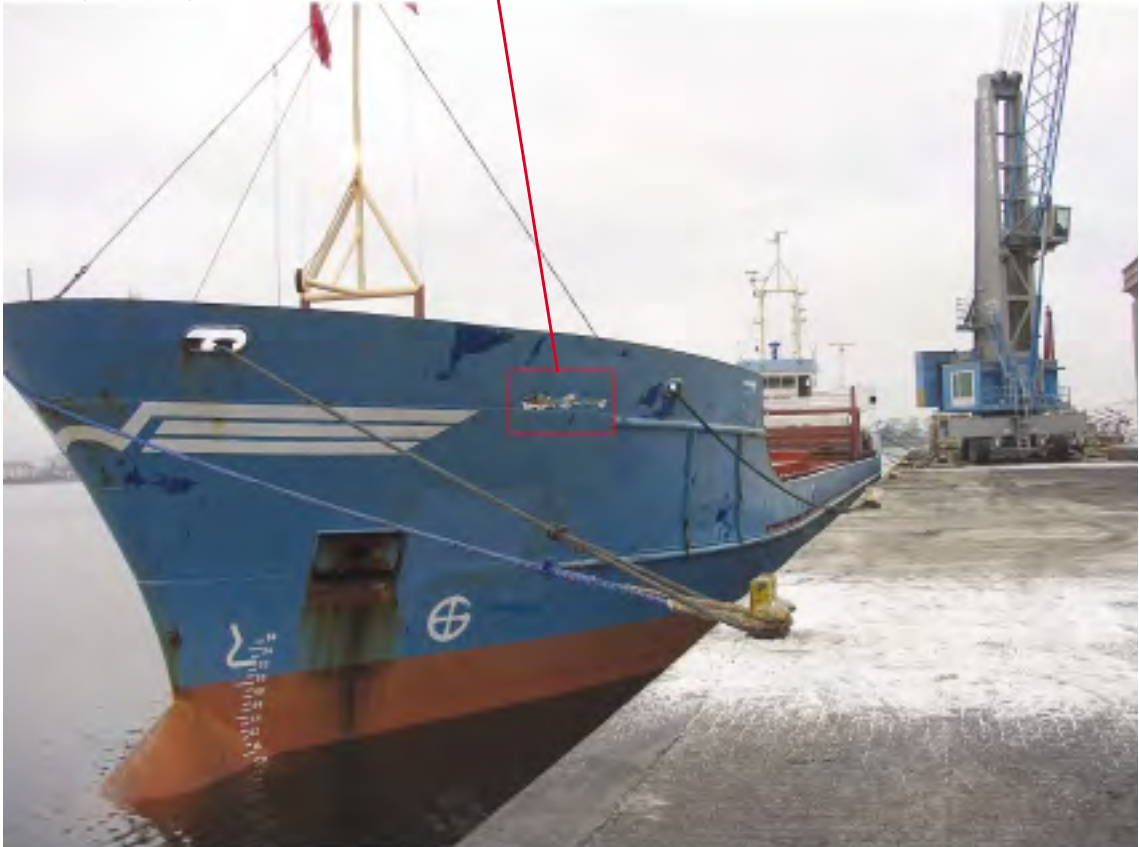
Damage to cargo vessel

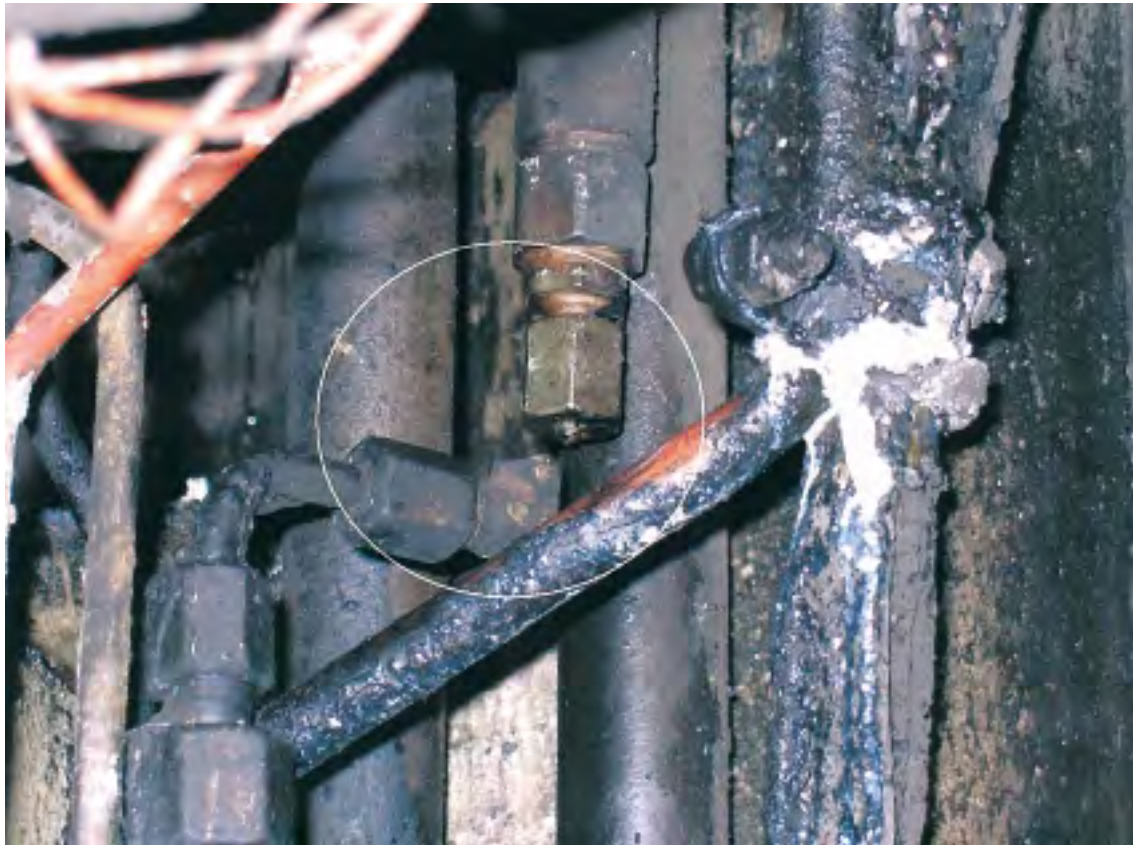
Figure 2 – Fractured fuel pipe

Subsequent examination revealed the cause of the fire to be a fractured fuel gauge pipe

(Figure 2) on the low pressure fuel line to the engine, which allowed fuel to spray onto the turbocharger and be drawn into it, thereby igniting. Examination of the other, similar, auxiliary engines revealed that a support bracket for the gauge line was missing on the engine in question and, indeed, appeared never to have been fitted from new.

1. Pipework support brackets must be examined regularly to ensure they are well designed, secure and adequate for their intended purpose.
2. Capillary gauge pipeworks are always vulnerable to breakage or leakages, particularly over a period of time. Alternative monitoring systems do exist, in the form of electrical transducer systems which remove the need for the use of susceptible capillary pipework. Use of such monitoring equipment should be considered, particularly for older, more vulnerable designs of engines on systems carrying flammable fluids such as fuel and lubricating oils. Alternatively, if such electrical monitoring is deemed inappropriate, for local monitoring, consideration should be given to fitting isolation cocks or valves in the capillary pipework at, or close to, the entablature (or pump casing) which can be kept closed under normal operation and opened only for sufficient time to read the gauges, when required.

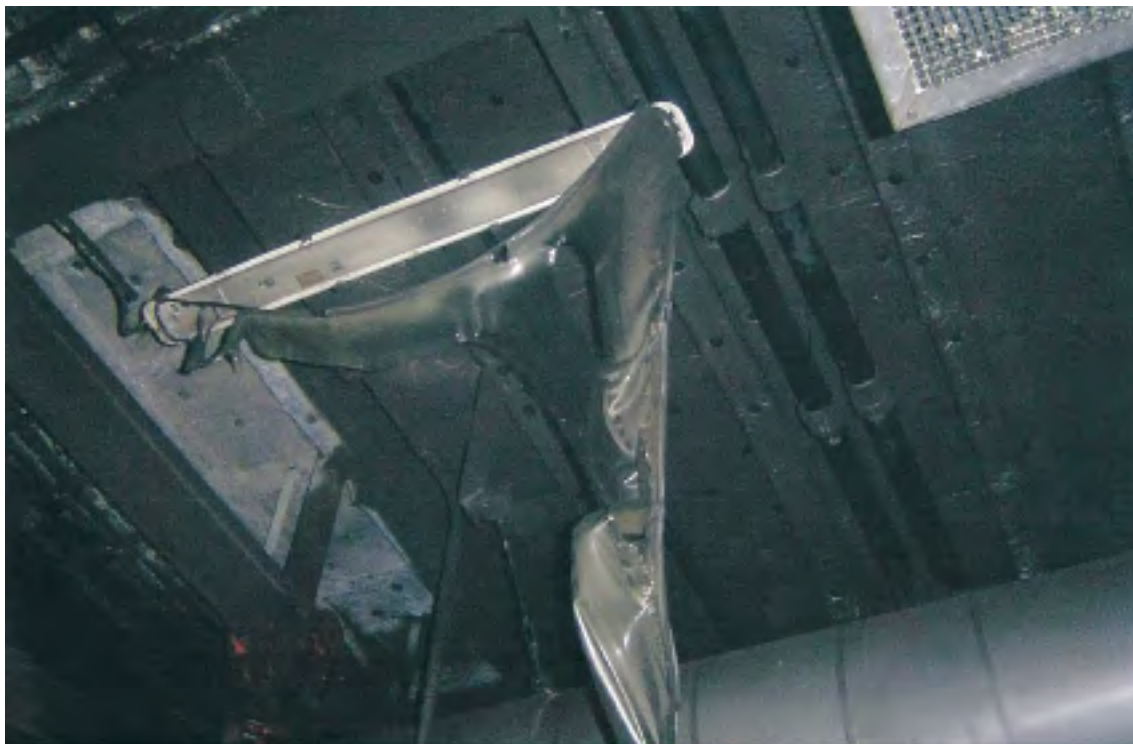
Figure 3 – Burnt out cabling

The fact that the vessel lost all main electrical power shortly after the fire started, was found to have resulted from damage to critical cabling passing over the burning engine. As a

result of the heat generated, the cabling was burnt (Figure 3) and fused, damaging the 24volt control to the vessel's Power Management System (PMS), causing it to fail. Although the emergency generator started correctly, on sensing loss of main power, failure of the PMS, early in the series of events, prevented use of the vessel's other generators located outside the auxiliary engine room. The PMS control panel was located in the auxiliary engine room, seat of the fire, and was therefore inaccessible for manual operation.

3. The existence of *single points of failure* is critical to the safe operation of any vessel and should be evaluated through a risk assessment approach. Where such possibilities are identified, efforts should be made to remove, or reduce, the possibility of such failures endangering the vessel's safe operation. In this instance, had the critical cabling been run through a safer route, it might not have been damaged as a result of the fire, and the ship's staff might have been able to utilise the vessel's other stand-by generators, thereby averting a total blackout situation which clearly endangered the vessel in a busy seaway. Such cable routings are ideally considered at a vessel's new building stage. However, for existing vessels, cable routings may be changed, or protection provided in vulnerable areas.

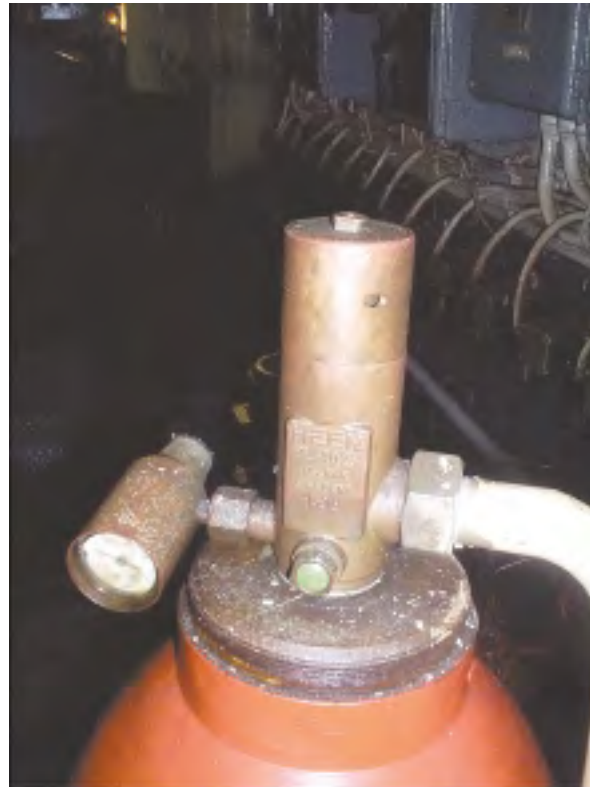
Figure 2 – Photograph showing cylinder with no transportation cap in place

To gain access to the control room from the generator room, the crew had to negotiate two steps and a doorway with a raised cill before stepping down into the room (Figure 1). Two crew members were lifting the last cylinder, base first, over the cill when the unprotected release valve (Figure 2) was knocked against a step, causing the valve to open.

The rapid escape of gas caused the cylinder to “fly” into the control room, where it hit the switchboard and tripped a breaker, causing a blackout. Two crew members were injured; one was detained in hospital with bone fractures.

1. Manual handling of large gas cylinders is hazardous in a number of ways:
 - They are heavy: lifting 123kg in an awkward space is likely to cause physical injury, either by over straining or by dropping the cylinder. Consider using a correct cylinder trolley which has wheels and lifting points, and can make the task of moving a heavy cylinder in a restricted space considerably less arduous.

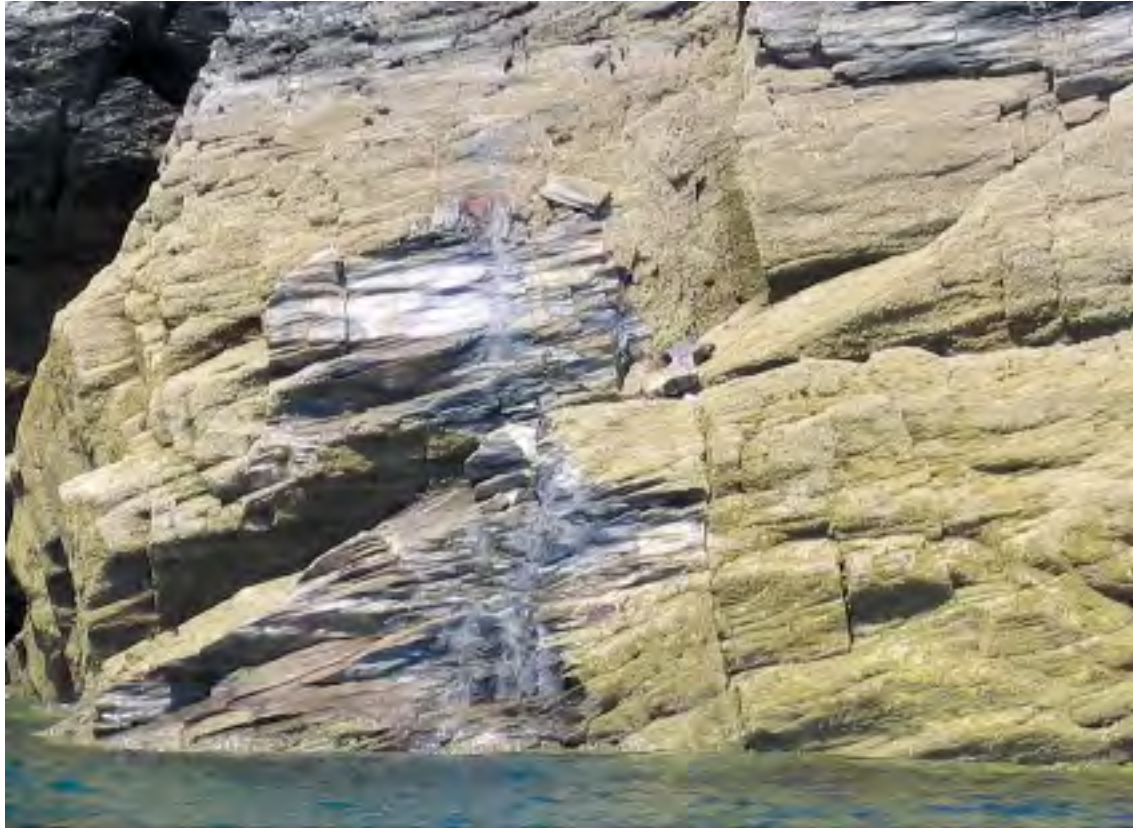
Scrape marks on cliff face caused by bulbous bow

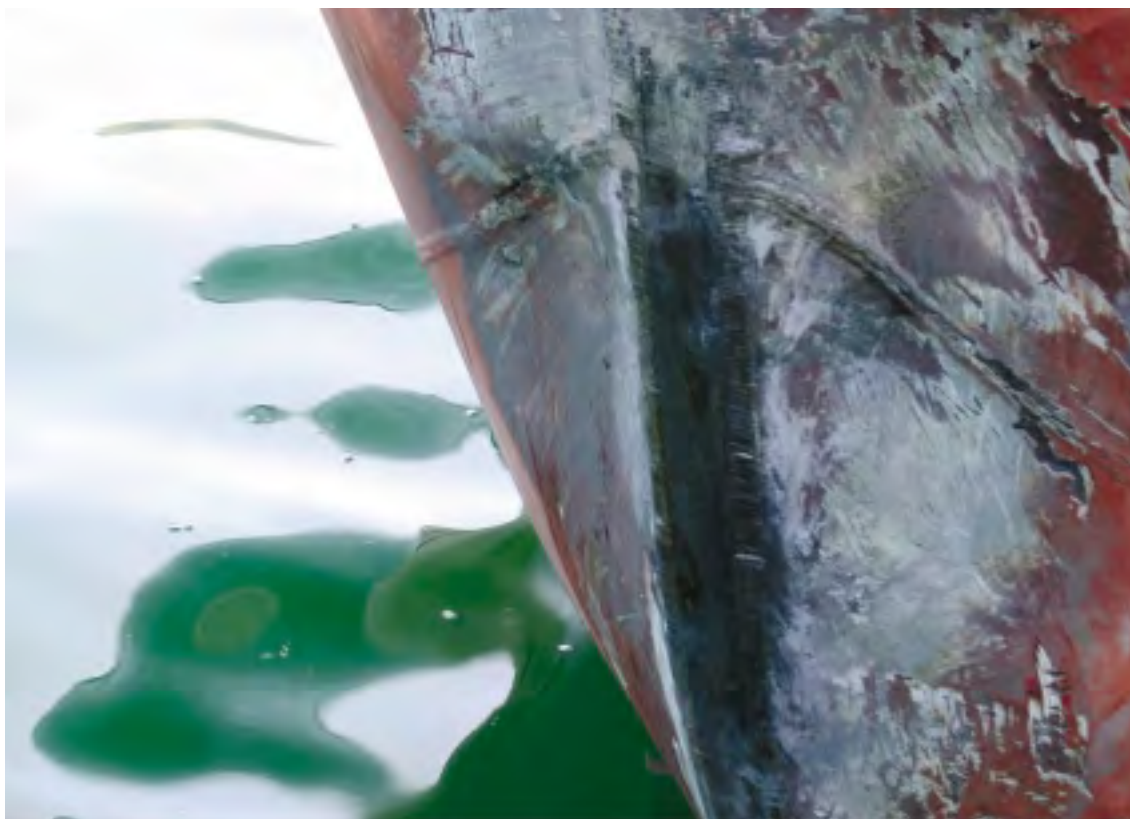
Damage to stern plate

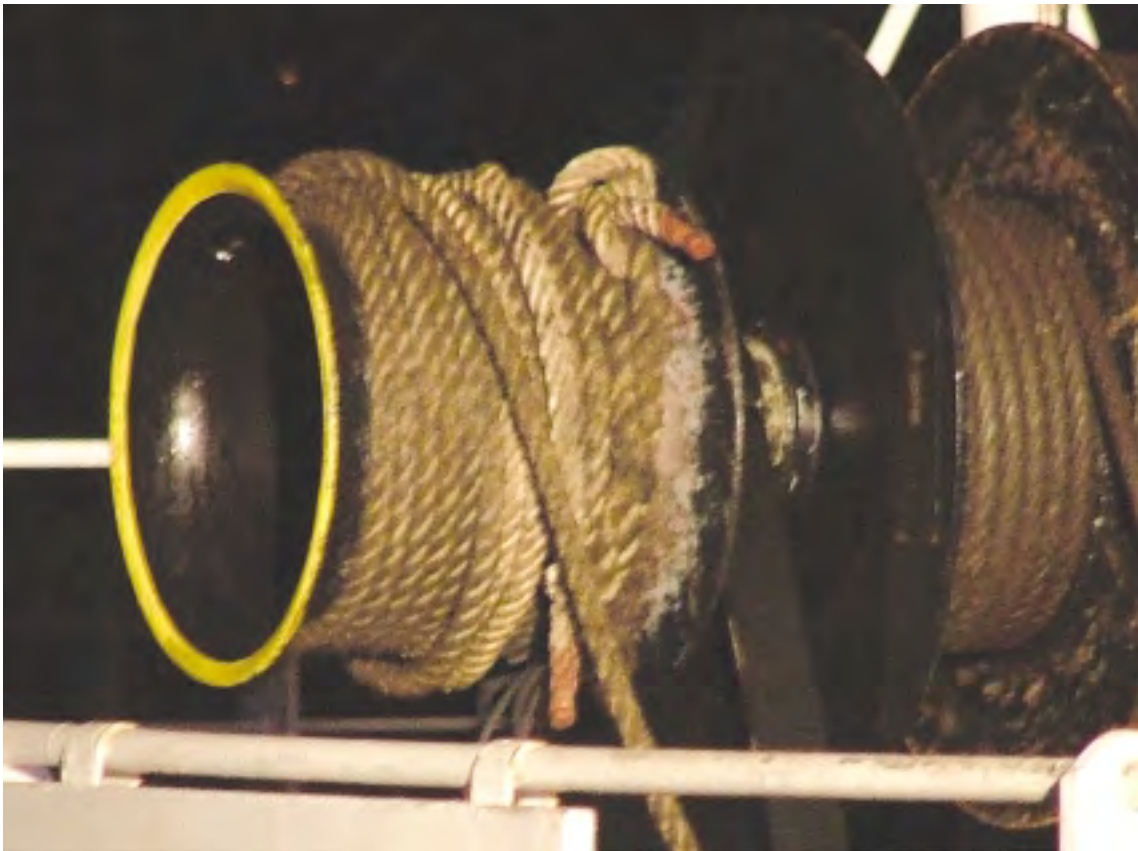
16 turns on drum end

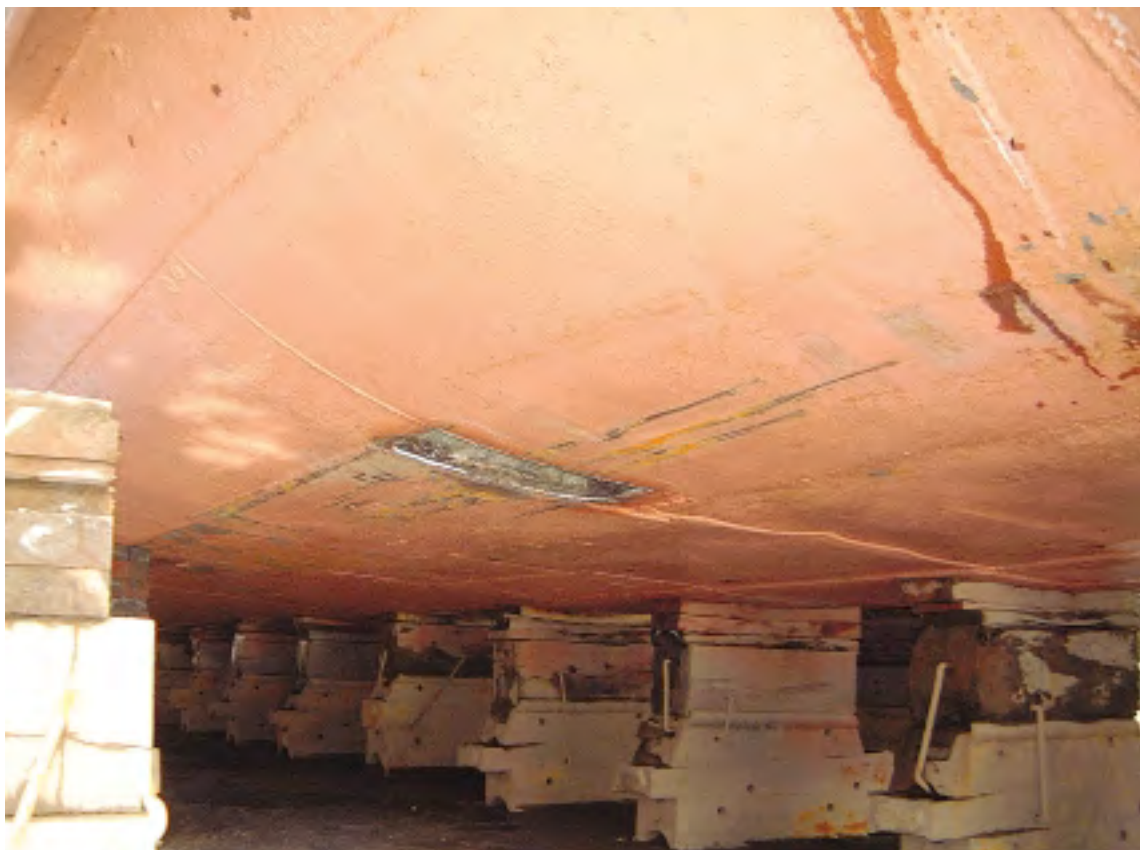
Note: Plate cut out in ship repair yard

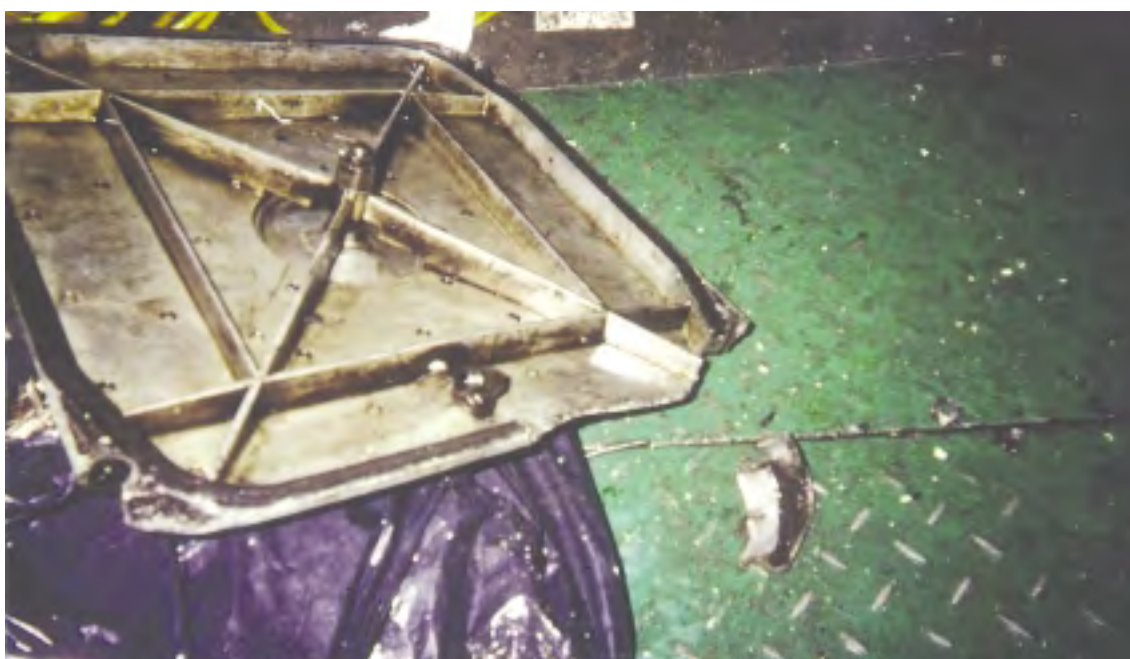
The other units inspected were also in poor condition, with number six piston firing (top) ring having broken 3cm from one end. The fuel injection system was also found to be set incorrectly and the oil mist detector was not working.

Figure 1 – Number 7 crankcase explosion relief door showing damaged mounting points

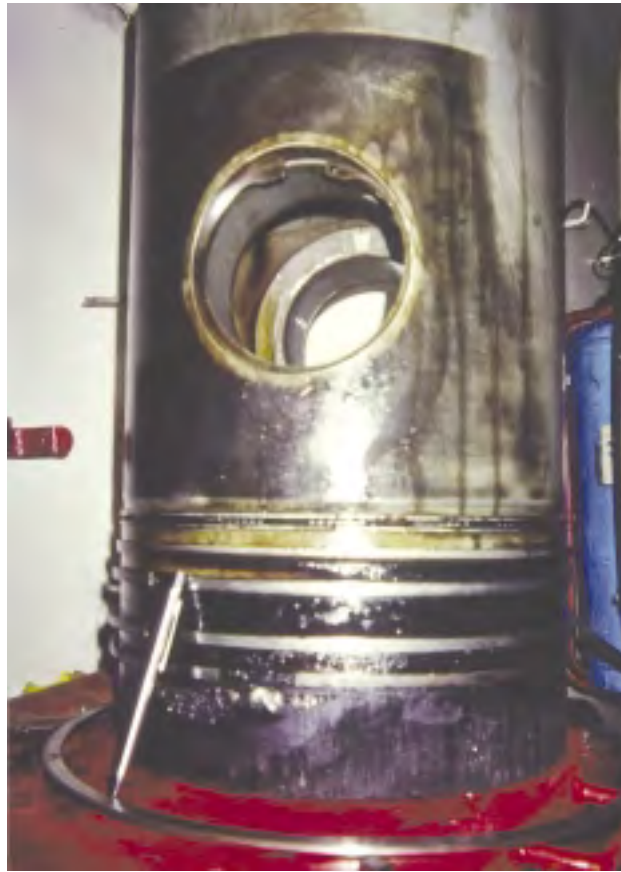
Figure 2 – Number 7 cylinder with heavy carbon deposits

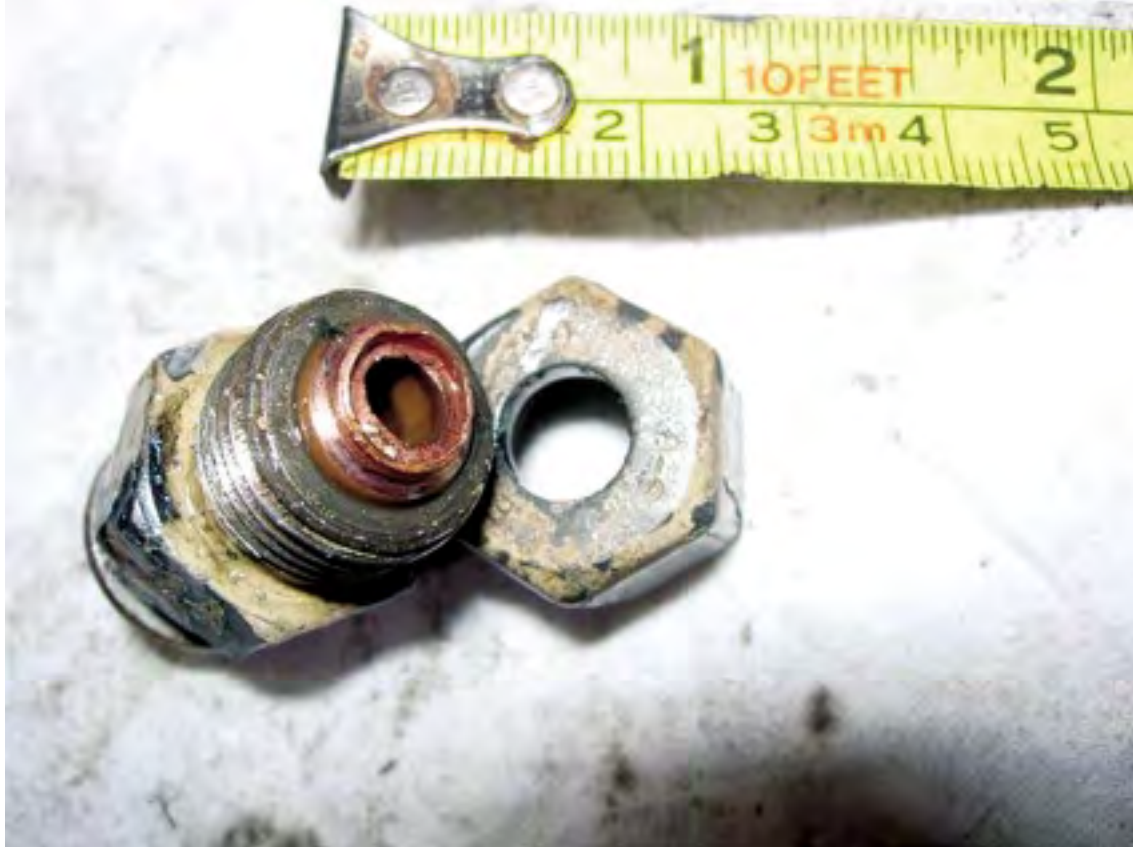
Fractured fuel pipe

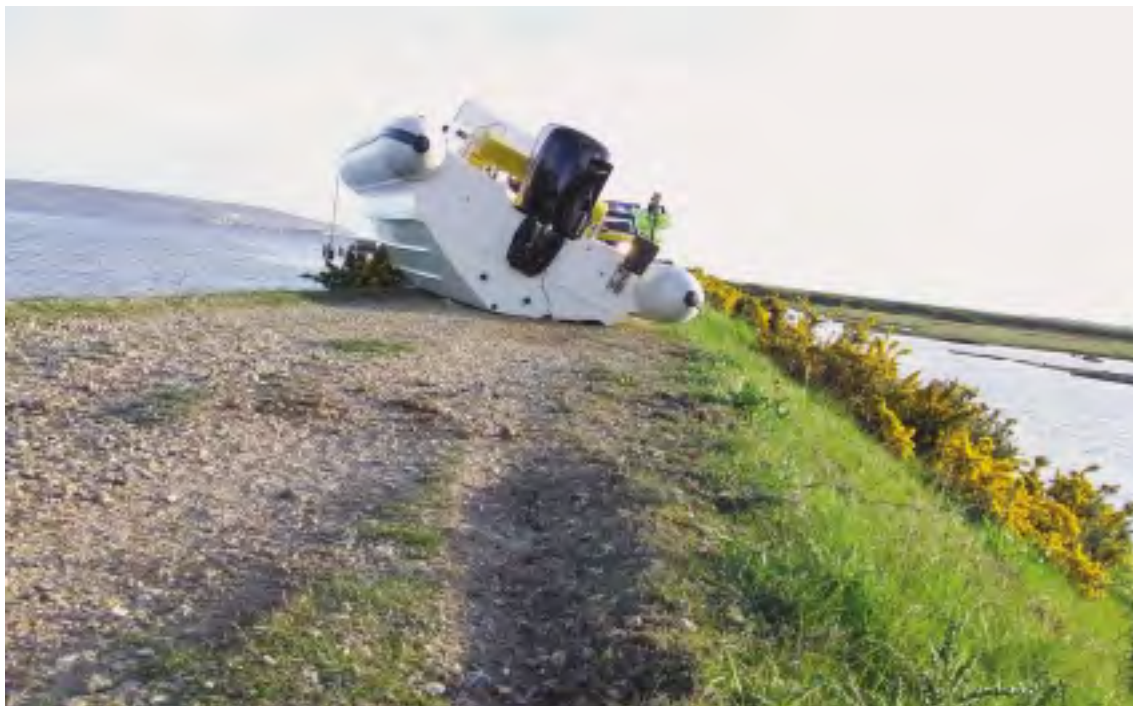
The RIB continued at high speed, constantly turning in a spiral and, fortunately, moving away from the people in the water. It grounded at speed and climbed to eventually come to rest on a footpath on top of a sea wall (see photograph).

RIB photographed after accident

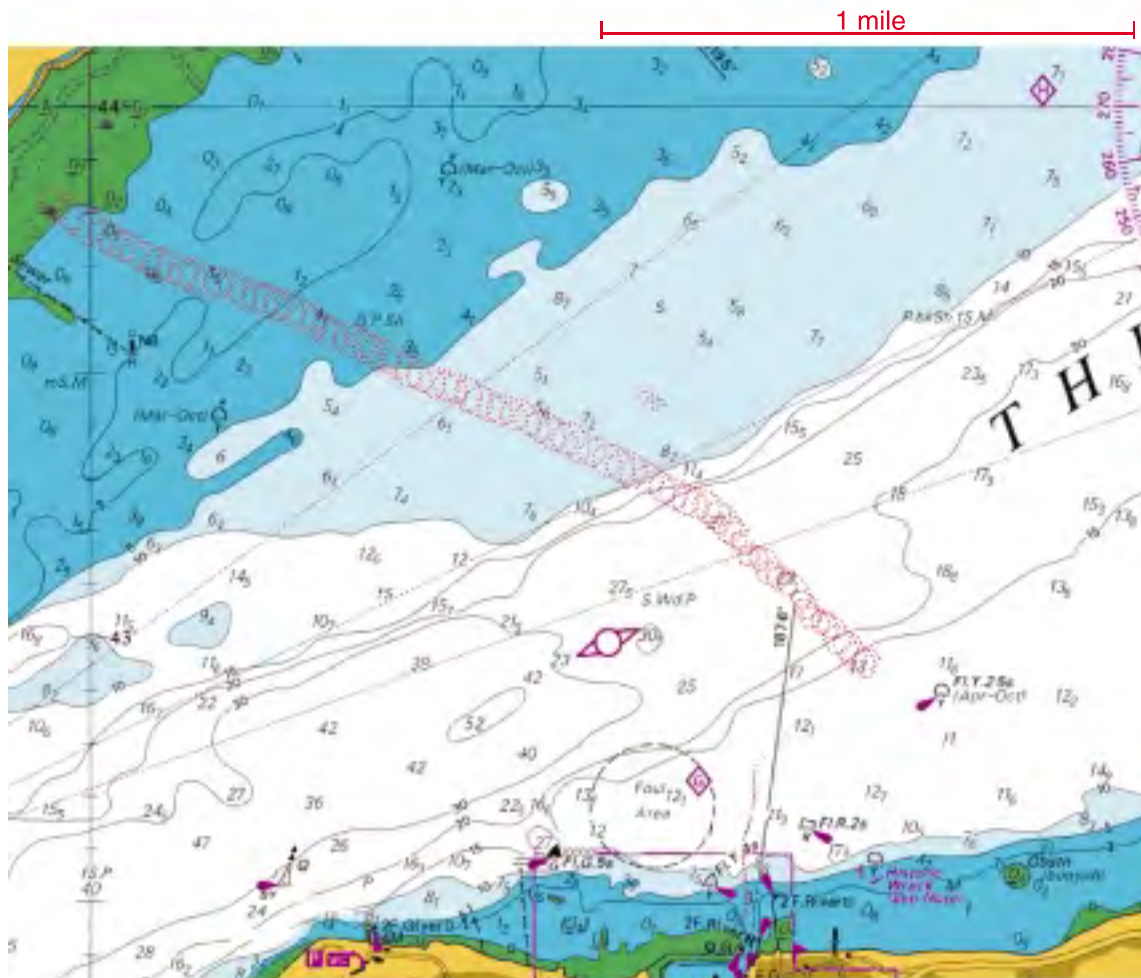
Vessel's actual GPS track after incident

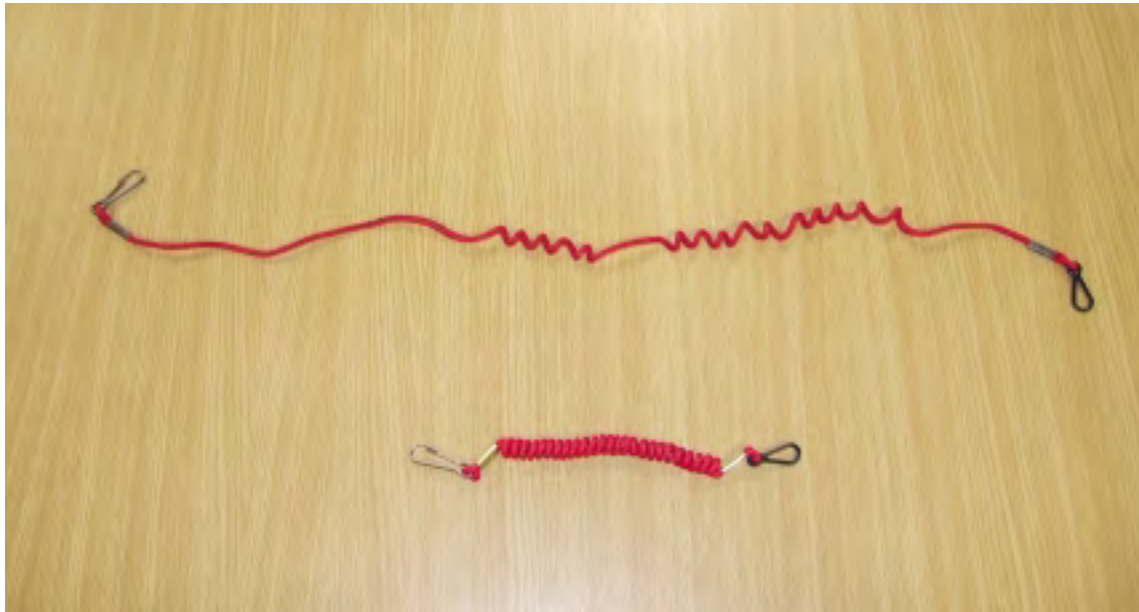
Stretched kill cord in comparison with new item
