MARINE ACCIDENT
INVESTIGATION BRANCH

SAFETY DIGEST

**Lessons from Marine
Accident Reports
1/2007**

No 1/2007

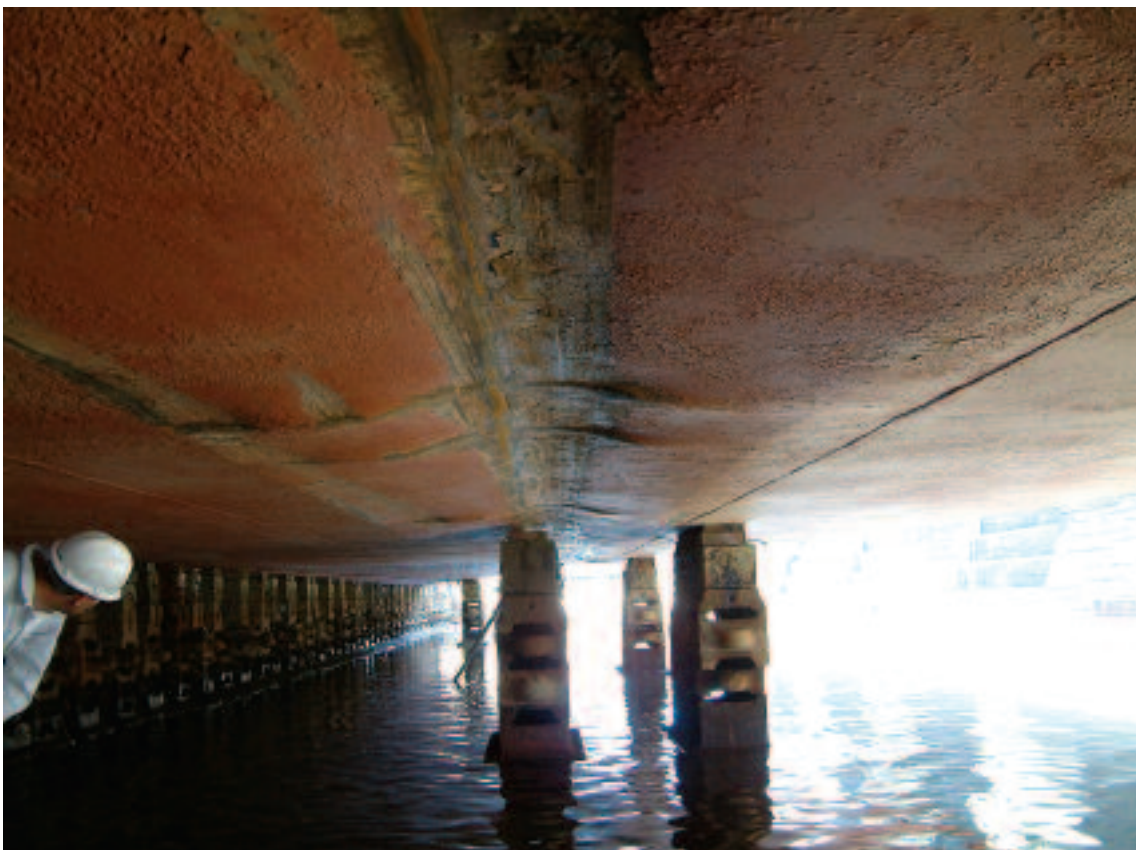
Bottom damage as a result of the grounding

There was significant damage to the vessel, with three long grooves in the double bottom, several small splits in the shell plating and damage to three of the propeller blade tips.

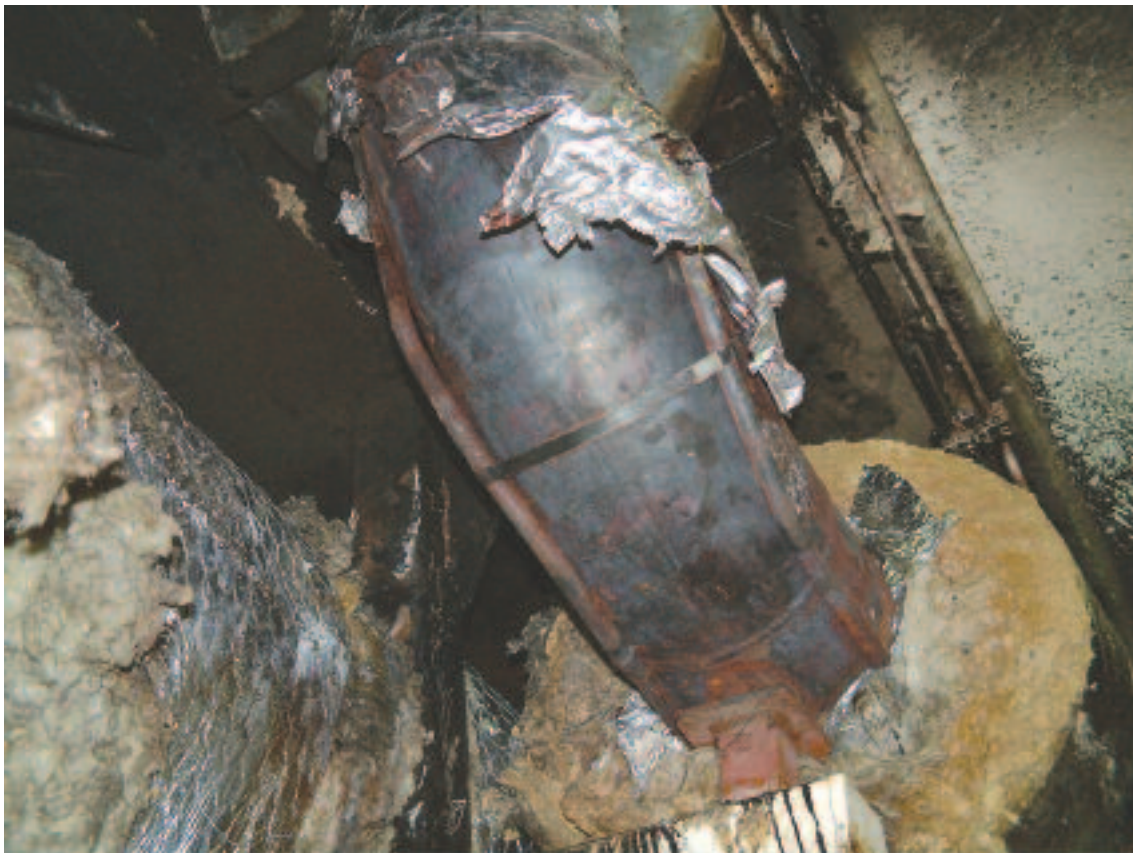
Bitumen pipe with lagging removed

The seat of the fire had been the lagging of a cargo discharge pipe, which, although empty of bitumen, was being kept warm by the trace heating lines. Above the cargo discharge pipe a hydraulic hose was found to be leaking from an end fitting. It is thought likely that hydraulic oil had dripped onto, and subsequently soaked into, the lagging. Spontaneous ignition had eventually occurred.

Good housekeeping and maintenance, including the prevention of leaks, cleanliness and the provision and regular inspection of sealed lagging are the simplest measures that can be taken to prevent lagging fires.

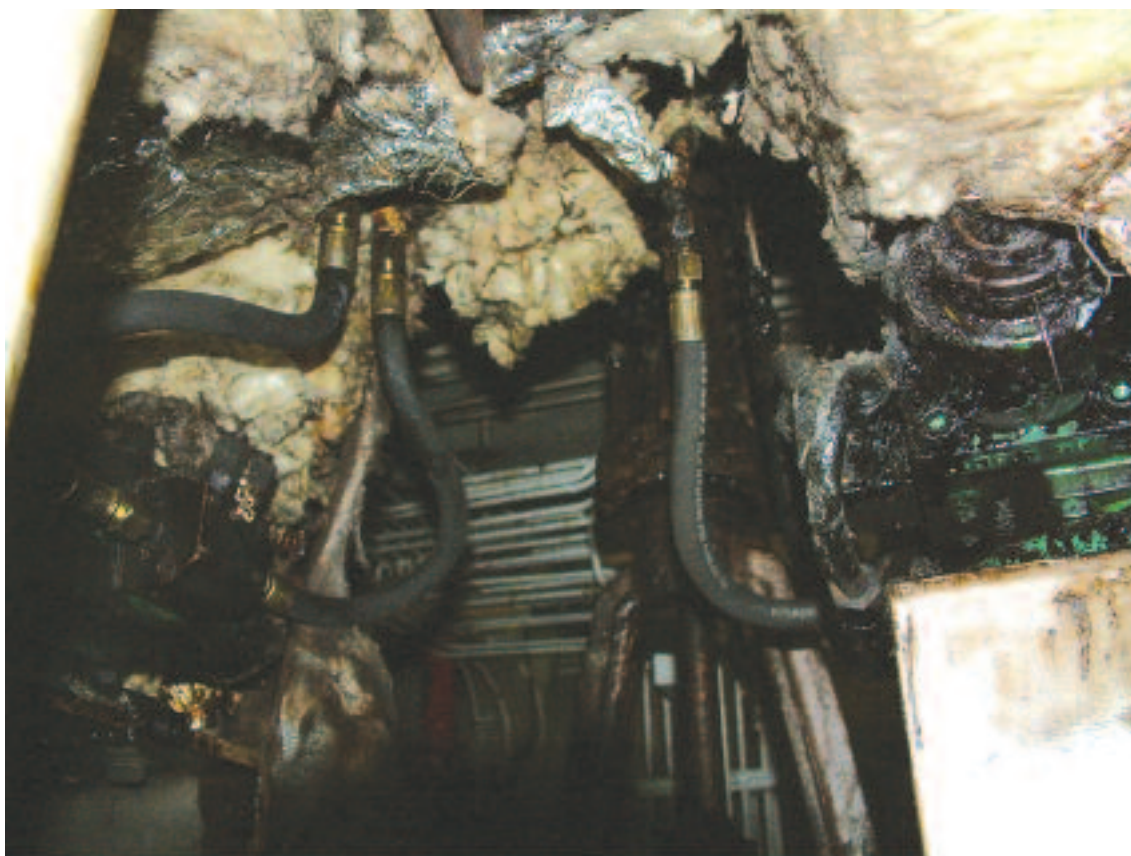
The source of the leak

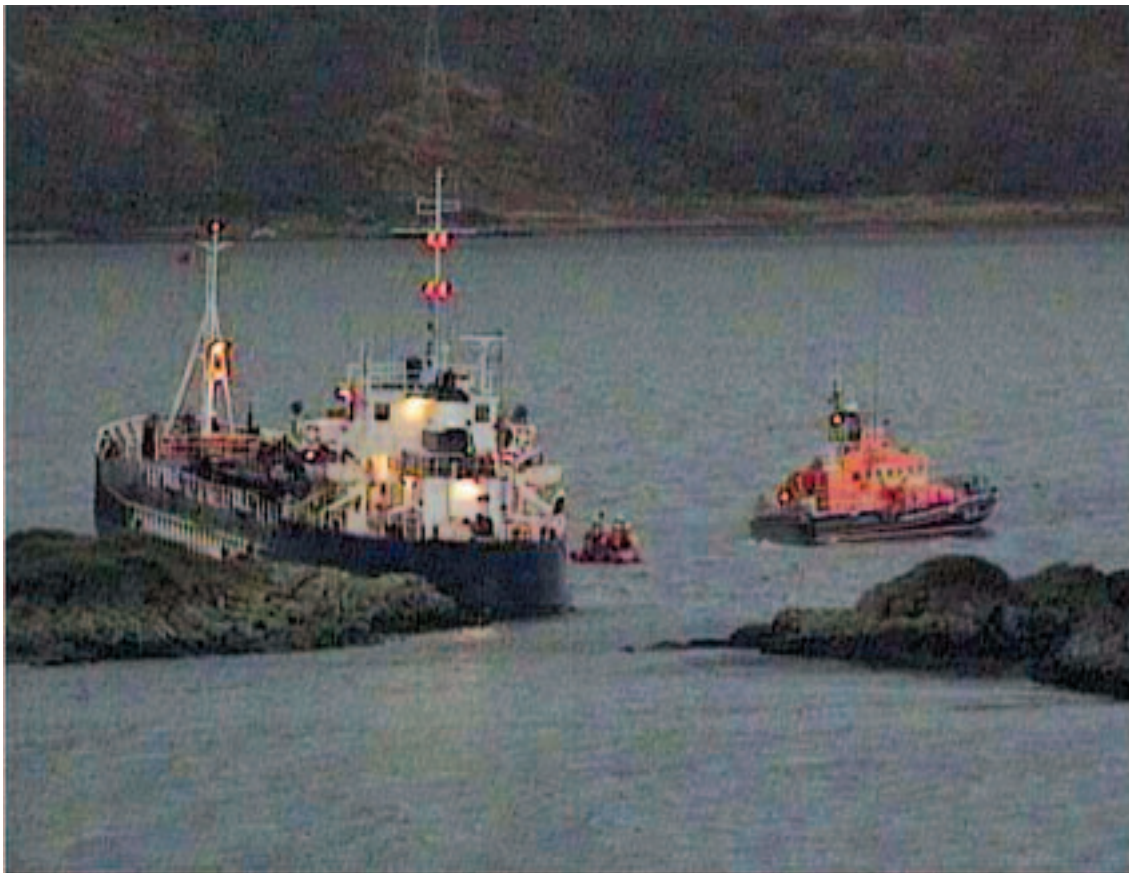
Vessel aground on rocks

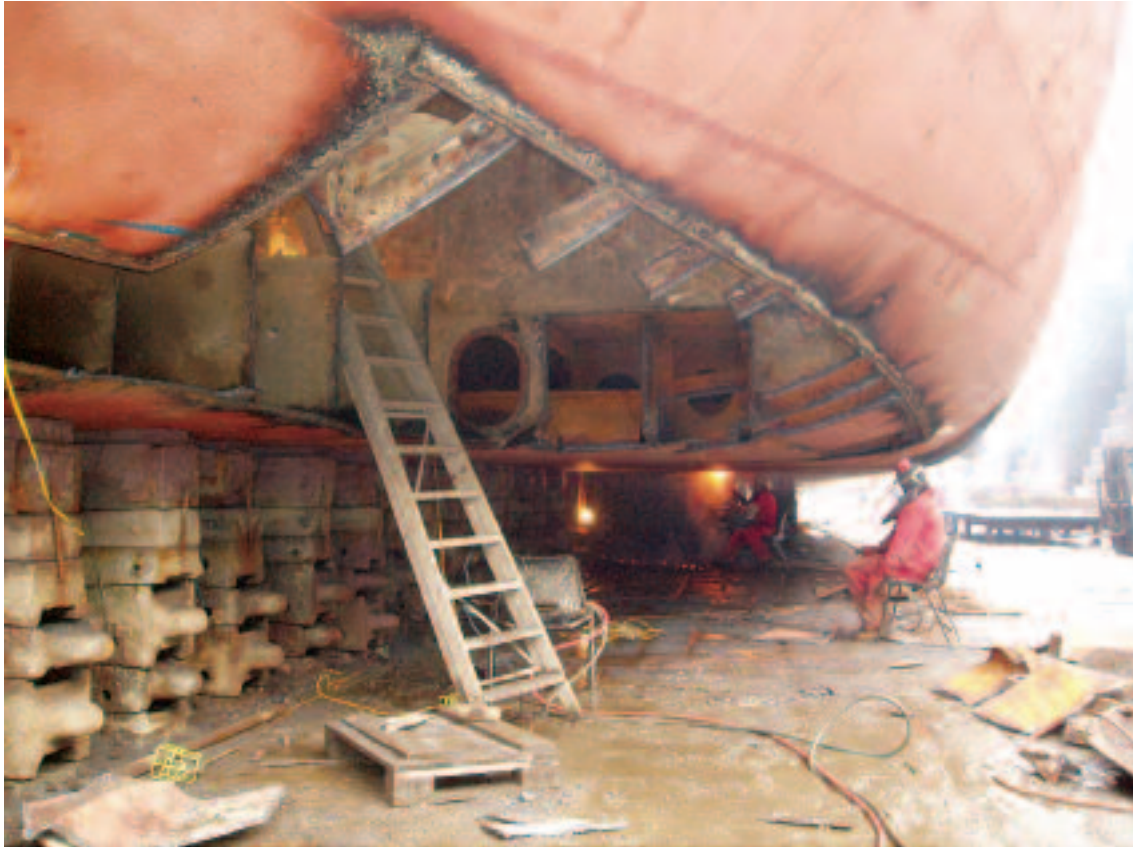
Bottom damage

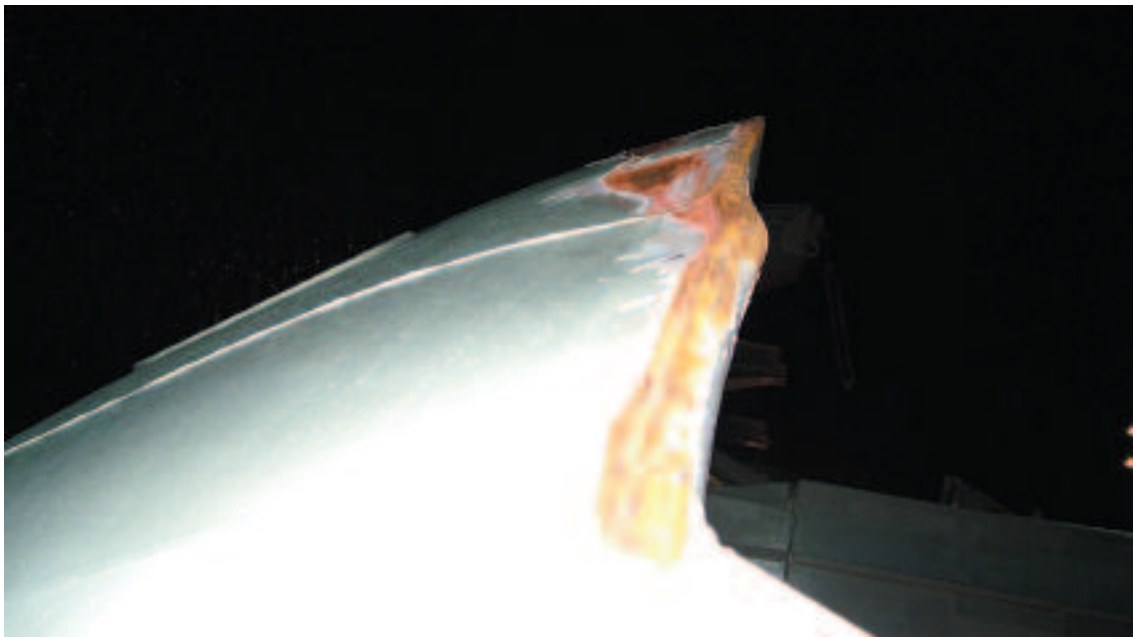
Damage to the container vessel's fore-castle bulwark edge

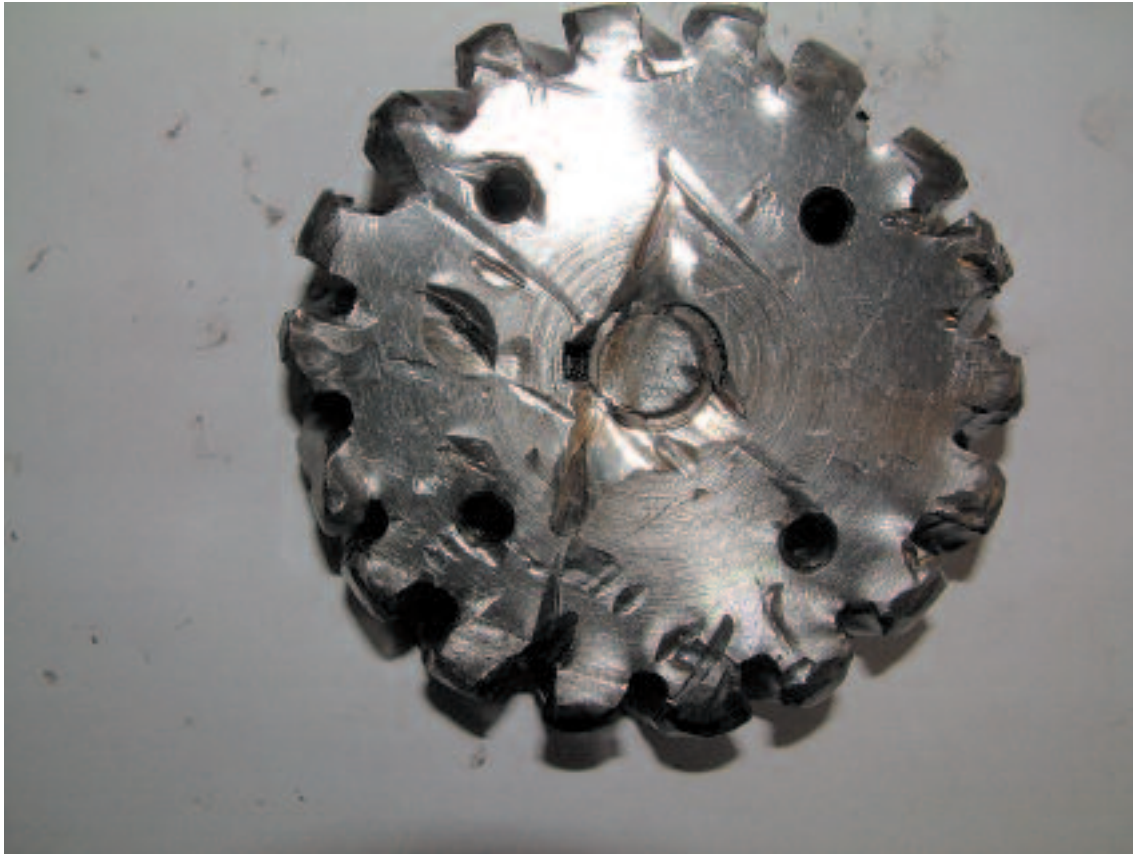
Figure 2 – Sheared drive shaft and pinion

Once the vessel was safely alongside, investigations revealed that the sump, oil return gearwheel pump drive shaft had sheared due to torsional overload (Figure 2), which was itself caused by the pump becoming seized by a sliver of metal (Figure 3). This allowed the drive pinion to fall into the sump which was thrown about the engine, detaching a section of No 1 cylinder liner (Figure 4) and fracturing the cast steel sump through which the oil escaped. The origin of the metal sliver is being assessed by the engine manufacturer, but laboratory analysis suggests it is part of a roller bearing race which had probably been in the engine for some considerable time and was drawn up from the sump by the scavenge pump.

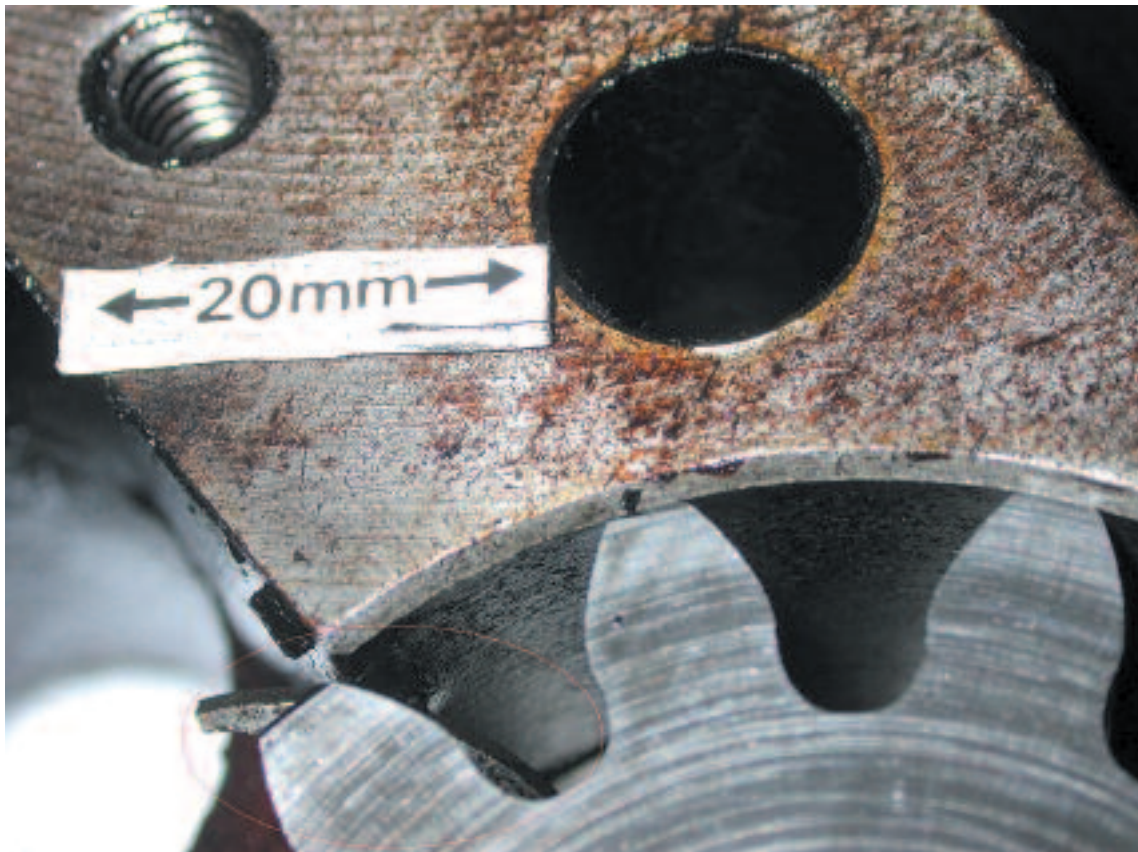
Figure 3 – Seized gear wheel pump

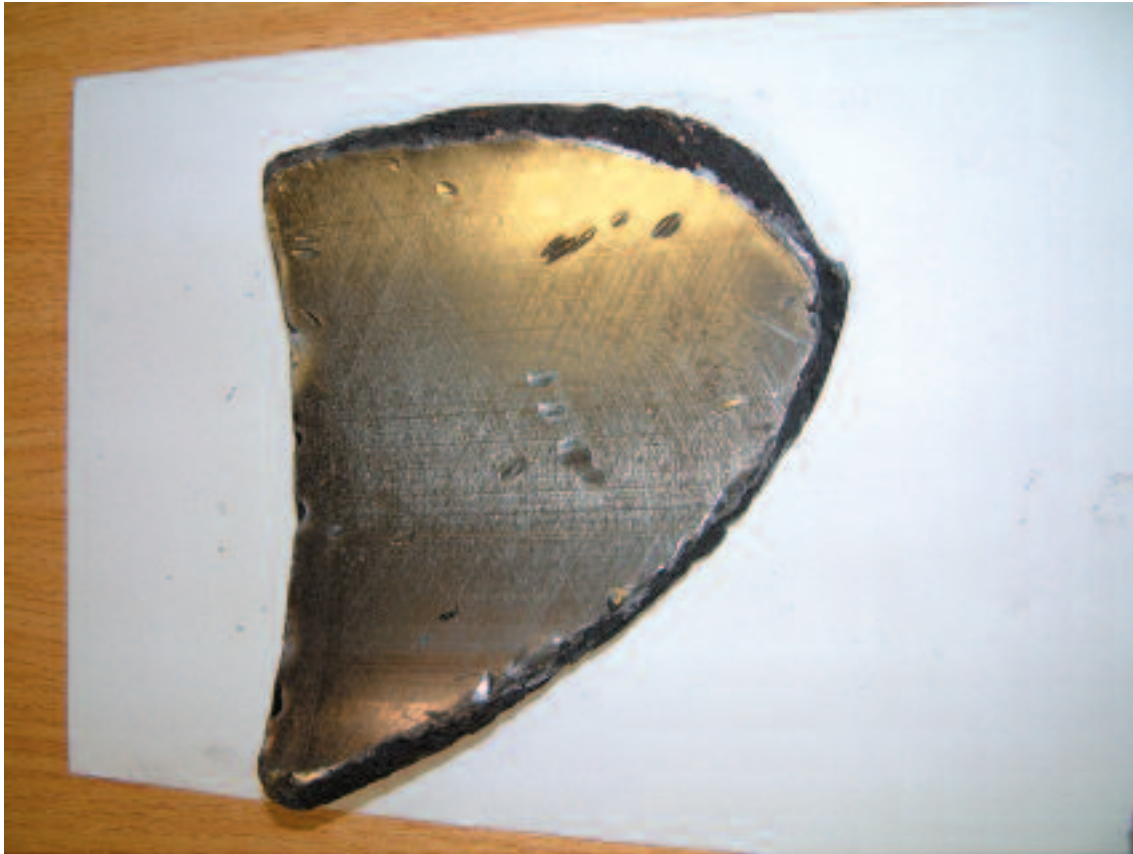
Figure 4 – Detached section for No 1 cylinder liner

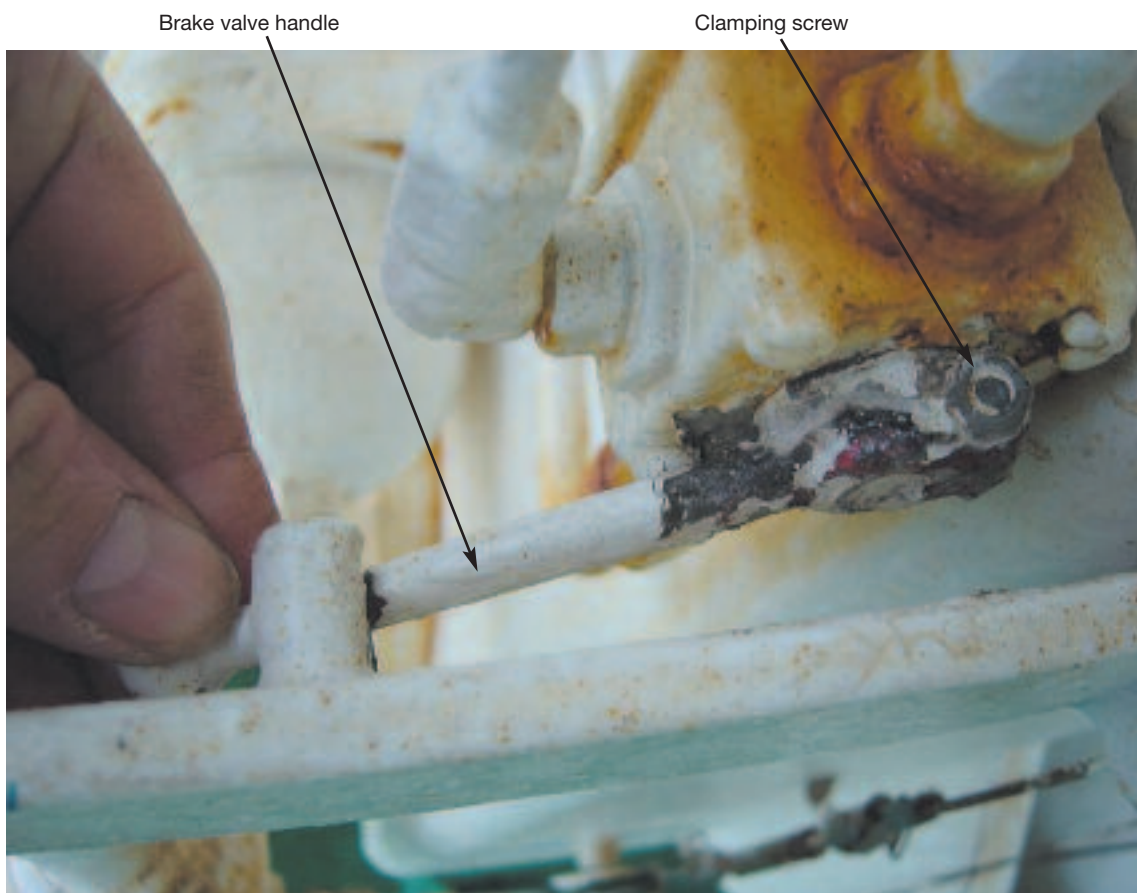
Original handle

Since the incident, the manufacturers have issued a product awareness notice to their service engineers and have fitted a new handle made from a more robust material.

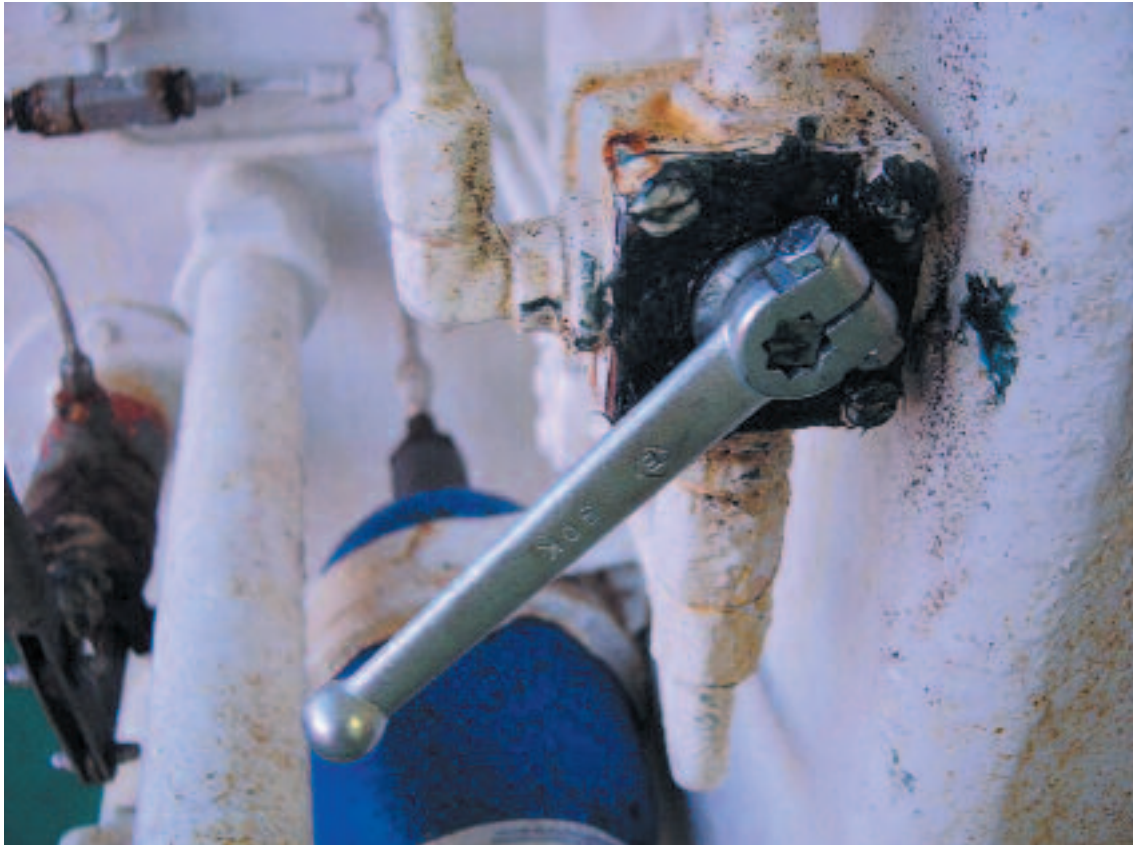
New handle fitted

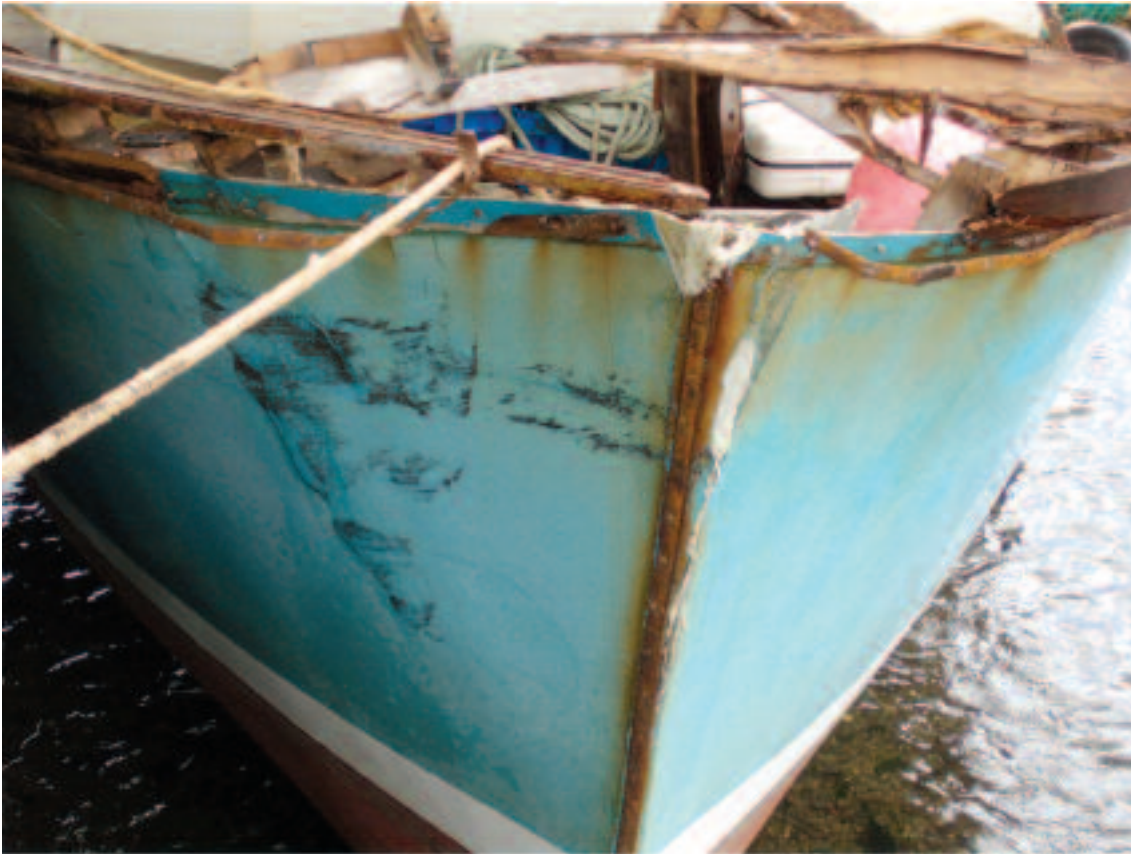
Photographs showing bow damage

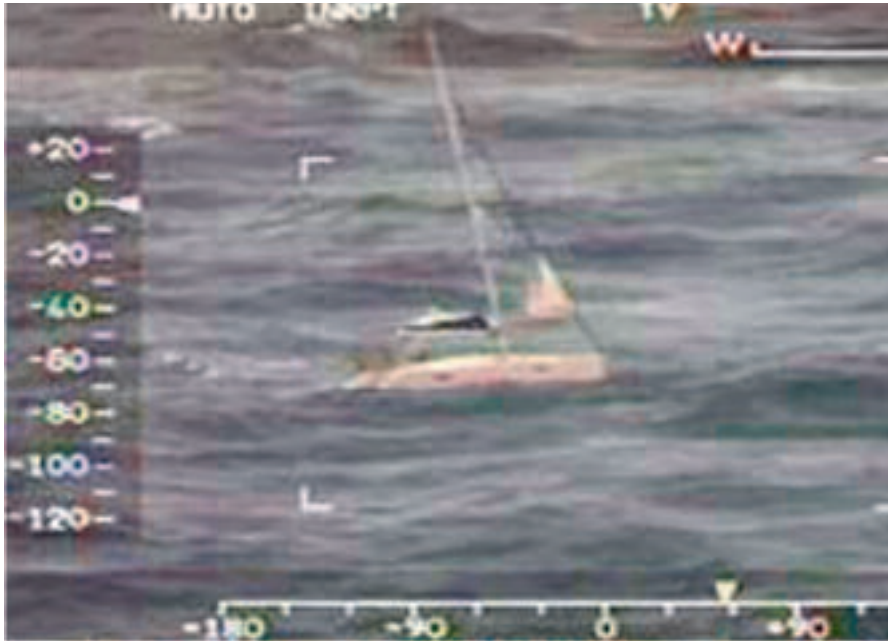
Photograph of yacht taken after the 3 crew were lost overboard *Image courtesy of the RAF*
