MARINE ACCIDENT
INVESTIGATION BRANCH

SAFETY DIGEST

**Lessons from Marine
Accident Reports
2/2006**

No 2/2006

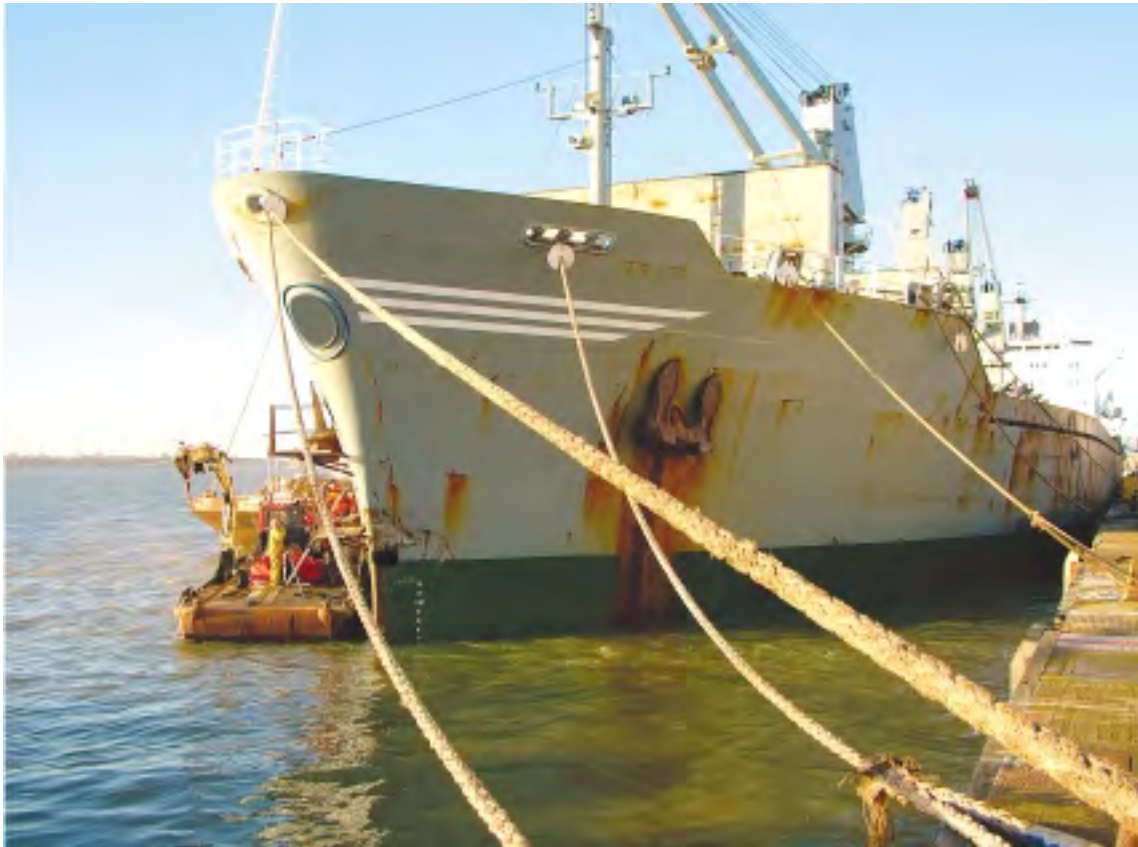
Figure 1

A 192m length bulk carrier was outbound at night on a UK river when she collided with five unlit barges. The vessel was holed in her fore peak and had to be repaired before she could continue her voyage (Figure 1). The barges were damaged to varying degrees and four of them sank.

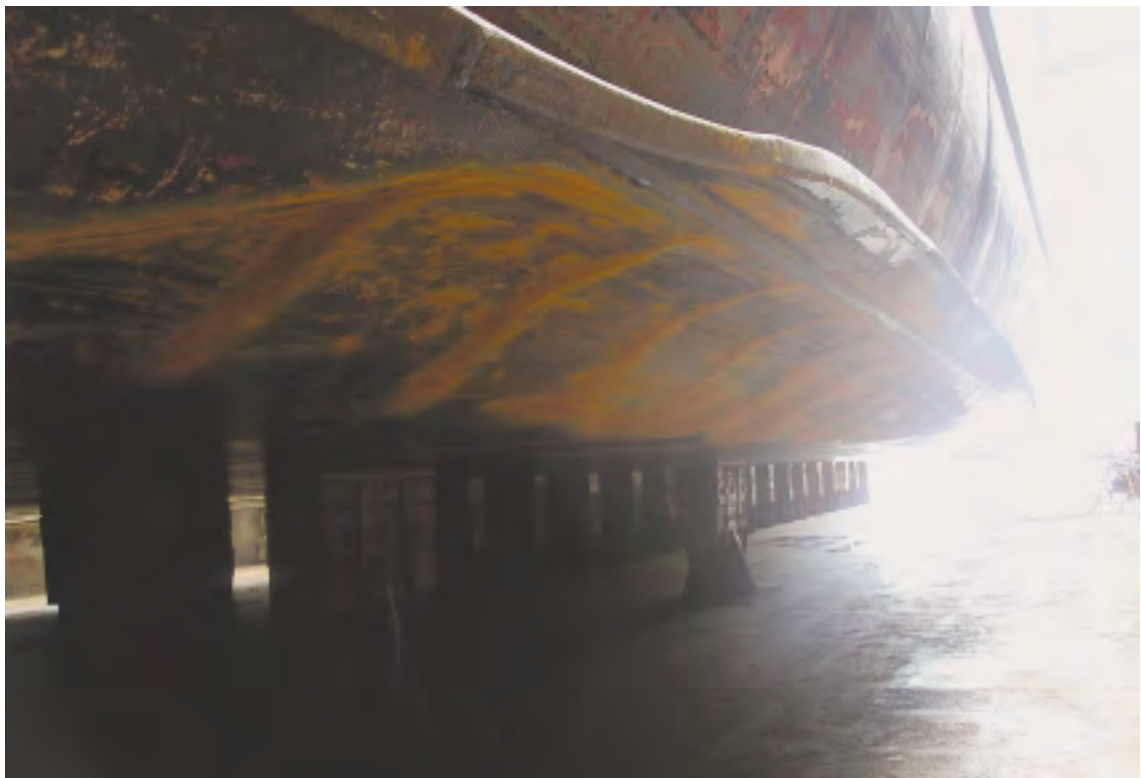
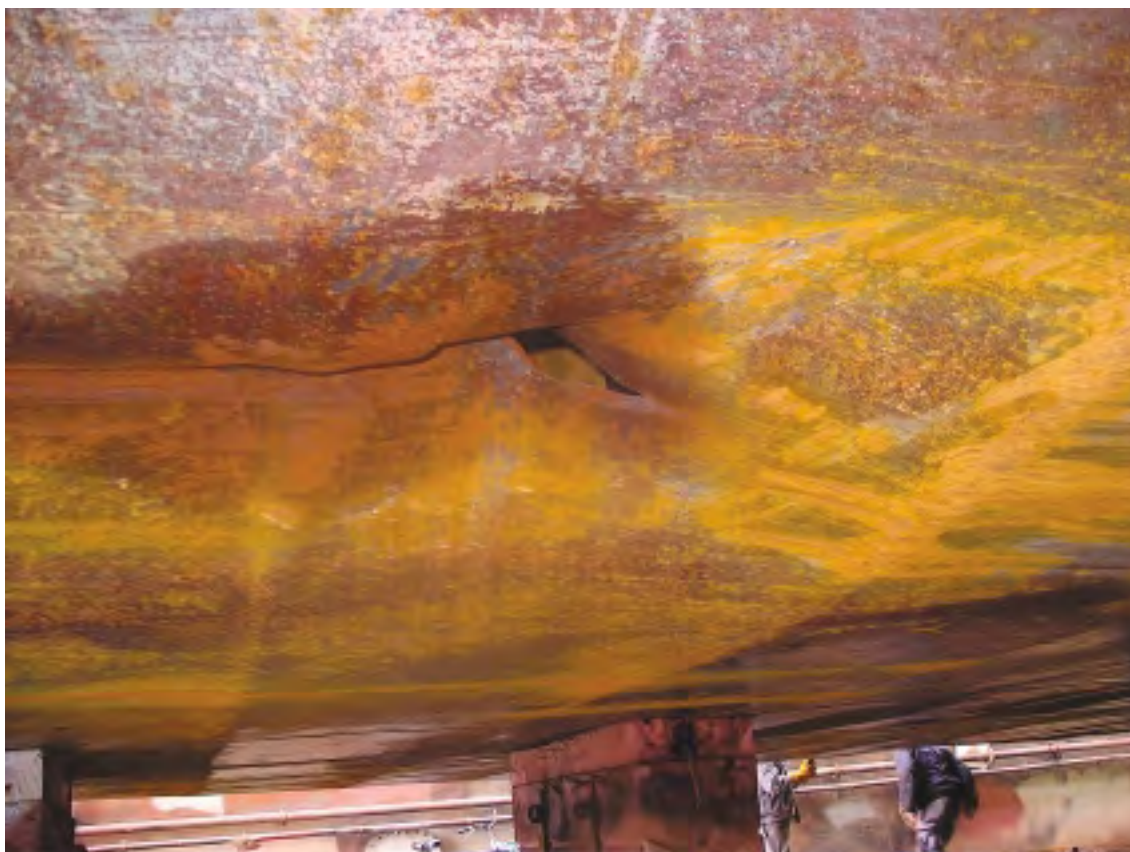
Figure 2

starboard and trimming by the head. Subsequent soundings found four ballast tanks had been opened to the sea (Figures 2 and 3).

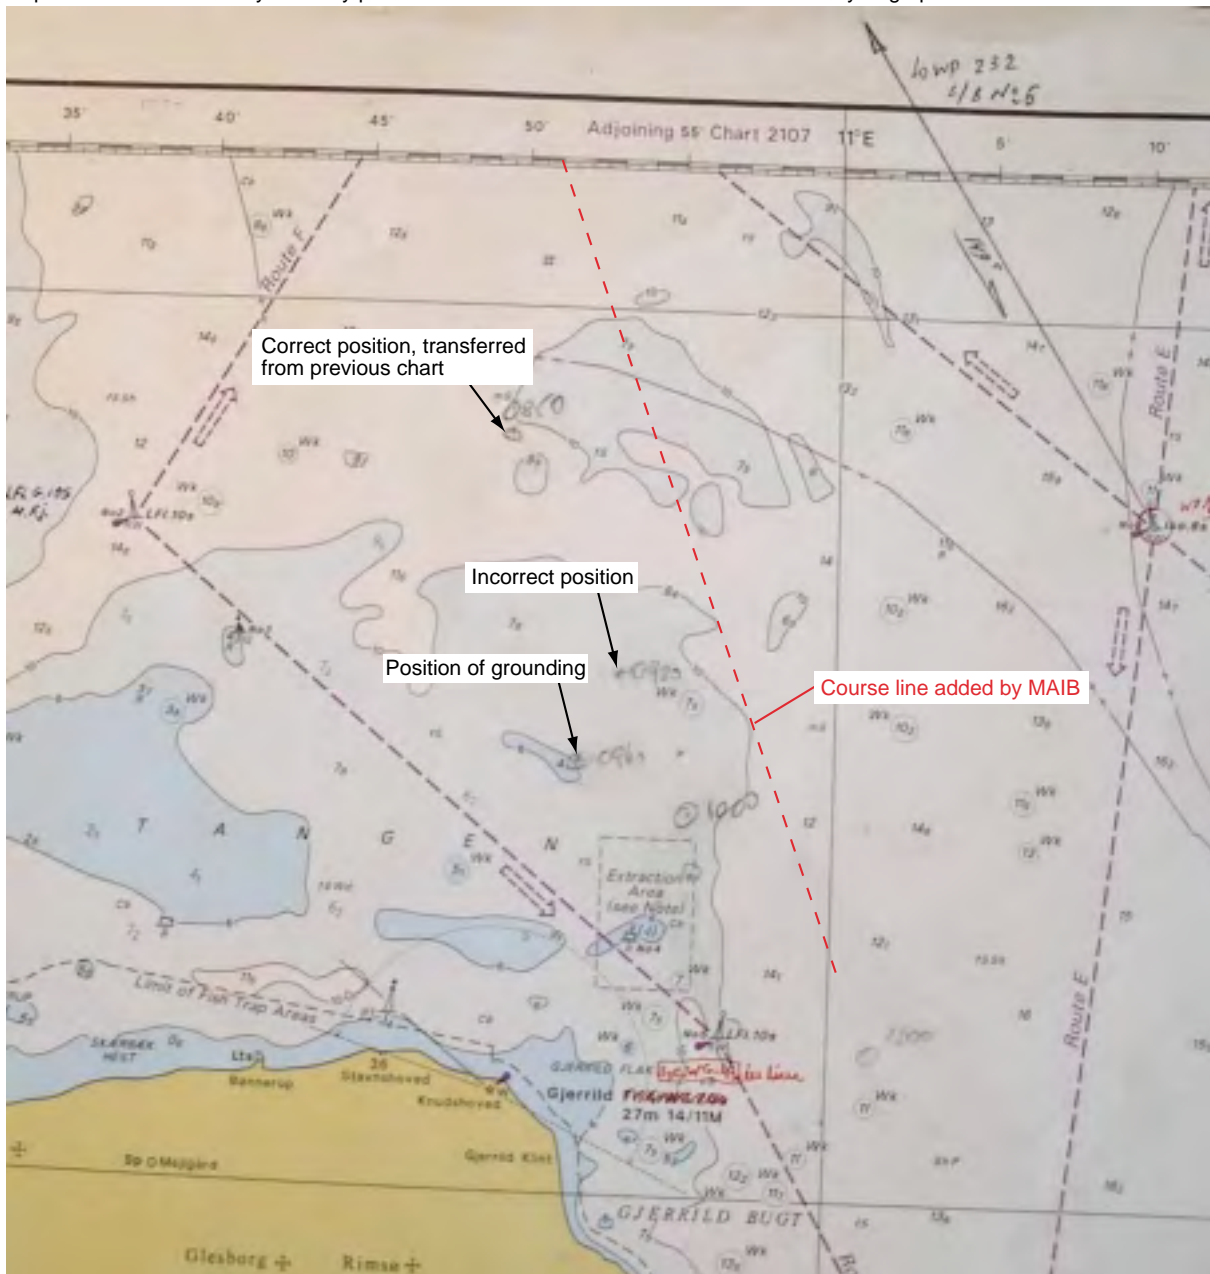
Figure 1 – Navigation chart on day of the accident. Note the lack of a course line laid down by the master

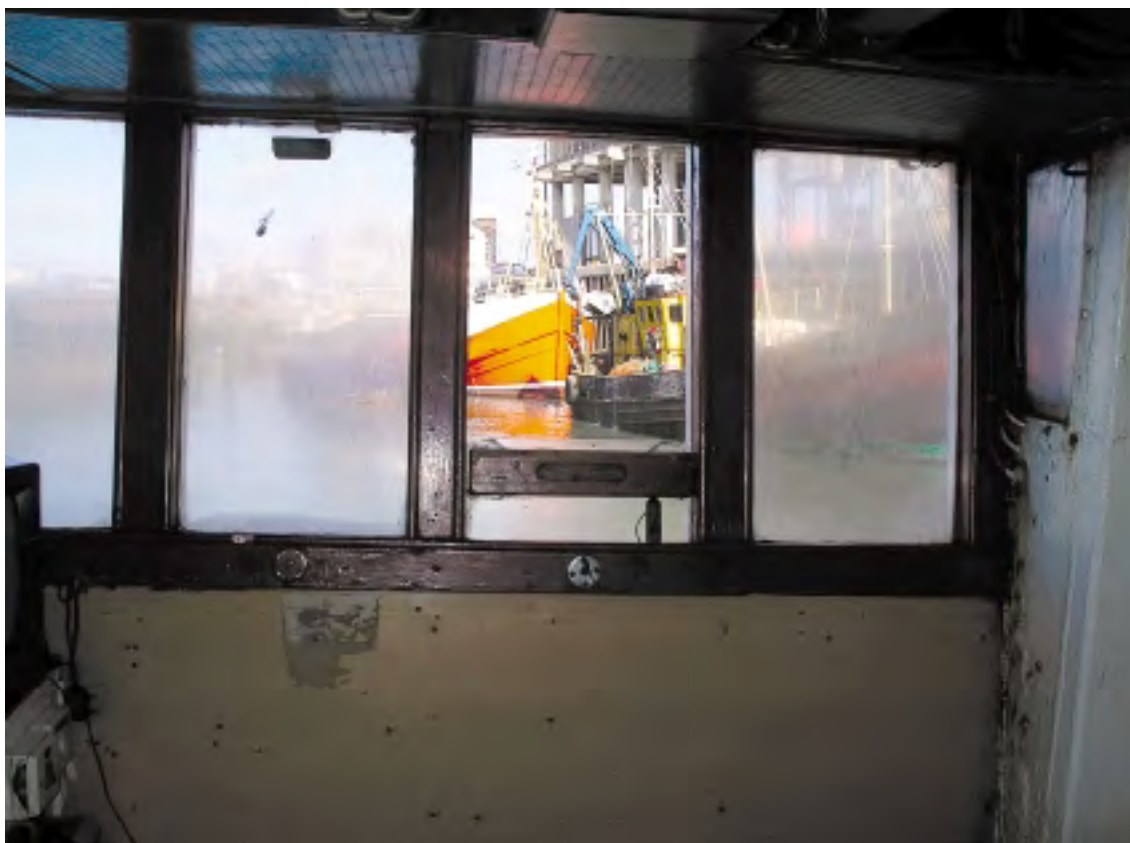
Figure 2 – Starboard wheelhouse windows

MAIB inspectors visited both vessels and spoke to everyone involved. The inspectors noticed, among other things, the poor condition of the Perspex type windows on the fishing vessel, which seriously obscured the visibility from the wheelhouse due to fading and crazing (Figures 2 and 3).

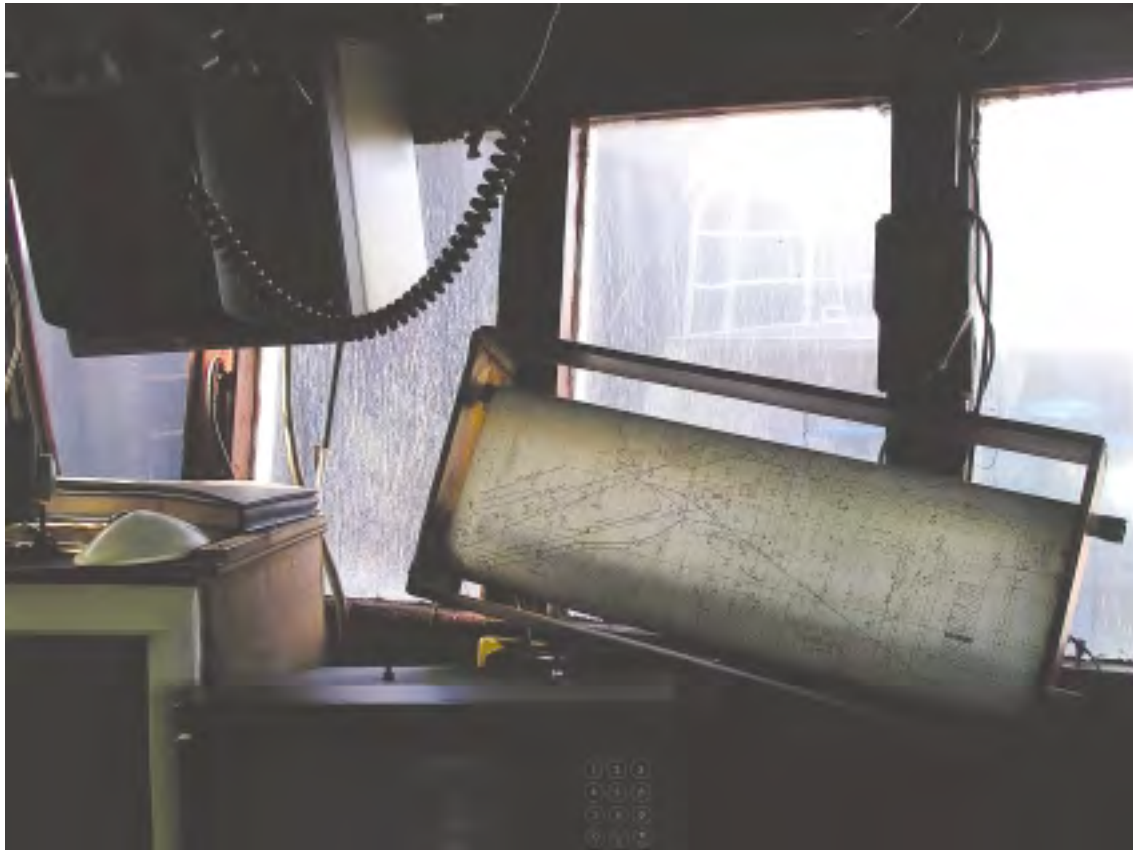
Figure 3 – Forward wheelhouse windows

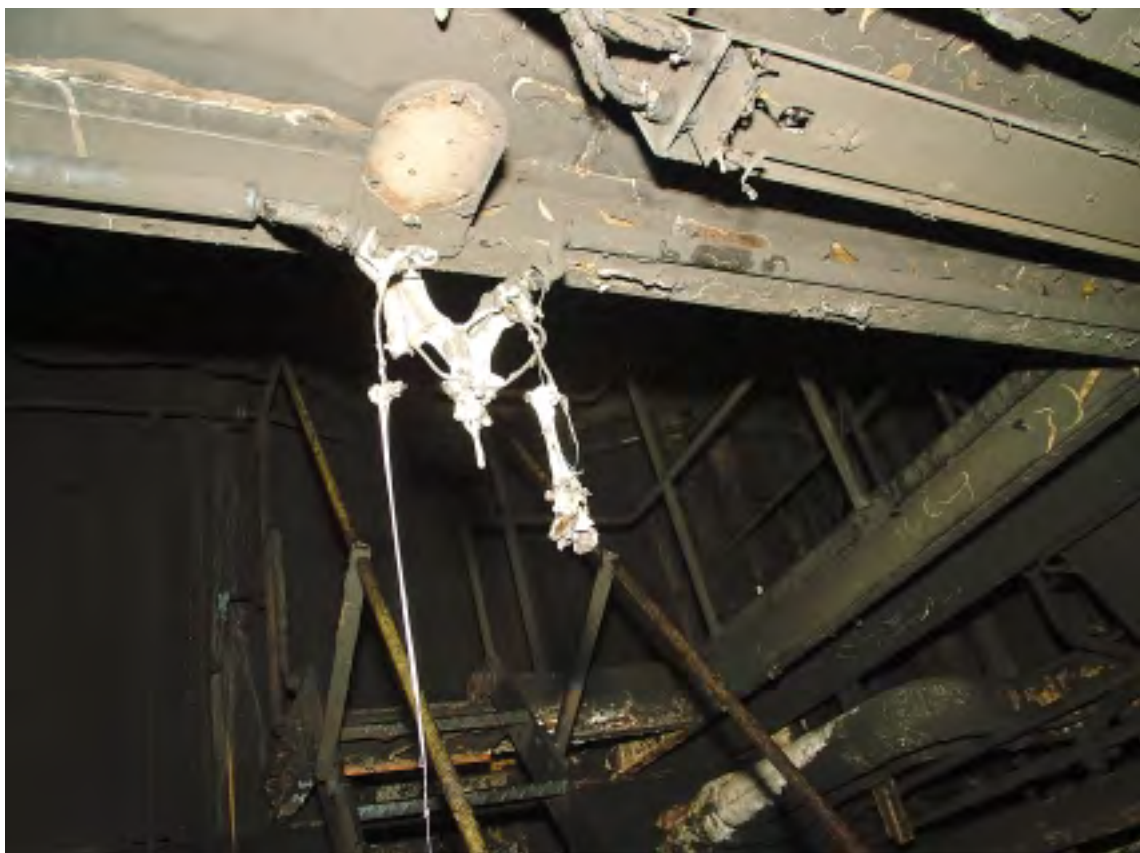
Figure 1 – Example of fire damage

The vessel sustained significant fire damage to the engine room equipment (Figure 1). There was also floodwater damage from the use of fire hoses, and collapse of some pipework systems.

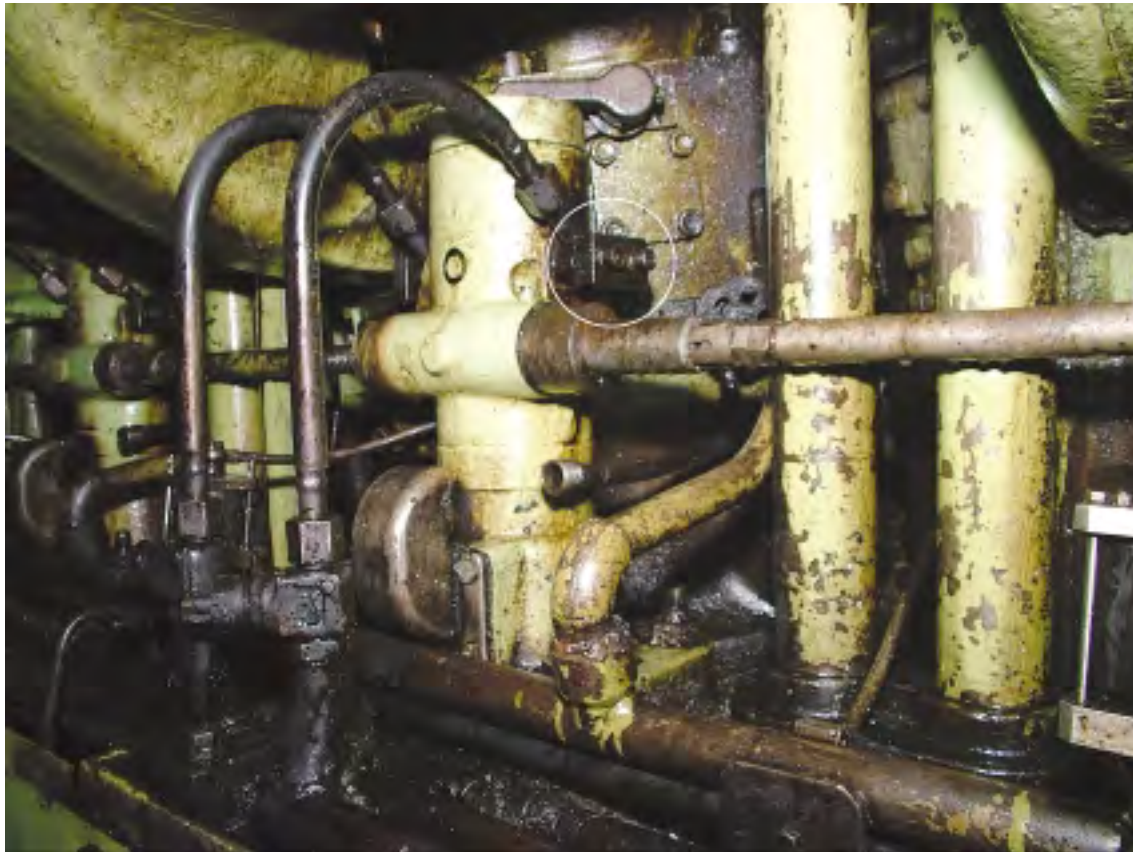
Figure 2 – Incorrectly fitted fuel inlet backing plate

The fuel pump had been last changed 5 months earlier. During the investigation, it was noticed that a similar fitting on another fuel pump on the engine had also been incorrectly fitted (Figure 2) – the securing plate had been reversed. This meant that the cap screws were only screwed into the fuel pump block by 2½ turns, as opposed to 8½ turns when correctly fitted. It is likely that the fitting which failed, was also incorrectly fitted, and it vibrated loose, leading to the accident.

1. At least one of the main engine fuel pump inlet pipe securing plates was incorrectly fitted, leaving them in an unsafe condition. It is likely that the fitting that became loose, which then led to the fire, was also fitted incorrectly when the fuel pump was last replaced.

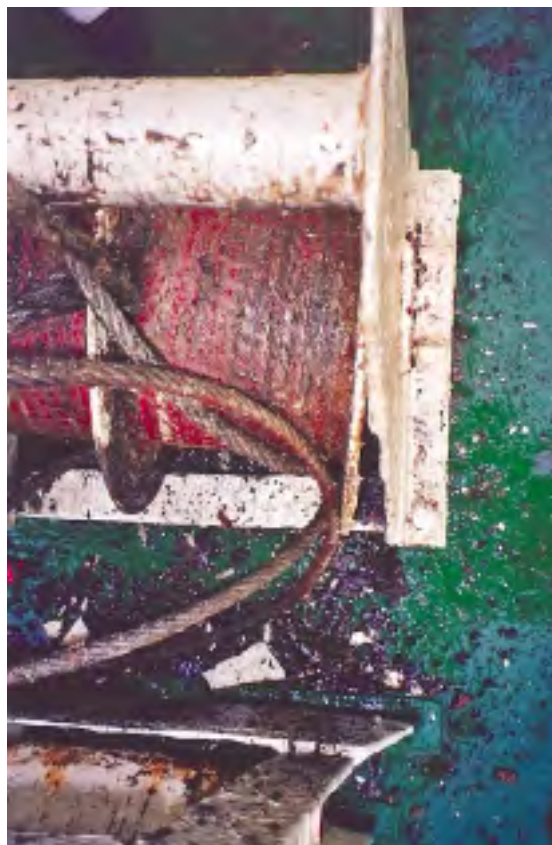
Figure 1

The winch failed because the drive between the wire drum and motor/brake was lost, as indicated by one end of the drum collapsing (Figure 1). The drive shaft of the winch passed through both ends of the drum and, at one end, was keyed to a boss welded to the drum's end. It was through this keyed connection that

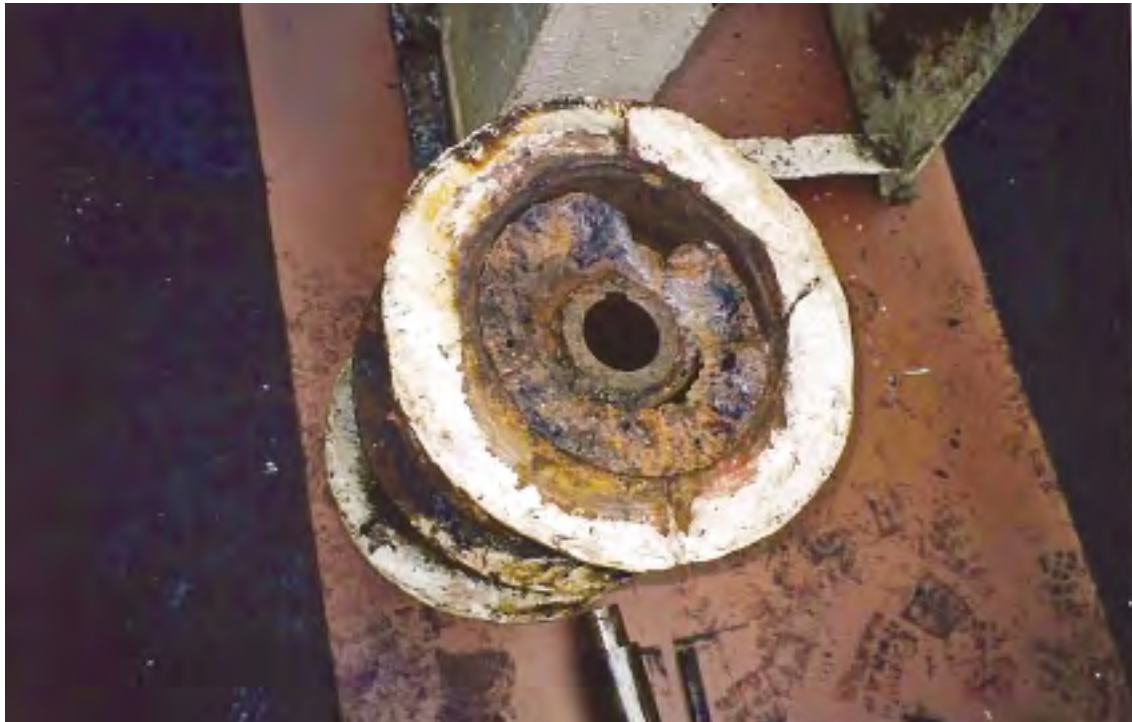
Figure 2

the hoisting and braking torques were transmitted. The drum end had failed at this end due to corrosion, and the keyed boss had separated from the cylindrical part of the drum (Figure 2).

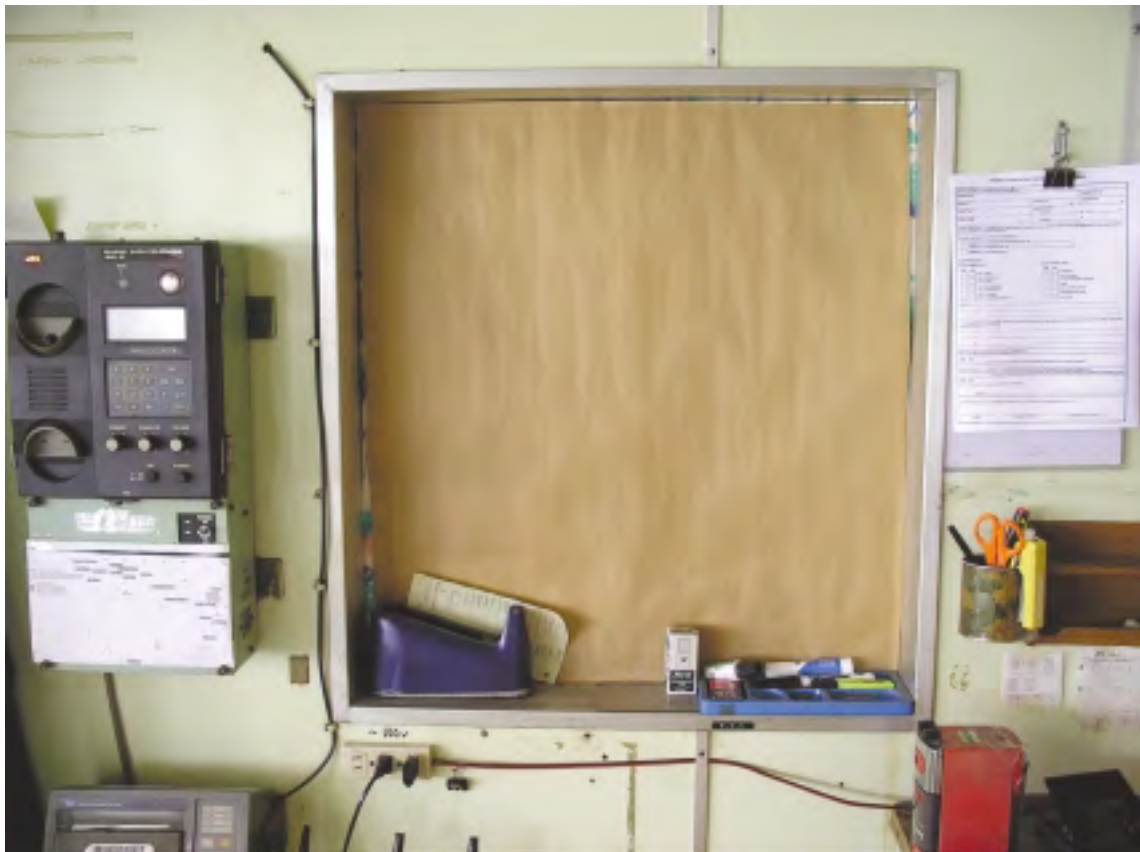
were approaching on his starboard bow. He had decided that the overtaking vessel was going to pass clear, but he neglected to keep monitoring her position and course. During the build up to the collision, he plotted his vessel's position a number of times in the curtained-off chart room. He might have noticed, and been reminded of the overtaking vessel, but the window in the chart room was permanently blocked to prevent light reflecting from the paintwork on the starboard bridge wing (Figure 3).

Figure 3 – Blocked starboard side chart room window

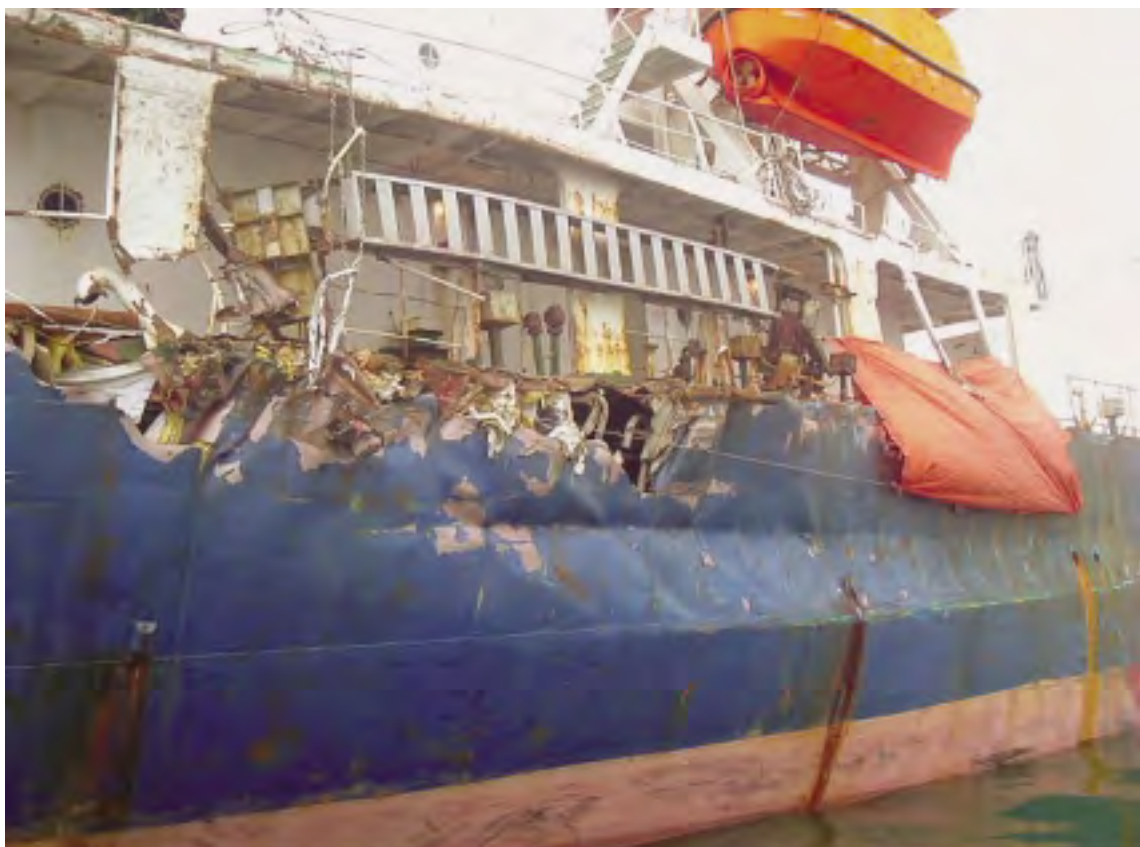
Figure 4 – Tanker's starboard quarter damage

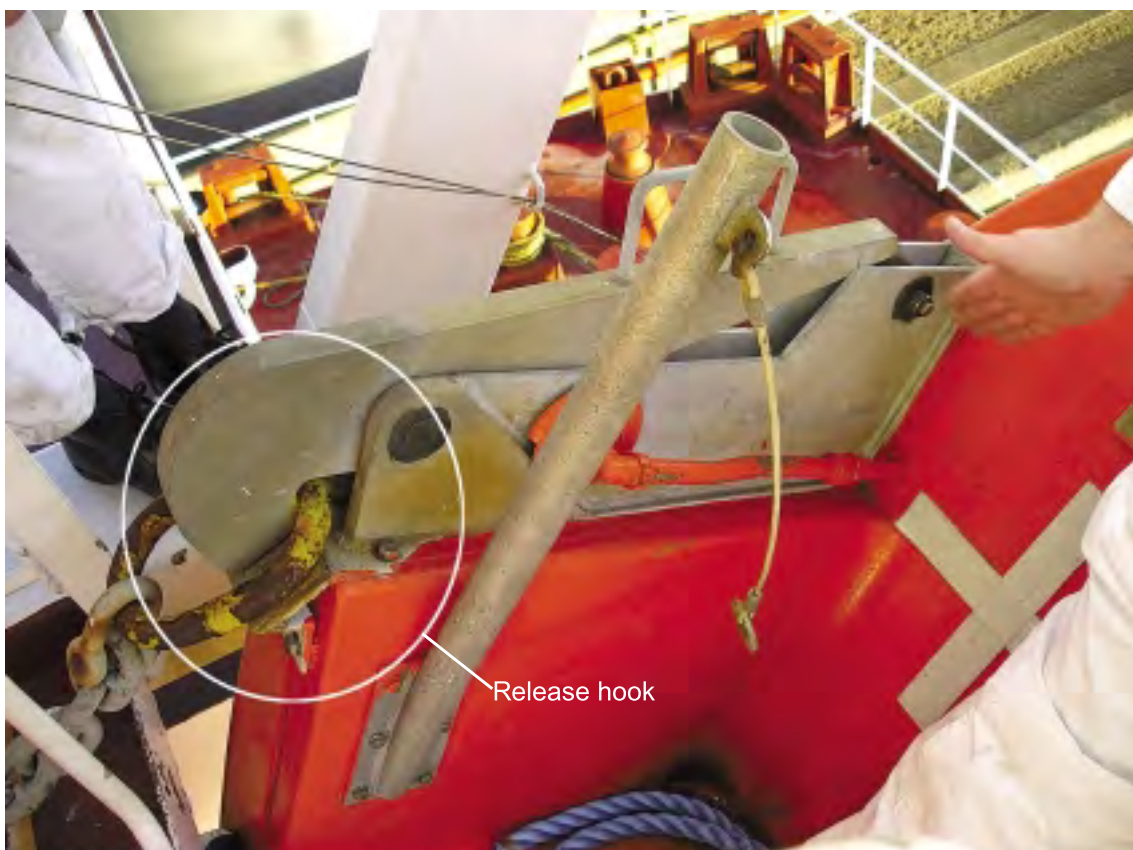
Figure 3

After the release hook had operated, an AB tried unsuccessfully to reset the hook (Figure 3). Suspecting the problem was that the release hand wheel had not been fully wound out, the chief officer shouted to the AB to get out of the lifeboat. The chief officer then leaned into the boat and unwound the hand wheel at the same time. After repeated attempts, the AB managed to reset the hook.

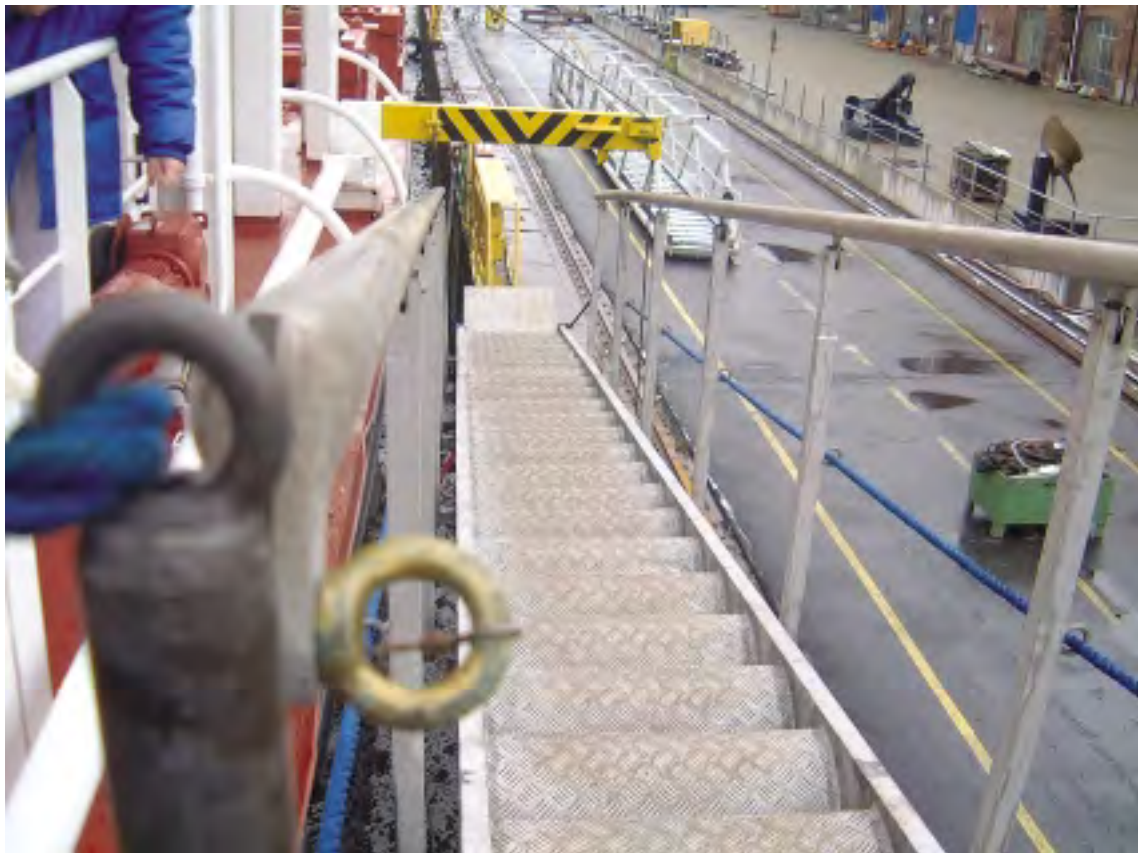
Figure 1

They removed the safety net and the pins securing the inner rail to the vertical stanchions at the end of the ladder (Figure 1). However, the inner rail remained wedged against the davit arm. After slackening the aft spring, which was possibly pushing against the upper platform of the ladder, one of the able seamen descended the ladder. As he did so, the other AB, who was standing on the ladder's upper platform, managed to pull the rail free. But the sudden release of the rail caused him to fall backwards over the rope protection fitted at the top of the ladder (Figures 2 and 3), which was only 65cm high. As he fell from the platform, the AB hit a large berthing fender, before landing in the water 8m below. The remaining AB heard his ship mate fall, and immediately ran to the position

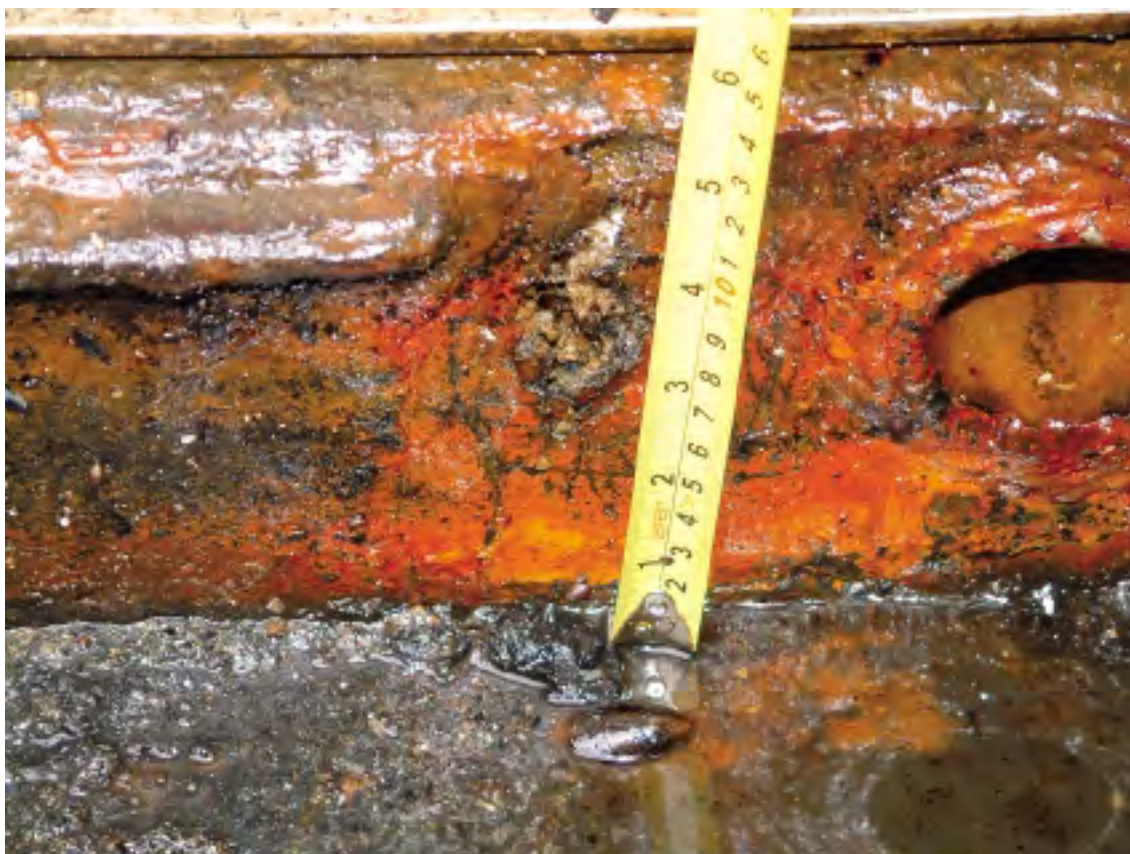
Figure 4 – Plate corrosion

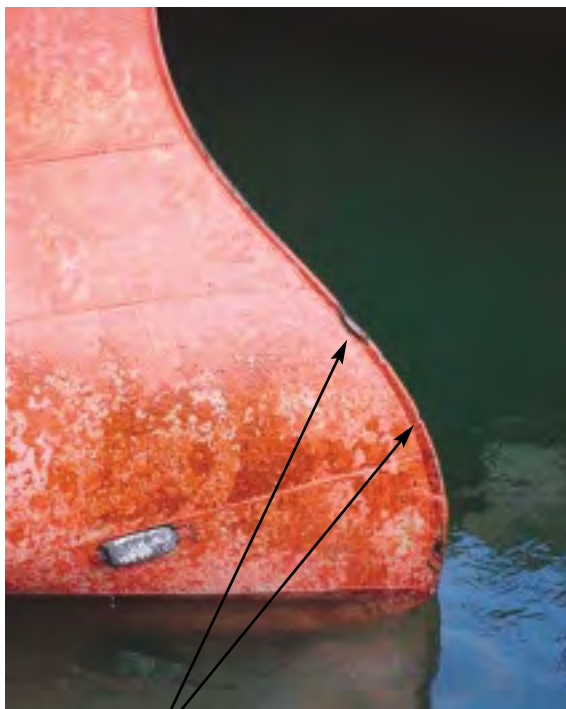
Minimal damage caused to bulbous bow of first fishing vessel

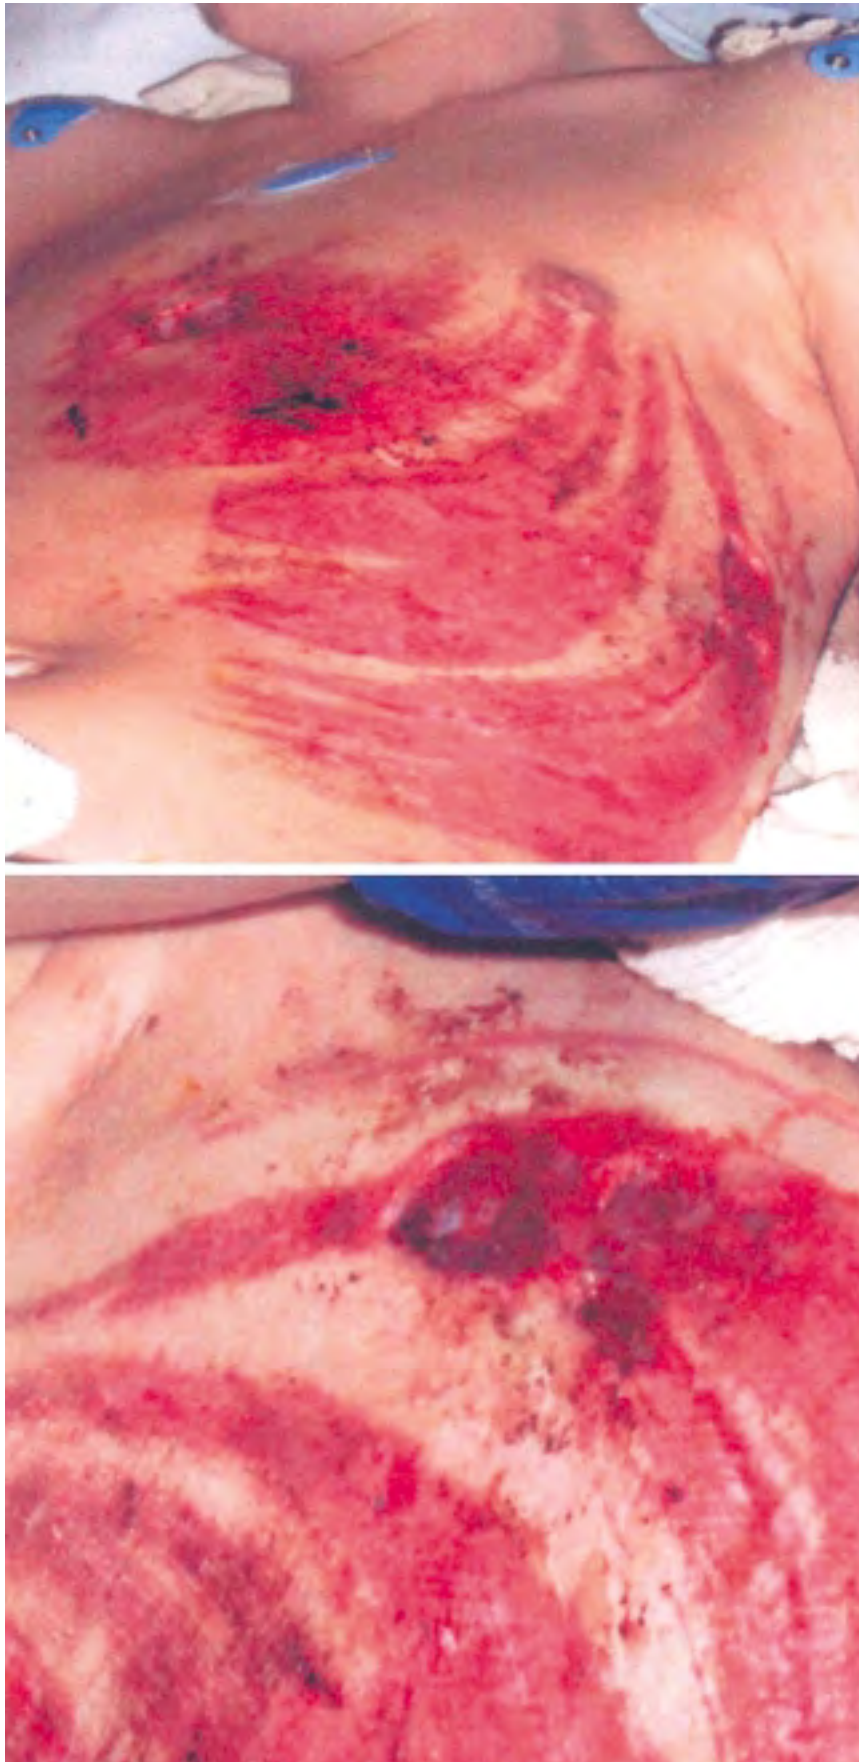
Figures 2 and 3 – Injuries to passenger

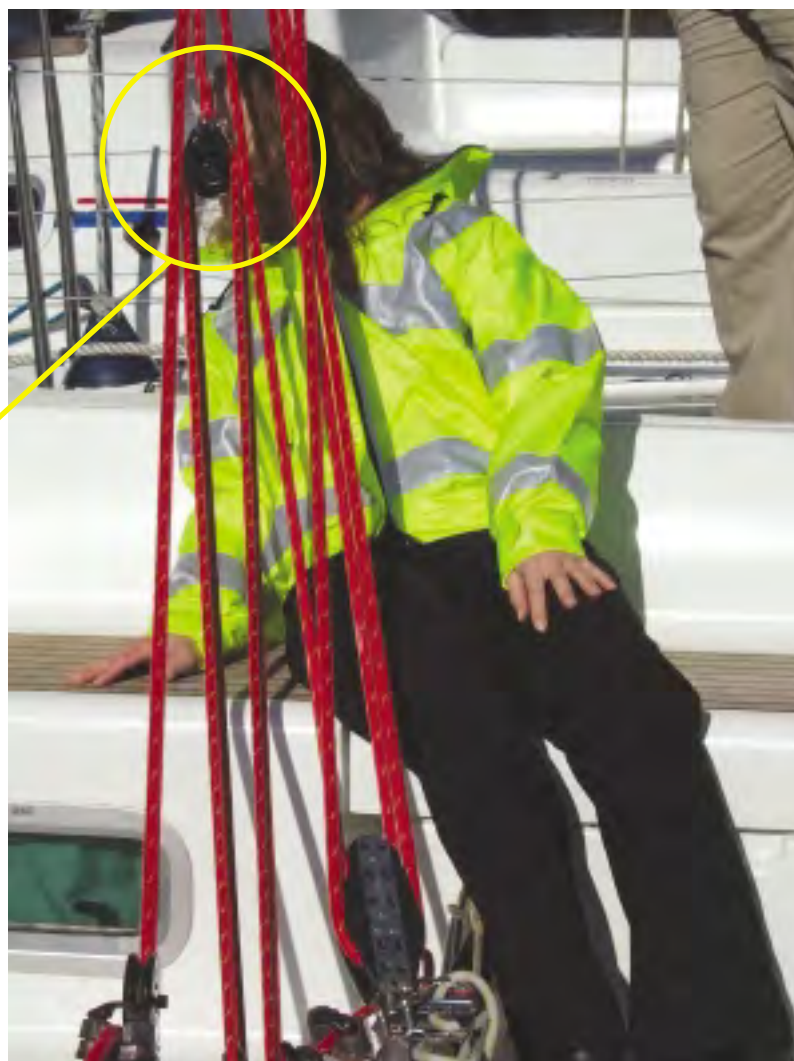
The fine tuning block is at head height when sailing — crew should keep clear of this, particularly during a gybe
