MARINE ACCIDENT
INVESTIGATION BRANCH

SAFETY DIGEST

**Lessons from Marine
Accident Reports
1/2008**

No 1/2008

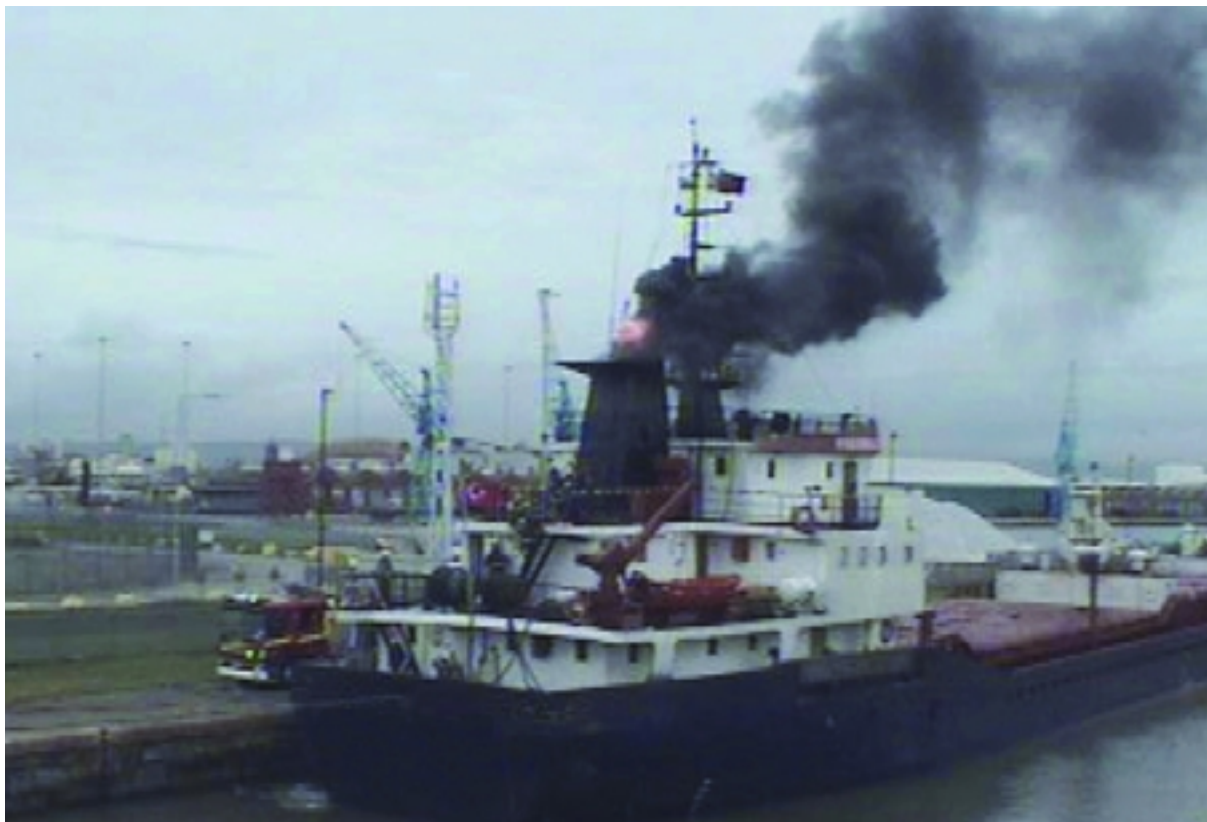
Figure 1: Fire Service attending to the fire (image captured from CCTV)

A 2500gt general dry cargo ship had arrived at a UK port following a passage from the eastern Mediterranean during which the ship had encountered particularly severe weather conditions. While manoeuvring in the locks, a fire occurred inside the upper part of the main engine exhaust uptakes, within the funnel area. Flames came out of the main engine exhaust at the funnel and ignited waste oil that was lying on the funnel top. This produced a spectacular ball of flames and much dense black smoke.

of the funnel. The engine room was evacuated, closed down and the CO₂ flooding system was operated without any problems. The fire was rapidly brought under control and was soon extinguished. There was some minor fire damage to both the internal and external paint finishes of the funnel and the lighting systems inside the funnel space.

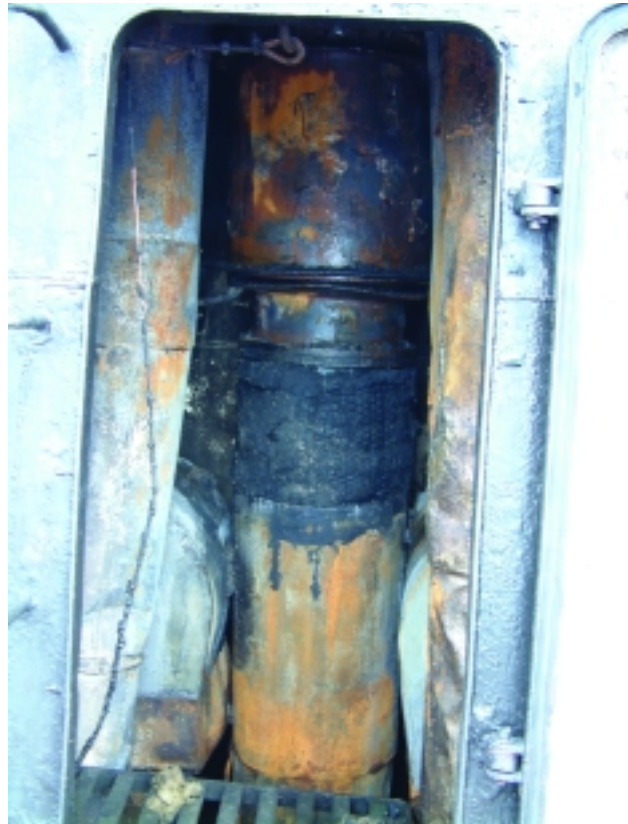
During the evening, there was a second, smaller incident. Increasing amounts of smoke were seen coming from the upper part of the funnel, in the area of the main engine silencer/spark arrestor. The local fire brigade was called again, and returned on board and located the seat of the fire. Hot spots remaining inside the main engine exhaust from the first fire had ignited the oily/greasy

Figure 2: The main engine/silencer arrester – the seat of the second fire

vapour residues in the mineral wool insulation that covered the exhaust uptakes. This second fire was extinguished by breaking open the outer metal cladding and applying water directly to the seat of the fire within the insulation itself. A small amount of water was also put down the exhaust uptake, care being taken to allow this to drain off before it reached the main engine.

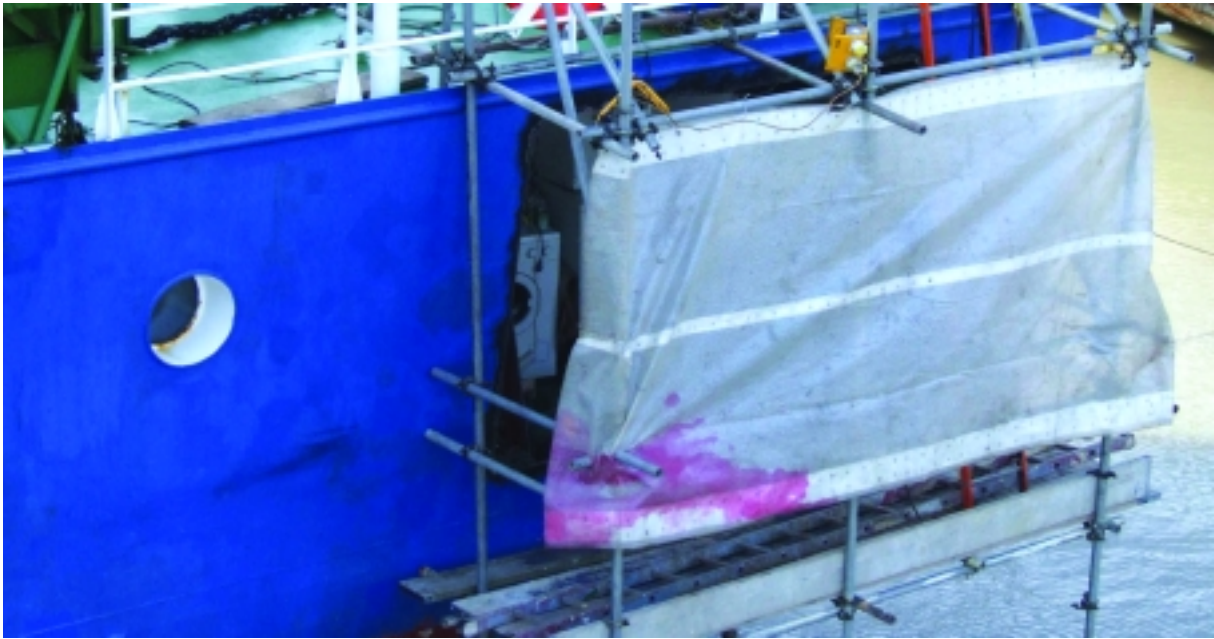
Figure 2

The cargo ship was holed above the waterline (see Figure 2) and diverted to a nearby port for survey and repair, but the trawler sustained only superficial damage and continued fishing.

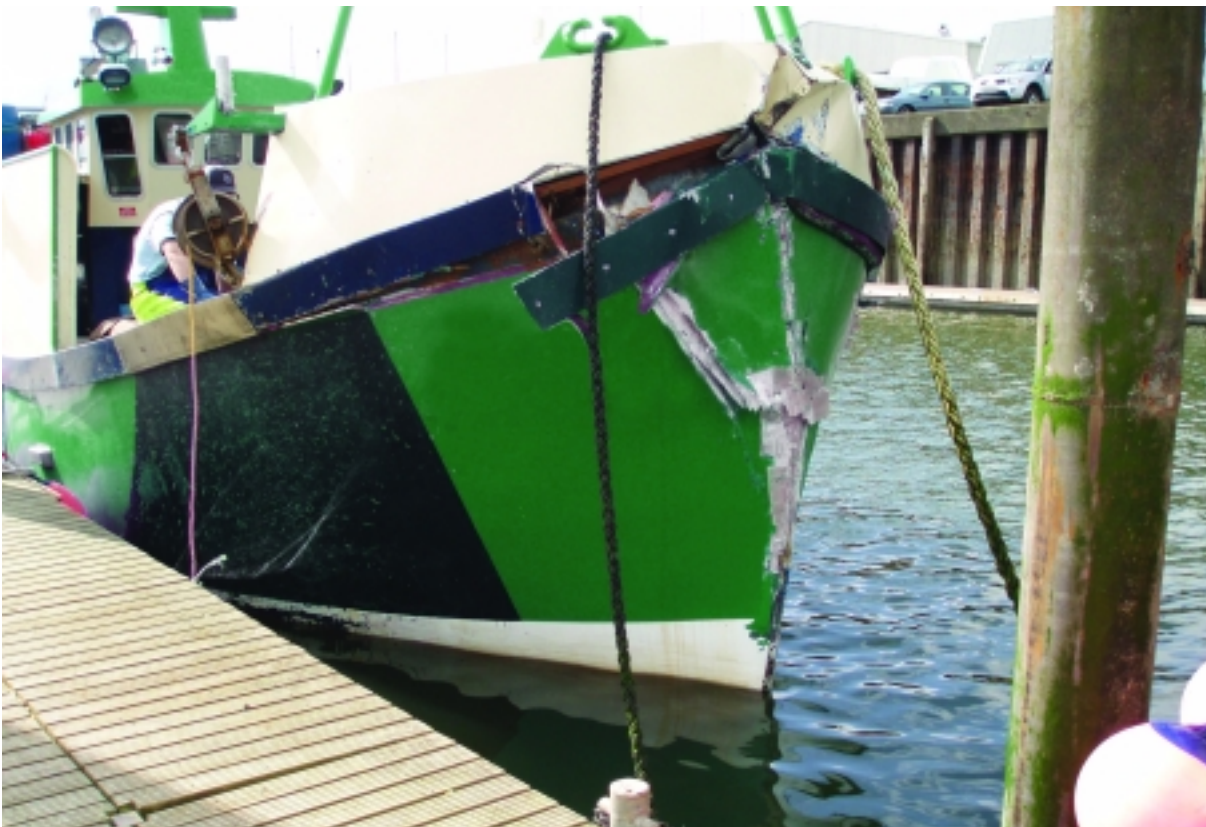
As a result of the collision, the tanker suffered some superficial damage, but the fishing vessel was damaged more substantially and was able only to limp into port with her bilge pumps working (see photograph).

Damage to the fishing vessel

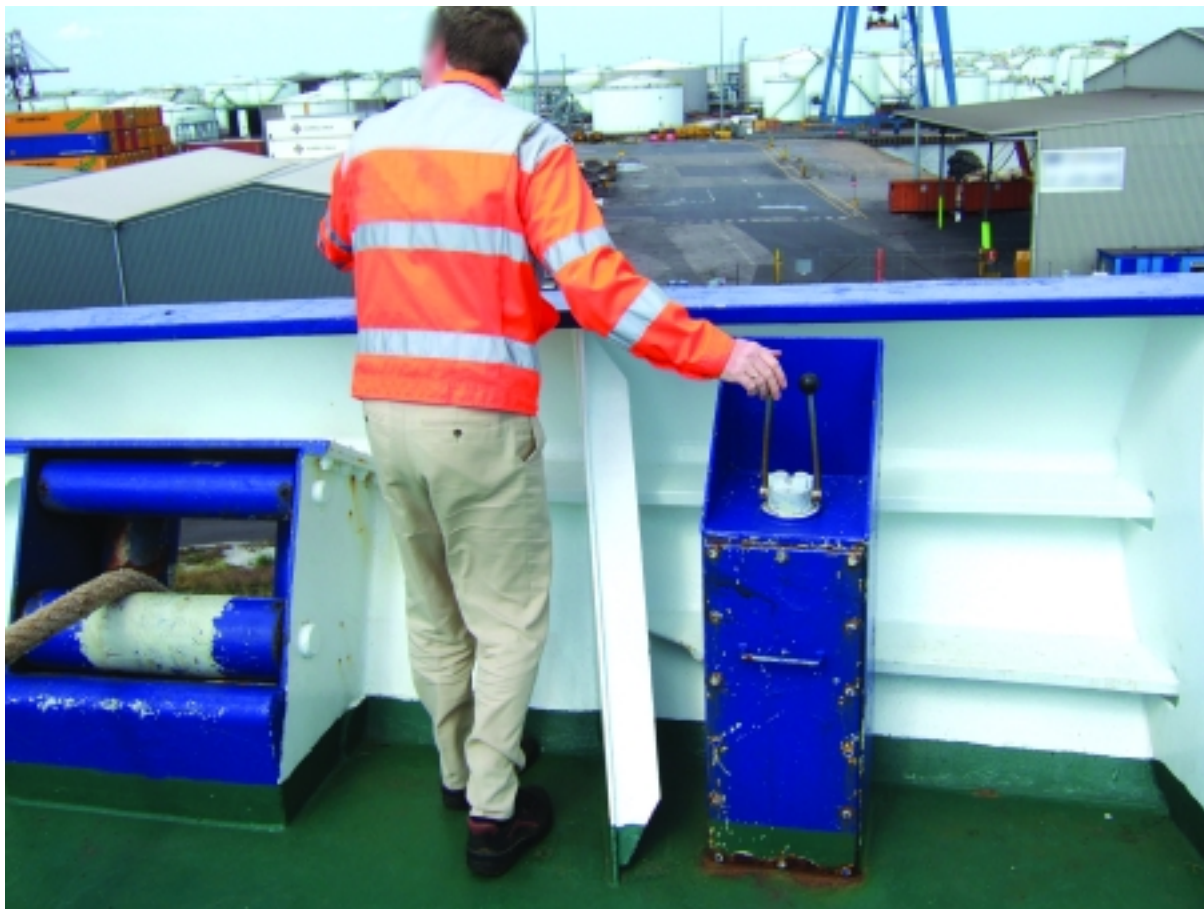
Figure 2: Position of casualty at controls

winch controls, which were located at the ship's side, next to the fairlead through which the backspring passed. As the ship rose in the lock, the backspring slipped off the bollard,

snapped back, and struck the leading hand in the face, causing lacerations and fractures to his cheek bone and nose. He had not been wearing a safety helmet.

2. It is essential that all personnel involved in mooring operations are provided with, and wear, personal protective equipment.
3. Complacency is a killer, and it is vital that ships' staff keep alert to the potential risks involved in mooring operations at all times.

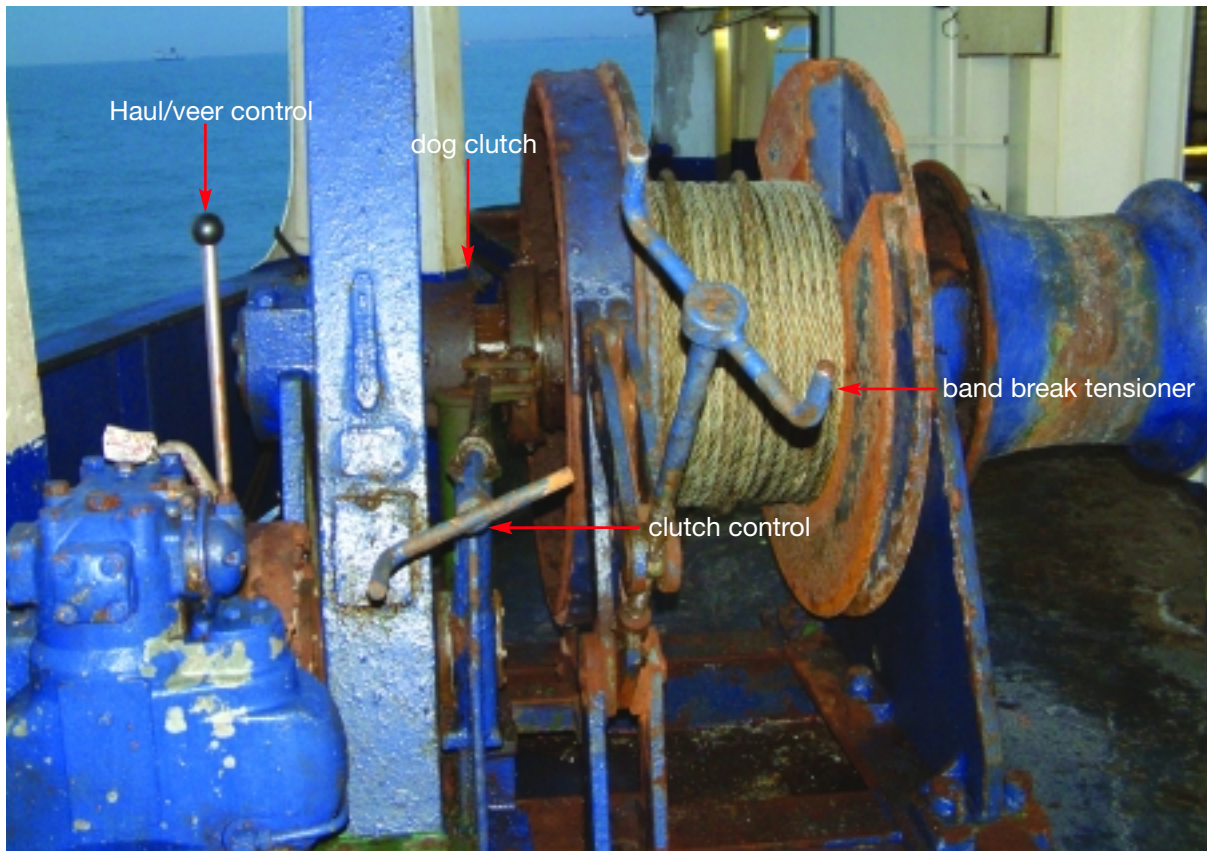
Figure 1: After winch mechanism

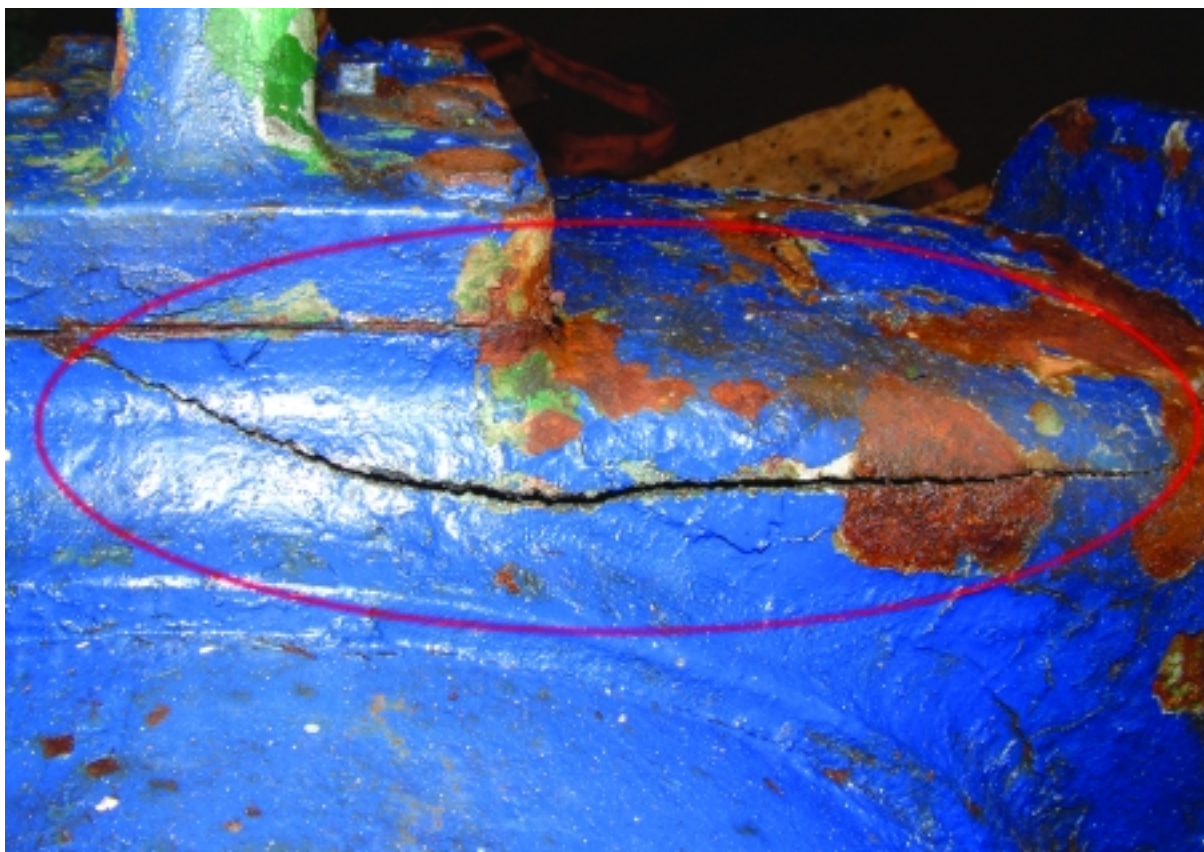
Figure 2: Fractured motor casing

As weight came onto the after ropes the loose turns were pulled from around the single bitts, and the winch warping drum rotated which, in turn, rotated the winch hydraulic motor backwards. This huge shock loading pressurised the motor casings and they fractured under the excessive pressure (Figure 2), spraying hydraulic oil across the port after winch deck.

1. Moorings should always take due account of the existing and predicted weather conditions.
2. Short lengths of line (nips) and mixing of wires and ropes for the same service i.e. for breast, head/stern lines should be avoided.
3. Masters should encourage positive reporting from the mooring decks, with a clear description of the moorings and status of winches.
4. The tie up should be supervised, where possible, by an officer, as laid out in STCW Chapter 25.
5. Ropes should be removed from winch warping drums and secured on bitts using figures of eight, using stoppers as appropriate.
6. Do not assume that moorings which cannot be seen are as satisfactory as those which are visible – do check; the effort is worth it.

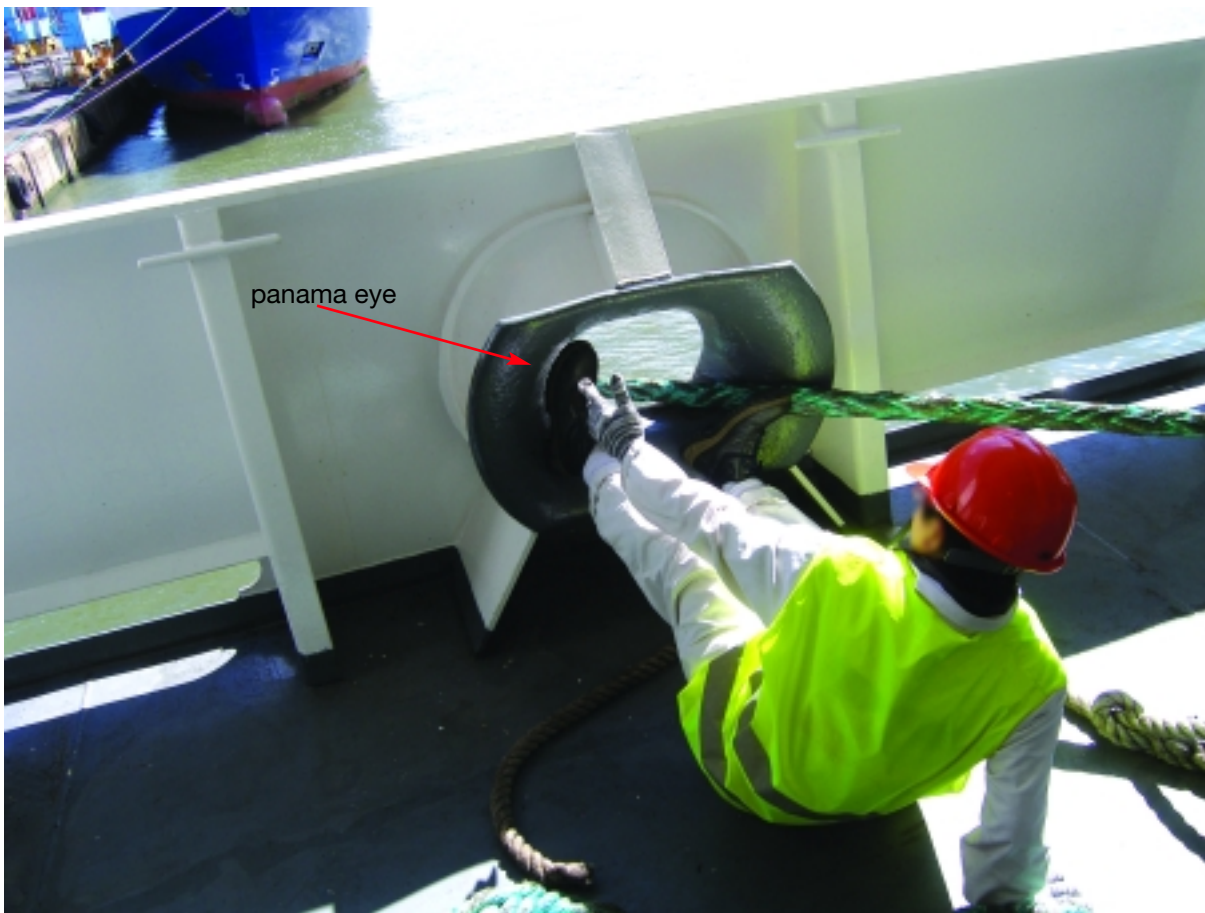
Figure 2: Position of the casualty before being dragged through the panama eye

The crewman braced himself against the panama eye while his fellow crew members tried to clear the heaving line. Just as the officer-in-charge took two paces to retrieve a knife from the galley, the seaman, concerned at losing his leg, decided to put his feet and legs together and, miraculously, was pulled through the panama eye (see Figure 2).

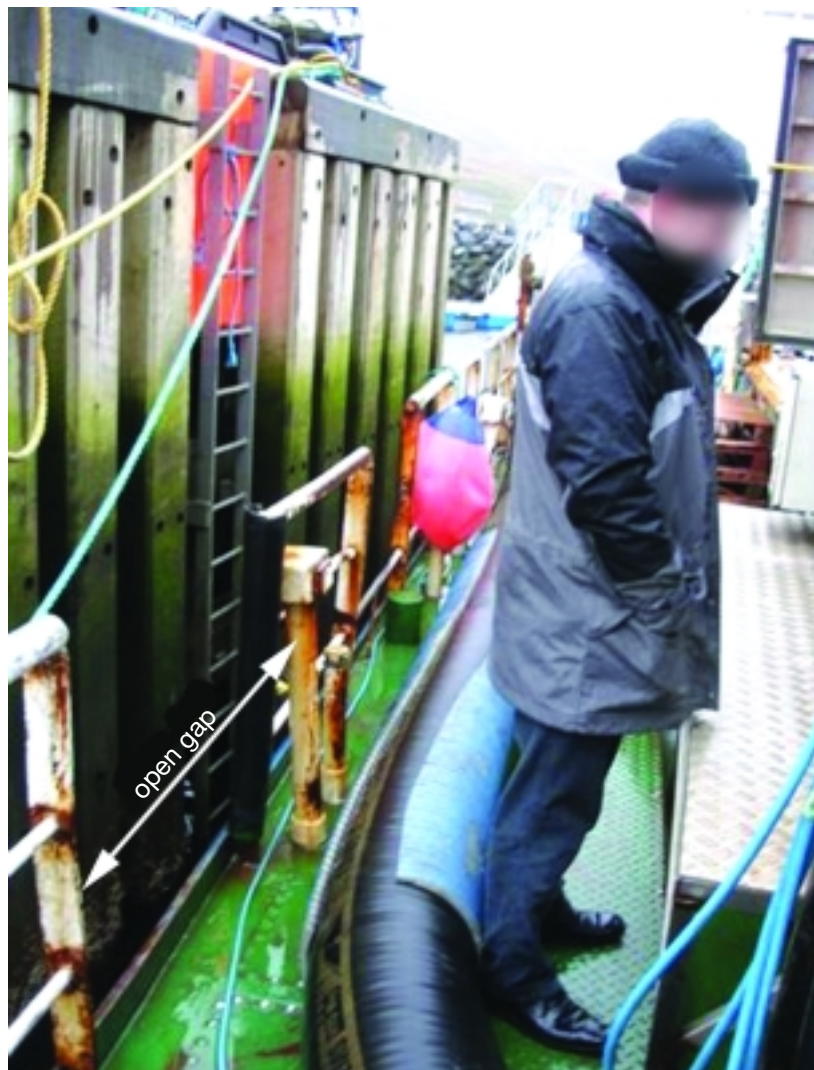
Opening in the side railings

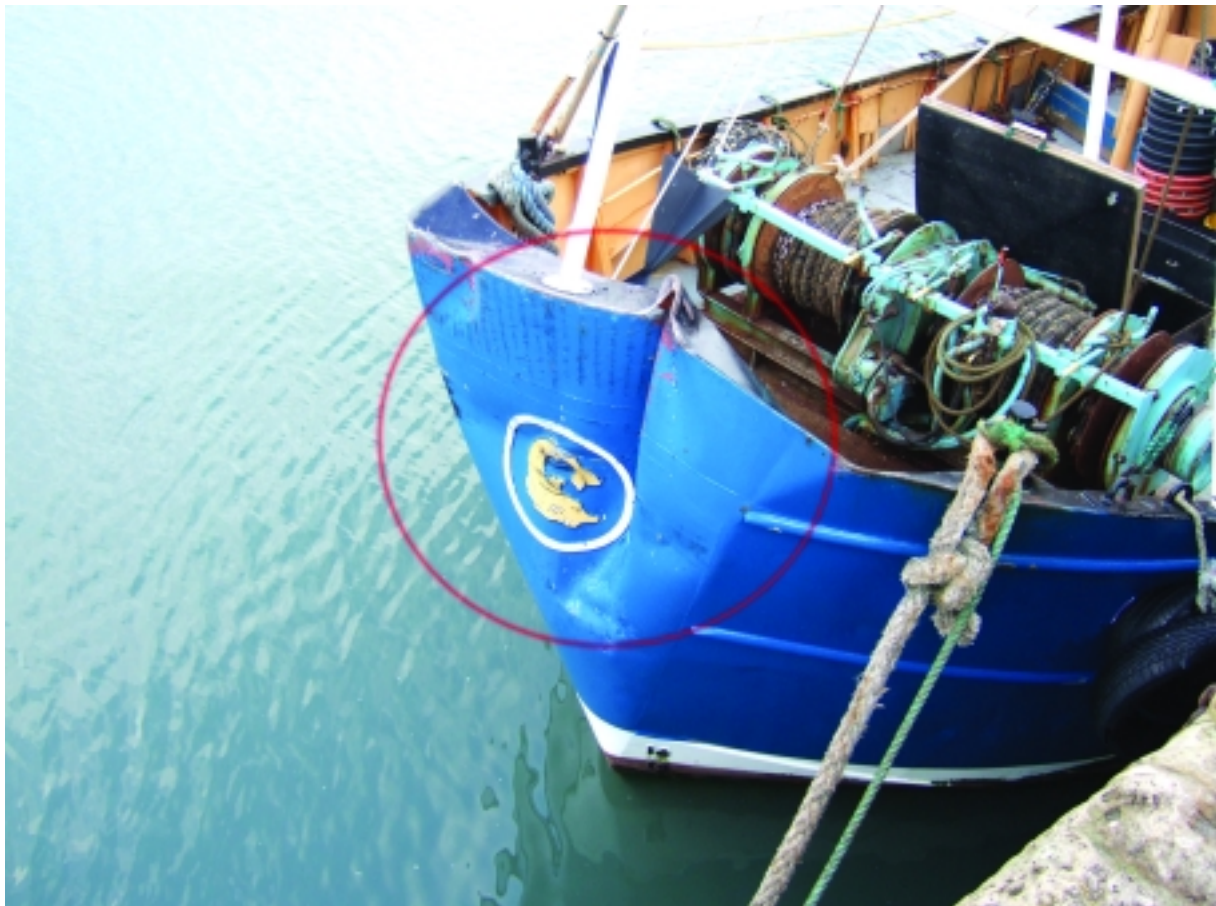
Damage to the vessel's bow

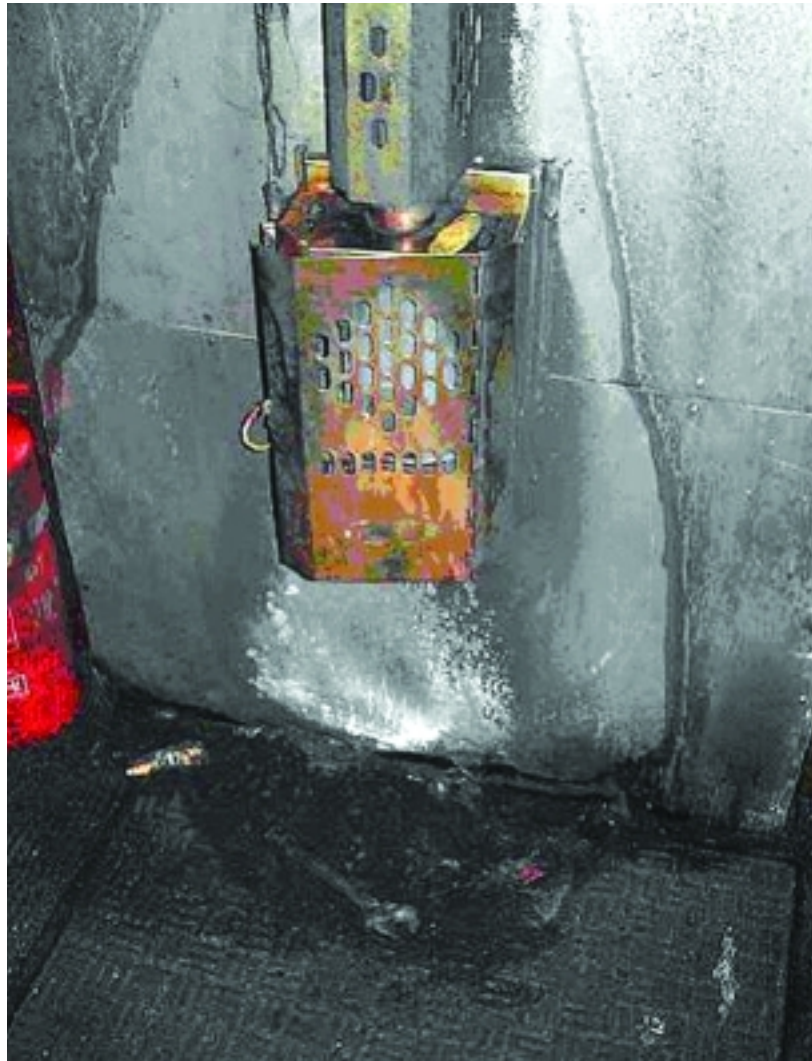
Damage around the diesel-fired heater

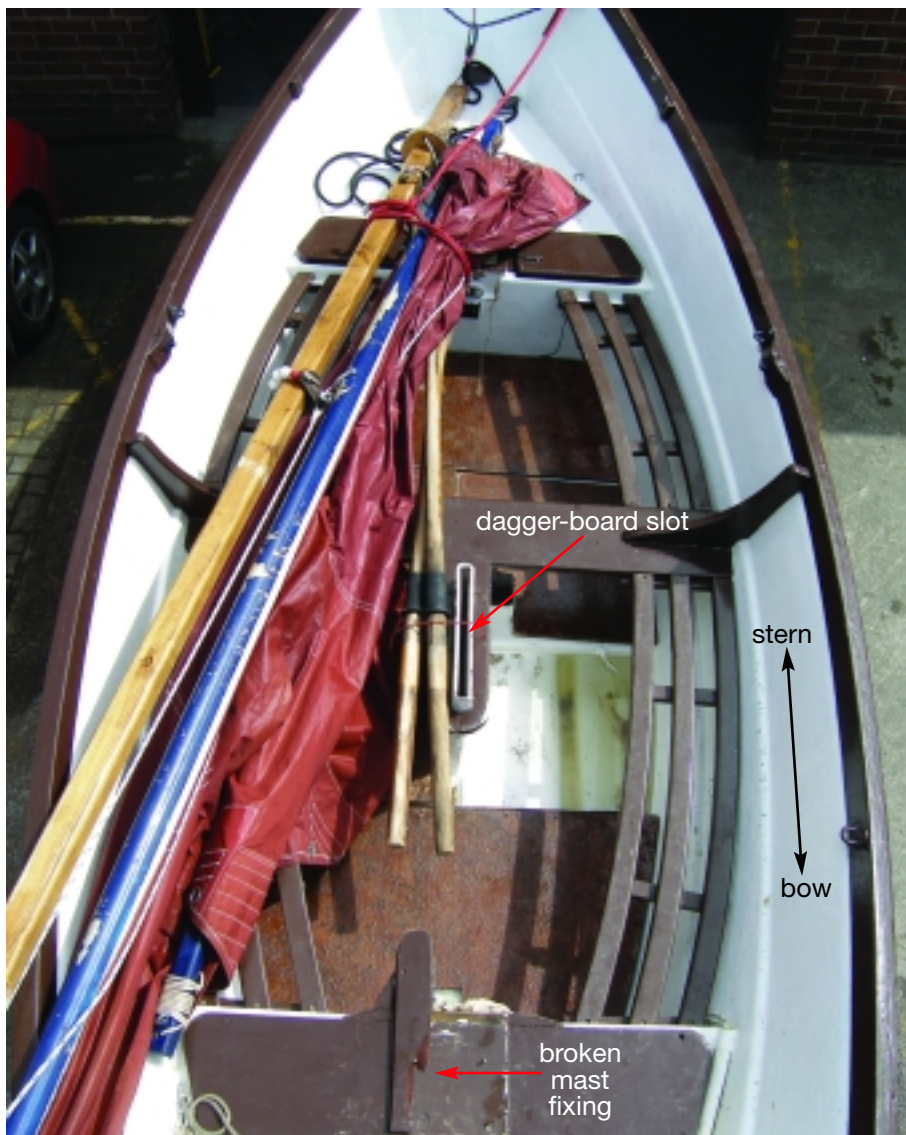
When the boat was recovered, a line was found secured over the dagger-board slot, indicating the dagger-board, which remains missing, probably dropped out of the bottom of the boat prior to its capsize.

Figure 2: Recovered vessel
