MARINE ACCIDENT  
INVESTIGATION BRANCH

# SAFETY DIGEST

**Lessons from Marine  
Accident Reports  
2/2008**

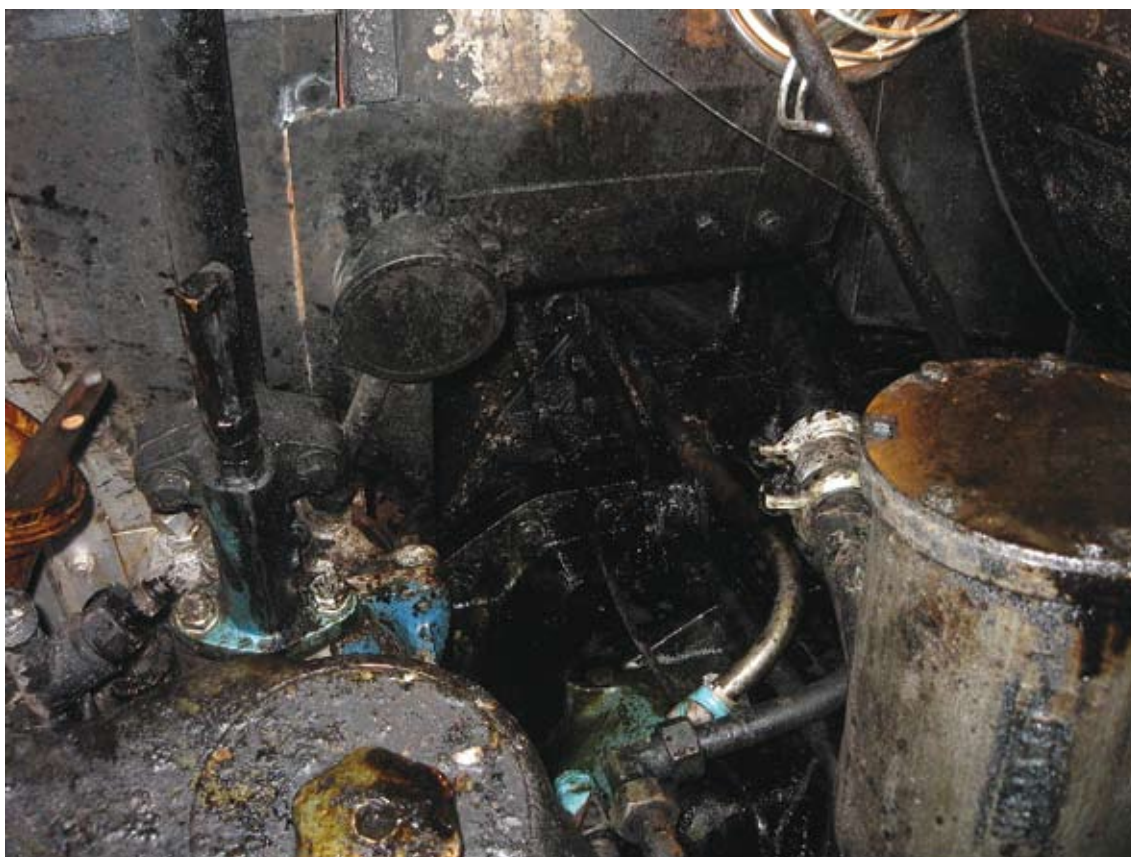
Figure 1 – Burst fuel pipe

100mm long had become detached. Pre-heated fuel oil had then spilt between the two banks of the V configured main engine and, despite splash guards being in place, ignited.

The fire caused severe damage in an area of 6m radius around the fractured pipe. Engine controls, the governor, cables, a turbocharger

2. Fuel and lubrication pipework should be inspected regularly and replaced if there are signs of any leakage or wear.
3. While it is always good practice to clamp pipework securely, clamps must fit correctly so that they do not introduce more stresses into the pipework.

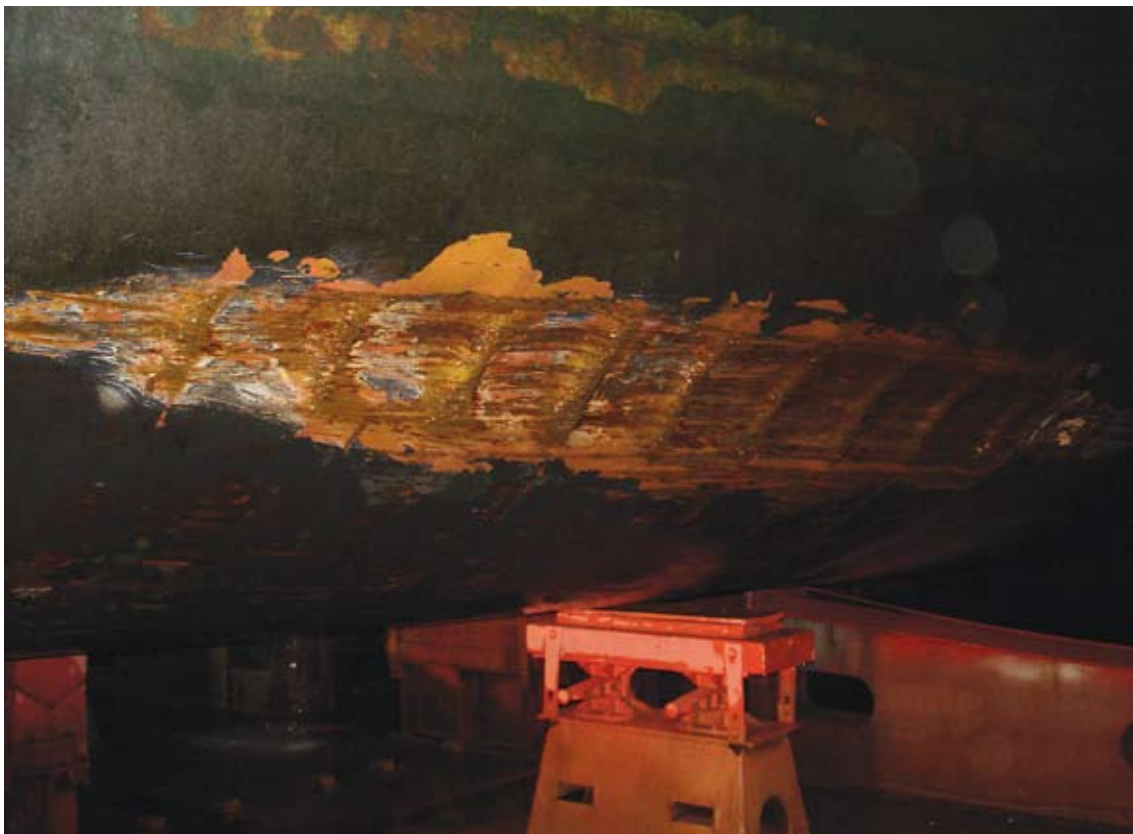
Fortunately, a pilot launch was able to pass a line to the vessel, which was re-floated within 5 minutes of grounding. The vessel was holed below the waterline in her forepeak and two double bottom tanks (see figures).

Damage below the waterline

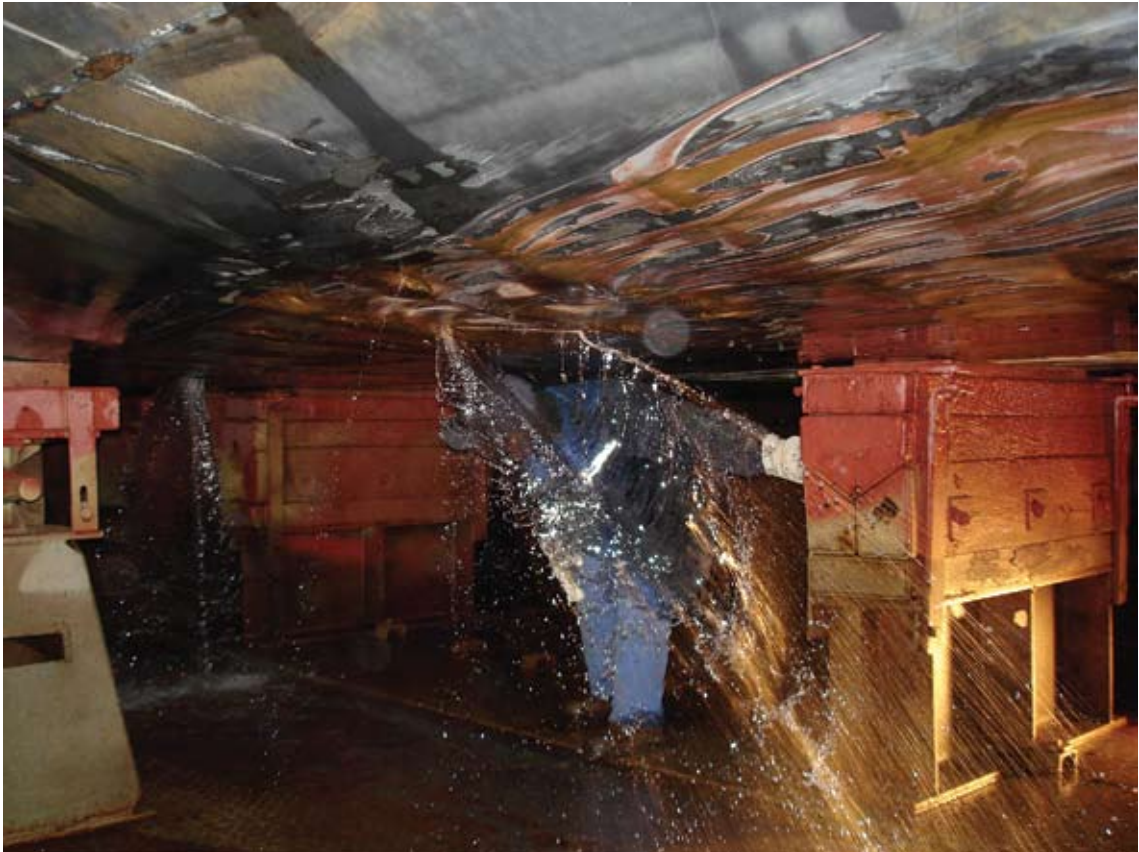
Damage below the waterline

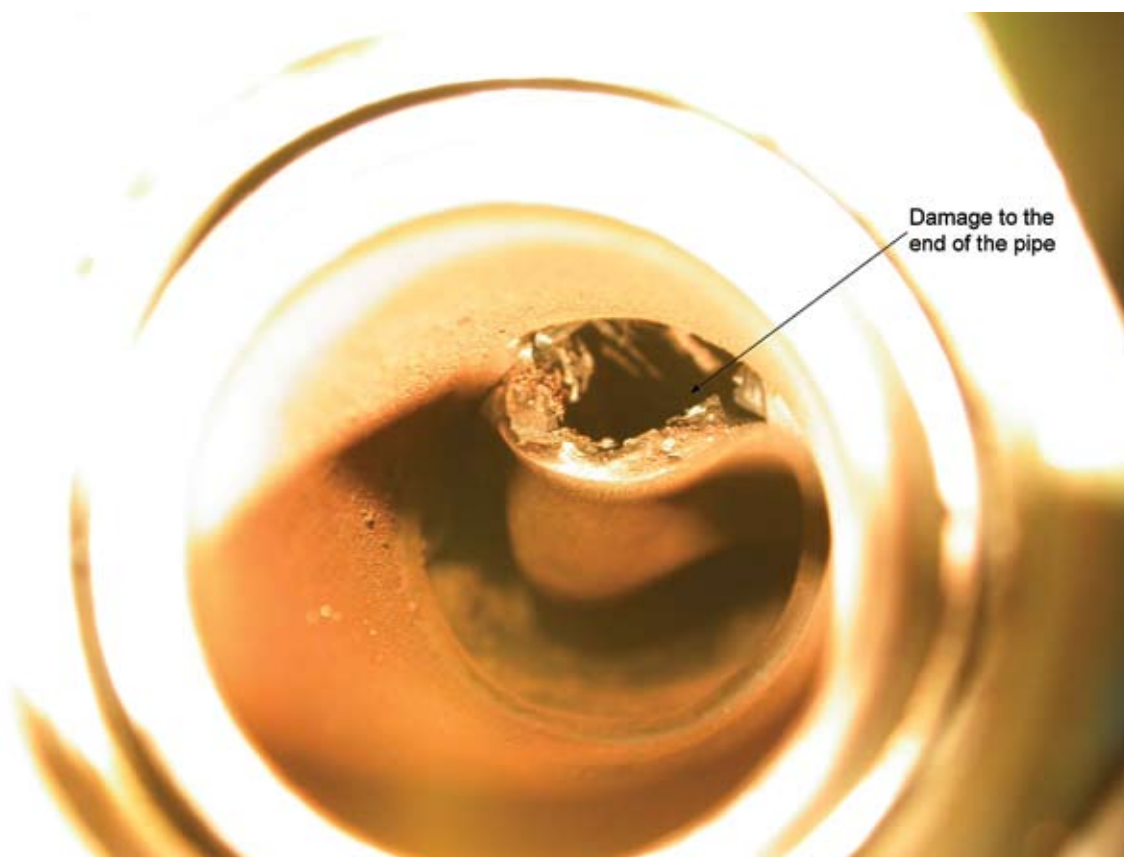
Figure 1

The cause of the fire was a ruptured low pressure fuel hose spraying marine gas oil on to exposed sections of the engine exhaust pipe. Laboratory tests carried out on the flexible pipe revealed a small area of damage to one end where it was crimped to a metal collar forming part of its end fixture. The inner layer had opened up slightly, causing gas oil to enter the space between the inner and outer layers (Figure 1). This resulted in the outer layer degrading gradually and

tearing. There were no shields fitted above the pipe to deflect any accidental release of fuel into the bilges. When the pipe ruptured, marine gas oil at 6 bars pressure sprayed on to the exposed sections of the engine exhaust pipe. A similar exposed section of exhaust

3. SOLAS also requires all fuel pipes and associated equipment in the vicinity of the engine to be shielded to prevent oil sprays resulting from damaged pipes, filter covers, etc. While high pressure systems are usually well protected, low pressure systems, which may contain fuel up to 6 bars pressure, are frequently overlooked. This is unfortunate because it is not difficult to fabricate a sheet metal cover to fit over the pipes in such a way that any oil leak would be directed to the bilges.

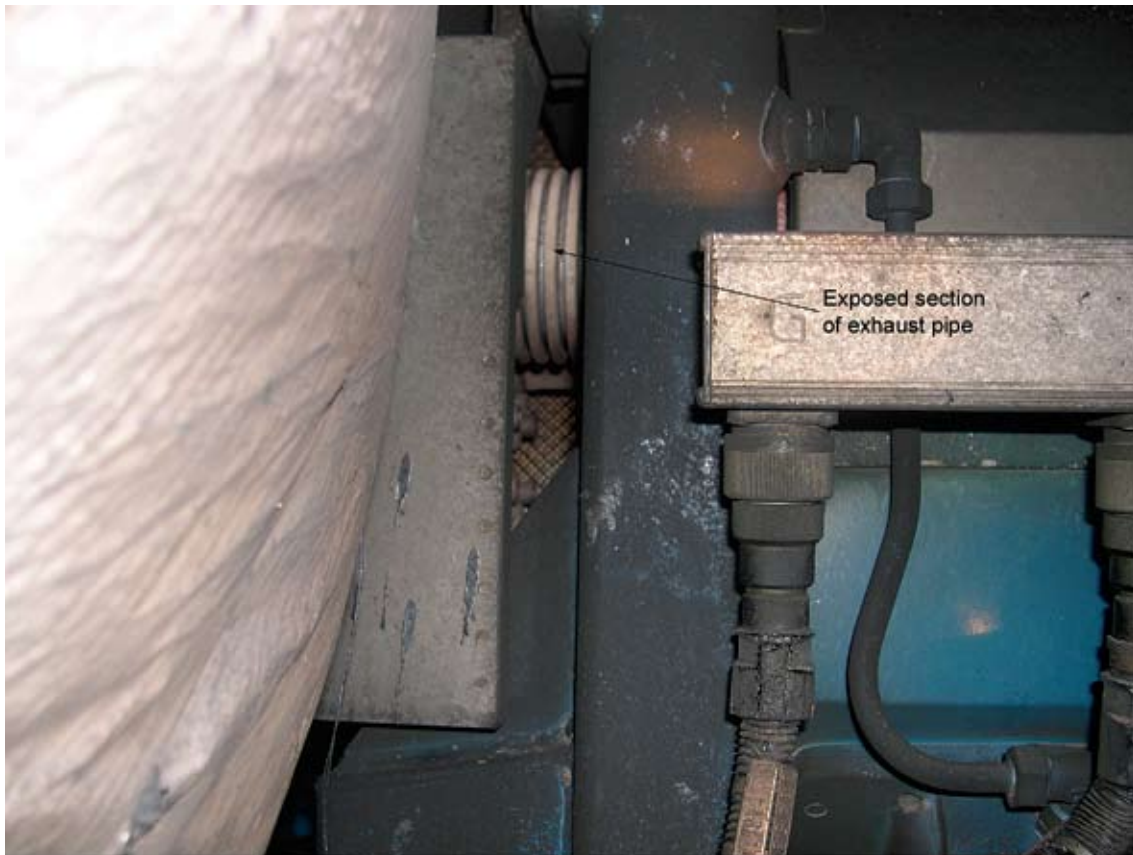
Figure 2

pipe on another of the ship's engines is shown at Figure 2. The fuel spray ignited, and spread to the bilges, where a substantial amount of fuel had accumulated. The fire continued to be fed by more fuel from the leaking hose.

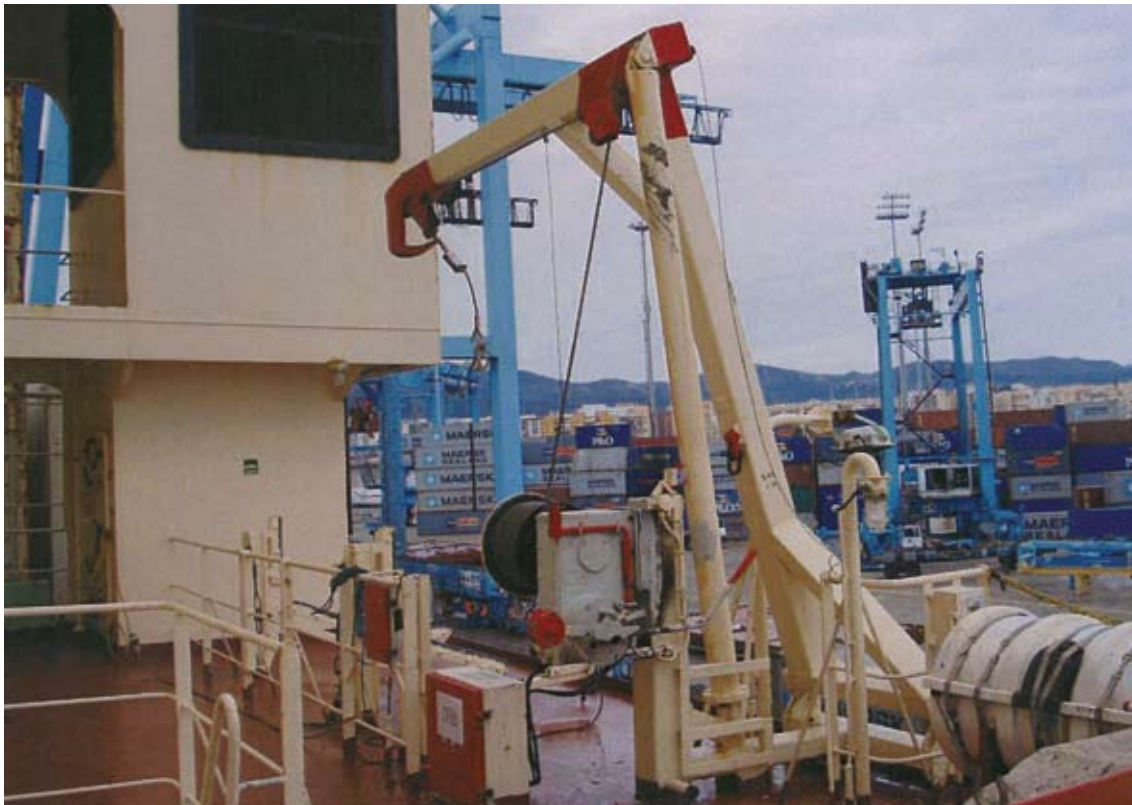
Figure 1

As the cable continued to heave in, the bob weight operated the limit switch (Figure 1), but once again the motor failed to stop and the cable continued to be heaved in. With the hook now hard up against the davit head, the heaving load was transferred to the structure. The winch bedplate gave way, and it fell into the water together with the rescue boat.

Investigations found that two out of three winch motor starter contacts had welded together. This prevented the manual stop and limit switch from isolating the electrical power. The contacts were static welded together due to excess current being drawn across them. This happened because they had, at some time prior to the accident, been changed from the original specification to a much lower maximum rating than that drawn by the winch motor.

2. When replacing items in electrical starters, or in any electrical components, make sure the alternative to the manufacturer's item(s) is suitable.
3. Electrical interlocks are fitted to ensure safe operation of equipment, either as part of normal operation sequencing, or to safeguard the system in the event of a fault. Interlock functional testing should be a periodic maintenance item – do not get caught out: check interlocks regularly and attend to defects without delay.

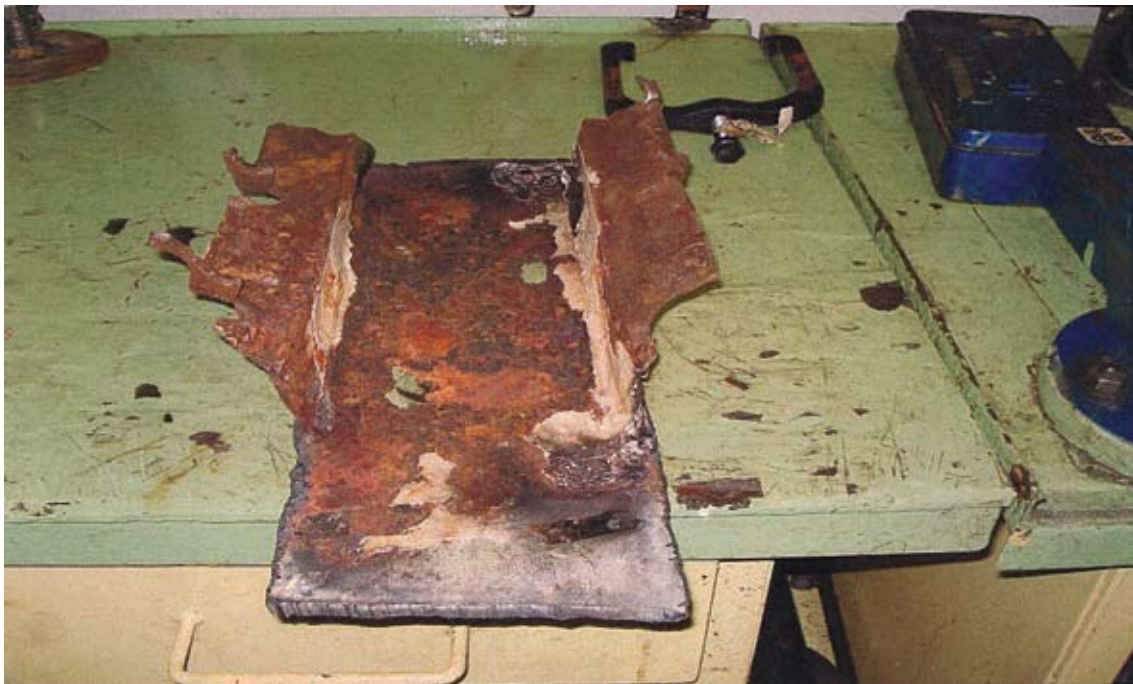
To complete this sorry tale, the winch bedplate was found to be badly corroded, which caused it to become detached from the winch (Figure 3). Access to the plate was difficult, so little attention had been paid to its preservation.

Figure 3 – Old bracket

4. Consideration should be given to fitting an emergency stop button to equipment where a risk assessment identifies that it is justified.
5. Dealing with structural corrosion is part and parcel of everyday life at sea. Access difficulties all too often mean areas of corrosion are neglected. Note the signs, because these areas will warrant extra attention – as this accident clearly illustrates.

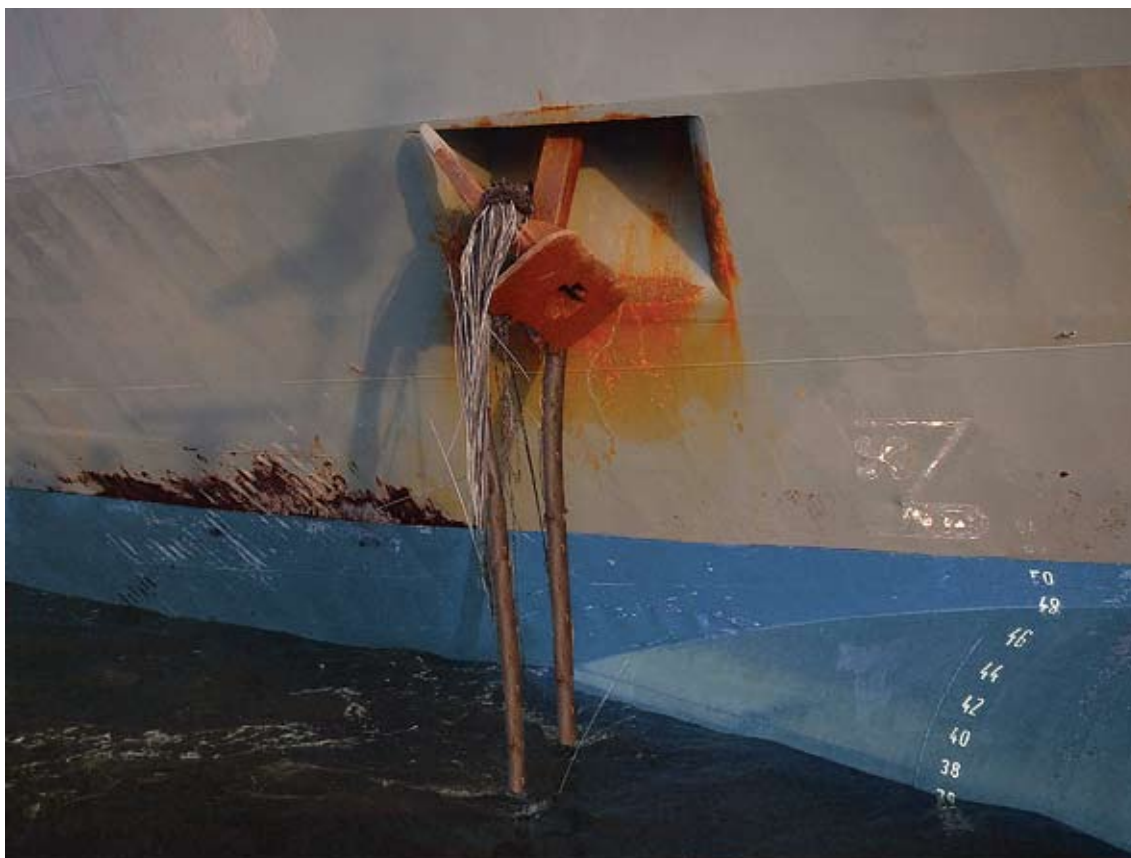
Vessel's anchor, fouled with a power cable

working on deck, heard a slow but loud banging noise from forward. Accompanied by another seaman, he went forward to investigate the noise and discovered that about 2 shackles of cable were outboard and banging against the hull. The windlass brake had not failed.

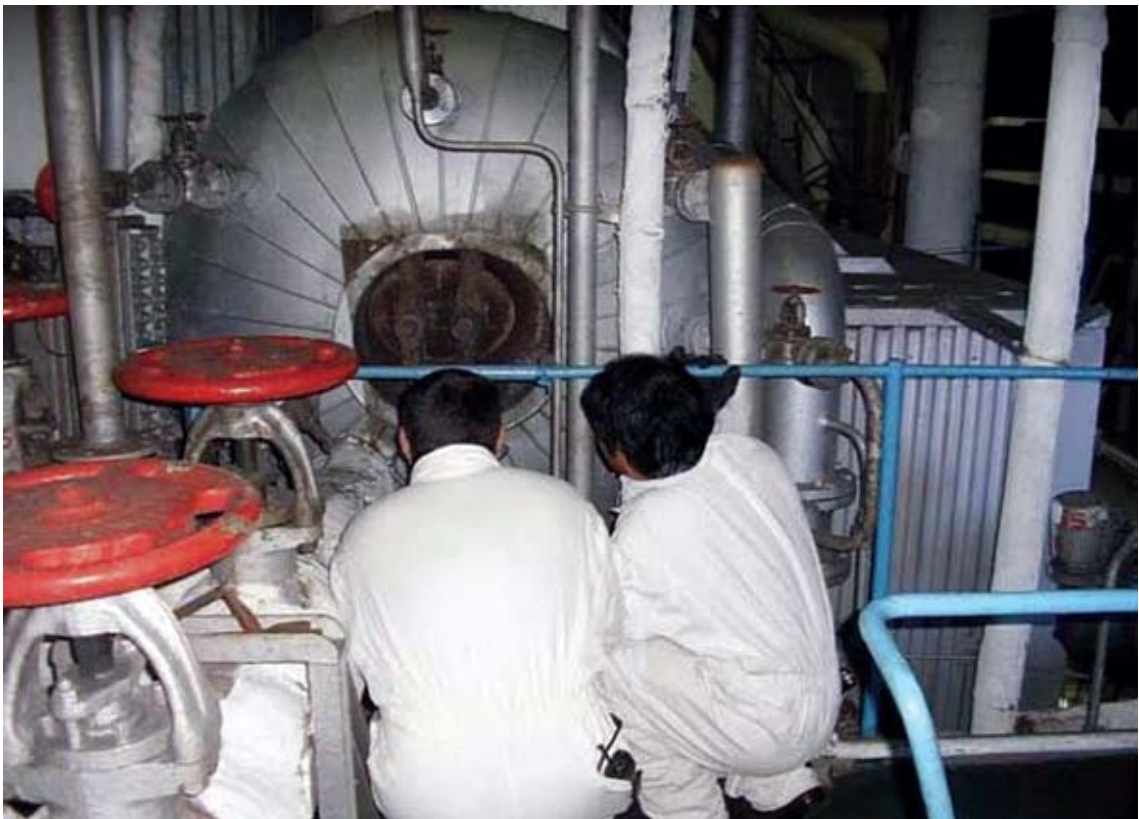
Figure 3

At 2200 both of the cleaning experts approached the steam drum door (Figure 3). No tests were conducted to check the steam drum atmosphere for either toxic or flammable gases. The UK expert picked up the halogen lamp (Figure 4) and placed it just inside the steam drum. The Danish expert saw a small flame or spark, and an explosion immediately followed.

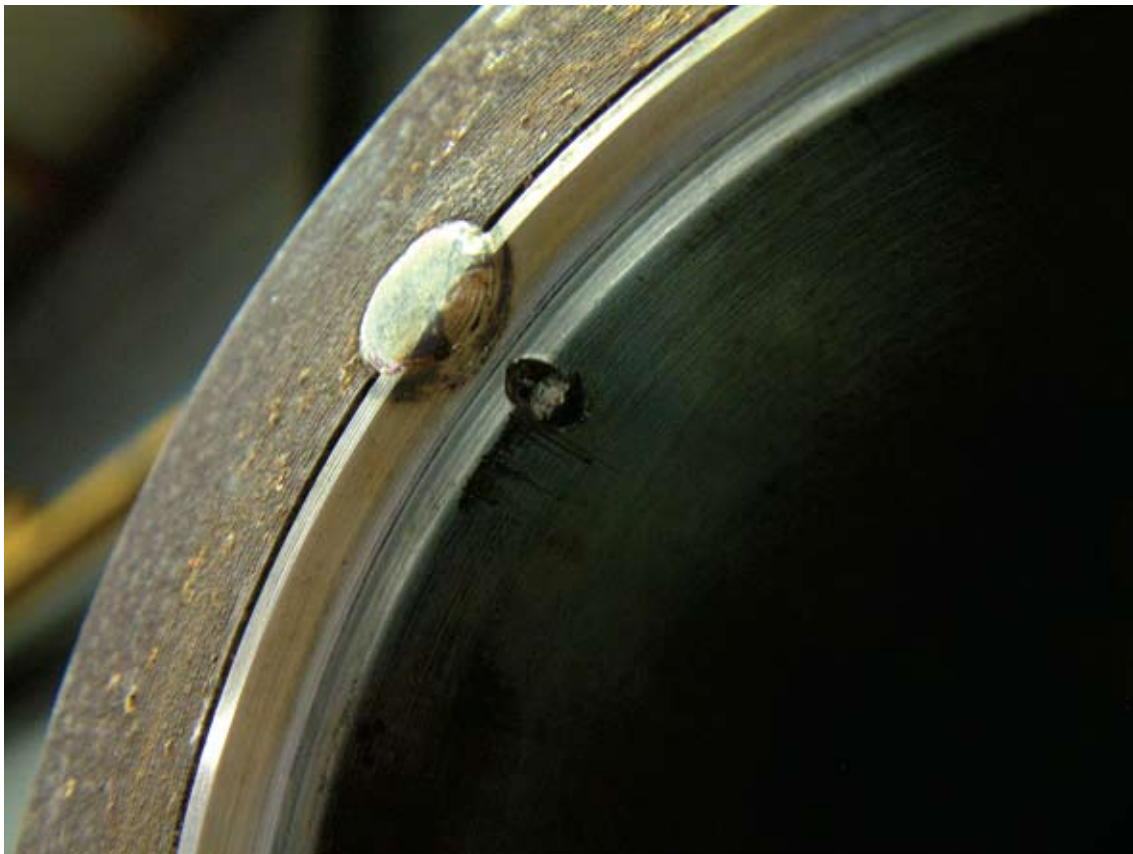
Burr on gas valve

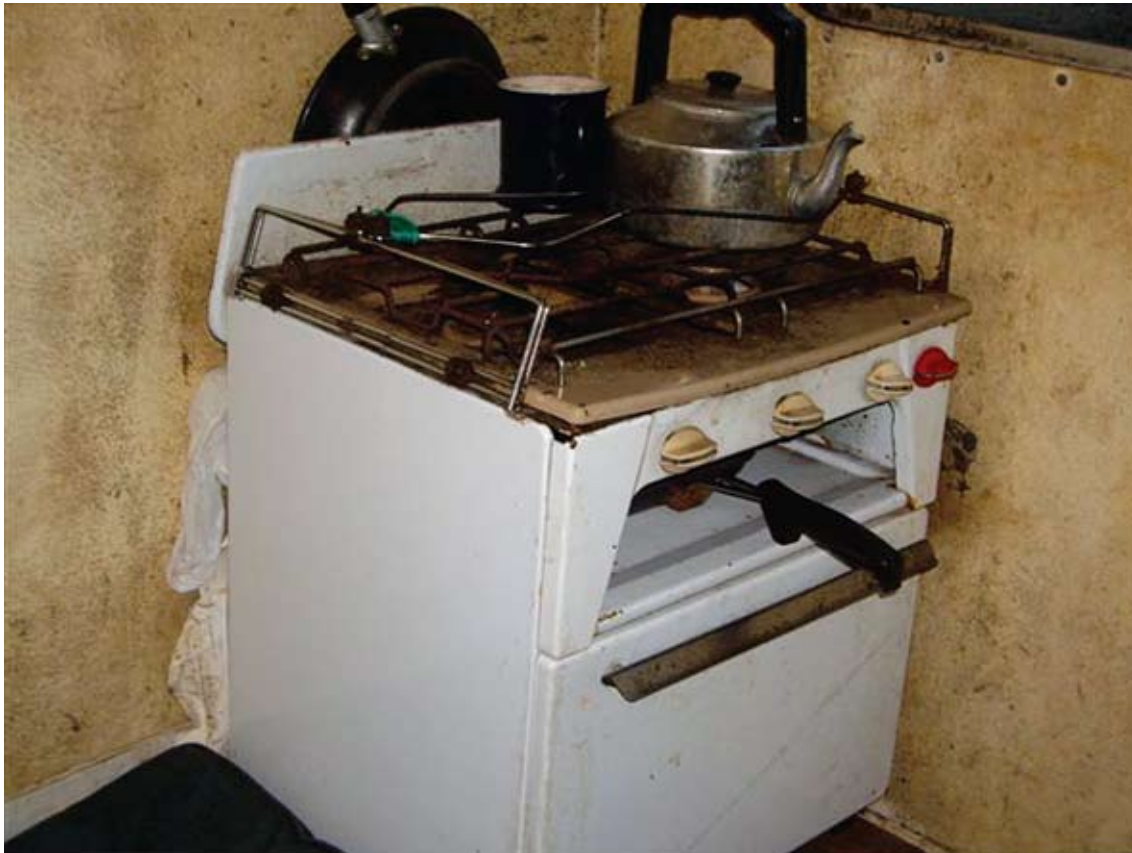
Cooker with old fiddle and kettle

The skipper ensured that the fiddle was properly adjusted to fit the kettle before the stove was used again.
