SAFETY DIGEST

Lessons from Marine Accident Reports

No 2/2007

MARINE ACCIDENT INVESTIGATION BRANCH

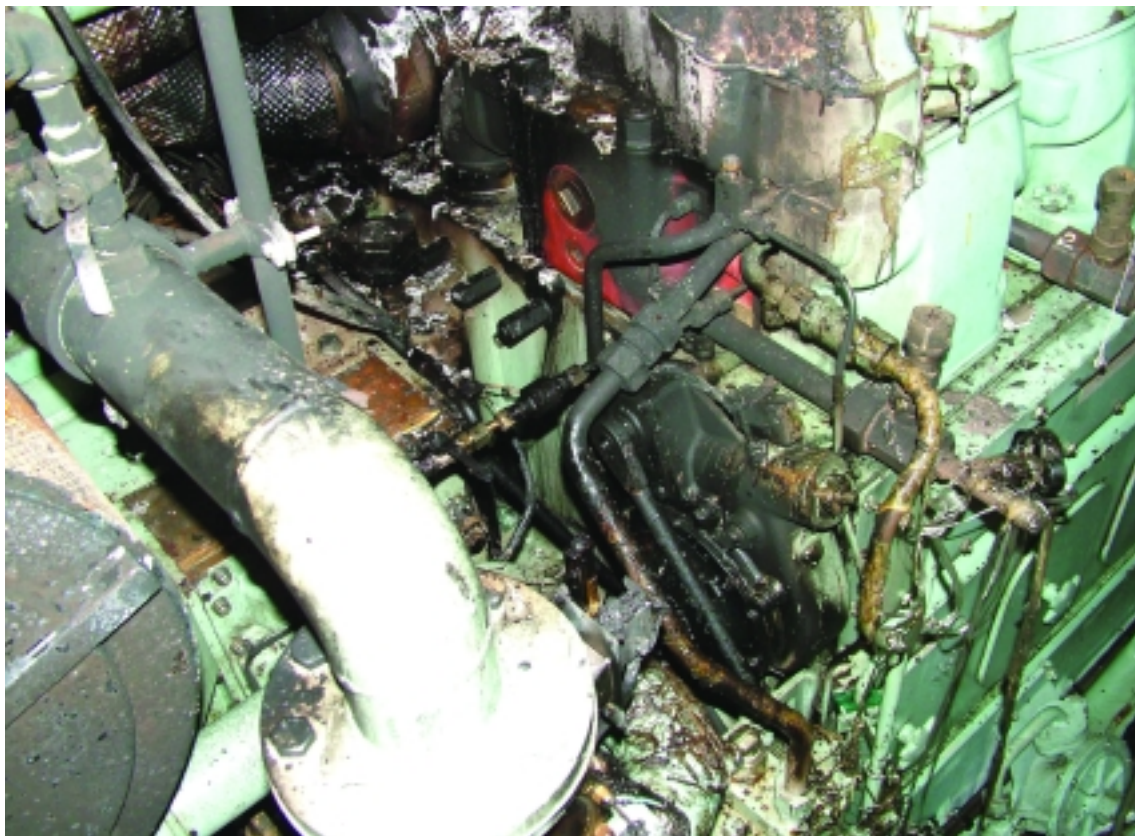
Fuel injector spill return pipe and associated fittings

extinguished, but a main engine fuel spill return pipe was found to be broken, and fuel was seen to be draining back into the engine room from the service tanks above.

Further investigation identified that the fuel injector spill return pipe had not been fitted correctly. Several compression fittings had been used in a very short run of pipe to accommodate valves and changes to the pipe's diameter. The pipe was inadequately supported and exposed to vibrations from the

engine. In an attempt to prevent earlier problems of fuel dilution of the main engine lubricating oil, a non return valve had been fitted in the spill line close to the engine, and the return pipework terminated in a gooseneck at the top of the service tank. Unfortunately, the failure occurred downstream of the non return valve, and with the base of the gooseneck immersed in the fuel tank, a siphon allowed fuel to drain back down to the seat of the fire, despite operation of the remote fuel shut off valves.

3. Although the fuel injector spill return was a low pressure system, its failure allowed fuel to leak onto hot, main engine components, causing the fire. All fuel system pipework should be properly mounted and use appropriate fittings to minimise the risk of failure.

4. Once the pipework had broken, fuel could drain under gravity from the service tanks onto the fire below, despite operation of the emergency fuel shut off valves. All pipework to and from fuel tanks should be examined to ensure that, if the fuel shut off valve has to be operated, fuel can not drain out by other means.

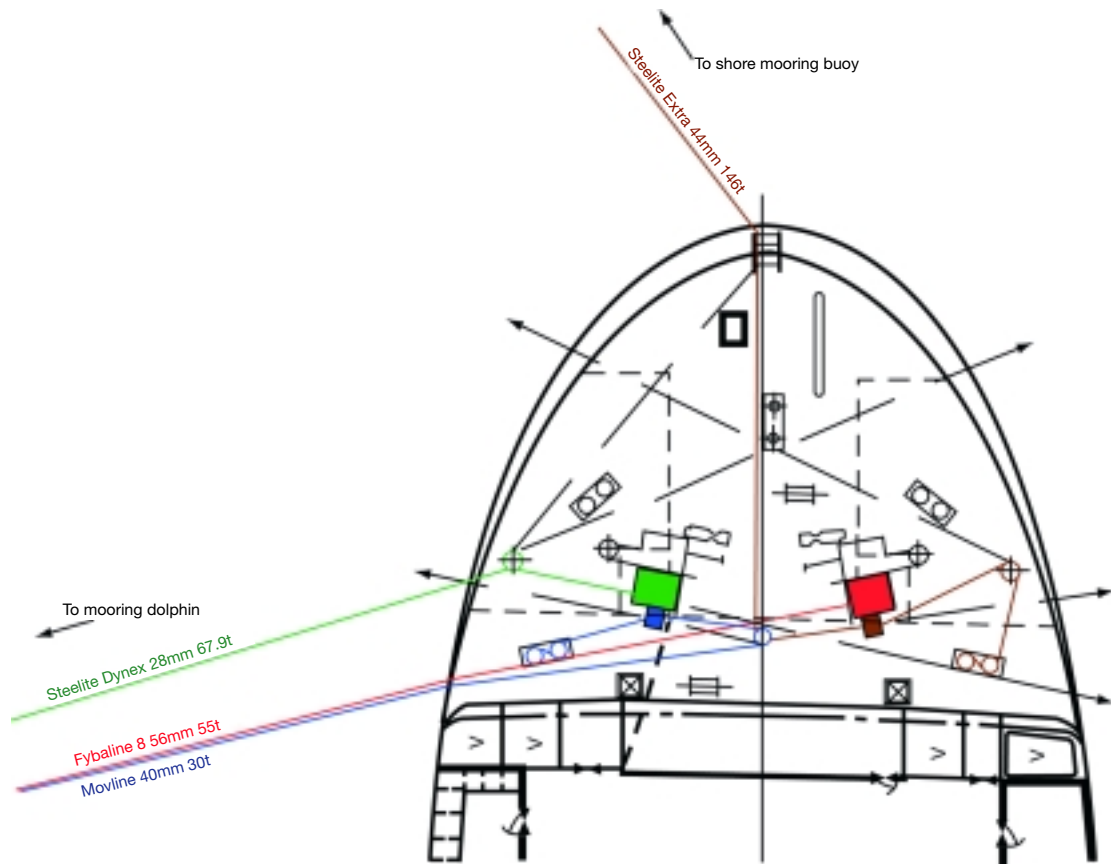
Mooring arrangement

1. Ensure your vessel's mooring arrangement is reviewed regularly and is suitable for the berth and likely weather conditions. In particular:
 - Mooring lines of the same size and type should be used for all leads but, if this is not possible, lines in the same service, i.e. breast lines, spring lines etc should be the same.

- Ensure fairleads and the handling of ropes does not cause excessive abrasion.
 - Captive drum brake rendering loads should be proportional to the strength of lines fitted.

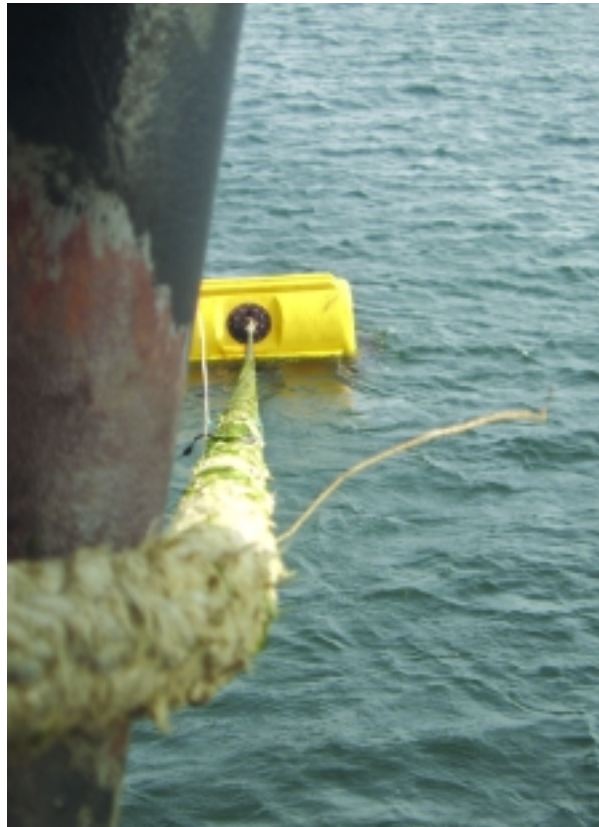
Head line to mooring buoy

2. Ensure lines are inspected in accordance with manufacturer's and industry guidelines (OCIMF, Cordage Institute). The head line in particular, although relatively new, was obviously abraded and in need of attention. The planned maintenance system had recorded the inspection of the head line 2 months previously, and found the rope in 'good condition', perhaps indicating an inability to be able to inspect the whole rope adequately.

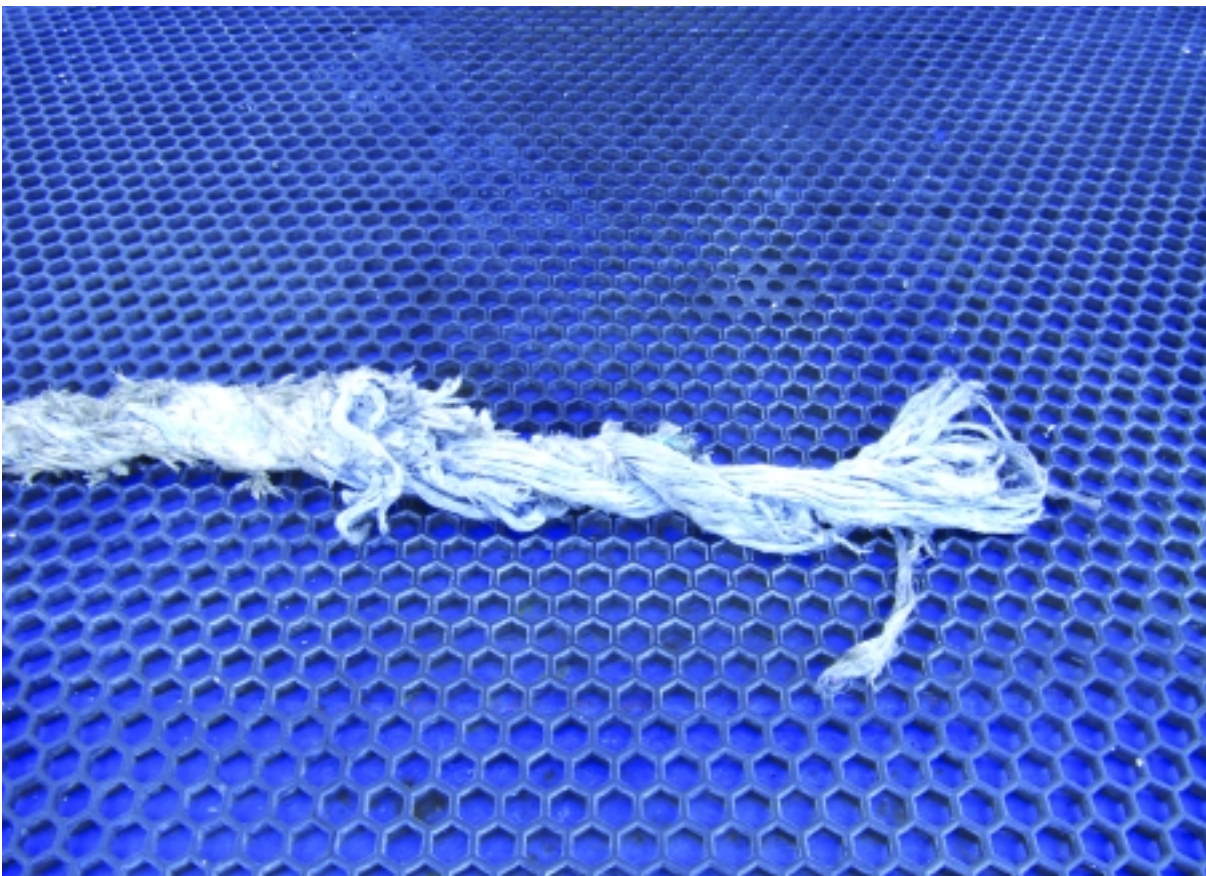
Parted line

After testing, it was found that the rope near to the failed area had a breaking load of 426kN, which represented a 30% residual strength. The rope was severely abraded in this area (see drawing) and was found to be significantly twisted with 3-4 turns per metre.

3. Twisting ropes can weaken them as much as, or more than, abrasion. This is especially true for HMPE braided ropes, which have high strength but low extension properties. The compound effect of abrasion and twisting can cause significant loss of strength, as in this case, where an 11 month old HMPE rope had weakened by 70%.

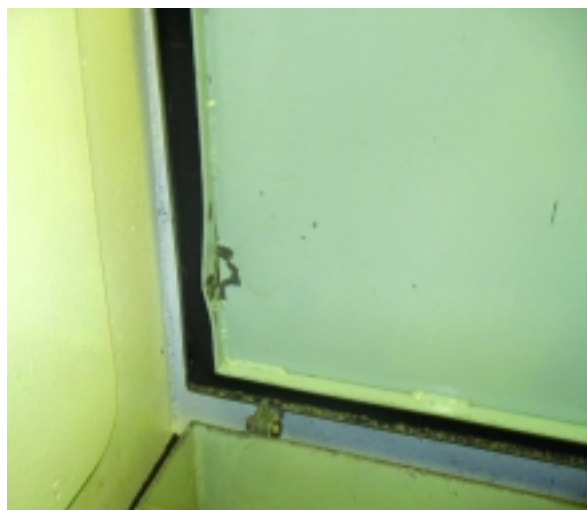
Damage to a hatch lid, caused by the explosion of a unit during replacement of MOB marker

Four years is a long time, and as the units headed towards their expiry date, a number of incidents occurred as they were being replaced. Not replacing the transportation safety pin, and inadvertently moving the unit enough to activate it without displacing the plug, caused the canister to explode exactly as described in the MGN. Fortunately, in each case reported to the MAIB, there were no injuries.

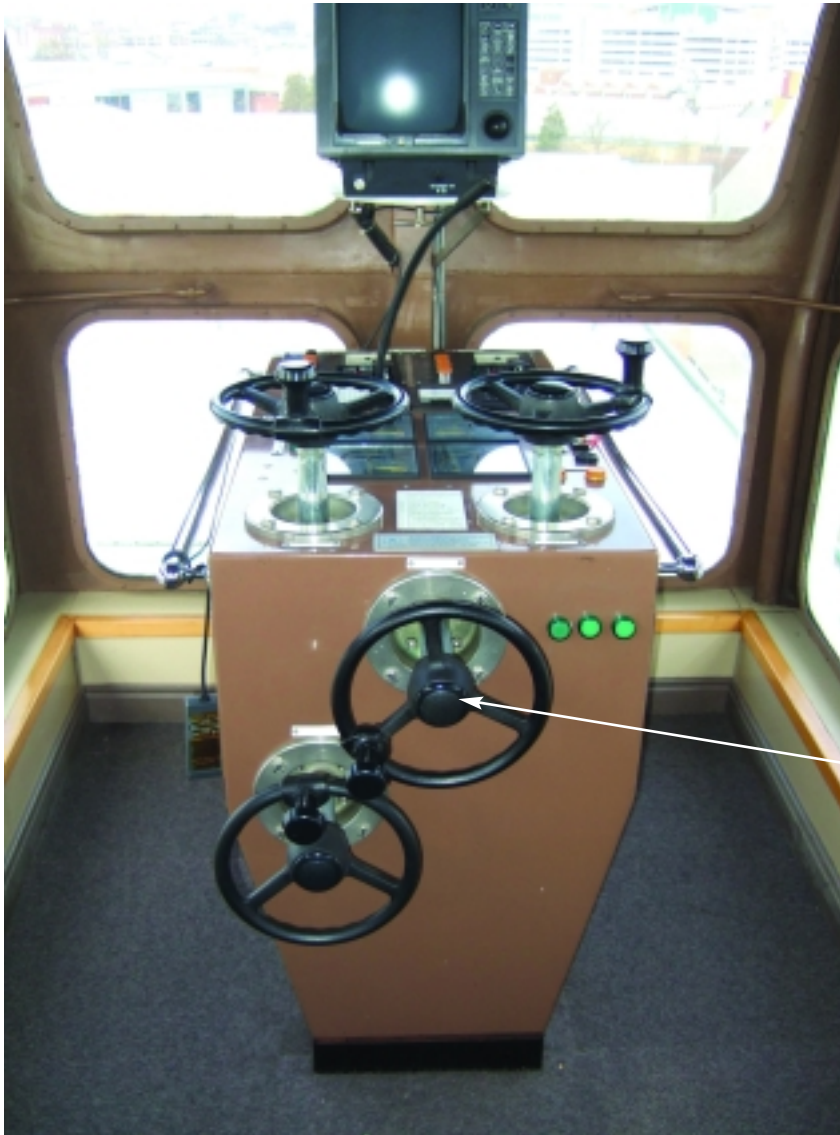
Starboard console

Chief Officer operated this wheel to reduce vessel's speed, thinking the control units were synchronised

When the vessel was clear of the fairway, the master took the vessel's two propulsion units out of synchronisation so that the vessel could make maximum speed on the passage. A display sign, indicating that the units were now out of synchronisation, was a requirement of the company's operating procedures. He failed to observe this requirement.

Although the master synchronised and stopped the propulsion units, it was too late to reduce the vessel's speed and prevent her from making heavy contact with the berth. This resulted in several passengers and crew members being injured, and caused material damage to the vessel.

1. Human memory is fallible. In everyday life we are all susceptible to forgetting to perform intended actions. These everyday lapses are mainly annoying and sometimes embarrassing, but in the operational world such lapses can cause accidents. It is therefore important that procedures are in place for all aspects of an operation, and that these procedures are sufficiently robust to ensure that a memory lapse cannot lead to an accident.

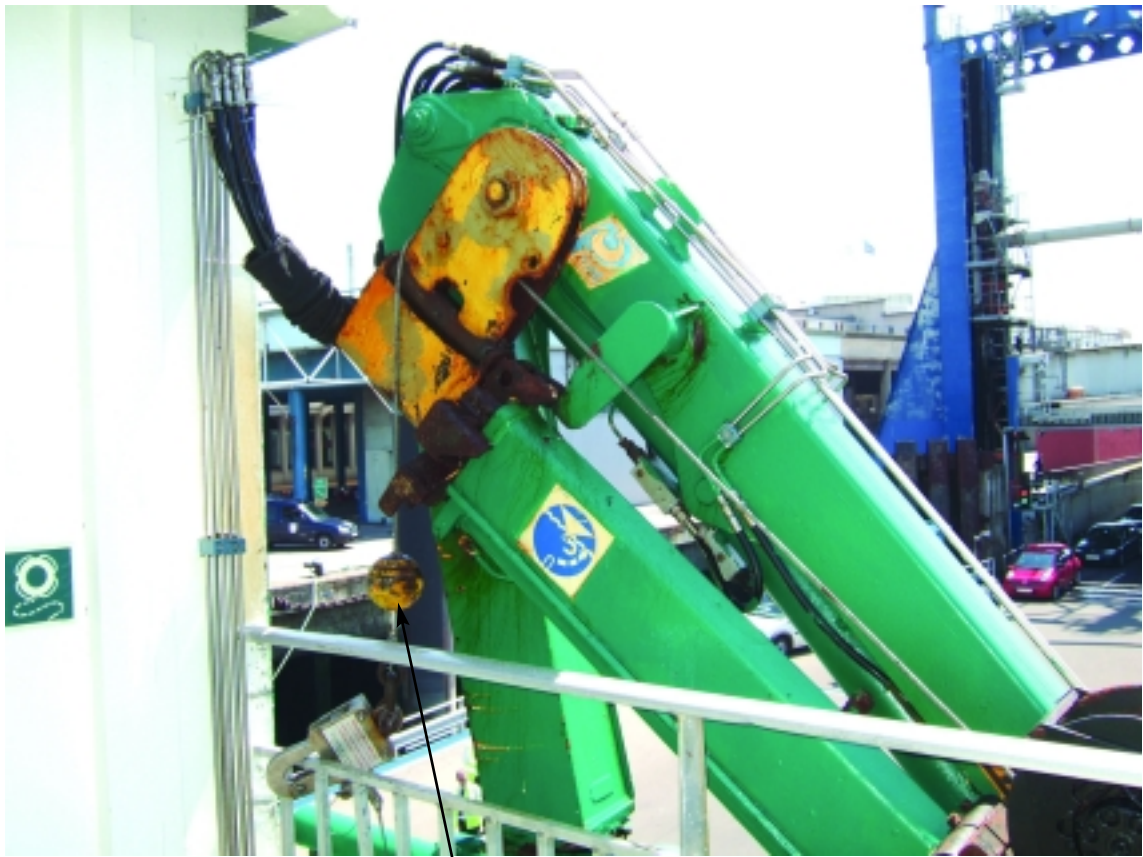
Figure 1

Steel ball counter weight

inspected/greased on a weekly basis as part of the ship's planned maintenance programme. Despite the checks, the incipient corrosion had not been discovered and the wire eventually failed at the top of the steel ball counter weight (see Figures 1 and 2).

The accelerated corrosion was partly due to the harsh environment in which the rescue boat and its crane were located, at the aft end of the vessel. The ball weight had a crevice at the top where the wire passed through, and this formed an ideal trap for sea water, salt and sulphur deposits from nearby exhaust outlets to accumulate and obstruct regular inspection.

The investigation discovered that unsuitable grease had been applied, and this had not been effective in lubricating the wire core and served to obscure the underlying corrosion (see photograph of wire and crane ball indicating the point of failure).

1. The inspection of all wire ropes should be thorough, and should include the removal of old grease to assess the condition of the wire rope before re-coating with fresh wire lubricant.
2. Senior staff should regularly monitor planned maintenance procedures which are carried out by crew.
3. Consideration should be given to the use of a thinner self penetrating lubricant on seldom used wire ropes, especially where they are used or stored in a harsh corrosive environment.

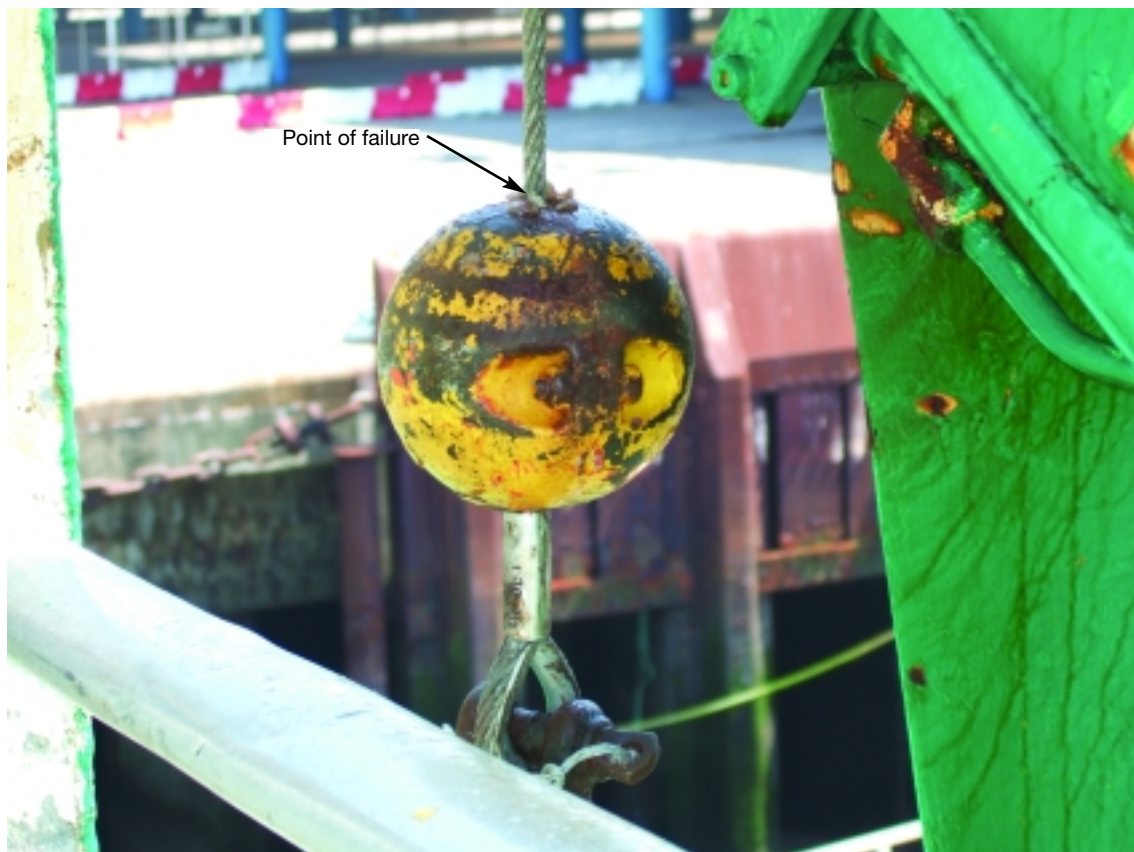
Figure 2

The failed segments of the wire rope were sent to a laboratory for testing, and the subsequent report confirmed that the wire rope had failed through ductile tensile fractures of wires wasted by corrosion. The

laboratory was also able to confirm that a contributory cause of the failure was inadequate maintenance greasing over a significant period of time.

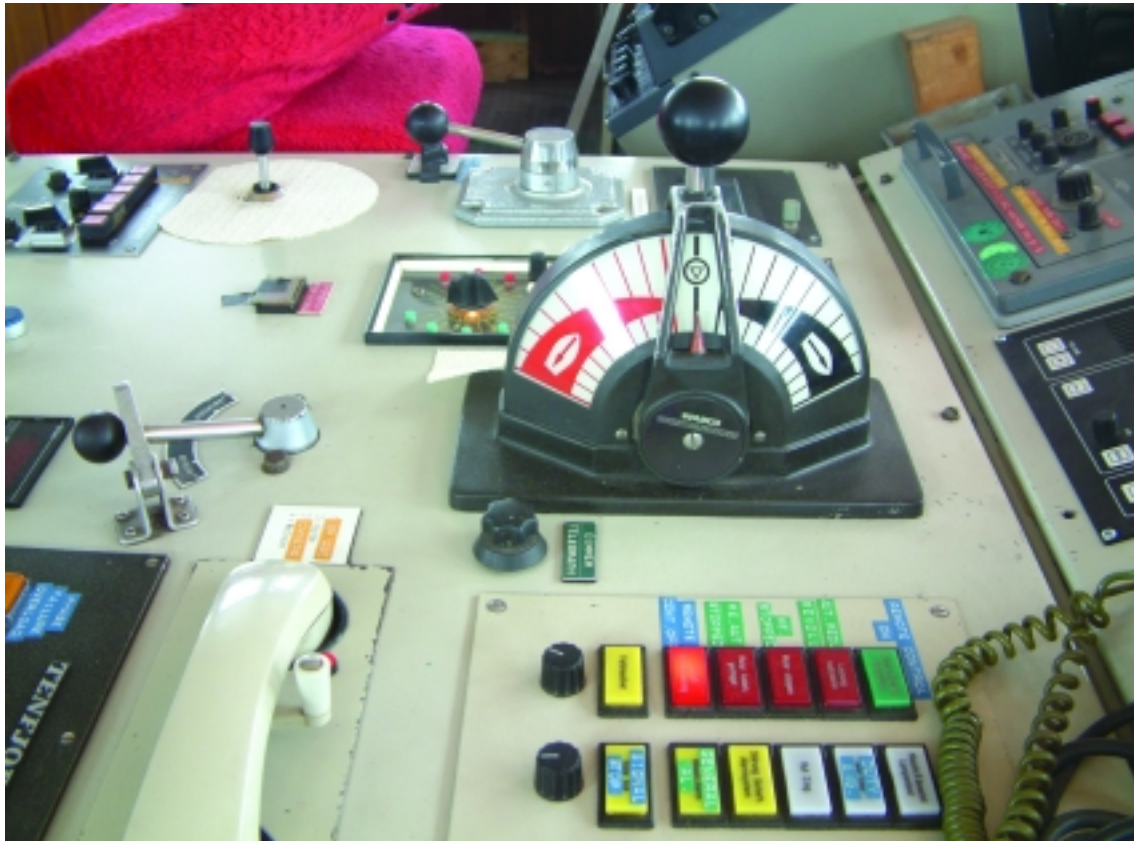
Figure 2

The master put the bridge pneumatic control lever (Figure 2) for engine and gearbox control to the "dead slow ahead" position; there was no response. The wind was on the port beam and the stern was swinging quickly towards the stone reinforced riverbank. The master immediately contacted the engineer to check the control system, but he could find nothing untoward, except that the gearbox selector was still in the "stop" position. The stress levels on the bridge rapidly increased as the bank drew ever closer. Unfortunately there was

Investigations identified that the control fault was due to a seized pneumatic shuttle which controlled the oil supply which activated the gearbox clutches.

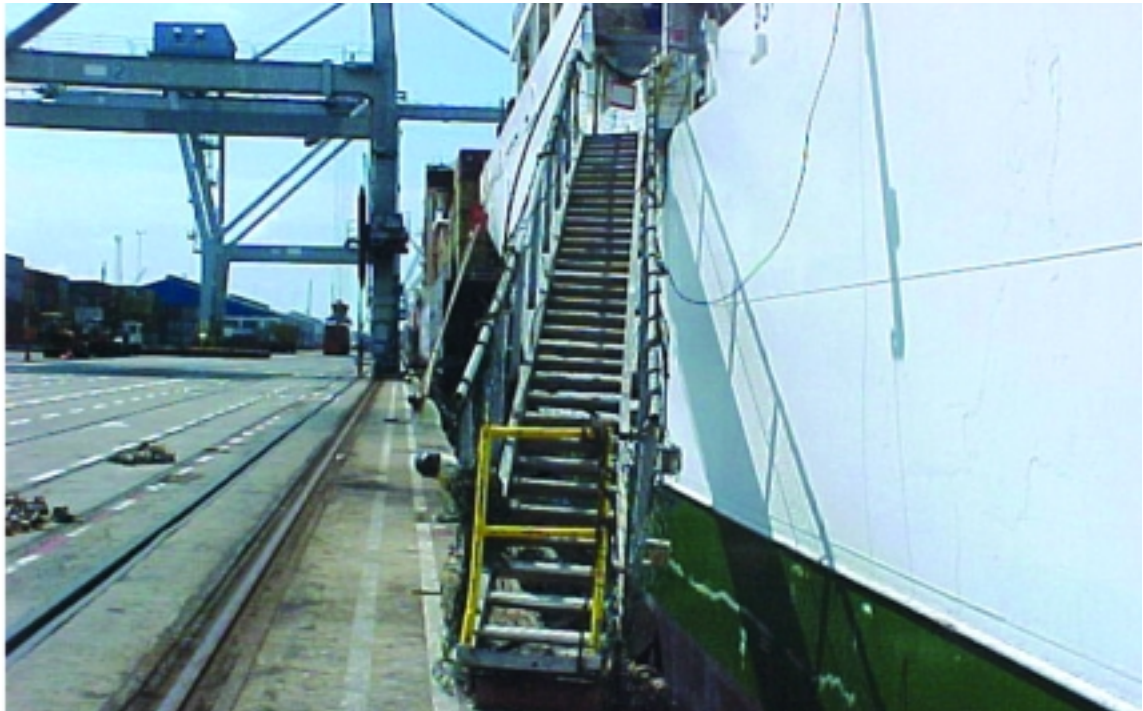
Figure 1

lowering wires. Of the last three contractors to step onto the gangway, two lost their balance when the gangway dropped, and fell into the water. The third managed to hold onto the safety net. Despite an immediate recovery attempt, one of the contractors, who fell into the water, drowned.

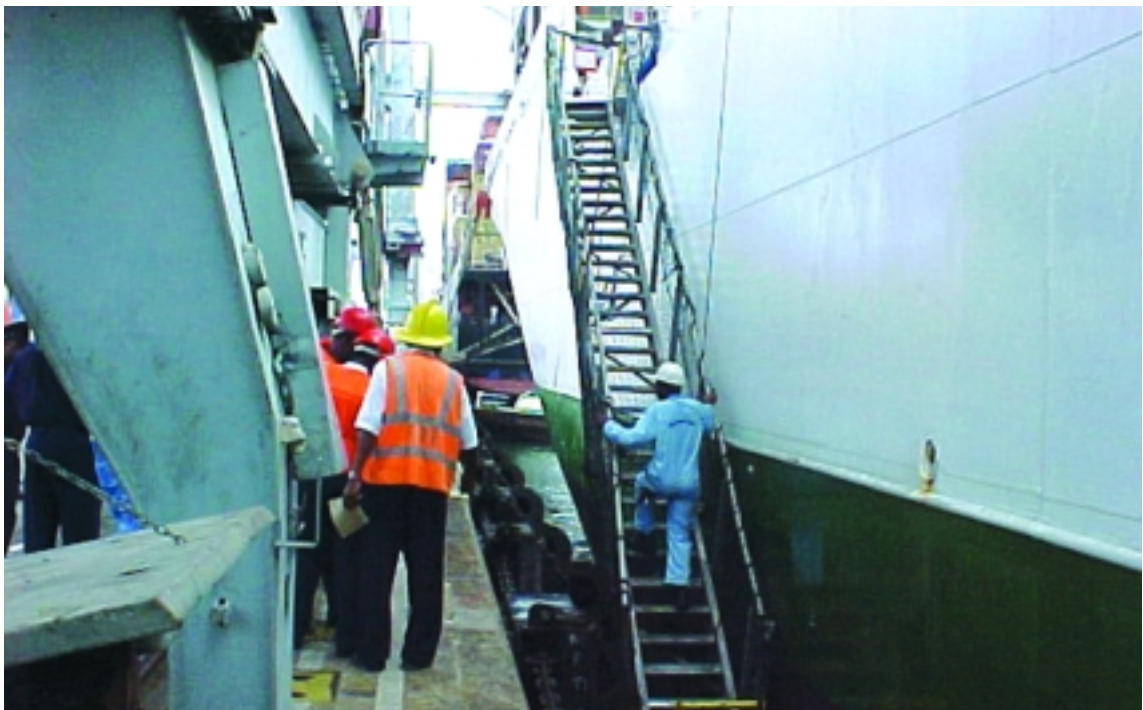
Figure 2

The roller at the bottom of the gangway had not been placed fully on the quay due to the proximity of a shore gantry. This resulted in the bottom roller projecting over the water below (Figure 1). As the contractors climbed the gangway, their combined weight was sufficient to cause a harmonic motion that moved the bottom roller off the quay (Figure 2).
