MARINE ACCIDENT  
INVESTIGATION BRANCH

# SAFETY DIGEST

**Lessons from Marine  
Accident Reports  
3/2008**

**No 3/2008**

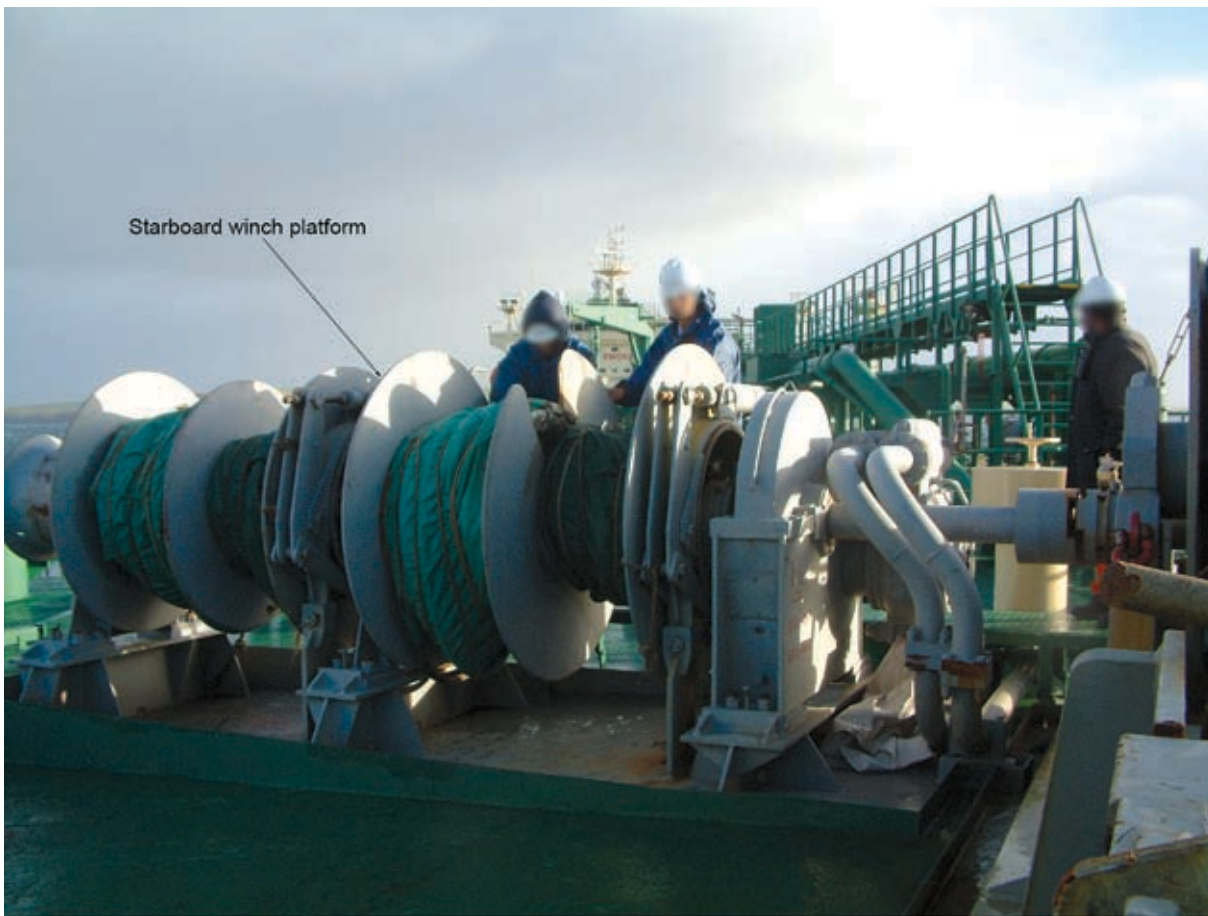
Position of crew at the starboard winch platform

1. The two large waves that were shipped over the bow could not have been considered abnormal and should have been expected in the prevailing weather conditions. It is dangerous to assume that it is safe to work on deck in marginal conditions, even in the largest ships.

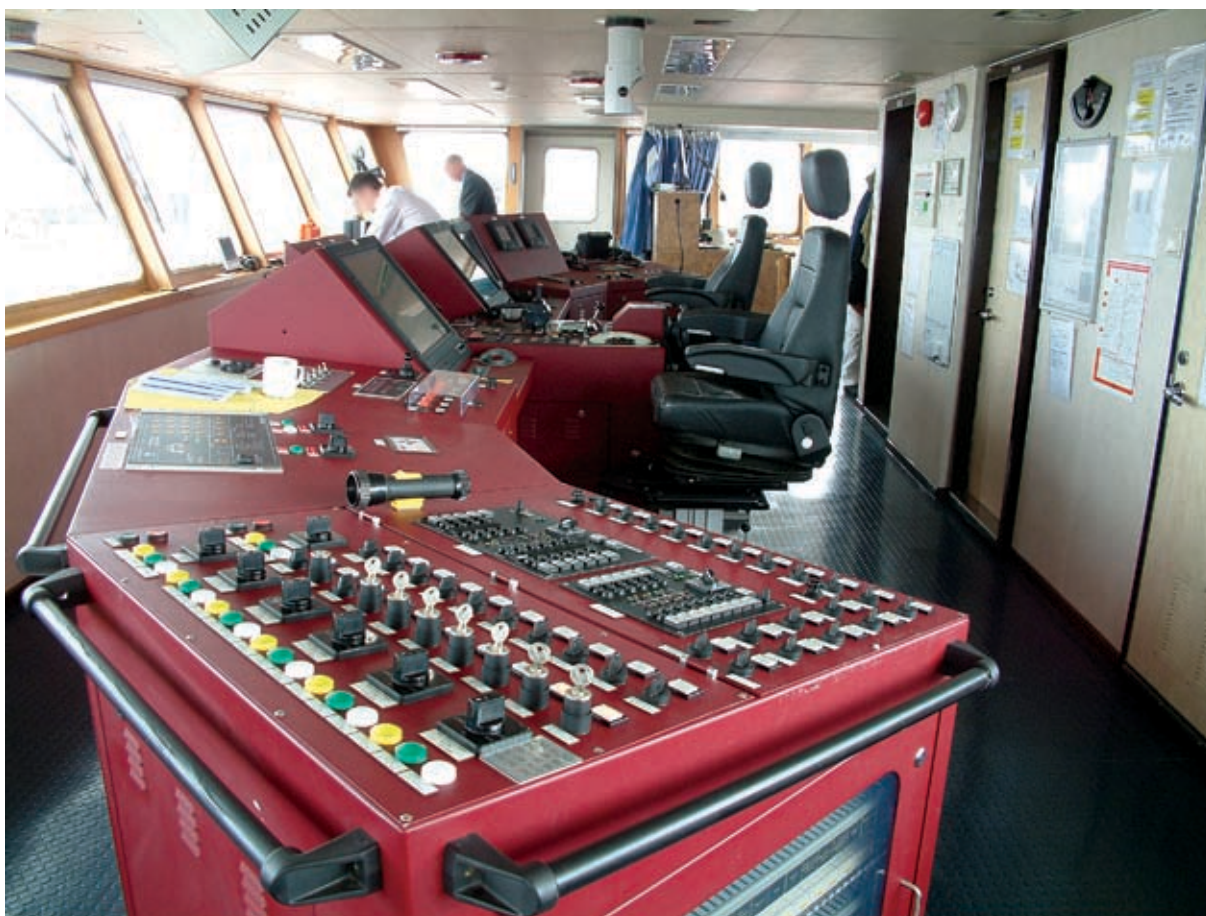
Figure 2: Bridge overview of the feeder container vessel

2. The failure to transfer the engine control from the bridge wing to the centre console required the master to make two mistakes: to not transfer control from the wing, and then to not confirm control at the centre. Effective communication between the master and second officer could have ensured that the engine control had been transferred correctly. Attempts to analyse the developing situation could have been successful had there been a suitable rapport on the bridge and the engine pitch indicator reading been checked. Bridge Team Management requires leadership from the top. It also requires persistence.

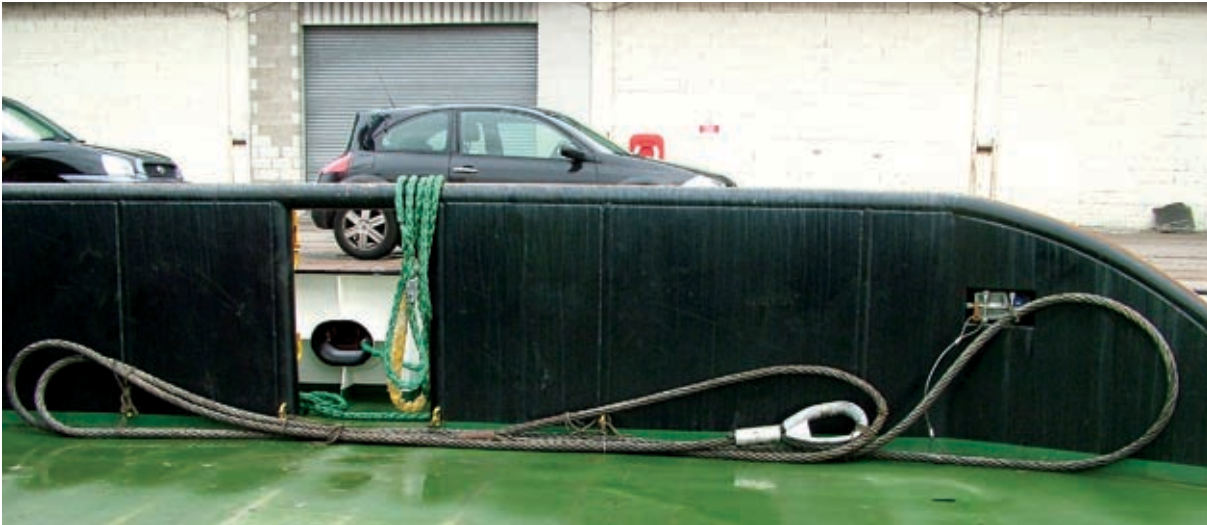
Towing gear

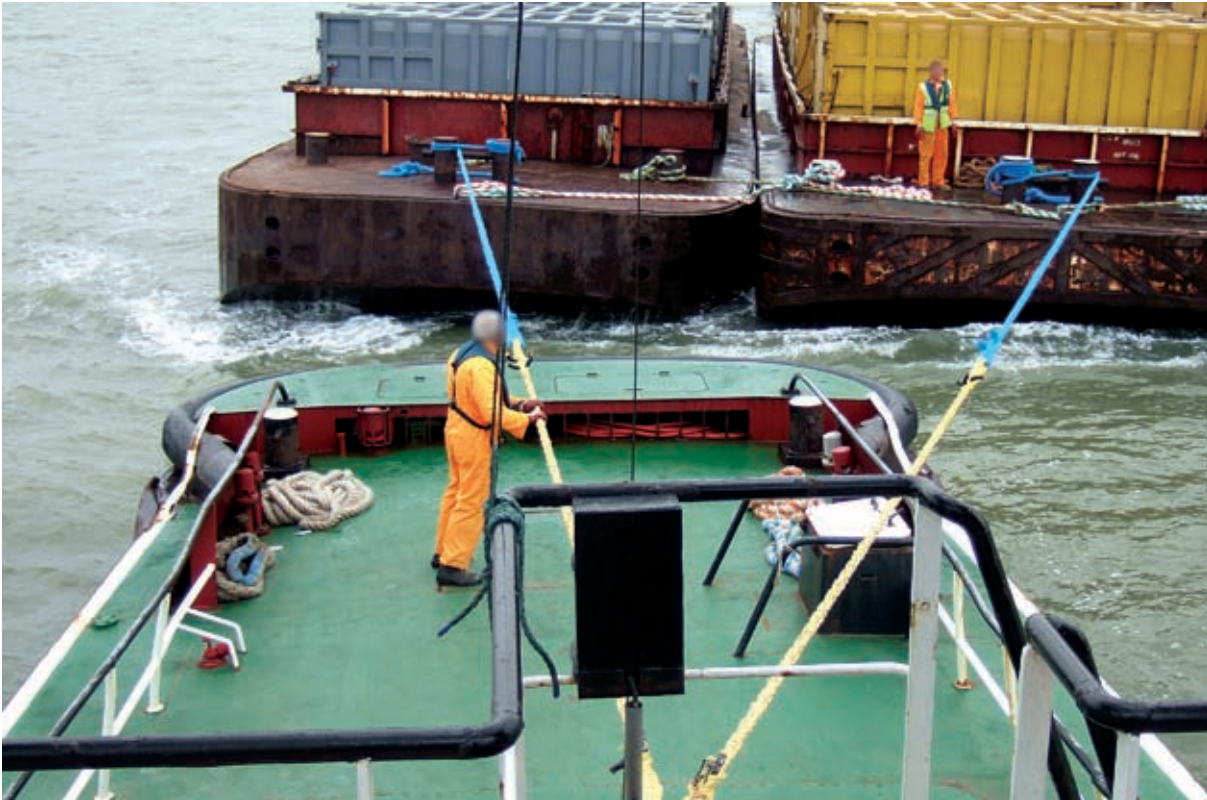
Towing arrangement – watch where you stand!

1. Unlike the hazards associated with parted lines, which are generally well understood, crews need also to be aware of the dangers posed by snagged lines and ensure they stand away from lines under tension, as recommended in CoSWP. As demonstrated by this accident, a relatively small deflection of a line under tension can result in significant forces, which must not be underestimated. Do not, on any account, lean or rest on lines which are under tension, even if the tow appears stable and steady.

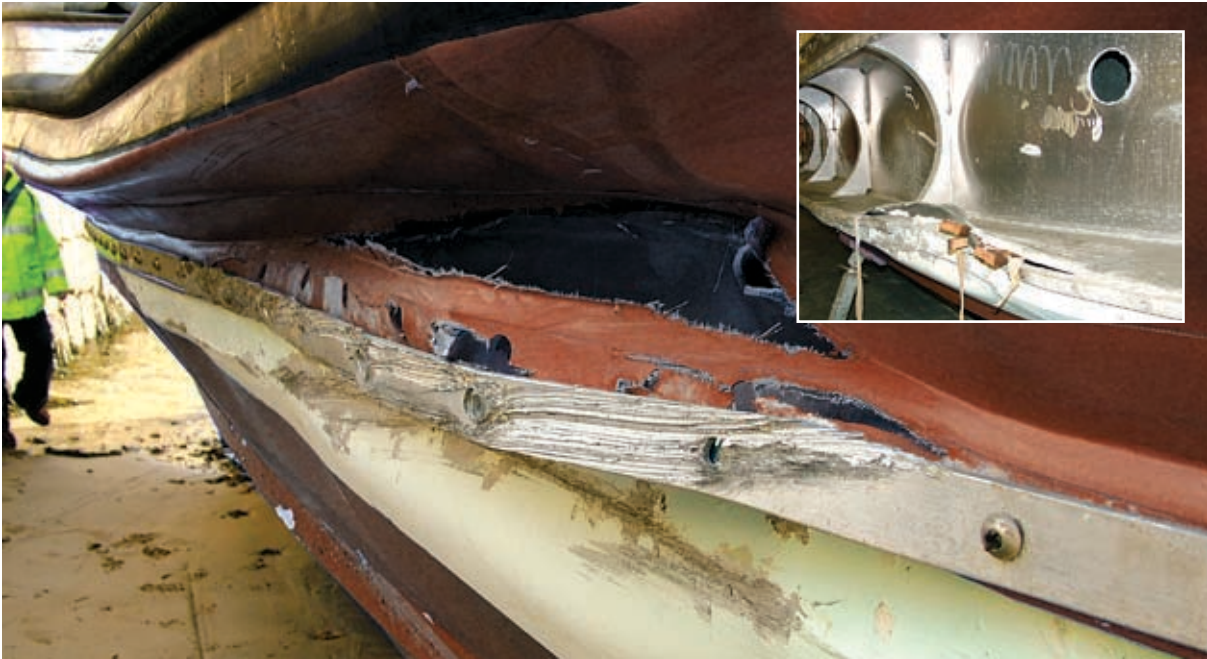
Fortunately the damage did not significantly affect the boat's watertight integrity. It suffered a puncture to the forward section of the hypalon tube, a 1 metre long split to the starboard side of the hull, and distortion to longitudinals and to hull plates near to the port side of the keel – Figure 3.

Figure 3: Damage to the vessel

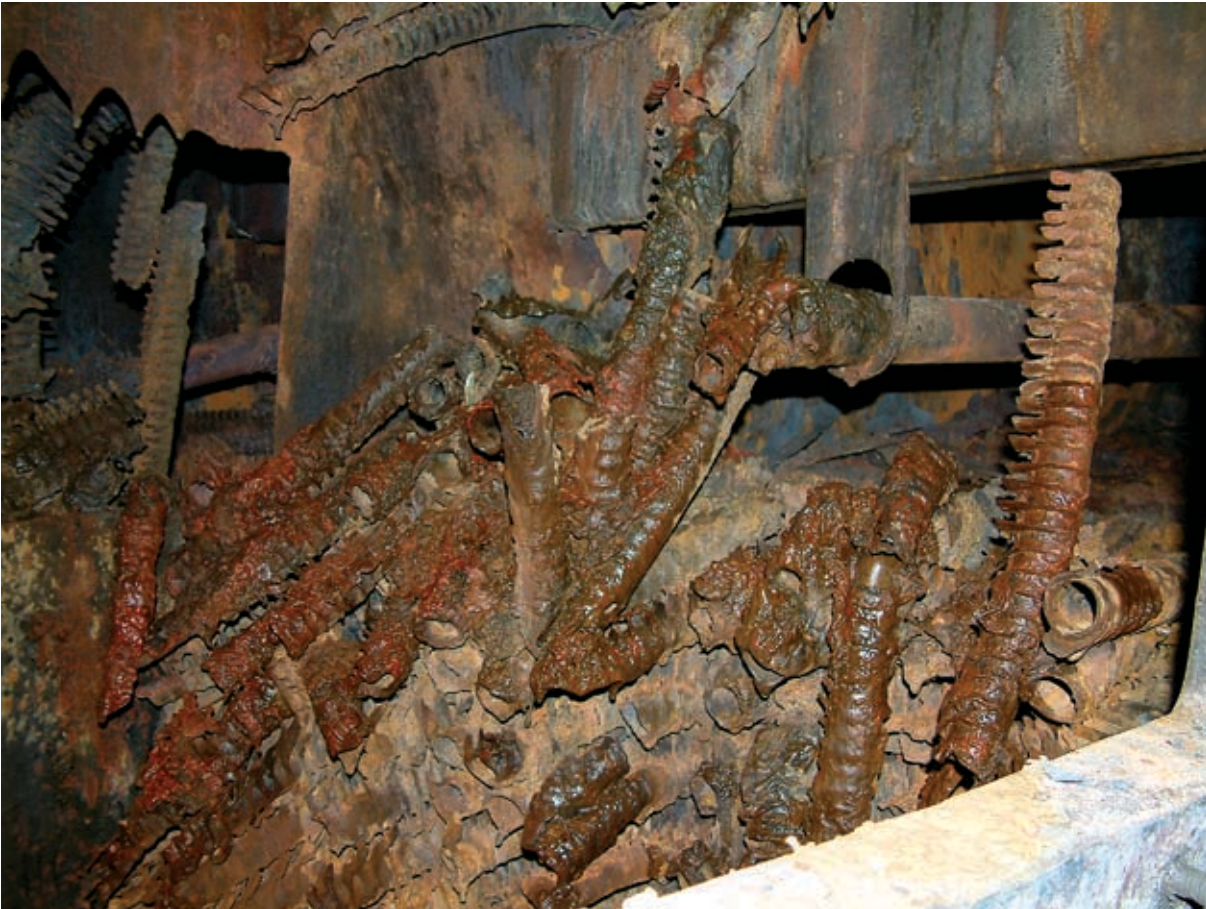
Heat damage

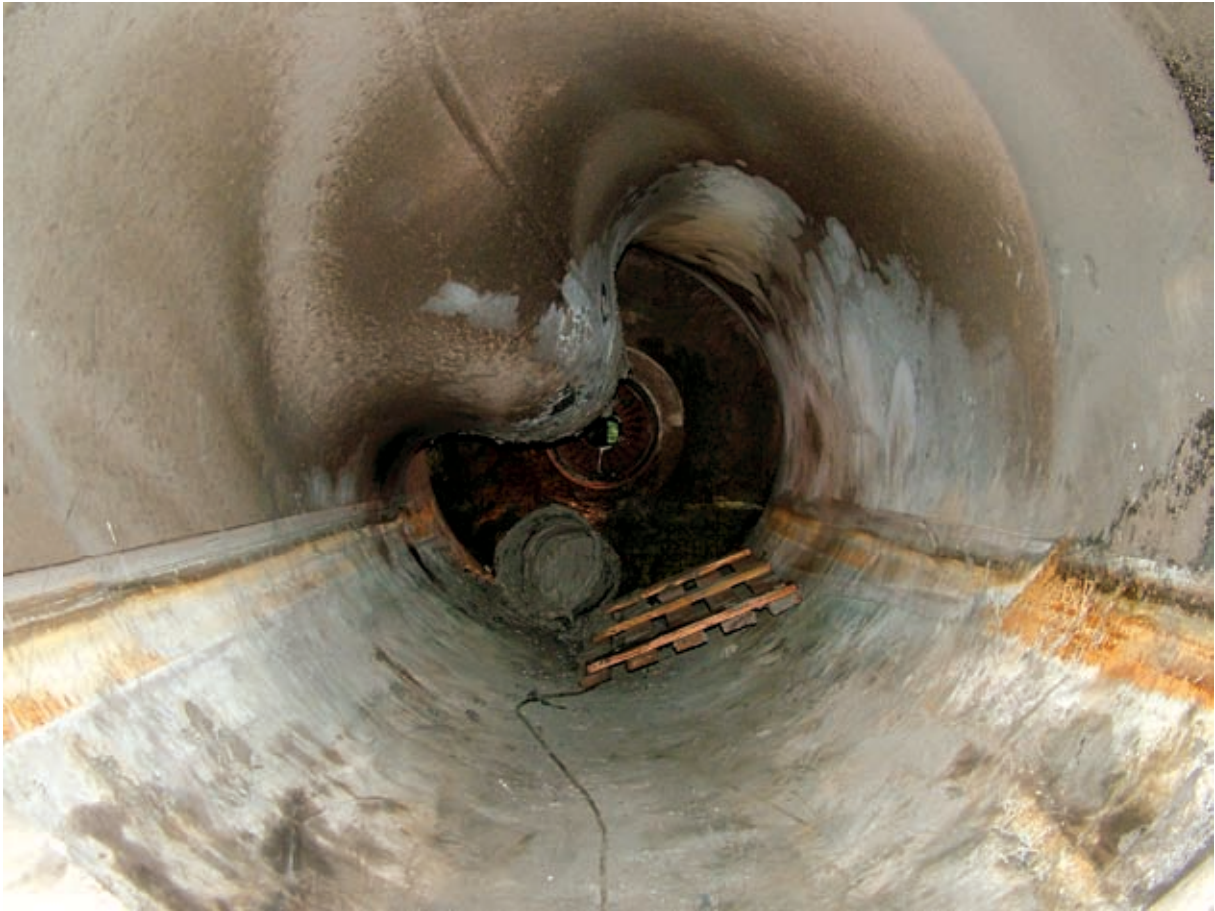
A new fire tube was fitted to the auxiliary boiler, but the EGE was damaged beyond repair. Repairs delayed the vessel by 2 weeks, spoiling perishable cargo and incurring further penalties.

Heat damage

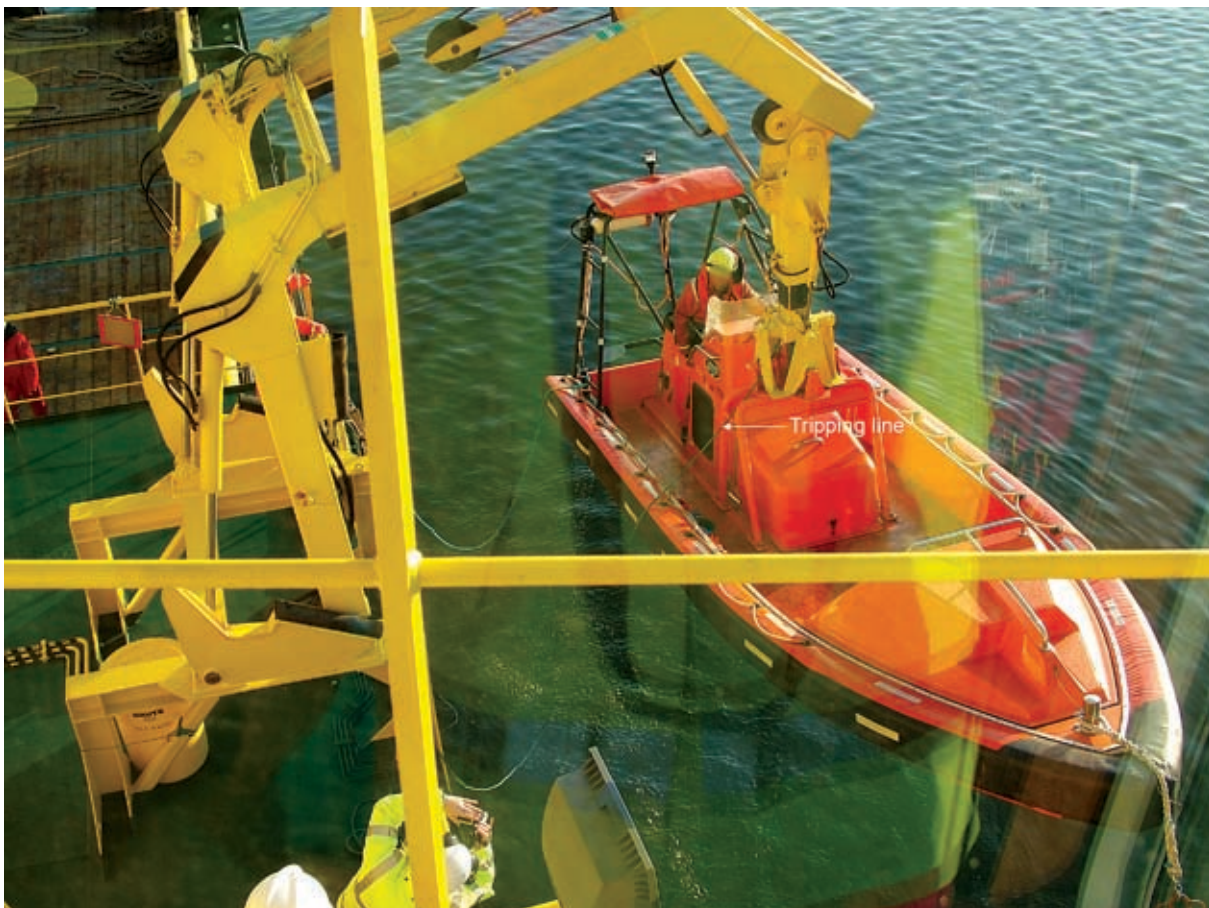
Post-accident investigation showed that the tripping line had jammed between the cruciform and the jaws of the docking head. With the hook cocked for release, the davit

Fast Rescue Craft securing arrangement

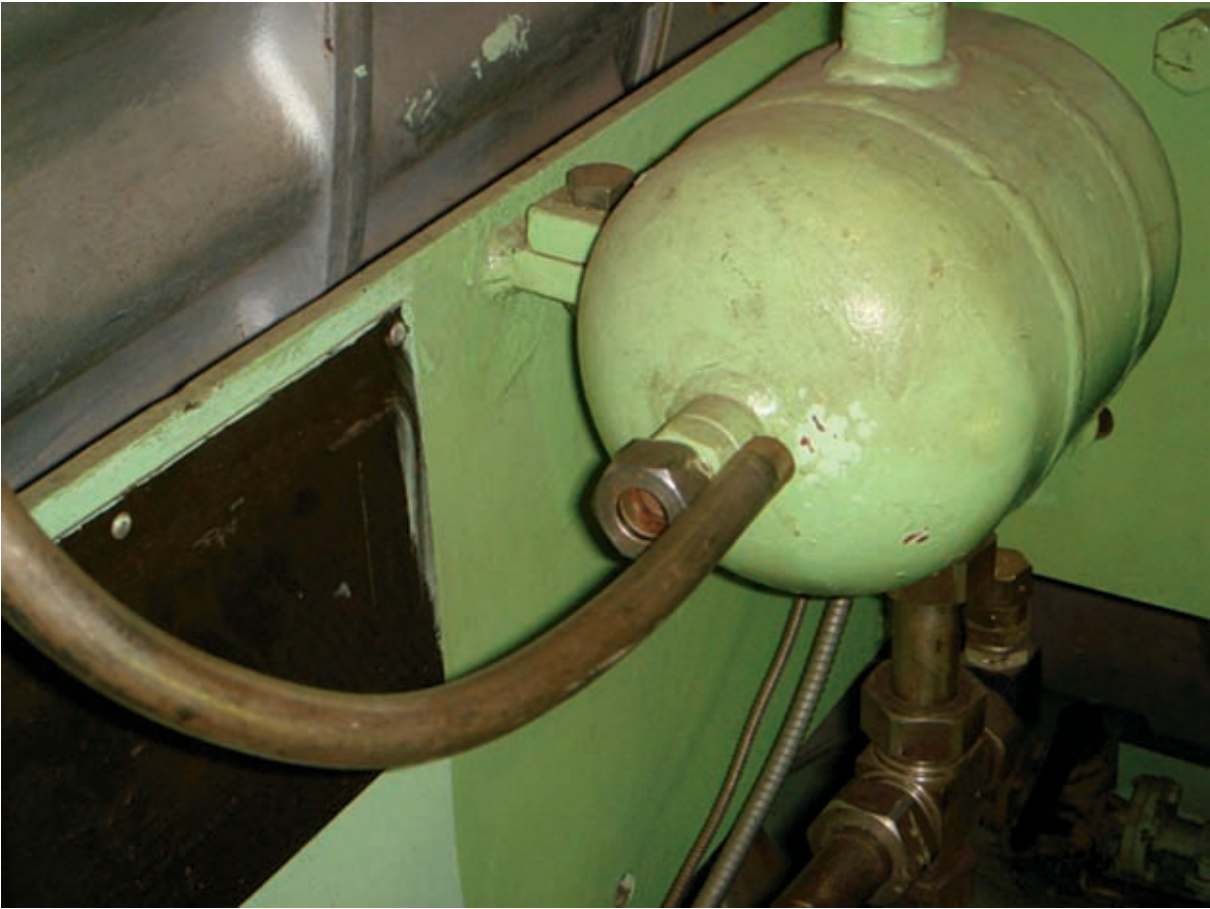
the correct level with crushed nut shells. The engineer then opened the air supply valve to pressurise the reservoir. As he prepared to open the discharge valve to the turbocharger, the long unsupported pipe blew out from the reservoir compression connection fitting – Figure 3.

Figure 3: Pipe disconnected from reservoir connection fitting

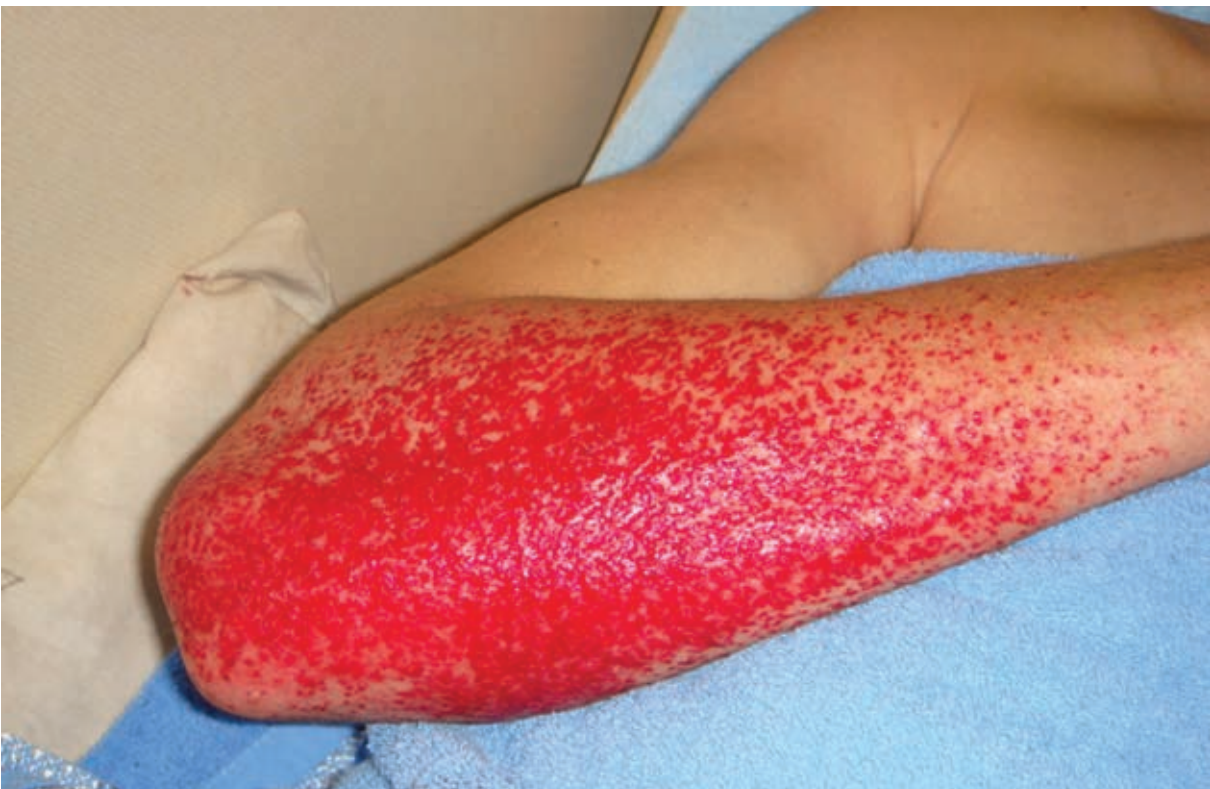
Figure 4: Abrasion injury to crewman's right arm

The engineer raised both his arms to protect himself from the crushed shells which were being sprayed from the failed connection at 7 bar pressure. He suffered severe abrasion wounds (Figure 4) before staggering away from the engine and raising the alarm.

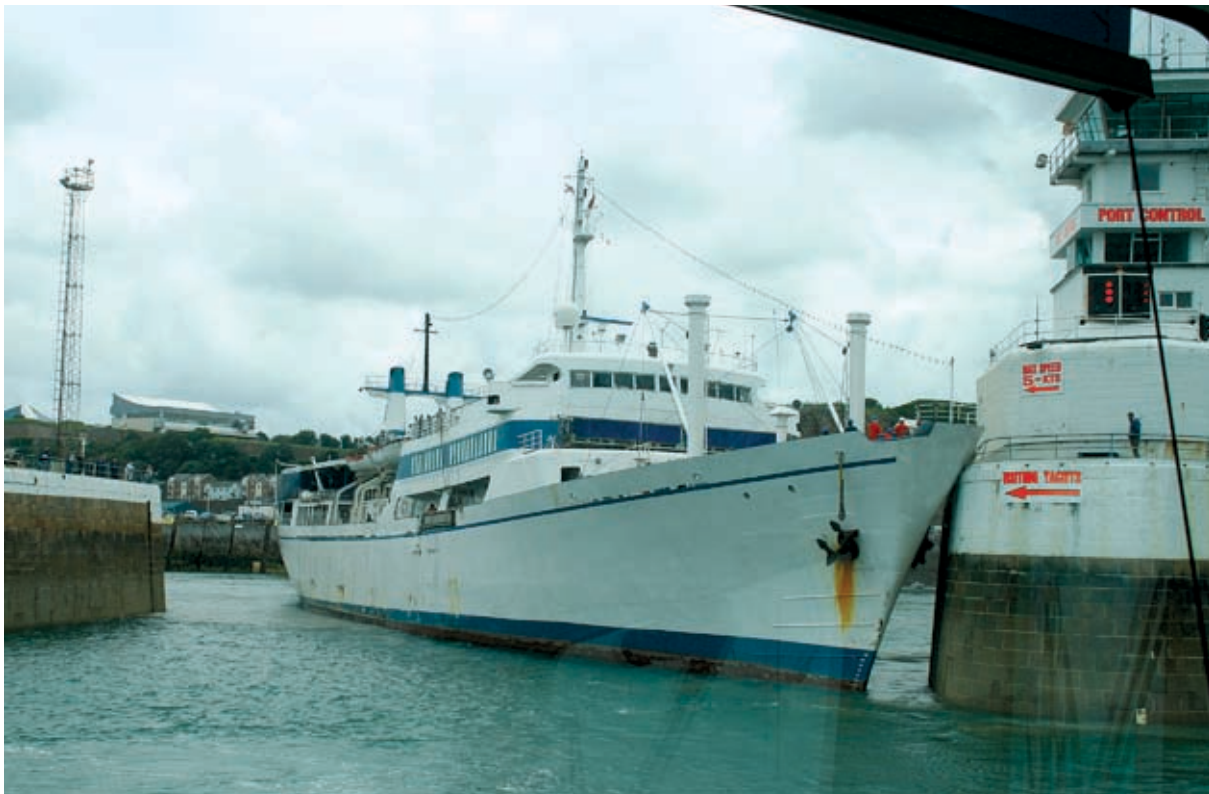
As the vessel approached the inner harbour entrance, the pilot realised that she was getting close to the southerly pier head, which was on the vessel's port bow. Consequently, he ordered the vessel engine to be put astern and for the tug to move to the starboard bow and pull towards the north. The tug was not kept informed of the vessel's engine movements and during this manoeuvre the tow line suddenly tensioned and parted. The ship came to rest on the southerly pier head. Fortunately, there were no injuries and, although material damage was caused to the pier head (figure), the vessel sustained only superficial scratches to her paintwork.

Contact with the pier head

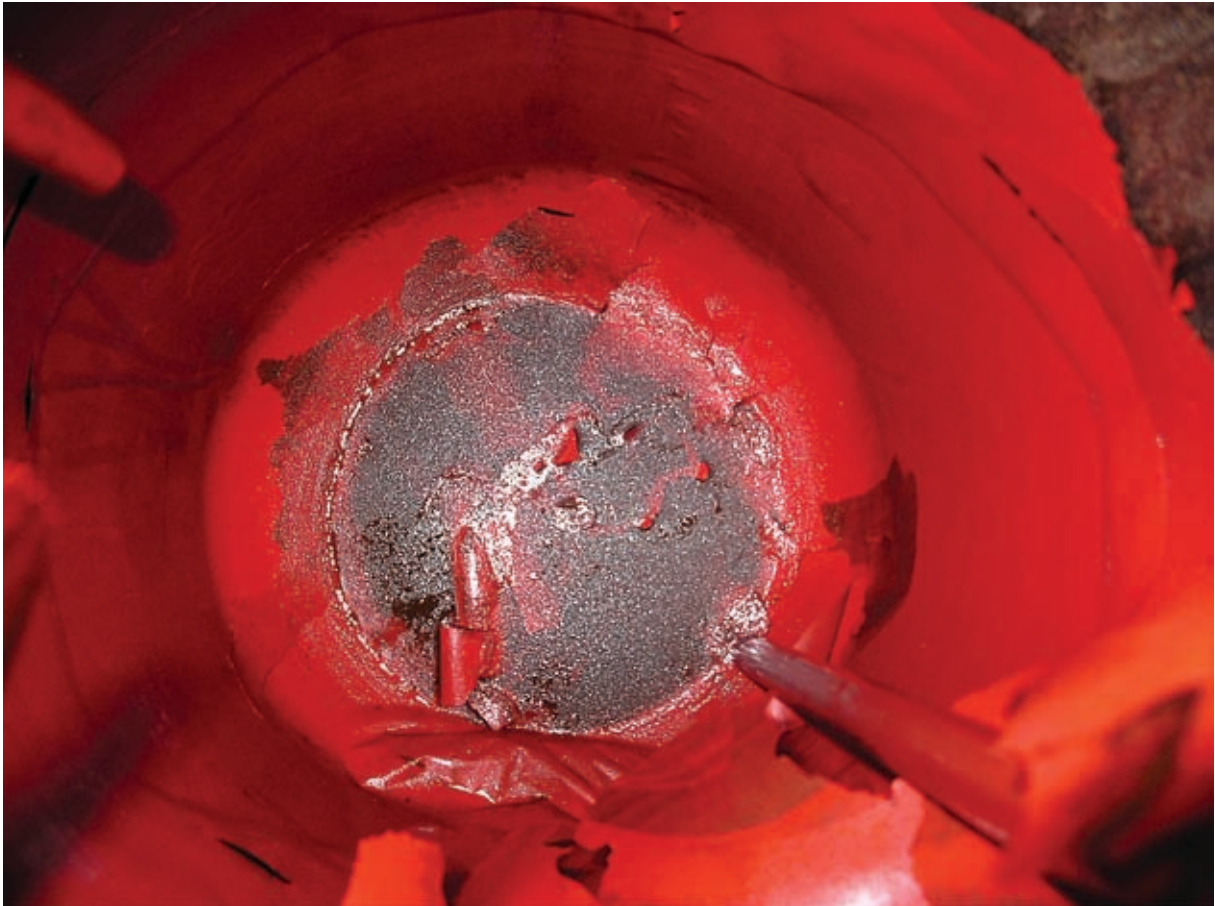
Damage inside the water tank

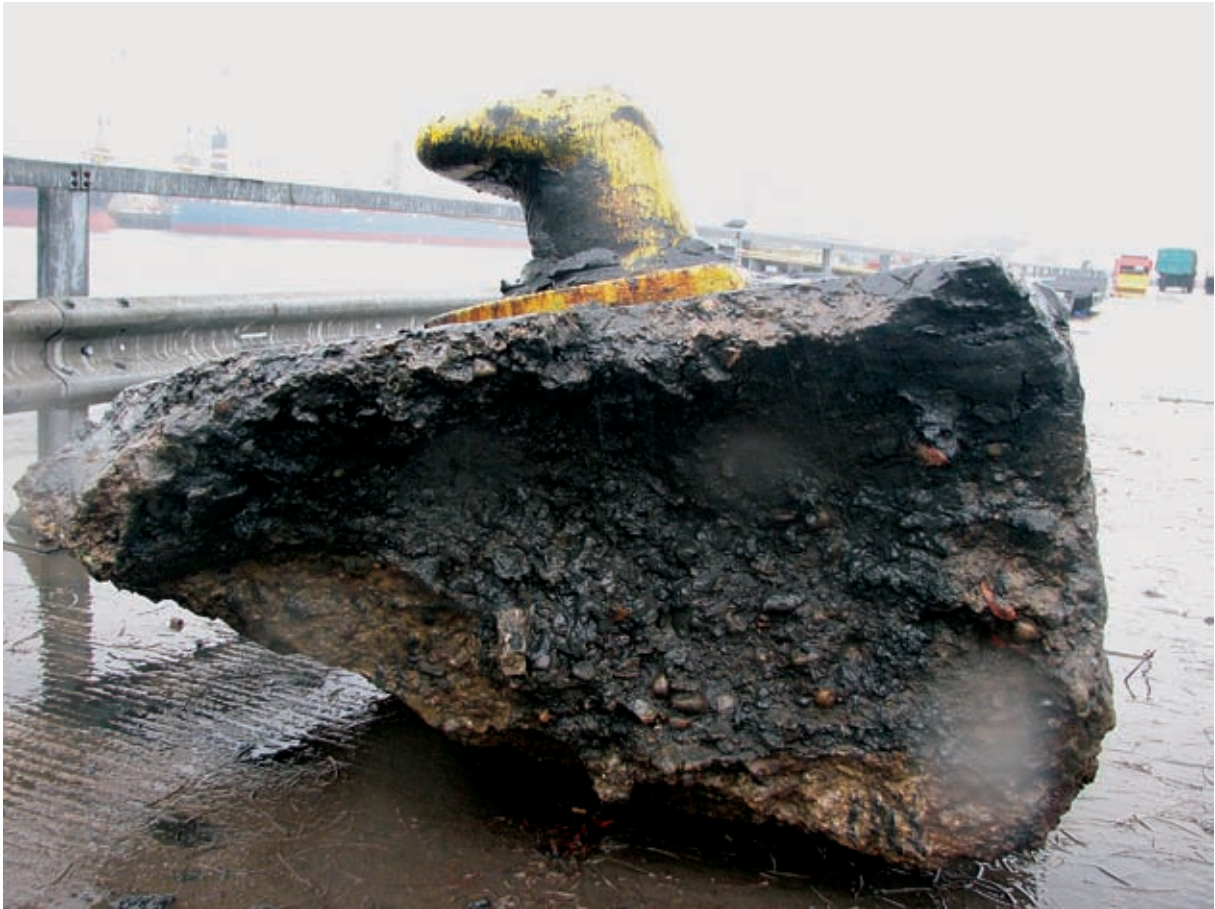
Damaged bollard

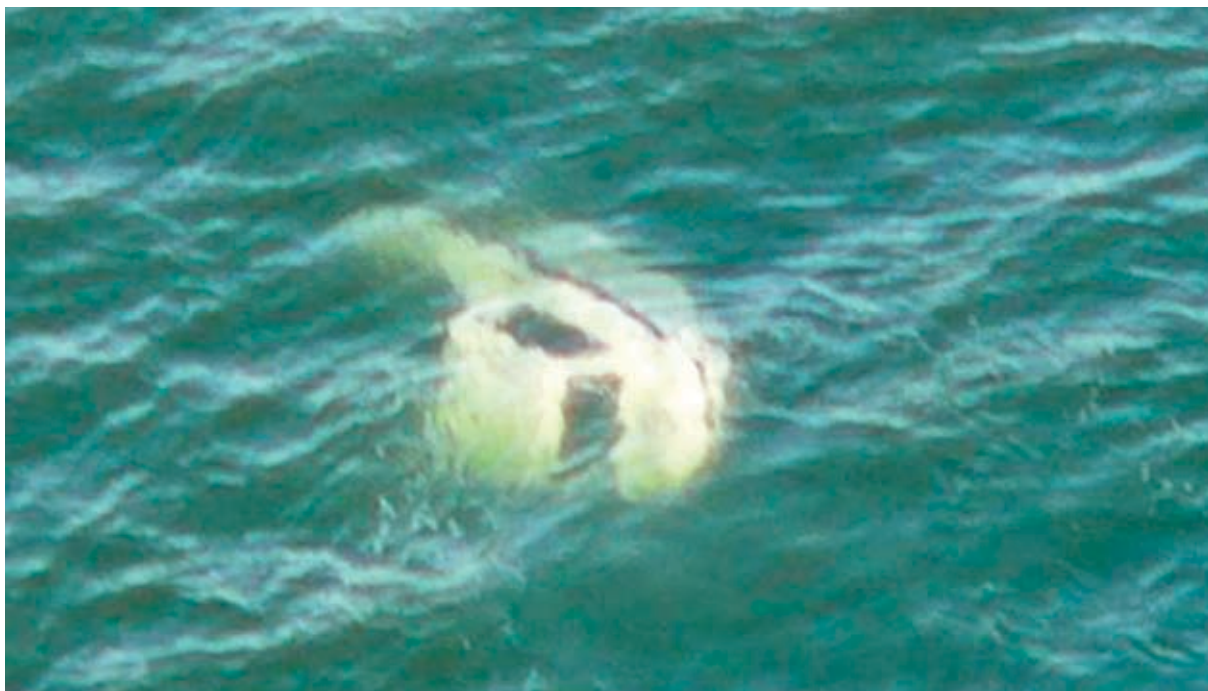
Figure 3: Boat found at sea

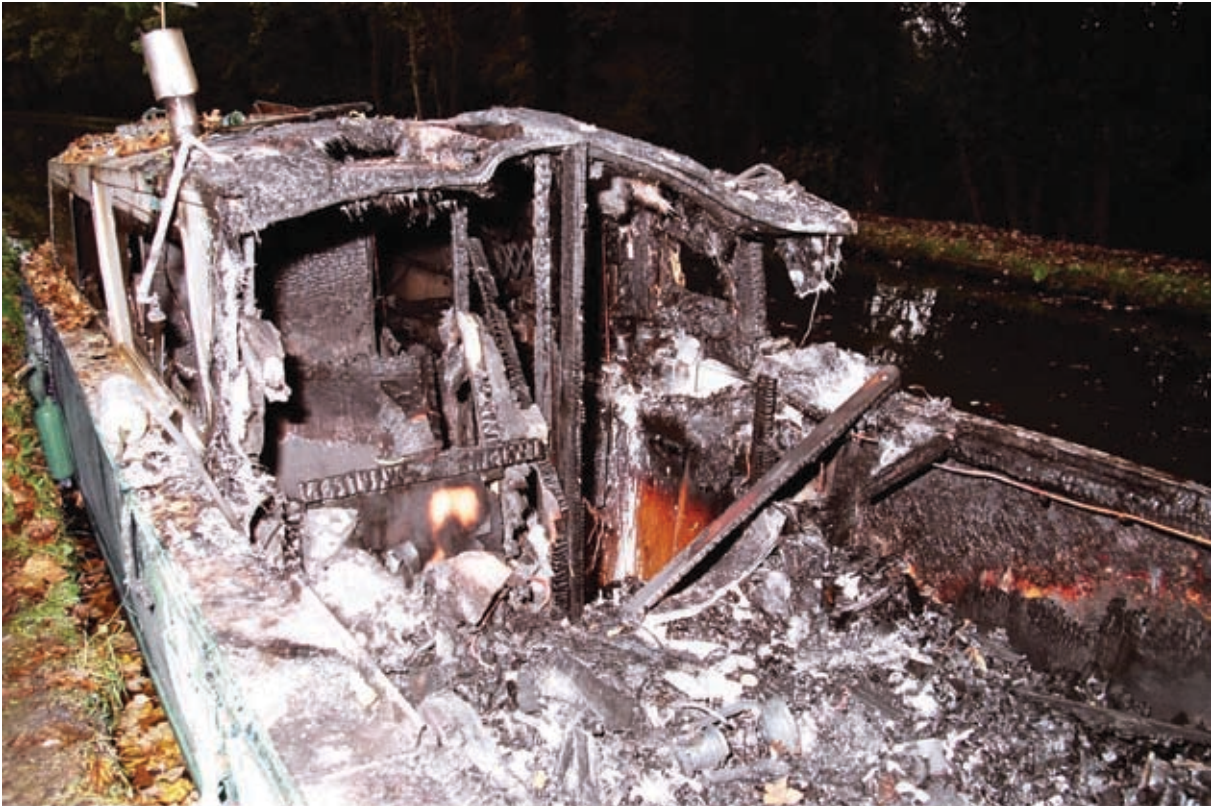
Figure 2: Vessel after the fire
