MARINE ACCIDENT  
INVESTIGATION BRANCH

# SAFETY DIGEST

**Lessons from Marine  
Accident Reports  
3/2009**

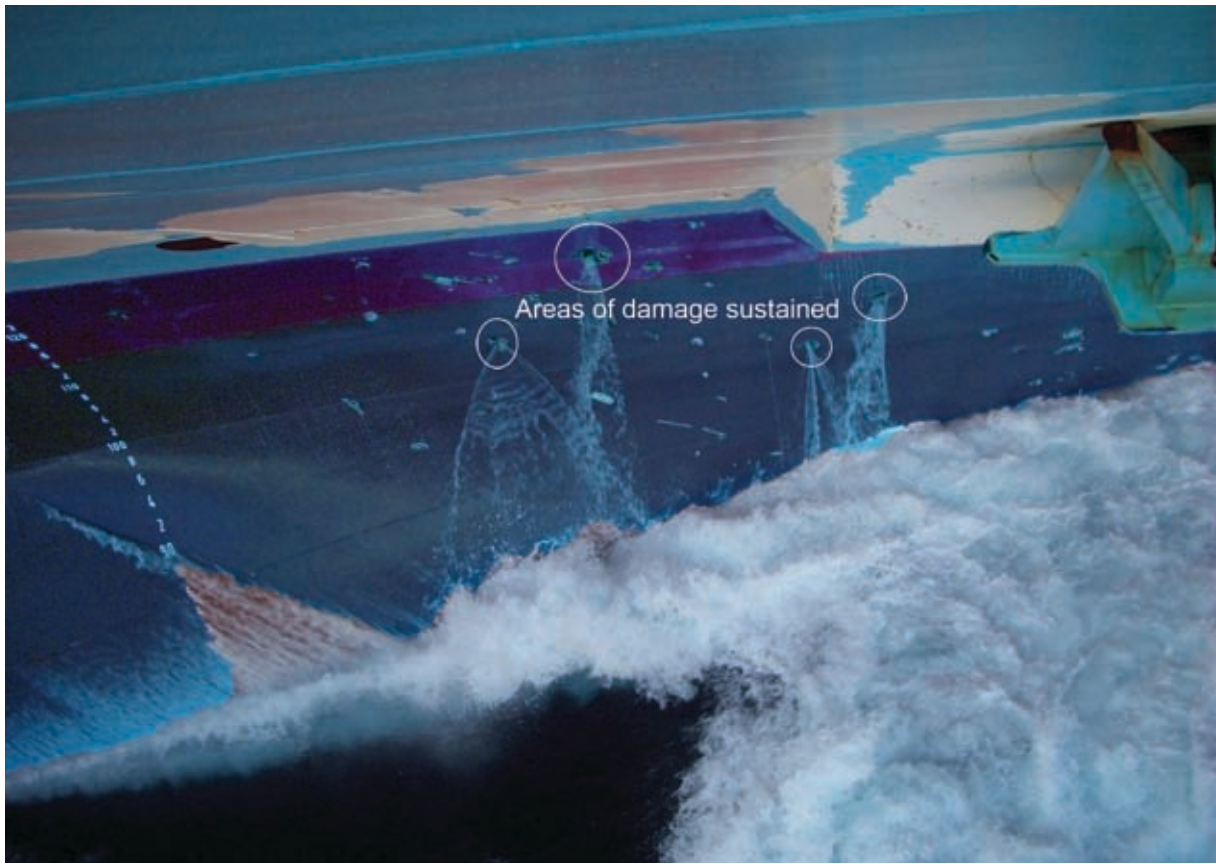
The master altered course to provide safe access across the deck. On entering the bow thruster room the cause of the confusion quickly became apparent. A number of holes were found in the port side of the bow thruster room shell plating, through which water was pouring. The crew blocked the holes with wedges and neoprene rubber, and this stemmed the water ingress. It was found that the port anchor chain lashing had released and the anchor had fallen

Figure 2: Hull holes and indentations

The heavy weather damage was caused because the chain lashing Senhouse slip tapered securing pin was not fully secured. As the ship pitched in the heavy seas, vibration would have been set up, and this would have been exacerbated by water rushing up the hawse pipes because the covers had not been fitted. As the pin became displaced, the slip released, allowing the chain lashing to fall into the hawse pipe. The anchor cable progressively dropped as the acceleration forces overcame the winch brake, which was not fully applied. As the ship pitched, the anchor made contact with the hull, causing the indentations and penetrations.

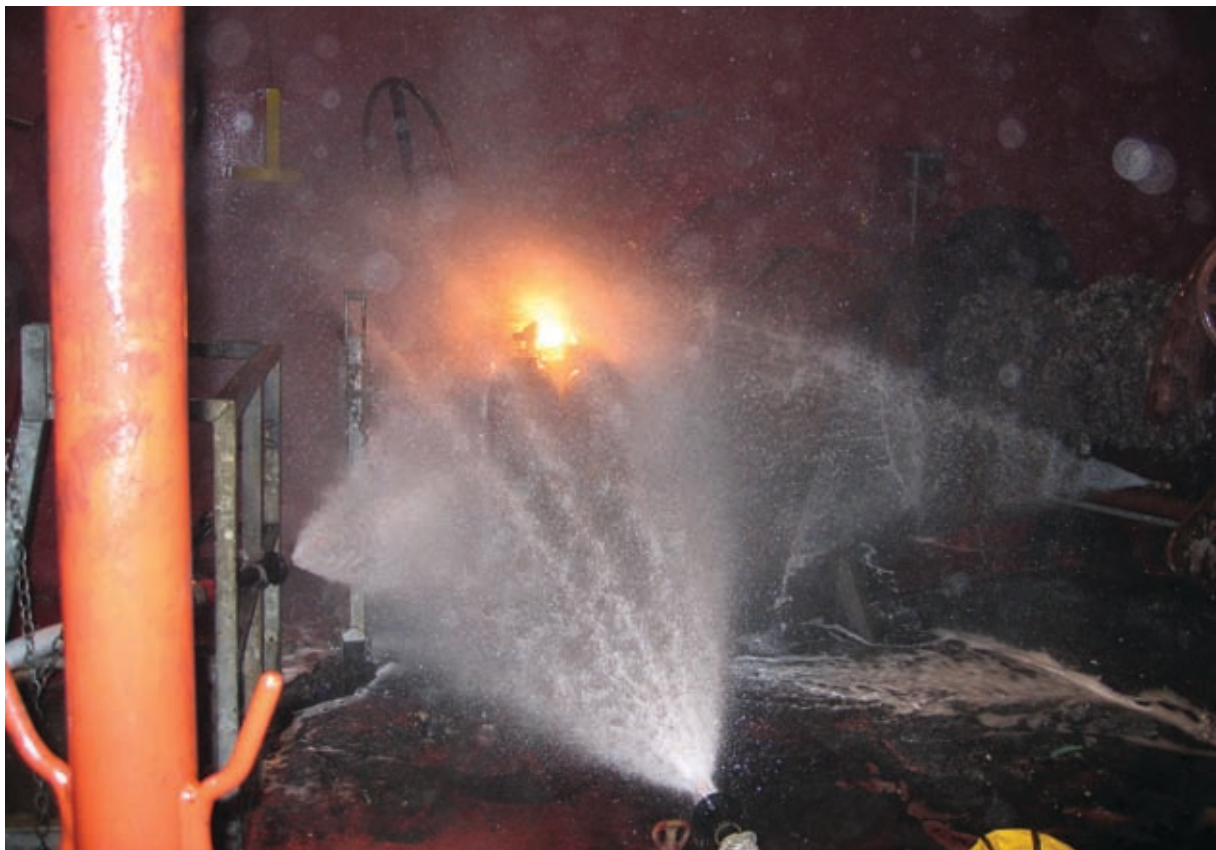
Figure 3: Fighting the fire on all acetylene bottles

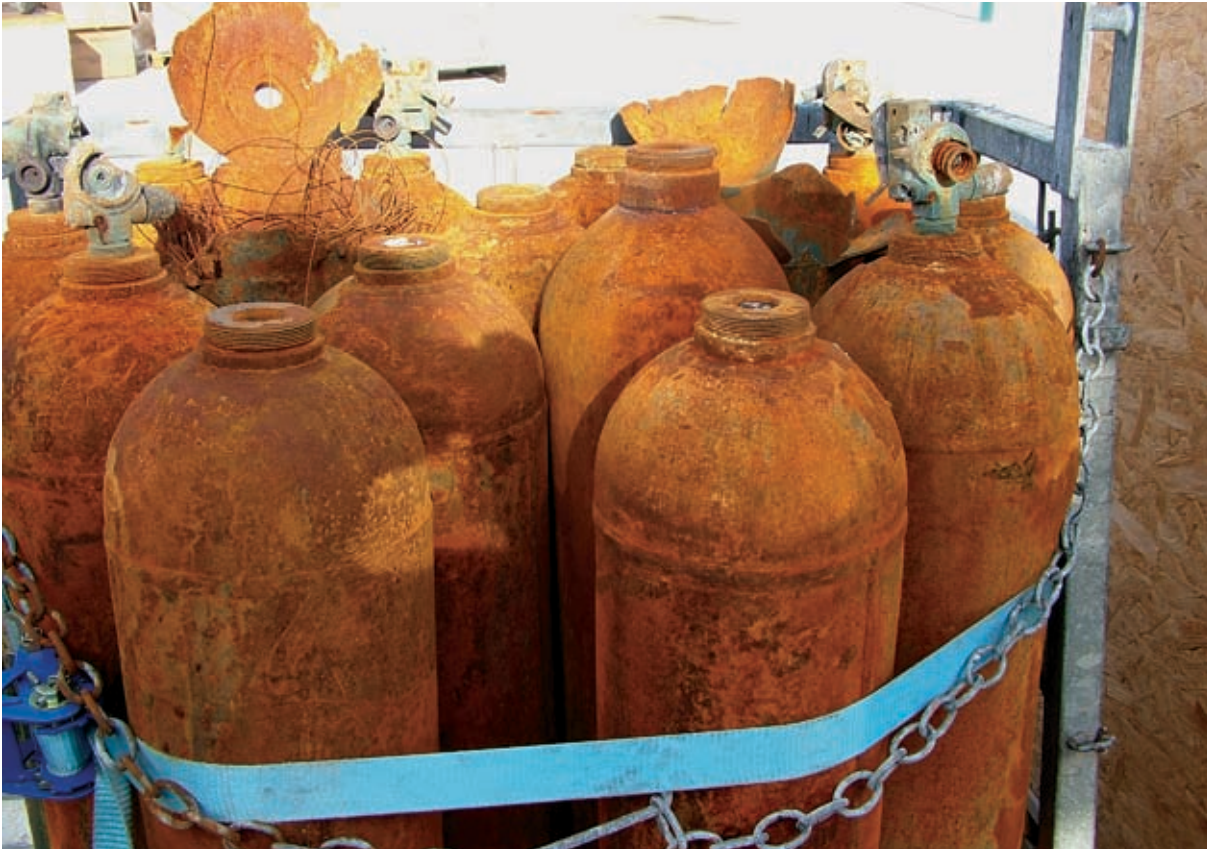
Figure 4: Acetylene bottle damage

the acetylene bottles, more of the bottles could easily have exploded, causing structural damage and personal injuries. All the acetylene and oxygen bottles were badly damaged (Figure 4), the deck plating was distorted and the mooring winch electrical supplies were burnt, as was the winch (Figure 5).

The fire was likely to have been caused by a discarded cigarette, which had ignited clothing found in the vicinity of the mooring rope and acetylene hoses. The acetylene ignited because the gas bottle valves were open. Because the “in use” bottles were co-located with the storage bottles, the fire spread to the other bottles and so escalated.

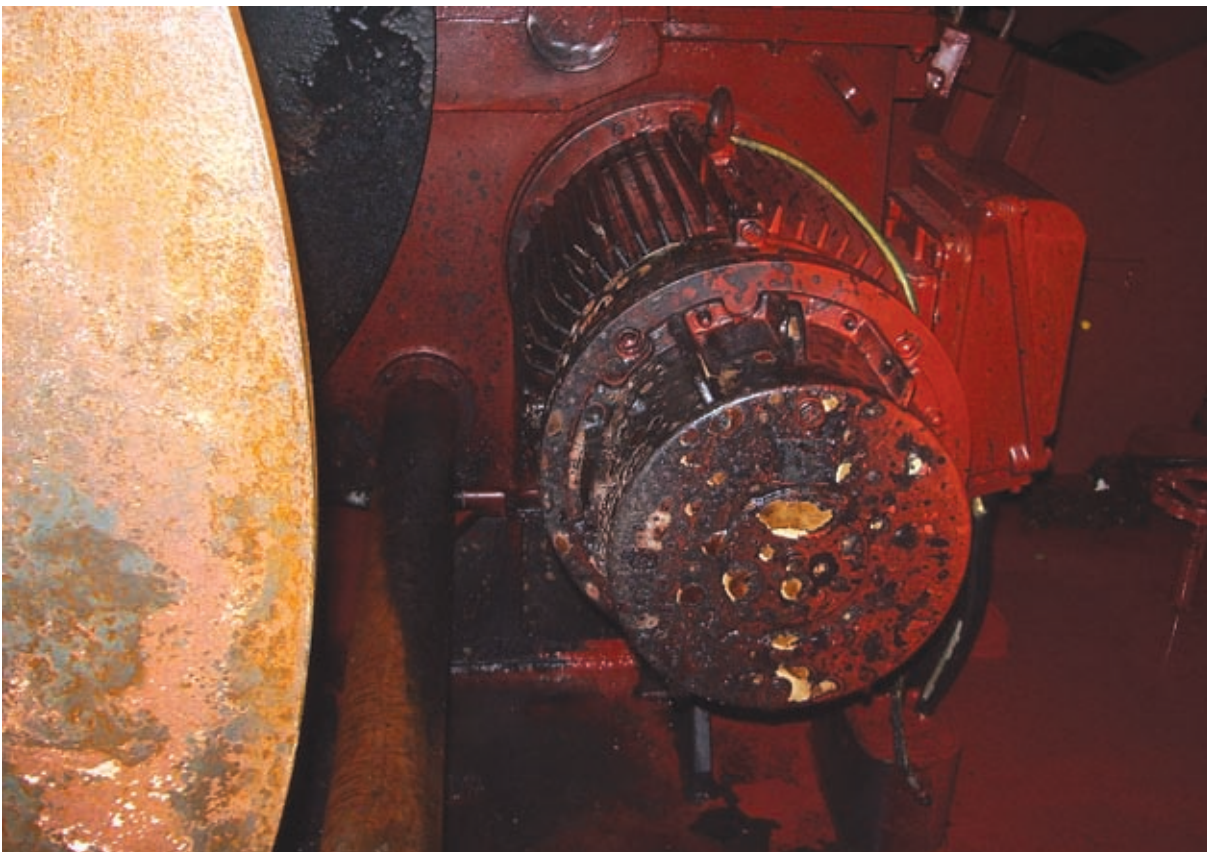
Figure 5: Winch motor damage

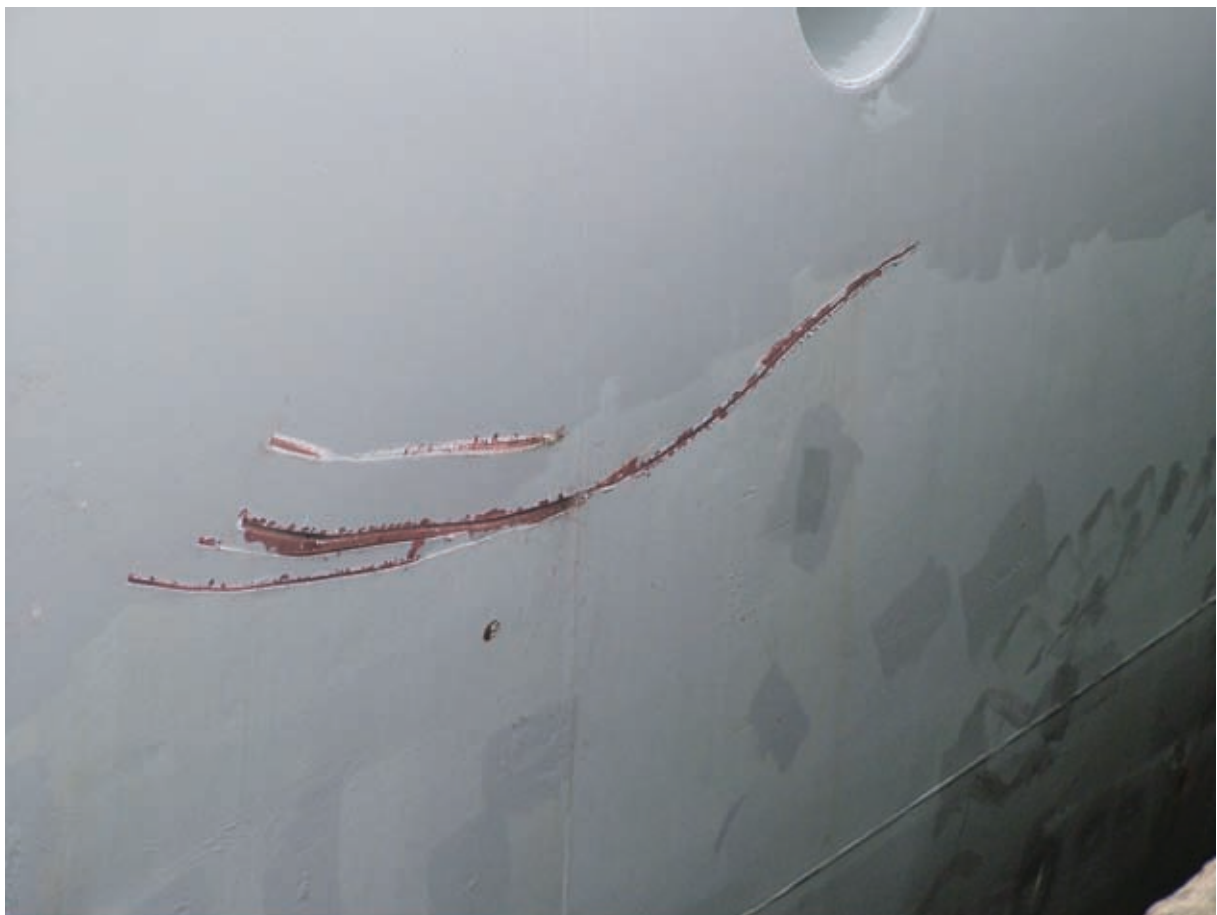
Figure 1: Damage to merchant vessel caused by contact with the derrick on the fishing vessel

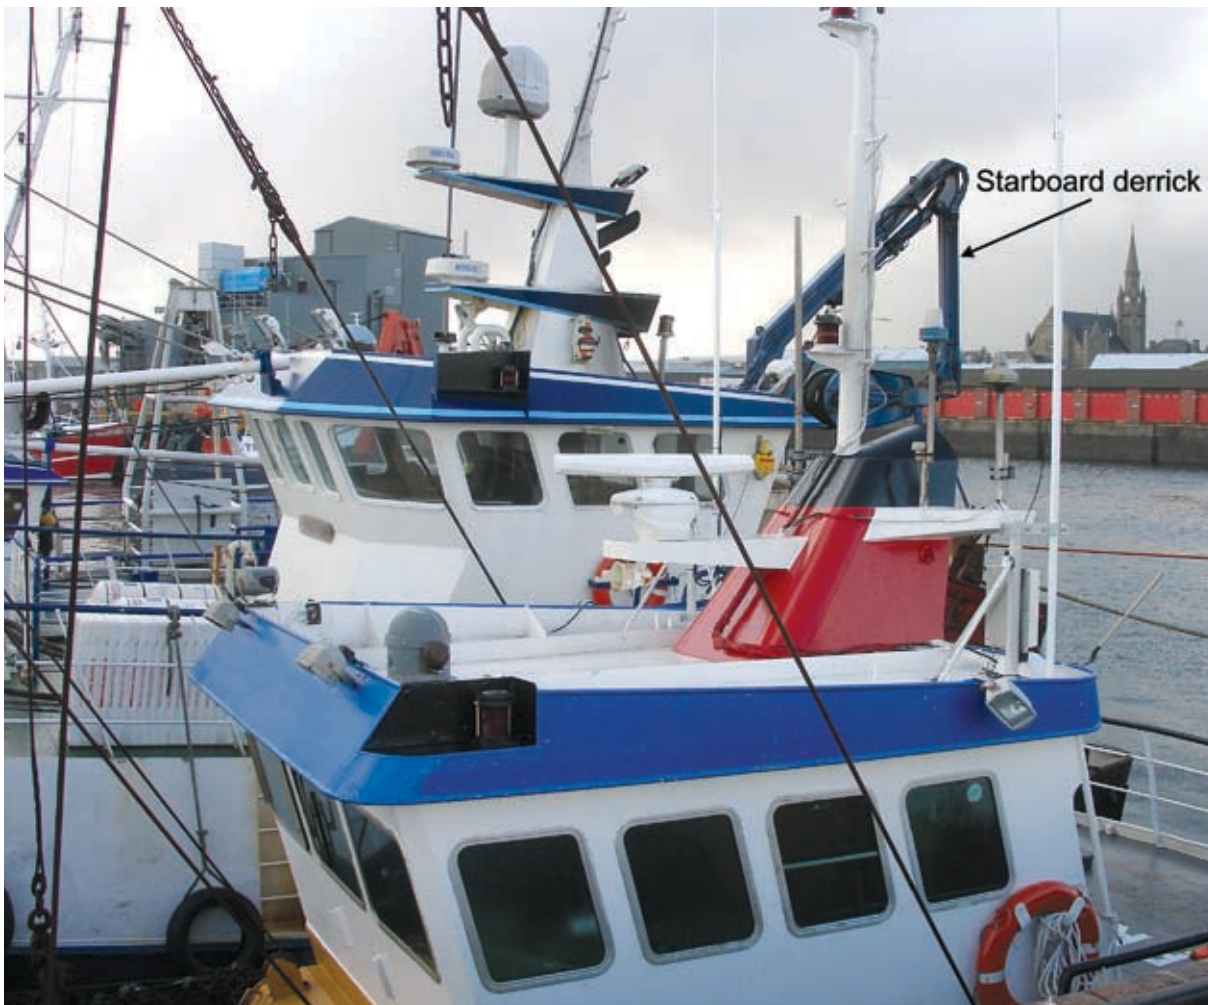
Figure 2: The derrick involved in the collision

Unfortunately these actions were insufficient to clear the vessels, and resulted in the merchant vessel striking the fishing vessel's starboard derrick. Fortunately the derrick's preventer stay snapped under the impact, thus preventing the trawler from serious damage.

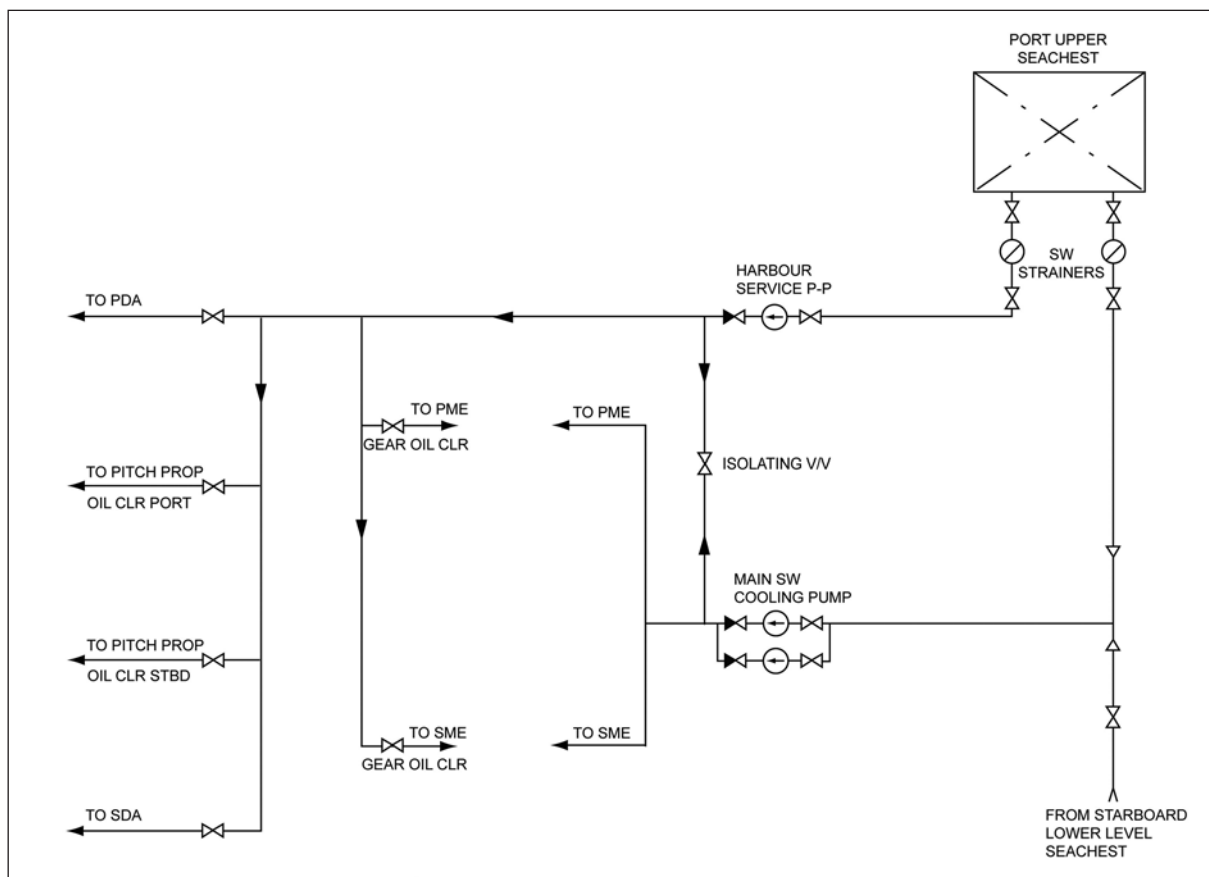
Figure 3: Schematic of the sea water cooling system

The investigation concluded that the generator's high fresh water temperature was due to the sea water system isolating valve supplying the generators not being properly opened during the system reconfiguration in readiness for departure. The poor use of the departure checklist is most likely to have contributed to this failure.

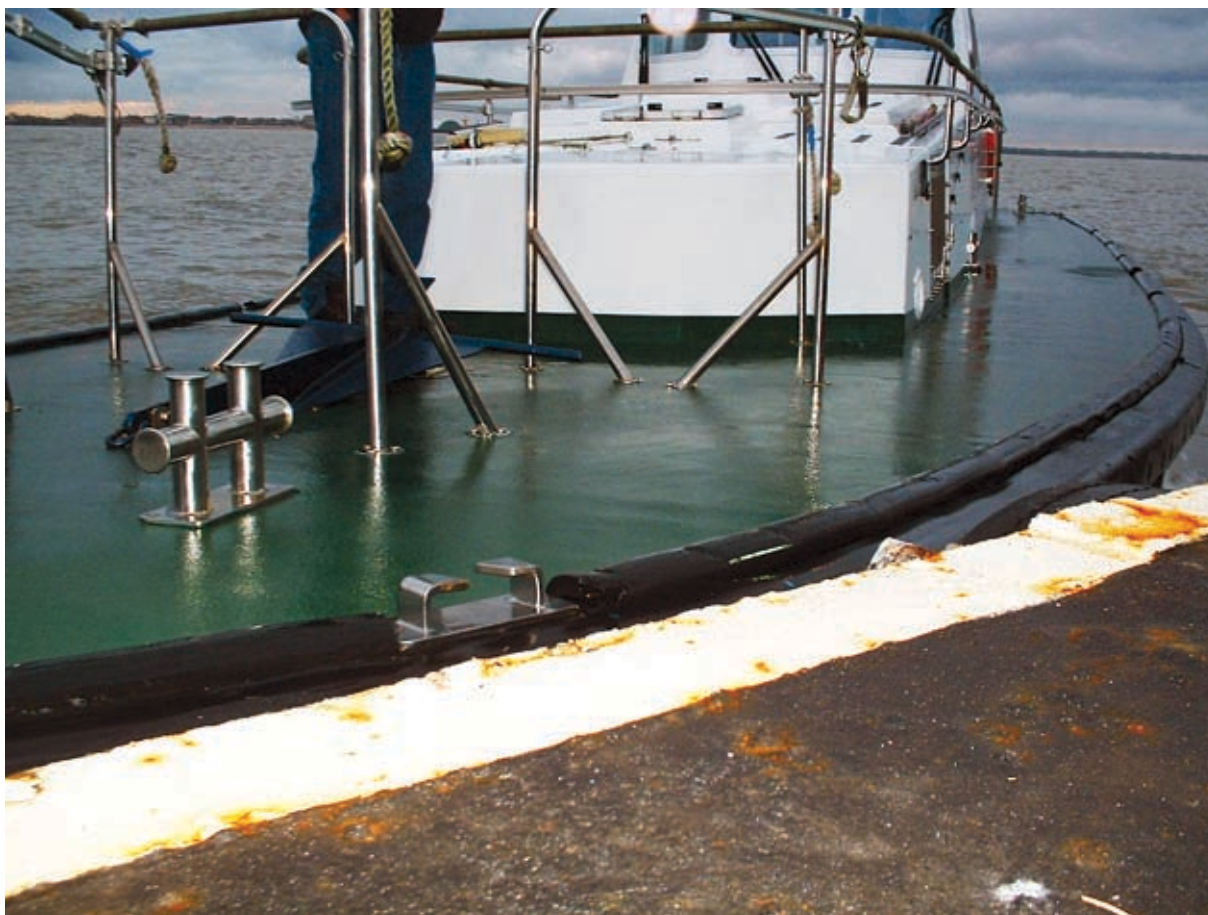
Figure 1: Pilot boat with port shoulder leaning against tyre fender of pontoon

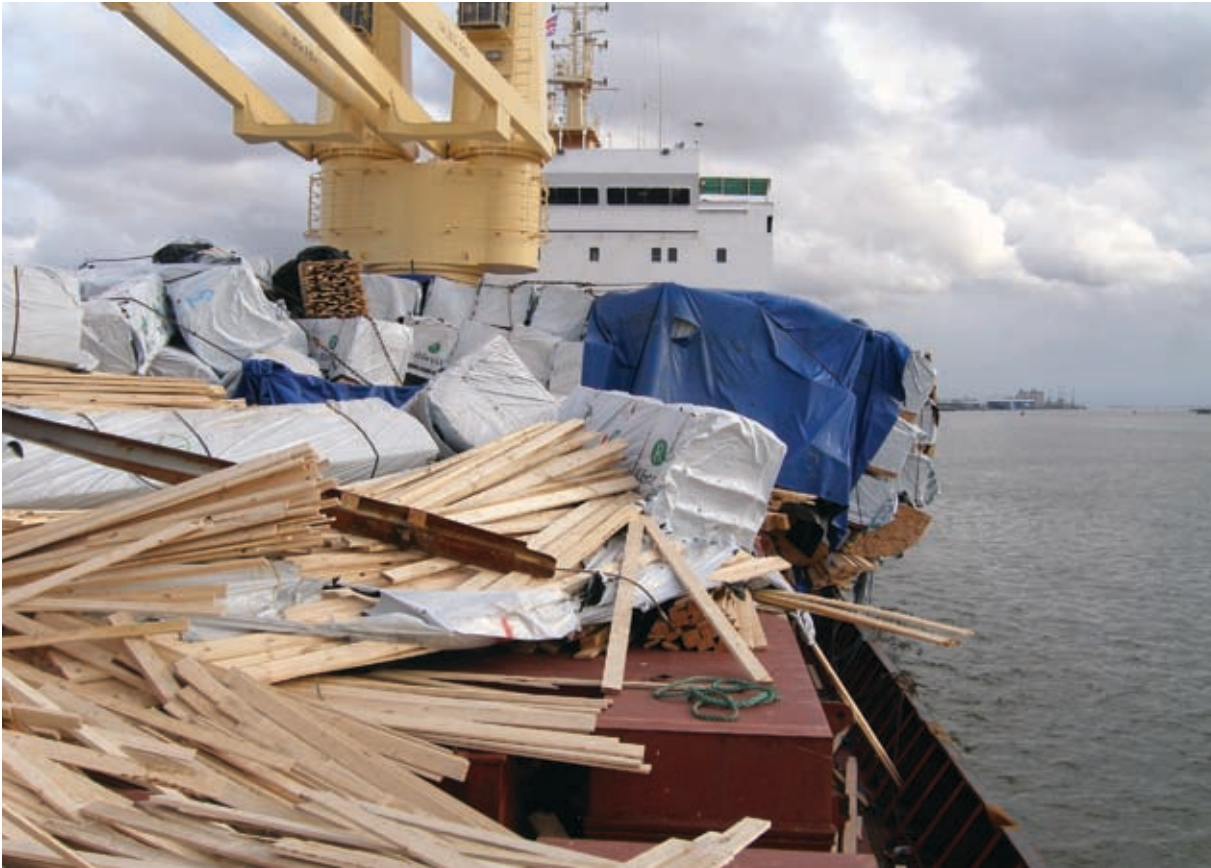
Figure 1: Port side – showing collapsed stow. Note the smooth surface on the hatch covers

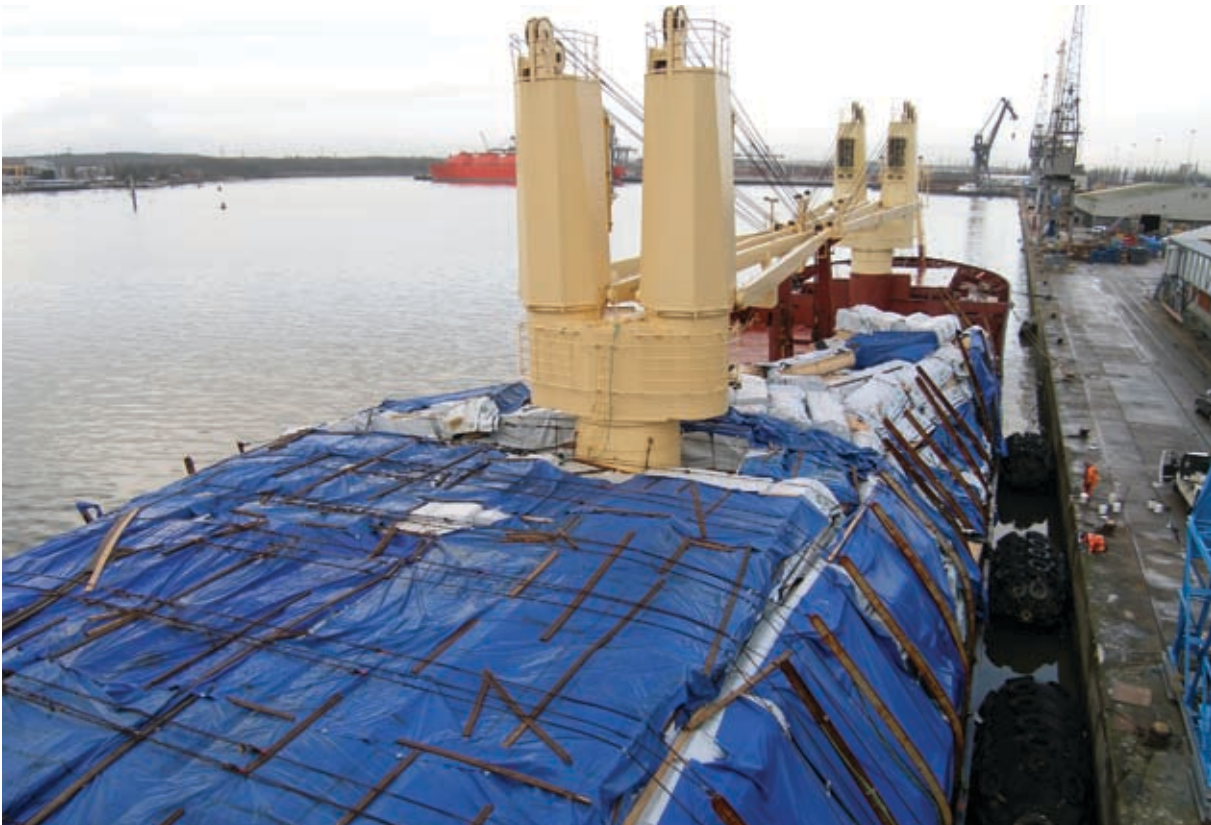
The coastguard was called and the ship was directed to port, where the cargo was unloaded and re-stowed for the onward voyage. The only damage sustained was to the uprights, lashings and the port bulwark upon which the uprights were mounted.

Figure 2: View forward, showing damaged uprights

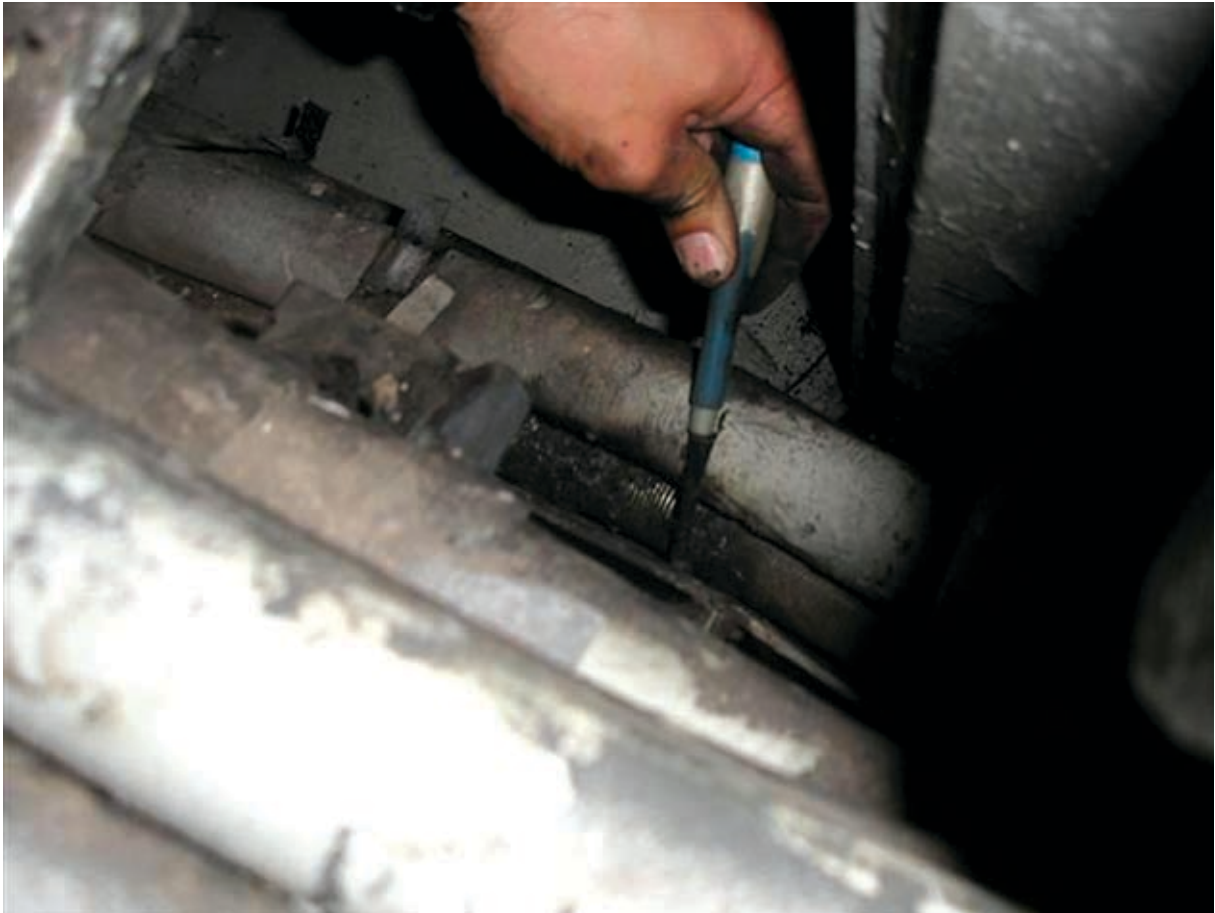
Figure 2: Charred rubberised sheathing of cable

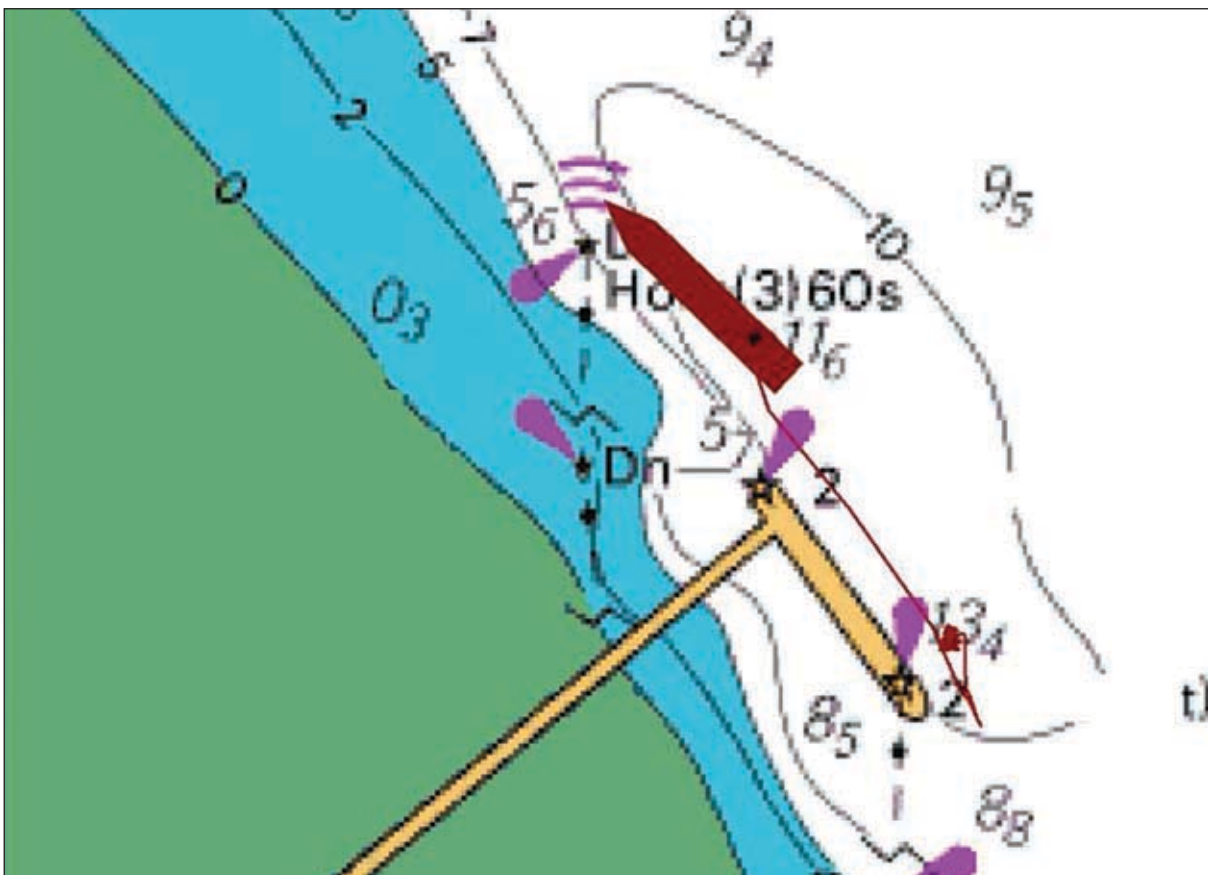
Figure 4: Vessel in contact with dolphin

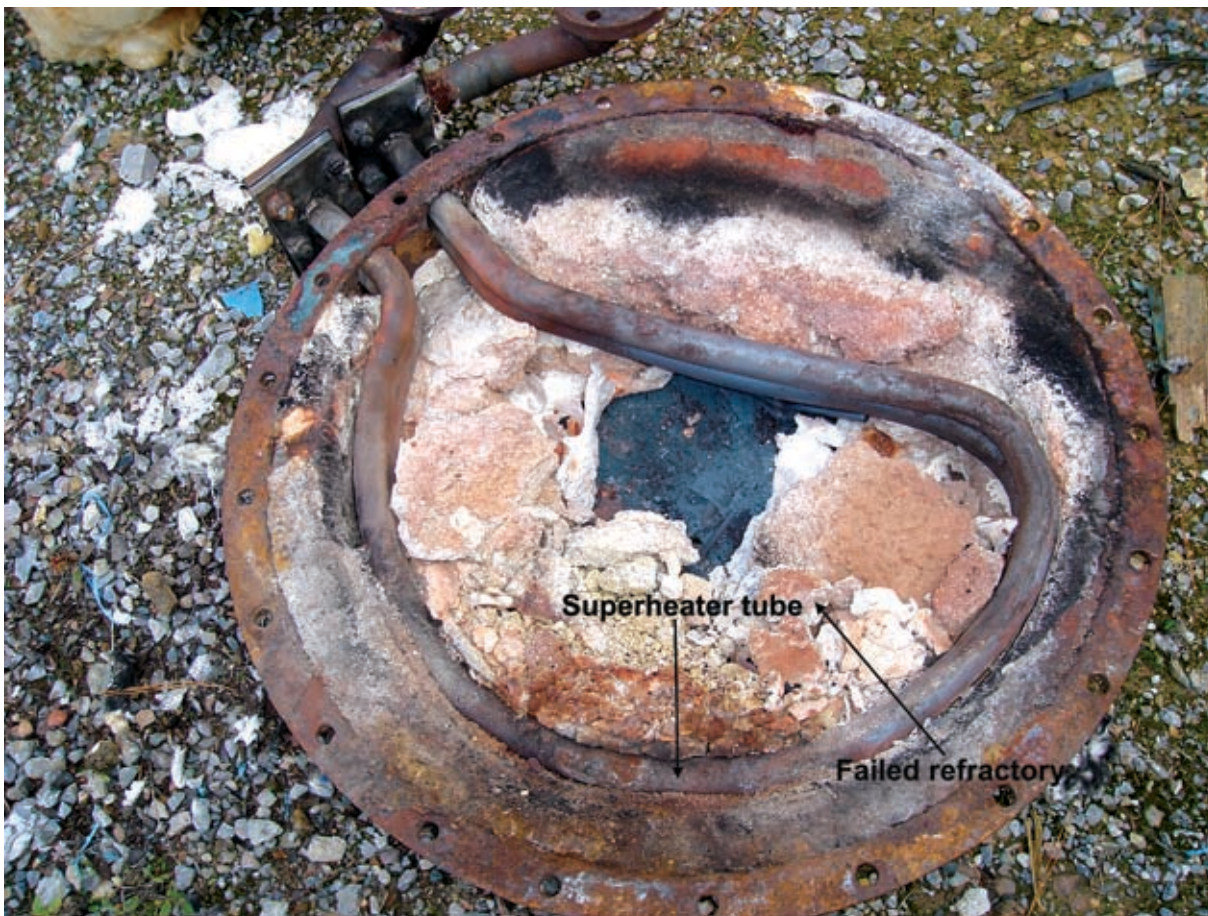
Figure 2

After removing the boiler lagging, the boiler rear casing was found to be severely discoloured. Further investigation identified that the superheater coil fitted behind the rear casing was too large for the boiler design. The continued expansion and contraction of the coil destroyed the insulation refractory lining

(Figure 2), allowing the heat to be transferred to the boiler rear casing. The discovery prompted the owners to bring in their own consultant who discovered a number of other

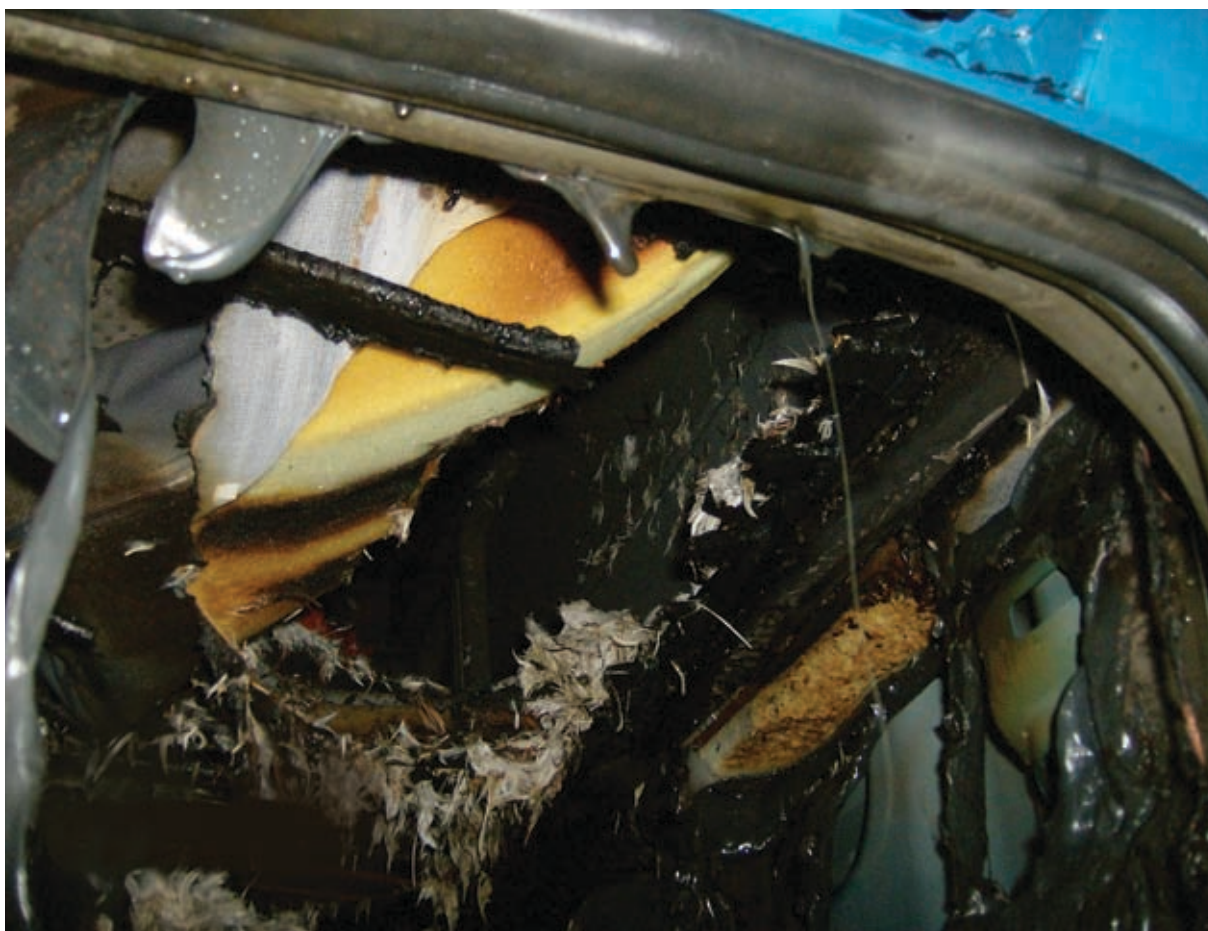
Figure 1: Damage inside the cab

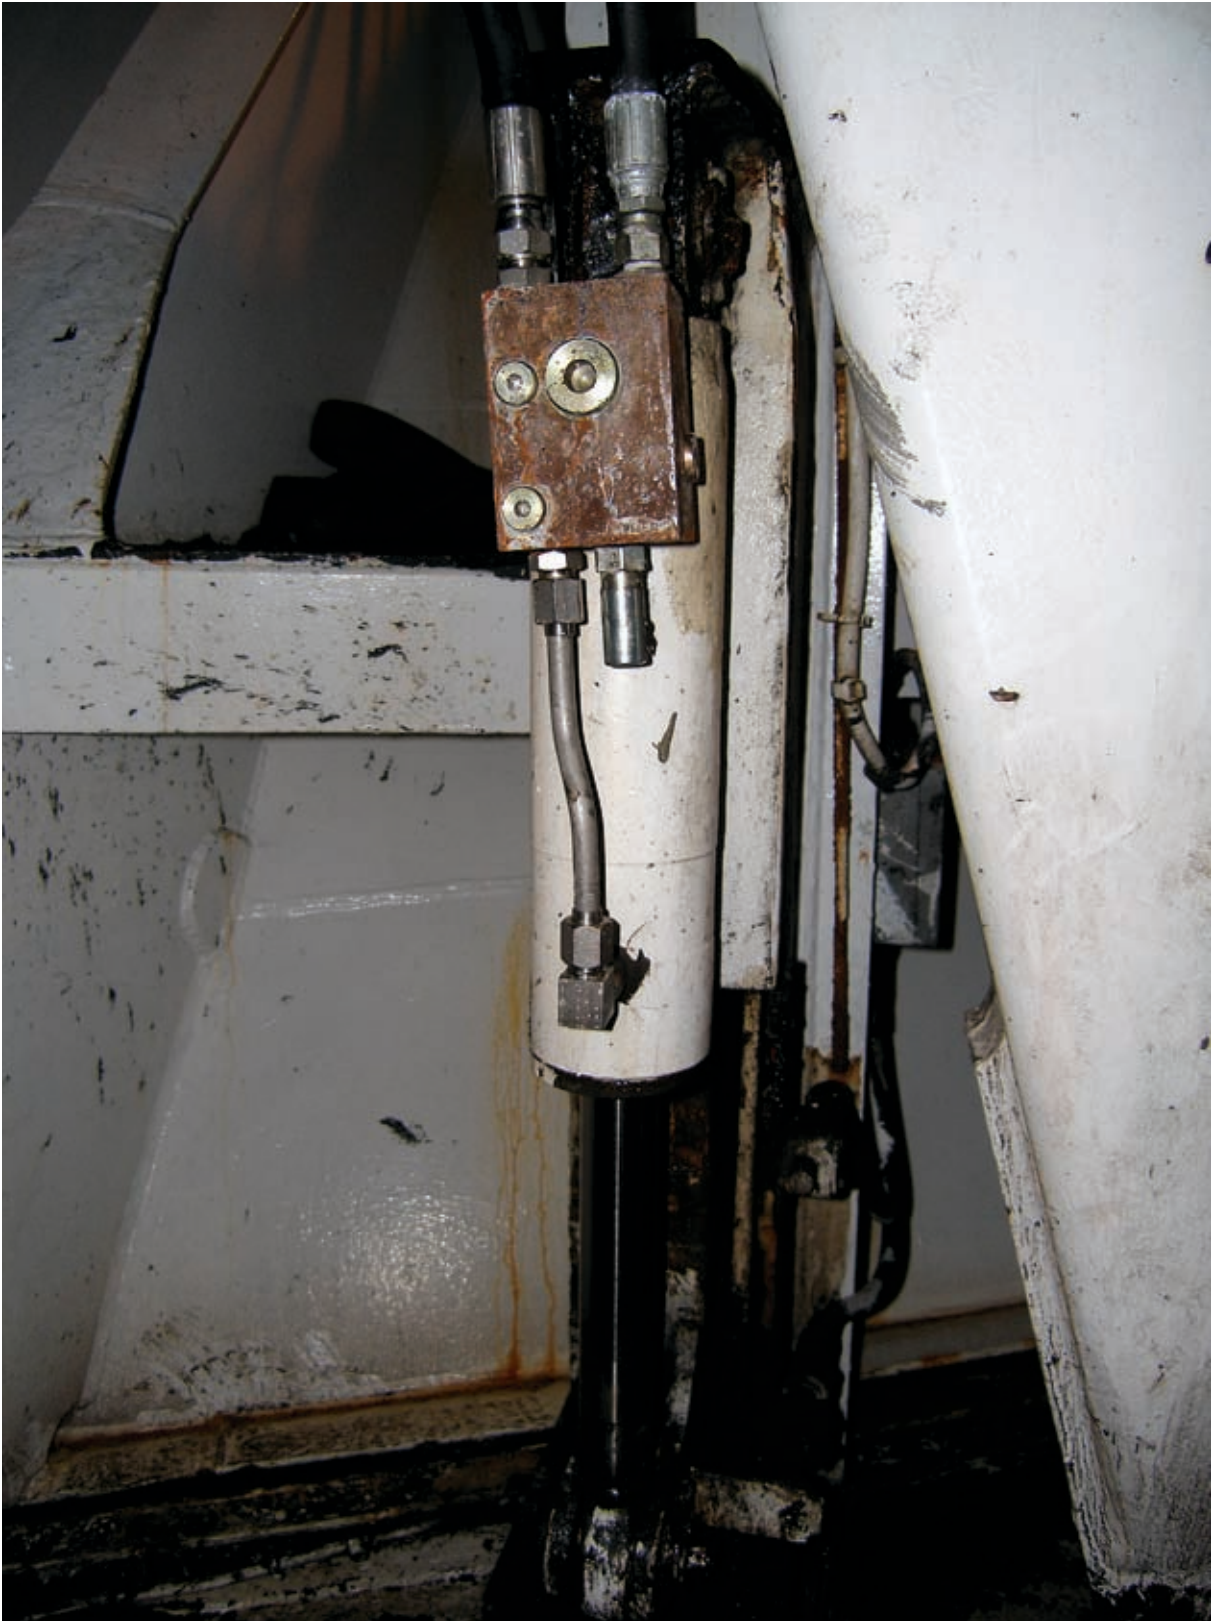
To recreate the accident, the pin was retracted by manually operating the appropriate solenoid valve until a red bow door light indicated in the bridge. The normal operating panel was then used to try and close the door. The first action of the hydraulic control system was to disengage the door cleating arrangement, but if the switch was held in the 'close' position, the cleats were subsequently reapplied. The bow door manufacturers confirmed that this sequence of disengaging all the cleats before re-engaging them was as intended. By holding the switch across until he heard the first clunk, and then releasing it, the chief officer had stopped the system halfway through its cycle, at a point when all the securing mechanisms were disengaged.

Figure 3: Starboard lower vertical locking pin

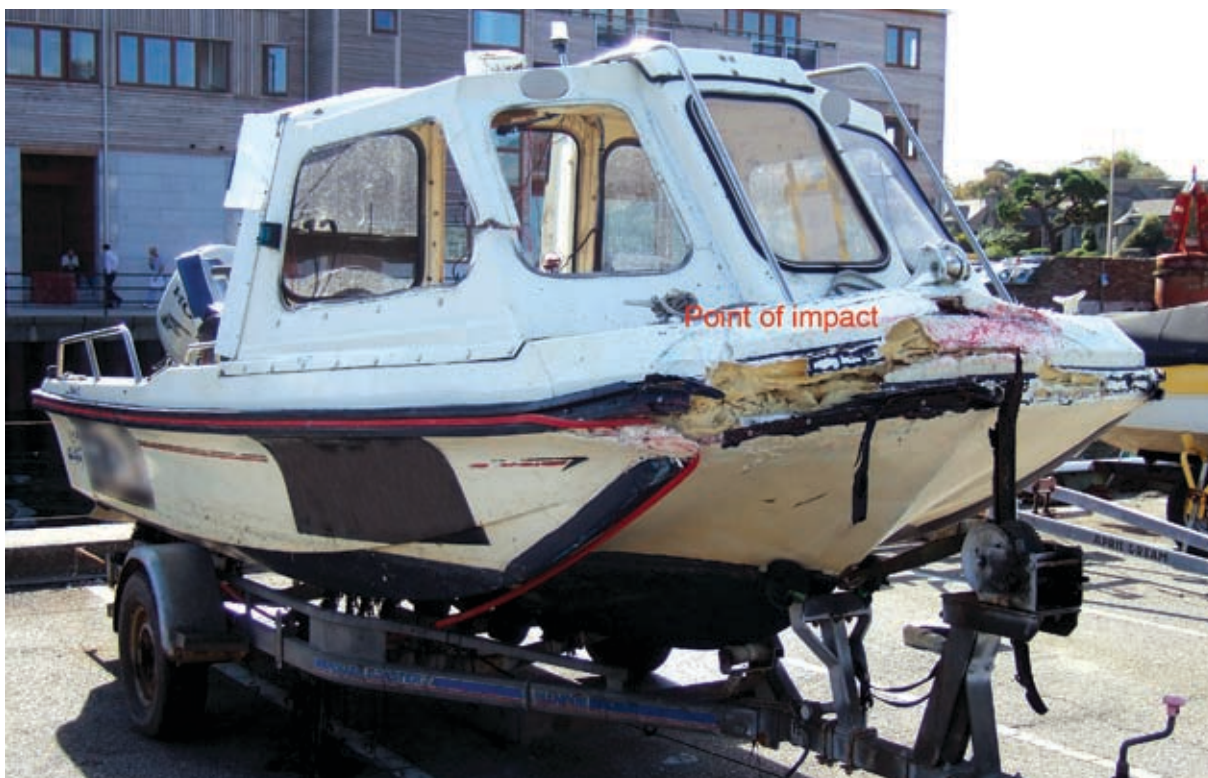
Figure 3: Damage to bow of the dory

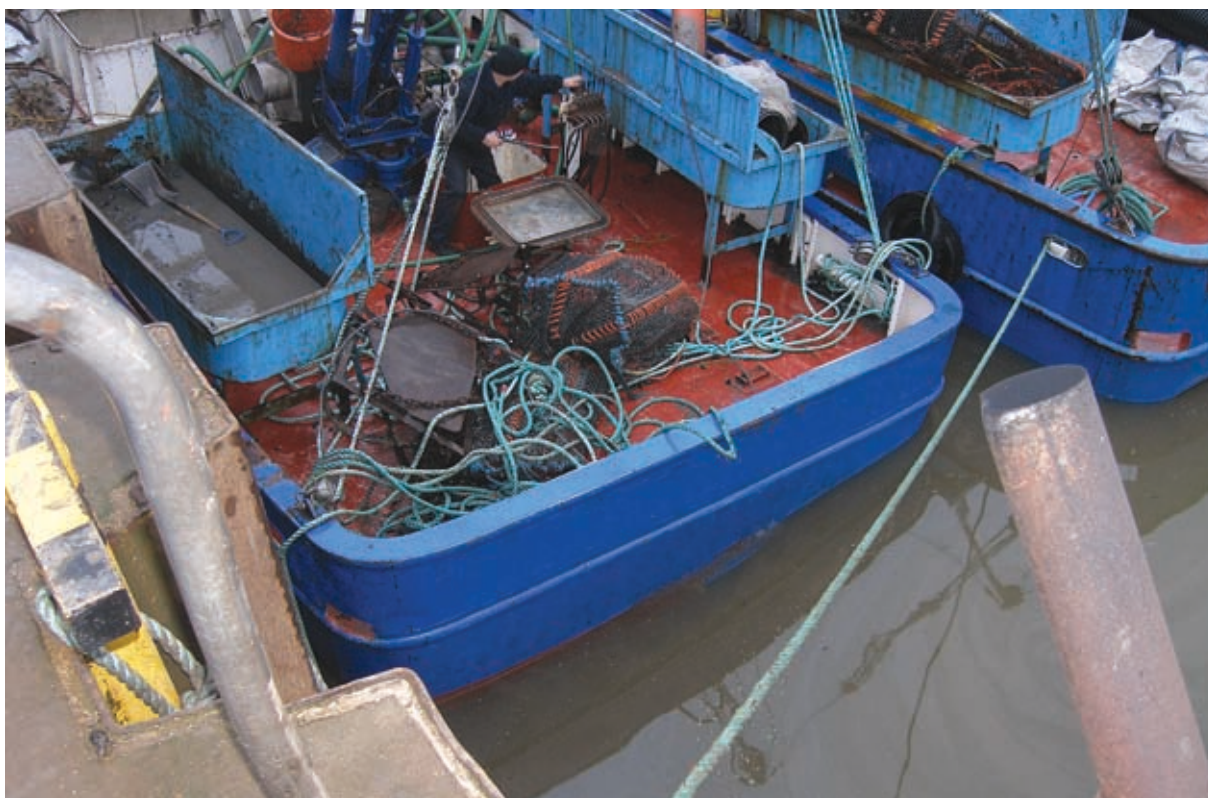
Figure 2: View of stern showing limited freeboard
