**Lessons from Marine
Accident Reports
2/2010**

SAFETY DIGEST
Lessons from Marine Accidents
No 2/2010

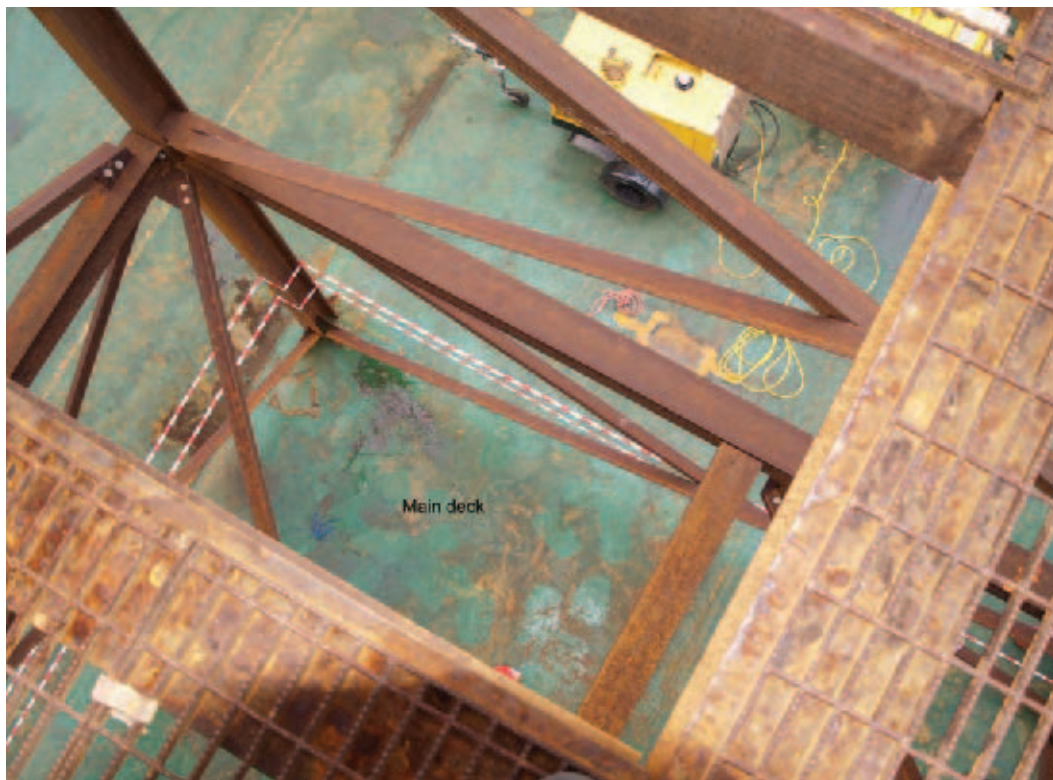
The shift supervisor then instructed two of the riggers to go onto the stowage working platform to remove any loose items before it was craned ashore. A number of items were lowered to the deck using the ship's 40 tonne crane. The two riggers, who were not wearing safety harnesses, then removed the plywood sheet covering the smaller of the two holes in the deck grating. The plywood was lowered to the deck. The two riggers then turned their attention to removing the grating covering the larger of the two holes. As one of the riggers used his radio to discuss the options with the crane driver, he stepped back from the platform guardrails and put his left foot through the smaller hole which was previously covered by the plywood. He lost his balance, struck the opening with his left hand and fell nearly 7 metres to the main deck below (Figure 3).

Figure 3: The deck grating from where the crewman fell to the main deck

2. It is all too easy to become distracted when working aloft, so personnel should wear a safety harness or other arresting device; in some cases a safety net may also be appropriate. Chapter 15 of the Maritime and Coastguard Agency’s (MCA) publication – Code of Safe Working Practices for Merchant Seamen provides more detailed guidance.

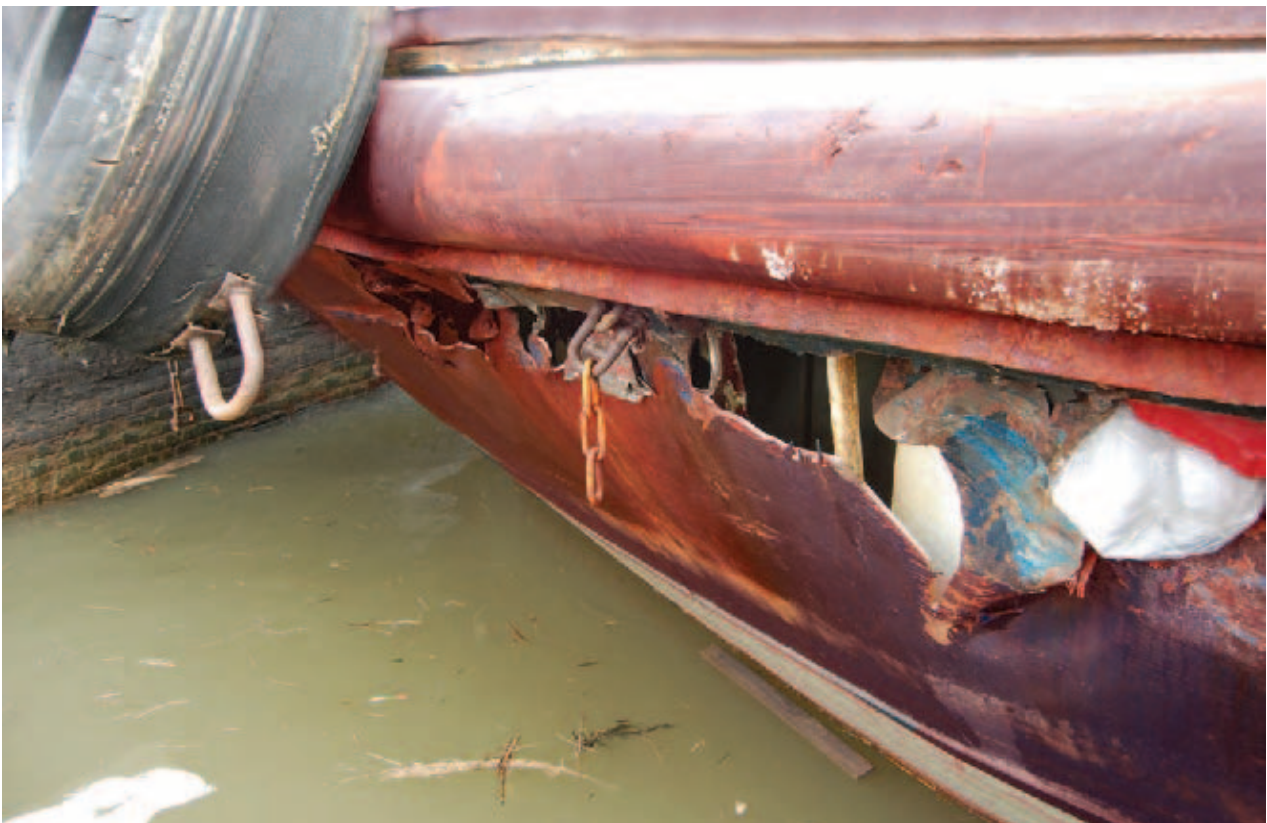
An emergency manoeuvre failed to prevent the tug from making heavy contact with the lock gate recess, causing the towline to part as the vessel continued into the dock. The tug was able to manoeuvre off the recess, and continued to assist the vessel berthing, but had sustained significant damage above the waterline (Figure 3). The lock gate and gate recess also sustained minor damage.

Figure 3: The damage sustained to the tug

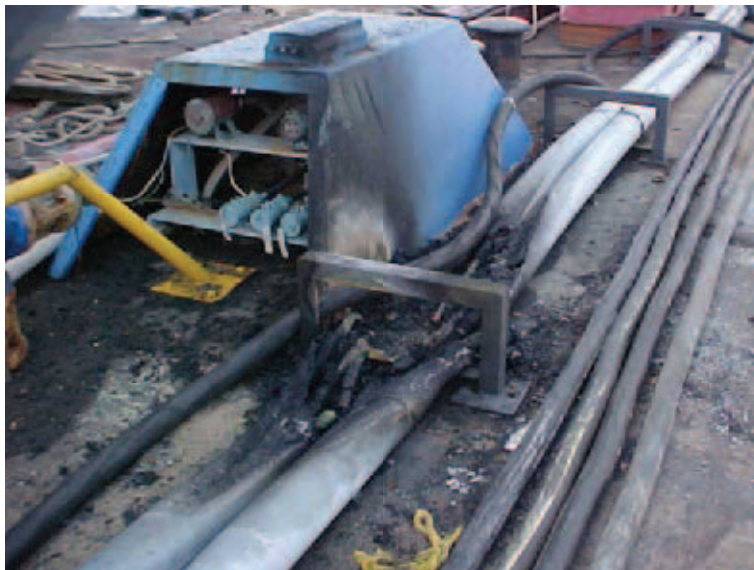
A few days later, the crew heard an explosion in the shipyard, following which shore electrical supplies were lost and the vessel suffered a blackout. Investigation showed that this time, one phase of the shore power had failed due to a poor mechanical connection, causing the remaining two phases to overload, resulting in significant damage to the supply cables before the breakers operated. Electric motors on board the ship were found to have been single phasing, and some were damaged as a result.

Figure 3: Damage to the supply lines

1. **Trust no one:** safety standards can vary enormously in different parts of the world.
2. Always ensure that appropriately qualified staff have properly checked connections on shore electrical supplies before they are made live.

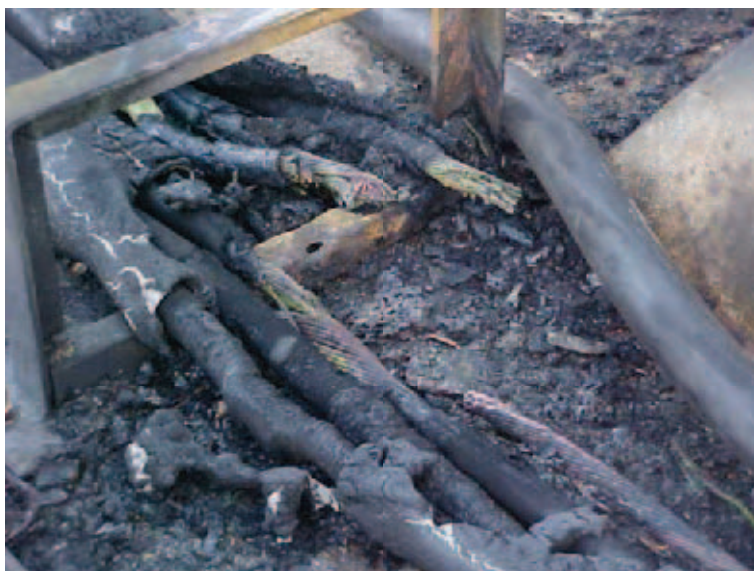
Figure 4: Close-up of the damaged cables

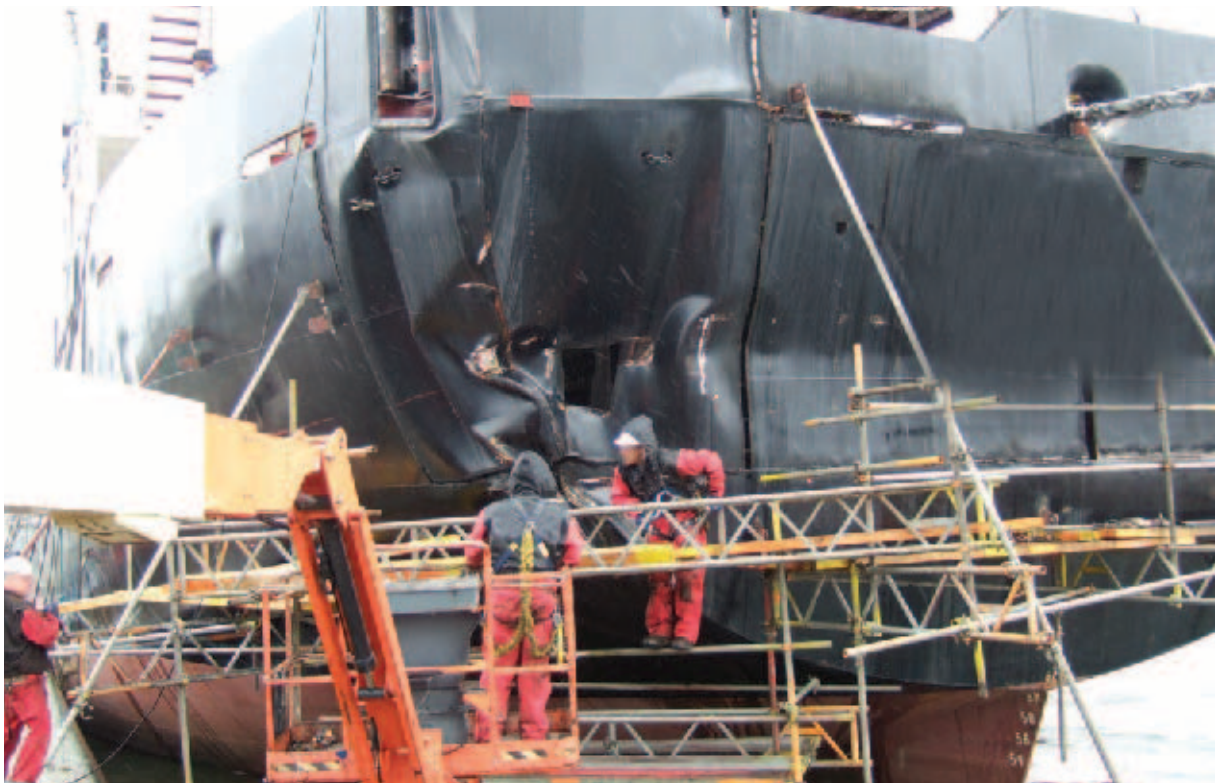
The vessel hit the lock gate at around 3 knots, significantly damaging her stern and causing minor damage to the lock gate.

Figure 1: Damage sustained to stern of vessel

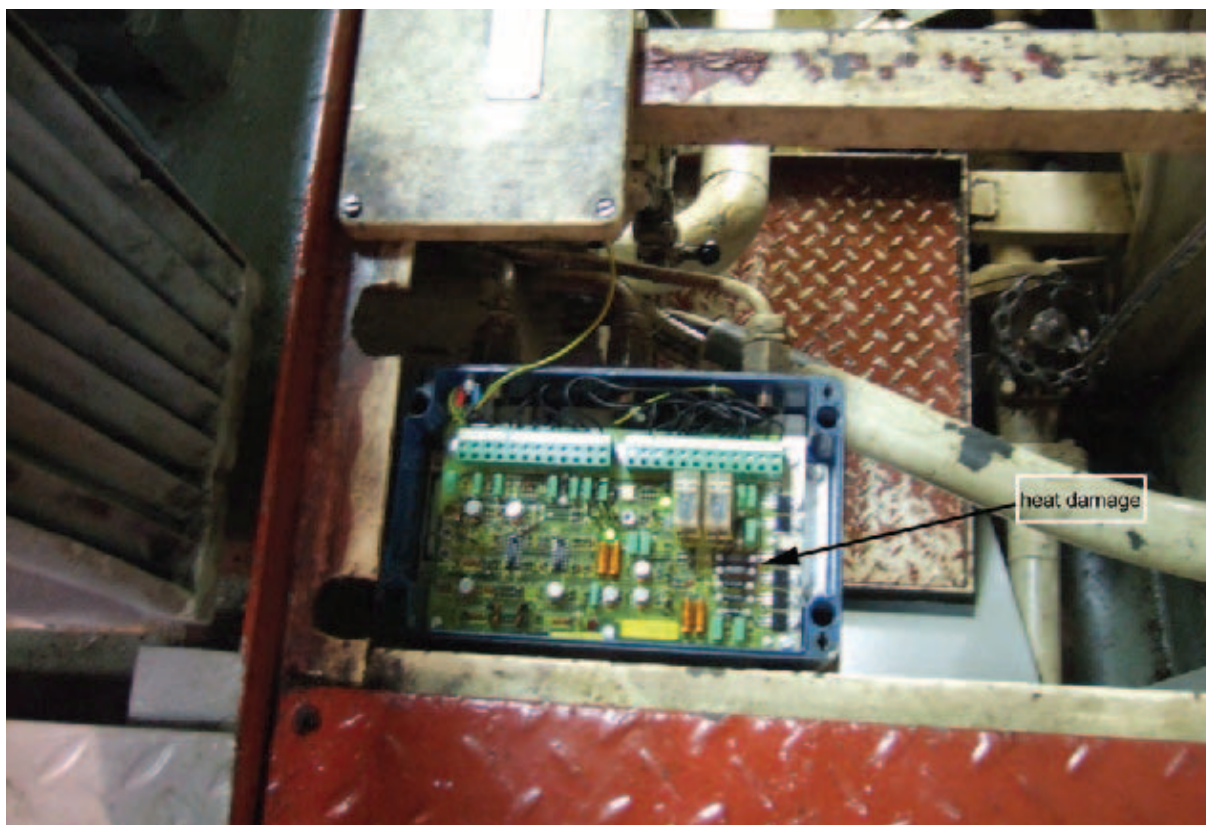
The subsequent investigation found that the most likely cause of the accident was the failure of the CPP servo unit control board, located below the engine room plates next to the propeller shaft. The control board, in situ for 17 years, showed some indication of heat damage.

Figure 2: CPP Servo unit

2. The CPP system servo unit was a single point of failure within the CPP system. *Critical systems such as these should be identified and the potential effects of their failure carefully considered.*

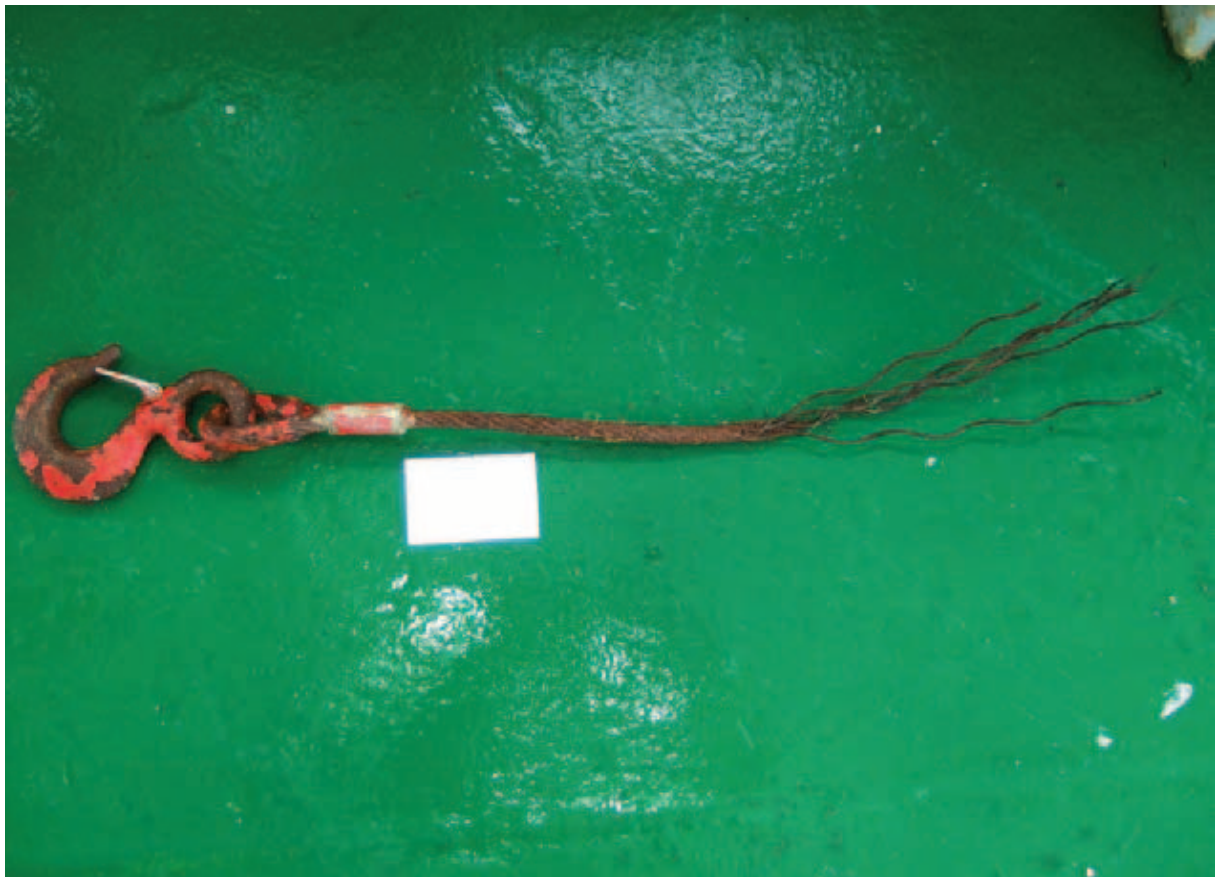
After the boat had descended about 2m the wire parted, close to the hook, and the boat and both occupants fell around 8m to the water. Both suffered serious injuries, but were able to climb out of the boat and up the vertical ladder on to the dockside, from where they were taken to hospital by the emergency services. Both required a lengthy time off work to recuperate.

Figure 2: Stores davit hook and parted wire

3. The wire was heavily corroded and was incapable of supporting the weight of the workboat and the crew.
 - a) The stores davit was not included in the list of maintainable items, so effective maintenance and testing was not carried out.

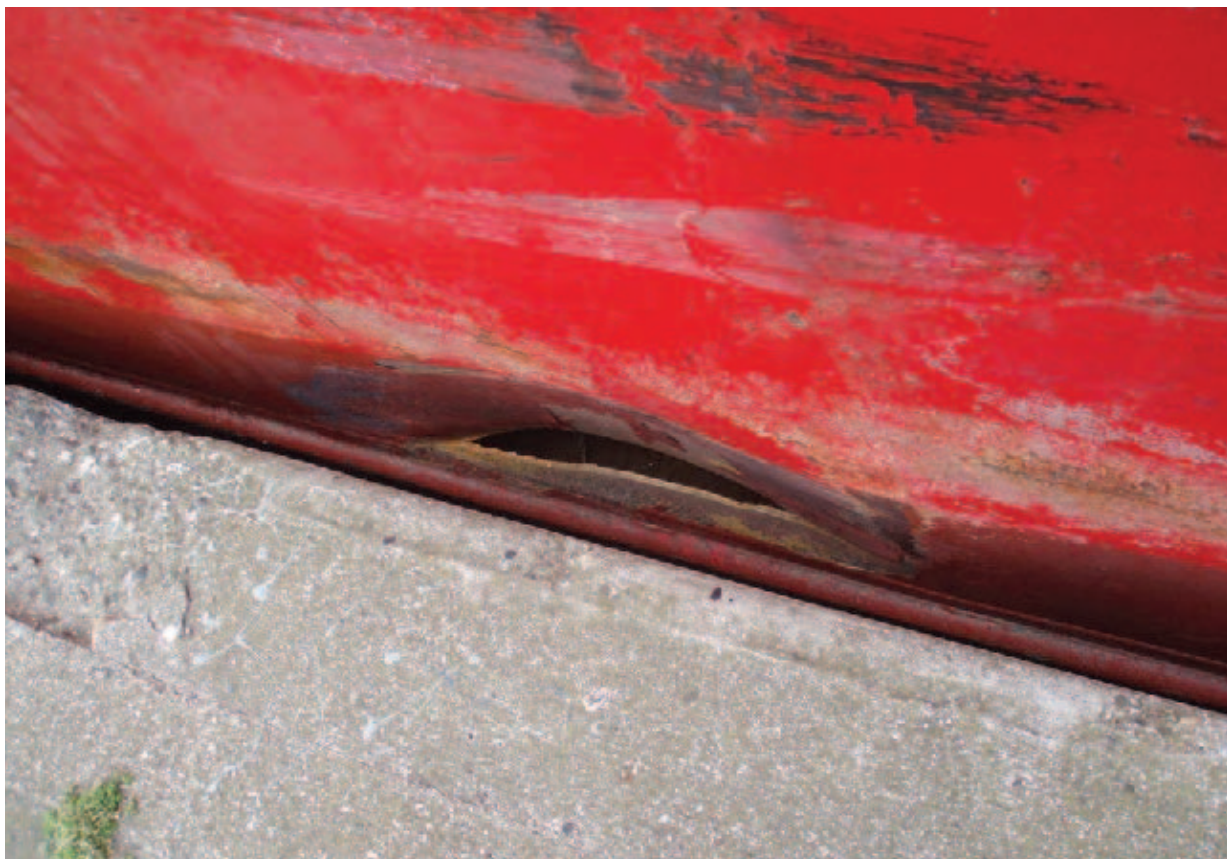
Figure 1: Damage sustained to the hull of the vessel

2. Vessels should avoid passing too close to navigation marks. However, if a contact or close quarters situation occurs, the mark should be monitored to ensure that it has not been damaged or moved from its assigned position. The vessel should then report the occurrence to the harbour authority or nearest coastal state, as appropriate.

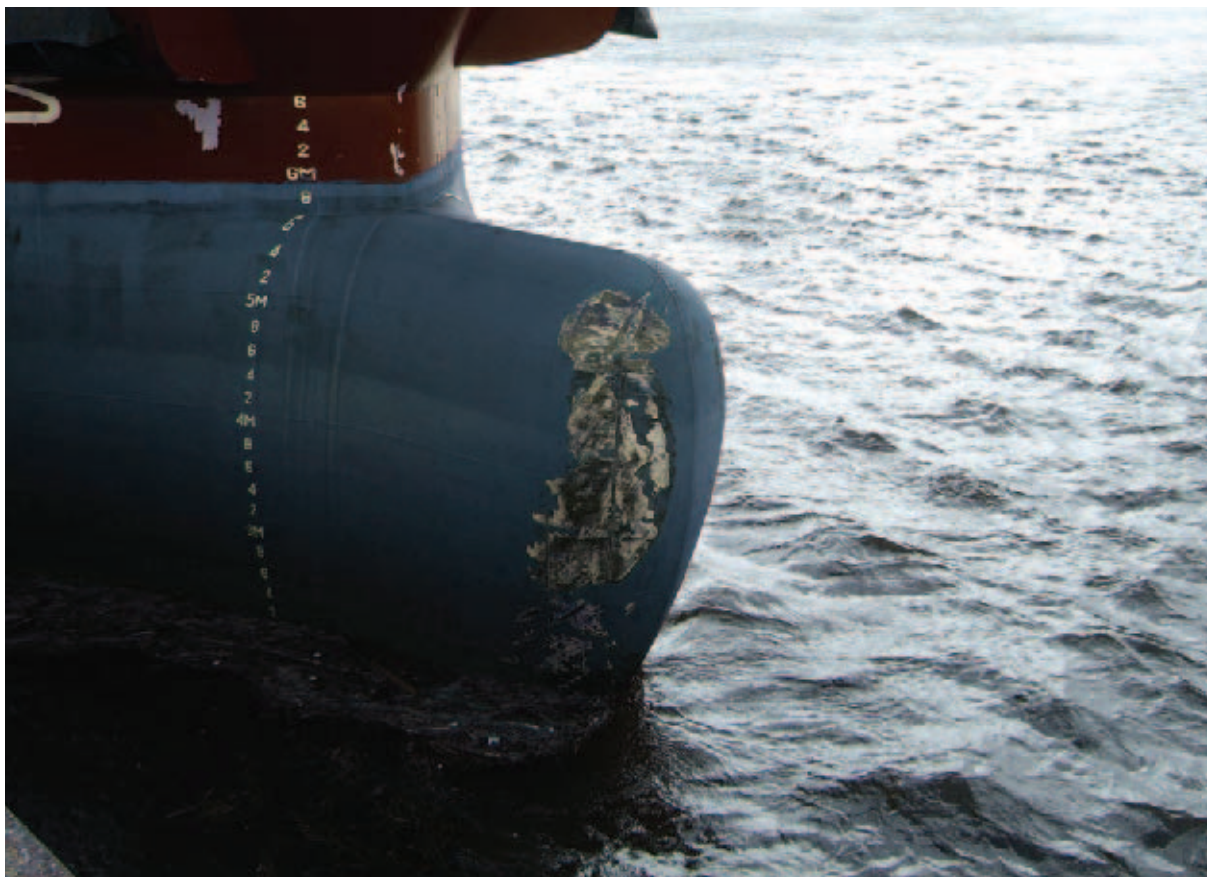
Figure 1: Damage sustained to the vessel

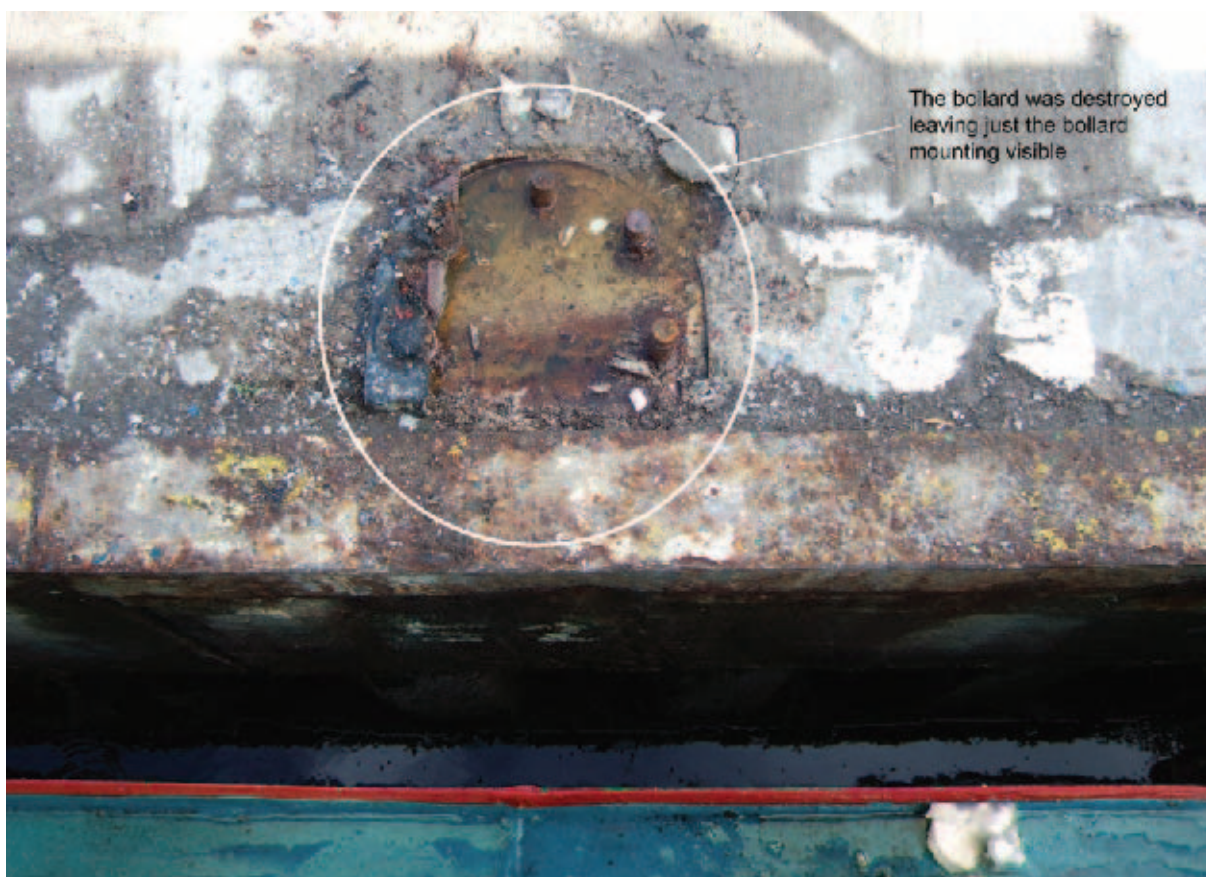
Figure 2: An aerial view of the damage sustained to the quayside

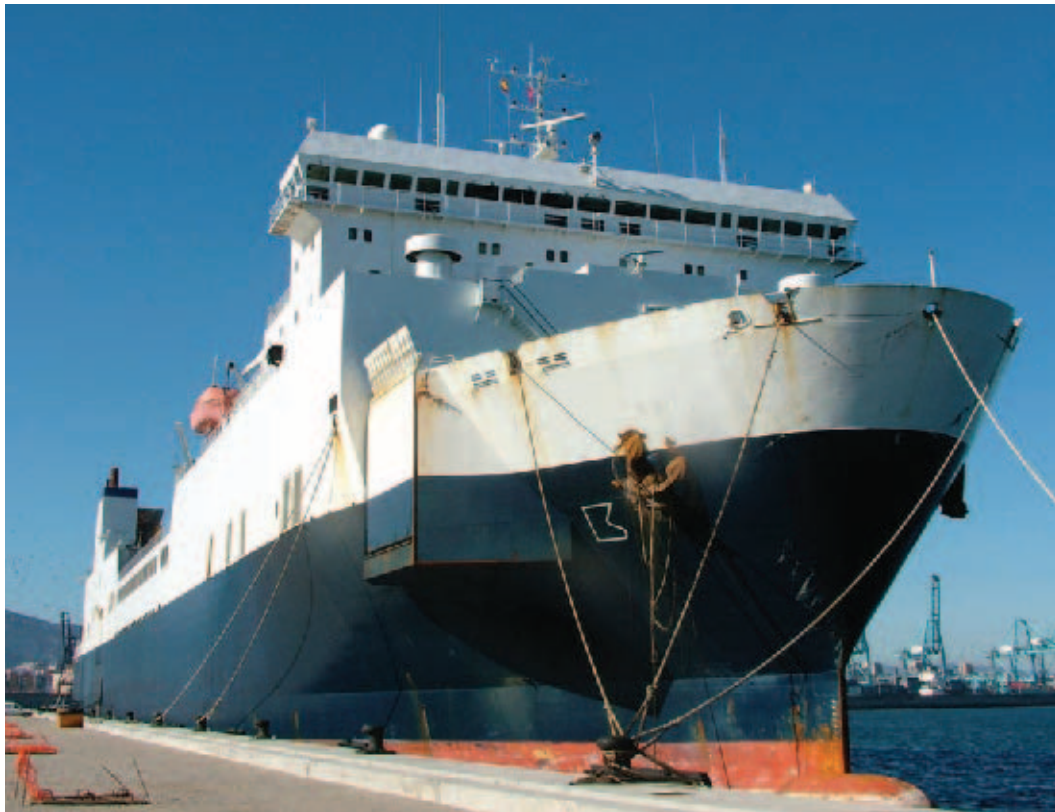
Figure 2: Ship's starboard bow

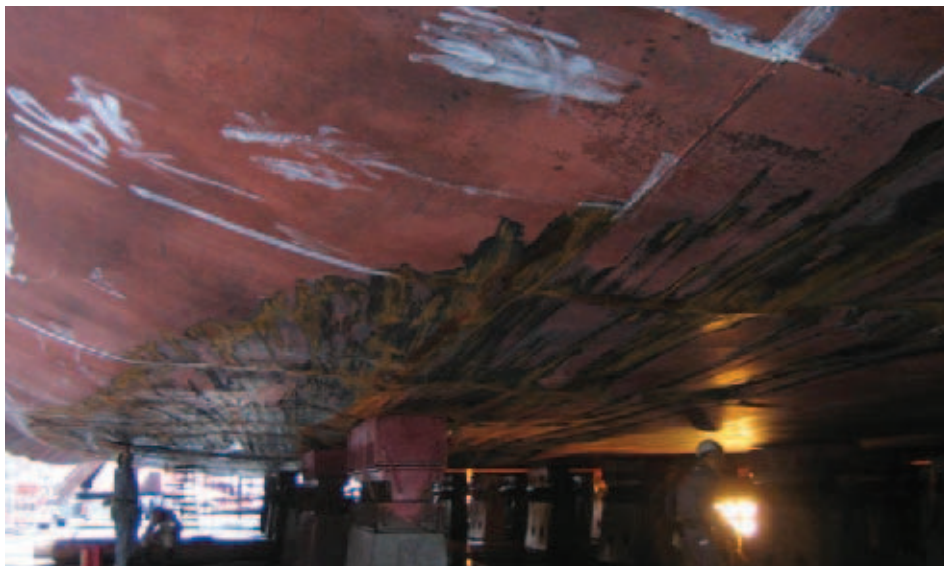
About a minute later, at 0708, the container ship passed over the reef. This resulted in the breaching of five of her ballast tanks.

Figure 1: Damage sustained to the hull of the vessel

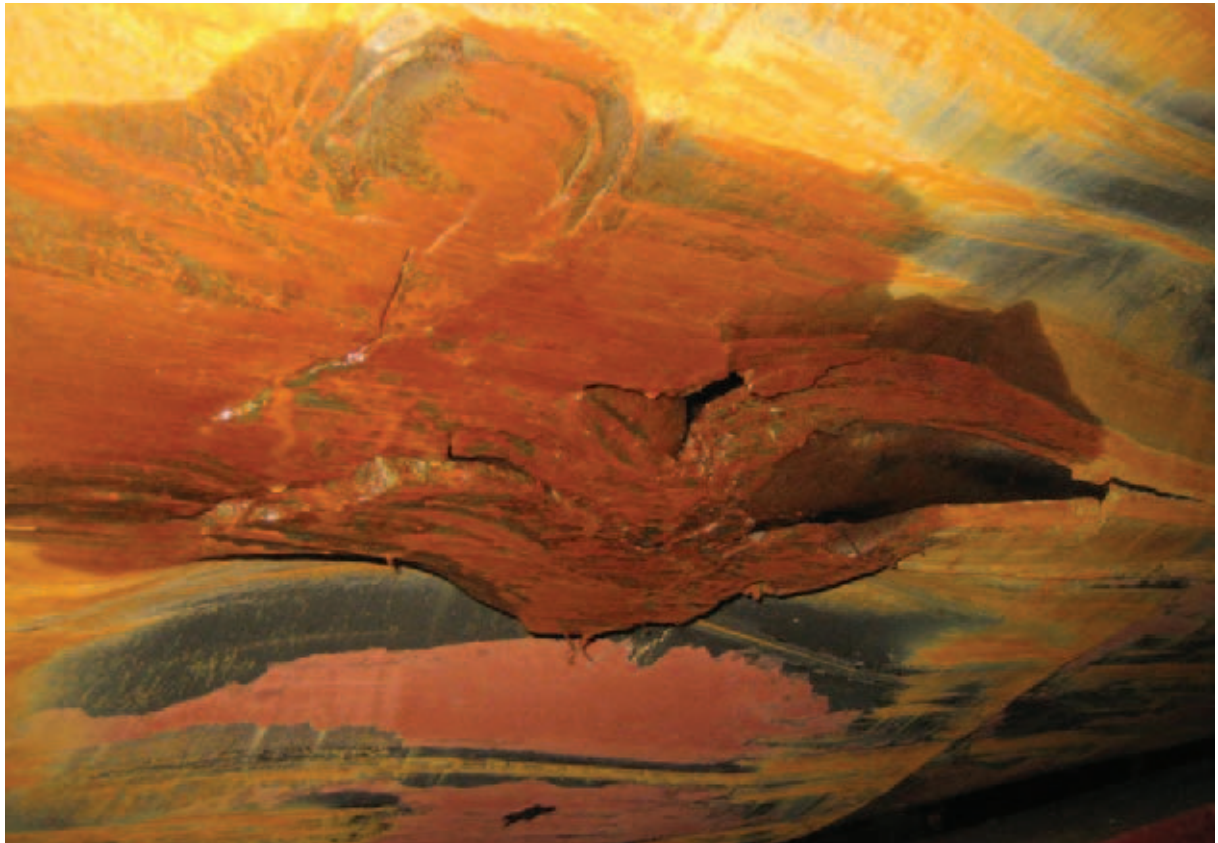
Figure 2: The extent of the hull penetration

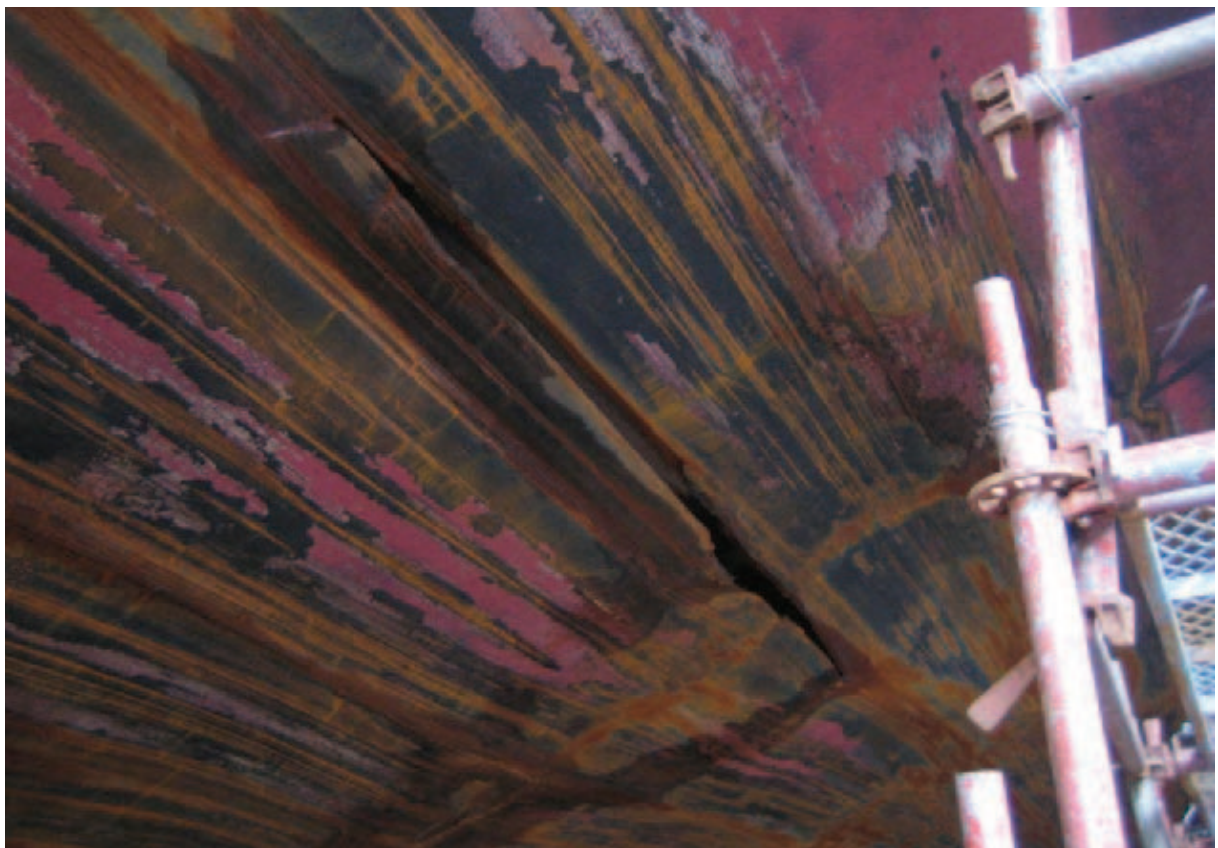
Figure 3: Hull penetration

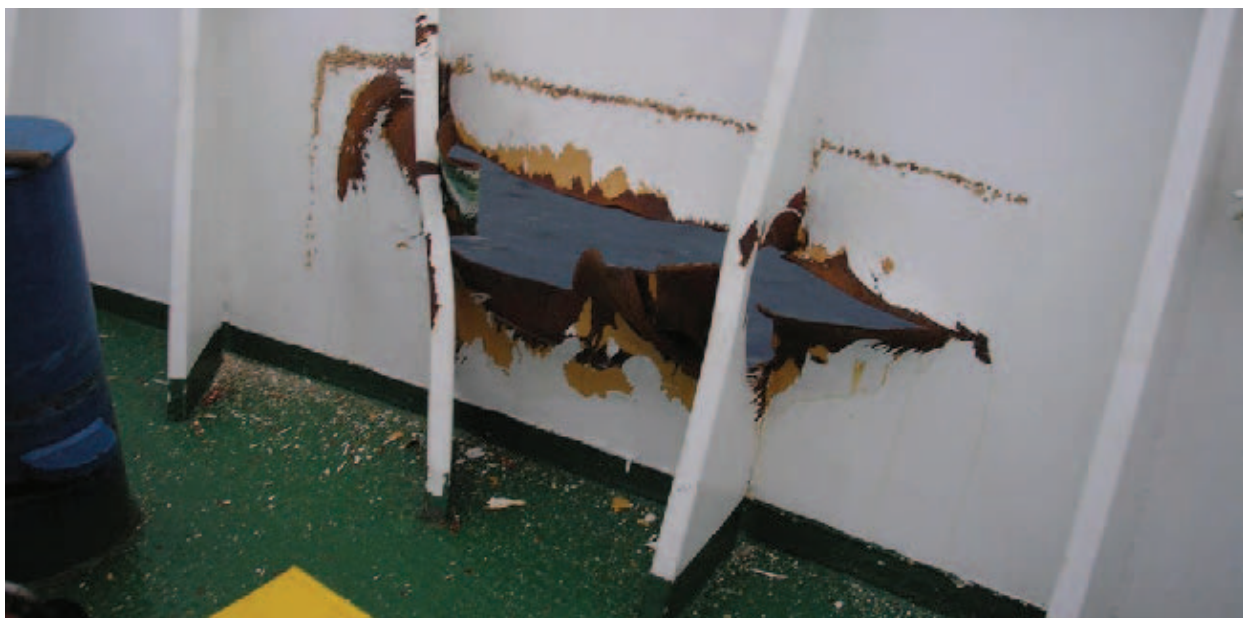
Figure 1: Damage sustained to port bow bulwark on cargo vessel

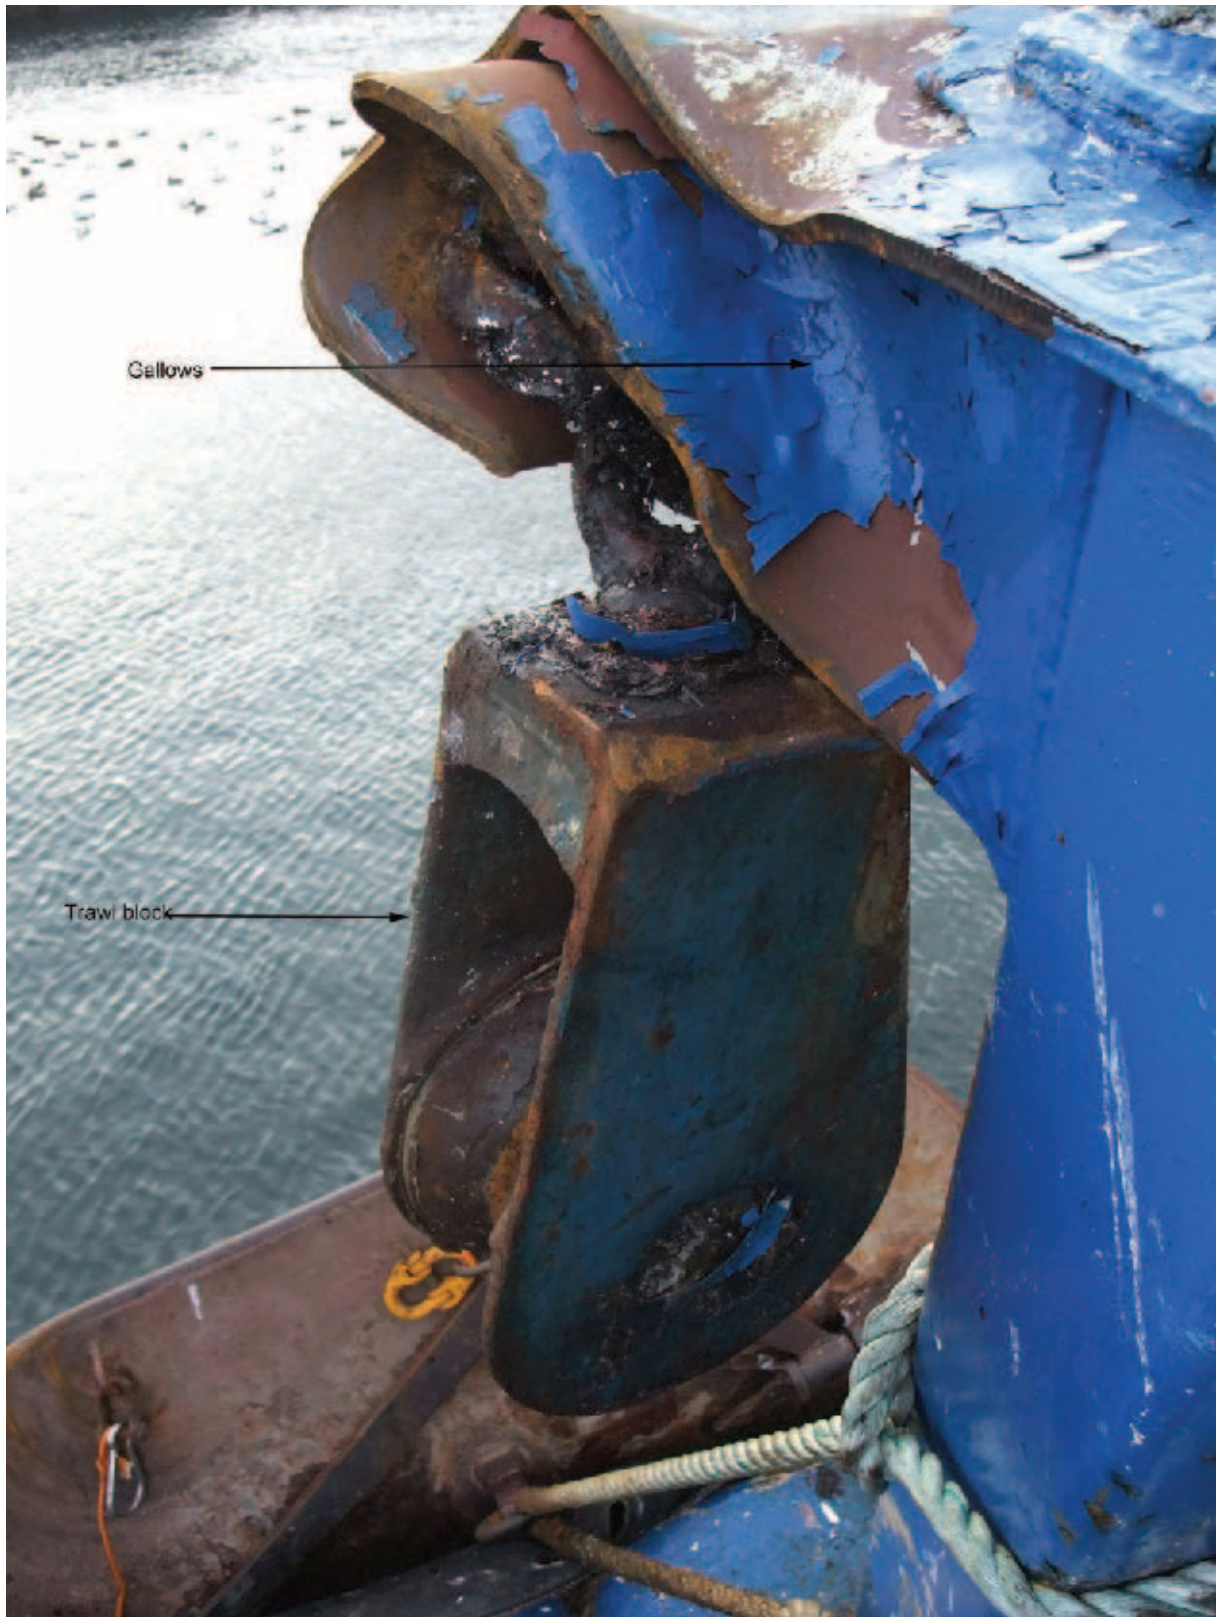
Figure 2: Damage sustained to gallows and trawl block of fishing vessel

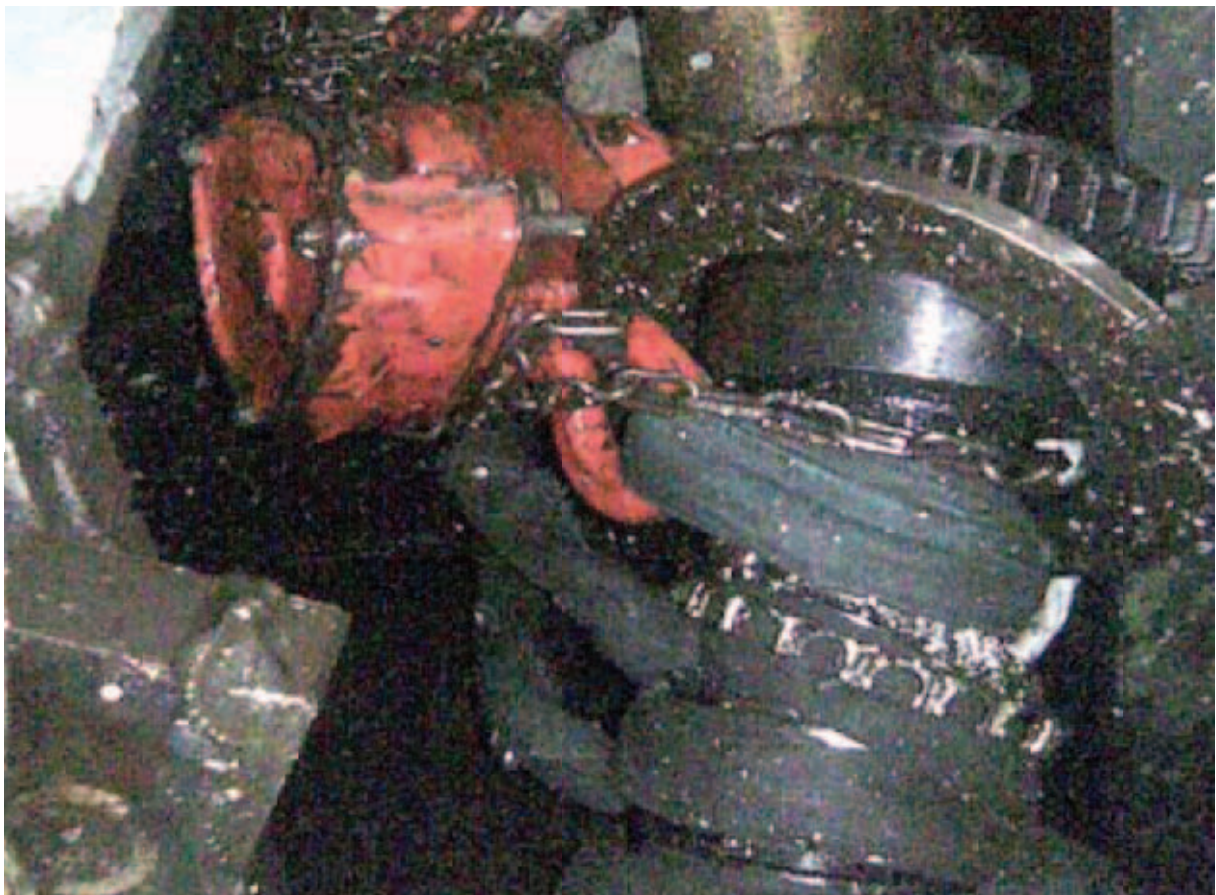
Chain block

A chain block (see figure) and sling that the contractor was using were found to have wrapped themselves around the shaft as the port engine started. This in turn stopped the shaft while the clutch and gear box were still running, and caused damage to the clutch, gearbox, shaft guard and associated wiring and piping in the immediate vicinity.

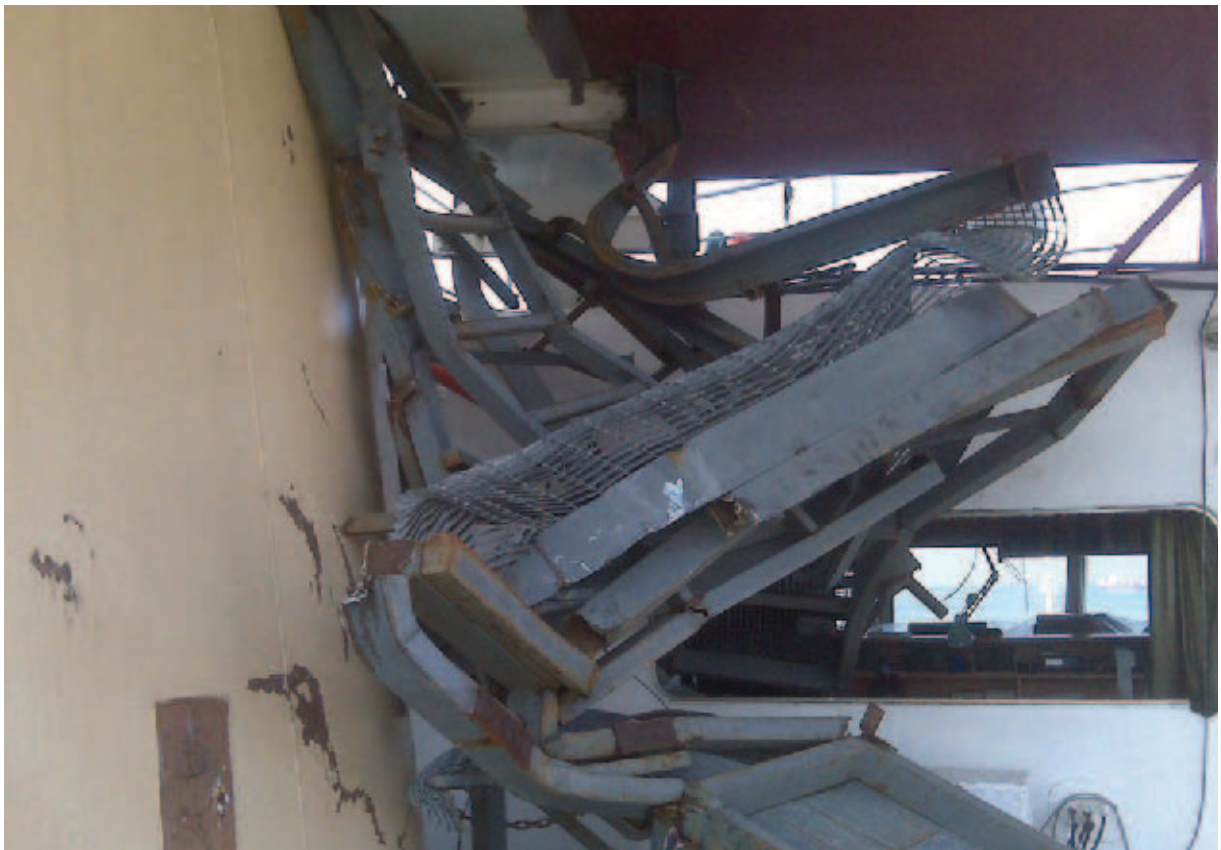
Figure 2: Damage to the container gantry jib

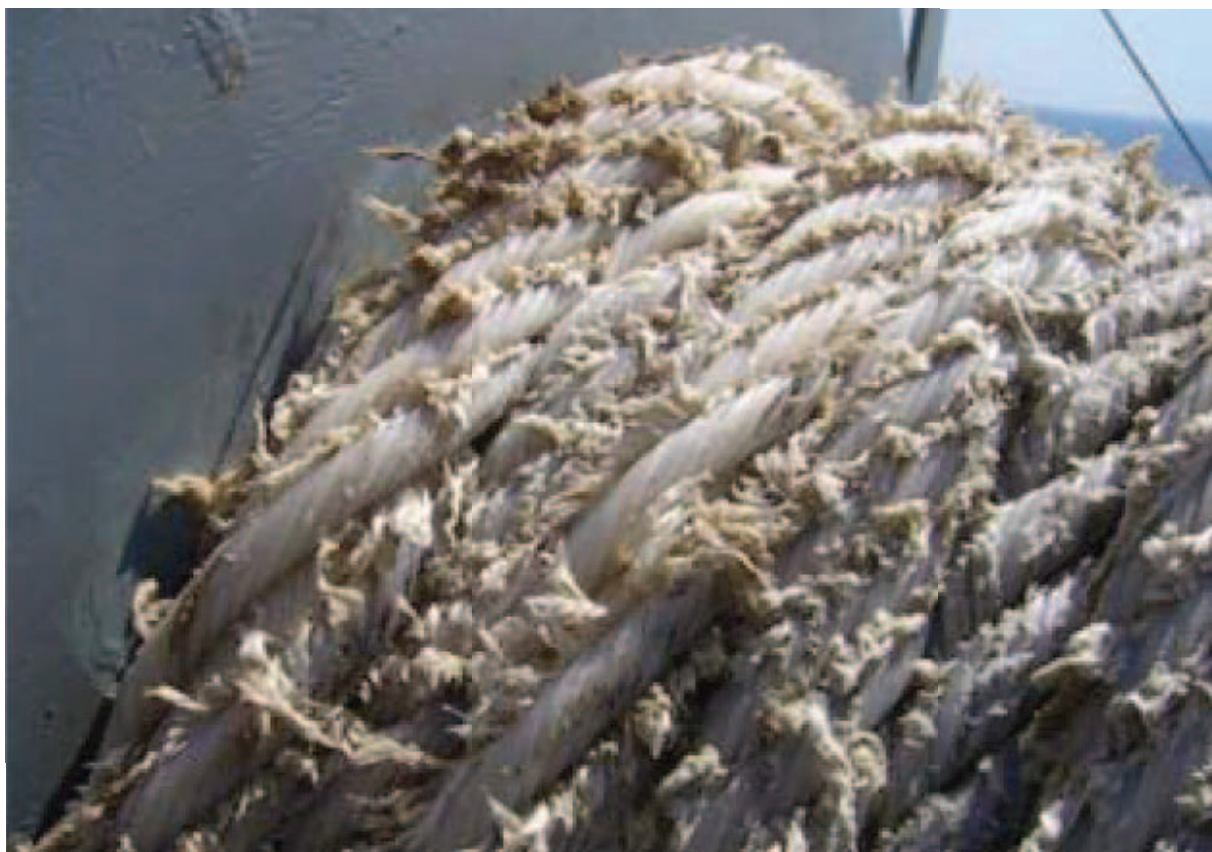
Figure 3: The mooring lines were in poor condition

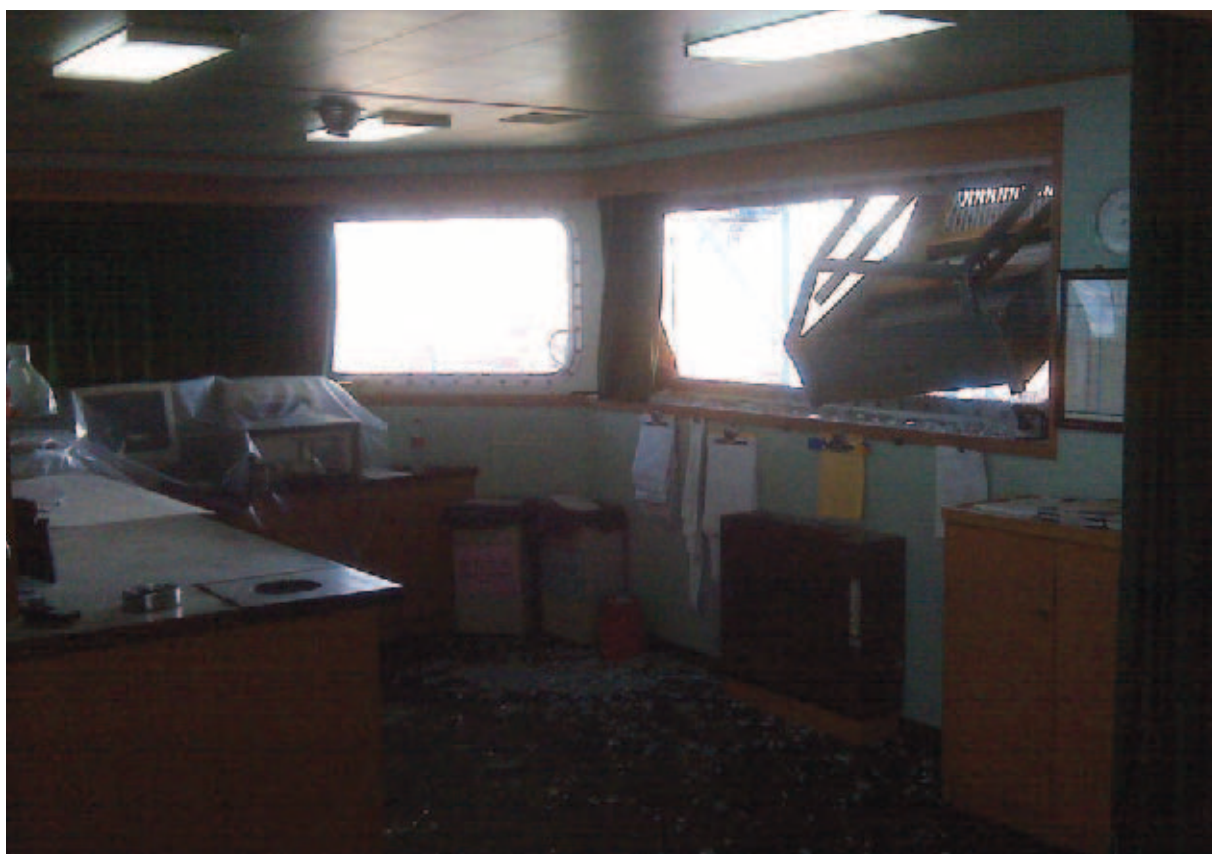
Figure 4: Damage to the bridge of the container vessel

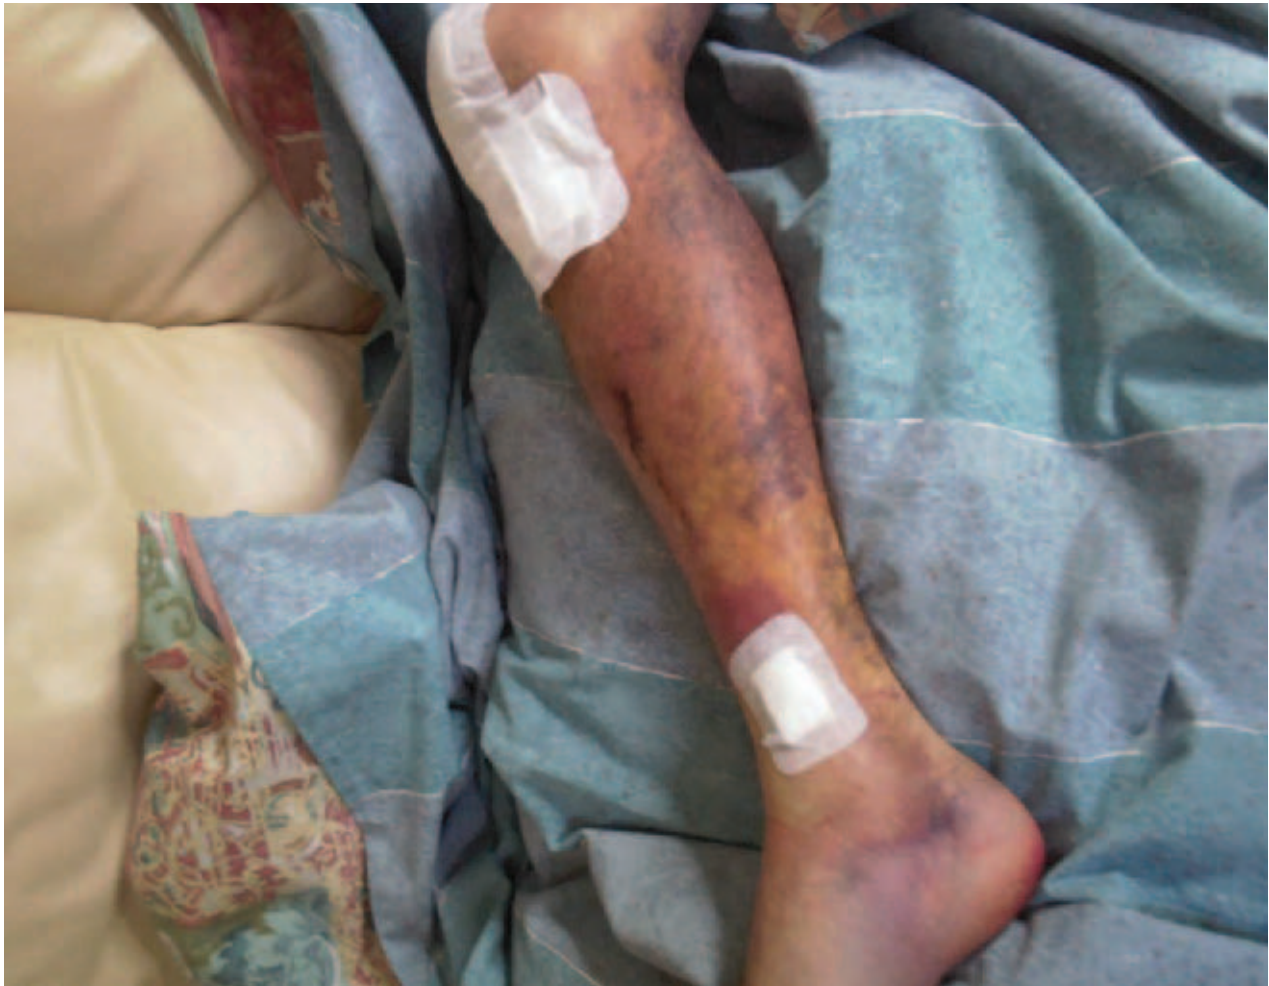
Figure 2: The skipper's injured leg
