**Lessons from Marine
Accident Reports
2/2010**

SAFETY DIGEST
Lessons from Marine Accidents
No 2/2010

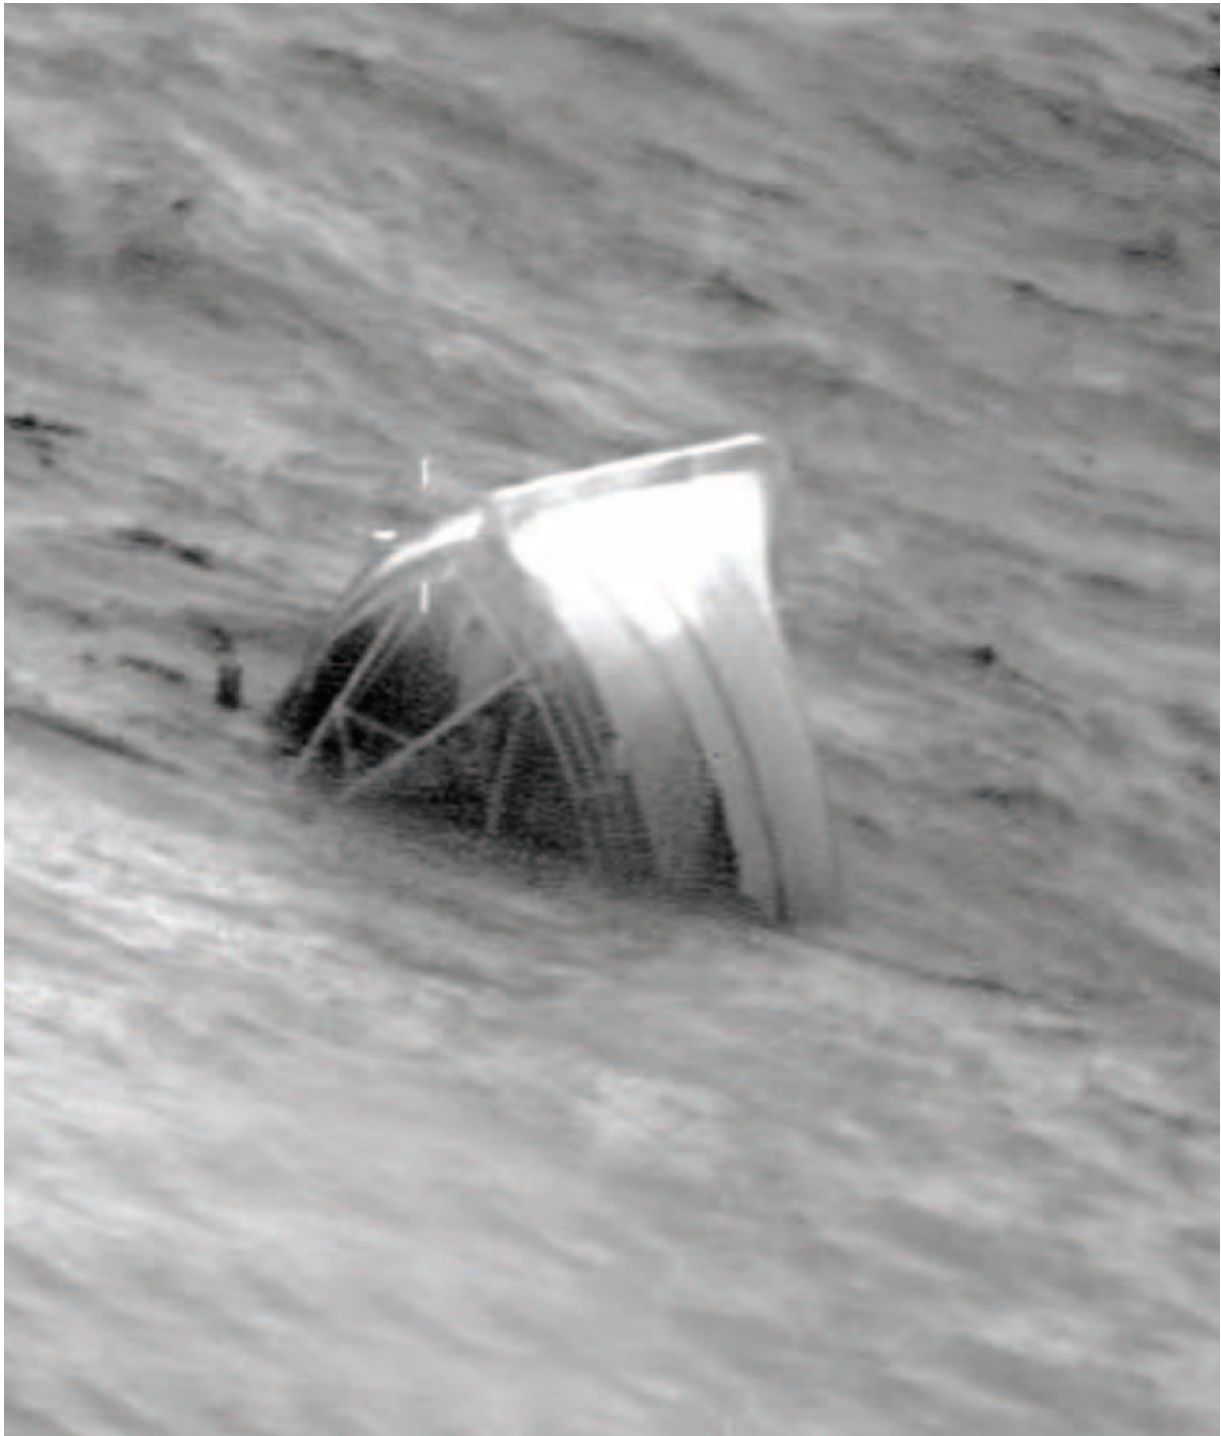
The flooding continued to increase, spreading to the cabin, and when the lub oil low pressure alarm sounded they decided to stop the engine, still hopeful that the vessel might be saved once salvage pumps arrived in a coastguard helicopter. With water up to the engine top, the skipper and engineer noticed an apparent ingress through hull planking in way of the starboard fuel tanks. Generator power was lost not long afterwards, and with only their portable pump running, they abandoned, about 3 hours after discovering the flooding. All five crew were later safely airlifted ashore. Around 10 minutes after abandoning the vessel, she capsized to starboard and then sank by her stern.

Figure 1: Vessel sinking by the stern
