Fishing 2003 Safety Digest

Marine Accident Investigation Branch

This *Safety Digest* draws the attention of the marine community to some of thelessons arising from investigations into ecent accidents. It contains facts which have been determined up to the time of issue.

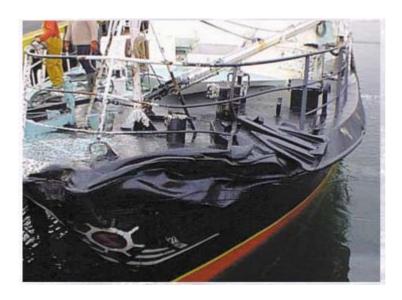
The fishing vessel collided with the shipsport bow at about 0429 causing a 6m gashin the No 1(port) tank, followed by lesserimpacts amidships and in the vicinity of theaccommodation. About 110 tonnes of oilleaked from the ruptured tank into the sea, before the contents of the tank were transferred

A feature of this incident is how late eachwatchkeeper detected the other vessel. Once again it reminds people howimportant it is to keep a very goodlookout, especially at night.
