# Marine Accident Investigation Branch (MAIB) - Safety Digest - Fishing 2001

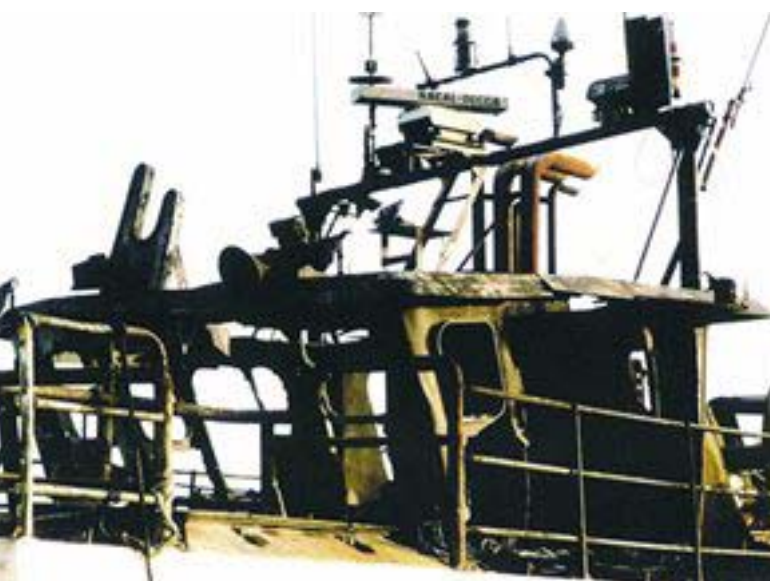
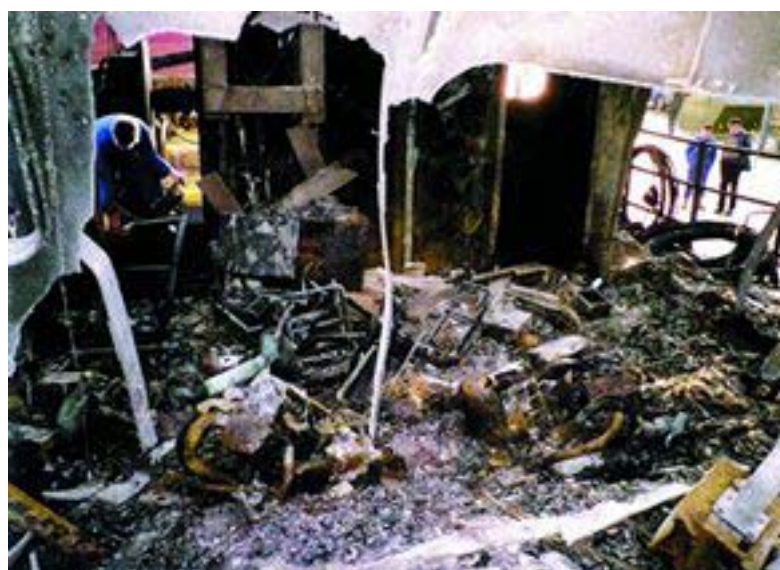
The galley fire is thought to have started due to a combination of a hot heating element on the cooker and items of clothing/drying cloths above or close to the hot plate. Once alight, and fanned by a strong draught from an open window on the starboard side shelter deck, and an open door on the port side, the fire rapidly gained strength and entered the accommodation.

1. When nobody is in the galley ALWAYS close and KEEP CLOSED the galley door. If a fire breaks out, this not only contains the fire within a protected space, but it also gives the crew valuable time to organise what course of action should be taken. Never tie or secure a fire door in the permanently open position. By doing so, you encourage the fire to spread, and then it can become too dangerous to risk closing the door.

2. Always turn off all hotplate elements and cookers after use. Never leave them on in an unattended galley. Leaving them on may save a few minutes in getting up to working temperature but it can also be the cause of a fire, or a bad burn as a result from a moments inattention by a fellow crew member.

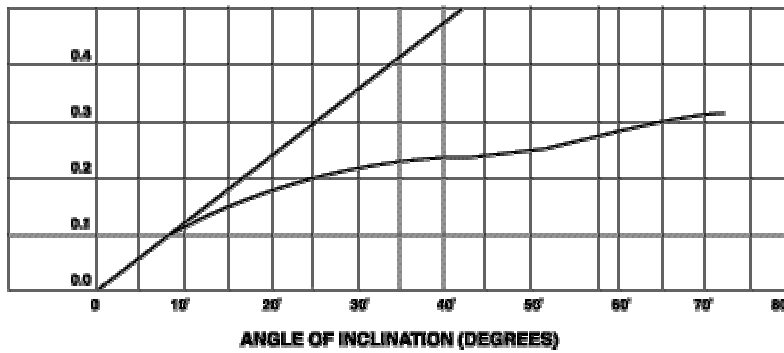
Curve (1) is with derricks horizontal and with weight of beams at their ends. Vessel complied with all stability criteria for twin beam trawlers.

Other beam trawlers might be affected to a similar degree, depending on the weight of their gear and geometry of their derricks. The MAIB has therefore recommended that the Maritime and Coastguard Agency (MCA) makes a study of this effect on operational beam trawlers, with a view to amending stability requirements of this type of vessel.

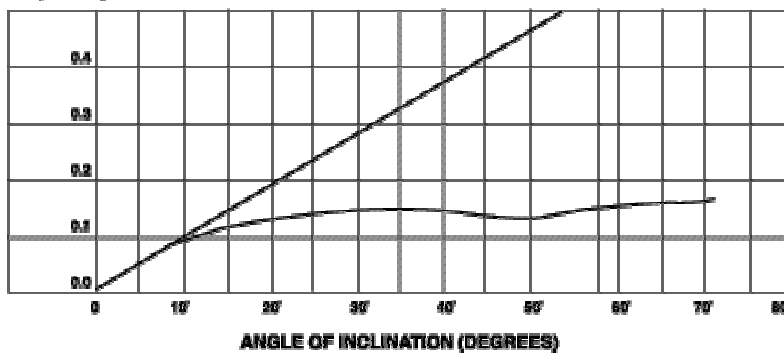
Curve (2) is with derricks 30° above the horizontal with weight of beams at their ends. Vessel did not satisfy four of the six criteria for twin beam trawlers, or the lesser standards of non-beam trawlers.

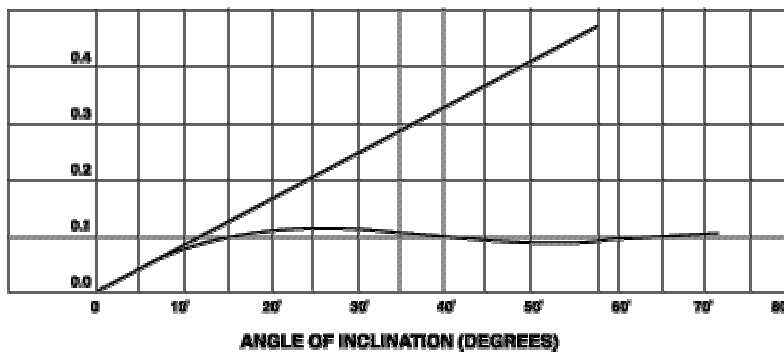
Curve (3) is with derricks 45° above the horizontal with weight of beams at their ends. Vessel did not satisfy four of the six criteria for twin beam trawlers, or the lesser standards of non-beam trawlers.
