# Fishing 2007 Safety Digest

MARINE ACCIDENT INVESTIGATION BRANCH

This *Safety Digest* draws the attention of the marine community to some of the lessons arising from investigations into recent accidents.

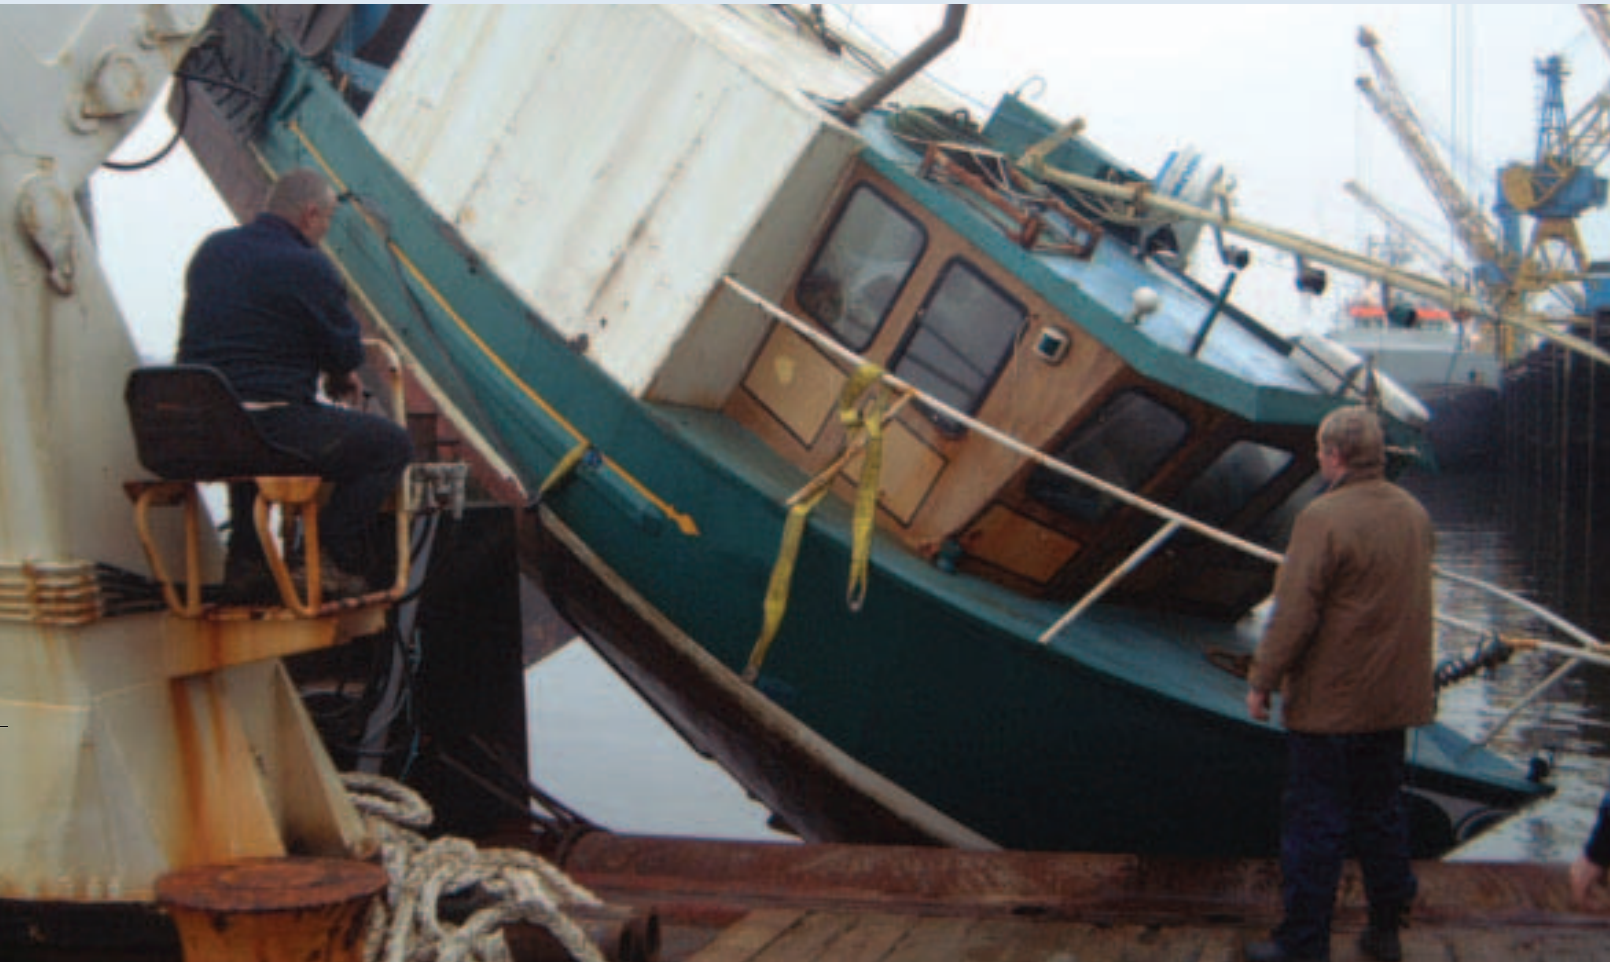
Figure 1: Salvage

Subsequent events included a search for the wreck. The wreck was located, and an underwater survey was carried out, during which the liferaft was found on the seabed and damage to the radar dome noted. The trawler was salvaged (Figure 1) to enable a more detailed structural survey, metallurgical examination of the hull plating and stability tests to be conducted. Neither of the brothers' bodies was found on board.

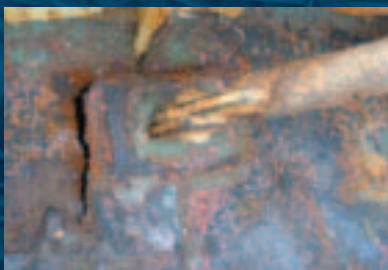
Figure 2: "A" frame supporting frame to deck split

The investigation found the vessel to be in a poor structural condition. There were splits and holes to her upper deck, hull shell plating and steering gear compartment forward watertight bulkhead (Figures 2, 3 and 4). In addition, the rudder stock gland was leaking, the engine room high level bilge alarm float switch had been disconnected, and one of her bilge pumps was not operational.

**2** Structural maintenance is an essential element in ensuring a vessel's watertight integrity. Although expensive, it is of comparatively little cost for a potentially great return: preventing the possible loss of a vessel. Hull repairs should be given the highest priority if downflooding and internal flooding is to be prevented.

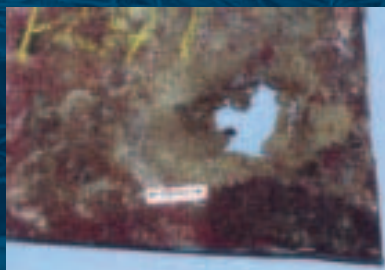
Figure 4: Steering compartment forward bulkhead hole

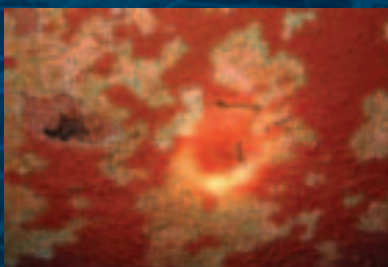
Figure 3: Vee split in hull

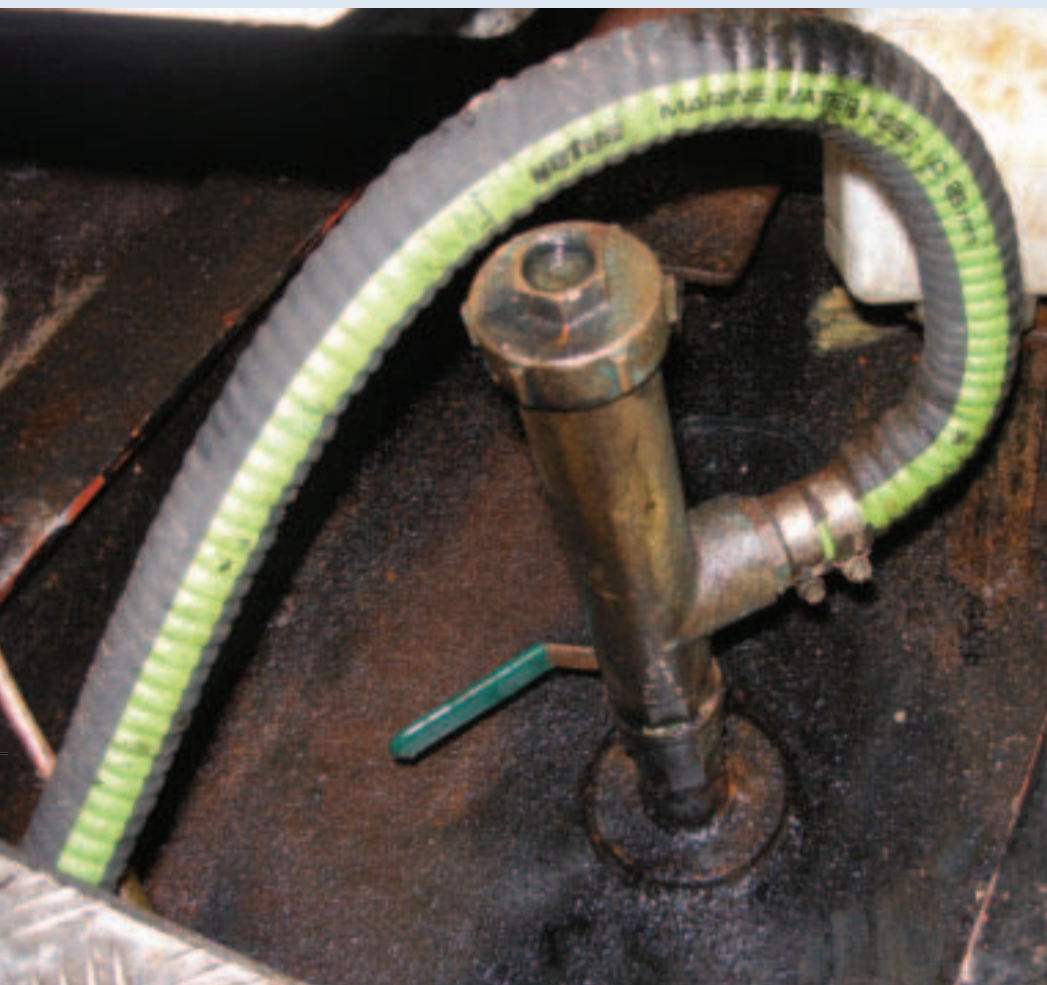
*Similar sea water inlet before accident*

- 4** Fittings are greatly weakened by threading; sea inlets of the stub pipe and flange type have been found to be superior. They are best positioned where they are not convenient to be stood on, and the supporting of associated pipework reduces leverage and vibration.

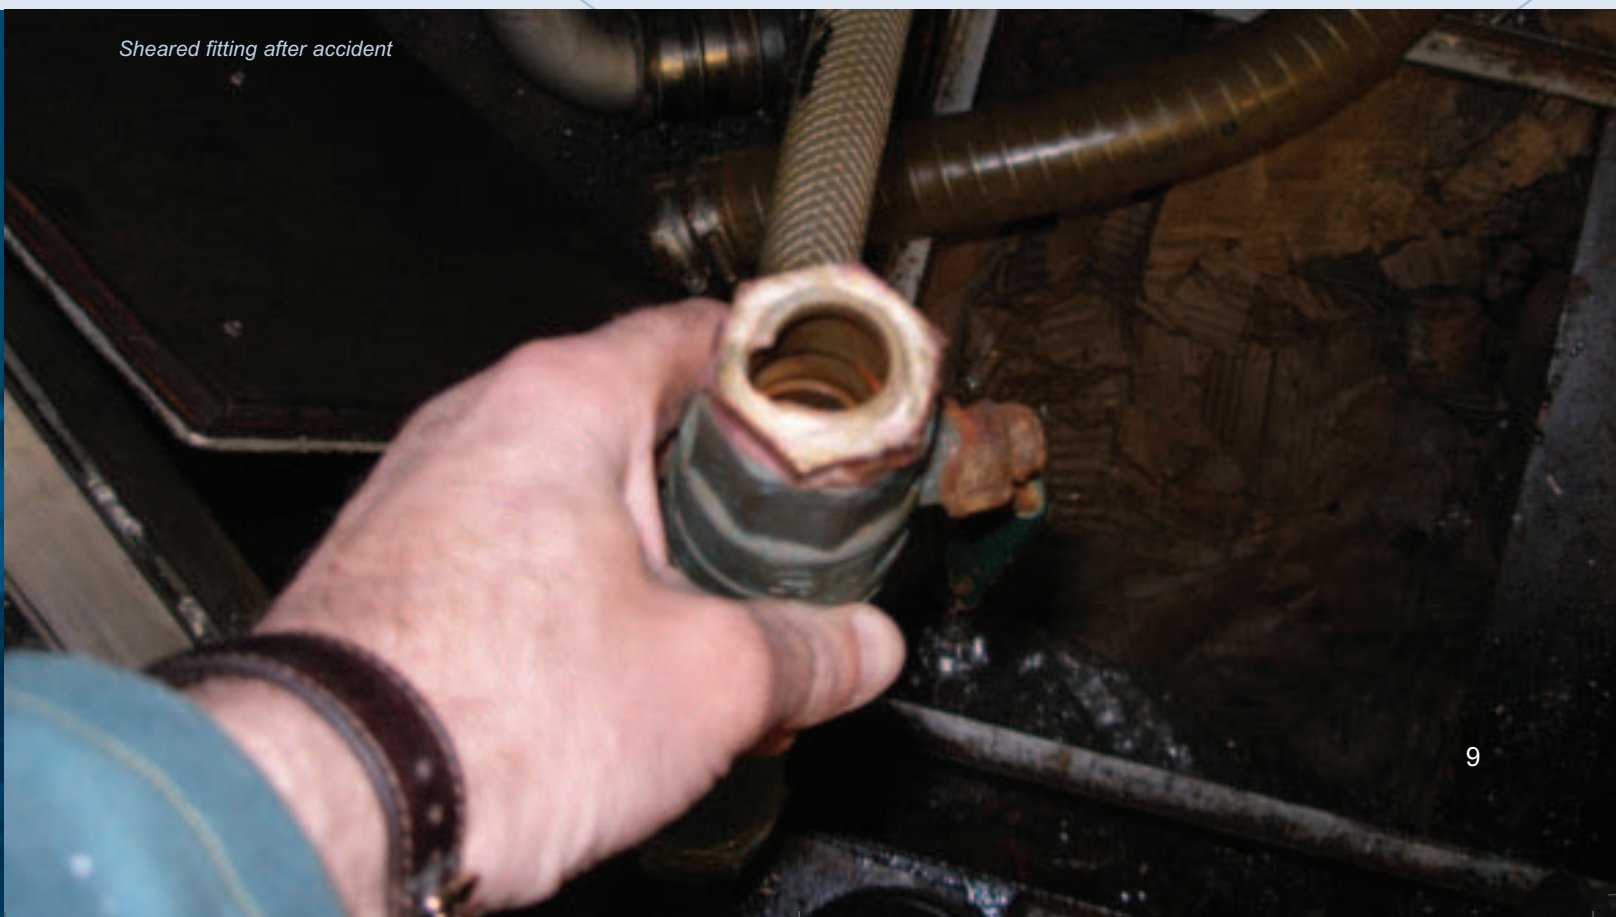
the boat with a salvage pump. As much water as possible was removed from her engine room, and a search was carried out for the cause of ingress. Sea water could be seen welling up through the hull at one point and, upon investigation, the skipper pulled on a sea inlet pipe to find that the sanitary supply line was adrift from the hull at a point below the shut off valve. The skipper probed in the water with a broom handle and could see that at times he was reducing the surge. He shaped the end of the handle into a plug and, after locating the ingress point, drove the broom handle into the sheared inlet hole, thus preventing further ingress. The vessel was

The vessel sustained no damage to her hull when she beached, but she did suffer serious water damage to machinery and electrics. Subsequent inspection showed various contributory factors to the flooding: the sheared sea inlet was threaded into a pad on the boat's side; the inlet fitting was unduly long and set at a convenient height for standing on; the vessel did not have non-return valves in her overboard discharges; no bilge alarm was fitted; holes were bored in the watertight toilet deck into the engine room to assist drainage when cleaning.

*Sheared fitting after accident*

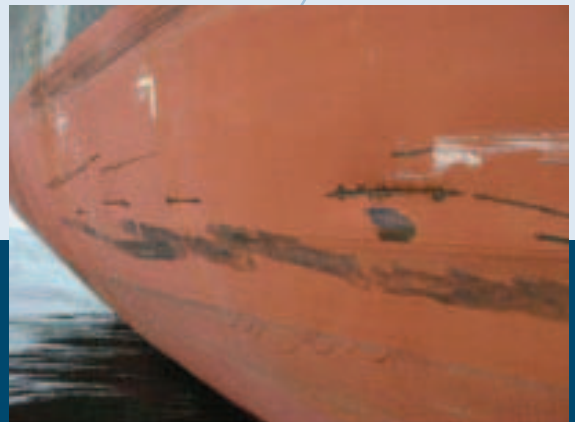
When the crew mustered for work about 3 hours after the collision, the skipper was informed of the call made by the coastguard. He immediately turned on the deck working lights and saw that a davit arm was damaged. As this meant the vessel was unable to fish, the skipper decided to return to harbour. Fortunately, the damage to neither vessel was serious (Figures).

*Shell plating damage to ore carrier*

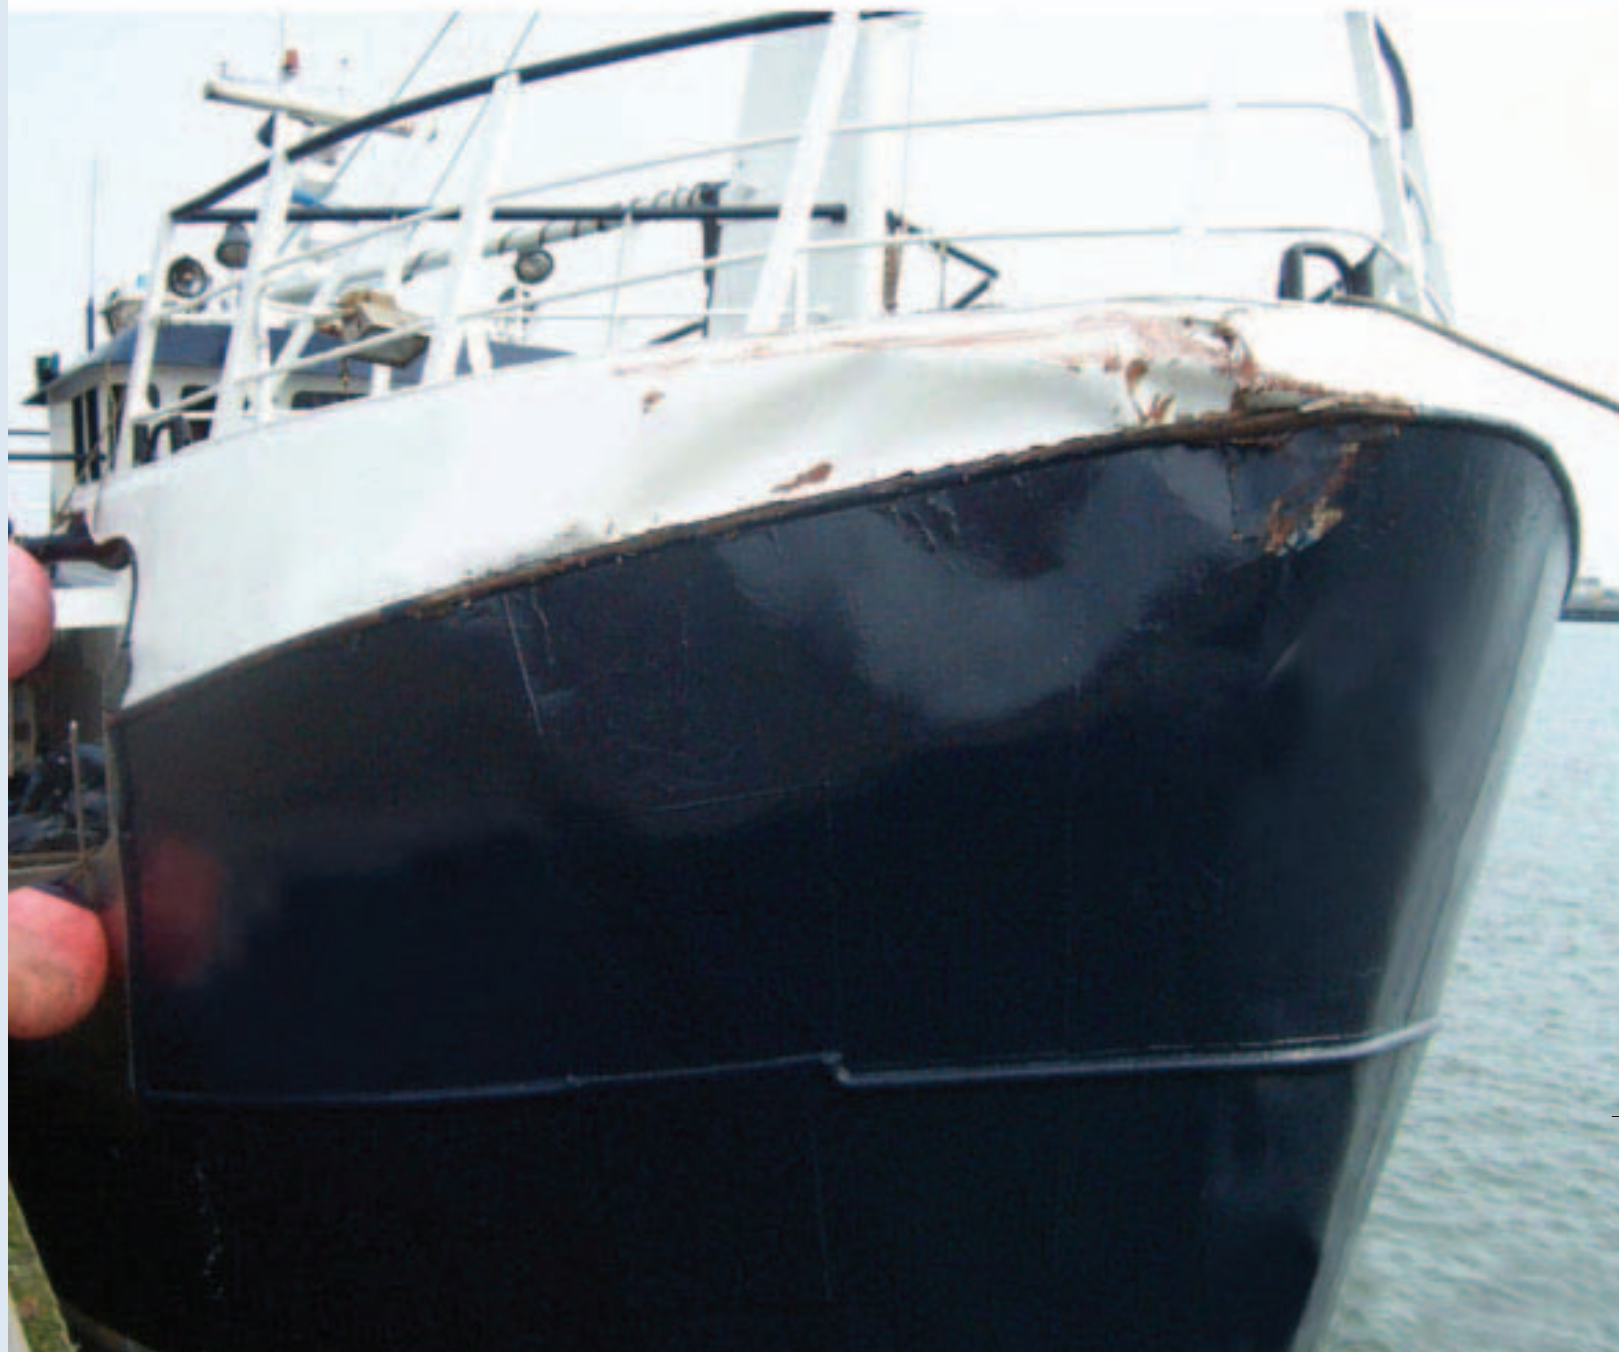
*Damage to fishing vessel*

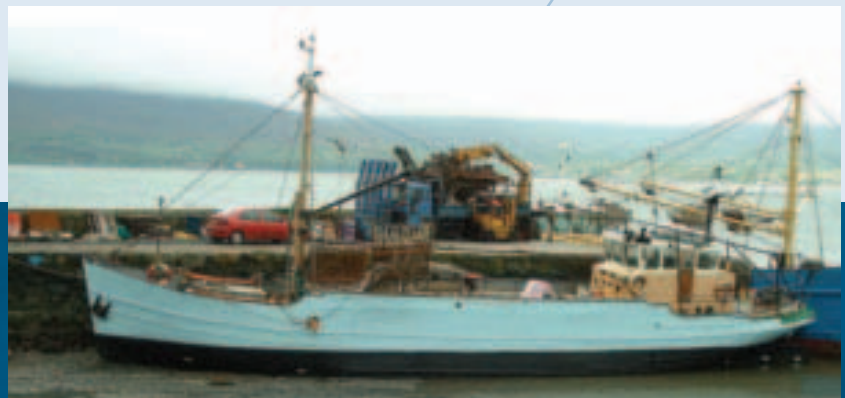
A 26 metre mussel dredger (Figure 1) converted from a Dutch river barge, built in 1908, was flagged into the UK register in 2002 having been inclined and surveyed. An MCA approved stability book was produced, setting out loading conditions, but it was not normal practice to hold it on board. Modifications, which added weight to the vessel, were made following inclining, but the MCA was not notified.

Figure 1:  
General view of the vessel

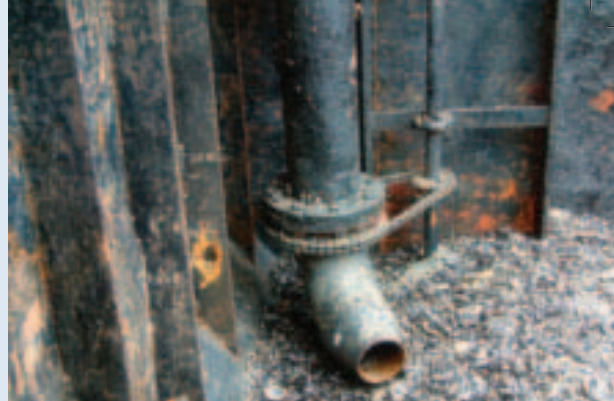
Figure 2: Slusher jet

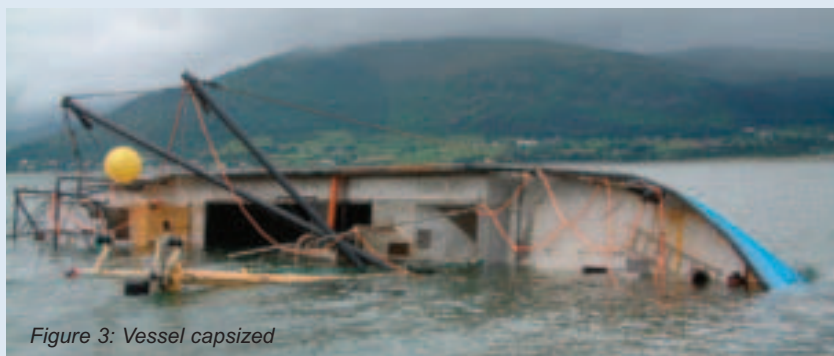
Following remodelling of the stability of the vessel, it was found that the probable cause of capsize was an obstructed seeding hatch. This led to an increase in the water level in the after hold, coupled with free surface in the double bottom and a cargo shift.

Figure 3: Vessel capsized

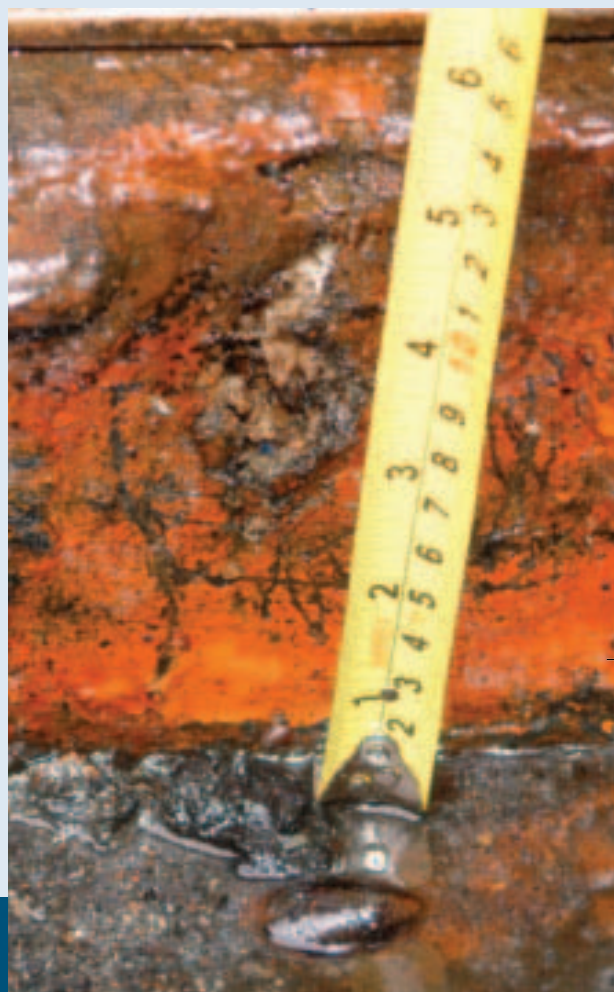
During the accident investigation, it was found that the double bottom “tell tale” pipe isolating valve was blocked. Once cleared, water gushed out, proving that the double bottom was flooded. The cause of ingress was found to be plate corrosion in the after hold bilge suction well (Figure 4). Now this is not a big problem if the double remains pressed full, but the slight drainage into the engine room removed some water, which resulted in a large free surface effect.

Figure 4: Plate corrosion

- 1** It is no use signing the stability book just to satisfy a regulatory requirement. It is a live document which must be carried on board for reference purposes to check that loading conditions are not exceeded. Keeping the book in an office serves no purpose!
- 2** It would be very helpful to skippers if holds were indicated internally with a load line, to ensure that loading is not exceeded. A welded plate could serve such a purpose.
- 3** If water is seen to be leaking from a “tell tale” system it should be investigated without delay. The investigation does not end there: the cause of water ingress must be determined and rectified. Your life could depend on it.
