# Fishing 2006 Safety Digest

MARINE ACCIDENT INVESTIGATION BRANCH

This *Safety Digest* draws the attention of the marine community to some of the lessons arising from investigations into recent accidents.

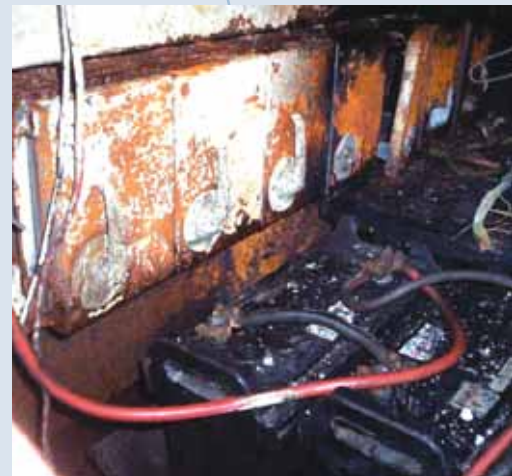
*Damaged area above batteries.*

attended. They entered the engine room and found no signs of fire, although there were still significant amounts of heat. Damage appeared to be confined to a group of electrical switchboxes just above the battery bank. It was presumed that an electrical fault started the fire.

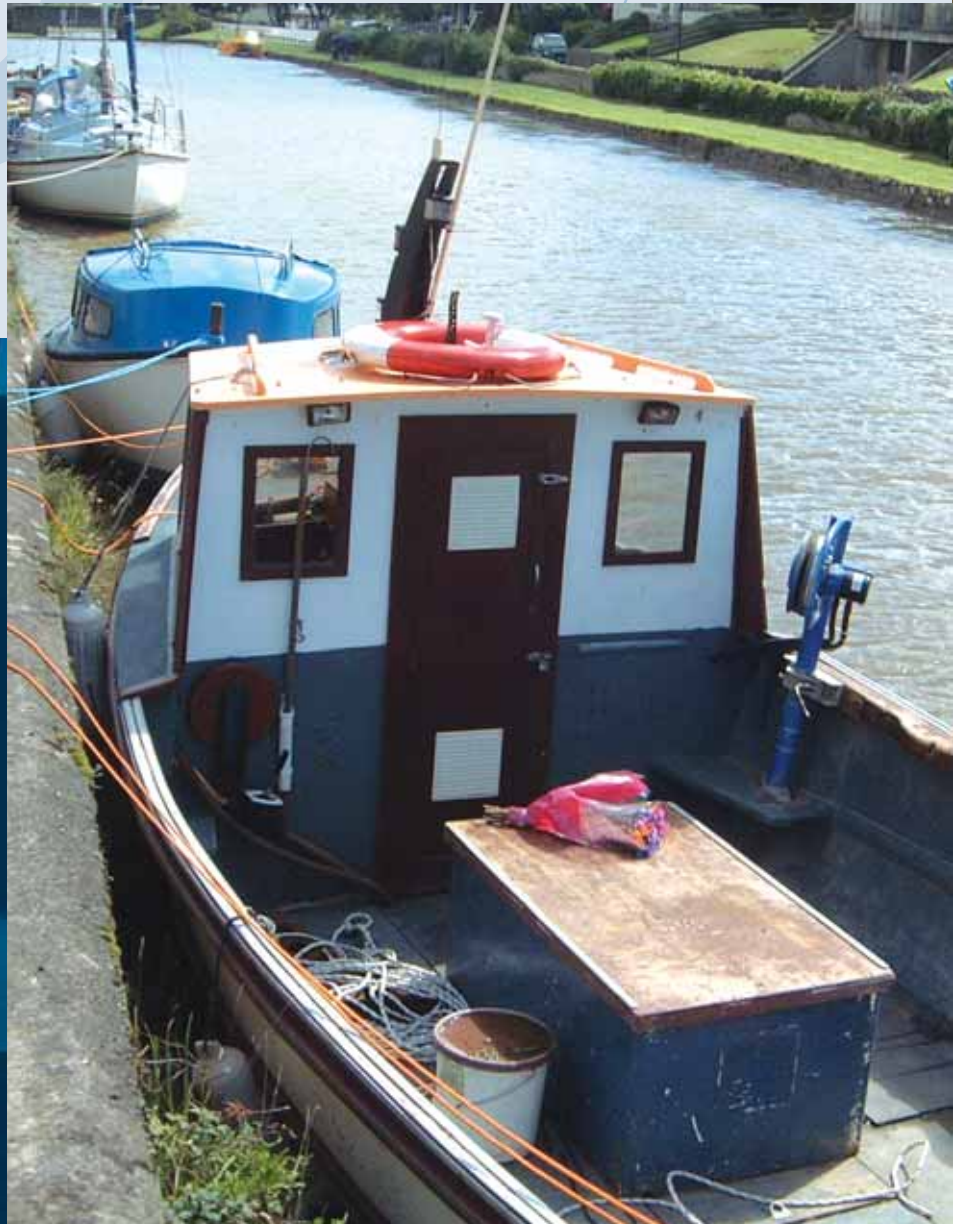
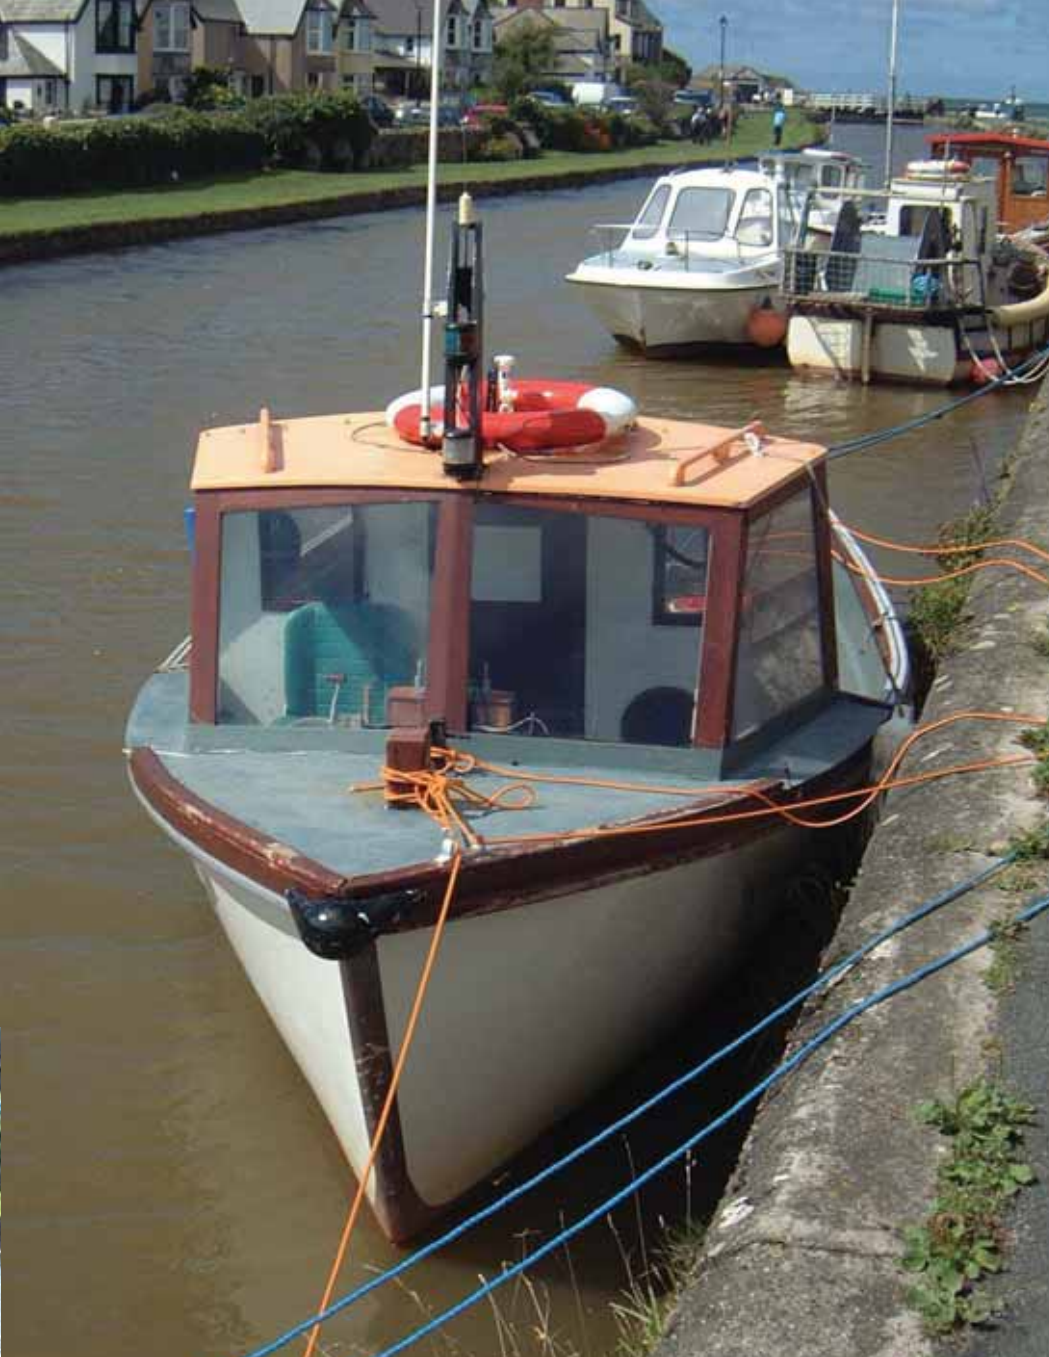
the vessel about 3 months before the accident. The vessel had been fitted with a shooting table, which prevented the back rope coming into contact with the crew when the gear was shot. However, for ease of single-handed operation, the skipper had removed it: a fatal decision.

*General views of the vessel.*

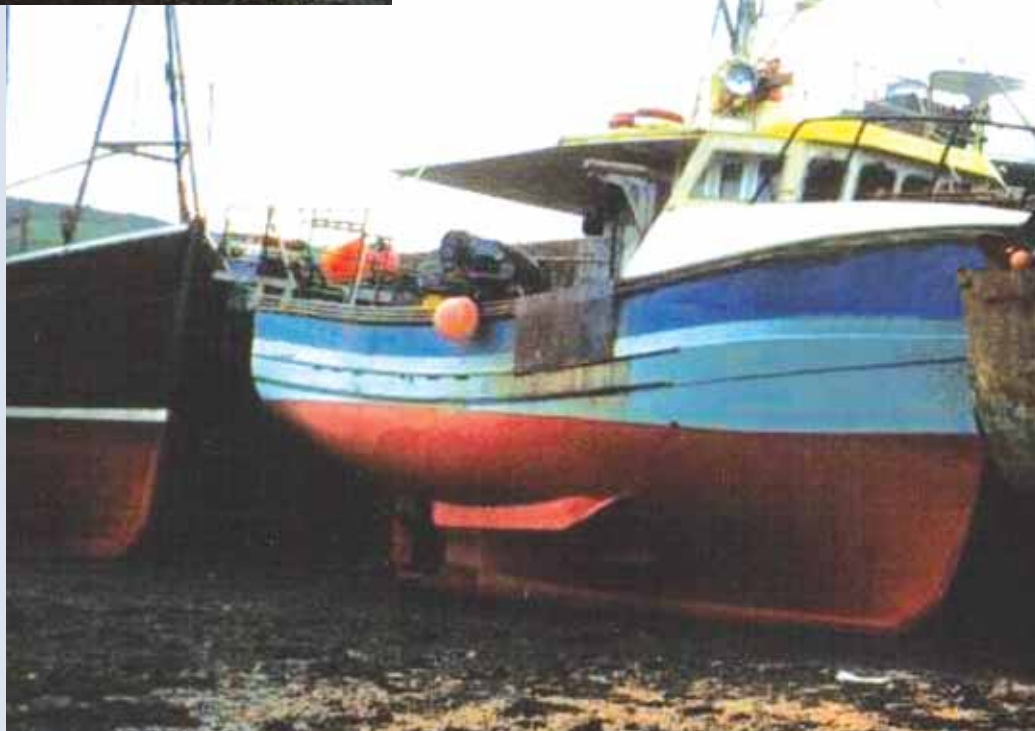
The exact reason for the boat sinking has not been established. However, the number of electrically isolated through hull metal fittings suggests that undetected corrosion of one of these, eventually caused a failure of the fitting and the subsequent loss of the boat.

**1** The boat was well supplied with sacrificial anodes, the bolts of one passing through the hull. The earthing straps from the pipework systems were connected to it, providing electrical continuity and therefore protecting these systems from galvanic corrosion. There were no earthing straps connected to the redundant sea cocks, and therefore no electrical connection between them and the sacrificial anodes. It is possible that one of the sea cocks became corroded due to galvanic action. It failed, allowing unrestricted flooding of the boat. To avoid areas of severe galvanic corrosion, redundant hull fittings on GRP hulls should, ideally, be removed and appropriate repairs made to the GRP. Where this is not possible, care should be taken to ensure that any redundant hull fittings retain electrical continuity.

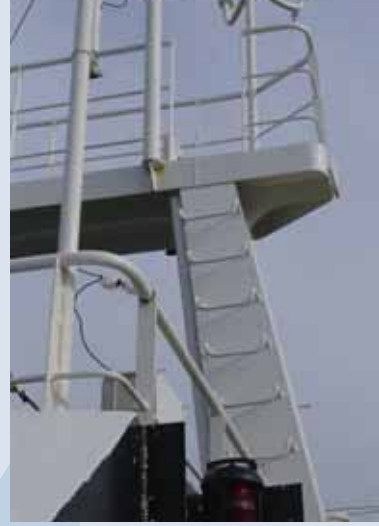
Figure 3 (above): Port side of the platform.

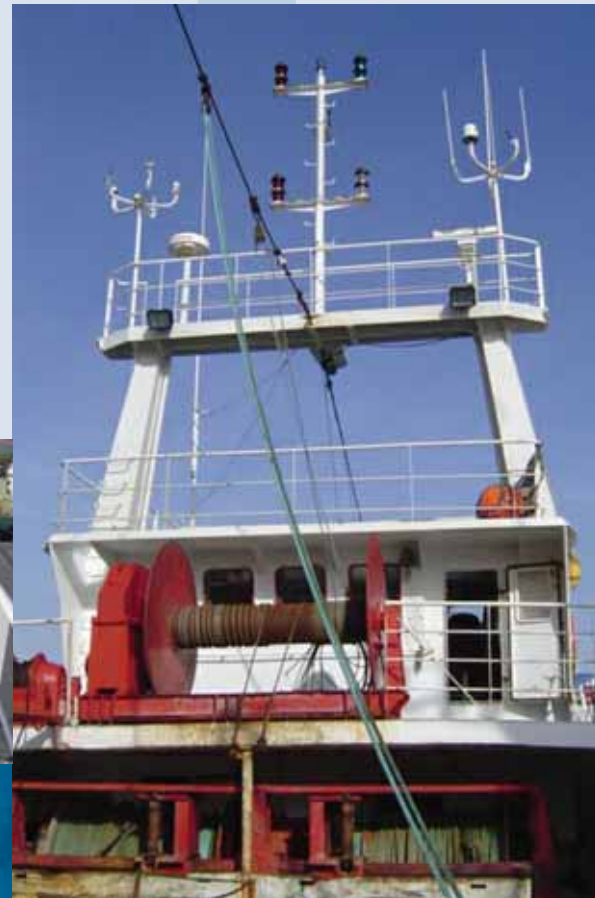
Figure 1 (right): General view from stern.

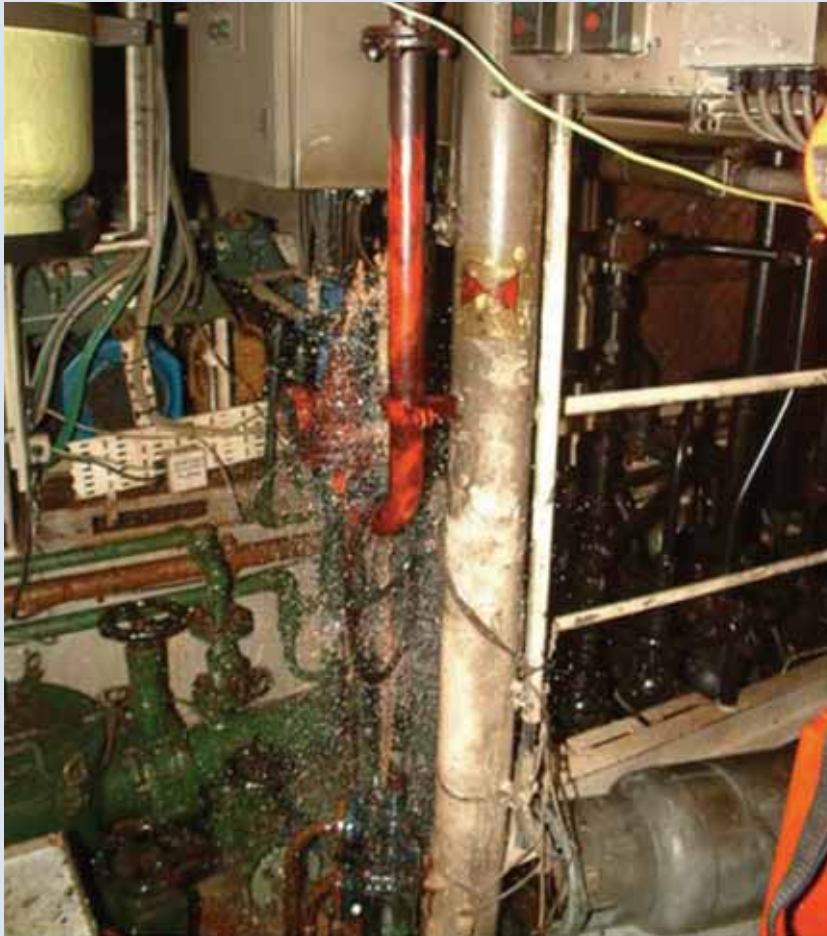
*Replicated fuel leakage from main engine duplex fuel filters.*

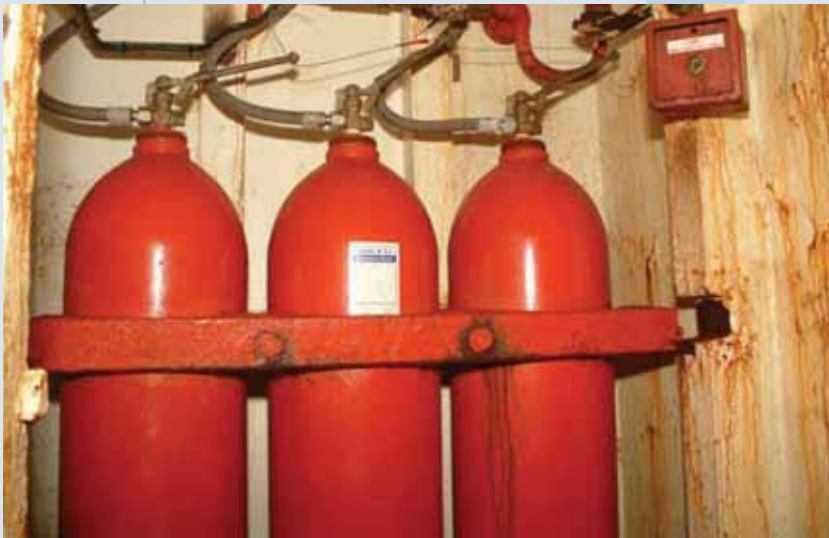
CO<sub>2</sub> bottle and operating arrangement.

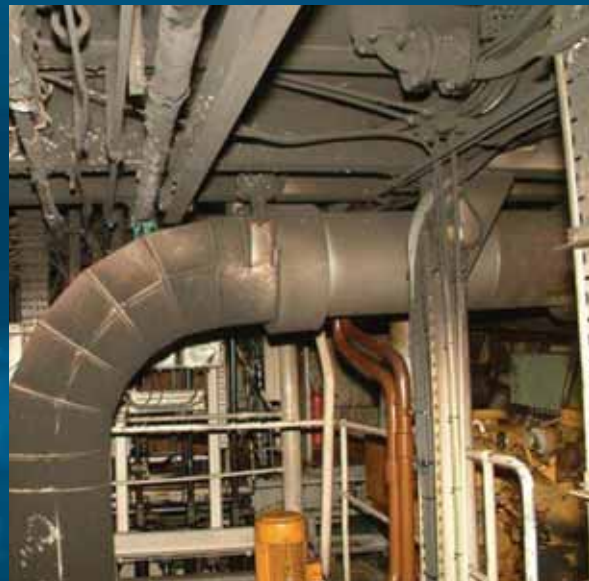
General smoke damage.

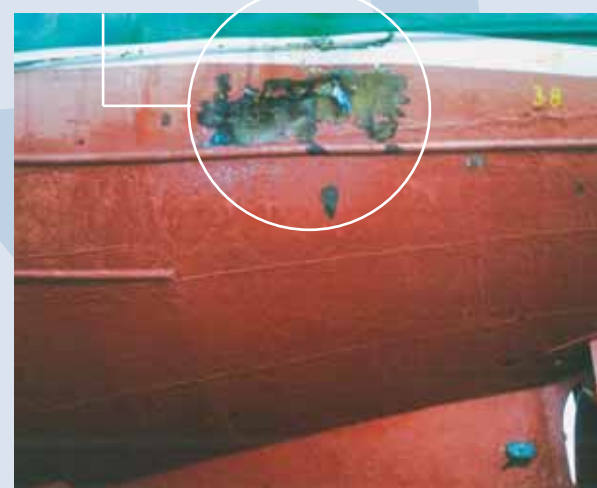
Damage to hull plating.

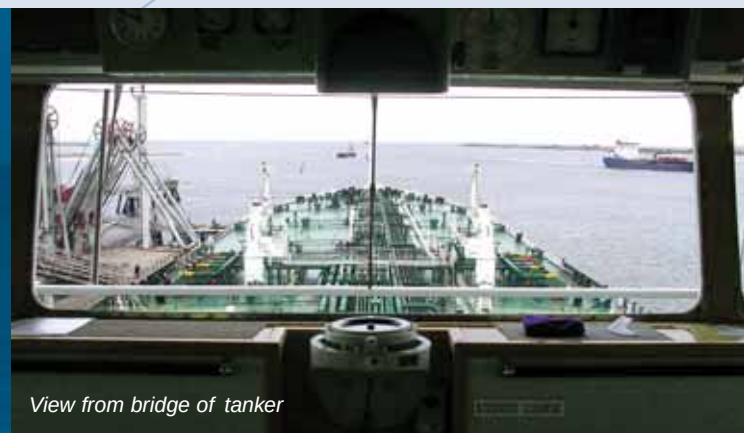
*View from bridge of tanker*
