# Fishing 2008 Safety Digest

MARINE ACCIDENT INVESTIGATION BRANCH

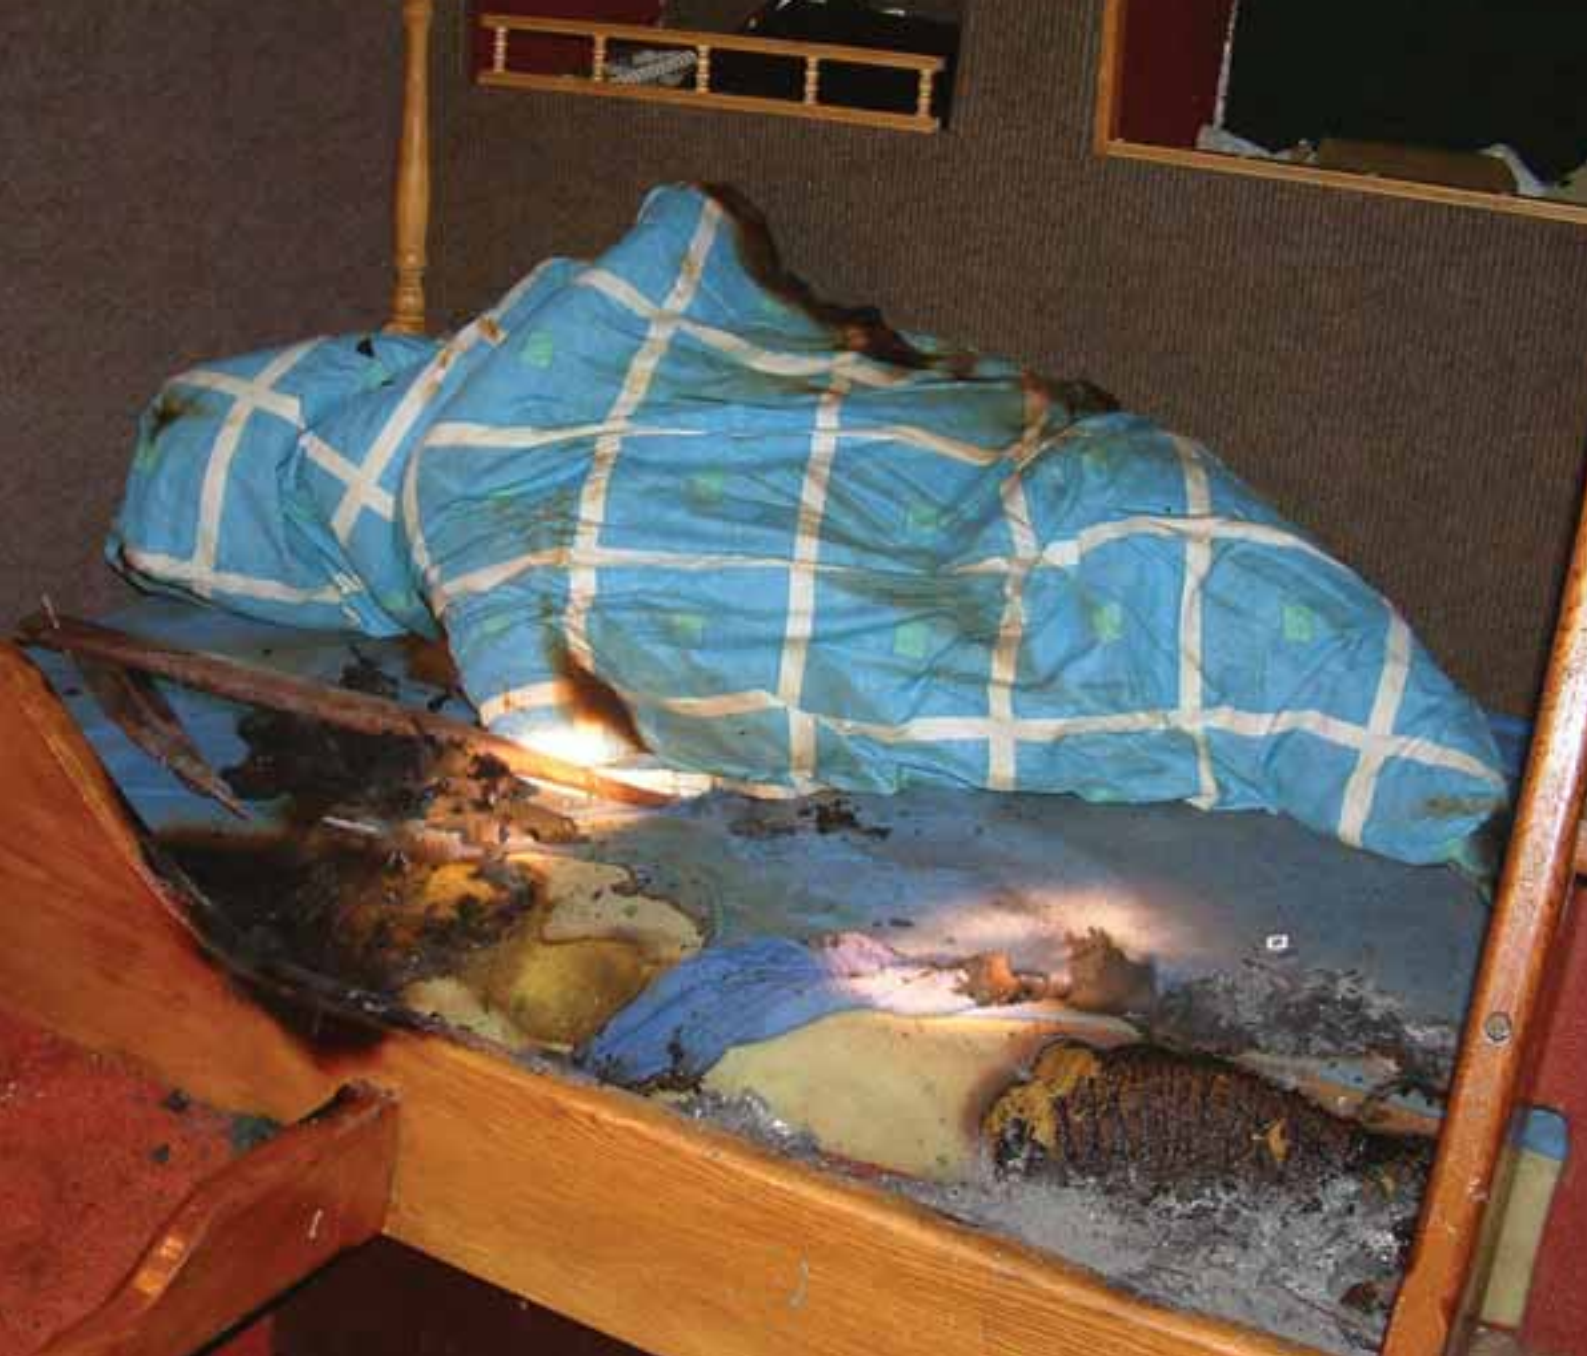
As he smoked, the crewman either fell asleep or became unconscious, and his cigarette started a smouldering fire which burnt a small amount of the bunk's foam mattress and woodwork (see photograph). The crewman died

**1** Neither the owner nor the skipper permitted smoking in the accommodation space, for good reason. However, perhaps due to the influence of alcohol, the crewman forgot this policy and paid the ultimate price.

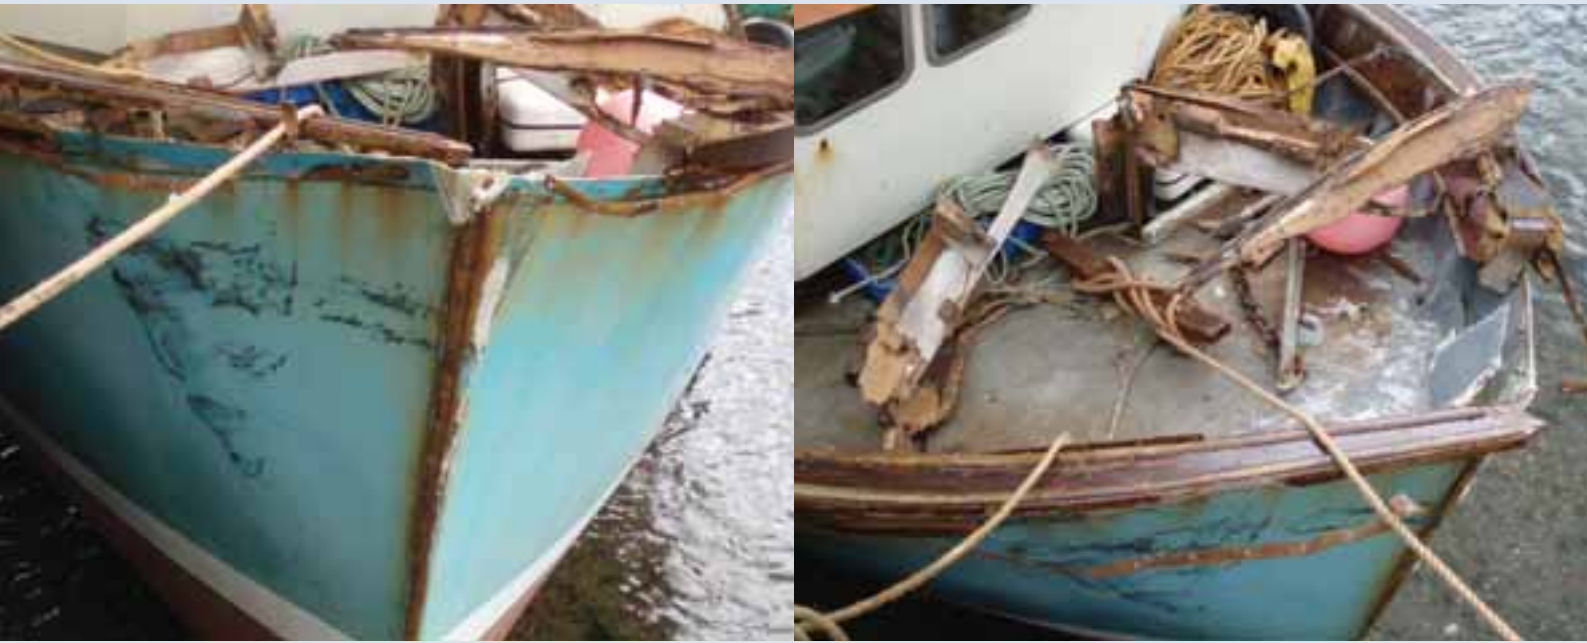
The vessel remained seaworthy, despite damage to its starboard bow (see photograph). The skipper called the coastguard by mobile phone, as power was not initially restored to the VHF; he calmly reported his position, that he had just been in collision with something he had not seen, and that he could see a tug steaming away from the scene. The coastguard then called out the local lifeboat to escort the fishing vessel, under its own power, back to its home port.

*Photographs showing bow damage*

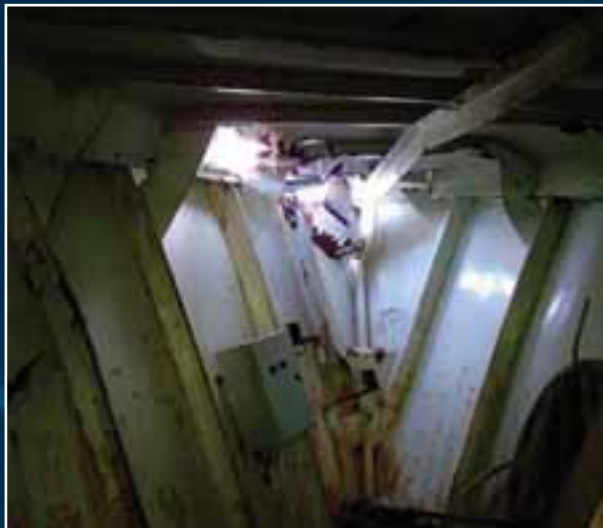
Figure 2: Internal view of bow damage

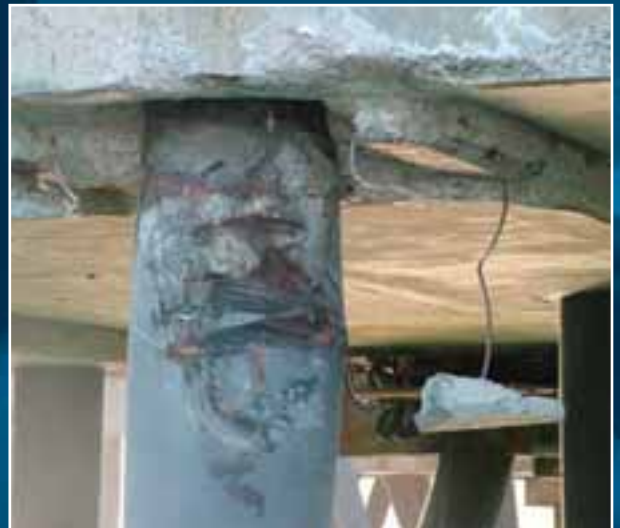
There were no injuries to the crew, and the damage to both vessel and jetty was relatively minor. Fortunately there was no oil tanker alongside the jetty at the time, otherwise the outcome could have been much worse.

Figure 3: Damage to the jetty

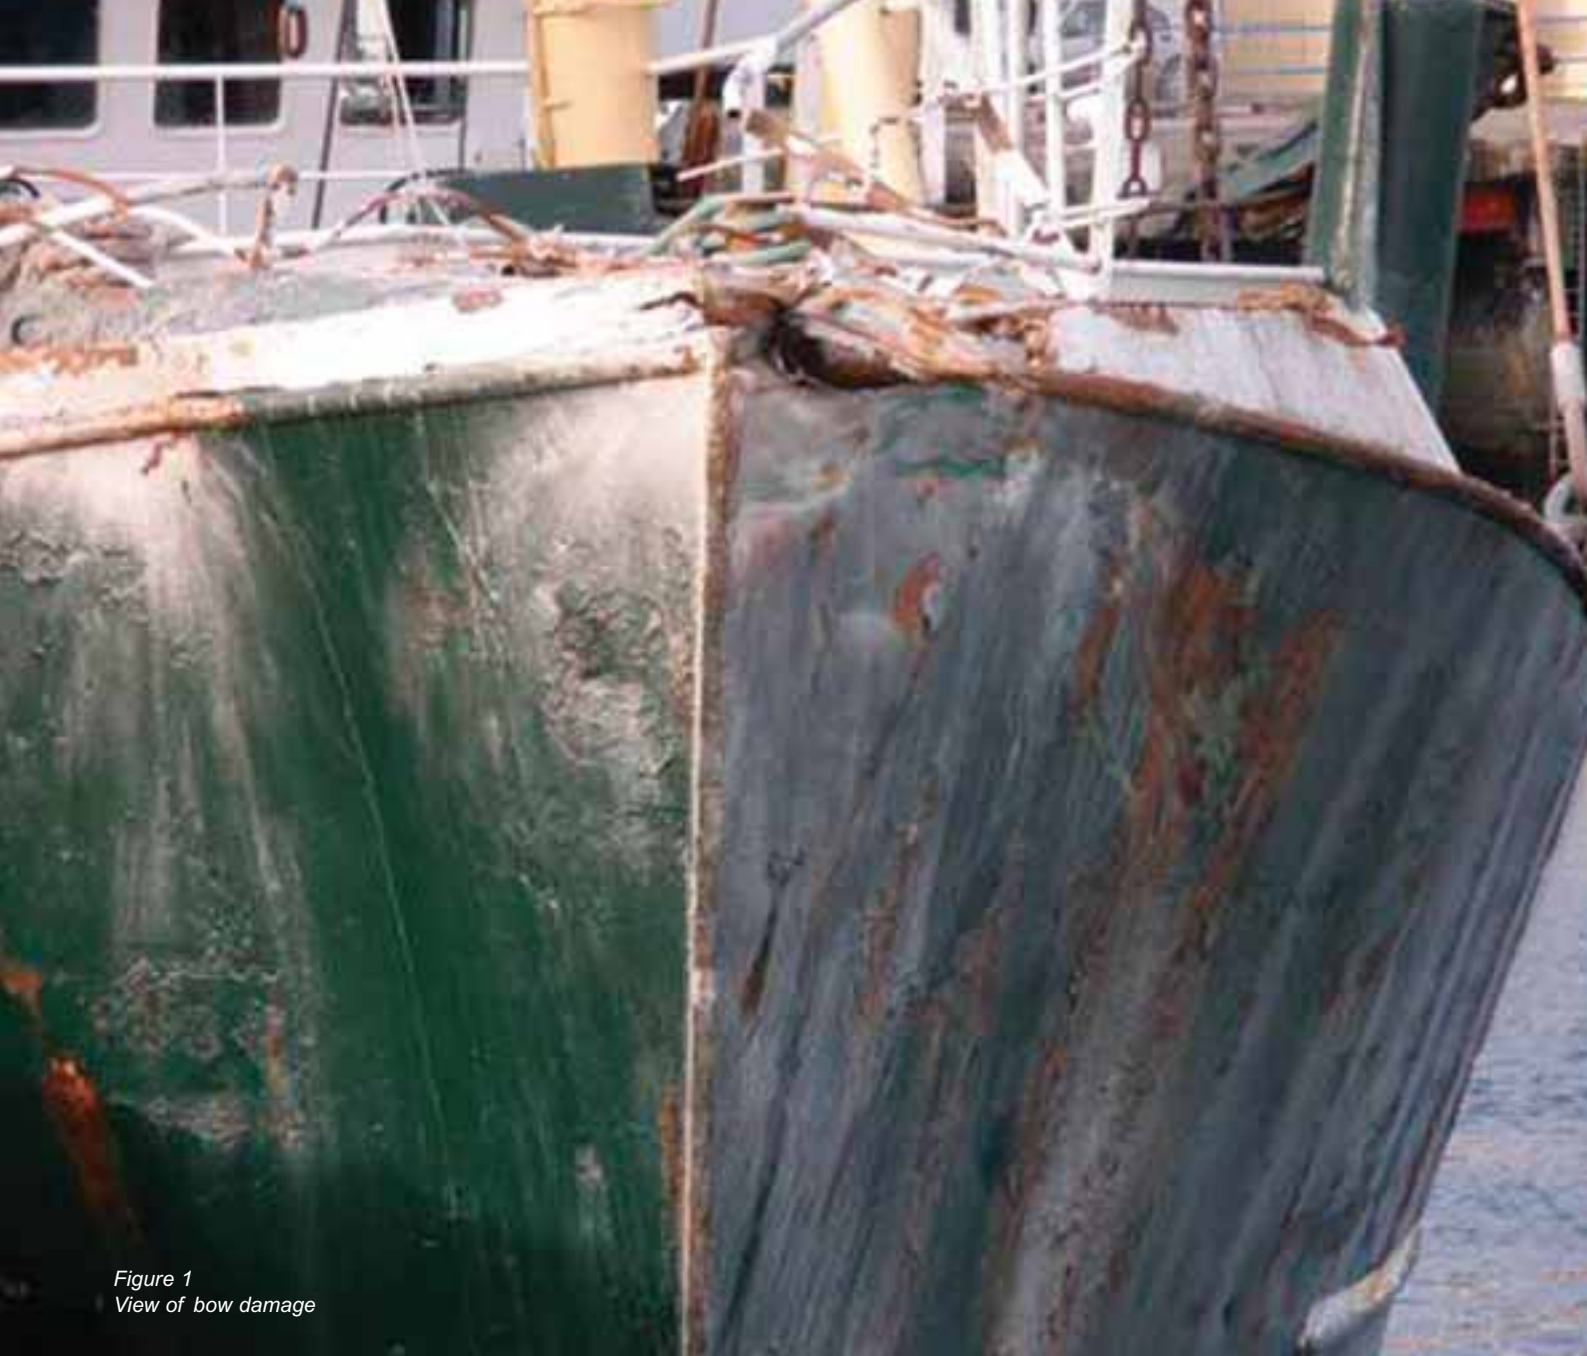
Figure 1  
View of bow damage

The resulting investigation concluded that the accident was caused by impaired judgment of the trawler skipper, probably brought about by alcohol consumption. Although the harbour authorities’ VTS centre played no part in causing the accident, they could have taken action to intervene in an attempt to prevent it.

**3** The vessel was travelling at an unsafe speed in relation to the circumstances and prevailing conditions. When travelling in confined waters close to the shore, a reduced speed gives time to weigh up the situation, make a balanced judgment and react appropriately and, in the worst event, an accident at slow speed will do far less damage than one at high speed.

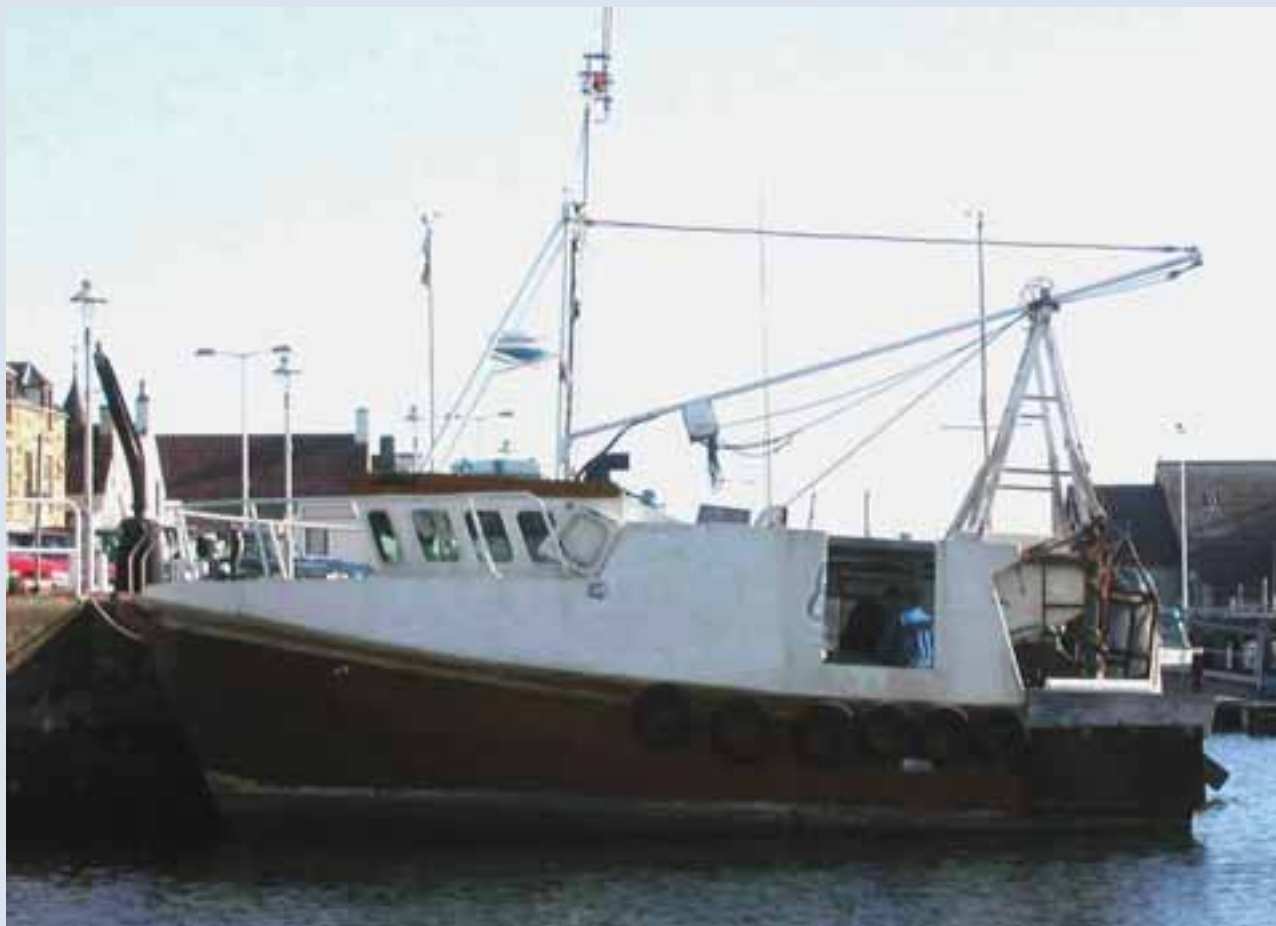
*Photograph showing the vessel's point of suspension for the dog rope and cod end*

**2** The danger of lifting/hauling from high points cannot be ignored on any vessel. Weights suspended from heights seriously compromise stability, as do fish in hoppers above deck level. Operators should take all necessary steps to reduce top weight as much as possible and keep the vessel in a stable condition.

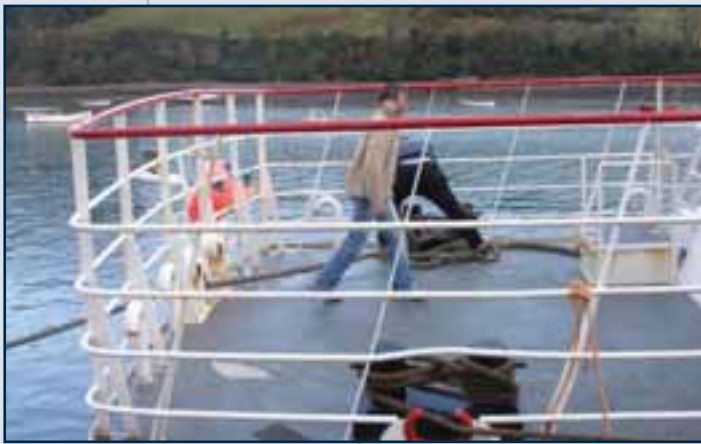
*Photograph of vessel's lifting area and height of rails*

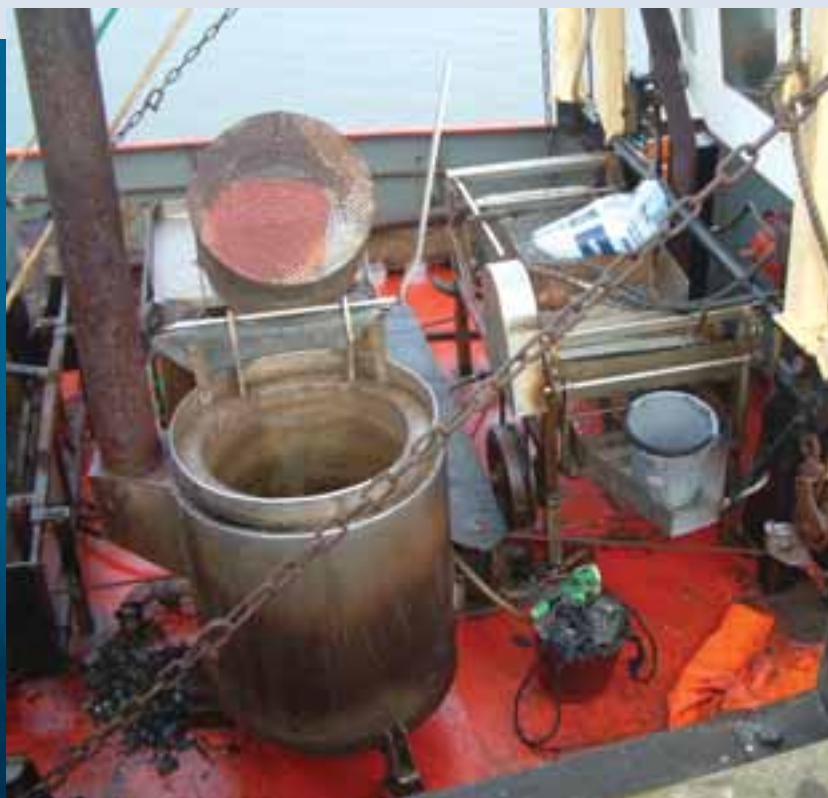
Figure 2: Shrimp boiler after the fire, with melted air supply pipe

**5** Where there is a risk of incorrect start up or shut-down sequences, consider fitting interlocks to prevent maloperation.

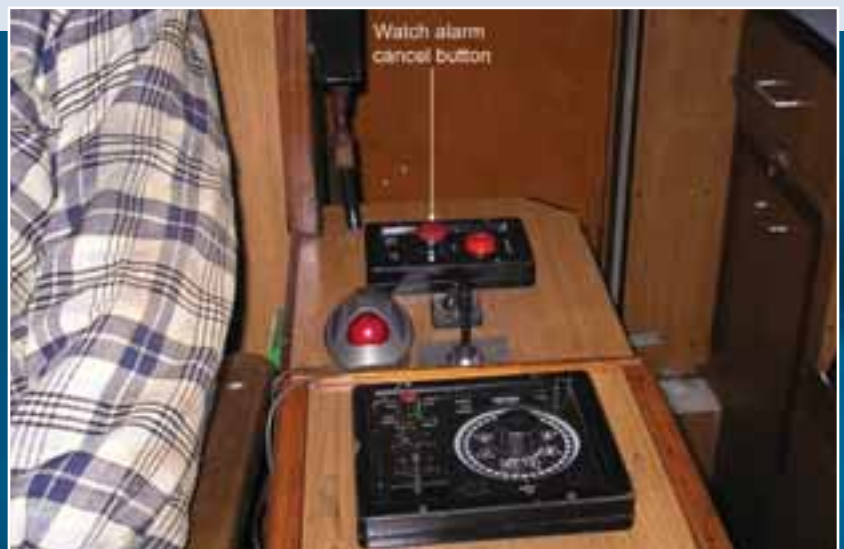
*Figure 1: Vessel's watch alarm cancel button next to the crewman on watch*

**1** The watchkeeper was very tired, and used the watch alarm in the same way as he would use a clock snooze alarm. The positioning of the reset button so close to his chair meant that he did not have to move from his chair to cancel the alarm.

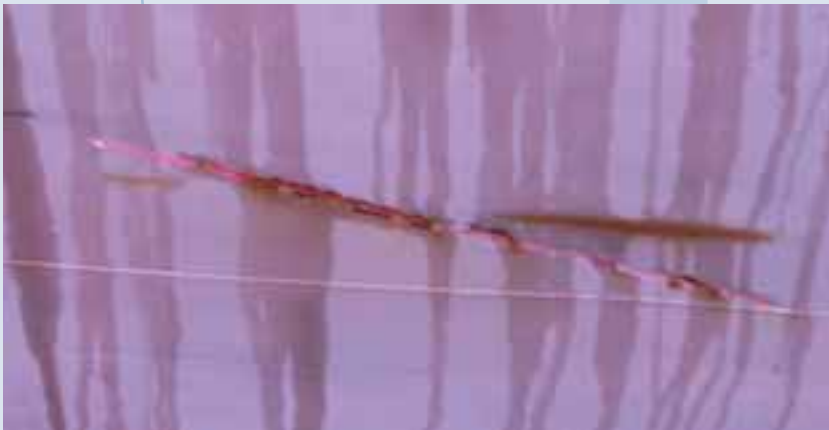
Figure 2: The damage to the tanker's side
