**MAIB**  
MARINE ACCIDENT INVESTIGATION BRANCH

# Safety Digest

**Fishing  
2014g**

Published May 2014

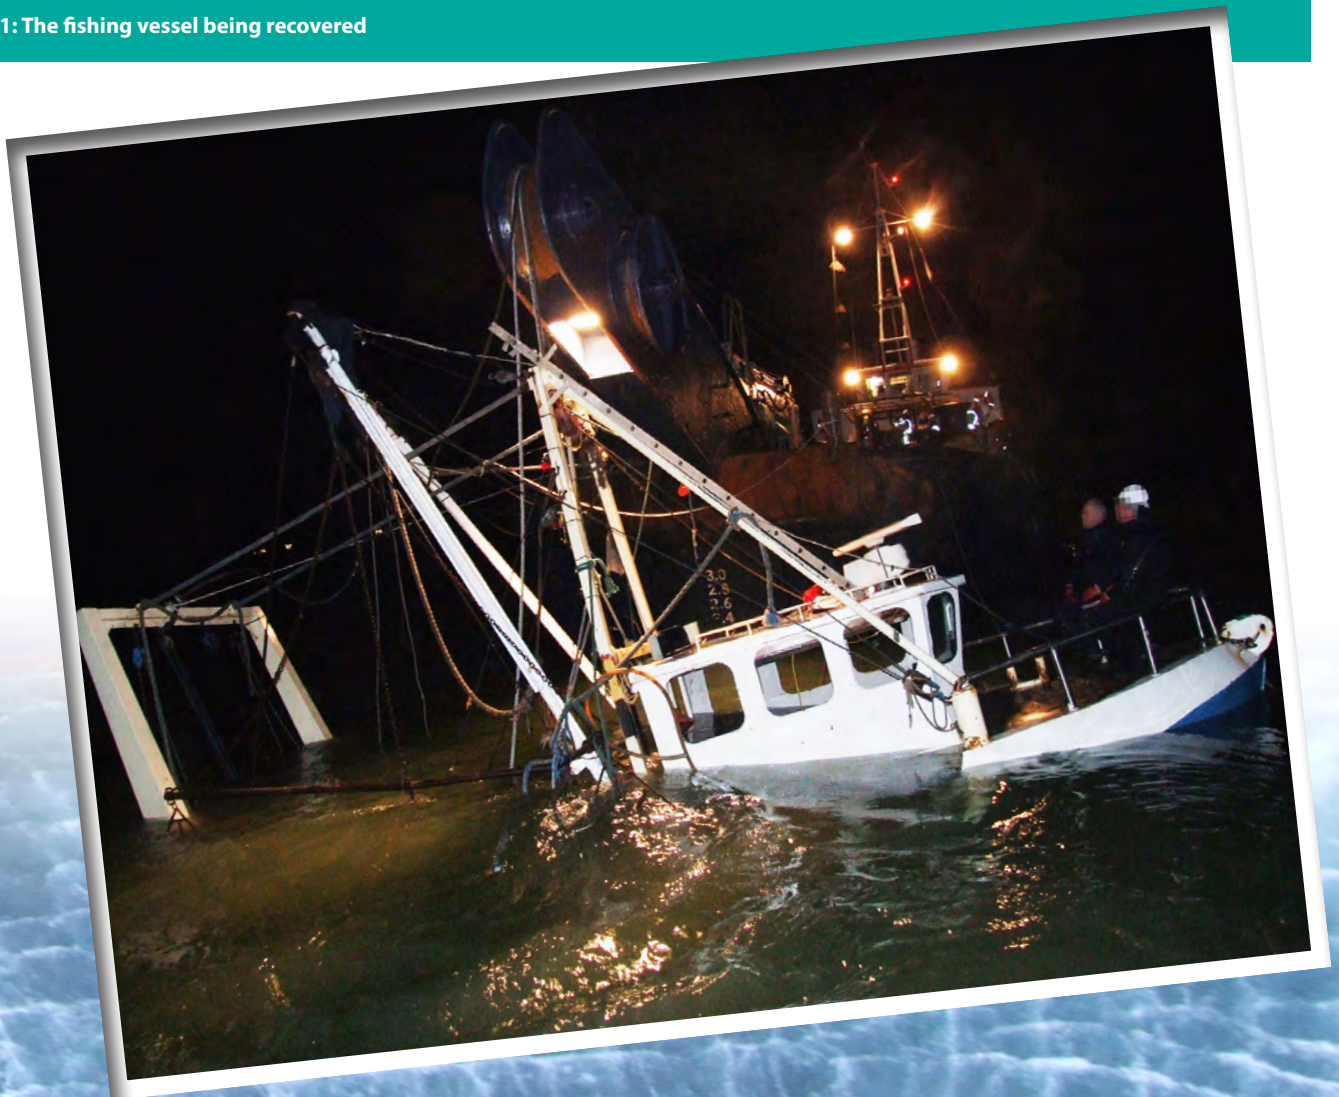
Figure 1: The fishing vessel being recovered

Subsequent examination of the vessel found that the hull was intact, with both of the deck hatches in place and with no obvious source of initial downflooding that might have contributed to the loss. The wheelhouse door was, however, missing and the displacement of some of the wheelhouse windows from their frames, along with the movement of other items on board, suggested that the vessel had most likely been overcome by the seas, and had capsized suddenly.

**3.** Although there is no regulatory requirement for a vessel of this size to carry an EPIRB, liferaft or Digital Selective Calling (DSC) capable VHF radio, all are recommended. None were on board this vessel (there was a VHF, but not DSC), and it is not inconceivable that any or all of these items might have helped identify that she was in difficulty and, indeed perhaps have saved the owner's life.

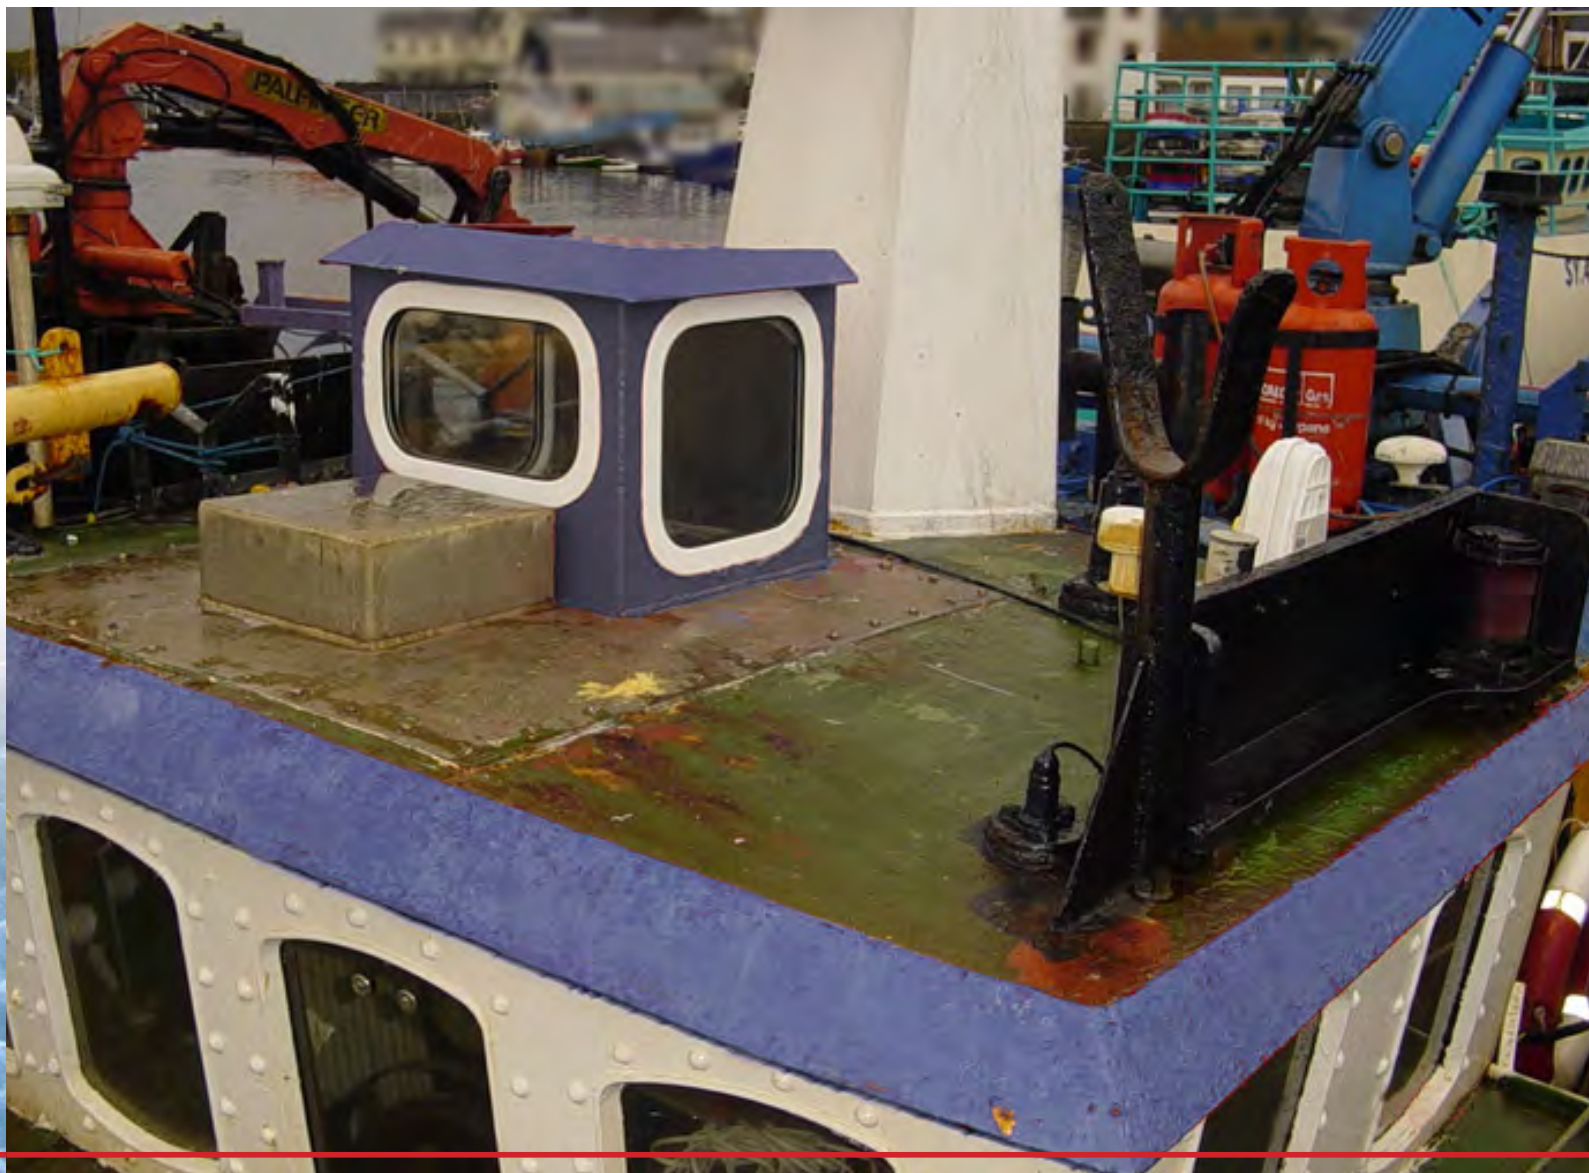
Figure 2: View of the modified wheelhouse

**3.** Poor visibility from the wheelhouse has been a contributory factor in several previous accidents involving fishing vessels. In this case, Boat A had a shelter which, with equipment fitted to the deck, might have obscured her skipper's view of Boat B during his occasional checks. Is the visibility from your wheelhouse good enough?

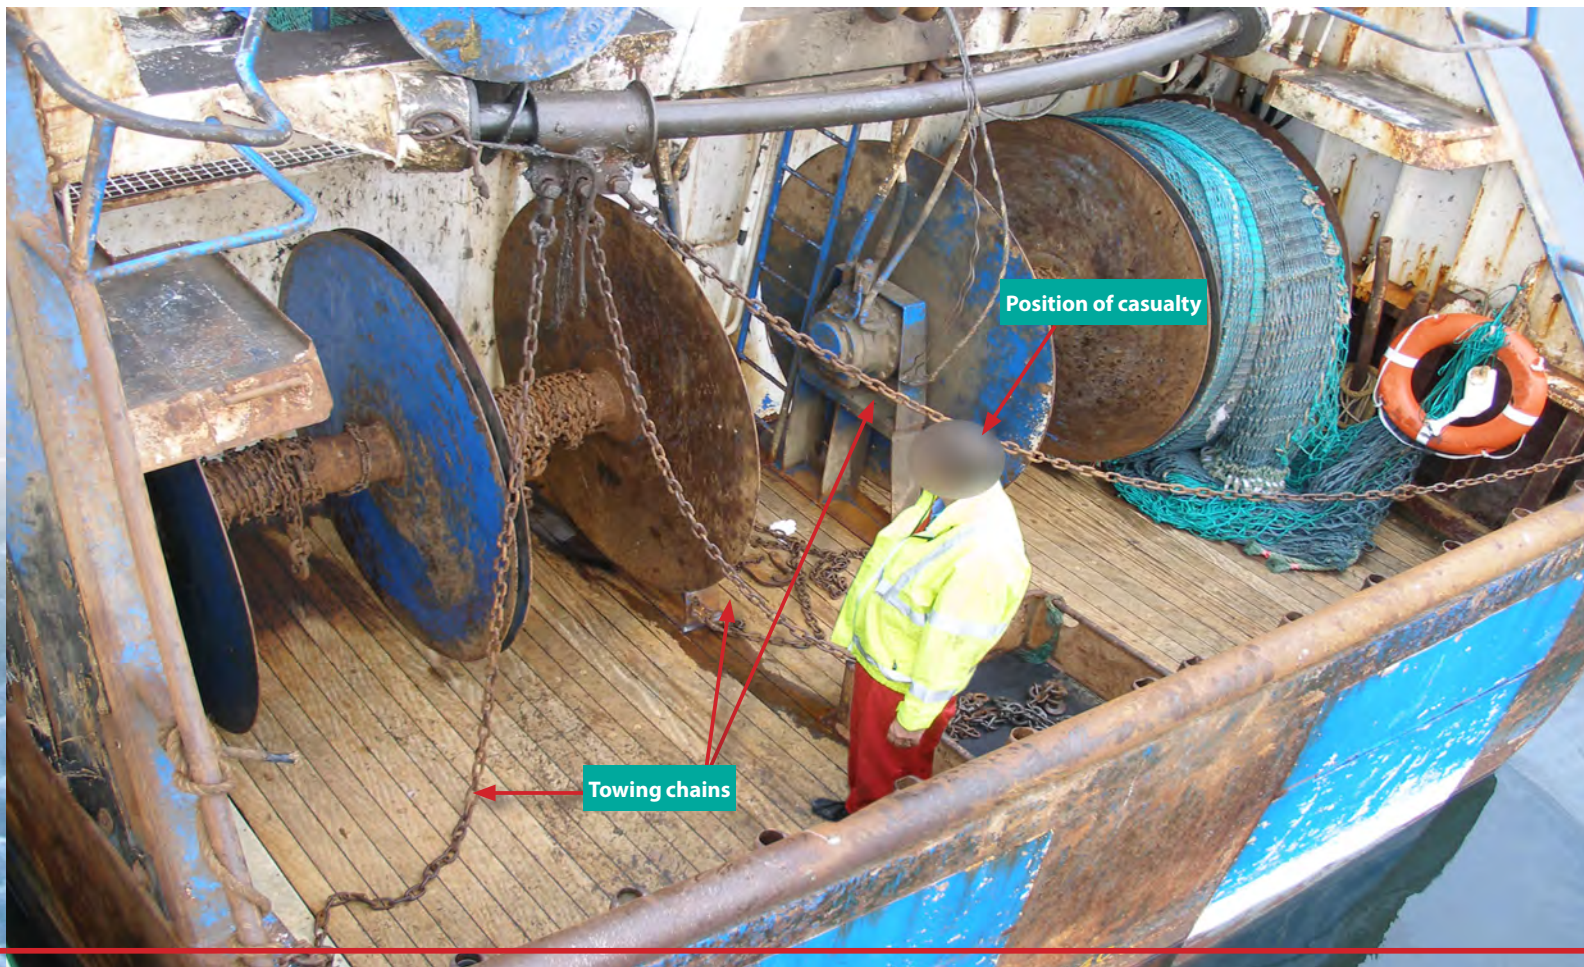
Figure 3: Demonstration of where the crewman was standing at the time of the incident

**3.** The casualty was wearing a 50 Newton flotation jacket. Although these do provide a degree of thermal protection, they are classified for "swimmers in sheltered waters use and where help is close at hand"; they are not lifejackets, and will not keep the wearer's face and mouth clear of the sea if they become unconscious. An inflatable lifejacket, on the other hand, gives no thermal protection. If not too cumbersome, both a lifejacket and thermal protection should be worn when on exposed open decks; this will maximise the chances of recovery in the event of going overboard.

**5.** This skipper's quick action in ordering the wires to be cut maximised the chances of gaining manoeuvrability of the vessel. Angle grinders, such as the one used in this instance, are now readily available. These enable the gear to be cut away if necessary and do not need to be plugged in to a boat's electric supply. Survival times of a man overboard can be counted in minutes and seconds, so no time should be wasted hauling gear which could be jettisoned and recovered later.

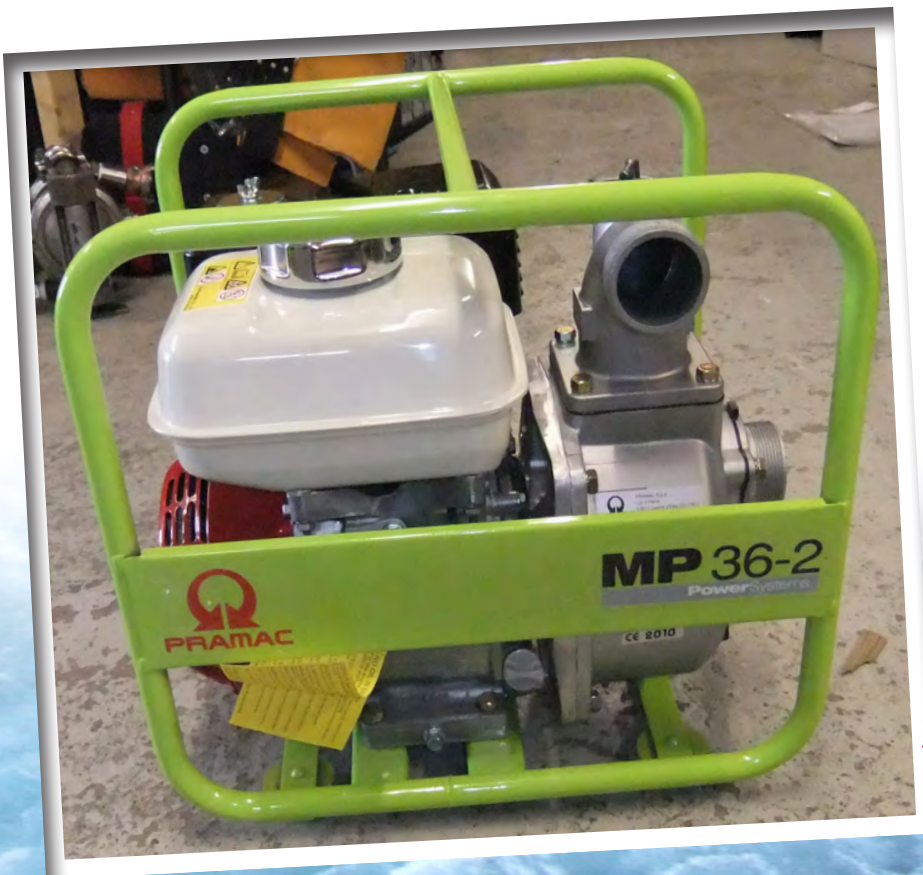
Figure 4: Pramac MP 36-2 petrol engine-powered pump

The three remaining crewmen then risked their lives, and two were seriously affected by carbon monoxide, as they entered the fish hold to try to rescue the collapsed man.

**3.** Think about the risks of operating portable pumps on board your boat, and where these should be best placed to avoid the risk of carbon monoxide poisoning.

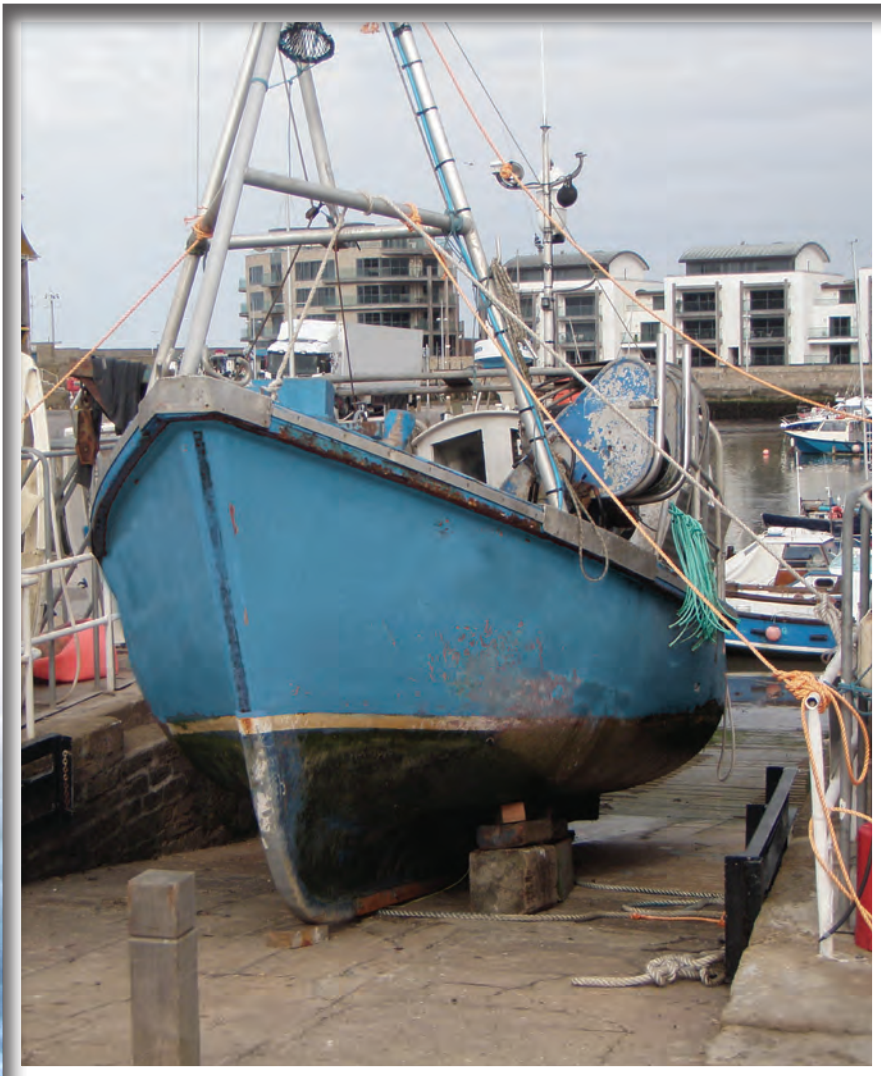
Figure 6 - Vessel on slipway after recovery

Fortunately for the men, who were left in the water clinging to pot marker buoys which had floated free as the vessel sank, the sinking had been seen by a nearby fishing vessel, which proceeded to the scene and recovered them from the water. They were taken back to port; wet, but otherwise unharmed. The vessel was later salvaged and the cause of the sinking was found to have been water entering the engine space via a sea water suction hose, which had become detached from the sea cock. This was a valve with a 2 inch diameter, through which water would have flowed into the engine

Once again, the importance of wearing lifejackets when working on deck is clearly demonstrated.

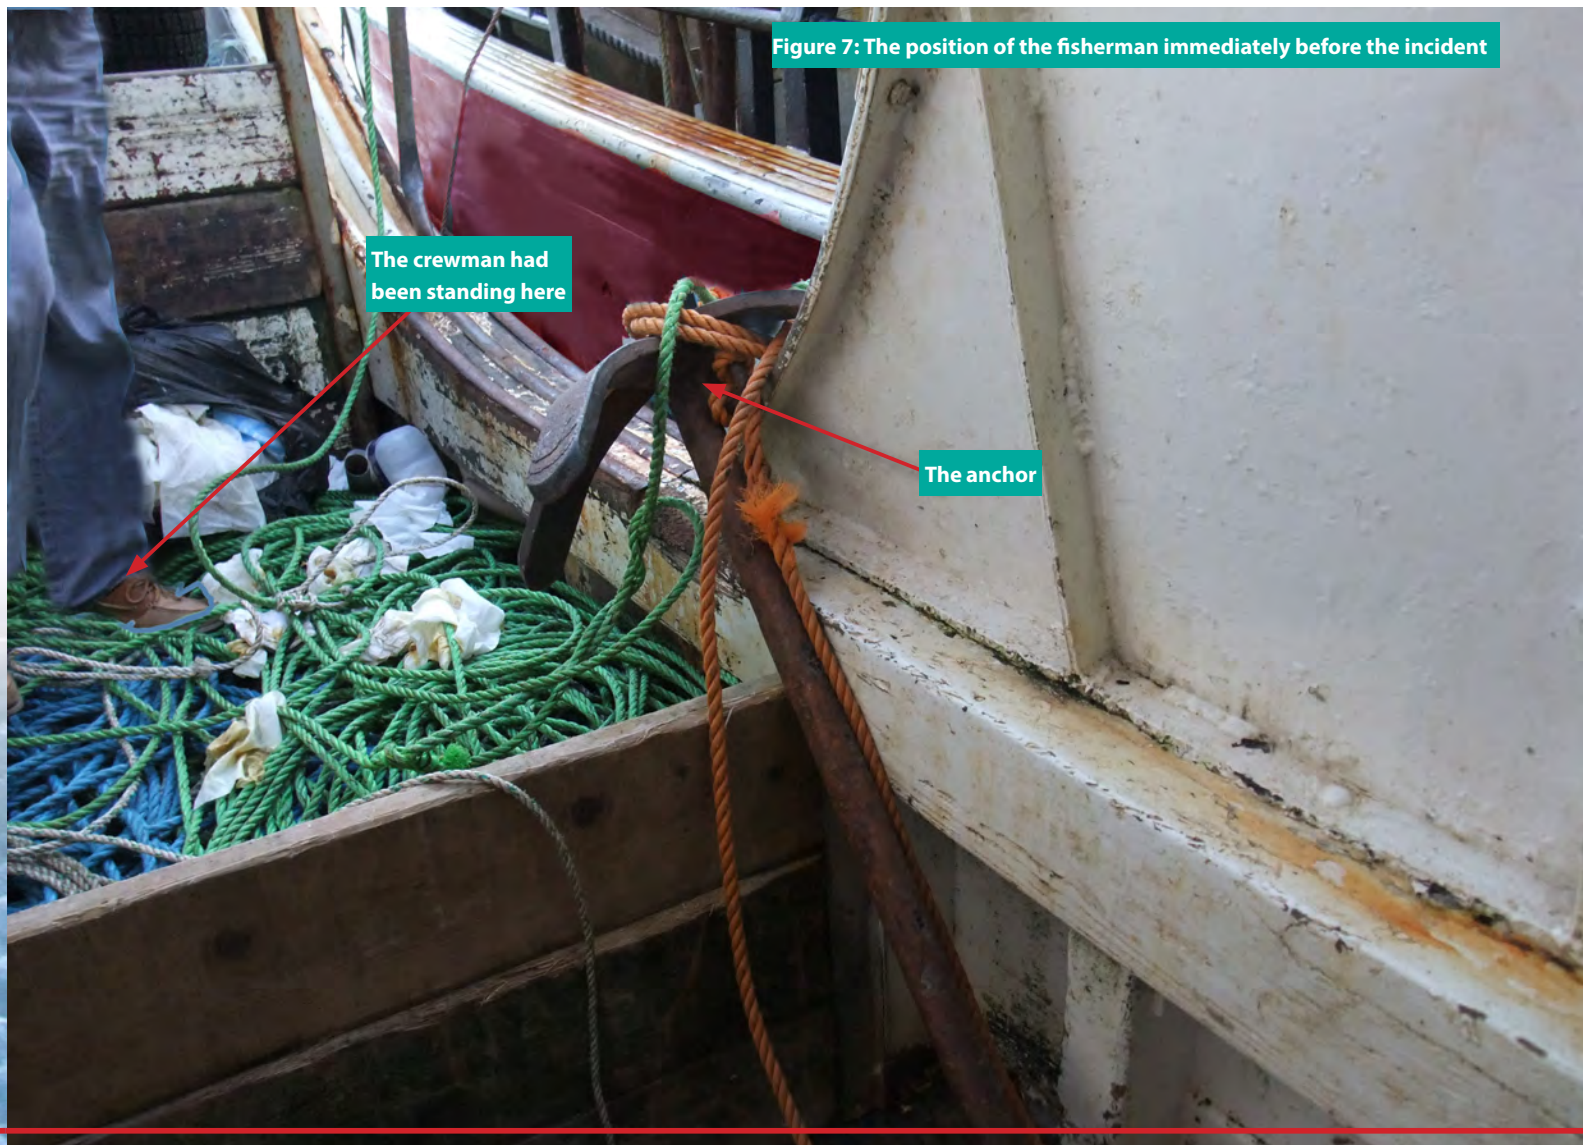
Figure 7: The position of the fisherman immediately before the incident

On hearing a shout from the deckhand, the skipper immediately throttled back the engine. The crewman and net anchor were then catapulted overboard. He was dragged underwater and, although injured and not wearing a lifejacket, he managed to free himself from the anchor and rope and surfaced close to the vessel. The deckhand was already exhausted and close to giving up.

**1.** Working decks are often cramped, and are potentially dangerous areas, particularly when shooting and hauling. To reduce the risk of entanglement, many vessels try to keep crew away from moving gear by fitting physical barriers such as pound boards. However, these are only effective if they are kept in place and not ignored. Crew must be made aware of the dangers of working on deck, and appropriate practices must be adopted and enforced. Lost or damaged gear can be replaced; a life cannot.

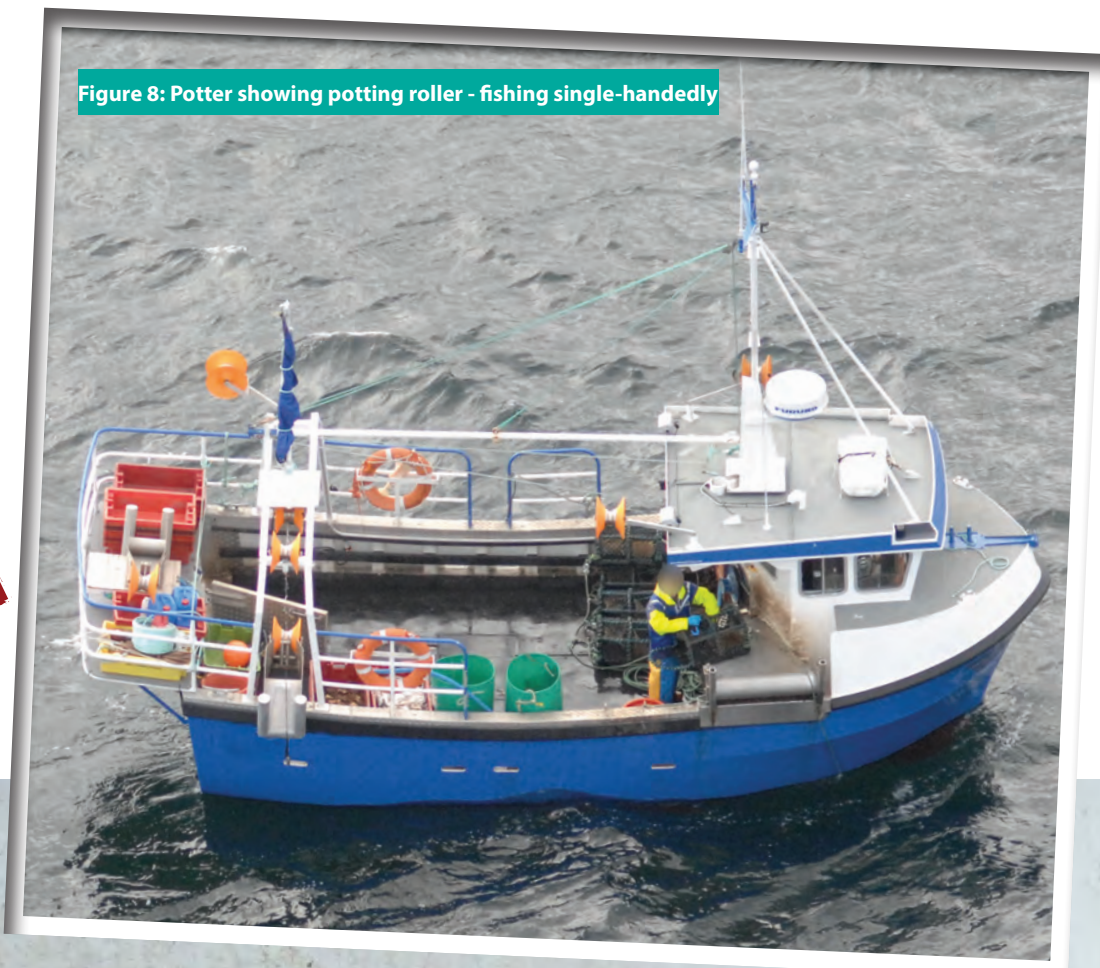
Figure 8: Potter showing potting roller - fishing single-handedly

**1.** The condition in which the boat was found after the accident, its contents, and the location of its gear, provided significant clues as to how the accident happened. It is considered most likely that the fisherman was knocked or dragged overboard when the tensioned back rope led aft on the potting roller, allowing the back rope to ride out of the 'V' hauler.

Careful boat handling is needed to make sure that the back rope leads onto the hauler correctly. This is best achieved by steering the boat so that the back rope leads from an angle forward of the beam. However, this is not always easy to achieve, particularly when working alone in demanding weather and tide conditions. If the back rope is allowed

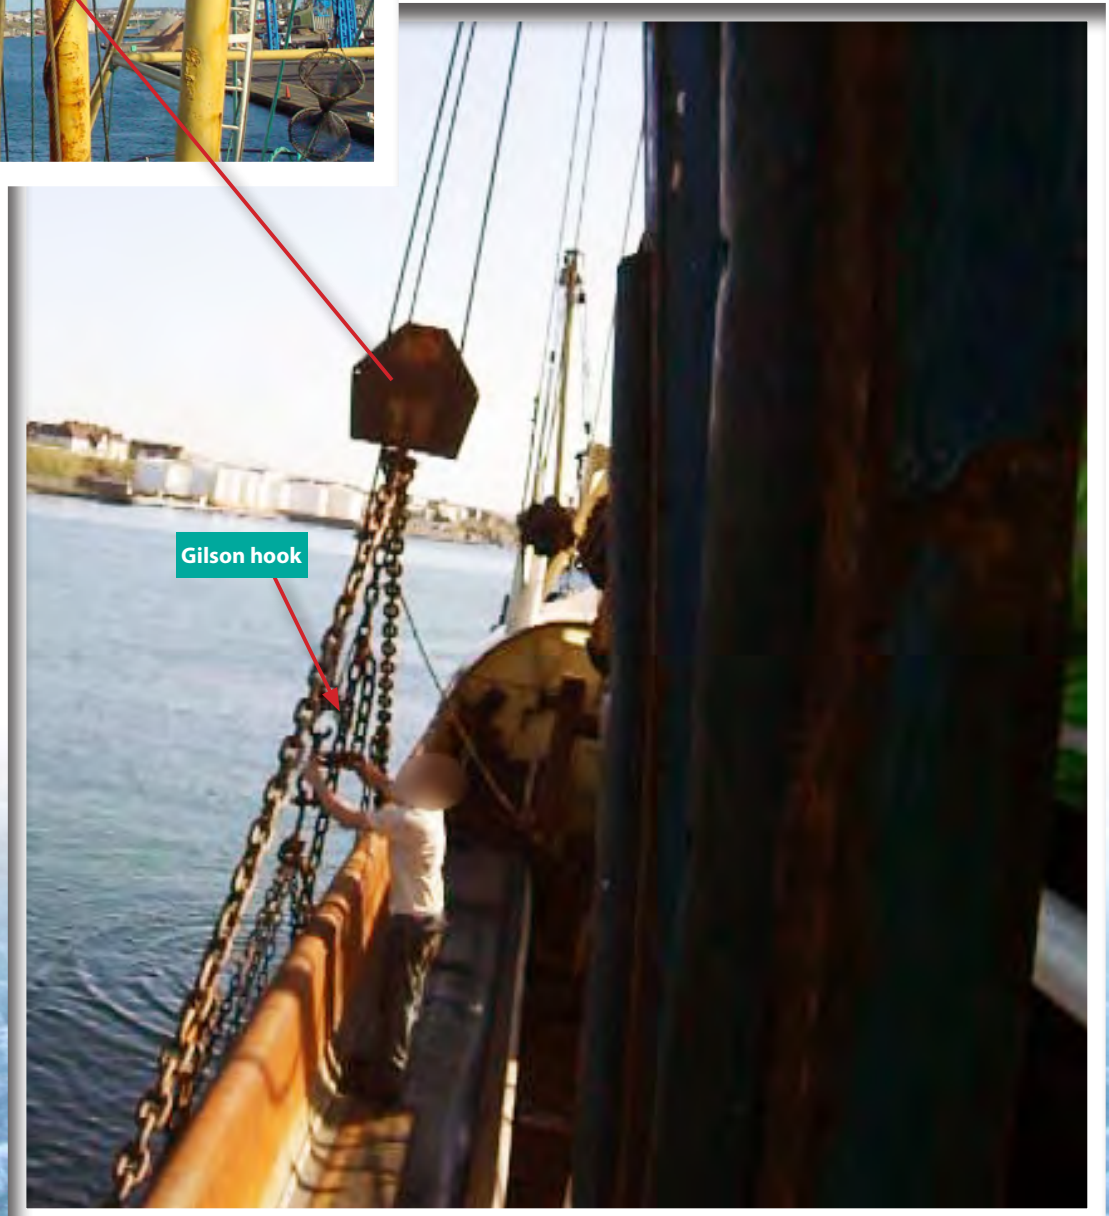
**Figure 10: Crewman standing on catch bin attaching gilson wire**

**1.** The main trawl wire parted because it was worn and had become brittle; this was not unexpected as the trawl wire had parted on several previous occasions.

**“Regular inspection of wires, particularly those that are used heavily, such as trawl wires, is essential to ensure they are safe for use.”**

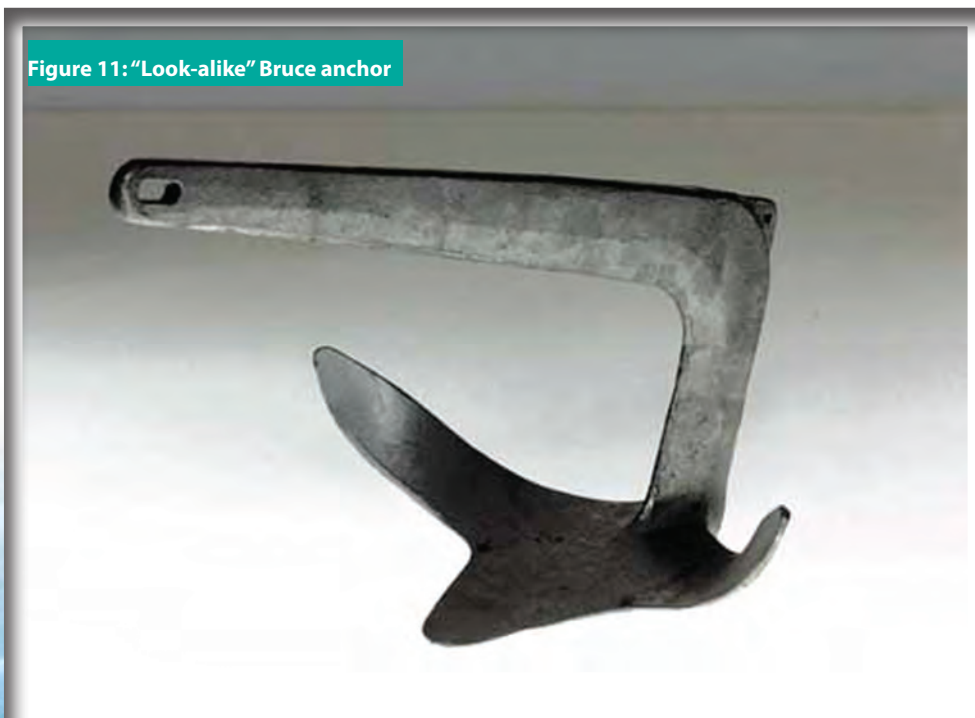
Figure 11: "Look-alike" Bruce anchor

Thirty minutes later, the skipper heard the chain rumbling across the seabed and got up, to discover the vessel was almost aground. He promptly raised the rest of the crew and hauled in on the anchor chain; only the anchor shank was on the end of it. They picked up the trip buoy, and on hauling in the line found the remainder of the anchor attached.

**“Beware the danger of cut-price look-alike equipment and, wherever possible, ask for a bona-fide test certificate on cast items such as anchors and blocks.”**

**2.** Beware the danger of cut-price look-alike equipment and, wherever possible, ask for a bona-fide test certificate on cast items such as anchors and blocks.

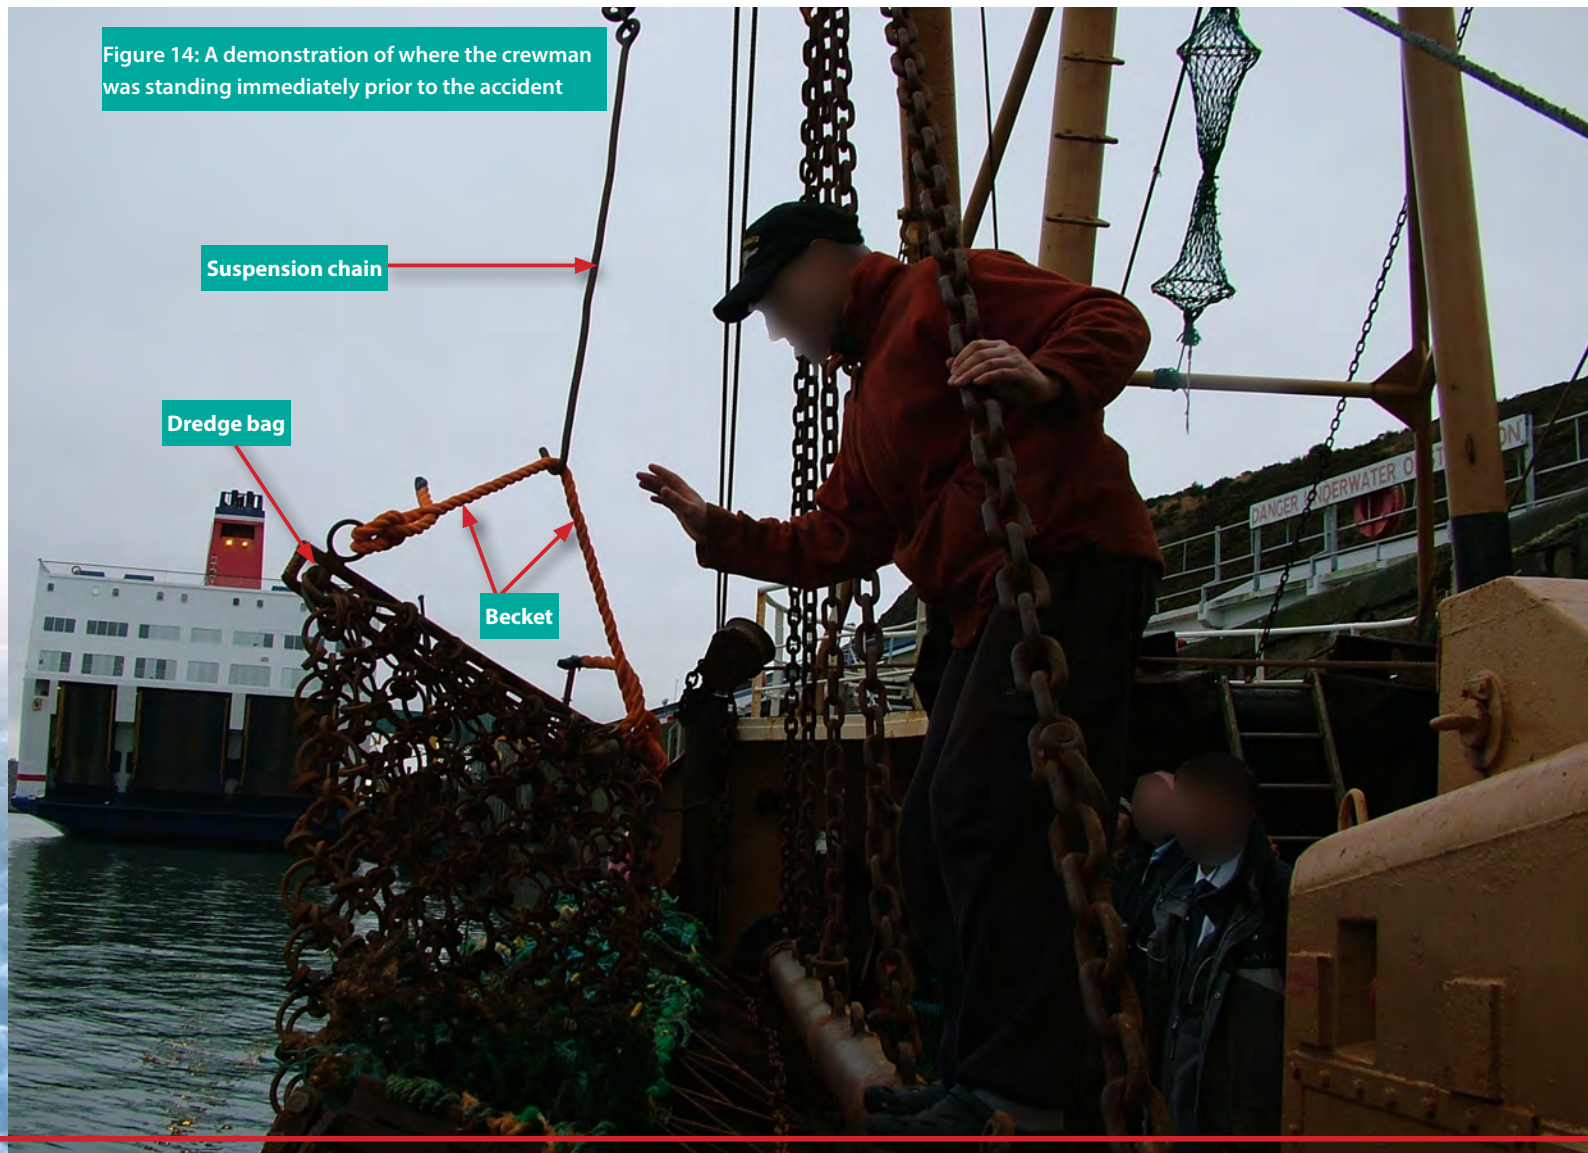
Figure 14: A demonstration of where the crewman was standing immediately prior to the accident

The deckhand was not wearing a personal flotation device or a safety harness when he stepped onto the elevated dredge beam, and it was not the practice for deckhands to do so. On this occasion, he let go of the suspension chain (Figure 14) to facilitate the emptying of one of the dredge bags. As he grasped the dredge bag with both hands, the lifting becket parted, causing him to fall forward and, with no protection from the bulwark, to continue to fall overboard.

**1.** The lifting becket parted at a point of attachment to the dredge bag which was prone to wear. A robust inspection and maintenance regime for the working gear might have identified the wear and have prevented the failure. Ensure you have a regime that does so.

**3.** The fitting of a 'tipping bar', commonly used on scallop dredgers, would have enabled all the dredge bags to be inverted at the same time and have avoided the need for deckhands to step onto the dredge beam or to lean over the gunwale. The best way to control a risk is to remove the hazard altogether.

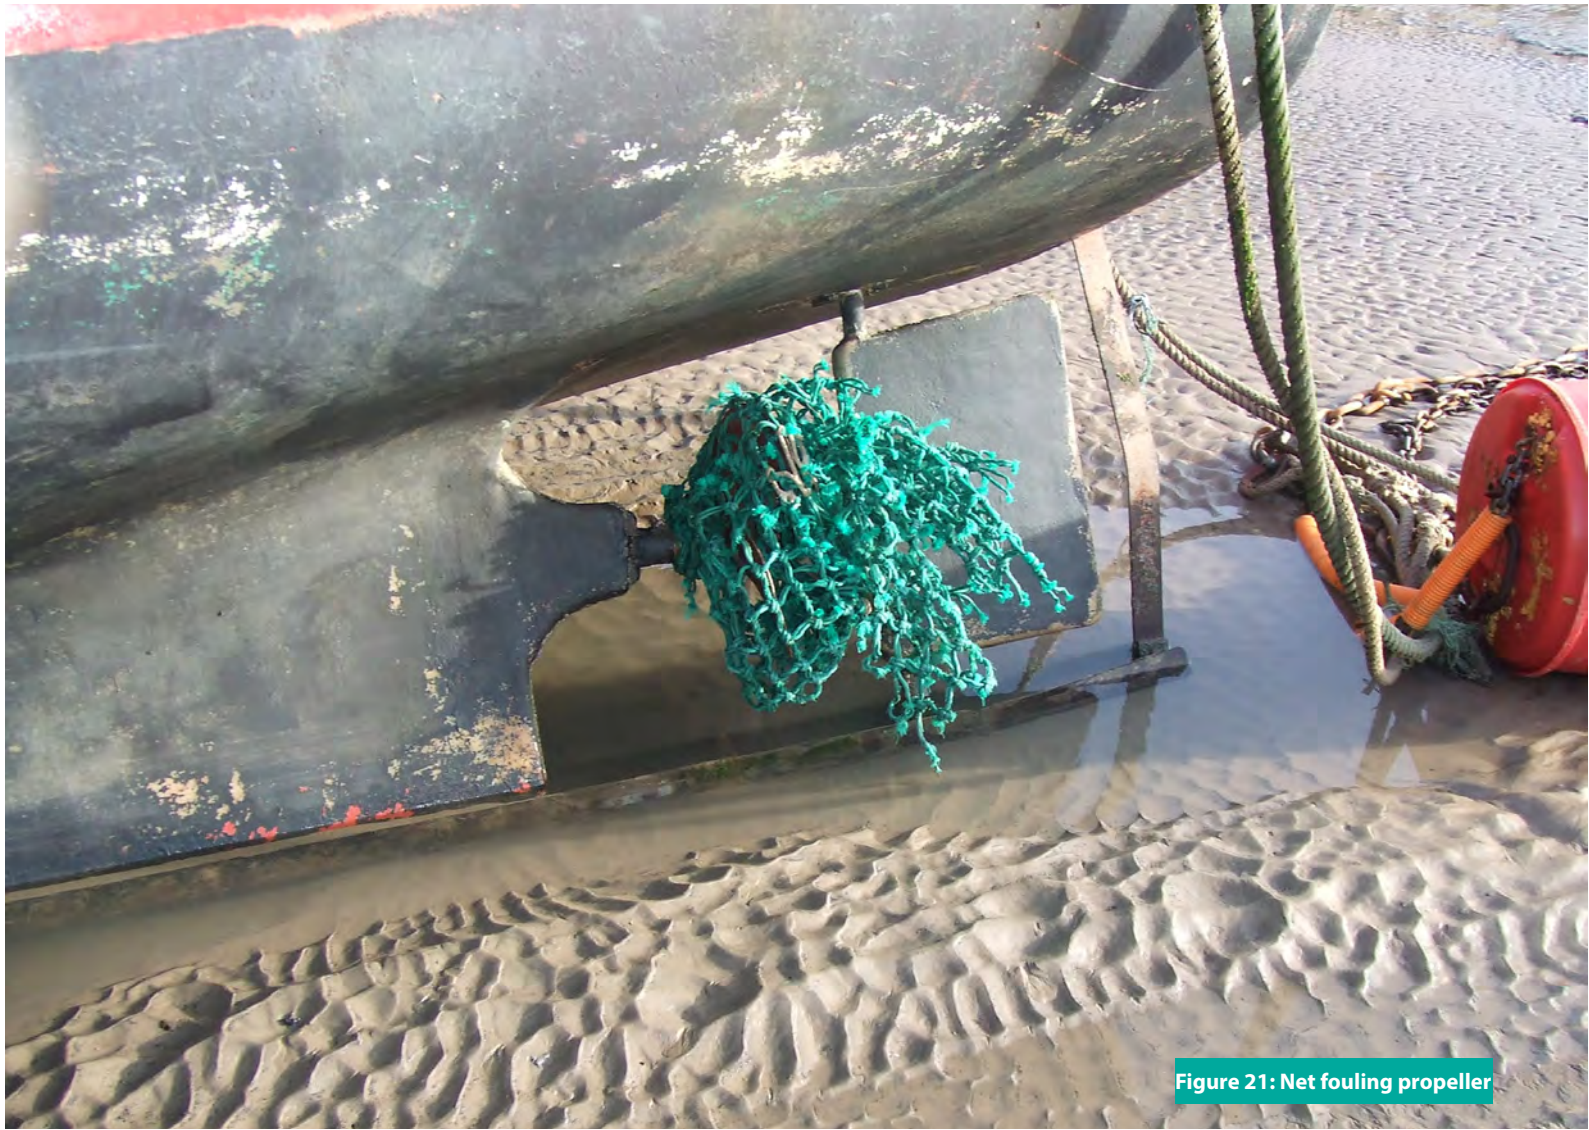
Figure 21: Net fouling propeller

**2.** The skipper recognised the signs of propeller fouling: the engine stopping suddenly, without gradual power loss, or the engine miss-firing. Dropping the anchor first was the most sensible and effective time-buying solution available to him. It arrested the boat's drift and bought time for investigating the cause.

The anchor is a vital part of safety equipment and should be maintained as such. It would have been of little value to this skipper if he'd had to break it out from under piles of gear or seek and attach an unprepared chain.

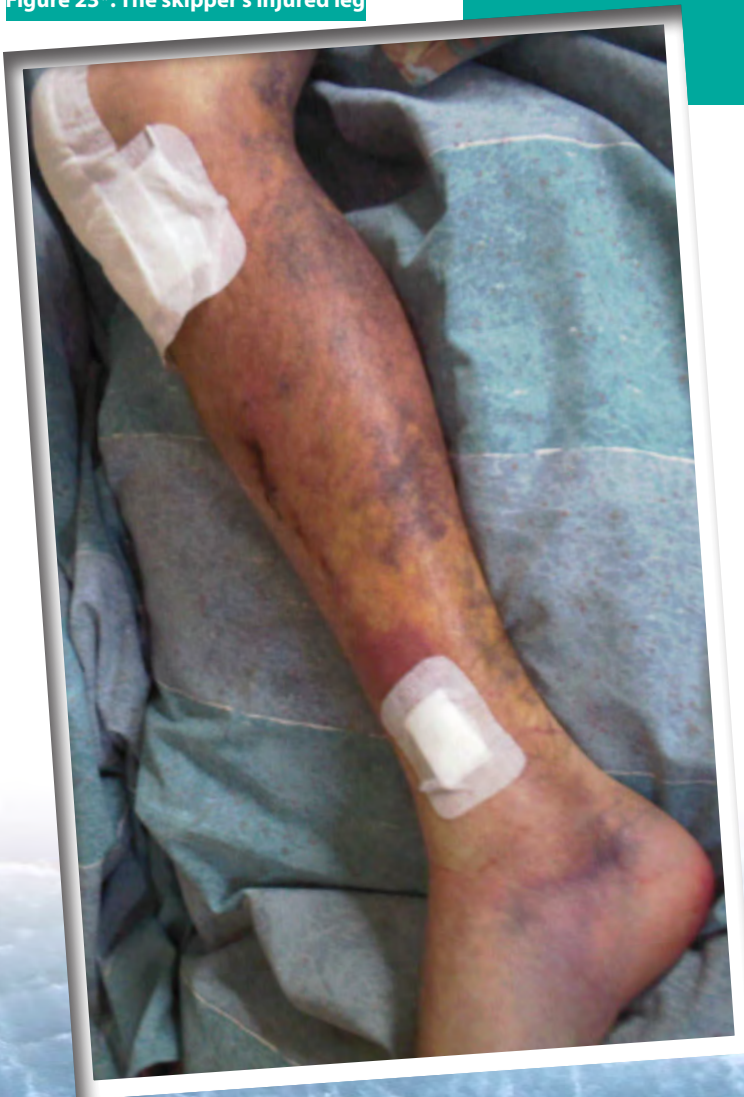
Figure 23\*: The skipper's injured leg

**3.** The skipper was wearing a full length oilskin, the back of which caught in the drum end. To avoid entrapment accidents, ensure the clothing you wear is not unnecessarily loose.

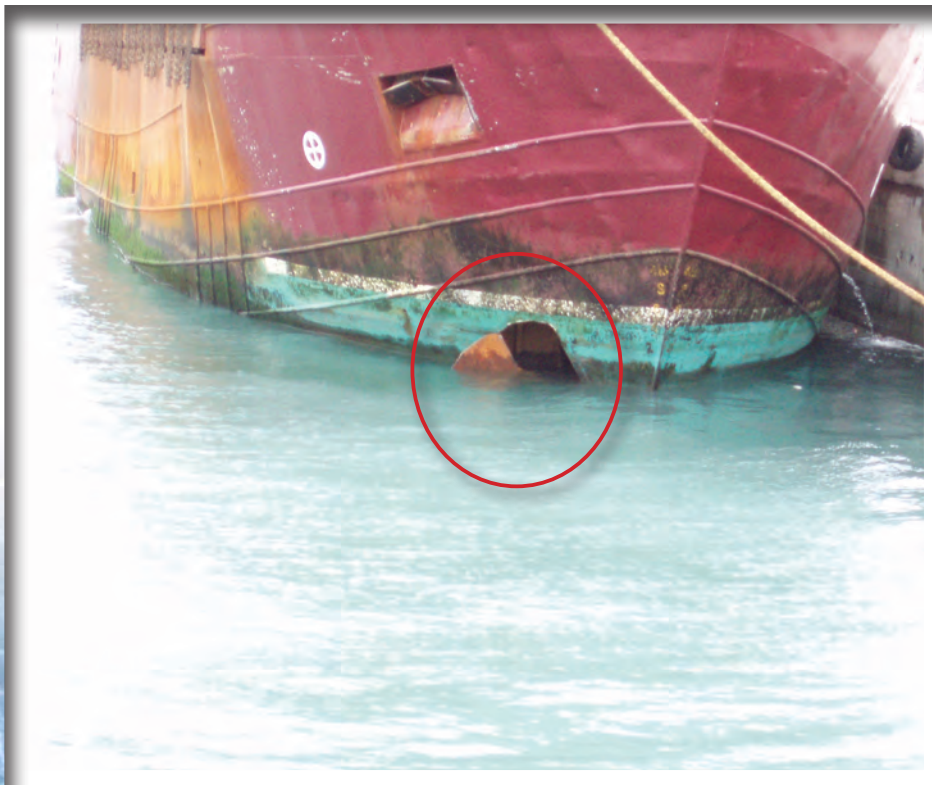
Figure 24: Shell plating damage

**5.** Finally, the collision bulkhead saved the boat from being lost. Collision bulkheads have more uses than their name suggests, and should be kept in good condition.

**4.** It is always a good idea to tell the Coastguard if your vessel has been damaged, even if you do not need help or are in immediate danger. This helps them to be more prepared and to take action if the situation does get worse.

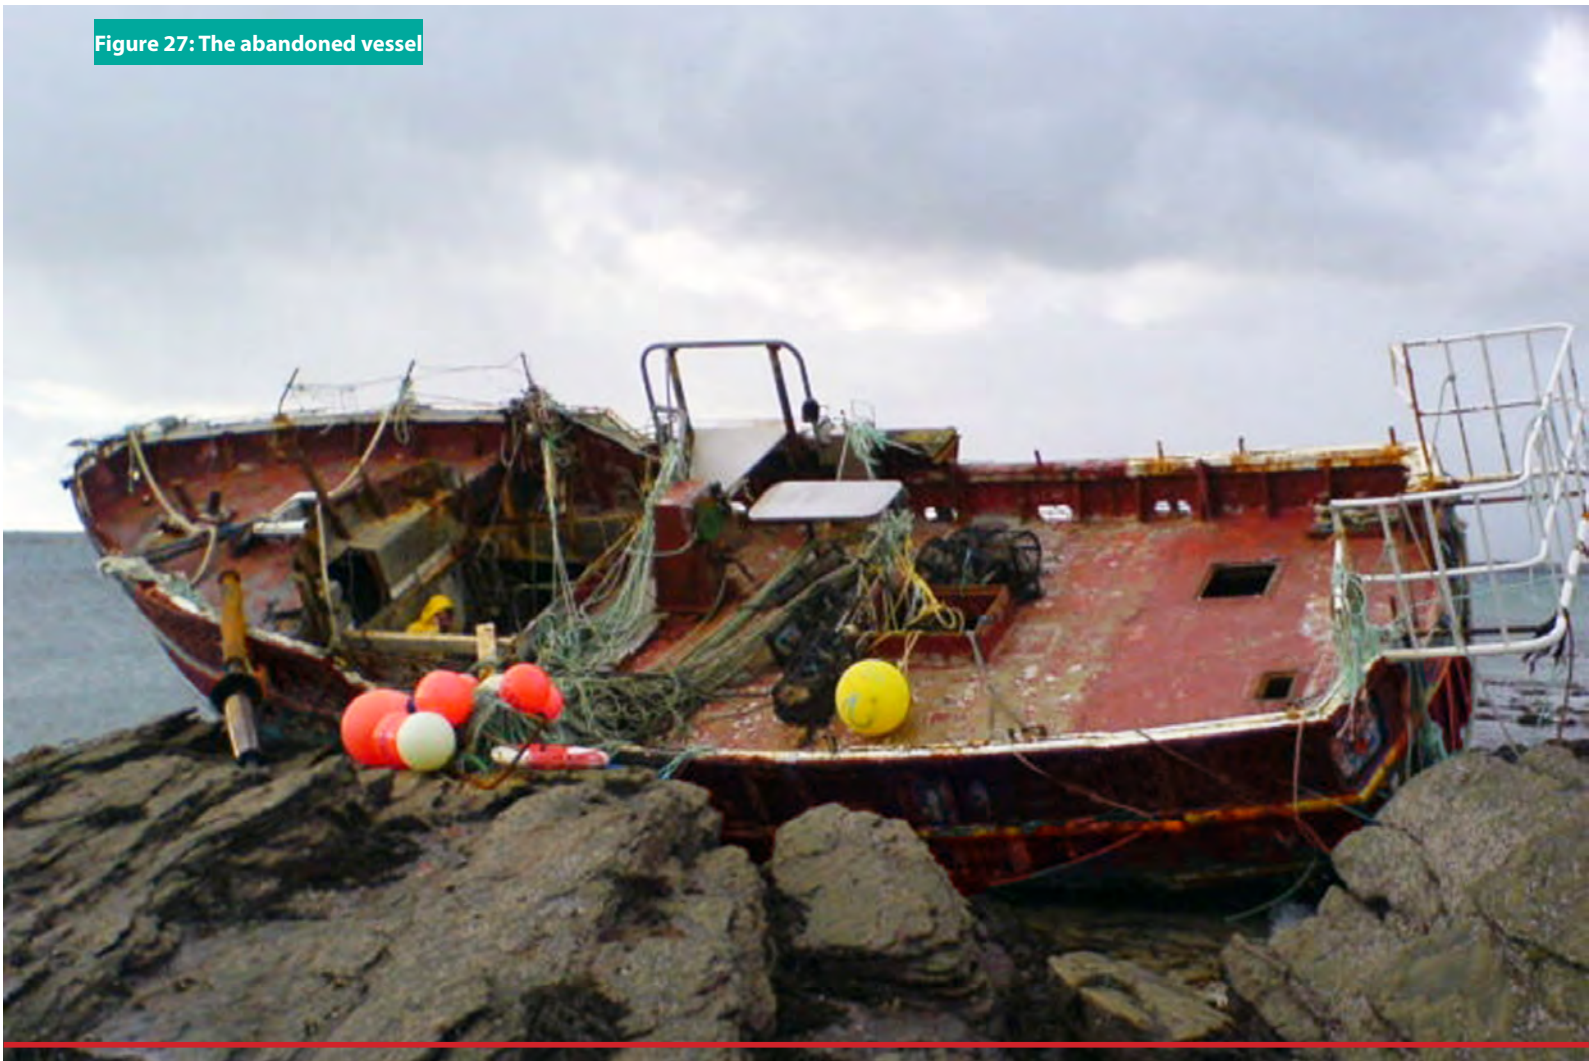
Figure 27: The abandoned vessel

Unfortunately, they were unable to get the vessel off the rocks immediately and were forced to abandon ship as the boat lay over dramatically in the ebbing tide. Neap tides and strong onshore winds in the following days resulted in the boat being completely destroyed before she could be salvaged.
