MARINE ACCIDENT INVESTIGATION BRANCH

# Leisure craft

SAFETY DIGEST

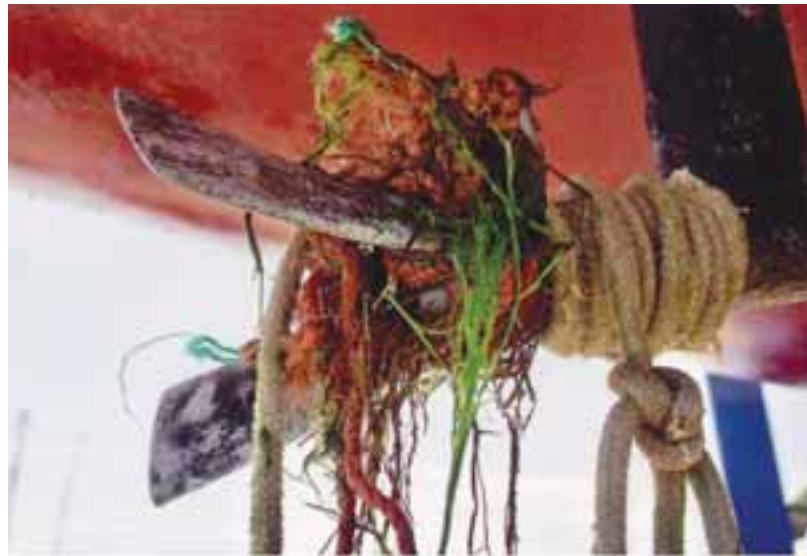
*Folding prop with entangled rope*

After the yacht had been lifted out of the water, to remove the rope that had been around the skipper, a further line was found tangled in the folding propeller that was preventing it from properly deploying. The line showed signs of having been there some time, and was probably the cause of their reduced speed under engine power.

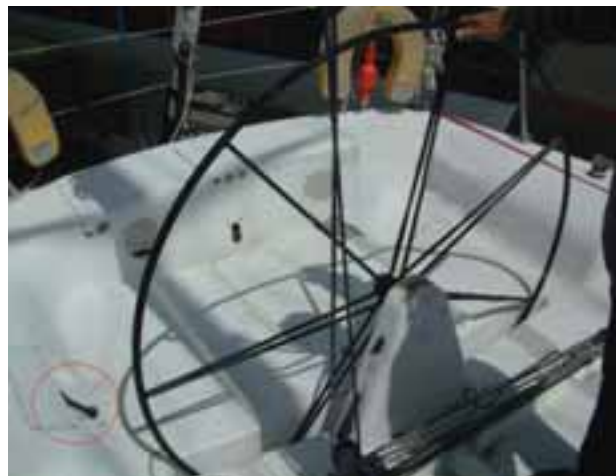
Figure 1 – Position of engine control lever

At 1426 the yacht was tacked back up the channel. The skipper then asked the Day Skipper to start the engine. The Day Skipper unclipped his safety line as he prepared to check that the engine control was in neutral, but he found the lever to be seized (Figure 1). He spent the next 2 minutes releasing it; he then moved in front of the wheel to go down below to start the engine, but he was brought to an abrupt halt. His foot became entangled in the traveller because his safety line became taut (Figure 2). His line had not been released as first

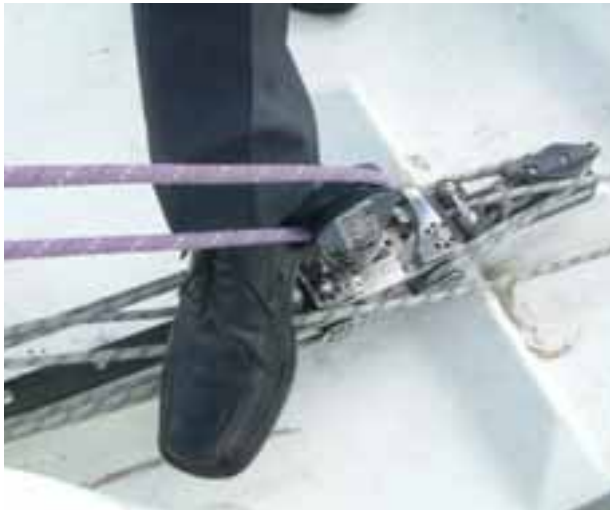
Figure 2 – Day skipper’s leg position on the traveller rig

thought. The skipper, now distracted, turned round to release the safety line and, at the same time, the yacht conducted an inadvertent gybe. The boom moved rapidly from starboard to port, trapping the Day Skipper’s leg with the mainsheet, causing multiple fractures to his right leg. The boom immediately returned to the starboard side.

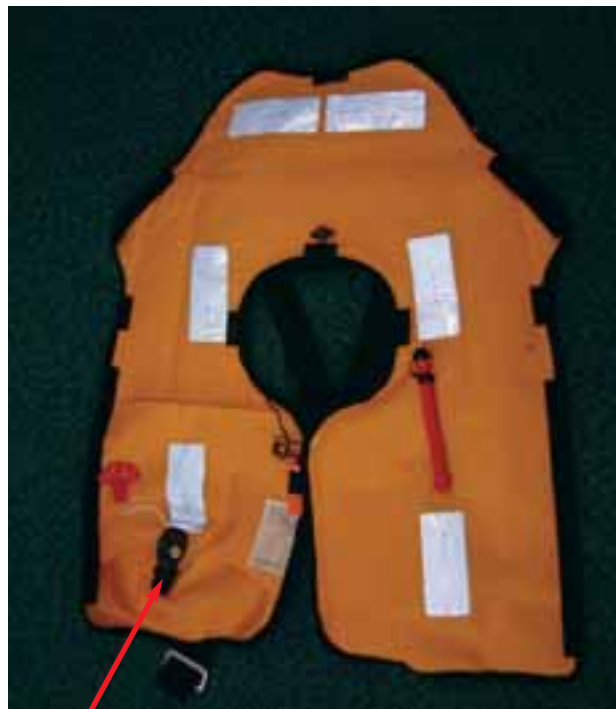
The two vessels were now extremely close and the pilot lost sight of the yacht under the bow. The yachtsman decided that collision was imminent, and dived off the yacht. He passed down the port side of the ship and was then recovered by the harbour launch. The yacht passed down the ship's starboard side before being swamped by her wash and foundering. The yachtsman's lifejacket did not inflate because it was not fitted with a CO<sub>2</sub> bottle (Figure).

CO<sub>2</sub> bottle missing

**3** A lifejacket that does not inflate is potentially a death jacket. Regular checks are not just recommended, they are essential. If in doubt, consult an

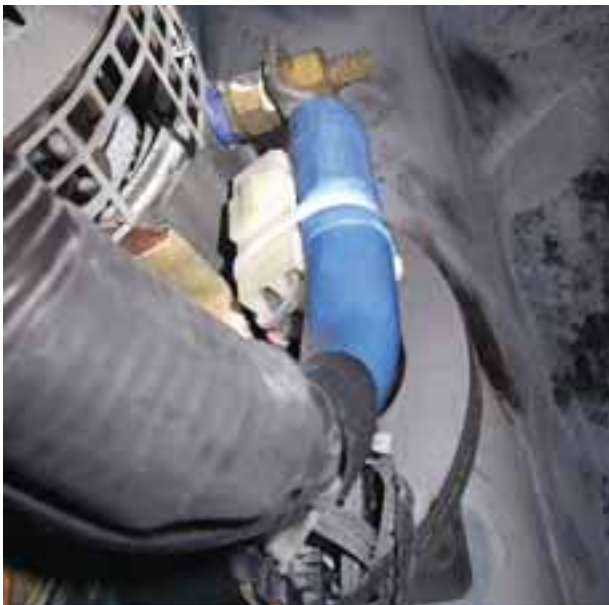
Figure 1 – Bow thruster showing exposed power cables and fire damage

A closer examination found that a metal cover to the brush gear of the bow thruster's motor had been displaced. The cover had then made contact with a terminal on one of the motor's power cables, causing arcing (Figure 1). This sparking had ignited a sail bag.

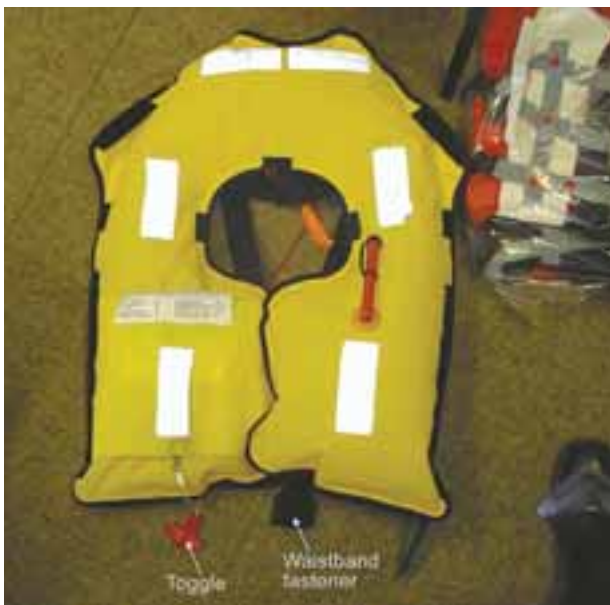
Figure 1 – Owner's lifejacket

Following the attempts to right the boat, it was noticed that the boat's owner had not been able to inflate his lifejacket. Consequently, the adult crewman located and pulled the toggle fitted to his lifejacket (Figure 1), which then inflated. However, the lifejacket did not appear to be fitted correctly, and the owner struggled to keep his

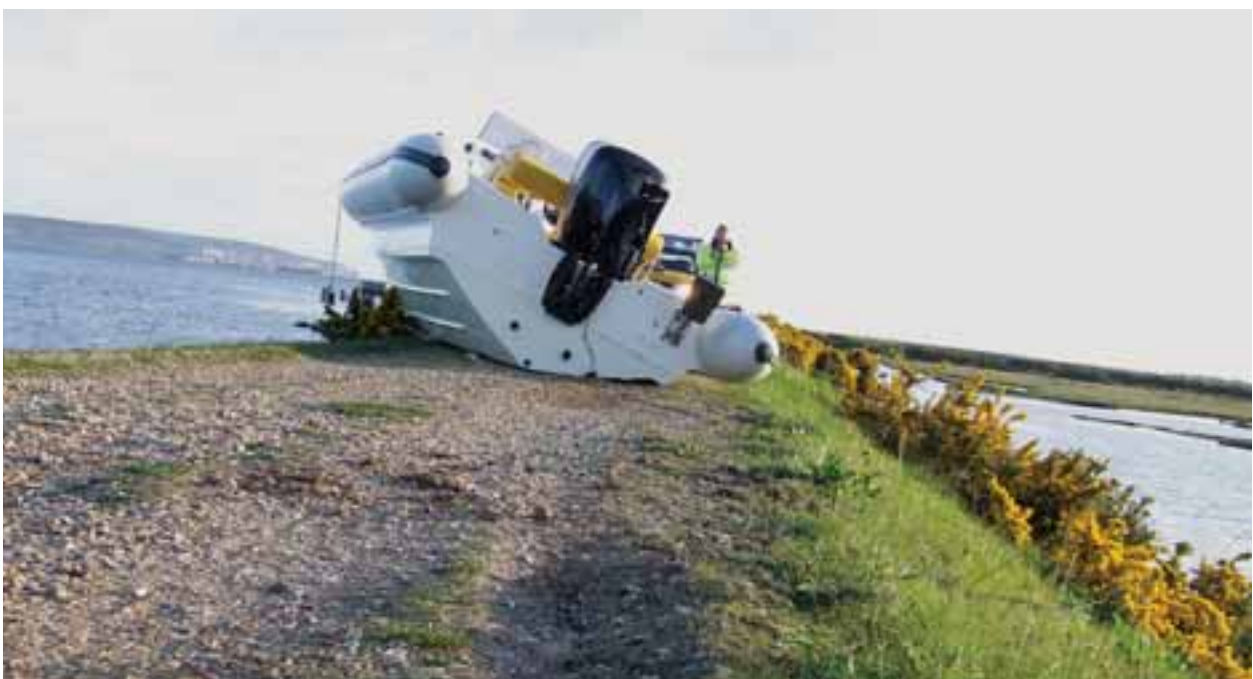
Figure 1 – RIB photographed after accident

The RIB continued at high speed, constantly turning in a spiral and, fortunately, moving away from the people in the water. It grounded at speed and climbed to eventually come to rest on a footpath on top of a sea wall (Figure 1).

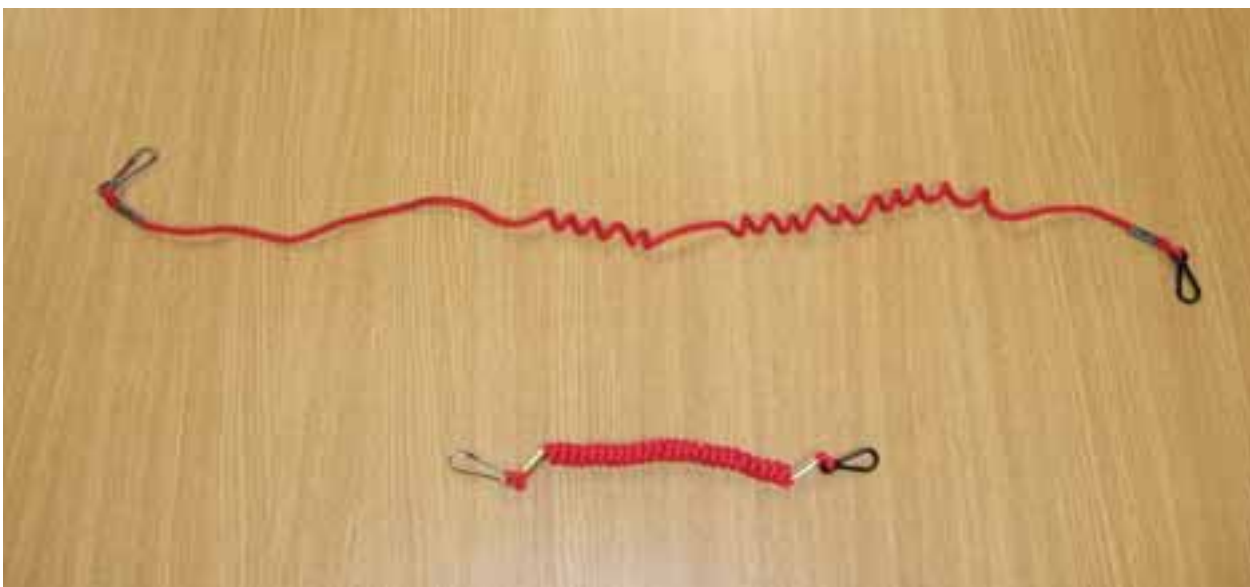
Figure 4 – Stretched kill cord in comparison with new item

It is thought likely that the driver had seen an object in the water close in front of the boat, and his instinctive reaction had been to turn to avoid it. This had occurred at high speed and at a time when the passenger had momentarily released his grip on the steadying grab handles to retrieve an object from the floor of the boat. While the boat heeled in the sudden turn, the driver reached across the controls to try to steady his friend. This left neither the driver nor the passenger holding on tightly, and resulted in both men being tipped from the boat. In reaching to steady his friend, the kill cord had become entangled with the throttle controls, and despite the cord being stretched as the driver entered the water, it slipped off his wrist before it acted to stop the engine.
