MAIB

MARINE ACCIDENT INVESTIGATION BRANCH

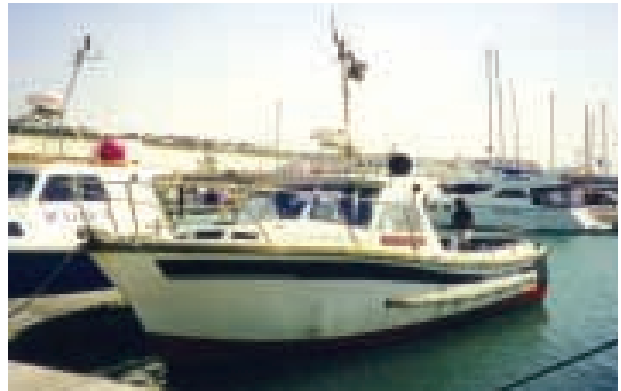
she was pumped dry and the cause of the leak was discovered: a brass, through-hull, 25mm diameter fitting to the toilet seawater inlet had failed.

In turn, this failure was caused by de-zincification. The fitting had been installed new only 16 months before, so the de-zincification was probably accelerated by stray electrical currents from the vessel's batteries.

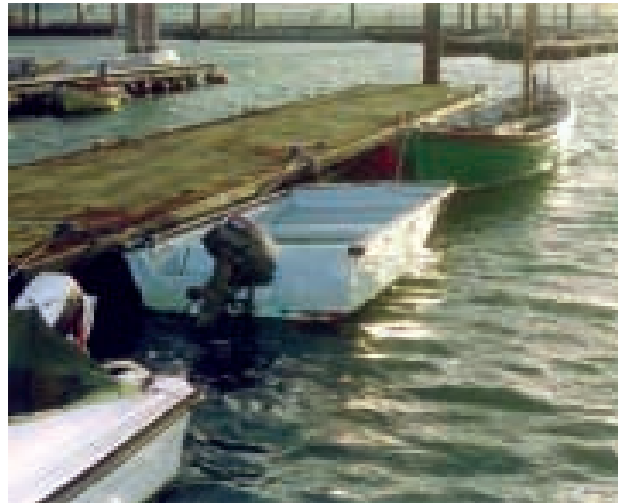
The outboard engine then stalled a second time but could not be restarted. The teacher told four of the pupils to start paddling but, when only 75m from the pontoon, the boat capsized and inverted. All 10 occupants were pitched into the water.

Following the accident, the boat was examined to reveal a substantial amount of water trapped in the void between the inner and outer hulls under the floor. The investigation revealed that uncontrolled movement of seawater in both the boat, and the void beneath the floor, combined to make it so unstable that she would eventually capsize. It was found that seawater had entered the void through two small holes in the bows where a towing bolt had been fastened, but had at some stage become detached.
