Report detailing the testing of an HPL rainscreen cladding system tested in accordance with the requirement as described in British Standard 8414

CUSTOMER TEST REPORT

BS 8414-1-2015+A1-2017 Test Report

Report Reference: 101856.8414

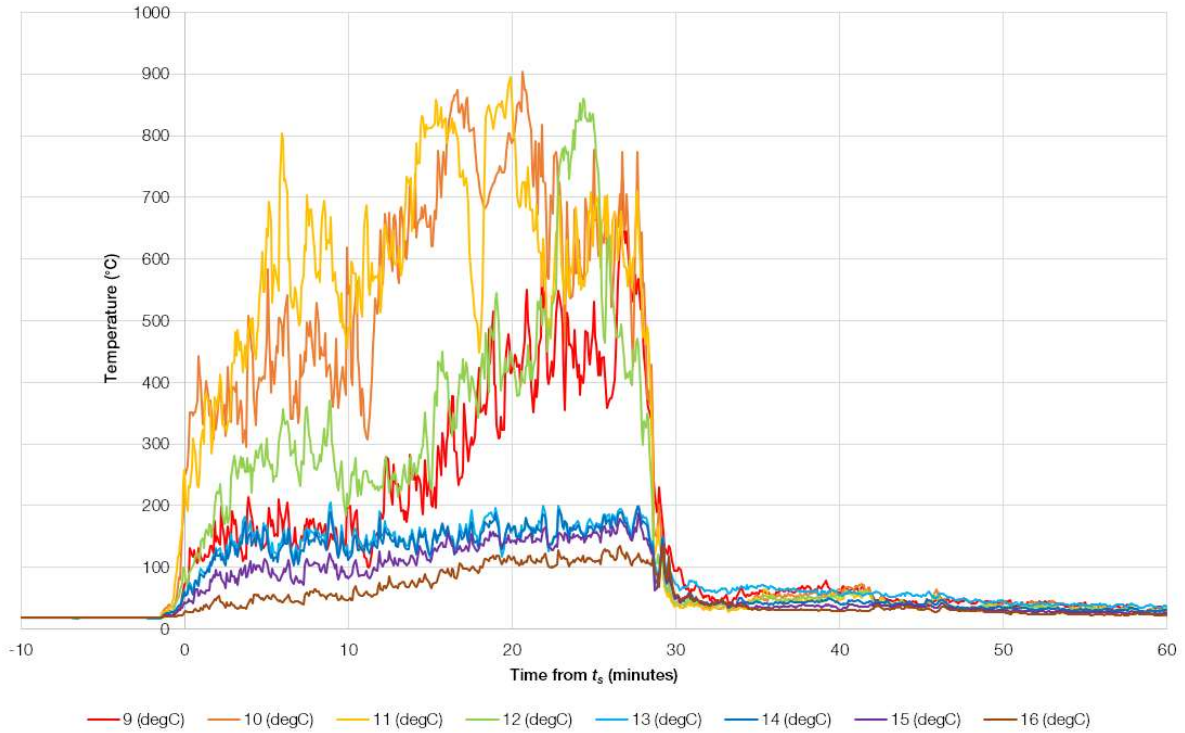
Parameter	Result
T _s , Start temperature – the mean temperature of the thermocouples at level 1 during the 5 minutes before ignition	17.87 °C
t _s , Start time – the time when the temperature of any external thermocouple at level 1 equals or exceeds a 200 °C temperature rise above T _s , and remains above this value for at least 30 seconds	100 seconds after ignition of the crib

Figure 3 – External temperatures at level 1

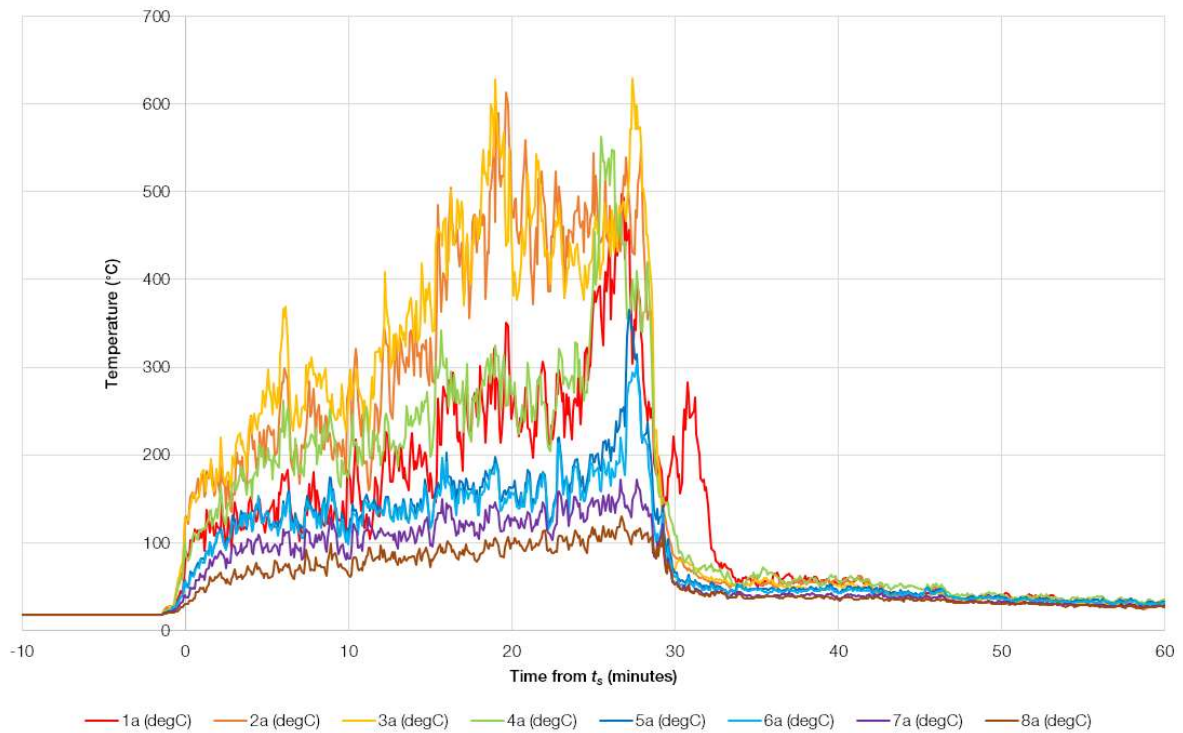
External fire spread								
Level 2, external thermocouples								
Thermocouple ID	1A	2A	3A	4A	5A	6A	7A	8A
Peak temperature (°C)	226.2	358.0	418.0	271.7	174.7	165.2	129.1	98.9
Internal fire spread								
Level 2, thermocouples in tile façade								
Thermocouple ID	1B	2B	3B	4B	5B	6B	7B	8B
Peak temperature (°C)	164.7	446.2	497.8	162.5	93.8	129.0	123.0	95.4
Level 2, thermocouples in cavity								
Thermocouple ID	1C	2C	3C	4C	5C	6C	7C	8C
Peak temperature (°C)	153.8	209.5	238.8	171.7	54.6	125.5	122.3	87.3
Level 2, thermocouples in insulation								
Thermocouple ID	1D	2D	3D	4D	5D	6D	7D	8D
Peak temperature (°C)	n/a*	40.3	54.3	65.0	23.1	38.1	85.0	38.9

Figure 4 – External temperatures at level 2

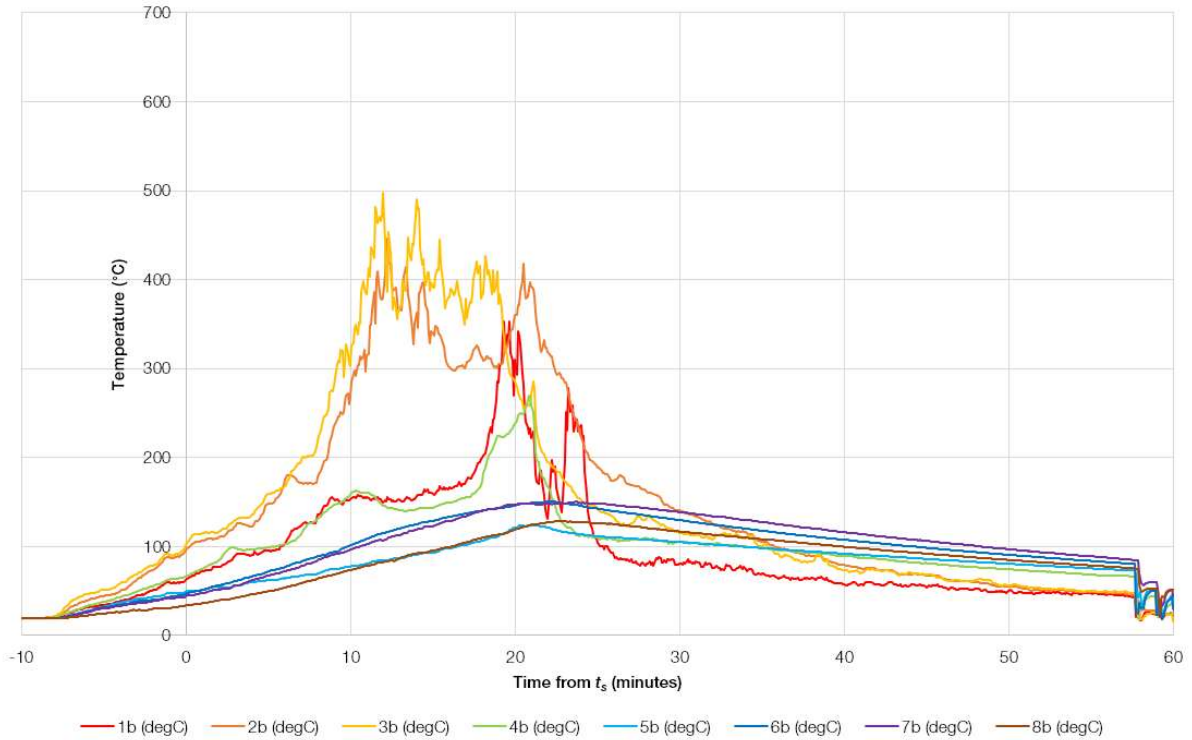
Figure 5 – Façade internal temperatures at level 2

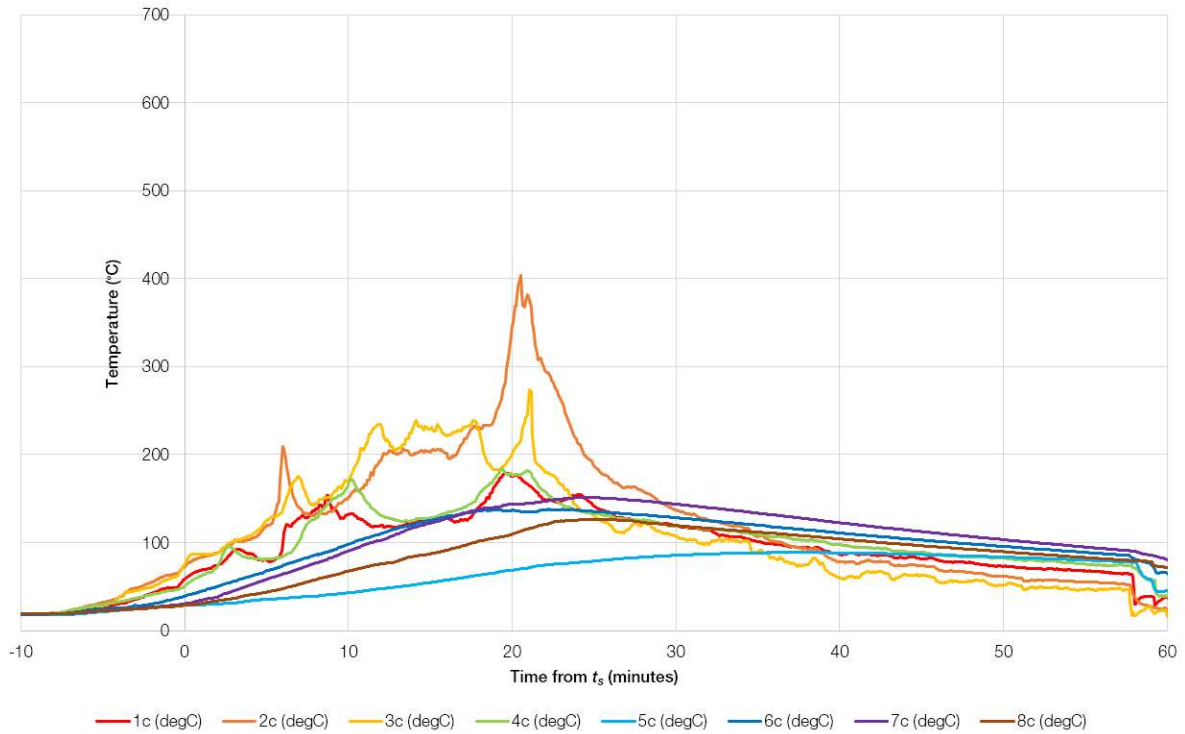
Figure 6 – Cavity internal temperatures at level 2

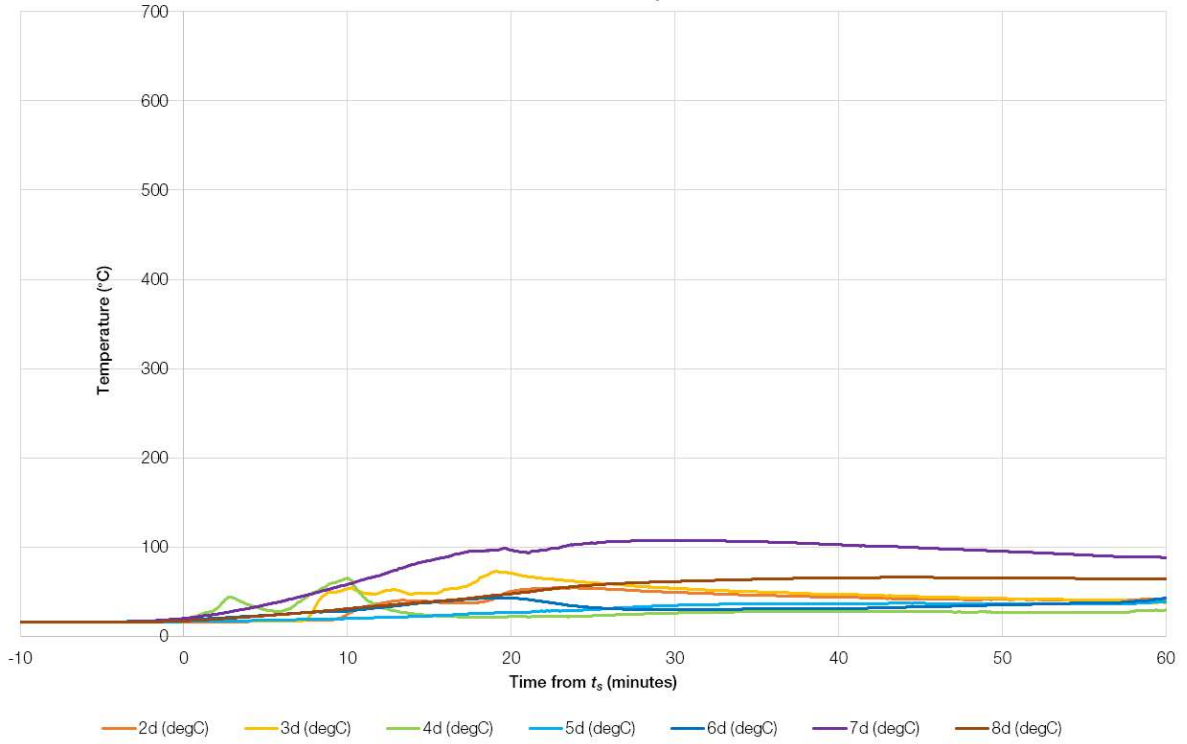
*Figure 7 – Insulation internal temperatures at level 2**

*Thermocouple 1D failed during the test and so its results have been omitted from this report.

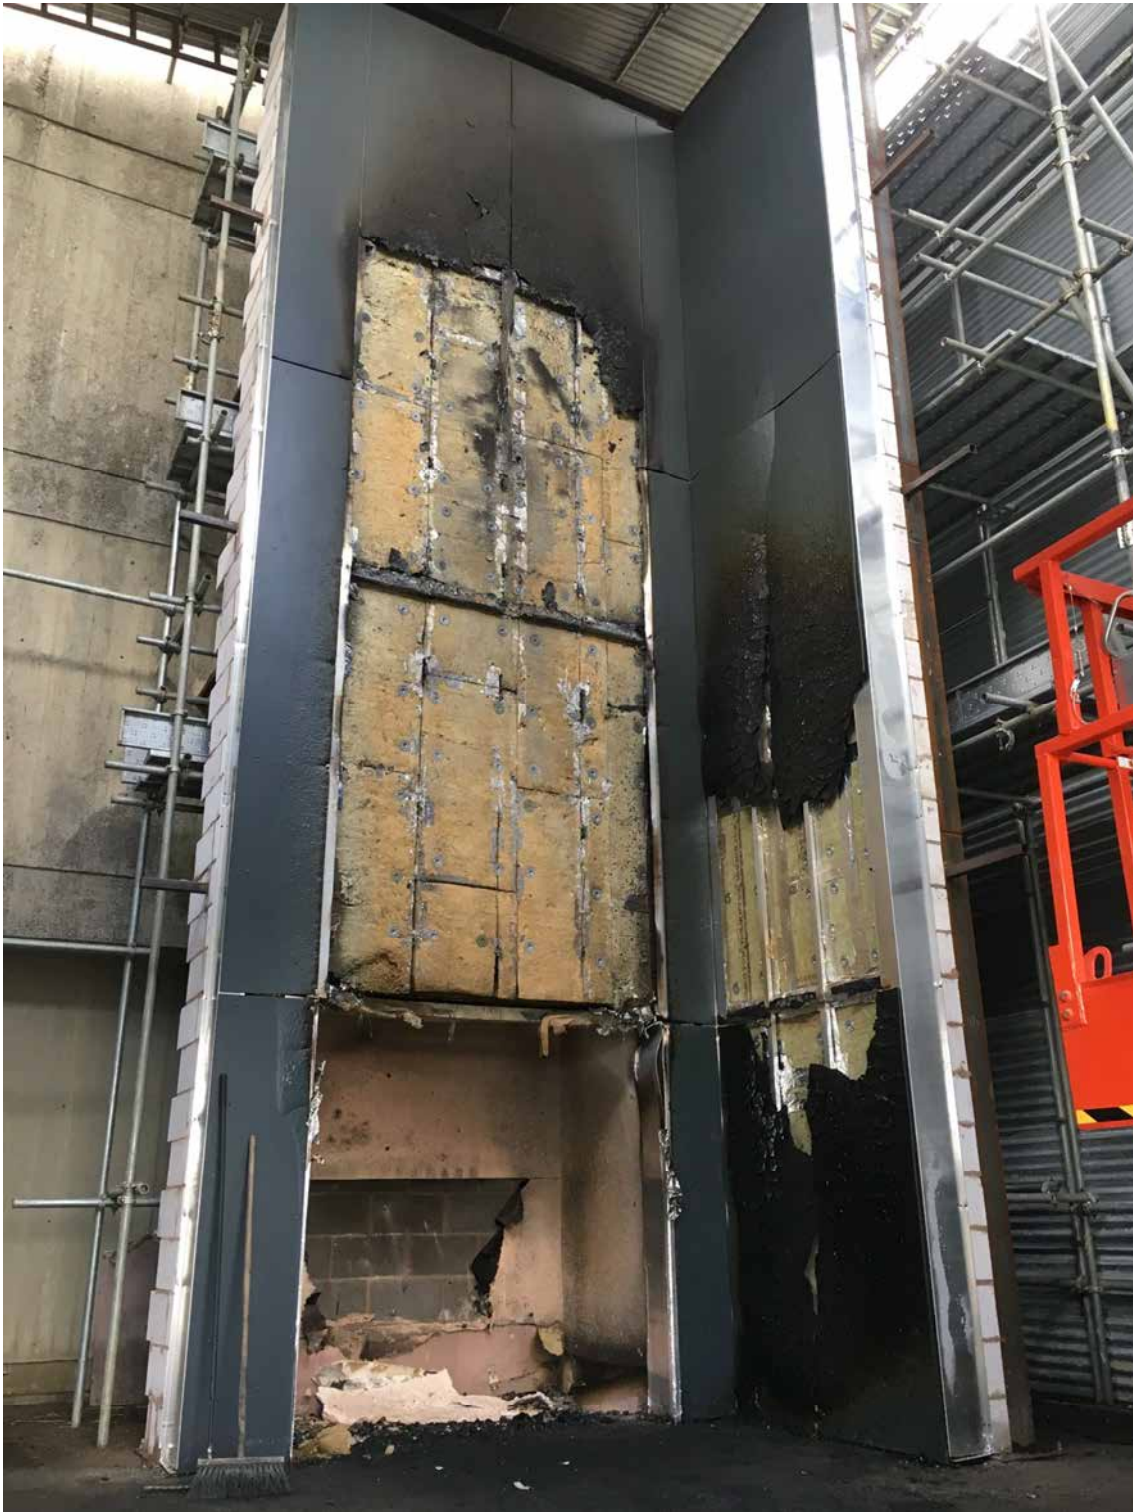
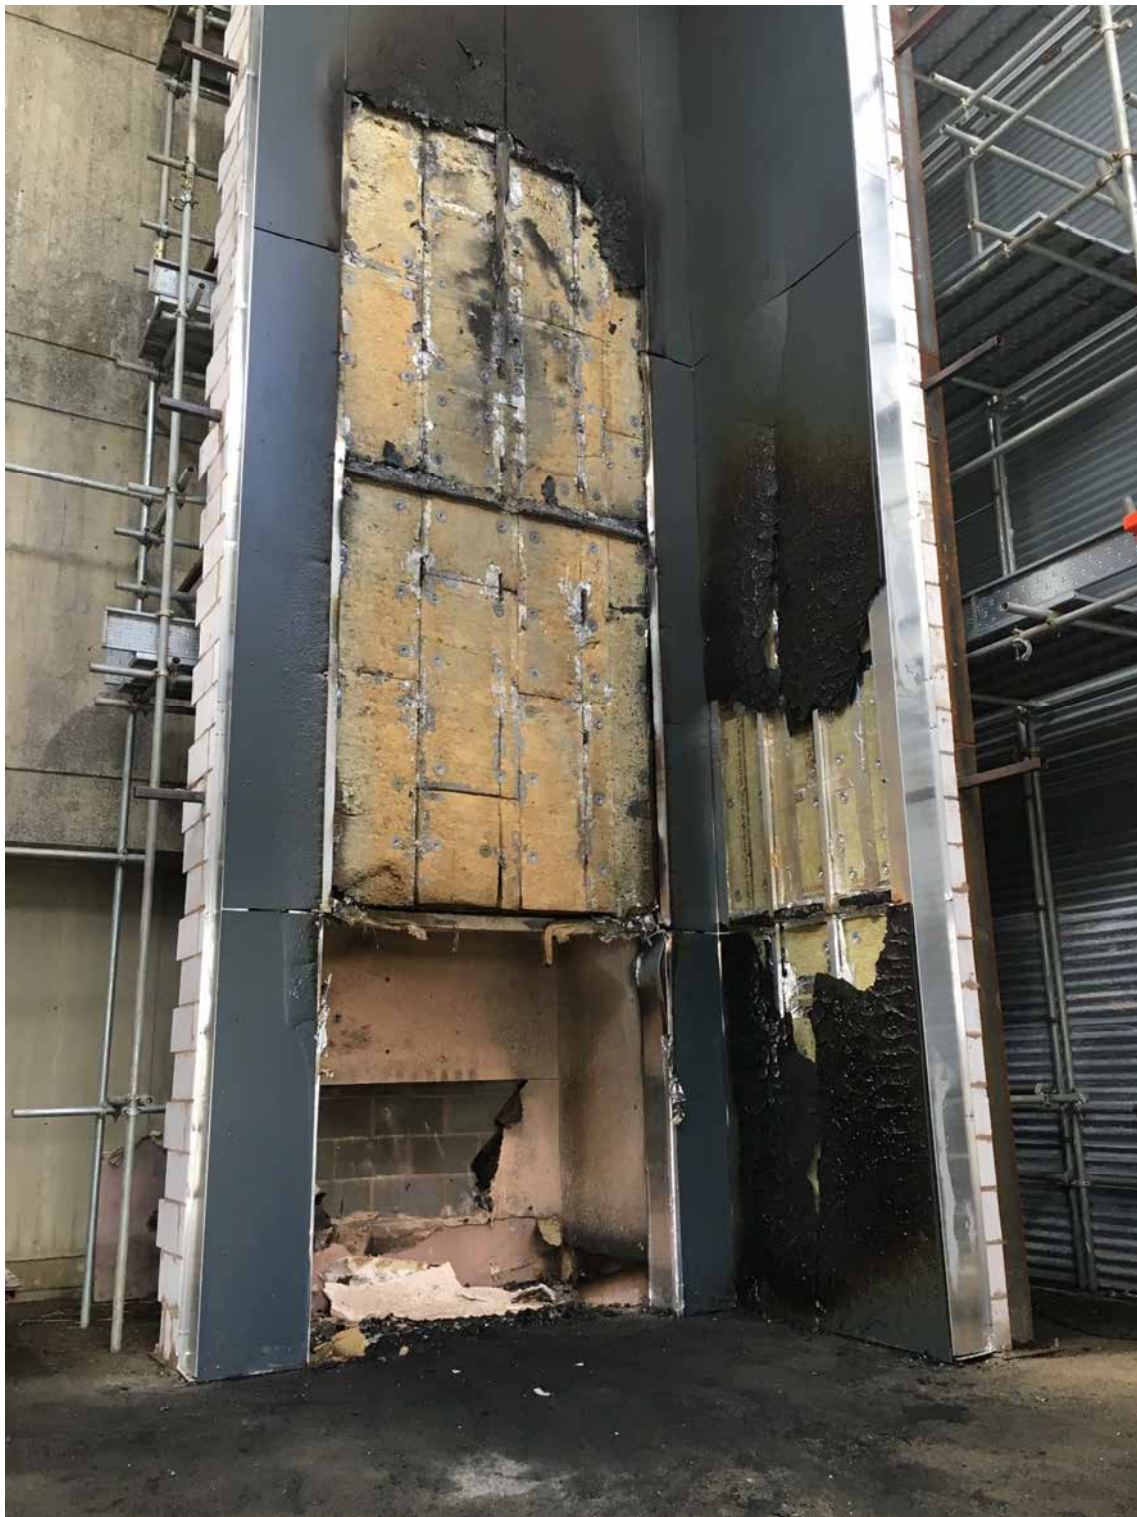
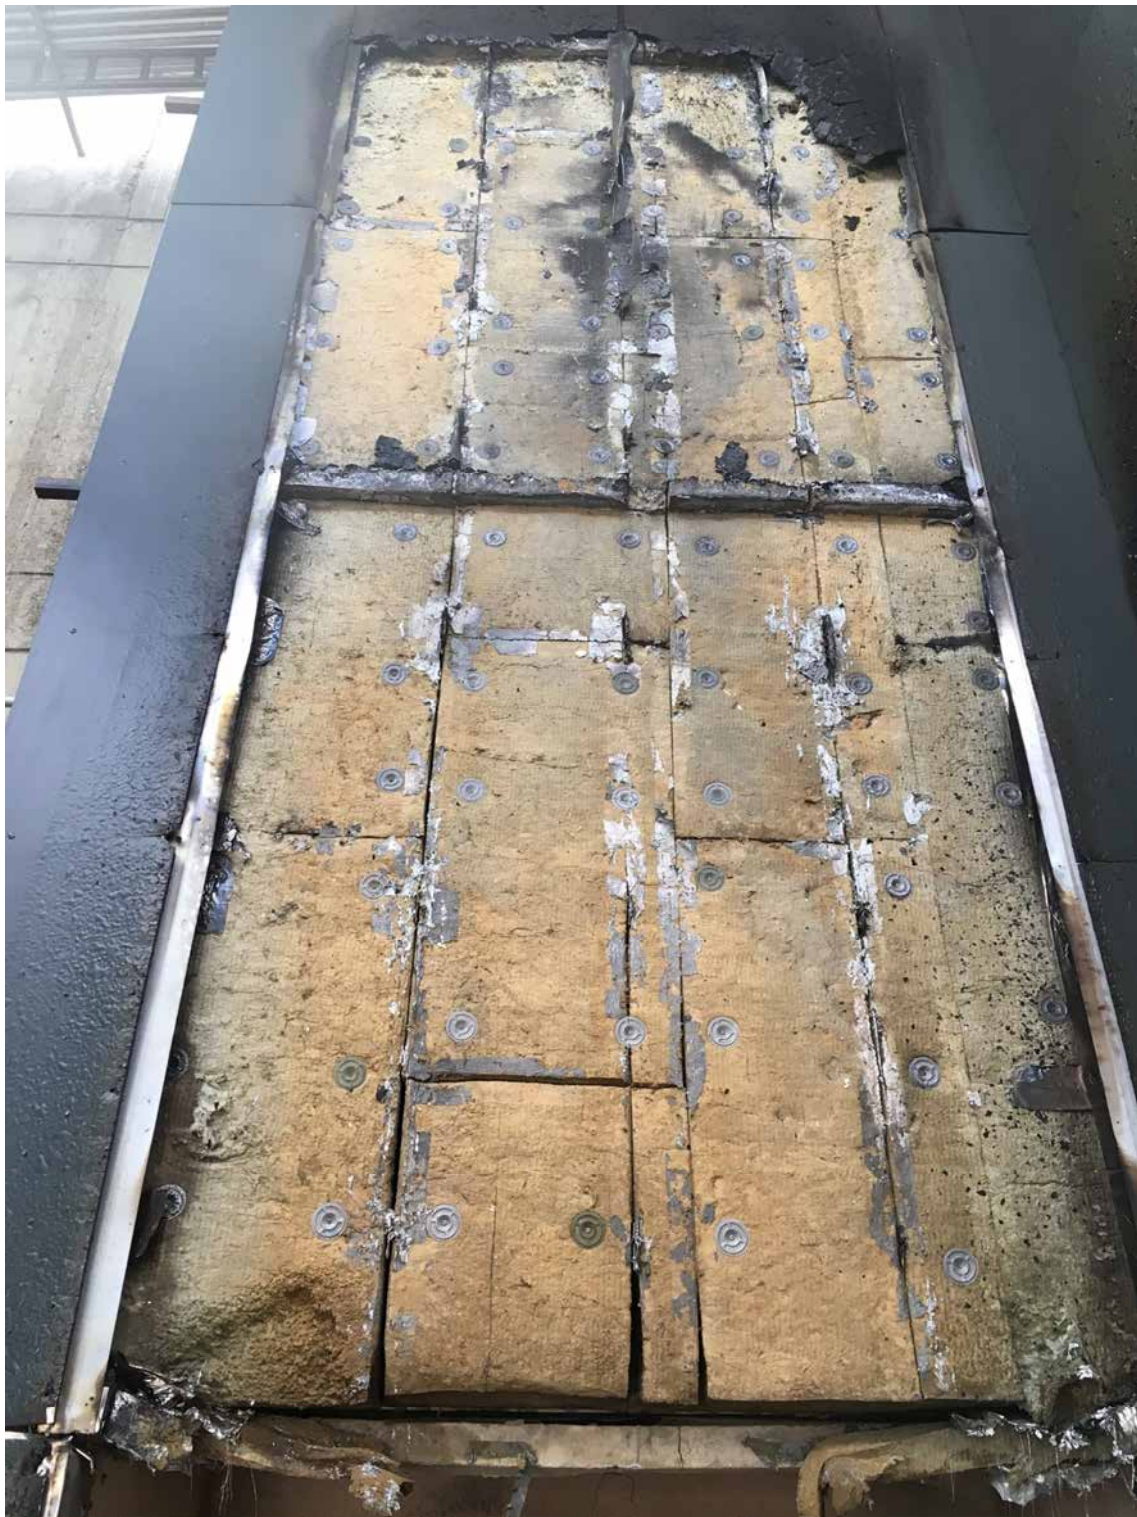
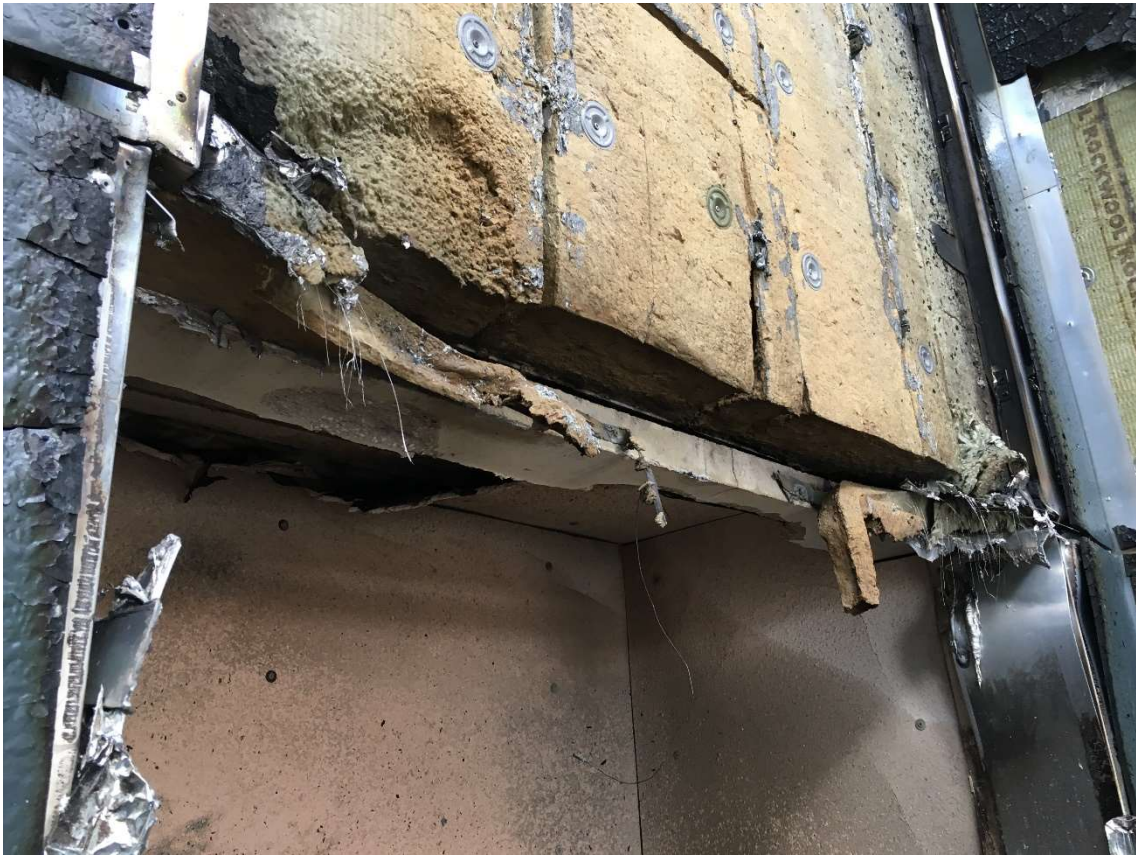
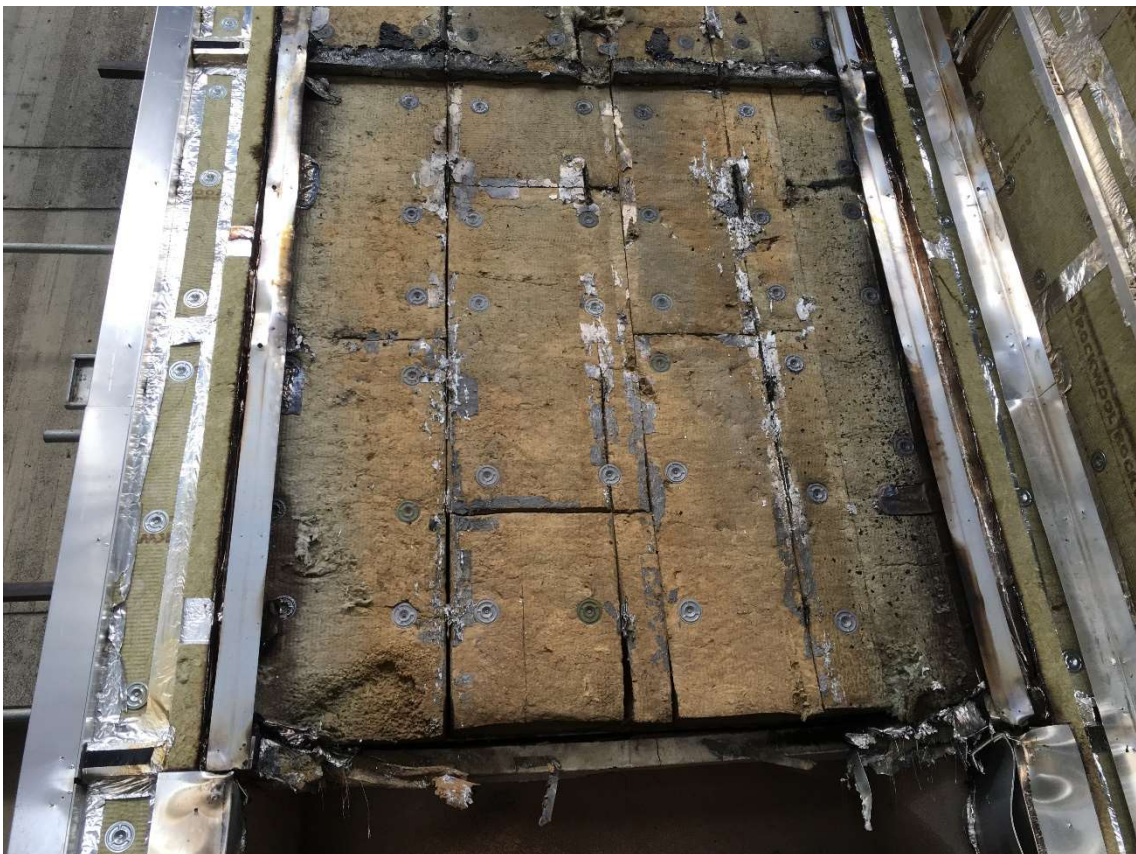
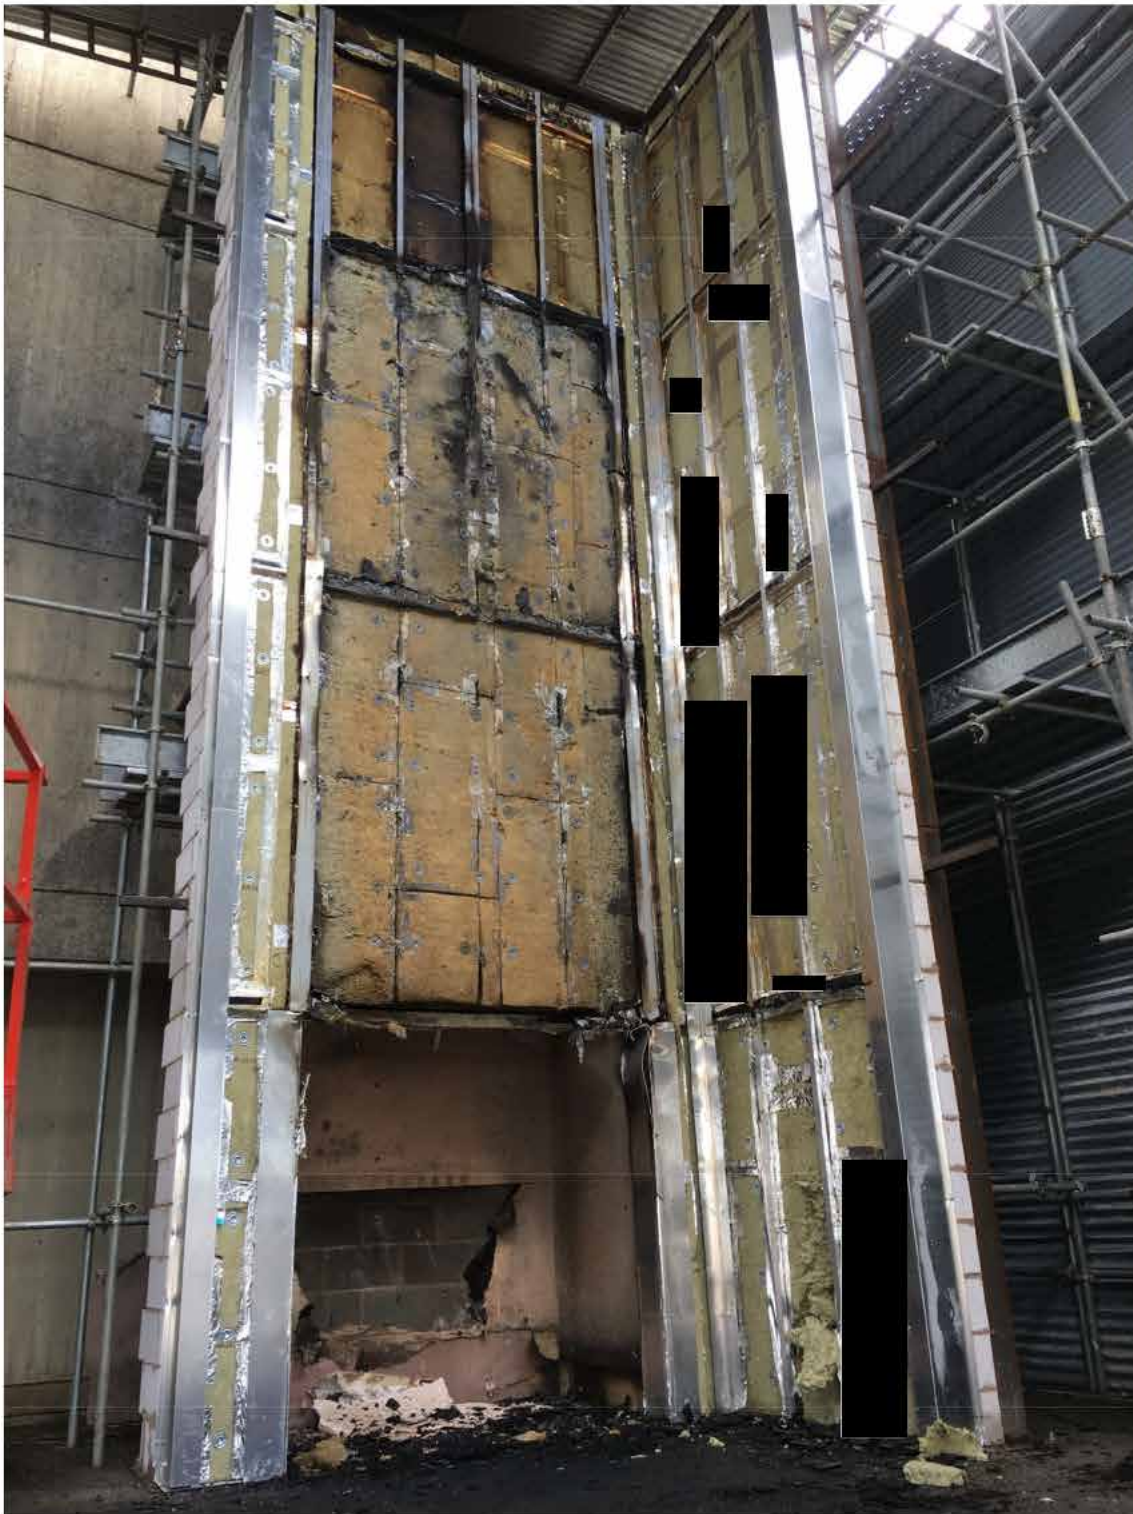
10 Appendix C – Post-test photographs

10.00	Crib lighting commences
14.00	Surface damage visible on façade panels, directly above fire
15.00	Aluminium frame begins to warp
15.30	Exterior skin of façade panels begins to blister

19.10	Aluminium frame around burn chamber fails
20.40	Small pieces of debris start to fall from fascia panels
21.50	Smoke emerging from gaps between lower panels

22.40	Lower façade panels visibly warped directly above fire
23.00	Smoke emerging from behind upper panels
24.00	Façade surface damage reaches upper panels

24.30	Façade surface damage visible on the wing panels
25.00	Surface of lower panels burnt away directly above fire
27.00	Cracks in lower panels directly above fire

29.40	Flames visible from behind the top of the lower panels
30.00	Bottom corners of lower façade panels warped
31.00	Larger pieces of debris falling from panels

32.00	Bottom of lower panels completely bunt away
33.16	Panels on wing wall warped
34.25	Large piece of debris falls from lower panel
36.40	Middle of lower panels, and bottom corners of upper panels burnt away

38.40	Loud audible bangs sounding from system – source uncertain
39.27	Remains of lower right panel falls
40.05	Crib extinguishment commences, water sprayed onto main wall façade panels
