Report No.: J094259
Nature of Work: Demolition Survey
Issue Date: 14/05/2018
Client Name: WYG Engineering Ltd
Geneva Building, Lake View Drive, Sherwood Business Park,
Annesley, Nottingham, NG15 0ED
Site Address: Student Union, Former City North Campus, Birmingham City
University, Perry Barr, B42 2US

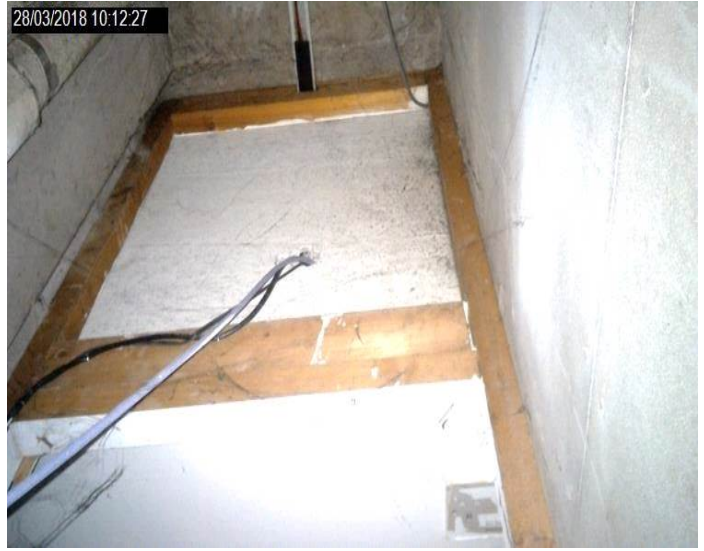
Location:	1.15 Bar Area	Block:	Commercial	Floor Level: Ground Floor
Sample No.:	DU001040	Portal Ref No.:	1

Item:	Insulating board panel to risers			
Asbestos Content:		Result Based on:		
No Asbestos Detected		Analysis of sample using PLM		
Sample Analysed By:	Reg 13(1)	Extent:	2 m ²	
Comments: Top panel to two risers see plan for location

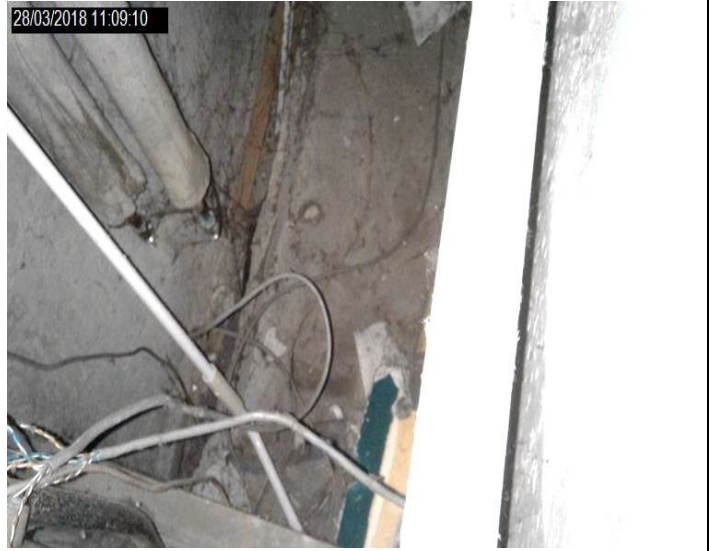
Item:	Insulating board debris to base of riser			
Asbestos Content:			Result Based on:	
No Asbestos Detected		Analysis of sample using PLM		
Sample Analysed By:	Reg 13(1)	Extent:	1 m ²	
Comments:

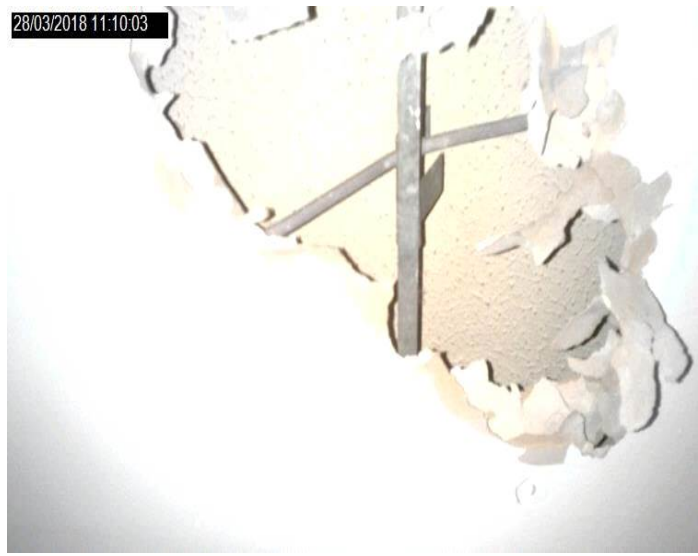
Item:	Asbestos Textured coating to concrete			
Asbestos Content:	Result Based on:			
Chrysotile	Strongly presumed			
Sample Analysed By:	Not applicable	Extent:	10 m ²	
Comments: Above suspended plasterboard ceiling to section of the room see plan for location

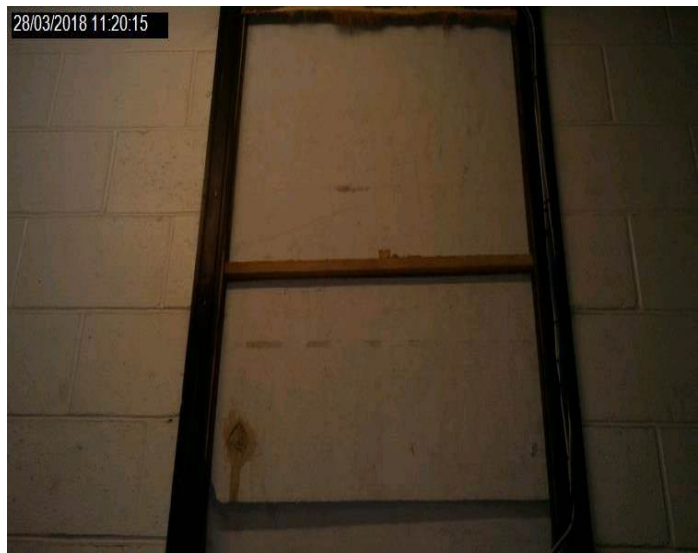
Item:	Asbestos Insulating board door header panel (double skin)			
Asbestos Content:	Result Based on:			
Chrysotile Amosite	Analysis of sample using PLM			
Sample Analysed By:	Reg 13(1)	Extent:	4 m ²	
Comments:

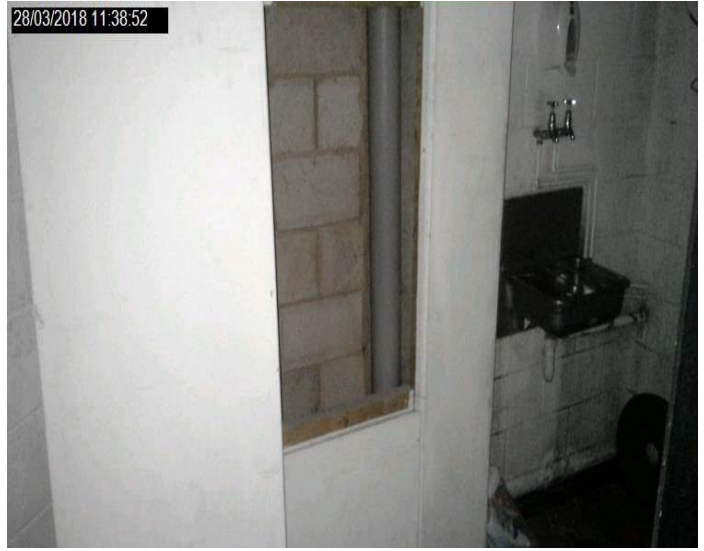
Item:	Insulating board panels to risers			
Asbestos Content:		Result Based on:		
No Asbestos Detected		Analysis of sample using PLM		
Sample Analysed By:	Reg 13(1)	Extent:	6 m ²	
Comments: 2 x riser both ends of the room all panels

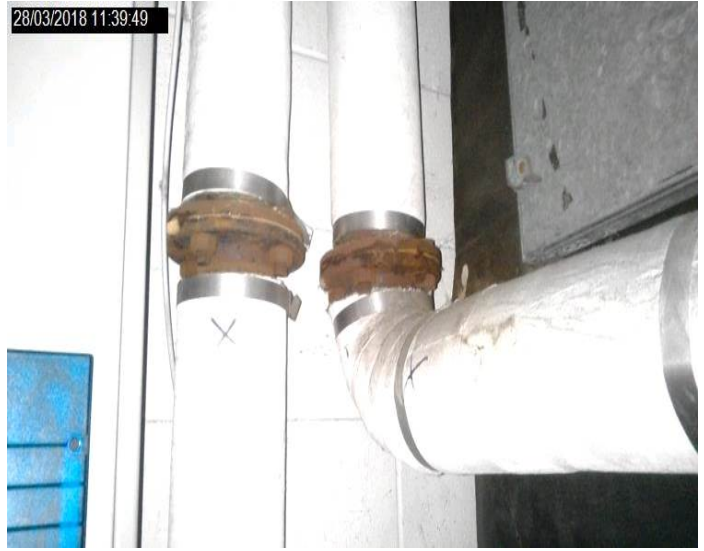
Item:	Asbestos Compressed fibre gaskets to pipework			
Asbestos Content:	Result Based on:			
Chrysotile	Analysis of sample using PLM			
Sample Analysed By:	Reg 13(1)	Extent:	2 units	
Comments:

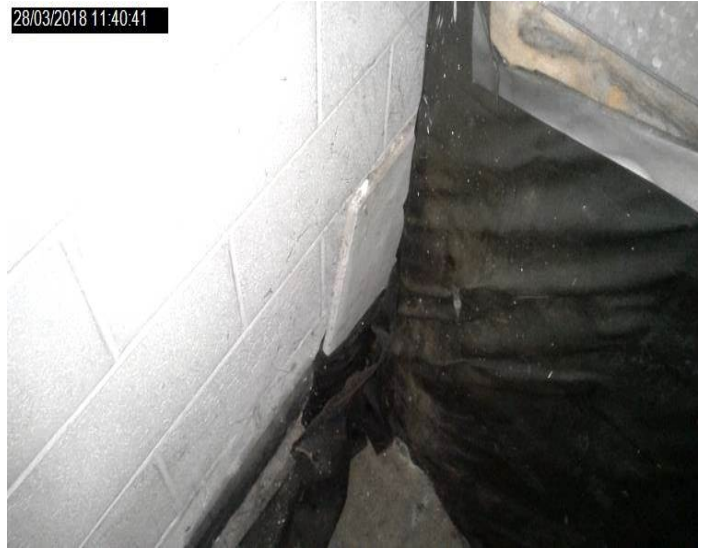
Item:	Insulating board panel debris			
Asbestos Content:		Result Based on:		
No Asbestos Detected		Analysis of sample using PLM		
Sample Analysed By:	Reg 13(1)	Extent:	1 m ²	
Comments: To left hand wall adjacent entrance

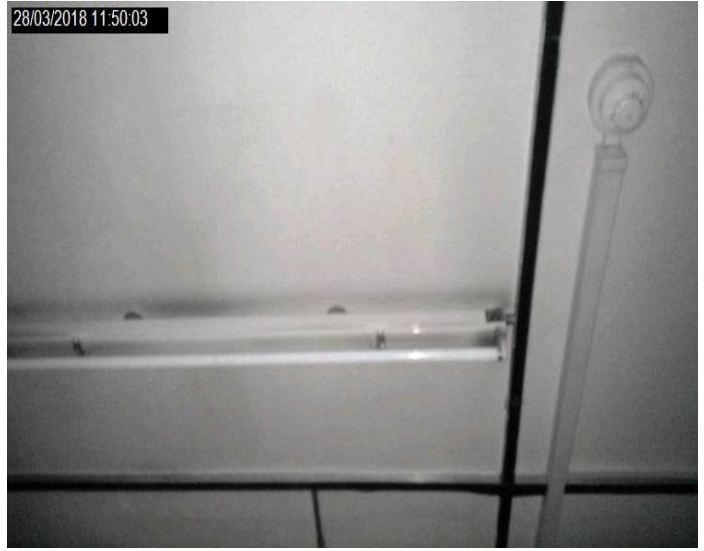
Item:	Asbestos Textured coating to concrete			
Asbestos Content:	Result Based on:			
Chrysotile	Analysis of sample using PLM			
Sample Analysed By:	Reg 13(1)	Extent:	12 m ²	
Comments:

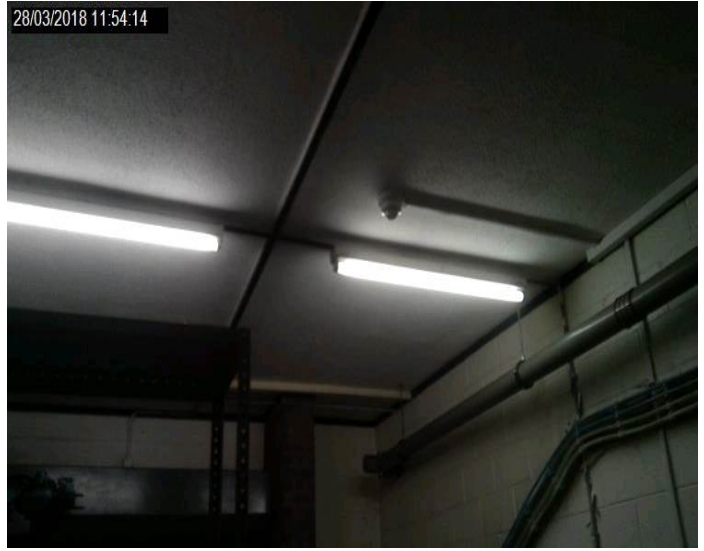
Item:	Asbestos Textured coating to concrete			
Asbestos Content:	Result Based on:			
Chrysotile	Strongly presumed			
Sample Analysed By:	Not applicable	Extent:	35 m ²	
Comments:

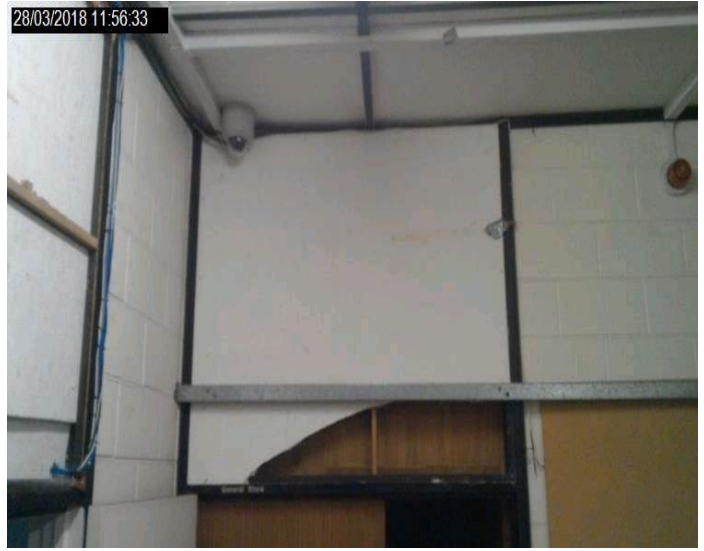
Item:	Insulating board door header panel			
Asbestos Content:		Result Based on:		
No Asbestos Detected		Analysis of sample using PLM		
Sample Analysed By:	Reg 13(1)	Extent:	10 m ²	
Comments: Above doors leading to 1.11, 1.13 and door leading to underpass area

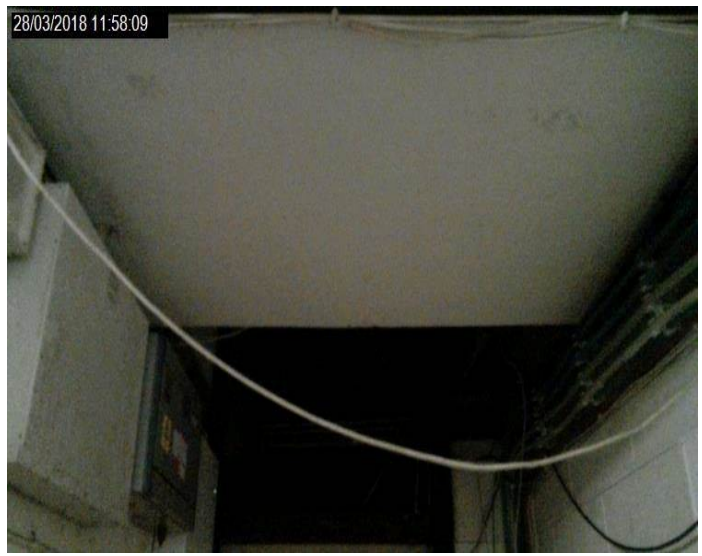
Item:	Asbestos Insulating board ceiling			
Asbestos Content:	Result Based on:			
Chrysotile Amosite	Analysis of sample using PLM			
Sample Analysed By: Reg 13(1)	Extent:	2 m ²		
Comments: Area leading to bar area, debris present to the top of the board

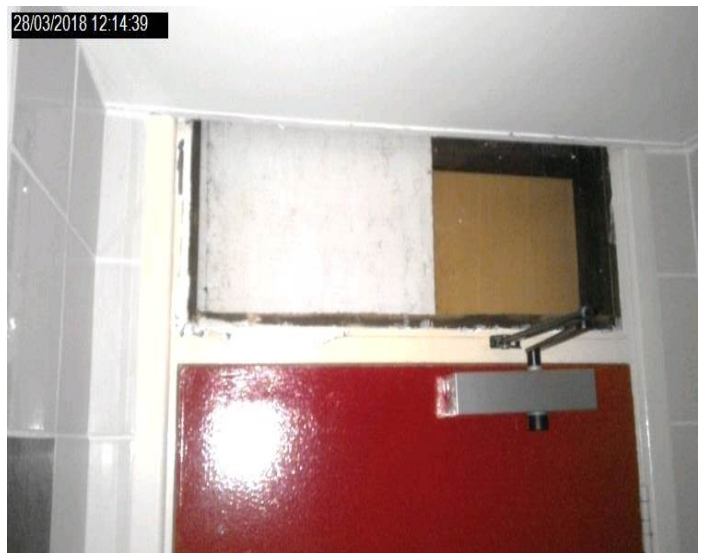
Item:	Asbestos Insulating board door headers			
Asbestos Content:	Result Based on:			
Chrysotile Amosite	Analysis of sample using PLM			
Sample Analysed By: Reg 13(1)	Extent:	3 m ²		
Comments: Above doors leading to female toilets see intrusion 024 for details of second area

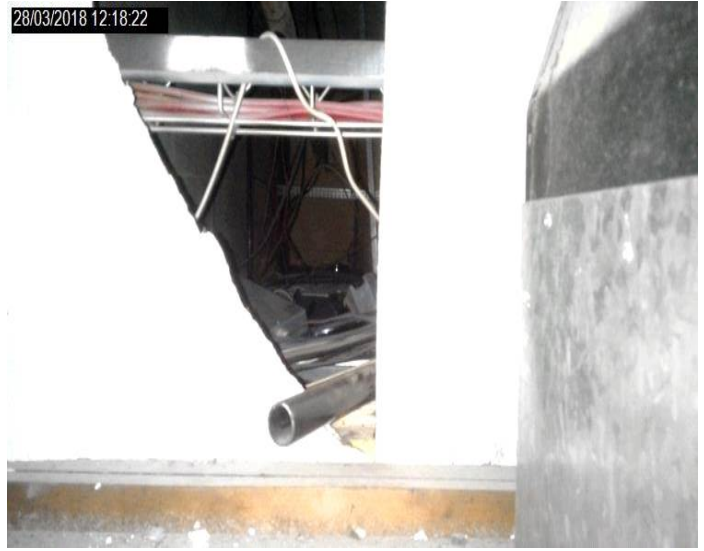
Item:	Asbestos Insulating board door headers			
Asbestos Content:	Result Based on:			
Chrysotile Amosite	Analysis of sample using PLM			
Sample Analysed By: Reg 13(1)	Extent:	2 m²		
Comments: Above doors leading to Male toilets see intrusion 025 for details of second area

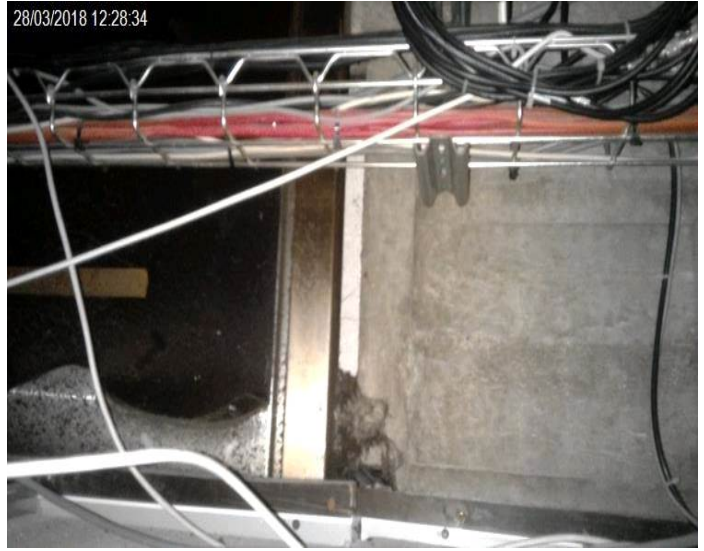
Item:	Insulating board to lift door header			
Asbestos Content:		Result Based on:		
No Asbestos Detected		Analysis of sample using PLM		
Sample Analysed By:	Reg 13(1)	Extent:	1 m ²	
Comments: Visible within ceiling void, behind metal panel

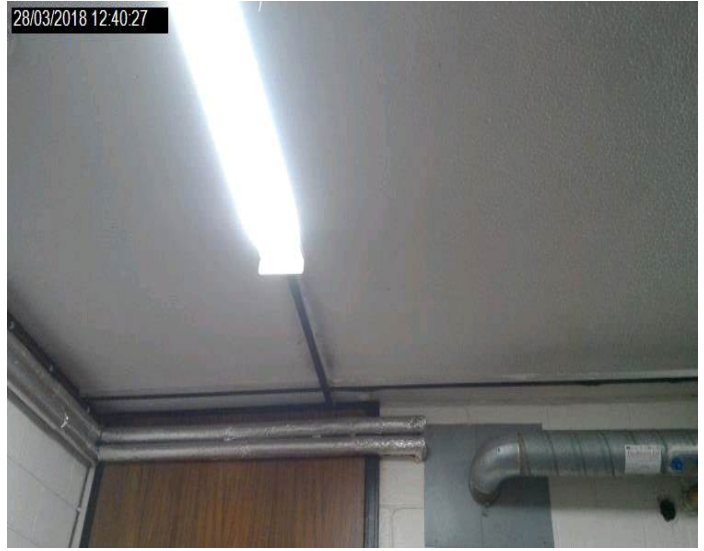
Item:	Asbestos Textured coating to concrete			
Asbestos Content:	Result Based on:			
Chrysotile	Strongly presumed			
Sample Analysed By:	Not applicable	Extent:	35 m ²	
Comments:

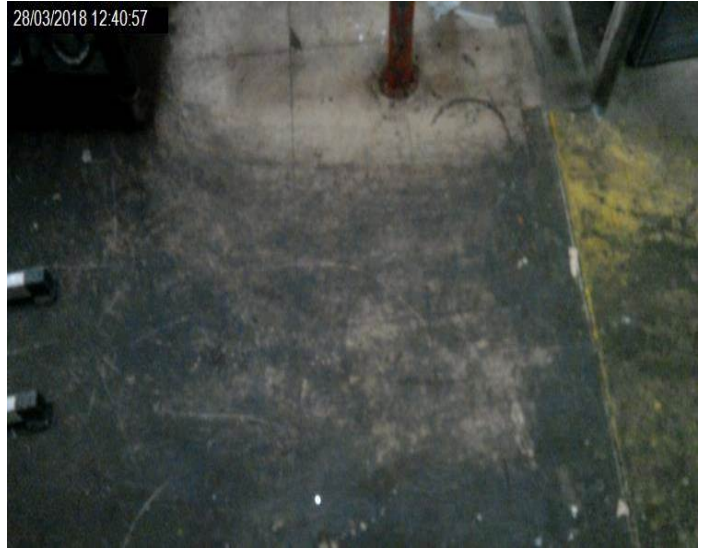
Item:	Asbestos Thermoplastic floor tiles with bitumen adhesive			
Asbestos Content:	Result Based on:			
Chrysotile in adhesive only		Analysis of sample using PLM		
Sample Analysed By:	Reg 13(1)	Extent:	14 m ²	
Comments:

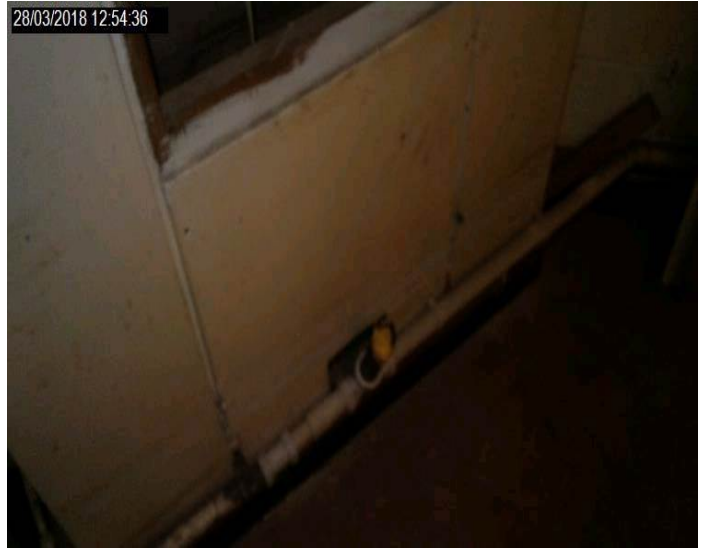
Item:	Insulating board panel to riser			
Asbestos Content:		Result Based on:		
No Asbestos Detected		Analysis of sample using PLM		
Sample Analysed By:	Reg 13(1)	Extent:	3 m ²	
Comments:

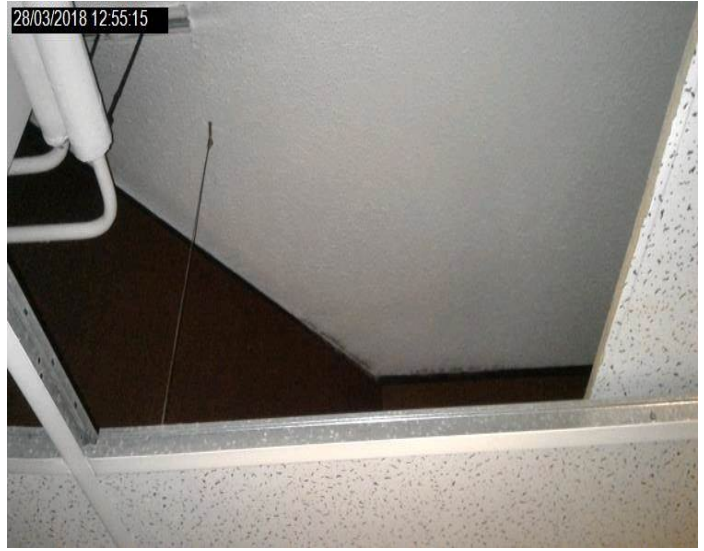
Item:	Asbestos Textured coating to concrete ceiling			
Asbestos Content:	Result Based on:			
Chrysotile	Strongly presumed			
Sample Analysed By:	Not applicable	Extent:	20 m ²	
Comments: Present above suspended ceiling

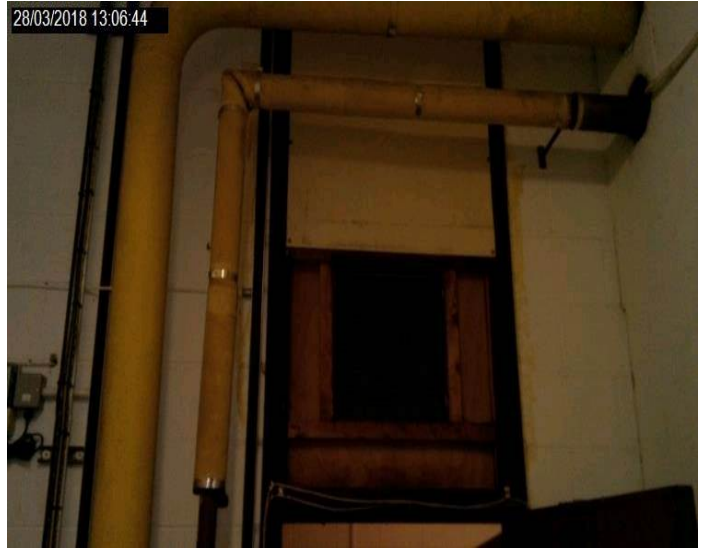
Item:	Insulating board door header			
Asbestos Content:		Result Based on:		
No Asbestos Detected		Analysis of sample using PLM		
Sample Analysed By:	Reg 13(1)	Extent:	3 m ²	
Comments:

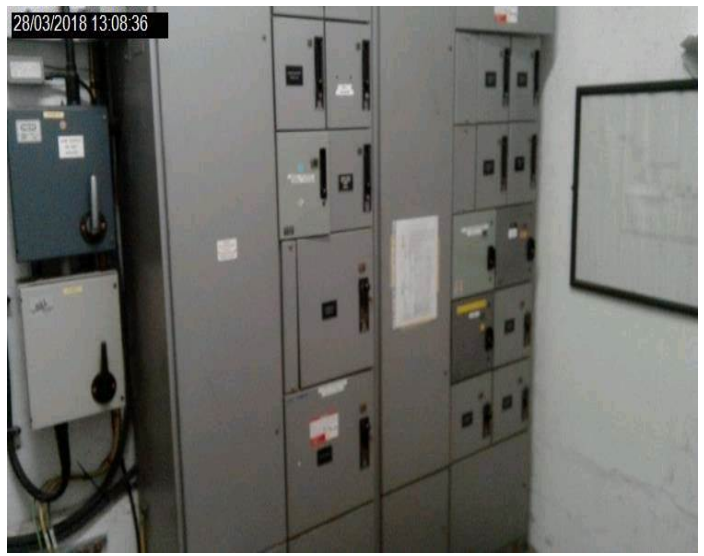
Item:	Asbestos Textile fuse tapes			
Asbestos Content:	Result Based on:			
Chrysotile	Presumed			
Sample Analysed By:	Not applicable	Extent:	5 m ²	
Comments: Live and connected, internally to distribution board

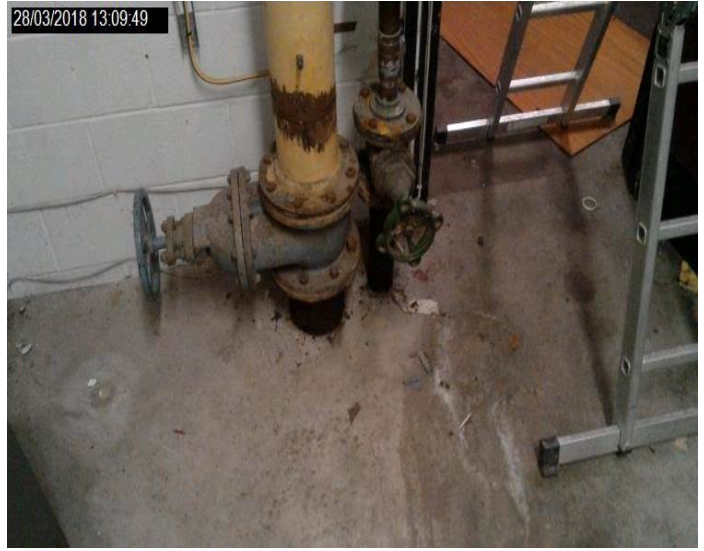
Item:	Asbestos Compressed fibre gaskets to pipework			
Asbestos Content:	Result Based on:			
Chrysotile	Analysis of sample using PLM			
Sample Analysed By:	Reg 13(1)	Extent:	5 units	
Comments:

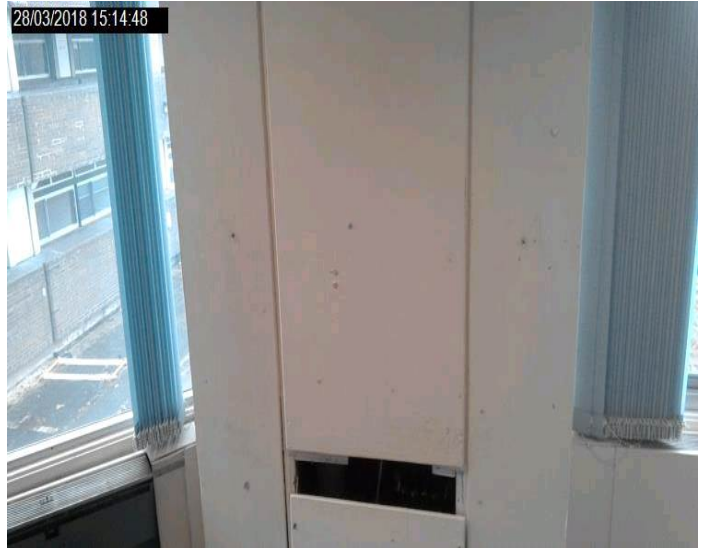
Item:	Insulating board panel to riser			
Asbestos Content:		Result Based on:		
No Asbestos Detected		Strongly presumed		
Sample Analysed By:	Not applicable	Extent:	6 m ²	
Comments:

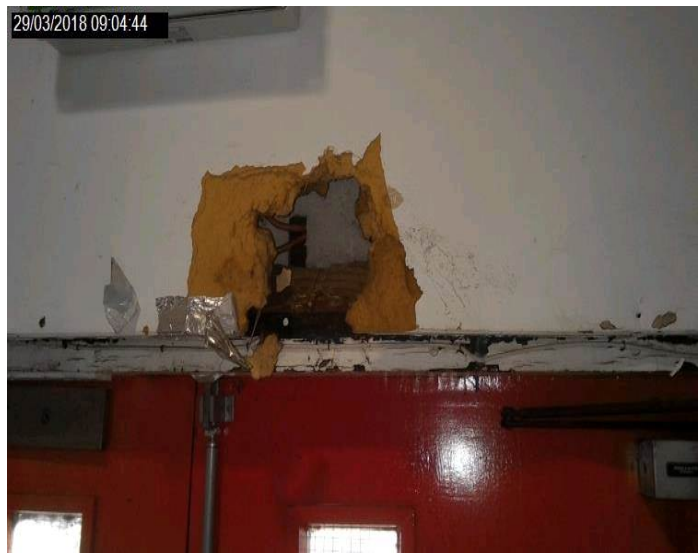
Item:	Insulating board door header			
Asbestos Content:			Result Based on:	
No Asbestos Detected		Analysis of sample using PLM		
Sample Analysed By:	Reg 13(1)	Extent:	2 m ²	
Comments: Single panel half height of timber in front of the item

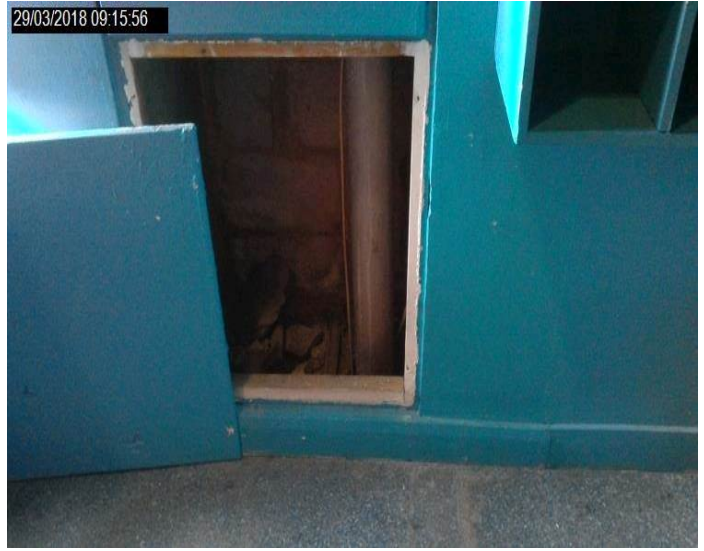
Item:	Insulating board panel to riser			
Asbestos Content:		Result Based on:		
No Asbestos Detected		Analysis of sample using PLM		
Sample Analysed By:	Reg 13(1)	Extent:	3 m ²	
Comments:

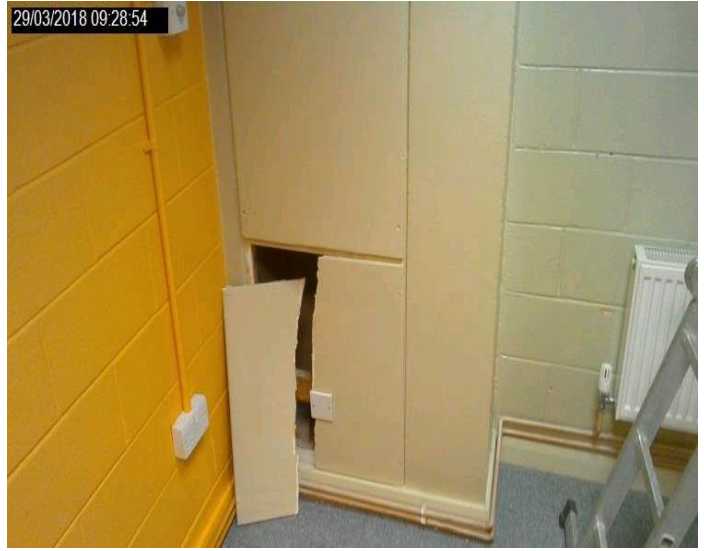
Item:	Insulating board panel to riser			
Asbestos Content:	Result Based on:			
No Asbestos Detected	Analysis of sample using PLM			
Sample Analysed By: Reg 13(1)	Extent:	3 m ²		
Comments:

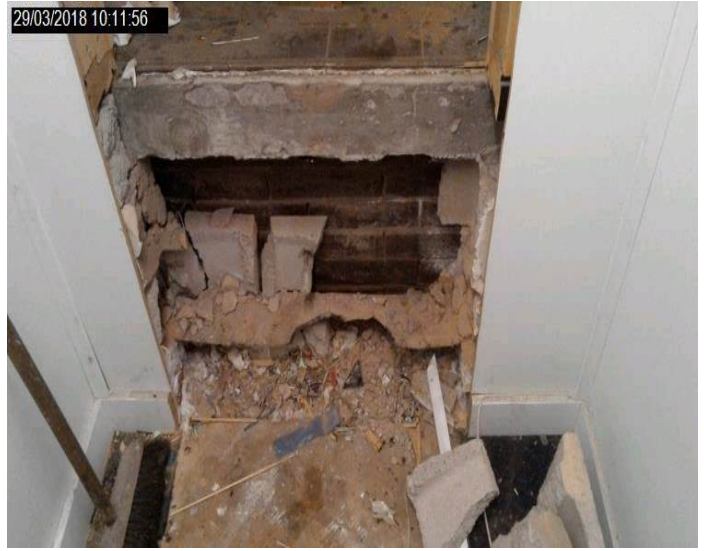
Item:	Asbestos Bitumen damp proof course			
Asbestos Content:			Result Based on:	
Chrysotile			Analysis of sample using PLM	
Sample Analysed By:	Reg 13(1)	Extent:	250 linear metres	
Comments: To entire external wall, this is evident to the perimeter of the building top and bottom of the internal blockwork, top of the blockwork meets the underside of the concrete sill damp proof course is present

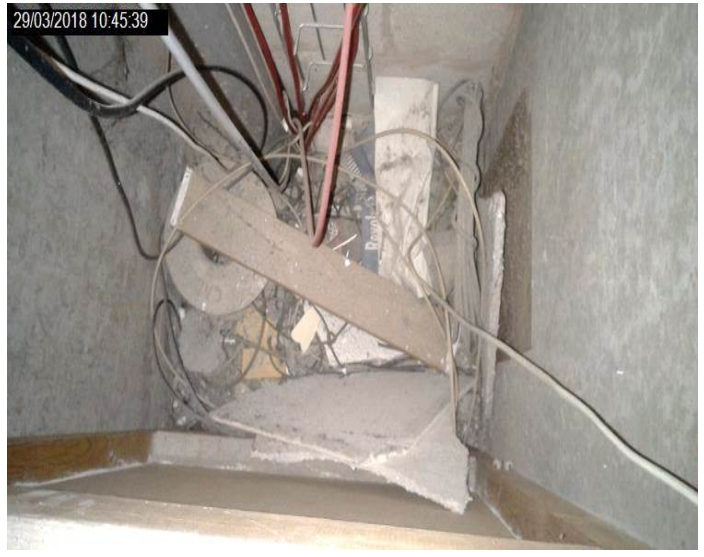
Item:	Insulating board debris to base of riser			
Asbestos Content:		Result Based on:		
No Asbestos Detected		Analysis of sample using PLM		
Sample Analysed By:	Reg 13(1)	Extent:	1 m ²	
Comments:

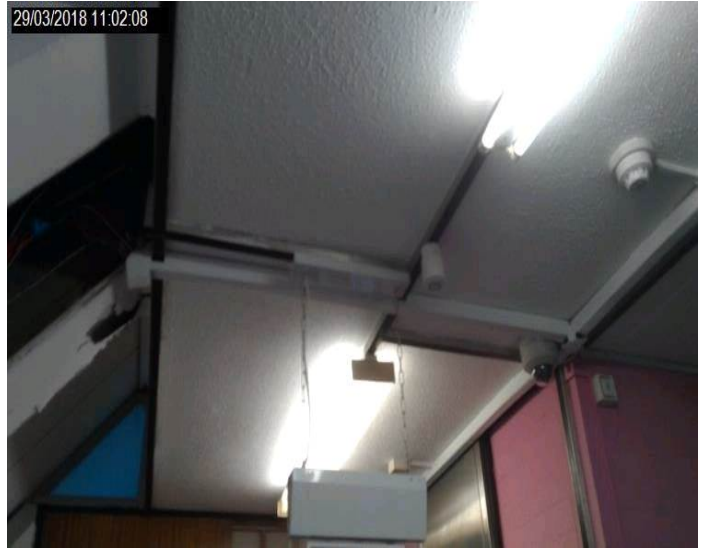
Item:	Asbestos Textured coating to concrete ceiling			
Asbestos Content:	Result Based on:			
Chrysotile	Analysis of sample using PLM			
Sample Analysed By:	Reg 13(1)	Extent:	14 m ²	
Comments:

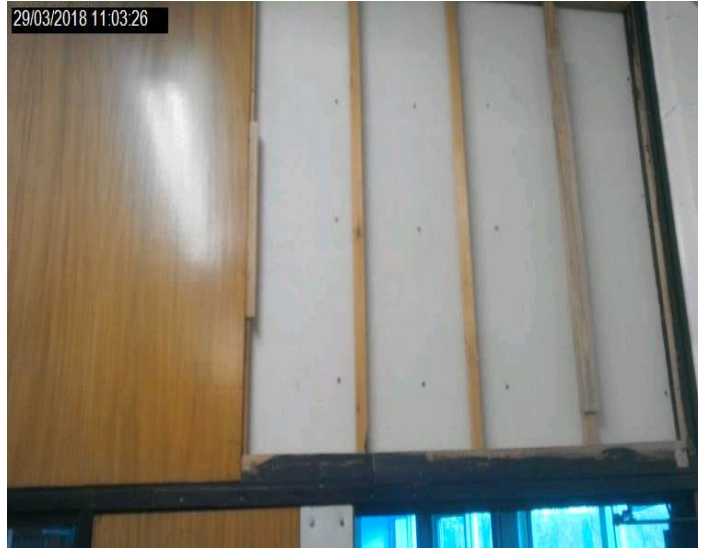
Item:	Insulating board door header panels			
Asbestos Content:		Result Based on:		
No Asbestos Detected		Analysis of sample using PLM		
Sample Analysed By:	Reg 13(1)	Extent:	8 m ²	
Comments: To both doors double leading to adjoining areas

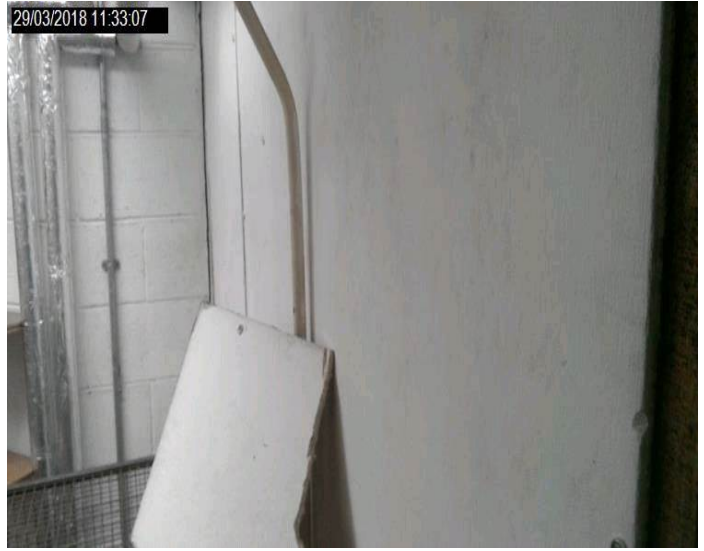
Item:	Insulating board panels to service duct			
Asbestos Content:		Result Based on:		
No Asbestos Detected		Analysis of sample using PLM		
Sample Analysed By:	Reg 13(1)	Extent:	8 m ²	
Comments:

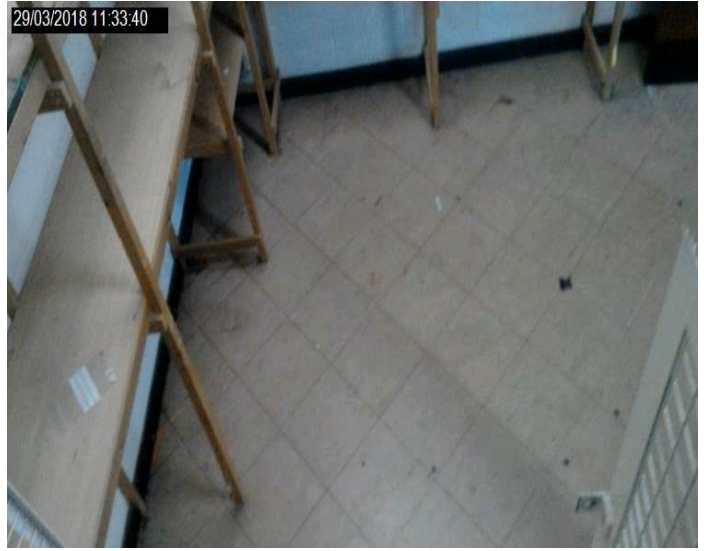
Item:	Asbestos Thermoplastic floor tiles with bitumen adhesive			
Asbestos Content:	Result Based on:			
Chrysotile in adhesive only	Analysis of sample using PLM			
Sample Analysed By: Reg 13(1)	Extent:	20 m ²		
Comments:

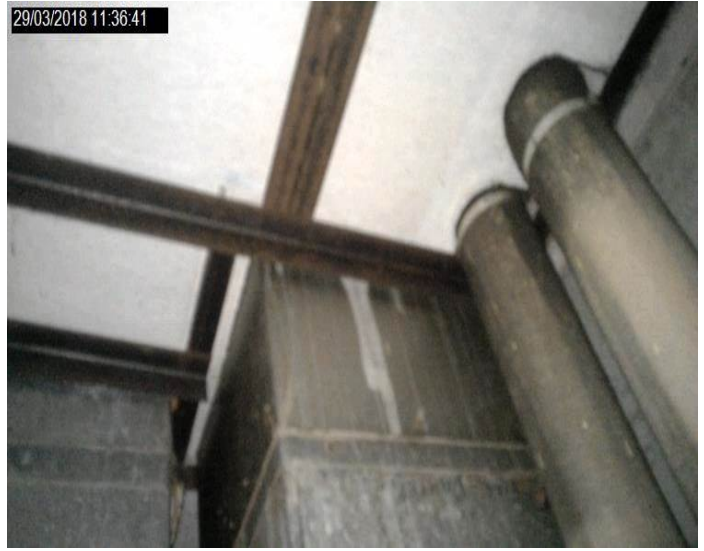
Item:	Insulating board panel to riser			
Asbestos Content:		Result Based on:		
No Asbestos Detected		Analysis of sample using PLM		
Sample Analysed By:	Reg 13(1)	Extent:	5 m ²	
Comments:

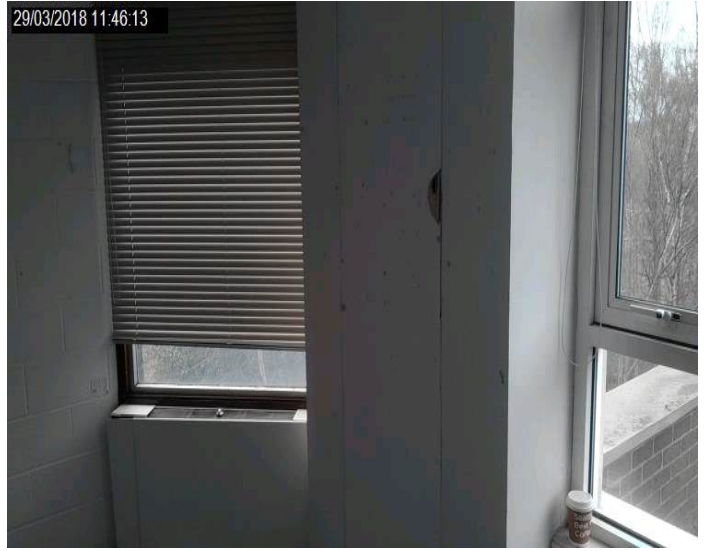
Item:	Insulating board panel to riser			
Asbestos Content:		Result Based on:		
No Asbestos Detected		Analysis of sample using PLM		
Sample Analysed By:	Reg 13(1)	Extent:	3 m ²	
Comments:

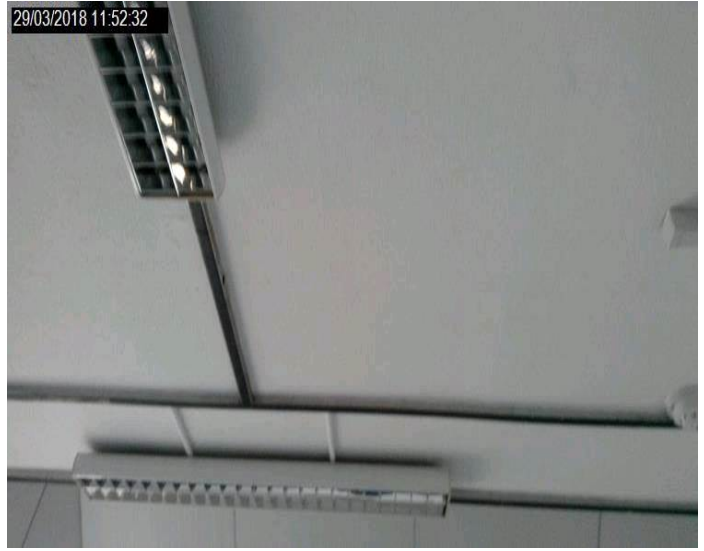
Item:	Asbestos Textured coating to concrete			
Asbestos Content:	Result Based on:			
Chrysotile	Strongly presumed			
Sample Analysed By:	Not applicable	Extent:	26 m ²	
Comments:

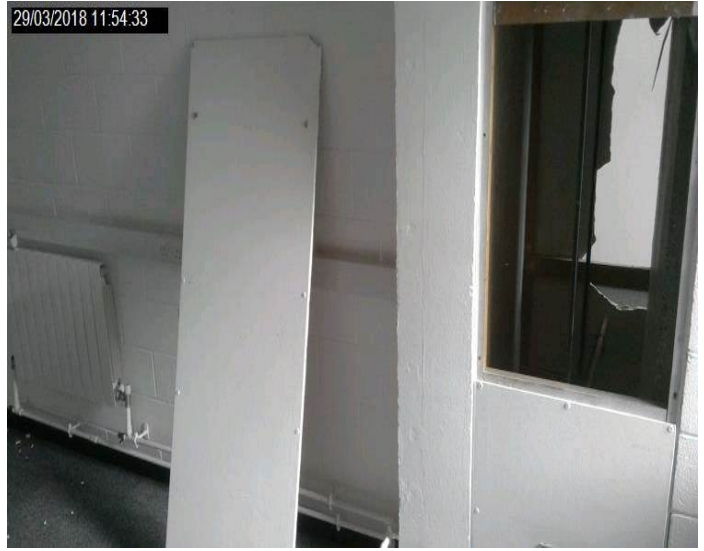
Item:	Insulating board panel to riser			
Asbestos Content:		Result Based on:		
No Asbestos Detected		Strongly presumed		
Sample Analysed By:	Not applicable	Extent:	3 m ²	
Comments:

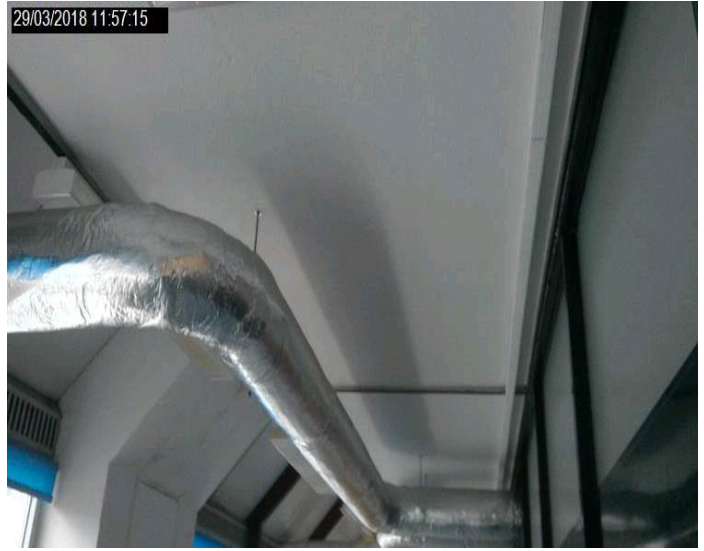
Item:	Asbestos Textured coating to concrete ceiling			
Asbestos Content:	Result Based on:			
Chrysotile	Analysis of sample using PLM			
Sample Analysed By:	Reg 13(1)	Extent:	58 m ²	
Comments:

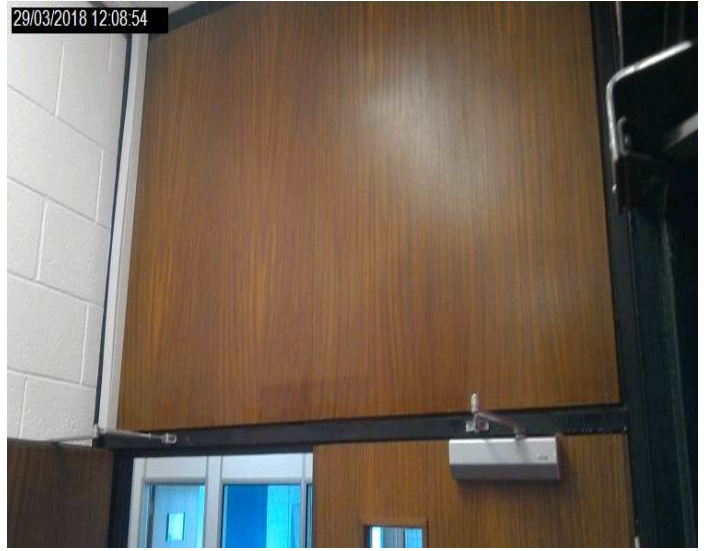
Item:	Insulating board door header			
Asbestos Content:		Result Based on:		
No Asbestos Detected		Analysis of sample using PLM		
Sample Analysed By:	Reg 13(1)	Extent:	4 m ²	
Comments: Double skin behind timber panel

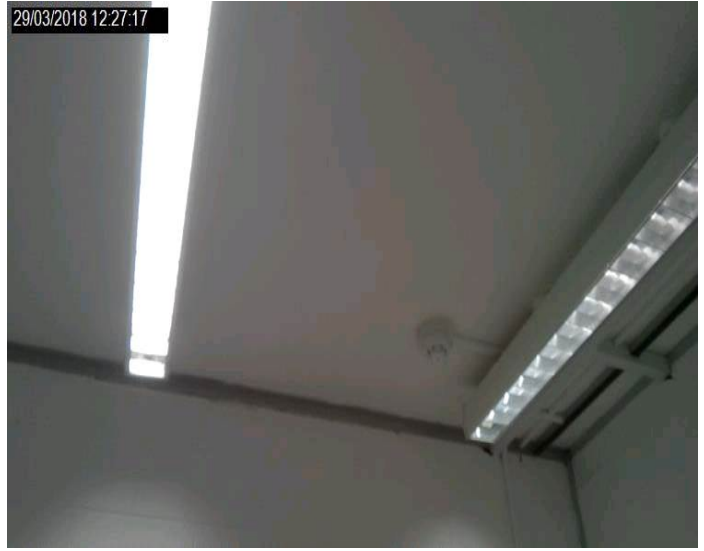
Item:	Asbestos Textured coating to concrete ceiling			
Asbestos Content:	Result Based on:			
Chrysotile	Strongly presumed			
Sample Analysed By:	Not applicable	Extent:	5 m ²	
Comments:

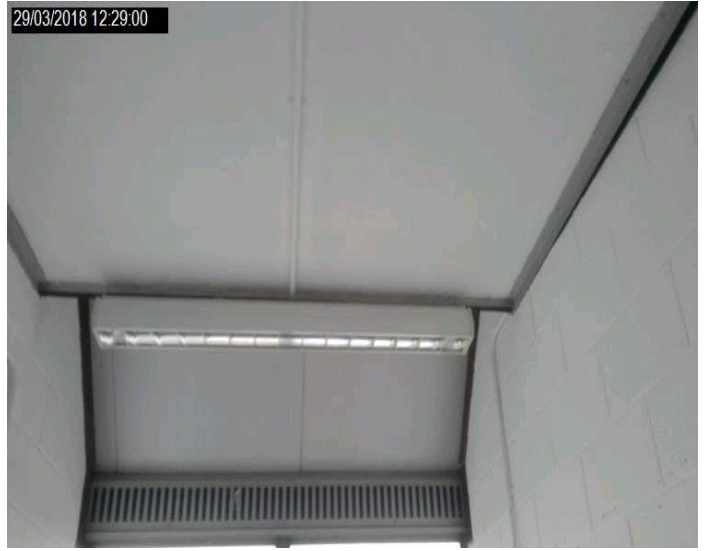
Item:	Asbestos Textured coating to concrete ceiling			
Asbestos Content:	Result Based on:			
Chrysotile	Strongly presumed			
Sample Analysed By:	Not applicable	Extent:	10 m ²	
Comments:

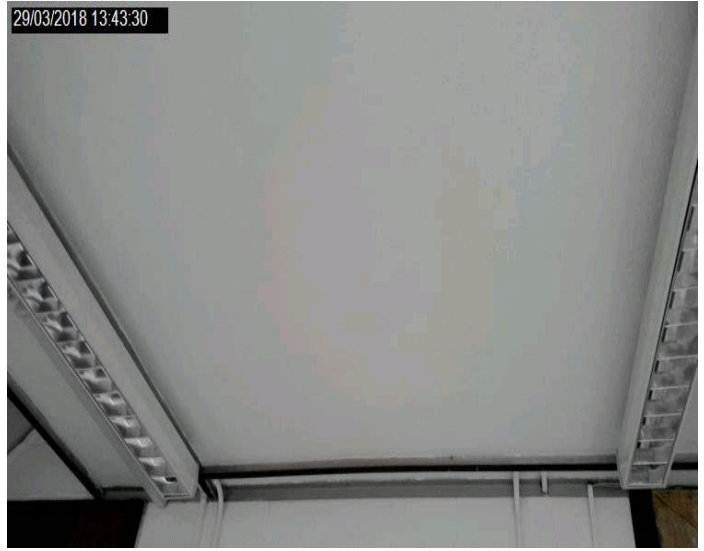
Item:	Asbestos Textured coating to concrete ceiling			
Asbestos Content:	Result Based on:			
Chrysotile	Strongly presumed			
Sample Analysed By:	Not applicable	Extent:	8 m ²	
Comments:

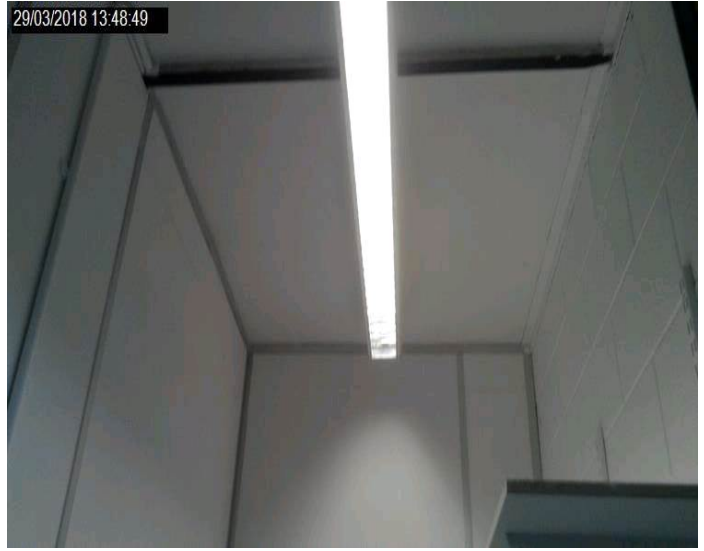
Item:	Asbestos Textured coating to concrete ceiling			
Asbestos Content:	Result Based on:			
Chrysotile	Strongly presumed			
Sample Analysed By:	Not applicable	Extent:	2 m ²	
Comments:

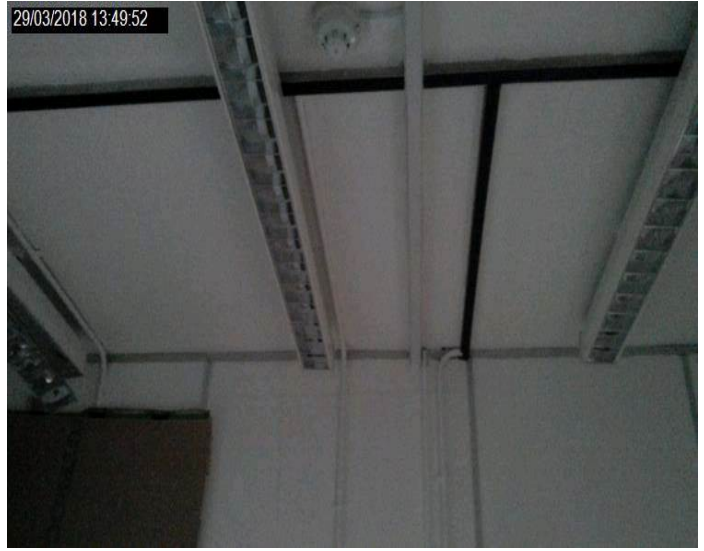
Item:	Asbestos Textured coating to concrete ceiling			
Asbestos Content:	Result Based on:			
Chrysotile	Strongly presumed			
Sample Analysed By:	Not applicable	Extent:	8 m ²	
Comments:

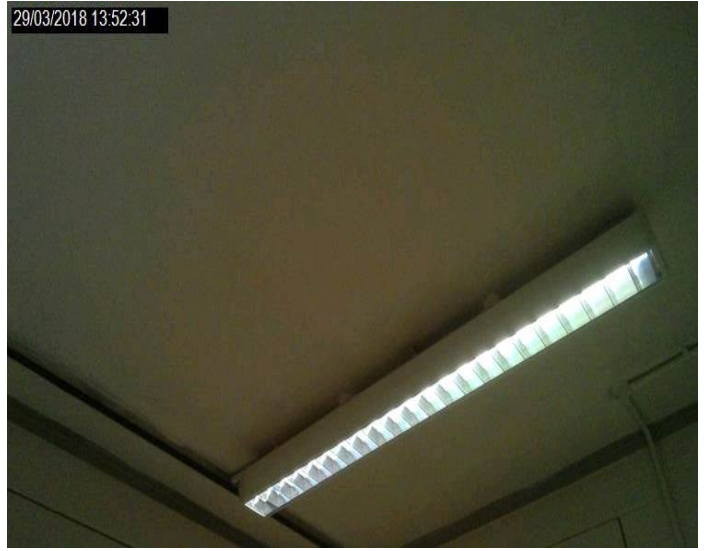
Item:	Asbestos Textured coating to concrete ceiling			
Asbestos Content:	Result Based on:			
Chrysotile	Strongly presumed			
Sample Analysed By:	Not applicable	Extent:	8 m ²	
Comments:

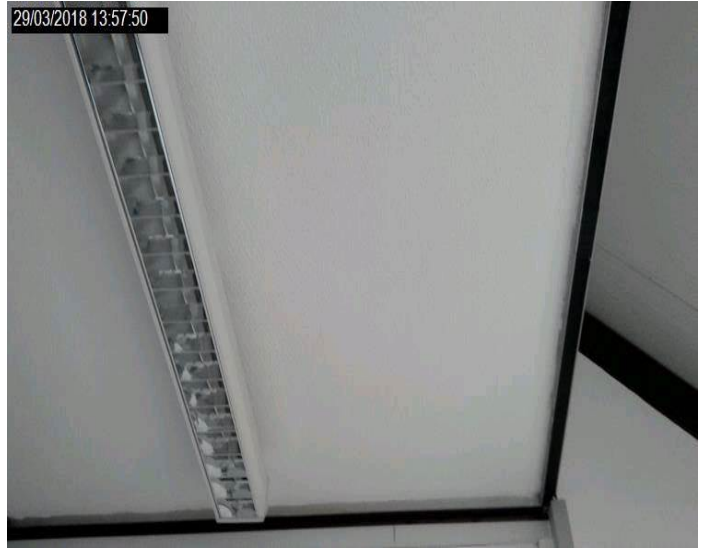
Item:	Asbestos Textured coating to concrete ceiling			
Asbestos Content:	Result Based on:			
Chrysotile	Analysis of sample using PLM			
Sample Analysed By:	Reg 13(1)	Extent:	8 m ²	
Comments:

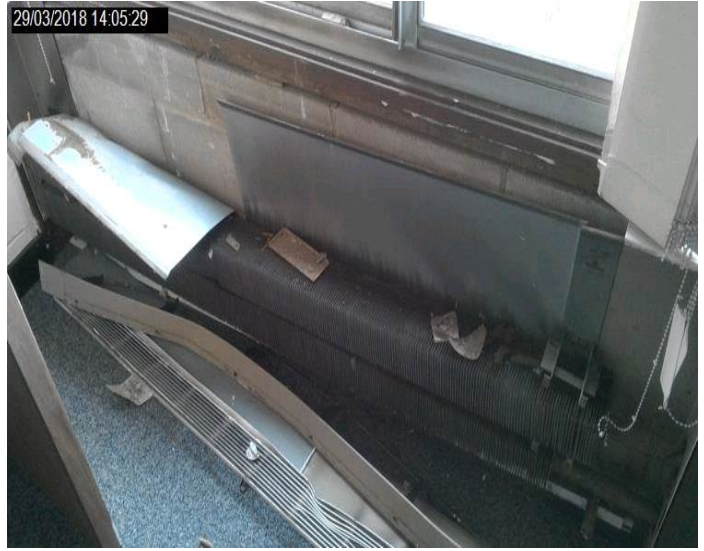
Item:	Bitumen damp proof course			
Asbestos Content:	Result Based on:			
No Asbestos Detected	Analysis of sample using PLM			
Sample Analysed By: Reg 13(1)	Extent:	250 linear metres		
<p>Comments: To entire external wall, this is evident to the perimeter of the building top and bottom of the internal blockwork, top of the blockwork meets the underside of the concrete sill dpc is present</p>

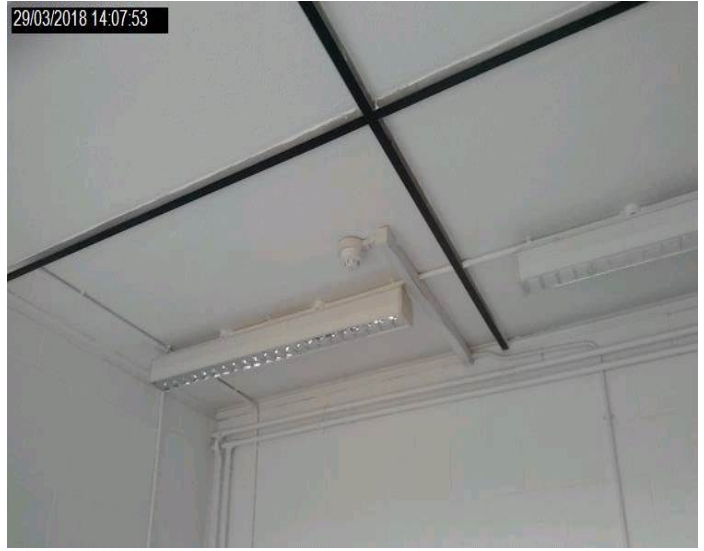
Item:	Asbestos Textured coating to concrete ceiling			
Asbestos Content:	Result Based on:			
Chrysotile	Strongly presumed			
Sample Analysed By:	Not applicable	Extent:	12 m ²	
Comments:

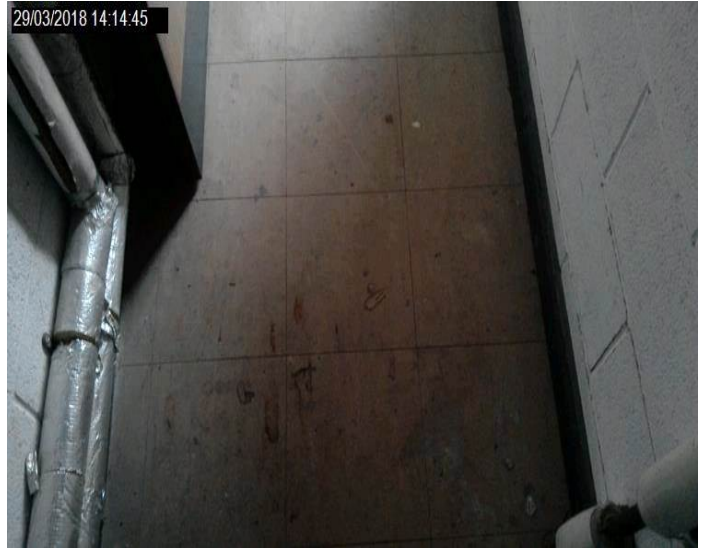
Item:	Asbestos Thermoplastic floor tiles with bitumen adhesive			
Asbestos Content:	Result Based on:			
Chrysotile in adhesive only	Analysis of sample using PLM			
Sample Analysed By: Reg 13(1)	Extent:	3 m ²		
Comments:

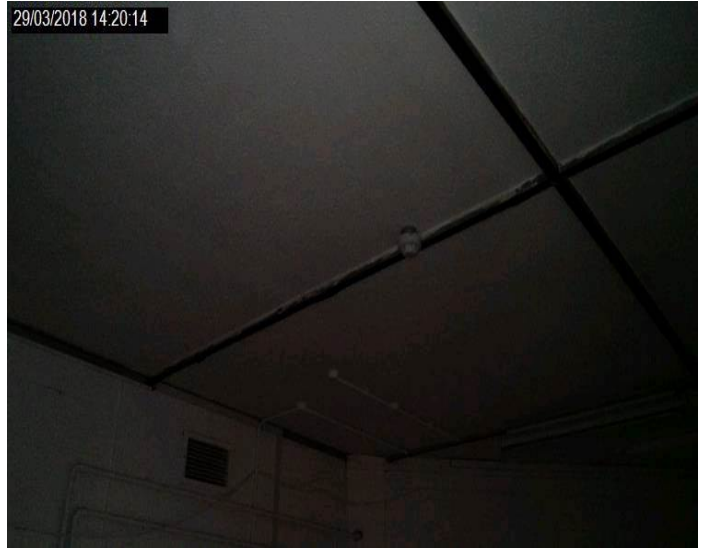
Item:	Asbestos Textured coating to concrete ceiling			
Asbestos Content:	Result Based on:			
Chrysotile	Strongly presumed			
Sample Analysed By:	Not applicable	Extent:	25 m ²	
Comments:

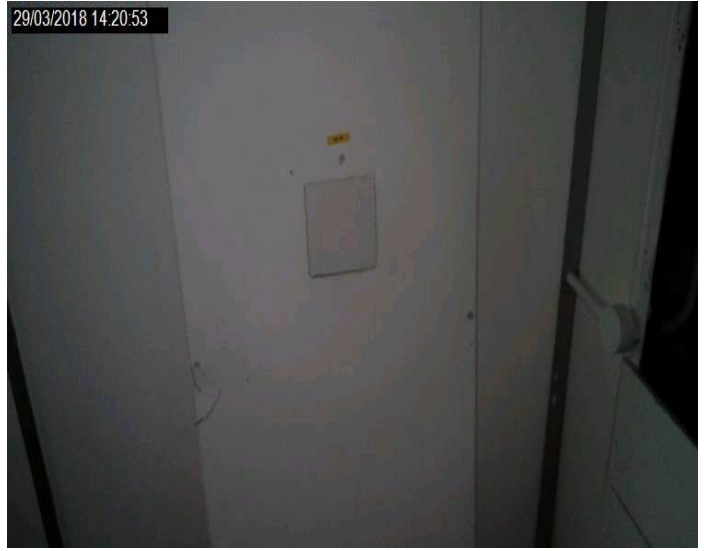
Item:	Insulating board panel to riser			
Asbestos Content:		Result Based on:		
No Asbestos Detected		Strongly presumed		
Sample Analysed By:	Not applicable	Extent:	3 m ²	
Comments:

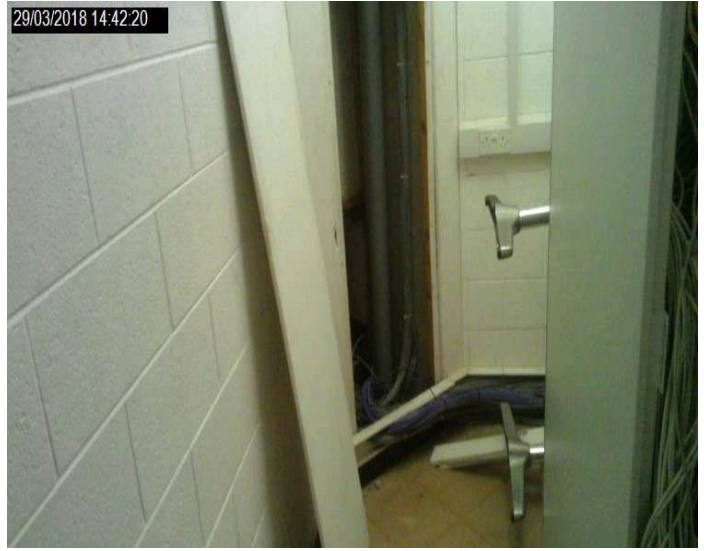
Item:	Insulating board panel to riser			
Asbestos Content:		Result Based on:		
No Asbestos Detected		Strongly presumed		
Sample Analysed By:	Not applicable	Extent:	3 m ²	
Comments:

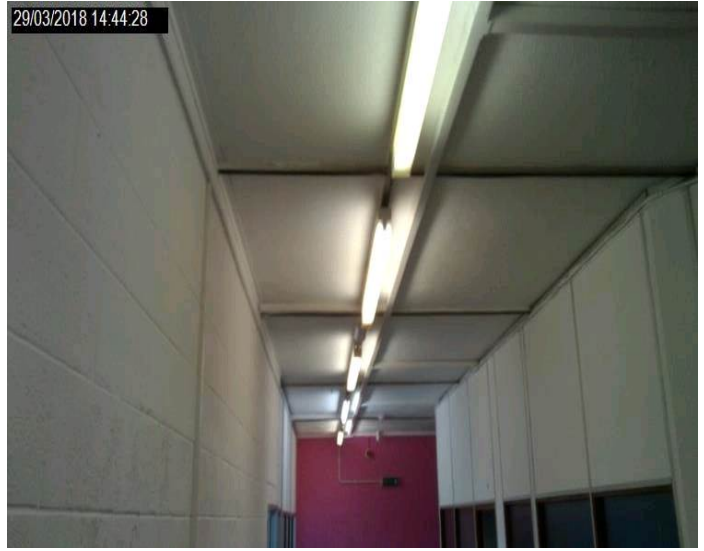
Item:	Asbestos Textured coating to concrete ceiling			
Asbestos Content:	Result Based on:			
Chrysotile	Strongly presumed			
Sample Analysed By:	Not applicable	Extent:	50 m ²	
Comments:
