Report No.: J094259
Nature of Work: Demolition Survey
Issue Date: 14/05/2018
Client Name: WYG Engineering Ltd
Geneva Building, Lake View Drive, Sherwood Business Park,
Annesley, Nottingham, NG15 0ED
Site Address: Student Union, Former City North Campus, Birmingham City
University, Perry Barr, B42 2US

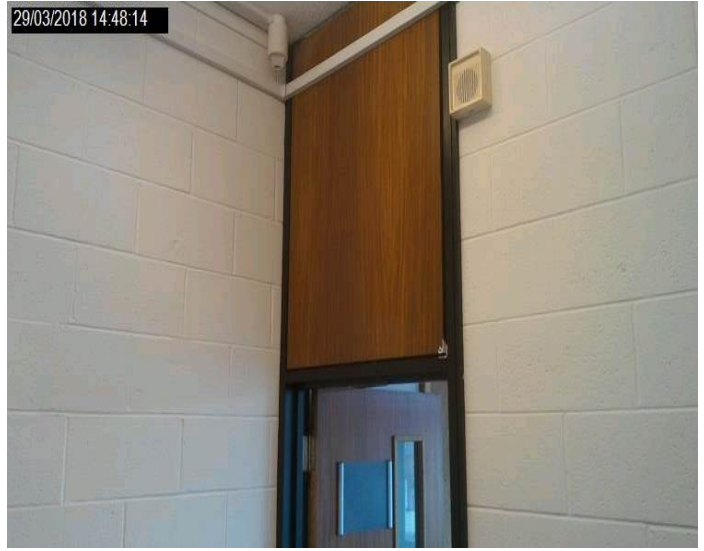
Item:	Insulating board door header			
Asbestos Content:		Result Based on:		
No Asbestos Detected		Analysis of sample using PLM		
Sample Analysed By:	Reg 13(1)	Extent:	2 m ²	
Comments: Double skin behind timber panel

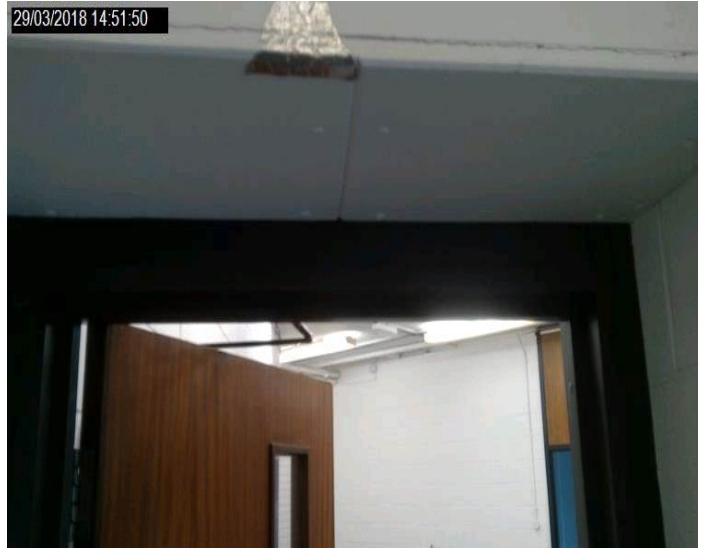
Item:	Asbestos Insulating board panel above doorway			
Asbestos Content:	Result Based on:			
Chrysotile Amosite	Analysis of sample using PLM			
Sample Analysed By: Reg 13(1)	Extent:	1 m ²		
Comments:

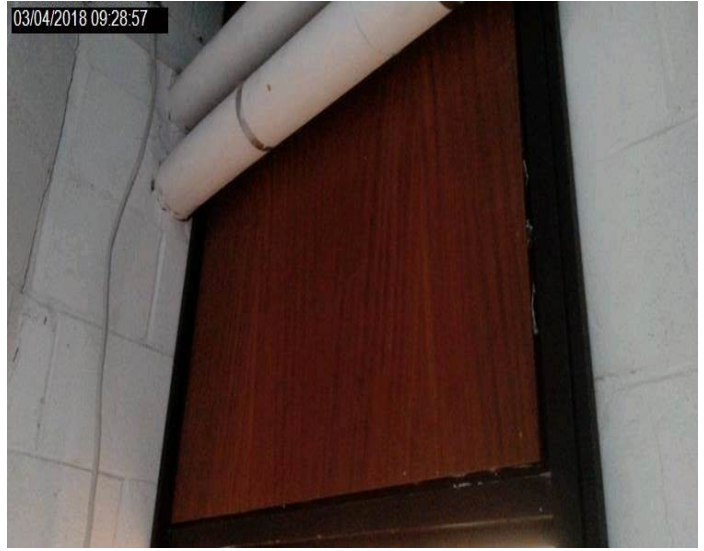
Item:	Insulating board door header panel			
Asbestos Content:		Result Based on:		
No Asbestos Detected		Analysis of sample using PLM		
Sample Analysed By:	Reg 13(1)	Extent:	2 m ²	
Comments: Behind timber panel

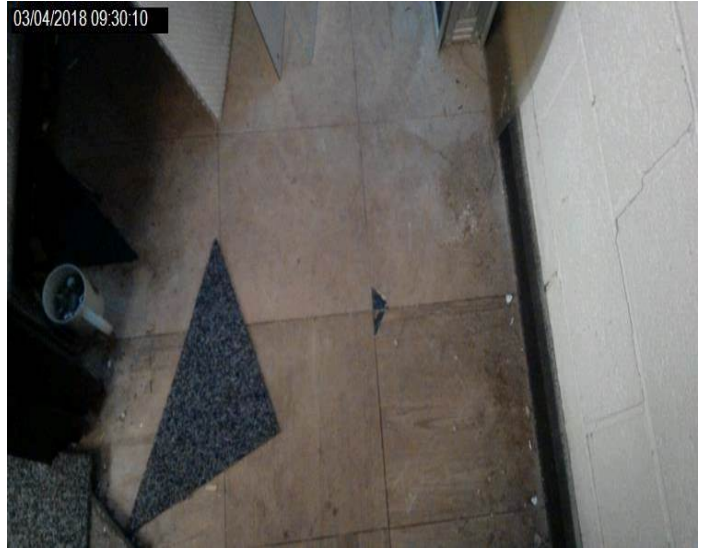
Item:	Asbestos Thermoplastic floor tiles with bitumen adhesive			
Asbestos Content:	Result Based on:			
Chrysotile in adhesive only	Analysis of sample using PLM			
Sample Analysed By: Reg 13(1)	Extent:	2 m ²		
Comments:

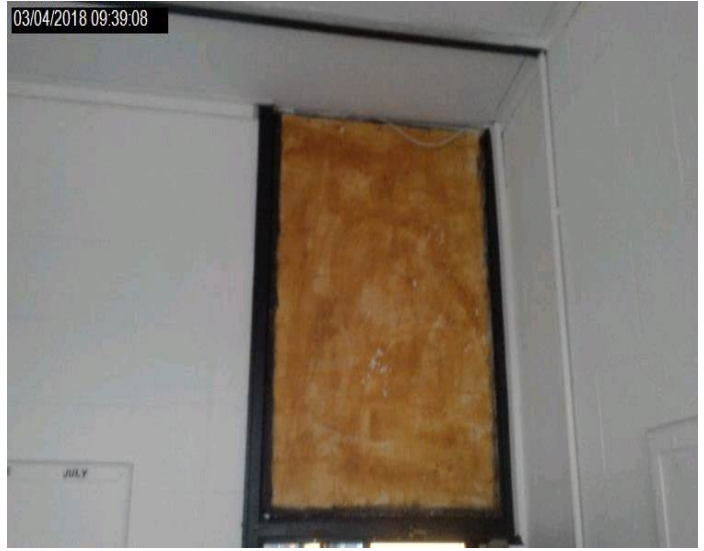
Item:	Insulating board door header panel			
Asbestos Content:	Result Based on:			
No Asbestos Detected	Analysis of sample using PLM			
Sample Analysed By: Reg 13(1)	Extent:	2 m ²		
Comments:

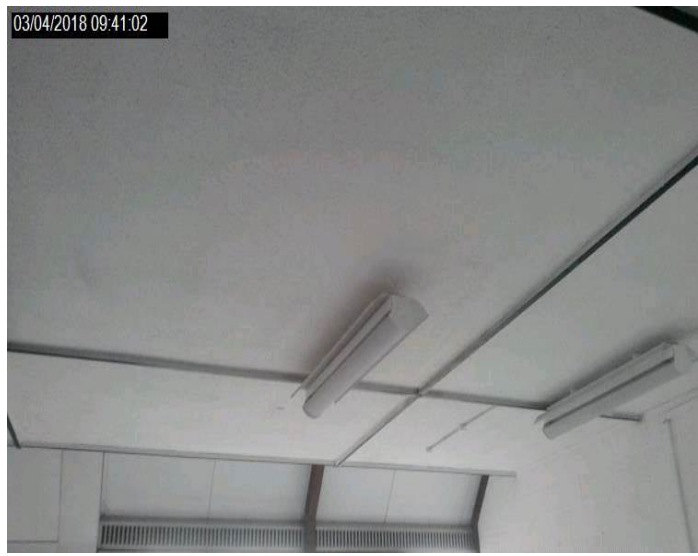
Item:	Asbestos Textured coating to concrete ceiling			
Asbestos Content:	Result Based on:			
Chrysotile	Strongly presumed			
Sample Analysed By:	Not applicable	Extent:	40 m ²	
Comments:
