**Report No.:** J094042  
**Nature of Work:** Demolition Survey  
**Issue Date:** 29/05/2018  
**Client Name:** WYG Engineering Ltd  
Geneva Building, Lake View Drive, Sherwood Business Park,  
Annesley, Nottingham, NG15 0ED  
**Site Address:** Cox Building, Former City North Campus, Birmingham City  
University, Perry Barr, B42 2US

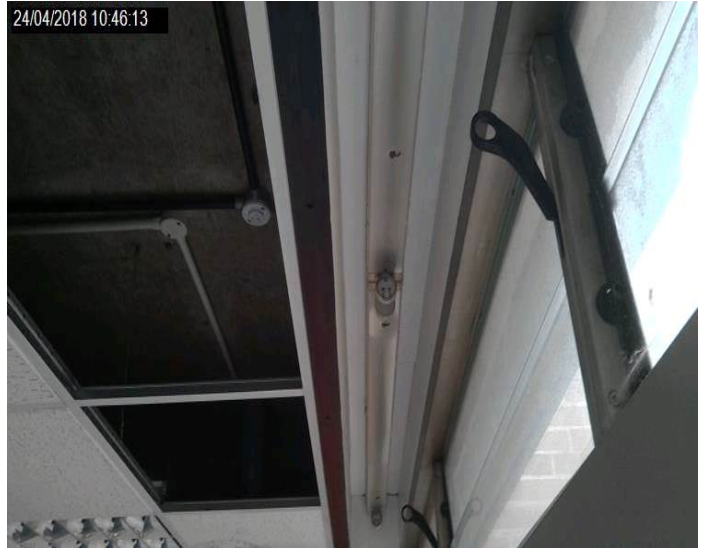
<b>Item:</b>	Insulating board surround to light fitting			
<b>Asbestos Content:</b>		<b>Result Based on:</b>		
No Asbestos Detected		Analysis of sample using PLM		
<b>Sample Analysed By:</b>	Reg 13(1)	<b>Extent:</b>	3 linear metres	
<b>Comments:</b>

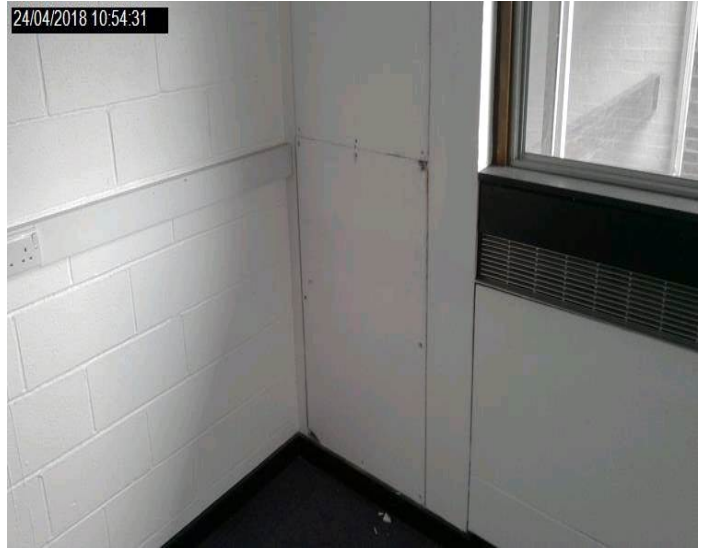
<b>Item:</b>	Insulating board panels to risers			
<b>Asbestos Content:</b>		<b>Result Based on:</b>		
No Asbestos Detected		Analysis of sample using PLM		
<b>Sample Analysed By:</b>	Reg 13(1)	<b>Extent:</b>	6 m <sup>2</sup>	
<b>Comments:</b> 2 x risers

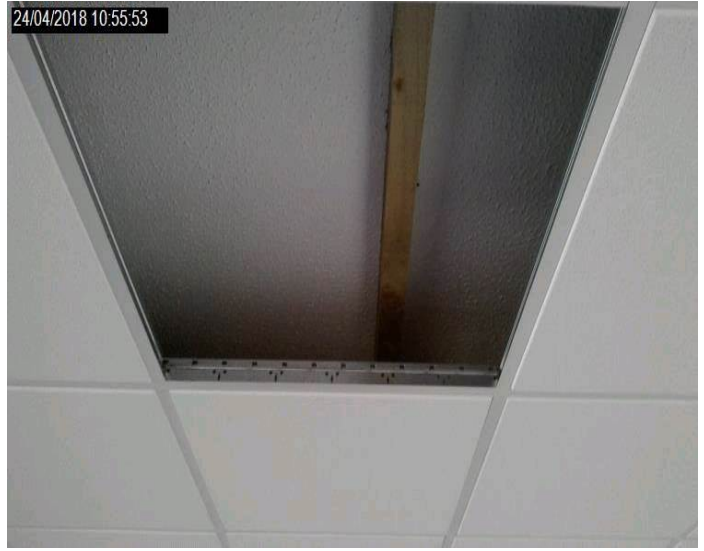
<b>Item:</b>	Asbestos Textured coating to concrete			
<b>Asbestos Content:</b>	Result Based on:			
Chrysotile	Analysis of sample using PLM			
<b>Sample Analysed By:</b> Reg 13(1)	<b>Extent:</b>	36 m <sup>2</sup>		
<b>Comments:</b> Above suspended tiles

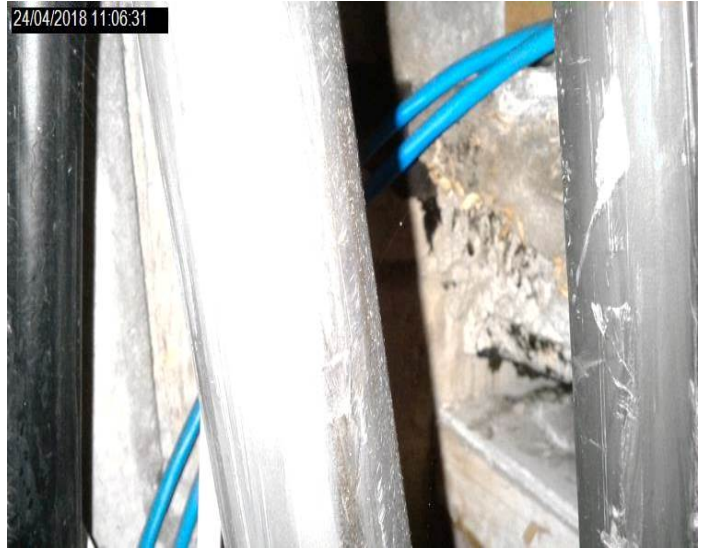
<b>Item:</b>	Bitumen damp proof course			
<b>Asbestos Content:</b>		<b>Result Based on:</b>		
No Asbestos Detected		Analysis of sample using PLM		
<b>Sample Analysed By:</b>	Reg 13(1)	<b>Extent:</b>	2 linear metres	
<b>Comments:</b> Built into wall visible within riser

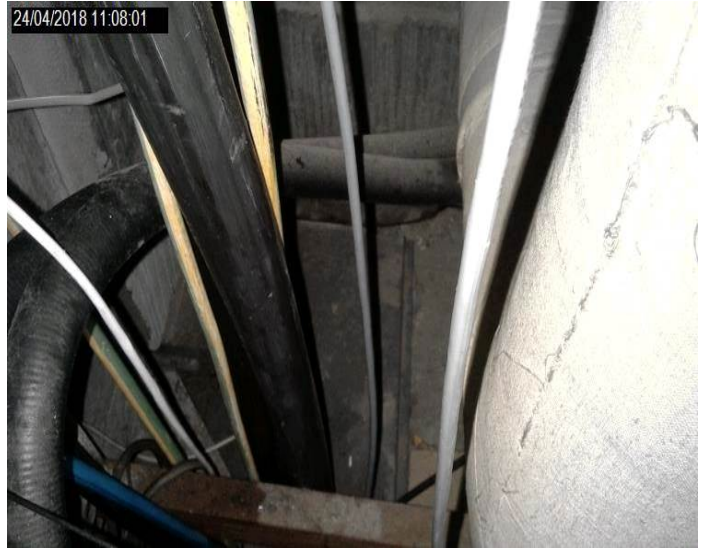
<b>Item:</b>	Bitumen damp proof course to perimeter of entire floor			
<b>Asbestos Content:</b>		<b>Result Based on:</b>		
No Asbestos Detected		Analysis of sample using PLM		
<b>Sample Analysed By:</b>	Reg 13(1)	<b>Extent:</b>	250 linear metres	
<b>Comments:</b> One sample for entire floor, visible within the wall void

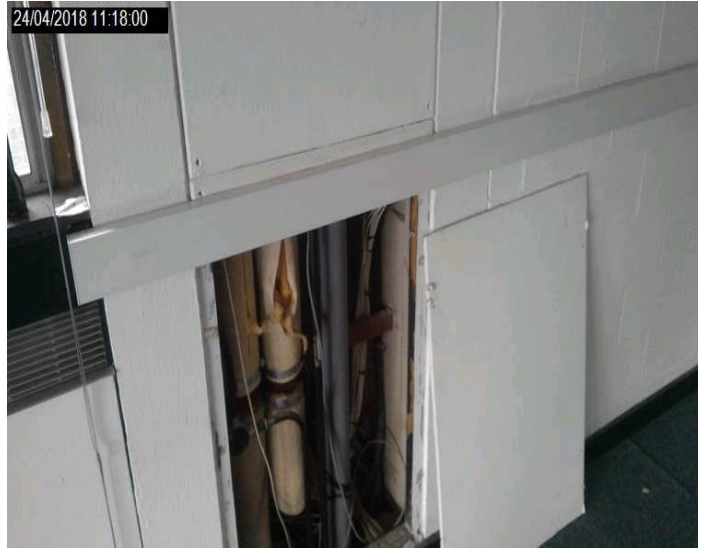
<b>Item:</b>	Insulating board panels to risers			
<b>Asbestos Content:</b>		<b>Result Based on:</b>		
No Asbestos Detected		Strongly presumed		
<b>Sample Analysed By:</b>	Not applicable	<b>Extent:</b>	6 m <sup>2</sup>	
<b>Comments:</b> 2 x risers

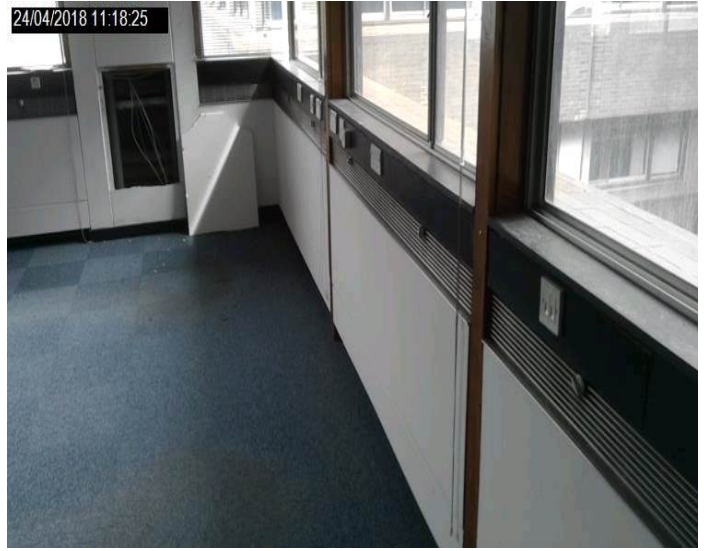
<b>Item:</b>	Asbestos Cement window sill			
<b>Asbestos Content:</b>	<b>Result Based on:</b>			
Chrysotile	Strongly presumed			
<b>Sample Analysed By:</b>	Not applicable	<b>Extent:</b>	10 linear metres	
<b>Comments:</b>

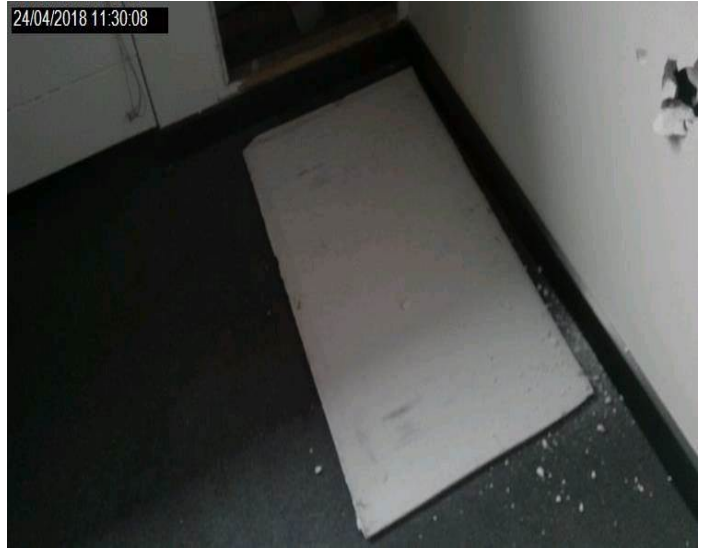
<b>Item:</b>	Insulating board panels to risers			
<b>Asbestos Content:</b>		<b>Result Based on:</b>		
No Asbestos Detected		Strongly presumed		
<b>Sample Analysed By:</b>	Not applicable	<b>Extent:</b>	6 m <sup>2</sup>	
<b>Comments:</b> 2 x risers

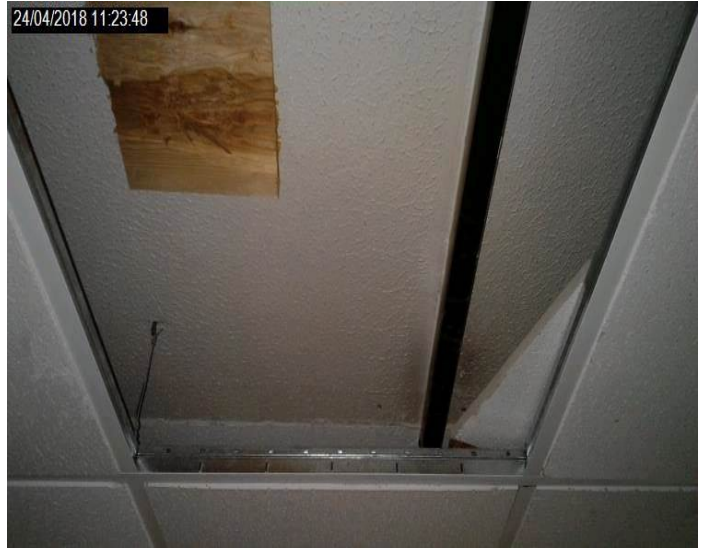
<b>Item:</b>	Asbestos Textured coating to concrete			
<b>Asbestos Content:</b>	<b>Result Based on:</b>			
Chrysotile	Strongly presumed			
<b>Sample Analysed By:</b>	Not applicable	<b>Extent:</b>	90 m <sup>2</sup>	
<b>Comments:</b> Above suspended tiles

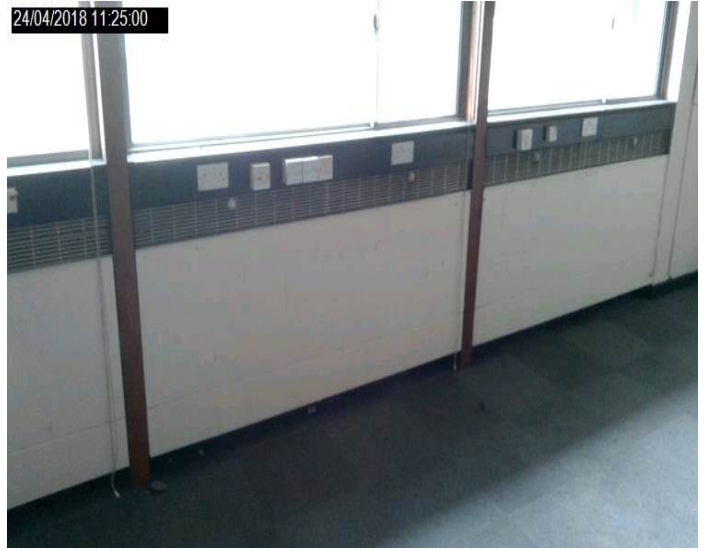
<b>Item:</b>	Asbestos Cement window sill			
<b>Asbestos Content:</b>	<b>Result Based on:</b>			
Chrysotile	Strongly presumed			
<b>Sample Analysed By:</b>	Not applicable	<b>Extent:</b>	6 linear metres	
<b>Comments:</b>

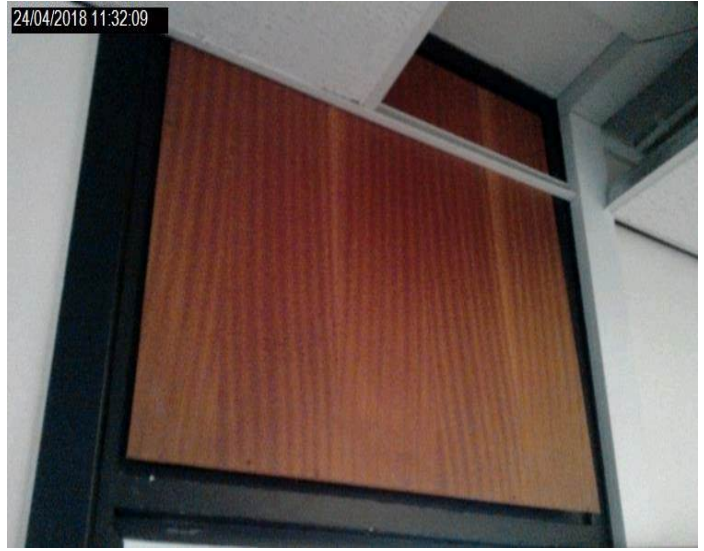
<b>Item:</b>	Insulating board door header panel			
<b>Asbestos Content:</b>		<b>Result Based on:</b>		
No Asbestos Detected		Analysis of sample using PLM		
<b>Sample Analysed By:</b>	Reg 13(1)	<b>Extent:</b>	1 m <sup>2</sup>	
<b>Comments:</b>

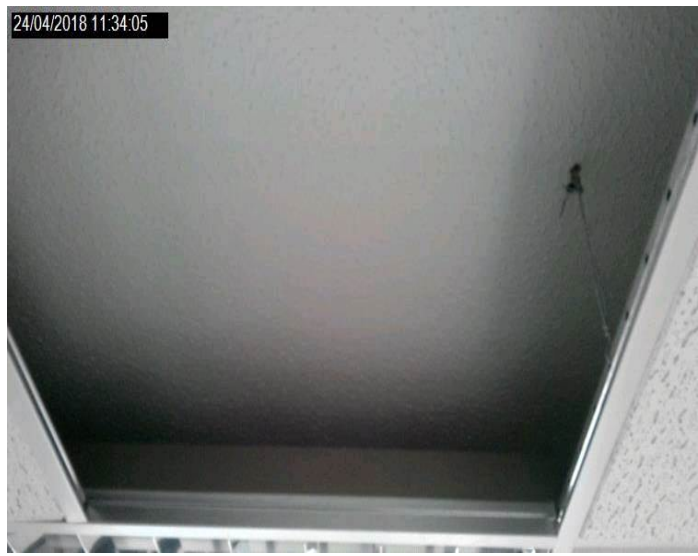
<b>Item:</b>	Asbestos Textured coating to concrete			
<b>Asbestos Content:</b>	<b>Result Based on:</b>			
Chrysotile	Strongly presumed			
<b>Sample Analysed By:</b>	Not applicable	<b>Extent:</b>	4 m <sup>2</sup>	
<b>Comments:</b> Above suspended tiles

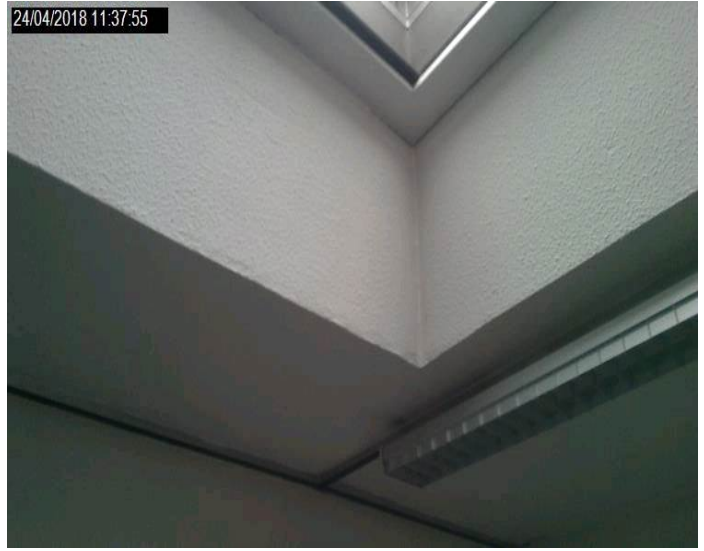
<b>Item:</b>	Asbestos Textured coating to concrete			
<b>Asbestos Content:</b>	<b>Result Based on:</b>			
Chrysotile	Strongly presumed			
<b>Sample Analysed By:</b>	Not applicable	<b>Extent:</b>	10 m <sup>2</sup>	
<b>Comments:</b> To upstands of skylight also

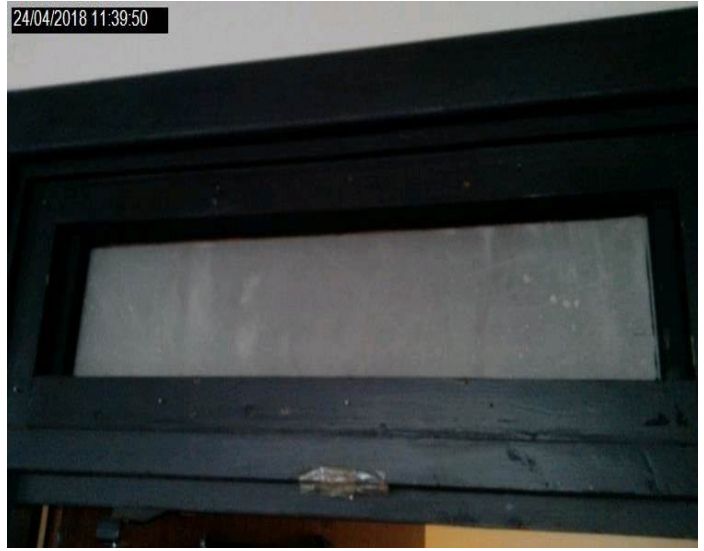
<b>Item:</b>	Insulating board internal door header			
<b>Asbestos Content:</b>		<b>Result Based on:</b>		
No Asbestos Detected		Analysis of sample using PLM		
<b>Sample Analysed By:</b>	Reg 13(1)	<b>Extent:</b>	1 m <sup>2</sup>	
<b>Comments:</b>

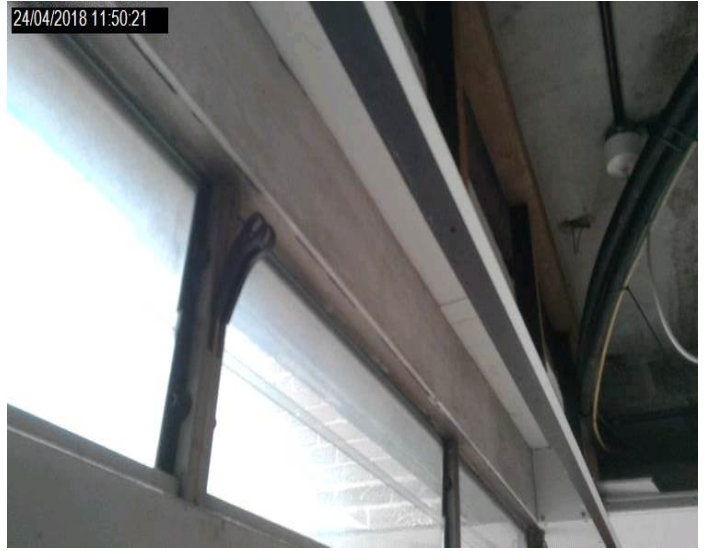
<b>Item:</b>	Insulating board surrounding light fitting			
<b>Asbestos Content:</b>		<b>Result Based on:</b>		
No Asbestos Detected		Analysis of sample using PLM		
<b>Sample Analysed By:</b>	Reg 13(1)	<b>Extent:</b>	3 linear metres	
<b>Comments:</b> To window wall

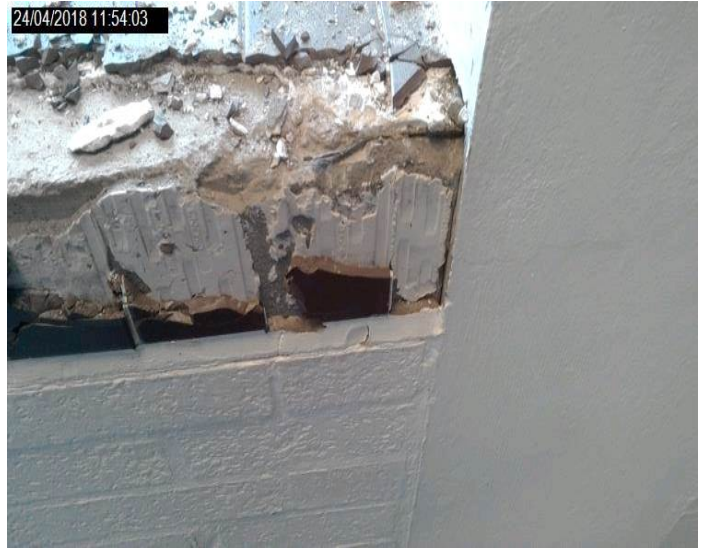
<b>Item:</b>	Bitumen damp proof course within wall			
<b>Asbestos Content:</b>		<b>Result Based on:</b>		
No Asbestos Detected		Analysis of sample using PLM		
<b>Sample Analysed By:</b>	Reg 13(1)	<b>Extent:</b>	1 linear metres	
<b>Comments:</b> Connects with sample DU001274

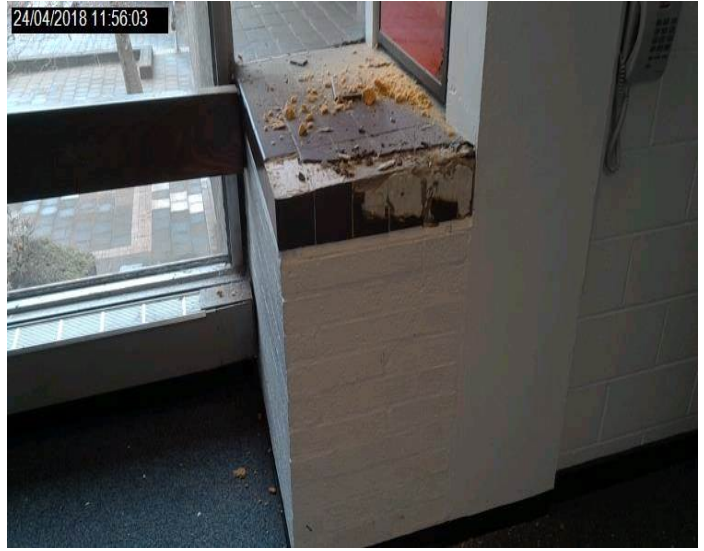
<b>Item:</b>	Asbestos Cement shuttering			
<b>Asbestos Content:</b>	<b>Result Based on:</b>			
Chrysotile	Strongly presumed			
<b>Sample Analysed By:</b>	Not applicable	<b>Extent:</b>	4 m <sup>2</sup>	
<b>Comments:</b> To ceiling of wall void, behind brick walls low level walls either side of the corridor item will also run into 3.38

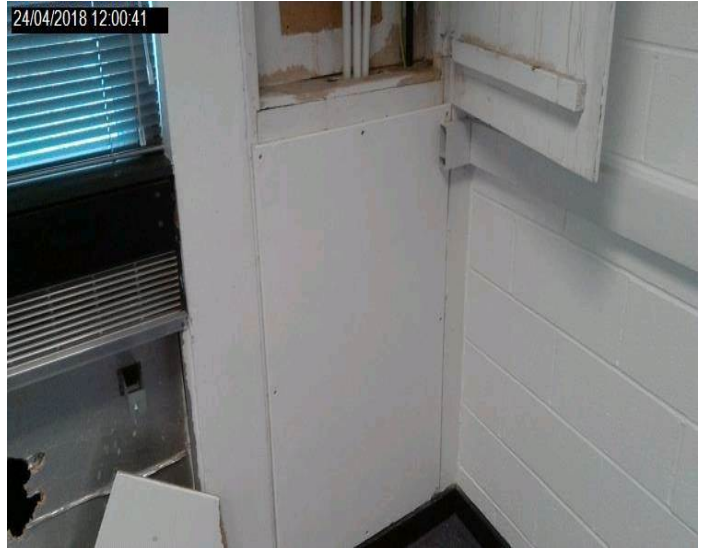
<b>Item:</b>	Insulating board panels to risers			
<b>Asbestos Content:</b>		<b>Result Based on:</b>		
No Asbestos Detected		Analysis of sample using PLM		
<b>Sample Analysed By:</b>	Reg 13(1)	<b>Extent:</b>	6 m <sup>2</sup>	
<b>Comments:</b> 2 x risers

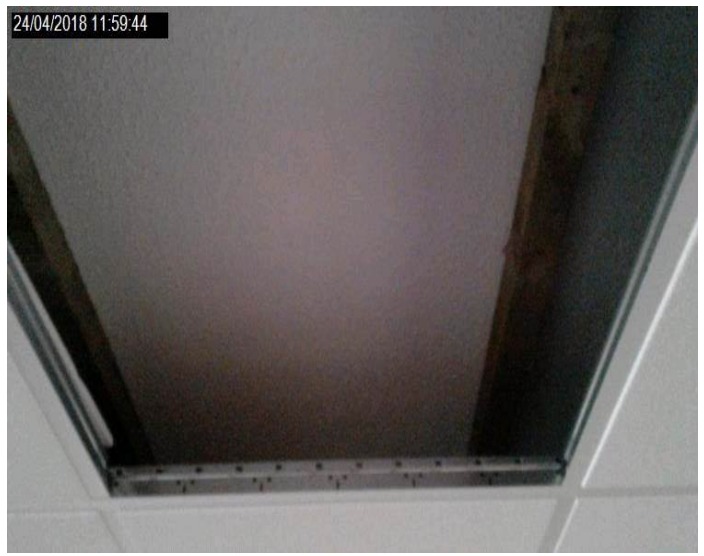
<b>Item:</b>	Asbestos Textured coating to concrete			
<b>Asbestos Content:</b>	Result Based on:			
Chrysotile	Analysis of sample using PLM			
<b>Sample Analysed By:</b> Reg 13(1)	<b>Extent:</b>	42 m <sup>2</sup>		
<b>Comments:</b> Above suspended tiles

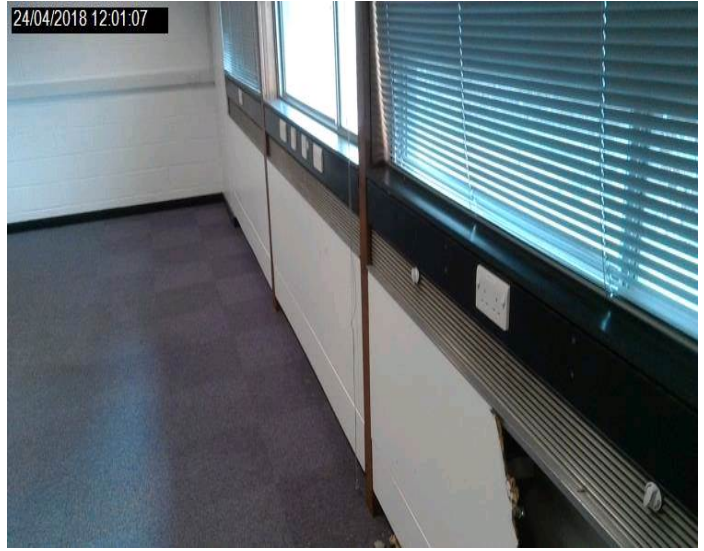
<b>Item:</b>	Asbestos Cement window sill			
<b>Asbestos Content:</b>	Result Based on:			
Chrysotile	Analysis of sample using PLM			
<b>Sample Analysed By:</b>	Reg 13(1)	<b>Extent:</b>	6 linear metres	
<b>Comments:</b>

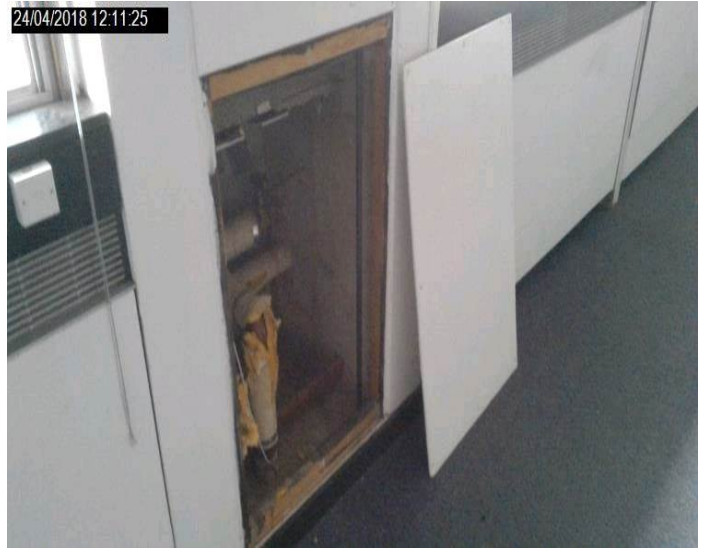
<b>Item:</b>	Insulating board panels to risers			
<b>Asbestos Content:</b>		<b>Result Based on:</b>		
No Asbestos Detected		Strongly presumed		
<b>Sample Analysed By:</b>	Not applicable	<b>Extent:</b>	6 m <sup>2</sup>	
<b>Comments:</b> 2 x risers

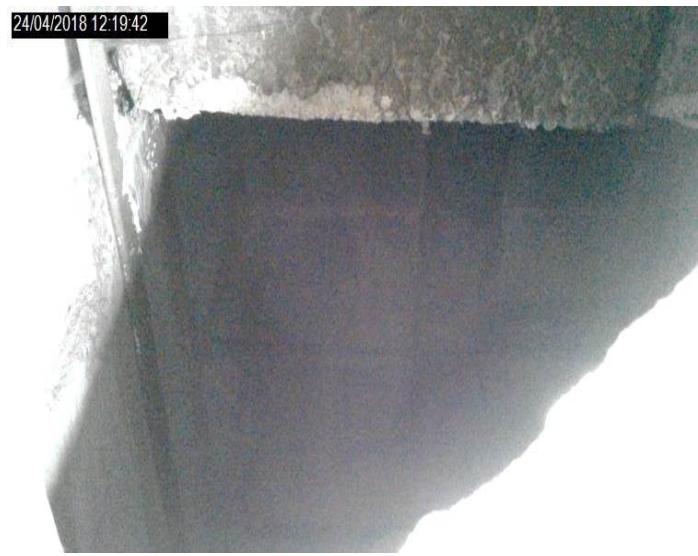
<b>Item:</b>	Asbestos Cement shuttering			
<b>Asbestos Content:</b>	<b>Result Based on:</b>			
Chrysotile	Strongly presumed			
<b>Sample Analysed By:</b>	Not applicable	<b>Extent:</b>	11 m <sup>2</sup>	
<b>Comments:</b> To ceiling of wall void, behind timber panels

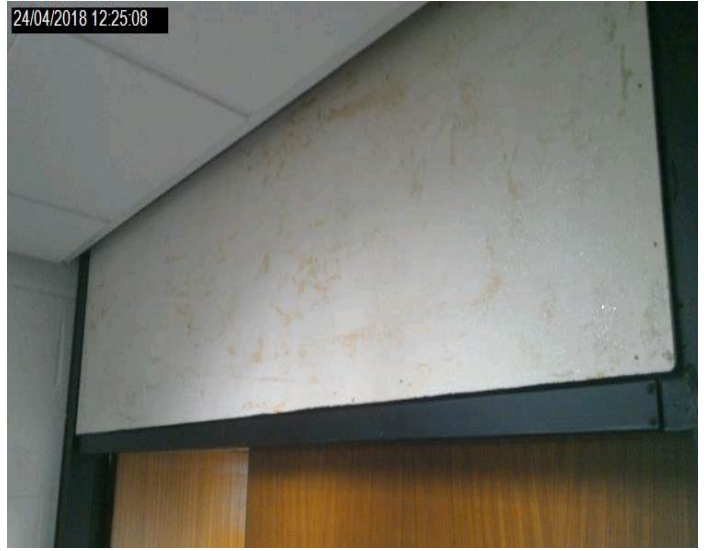
<b>Item:</b>	Insulating board door header panels			
<b>Asbestos Content:</b>		<b>Result Based on:</b>		
No Asbestos Detected		Analysis of sample using PLM		
<b>Sample Analysed By:</b>	Reg 13(1)	<b>Extent:</b>	8 m <sup>2</sup>	
<b>Comments:</b> Double doors leading to corridor above doors to rooms 3.14, 3.15, 3.18 and double doors leading to stairs

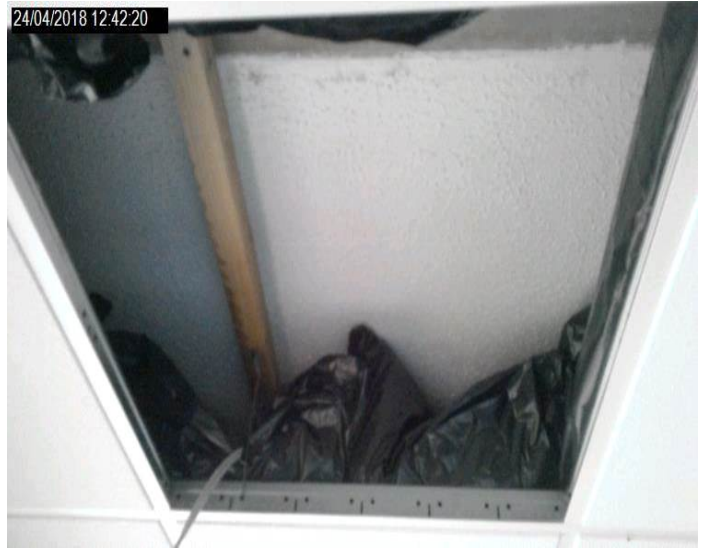
<b>Item:</b>	Asbestos Textured coating to concrete			
<b>Asbestos Content:</b>	<b>Result Based on:</b>			
Chrysotile	Strongly presumed			
<b>Sample Analysed By:</b>	Not applicable	<b>Extent:</b>	30 m <sup>2</sup>	
<b>Comments:</b>

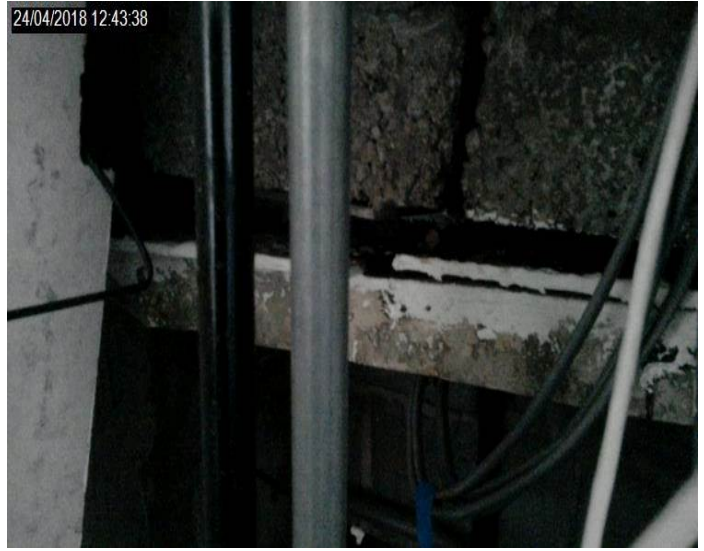
<b>Item:</b>	Asbestos Cement shuttering			
<b>Asbestos Content:</b>	<b>Result Based on:</b>			
Chrysotile	Strongly presumed			
<b>Sample Analysed By:</b>	Not applicable	<b>Extent:</b>	6 m <sup>2</sup>	
<b>Comments:</b> To ceiling of wall void, behind timber panels

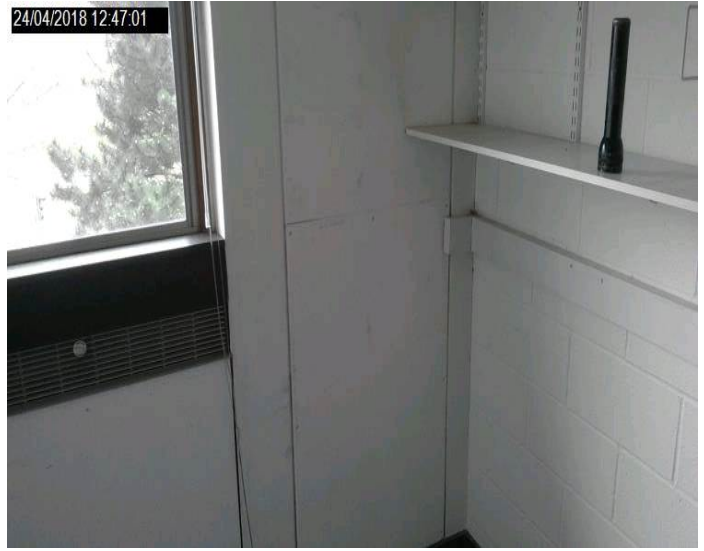
<b>Item:</b>	Insulating board panels to risers			
<b>Asbestos Content:</b>		<b>Result Based on:</b>		
No Asbestos Detected		Strongly presumed		
<b>Sample Analysed By:</b>	Not applicable	<b>Extent:</b>	3 m <sup>2</sup>	
<b>Comments:</b> 1 x riser

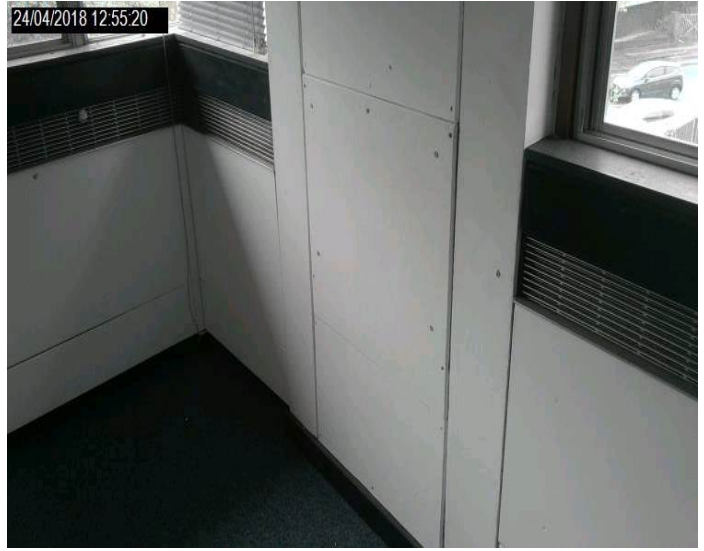
<b>Item:</b>	Insulating board panels to risers			
<b>Asbestos Content:</b>		<b>Result Based on:</b>		
No Asbestos Detected		Strongly presumed		
<b>Sample Analysed By:</b>	Not applicable	<b>Extent:</b>	3 m <sup>2</sup>	
<b>Comments:</b> 1 x riser

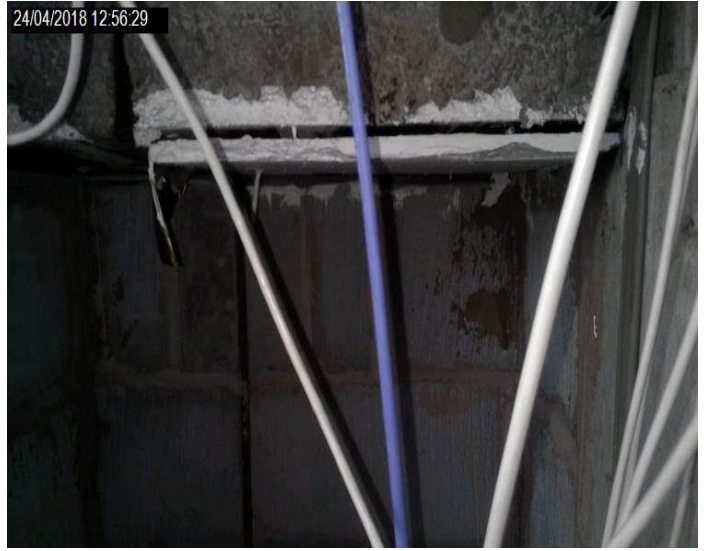
<b>Item:</b>	Asbestos Cement shuttering			
<b>Asbestos Content:</b>	<b>Result Based on:</b>			
Chrysotile	Strongly presumed			
<b>Sample Analysed By:</b>	Not applicable	<b>Extent:</b>	12 m <sup>2</sup>	
<b>Comments:</b> To ceiling of wall void, behind timber panels

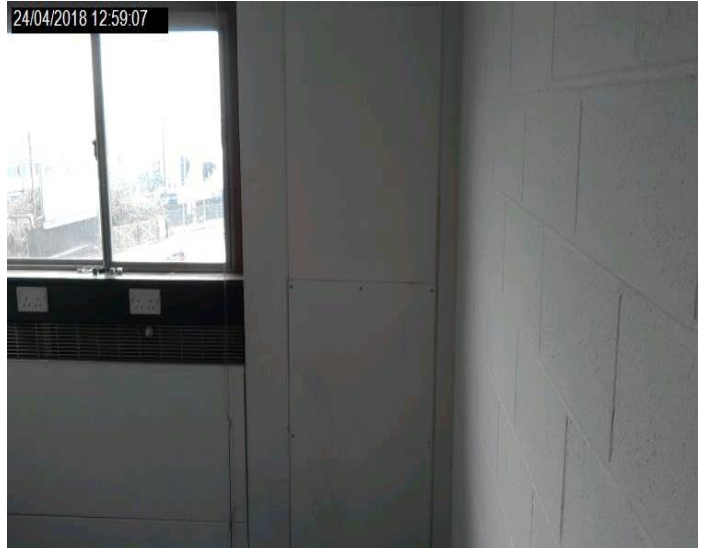
<b>Item:</b>	Insulating board panels to risers			
<b>Asbestos Content:</b>		<b>Result Based on:</b>		
No Asbestos Detected		Strongly presumed		
<b>Sample Analysed By:</b>	Not applicable	<b>Extent:</b>	3 m <sup>2</sup>	
<b>Comments:</b> 1 x riser

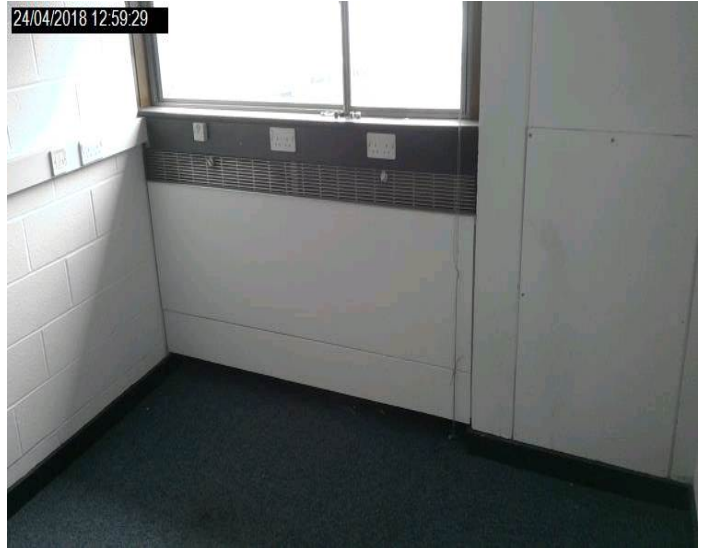
<b>Item:</b>	Asbestos Cement window sill			
<b>Asbestos Content:</b>	<b>Result Based on:</b>			
Chrysotile	Strongly presumed			
<b>Sample Analysed By:</b>	Not applicable	<b>Extent:</b>	2 linear metres	
<b>Comments:</b>

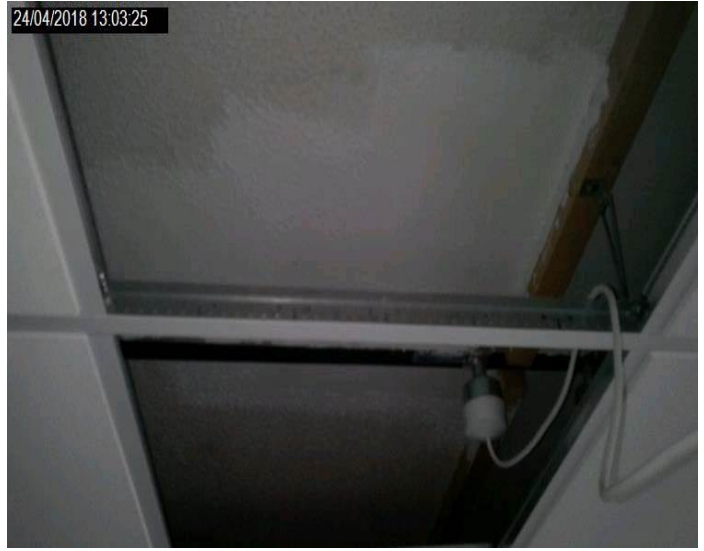
<b>Item:</b>	Asbestos Textured coating to concrete			
<b>Asbestos Content:</b>	<b>Result Based on:</b>			
Chrysotile	Strongly presumed			
<b>Sample Analysed By:</b>	Not applicable	<b>Extent:</b>	20 m <sup>2</sup>	
<b>Comments:</b> Above suspended ceiling tiles

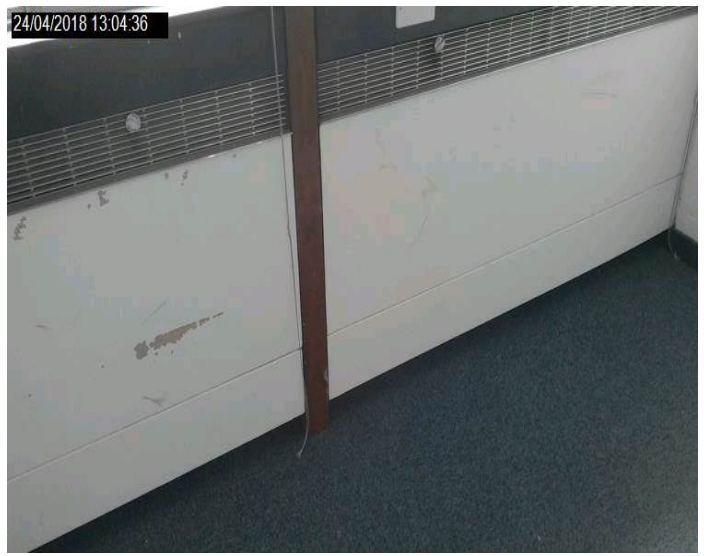
<b>Item:</b>	Asbestos Cement shuttering			
<b>Asbestos Content:</b>	<b>Result Based on:</b>			
Chrysotile	Strongly presumed			
<b>Sample Analysed By:</b>	Not applicable	<b>Extent:</b>	5 m <sup>2</sup>	
<b>Comments:</b> To ceiling of wall void, behind timber panels

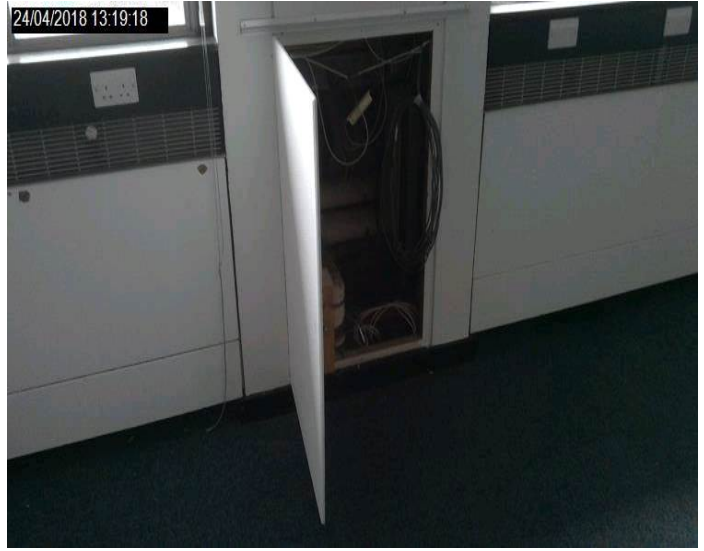
<b>Item:</b>	Insulating board panels to risers			
<b>Asbestos Content:</b>		<b>Result Based on:</b>		
No Asbestos Detected		Analysis of sample using PLM		
<b>Sample Analysed By:</b>	Reg 13(1)	<b>Extent:</b>	3 m <sup>2</sup>	
<b>Comments:</b> 1 x riser

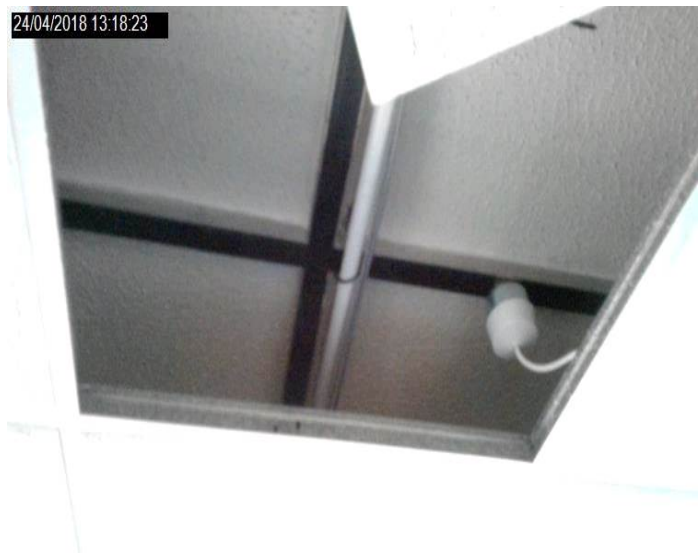
<b>Item:</b>	Asbestos Textured coating to concrete			
<b>Asbestos Content:</b>	<b>Result Based on:</b>			
Chrysotile	Strongly presumed			
<b>Sample Analysed By:</b>	Not applicable	<b>Extent:</b>	50 m <sup>2</sup>	
<b>Comments:</b> Above suspended ceiling tiles

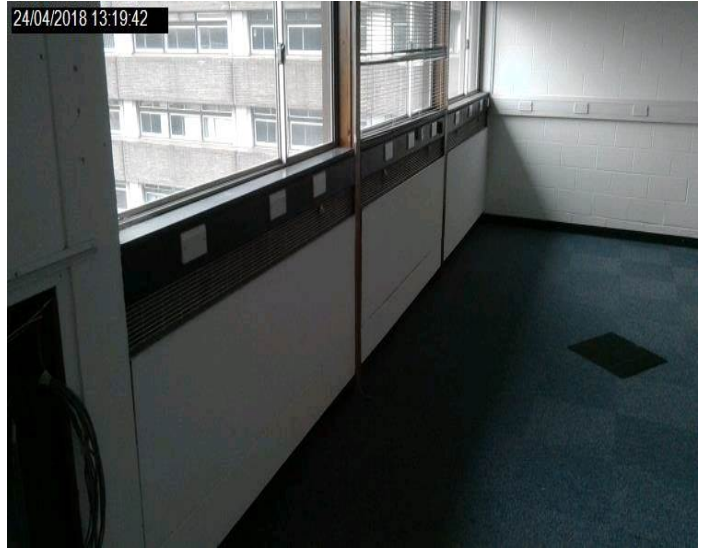
<b>Item:</b>	Asbestos Cement window sill			
<b>Asbestos Content:</b>	Result Based on:			
Chrysotile	Analysis of sample using PLM			
<b>Sample Analysed By:</b>	Reg 13(1)	<b>Extent:</b>	8 linear metres	
<b>Comments:</b>

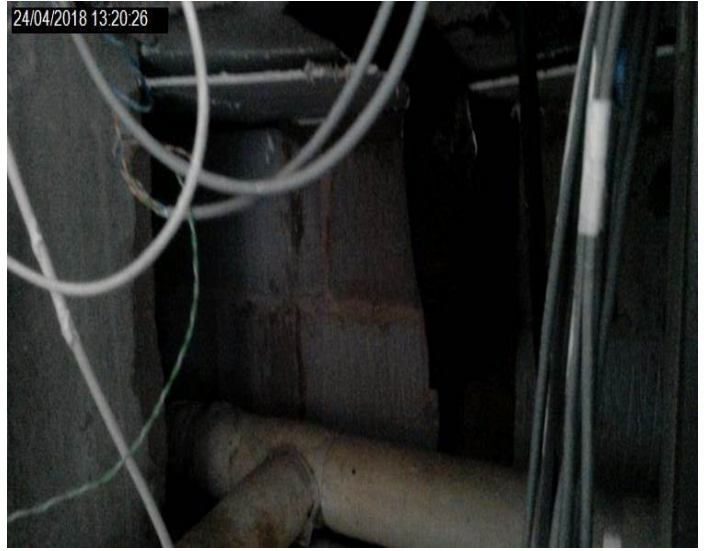
<b>Item:</b>	Asbestos Cement shuttering			
<b>Asbestos Content:</b>	Result Based on:			
Chrysotile	Analysis of sample using PLM			
<b>Sample Analysed By:</b> Reg 13(1)	<b>Extent:</b>	8 m <sup>2</sup>		
<b>Comments:</b> To ceiling of wall void, behind timber panels

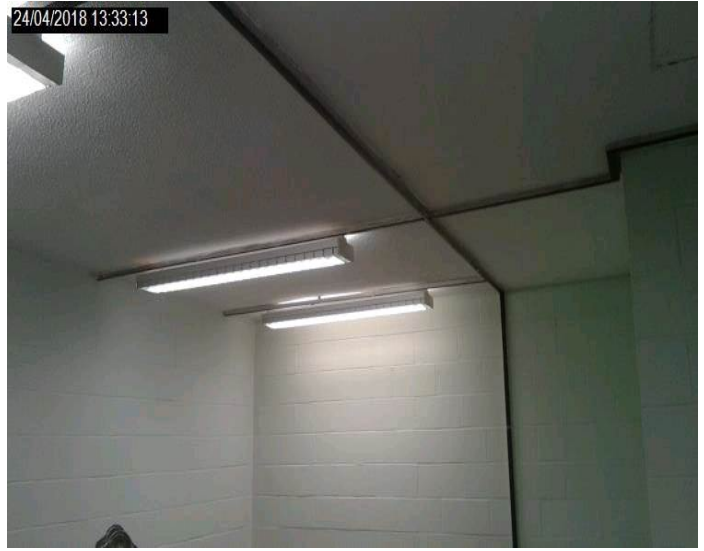
<b>Item:</b>	Asbestos Textured coating to concrete			
<b>Asbestos Content:</b>	<b>Result Based on:</b>			
Chrysotile	Strongly presumed			
<b>Sample Analysed By:</b>	Not applicable	<b>Extent:</b>	25 m <sup>2</sup>	
<b>Comments:</b> Above suspended ceiling tiles

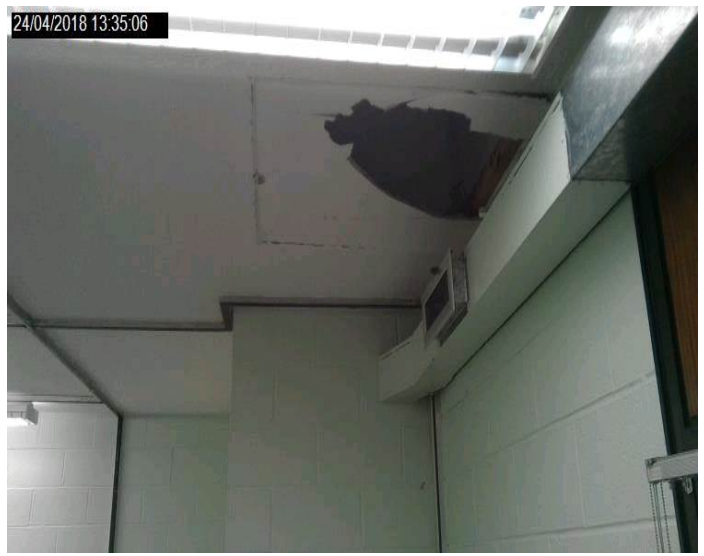
<b>Item:</b>	Insulating board to external vent cover			
<b>Asbestos Content:</b>	<b>Result Based on:</b>			
No Asbestos Detected	Analysis of sample using PLM			
<b>Sample Analysed By:</b> Reg 13(1)	<b>Extent:</b>	1 m <sup>2</sup>		
<b>Comments:</b> Sampled to prove negative

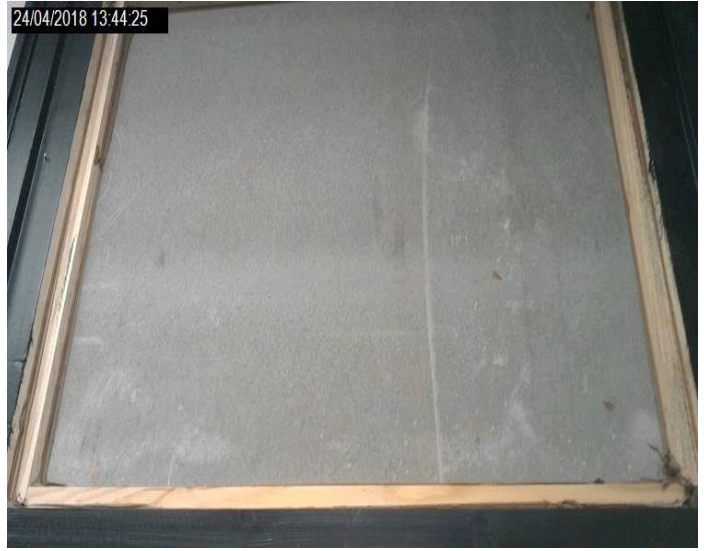
<b>Item:</b>	Insulating board door header panels			
<b>Asbestos Content:</b>		<b>Result Based on:</b>		
No Asbestos Detected		Analysis of sample using PLM		
<b>Sample Analysed By:</b>	Reg 13(1)	<b>Extent:</b>	5 m <sup>2</sup>	
<b>Comments:</b> Door leading to rooms 3.33, 3.29, and 3.34

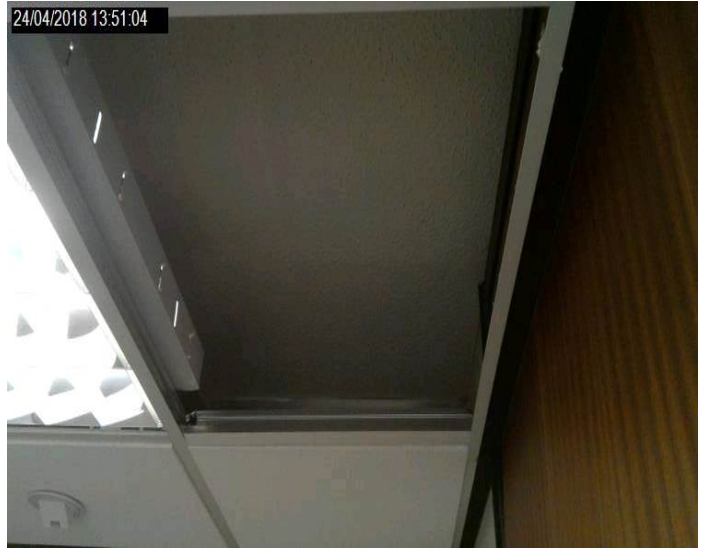
<b>Item:</b>	Asbestos Textured coating to concrete ceiling			
<b>Asbestos Content:</b>	<b>Result Based on:</b>			
Chrysotile	Strongly presumed			
<b>Sample Analysed By:</b>	Not applicable	<b>Extent:</b>	20 m <sup>2</sup>	
<b>Comments:</b> Above suspended tiles and glass fibre

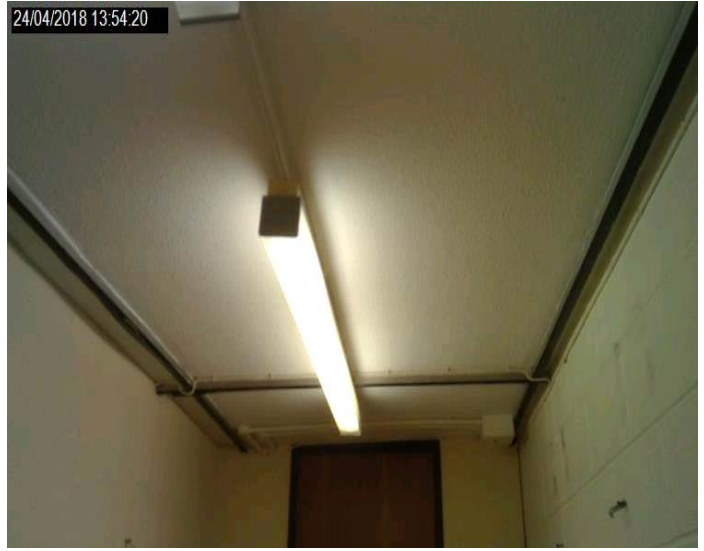
<b>Item:</b>	Asbestos Textured coating to concrete			
<b>Asbestos Content:</b>	<b>Result Based on:</b>			
Chrysotile	Strongly presumed			
<b>Sample Analysed By:</b>	Not applicable	<b>Extent:</b>	10 m <sup>2</sup>	
<b>Comments:</b>

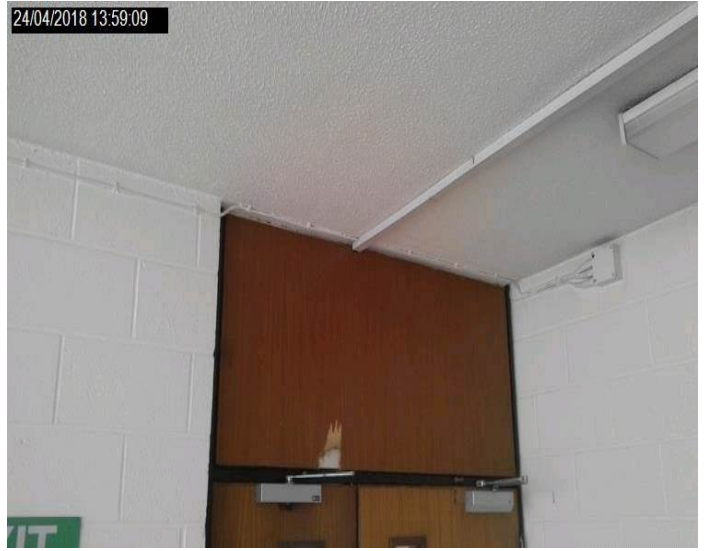
<b>Item:</b>	Insulating board door header panel			
<b>Asbestos Content:</b>		<b>Result Based on:</b>		
No Asbestos Detected		Analysis of sample using PLM		
<b>Sample Analysed By:</b>	Reg 13(1)	<b>Extent:</b>	2 m <sup>2</sup>	
<b>Comments:</b>

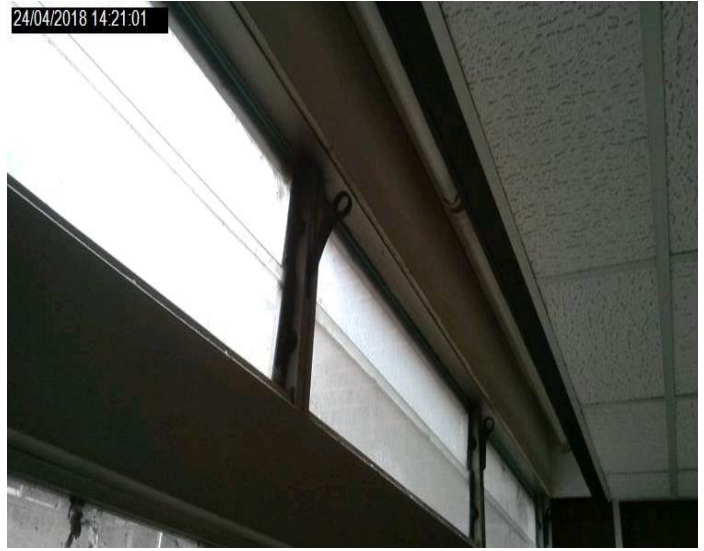
<b>Item:</b>	Insulating board surround to light fitting			
<b>Asbestos Content:</b>	<b>Result Based on:</b>			
No Asbestos Detected	Analysis of sample using PLM			
<b>Sample Analysed By:</b> Reg 13(1)	<b>Extent:</b>	3 linear metres		
<b>Comments:</b>

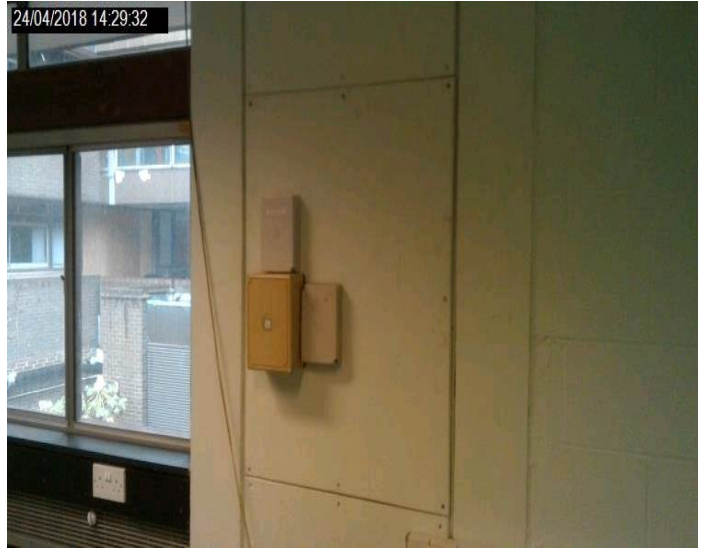
<b>Item:</b>	Insulating board panel to riser			
<b>Asbestos Content:</b>	<b>Result Based on:</b>			
No Asbestos Detected	Analysis of sample using PLM			
<b>Sample Analysed By:</b> Reg 13(1)	<b>Extent:</b>	3 m <sup>2</sup>		
<b>Comments:</b>

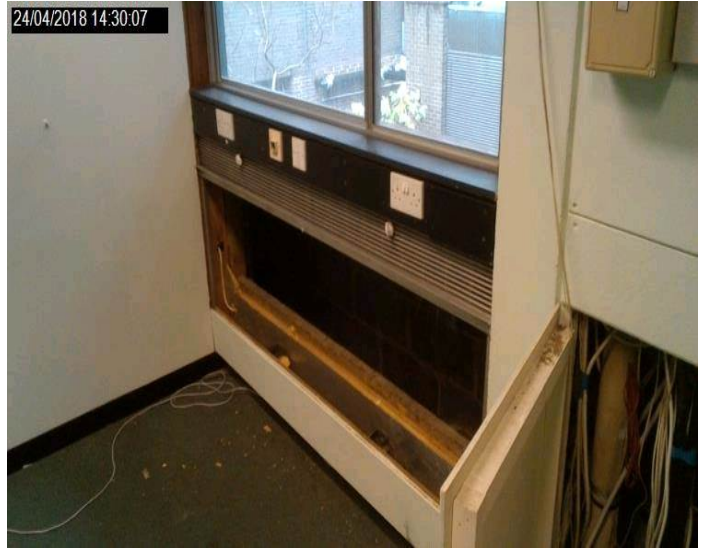
<b>Item:</b>	Asbestos Cement window sill			
<b>Asbestos Content:</b>	<b>Result Based on:</b>			
Chrysotile Amosite	Analysis of sample using PLM			
<b>Sample Analysed By:</b> Reg 13(1)	<b>Extent:</b>	2 linear metres		
<b>Comments:</b>

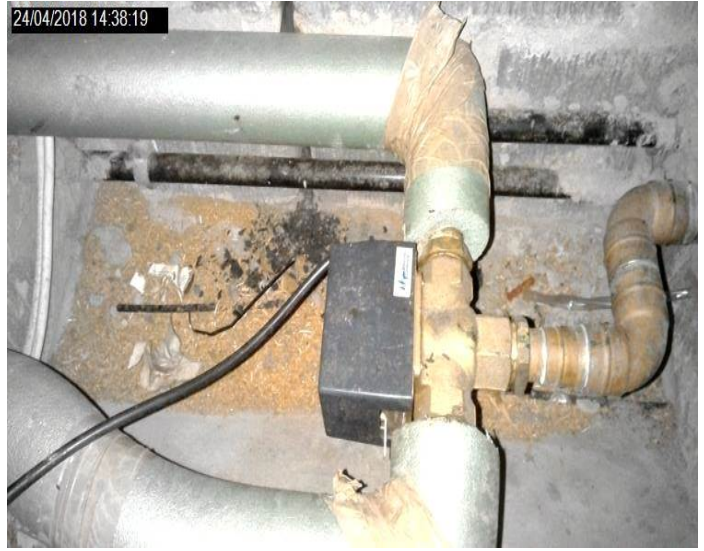
<b>Item:</b>	Bitumen damp proof course to entire perimeter			
<b>Asbestos Content:</b>		<b>Result Based on:</b>		
No Asbestos Detected		Analysis of sample using PLM		
<b>Sample Analysed By:</b>	Reg 13(1)	<b>Extent:</b>	250 linear metres	
<b>Comments:</b> To the outer wall of the heater wall void

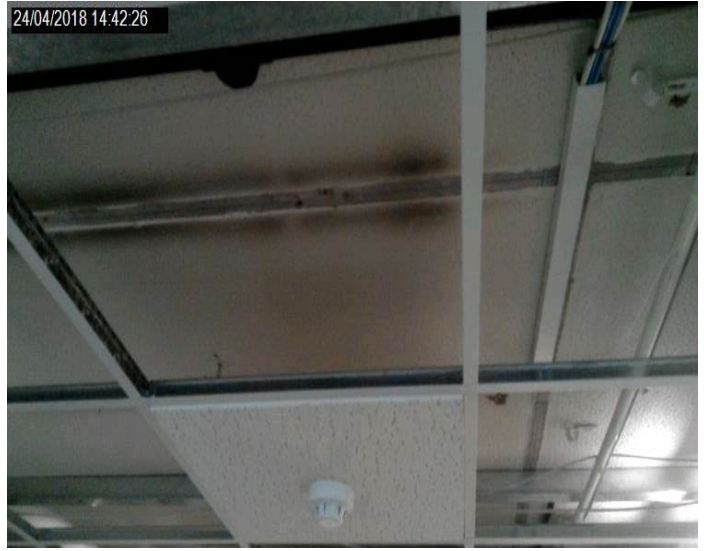
<b>Item:</b>	Asbestos Textured coating to concrete			
<b>Asbestos Content:</b>	<b>Result Based on:</b>			
Chrysotile	Strongly presumed			
<b>Sample Analysed By:</b>	Not applicable	<b>Extent:</b>	60 m <sup>2</sup>	
<b>Comments:</b> Above suspended tiles

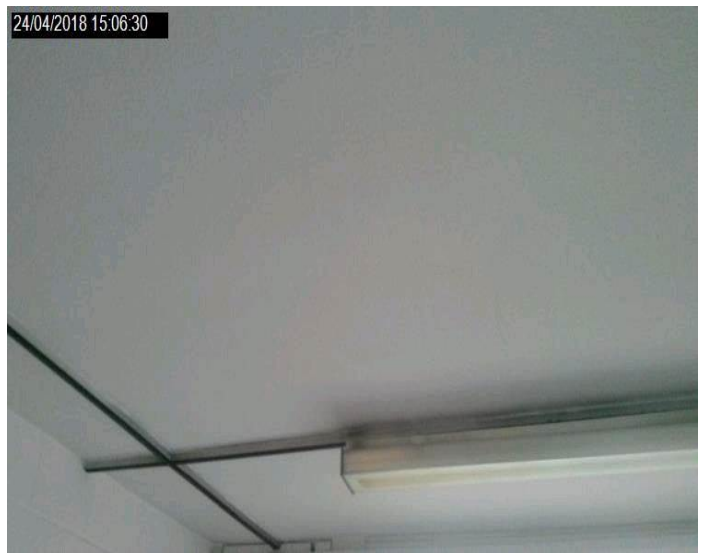
<b>Item:</b>	Asbestos Textured coating to concrete			
<b>Asbestos Content:</b>	<b>Result Based on:</b>			
Chrysotile	Strongly presumed			
<b>Sample Analysed By:</b>	Not applicable	<b>Extent:</b>	12 m <sup>2</sup>	
<b>Comments:</b>

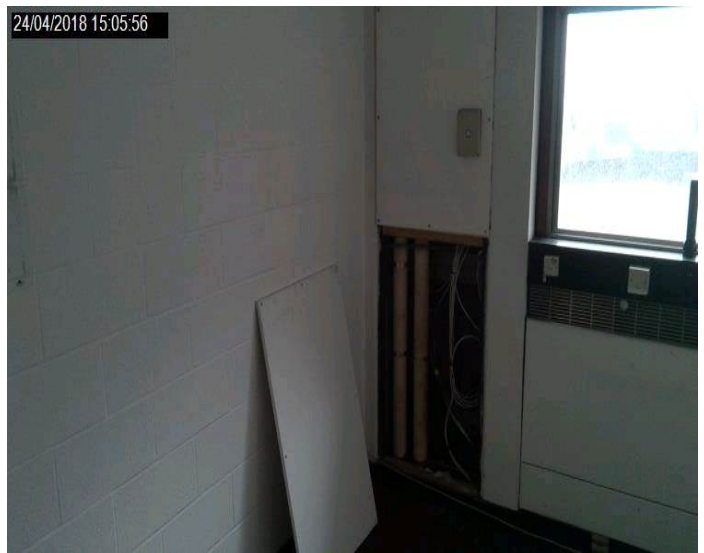
<b>Item:</b>	Insulating board panel to riser			
<b>Asbestos Content:</b>	<b>Result Based on:</b>			
No Asbestos Detected	Analysis of sample using PLM			
<b>Sample Analysed By:</b> Reg 13(1)	<b>Extent:</b>	3 m <sup>2</sup>		
<b>Comments:</b>
