Report No.: J094099
Nature of Work: Demolition Survey
Issue Date: 11/06/2018
Client Name: WYG Engineering Ltd
Geneva Building, Lake View Drive, Sherwood Business Park,
Annesley, Nottingham, NG15 0ED
Site Address: Dawson building, Former City North Campus, Birmingham City
University, Perry Barr, B42 2US

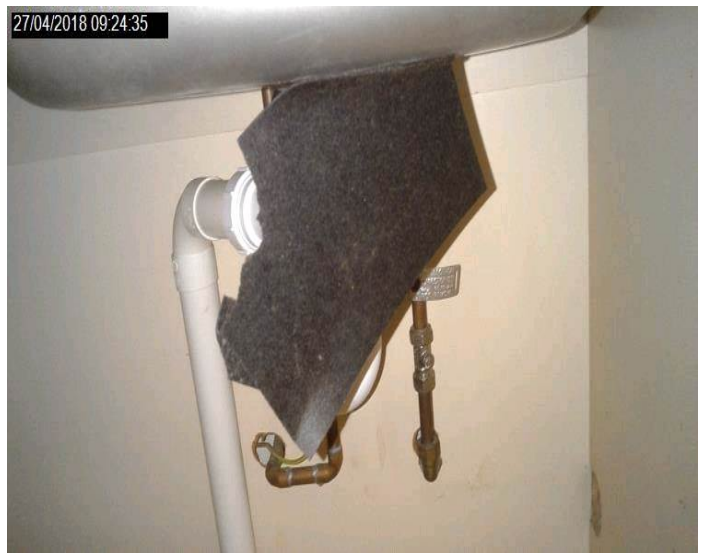
Location:	1.03	Block:	University	Floor Level: Ground Floor
Sample No.:	DU001360	Portal Ref No.:	19

Item:	Bitumen sink pad			
Asbestos Content:		Result Based on:		
No Asbestos Detected		Analysis of sample using PLM		
Sample Analysed By:	Reg 13(1)	Extent:	2 units	
Comments:

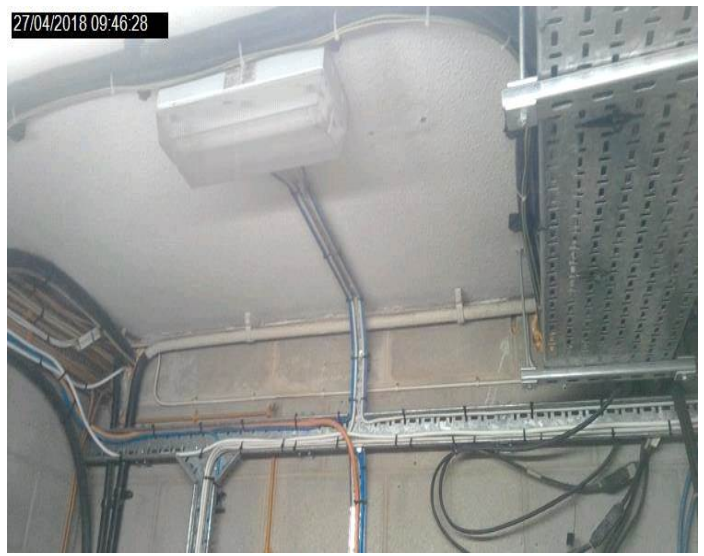
Item:	Asbestos Textured coating to concrete ceiling			
Asbestos Content:	Result Based on:			
Chrysotile	Analysis of sample using PLM			
Sample Analysed By:	Reg 13(1)	Extent:	10 m ²	
Comments:

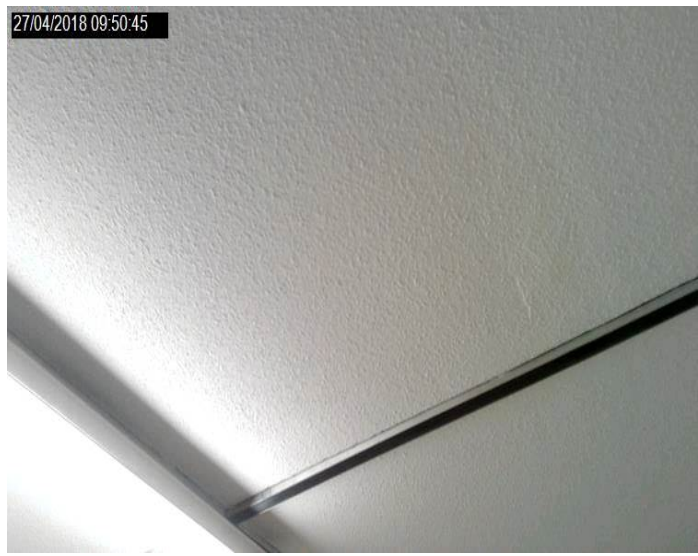
Item:	Asbestos Textured coating to concrete ceiling			
Asbestos Content:	Result Based on:			
Chrysotile	Analysis of sample using PLM			
Sample Analysed By:	Reg 13(1)	Extent:	10 m ²	
Comments:

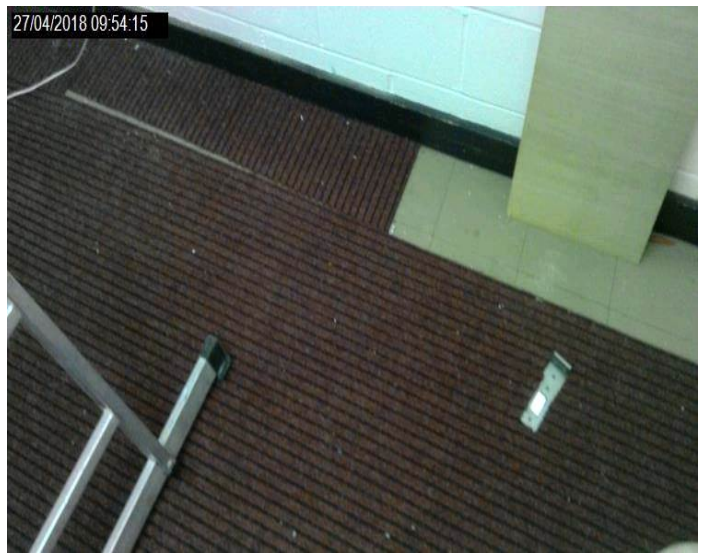
Item:	Asbestos Thermoplastic floor tiles with bitumen adhesive			
Asbestos Content:	Result Based on:			
Chrysotile in adhesive only	Strongly presumed			
Sample Analysed By:	Not applicable	Extent:	10 m ²	
Comments:

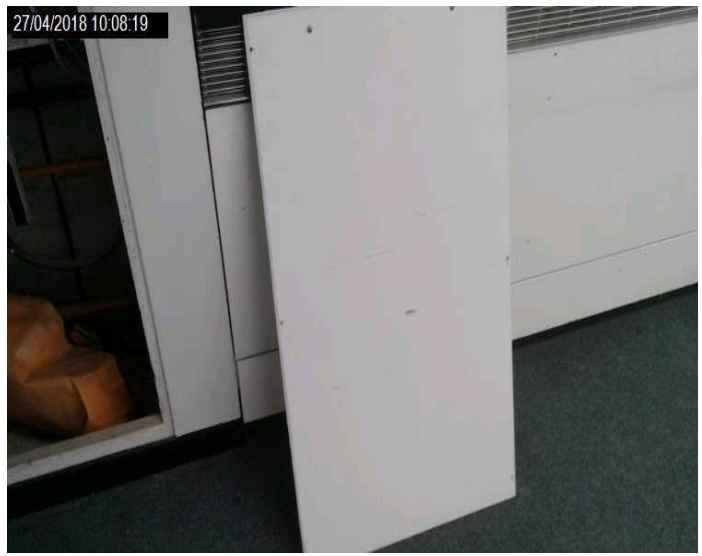
Item:	Insulating board panels to risers			
Asbestos Content:		Result Based on:		
No Asbestos Detected		Analysis of sample using PLM		
Sample Analysed By:	Reg 13(1)	Extent:	8 m ²	
Comments: 3 x risers

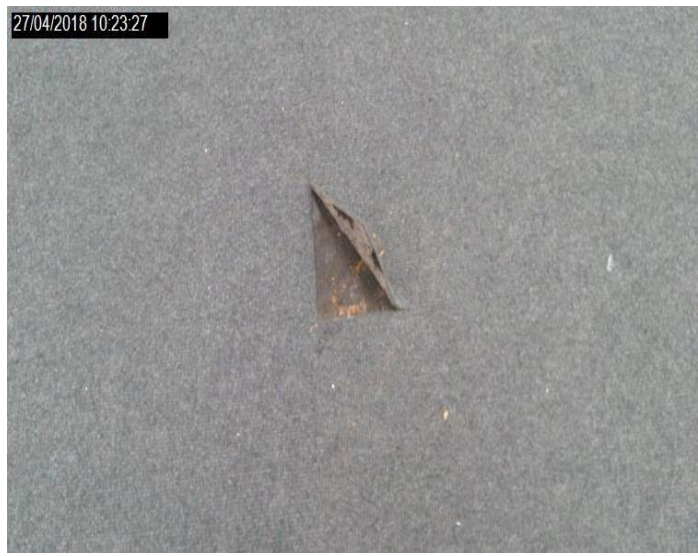
Item:	Asbestos Bitumen adhesive to concrete			
Asbestos Content:	Result Based on:			
Chrysotile	Analysis of sample using PLM			
Sample Analysed By: Reg 13(1)	Extent:	88 m ²		
Comments: Present beneath carpet

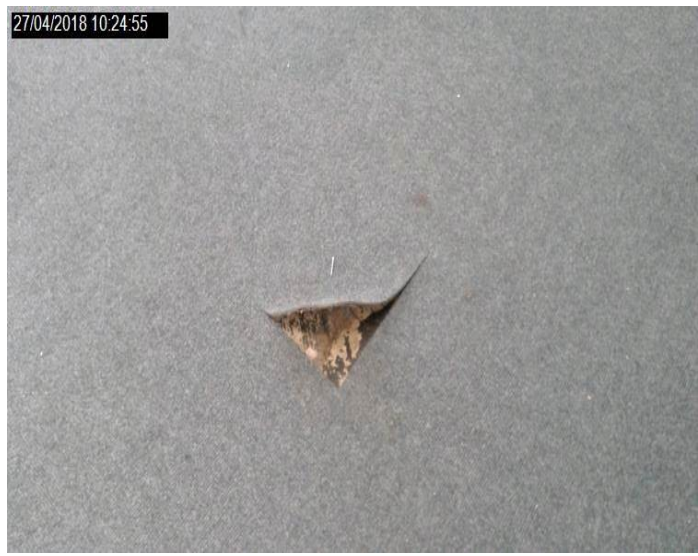
Item:	Asbestos Bitumen adhesive			
Asbestos Content:	Result Based on:			
Chrysotile	Strongly presumed			
Sample Analysed By:	Not applicable	Extent:	80 m ²	
Comments: Present beneath carpet

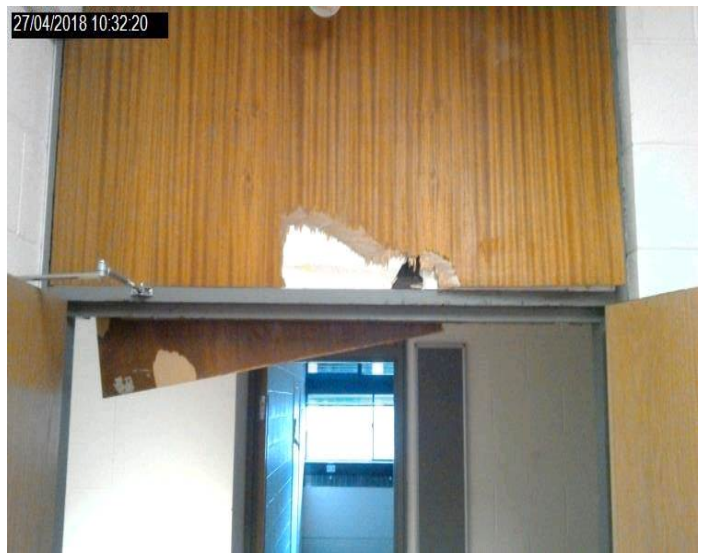
Item:	Insulating board door headers			
Asbestos Content:		Result Based on:		
No Asbestos Detected		Analysis of sample using PLM		
Sample Analysed By:	Reg 13(1)	Extent:	3 m ²	
Comments: Above double doors leading to room 1.99D and 1.22

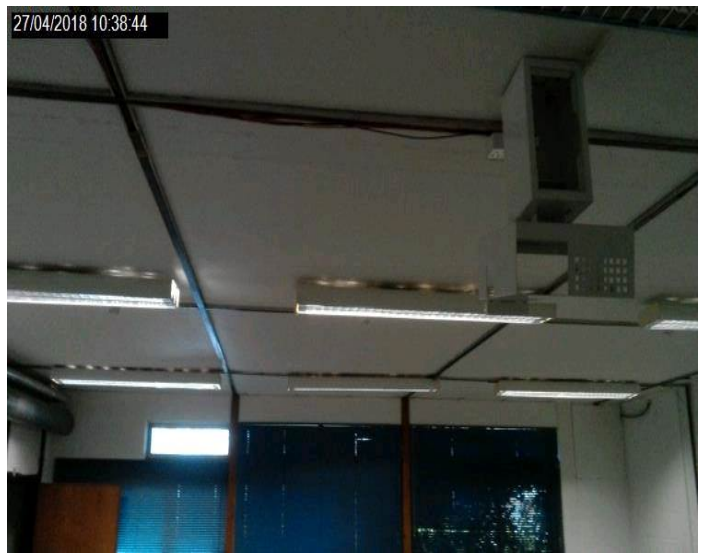
Item:	Asbestos Textured coating to concrete ceiling			
Asbestos Content:	Result Based on:			
Chrysotile	Strongly presumed			
Sample Analysed By:	Not applicable	Extent:	50 m ²	
Comments:

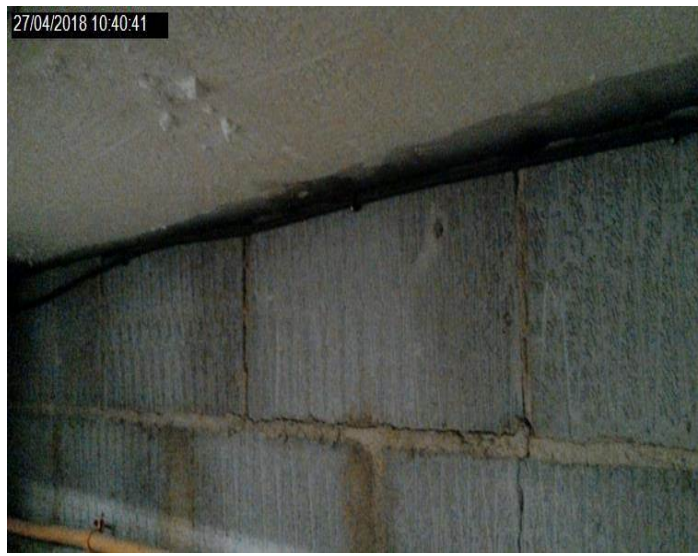
Item:	Asbestos Cement shuttering			
Asbestos Content:	Result Based on:			
Chrysotile	Strongly presumed			
Sample Analysed By:	Not applicable	Extent:	6 m ²	
Comments: To ceiling of wall void behind polystyrene sheets

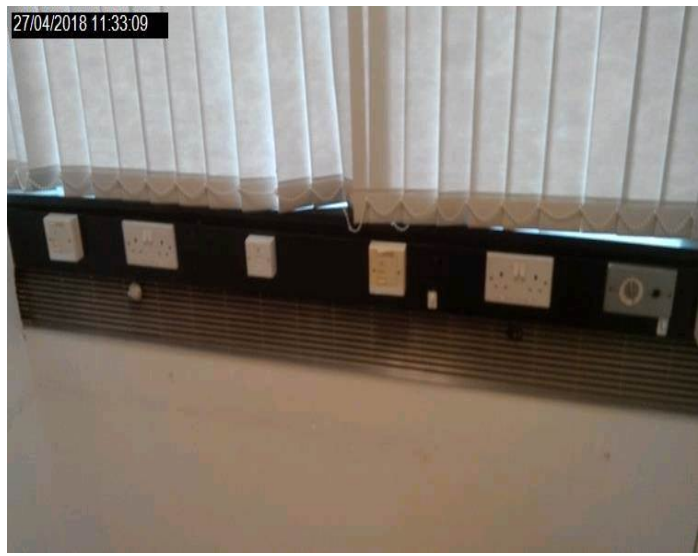
Item:	Asbestos Cement window sill			
Asbestos Content:	Result Based on:			
Chrysotile	Strongly presumed			
Sample Analysed By:	Not applicable	Extent:	2 linear metres	
Comments:

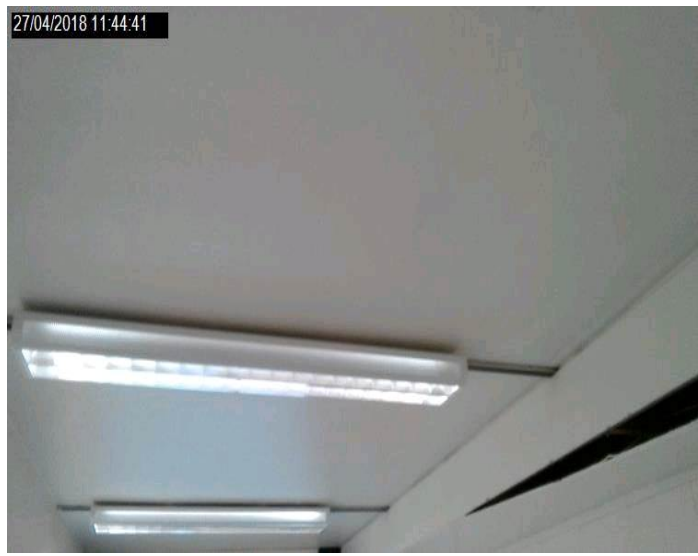
Item:	Asbestos Textured coating to concrete ceiling			
Asbestos Content:	Result Based on:			
Chrysotile	Analysis of sample using PLM			
Sample Analysed By:	Reg 13(1)	Extent:	18 m ²	
Comments:

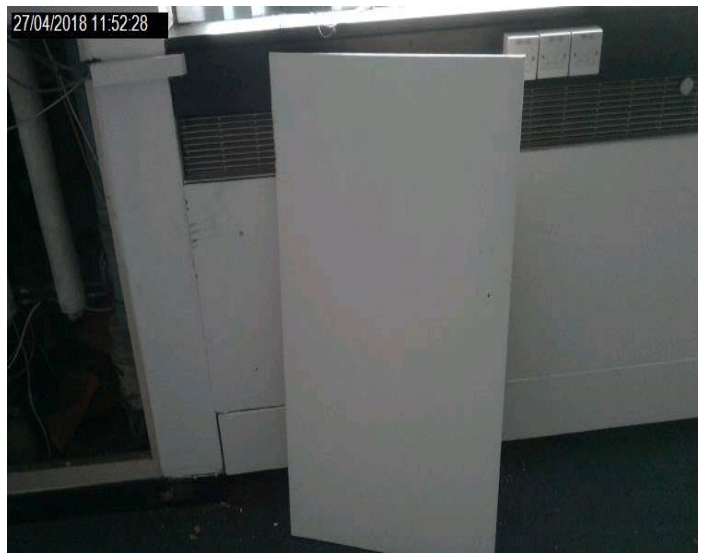
Item:	Insulating board panel to riser			
Asbestos Content:		Result Based on:		
No Asbestos Detected		Strongly presumed		
Sample Analysed By:	Not applicable	Extent:	2 m ²	
Comments: 1 x riser top 2 panels

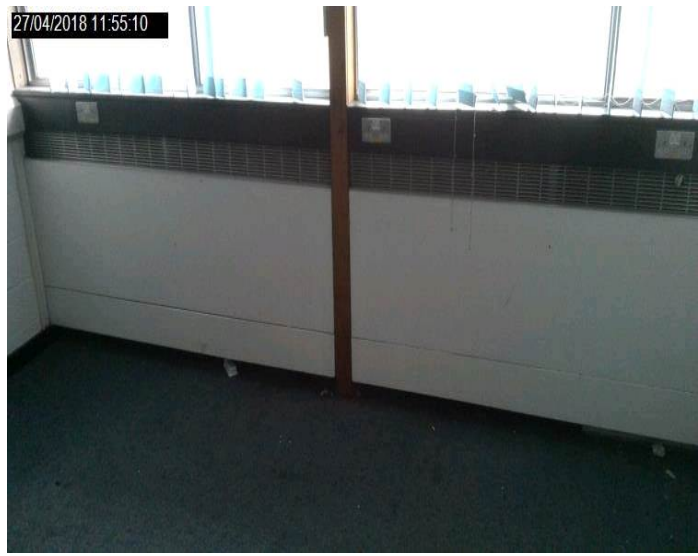
Item:	Asbestos Cement window sill			
Asbestos Content:	Result Based on:			
Chrysotile	Strongly presumed			
Sample Analysed By:	Not applicable	Extent:	4 linear metres	
Comments:

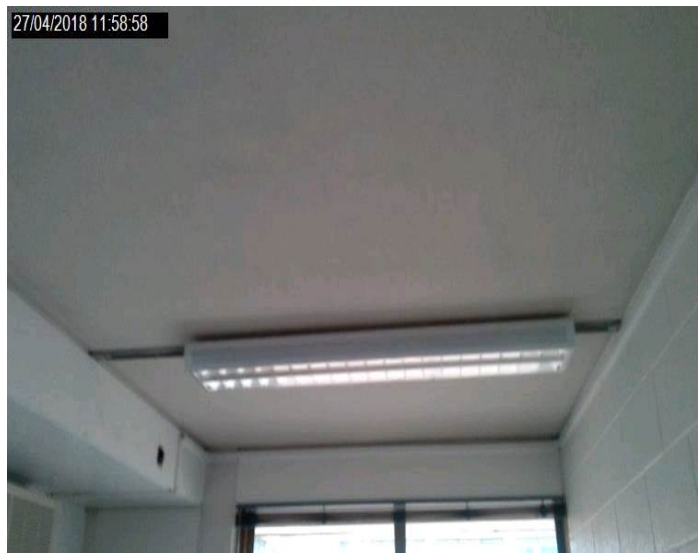
Item:	Asbestos Textured coating to concrete ceiling			
Asbestos Content:	Result Based on:			
Chrysotile	Strongly presumed			
Sample Analysed By:	Not applicable	Extent:	15 m ²	
Comments:

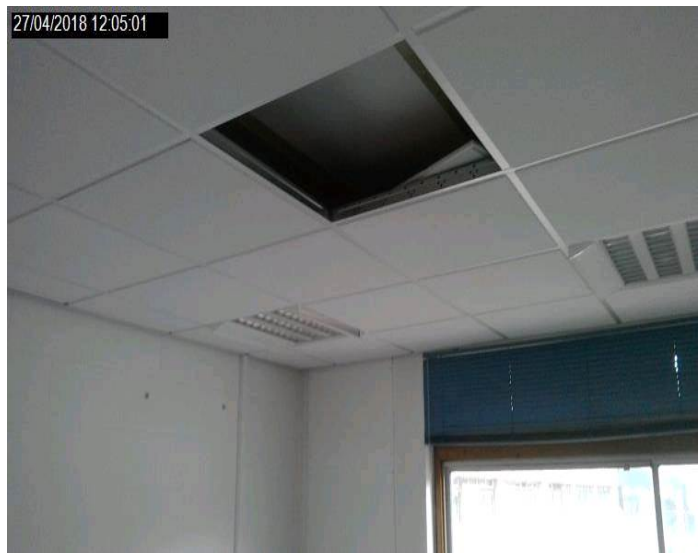
Item:	Asbestos Textured coating to concrete ceiling			
Asbestos Content:	Result Based on:			
Chrysotile	Strongly presumed			
Sample Analysed By:	Not applicable	Extent:	12 m ²	
Comments: Present above suspended ceiling

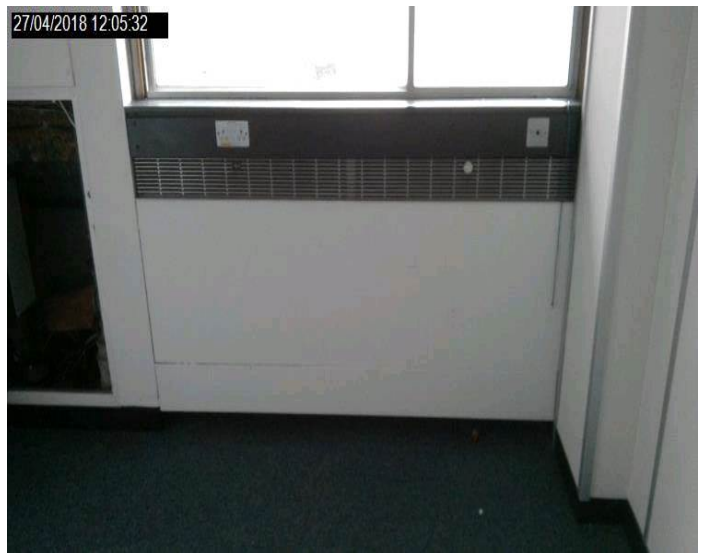
Item:	Asbestos Cement shuttering			
Asbestos Content:	Result Based on:			
Chrysotile	Strongly presumed			
Sample Analysed By:	Not applicable	Extent:	3 m ²	
Comments: To ceiling of wall void behind polystyrene

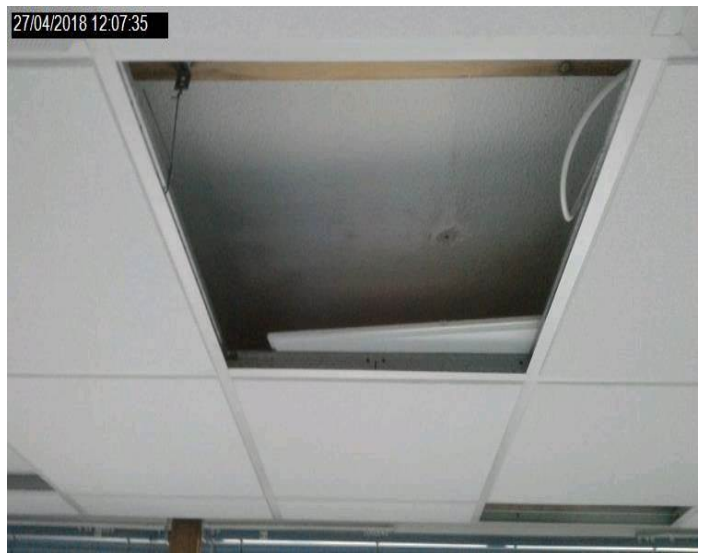
Item:	Asbestos Textured coating to concrete ceiling			
Asbestos Content:	Result Based on:			
Chrysotile	Strongly presumed			
Sample Analysed By:	Not applicable	Extent:	10 m ²	
Comments: Above suspended ceiling tiles

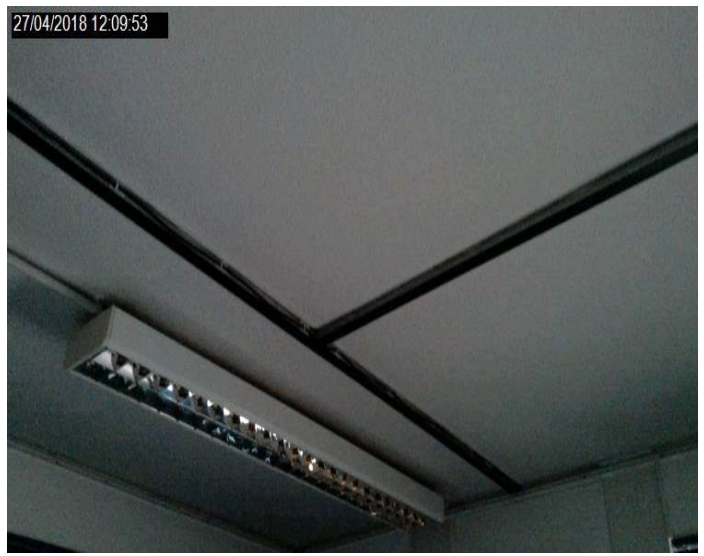
Item:	Asbestos Textured coating to concrete ceiling			
Asbestos Content:	Result Based on:			
Chrysotile	Strongly presumed			
Sample Analysed By:	Not applicable	Extent:	16 m ²	
Comments:

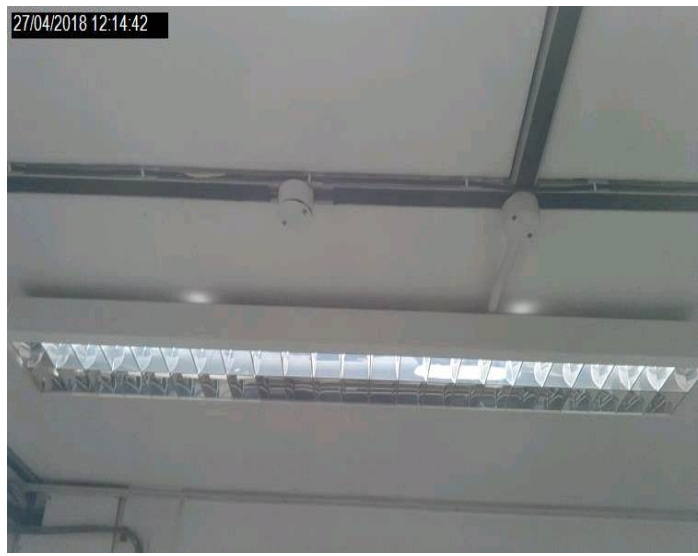
Item:	Asbestos Textured coating to concrete ceiling			
Asbestos Content:	Result Based on:			
Chrysotile	Strongly presumed			
Sample Analysed By:	Not applicable	Extent:	10 m ²	
Comments:

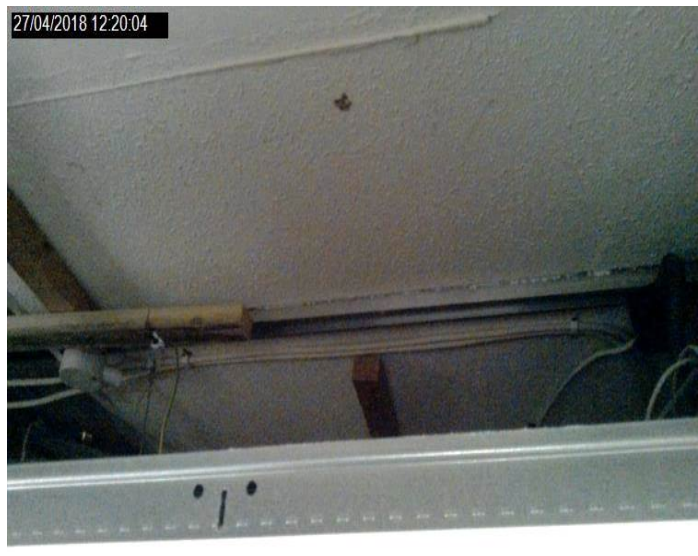
Item:	Asbestos Textured coating to concrete ceiling			
Asbestos Content:	Result Based on:			
Chrysotile	Strongly presumed			
Sample Analysed By:	Not applicable	Extent:	10 m ²	
Comments: Small section of ceiling, above suspended tiles

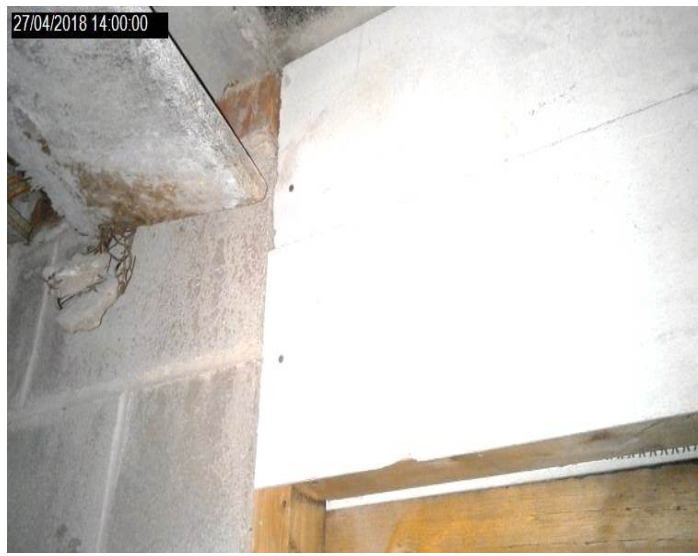
Item:	Asbestos Insulating board panels			
Asbestos Content:	Result Based on:			
Chrysotile Amosite	Analysis of sample using PLM			
Sample Analysed By: Reg 13(1)	Extent:	1 m ²		
Comments: Also visible packed in brickwork

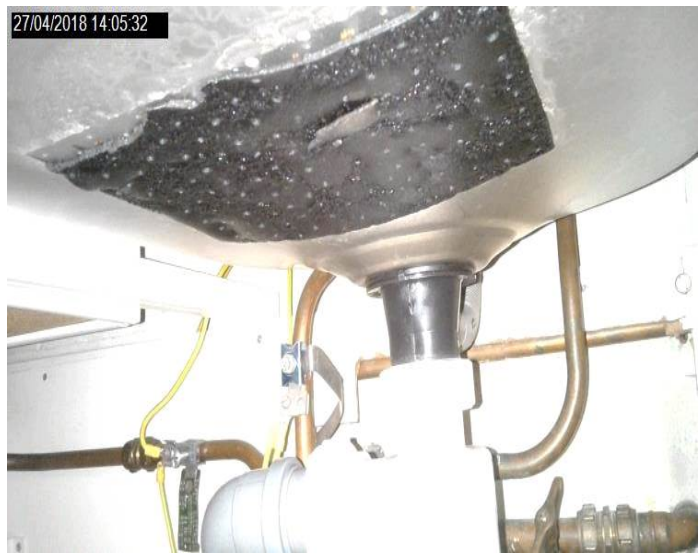
Item:	Bitumen sink pad			
Asbestos Content:		Result Based on:		
No Asbestos Detected		Analysis of sample using PLM		
Sample Analysed By:	Reg 13(1)	Extent:	2 units	
Comments:

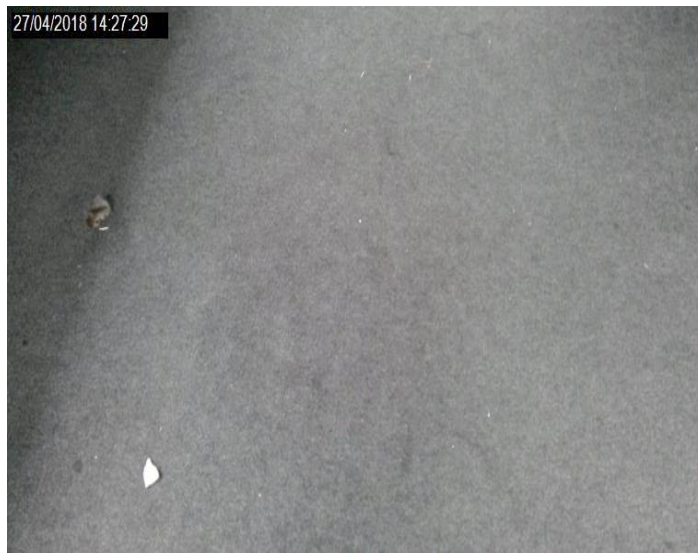
Item:	Asbestos Thermoplastic floor tiles with bitumen adhesive			
Asbestos Content:	Result Based on:			
Chrysotile in adhesive only	Strongly presumed			
Sample Analysed By:	Not applicable	Extent:	14 m ²	
Comments: Present beneath carpet

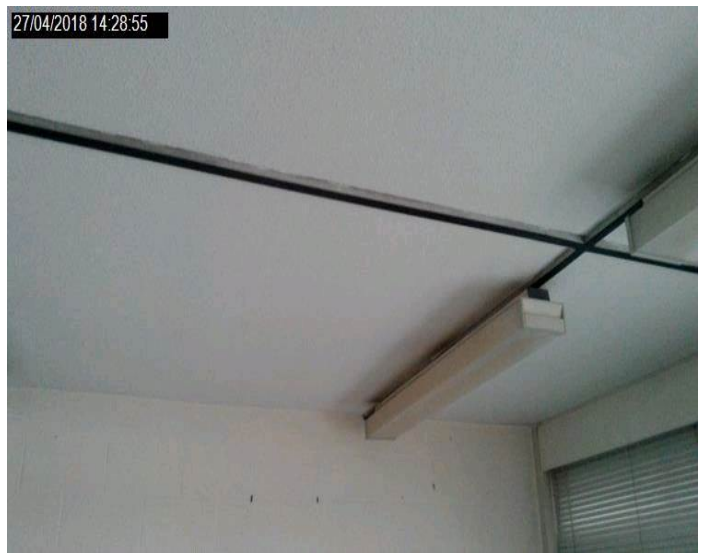
Item:	Asbestos Textured coating to concrete ceiling			
Asbestos Content:	Result Based on:			
Chrysotile	Strongly presumed			
Sample Analysed By:	Not applicable	Extent:	16 m ²	
Comments:

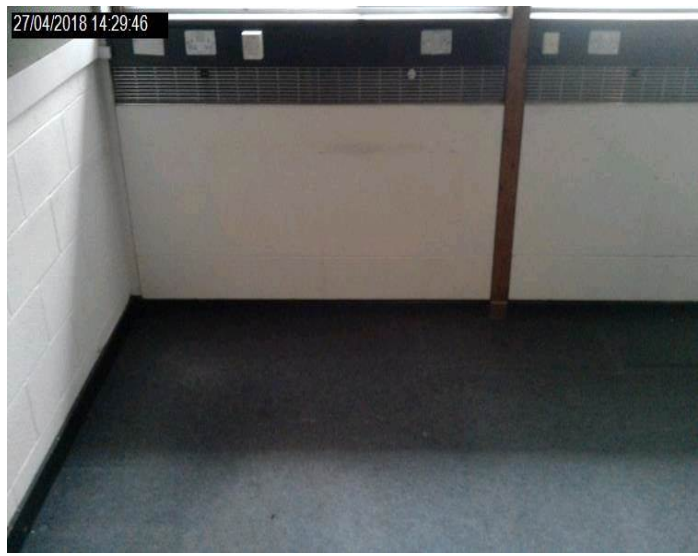
Item:	Asbestos Cement shuttering			
Asbestos Content:	Result Based on:			
Chrysotile	Strongly presumed			
Sample Analysed By:	Not applicable	Extent:	4 m ²	
Comments: To ceiling of wall void behind polystyrene sheets

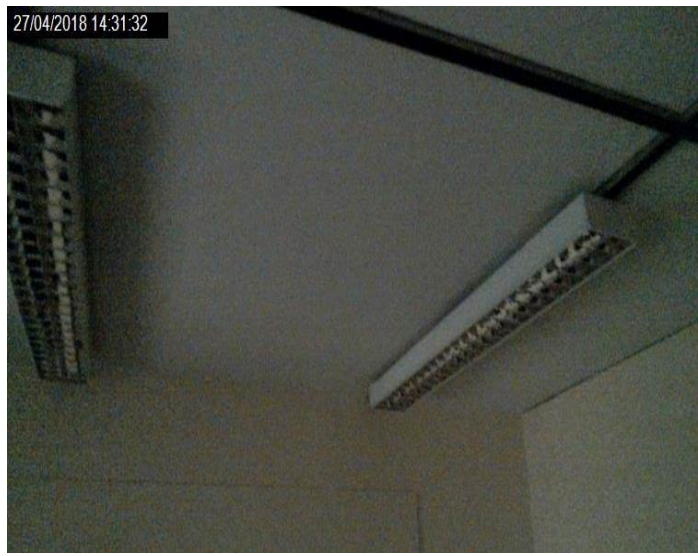
Item:	Asbestos Textured coating to concrete ceiling			
Asbestos Content:	Result Based on:			
Chrysotile	Strongly presumed			
Sample Analysed By:	Not applicable	Extent:	16 m ²	
Comments:

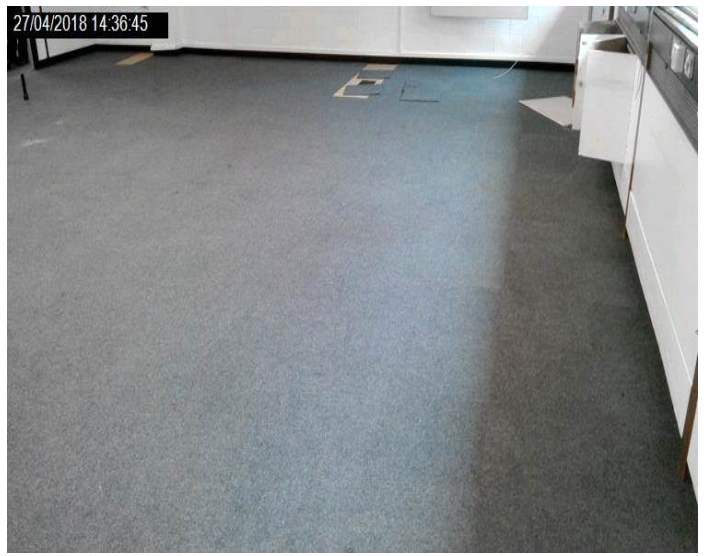
Item:	Asbestos Thermoplastic floor tiles with bitumen adhesive			
Asbestos Content:	Result Based on:			
Chrysotile in adhesive only	Strongly presumed			
Sample Analysed By:	Not applicable	Extent:	80 m ²	
Comments: Present beneath carpet

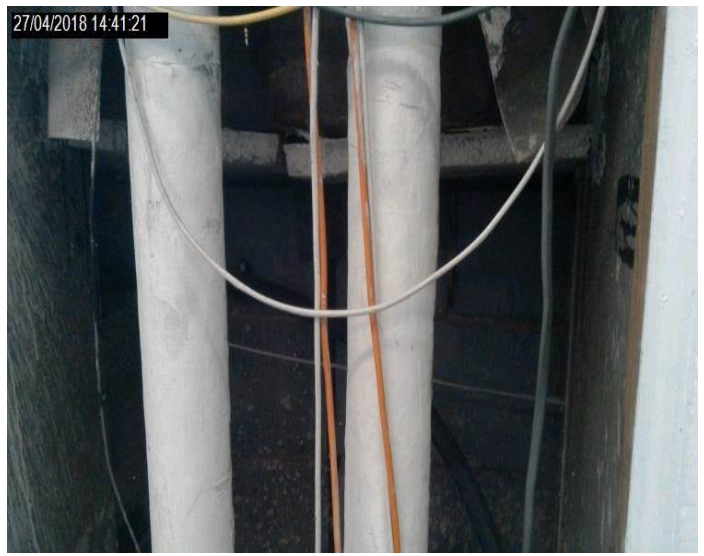
Item:	Asbestos Cement shuttering			
Asbestos Content:	Result Based on:			
Chrysotile	Strongly presumed			
Sample Analysed By:	Not applicable	Extent:	8 m ²	
Comments: To ceiling of wall void behind polystyrene sheets

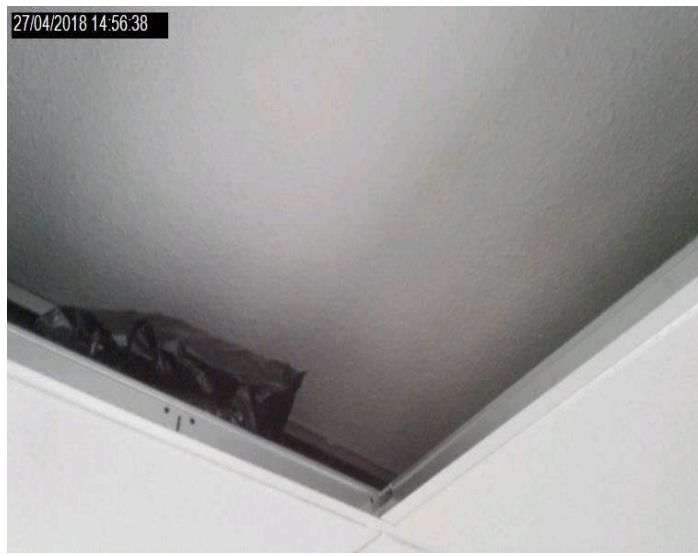
Item:	Asbestos Textured coating to concrete ceiling			
Asbestos Content:	Result Based on:			
Chrysotile	Strongly presumed			
Sample Analysed By:	Not applicable	Extent:	15 m ²	
Comments: Above suspended tiles

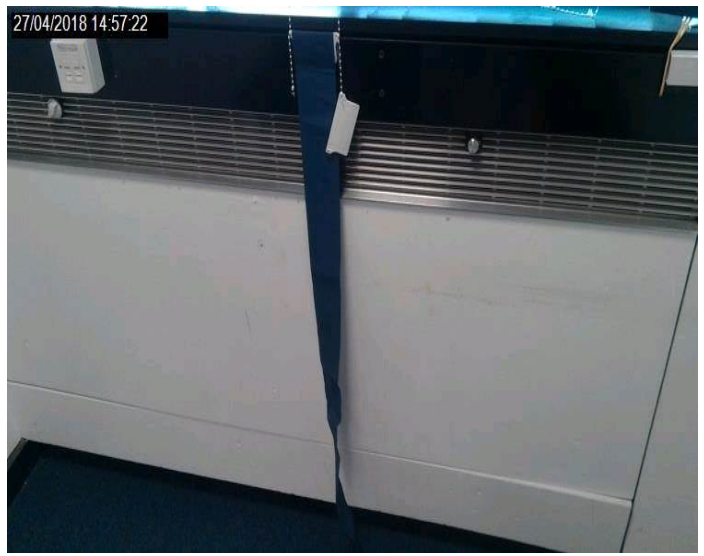
Item:	Asbestos Cement shuttering			
Asbestos Content:	Result Based on:			
Chrysotile	Strongly presumed			
Sample Analysed By:	Not applicable	Extent:	2 m ²	
Comments: To ceiling of wall void behind polystyrene sheets

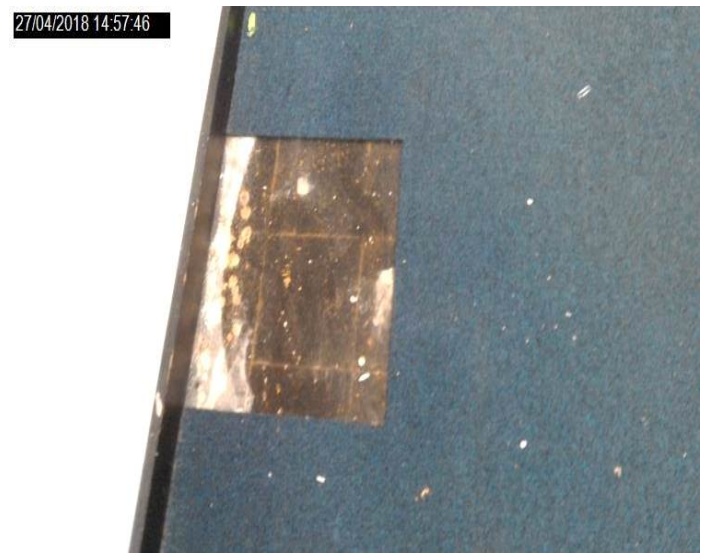
Item:	Asbestos Bitumen adhesive			
Asbestos Content:	Result Based on:			
Chrysotile	Strongly presumed			
Sample Analysed By:	Not applicable	Extent:	15 m ²	
Comments: Present beneath carpet

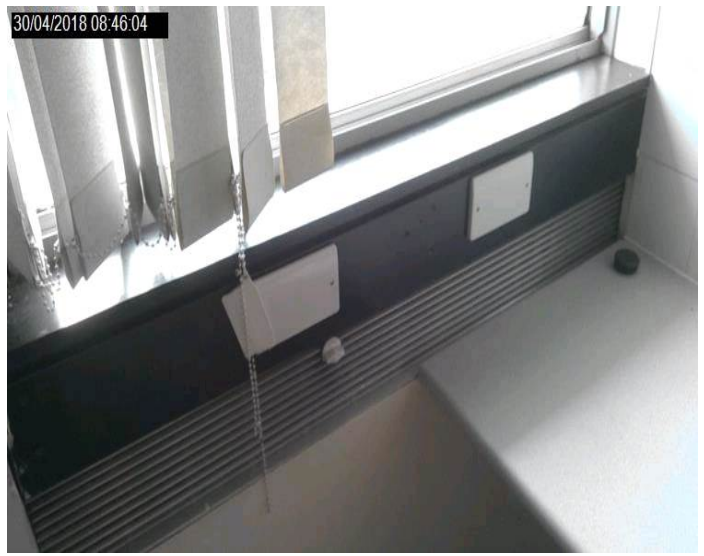
Item:	Asbestos Cement window sill			
Asbestos Content:	Result Based on:			
Chrysotile	Strongly presumed			
Sample Analysed By:	Not applicable	Extent:	1 linear metres	
Comments:

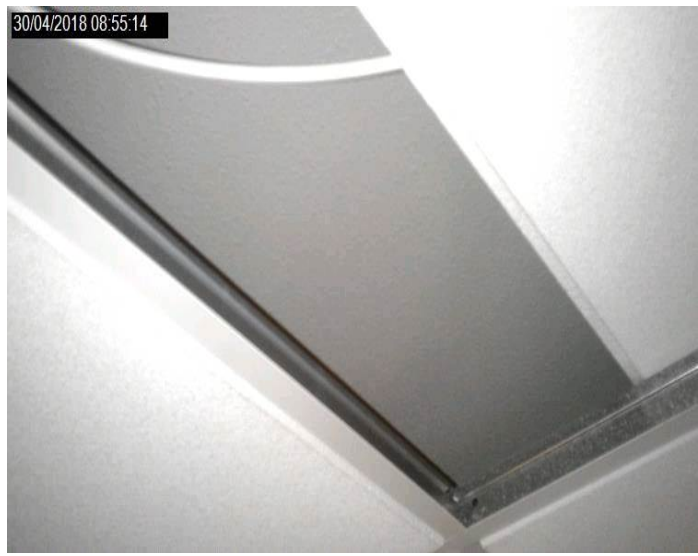
Item:	Asbestos Textured coating to concrete ceiling			
Asbestos Content:	Result Based on:			
Chrysotile	Strongly presumed			
Sample Analysed By:	Not applicable	Extent:	30 m ²	
Comments: Above suspended tiles

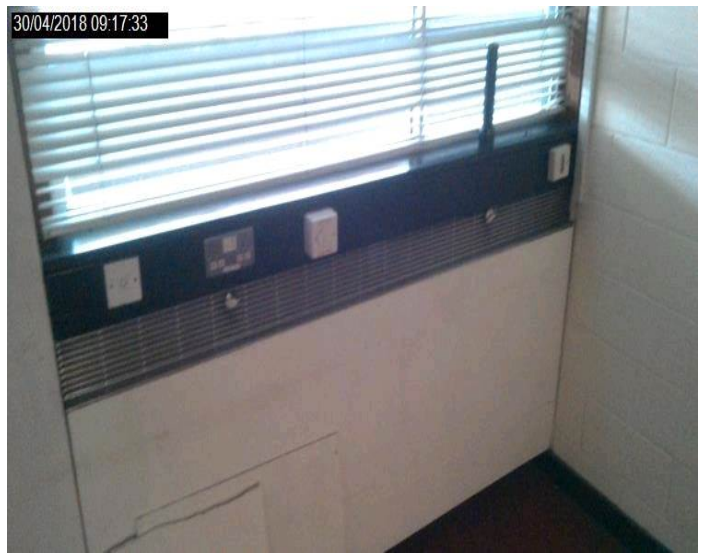
Item:	Asbestos Cement window sill			
Asbestos Content:	Result Based on:			
Chrysotile	Strongly presumed			
Sample Analysed By:	Not applicable	Extent:	3 linear metres	
Comments:

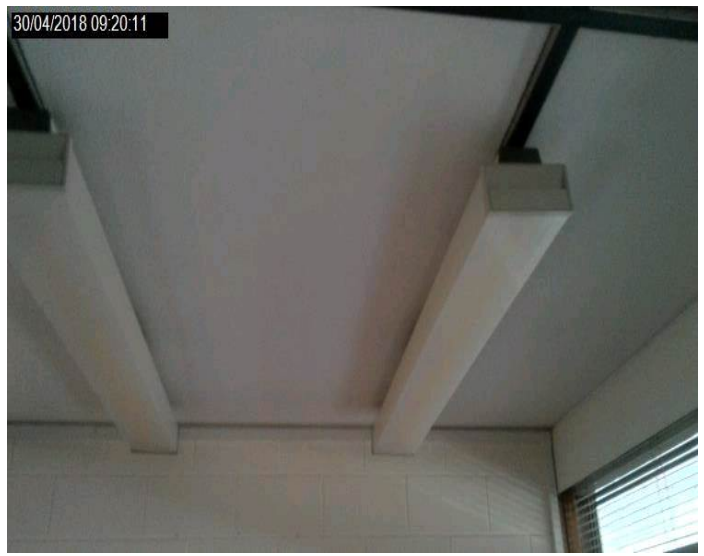
Item:	Asbestos Textured coating to concrete ceiling			
Asbestos Content:	Result Based on:			
Chrysotile	Strongly presumed			
Sample Analysed By:	Not applicable	Extent:	12 m ²	
Comments:

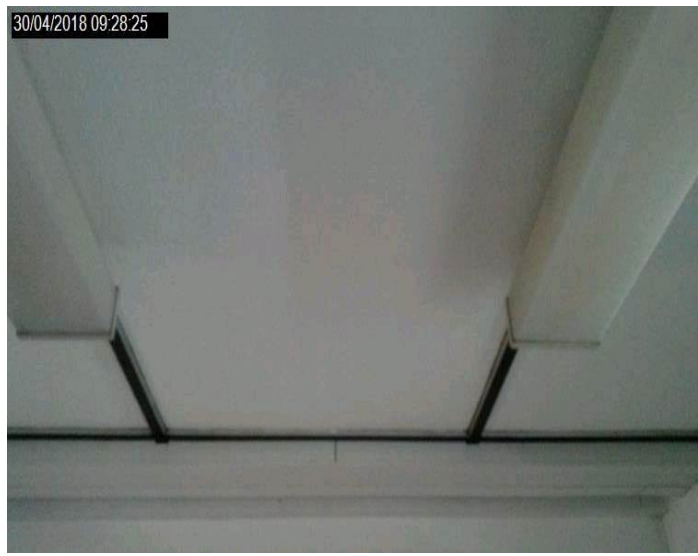
Item:	Asbestos Textured coating to concrete ceiling			
Asbestos Content:	Result Based on:			
Chrysotile	Strongly presumed			
Sample Analysed By:	Not applicable	Extent:	9 m ²	
Comments:

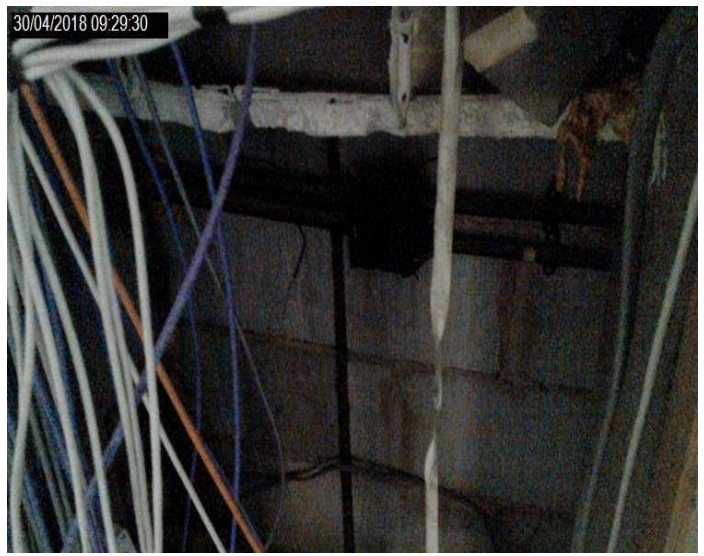
Item:	Asbestos Cement shuttering			
Asbestos Content:	Result Based on:			
Chrysotile	Strongly presumed			
Sample Analysed By:	Not applicable	Extent:	3 m ²	
Comments: To ceiling of wall void behind polystyrene sheets

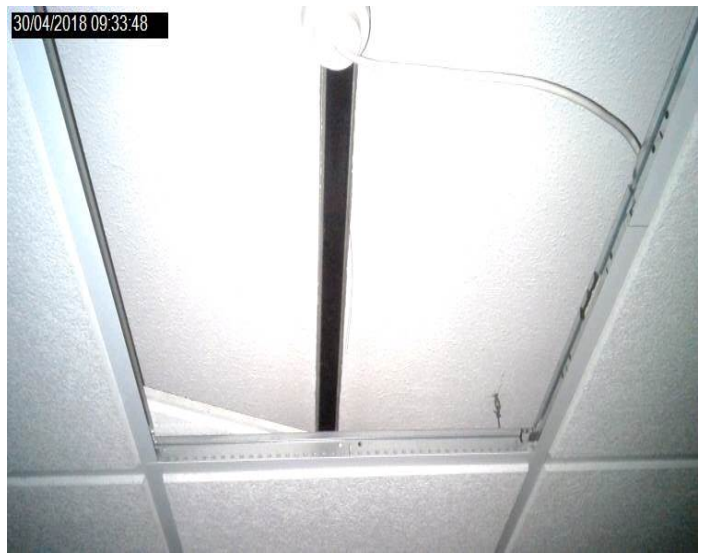
Item:	Asbestos Textured coating to concrete ceiling			
Asbestos Content:	Result Based on:			
Chrysotile	Strongly presumed			
Sample Analysed By:	Not applicable	Extent:	18 m ²	
Comments:

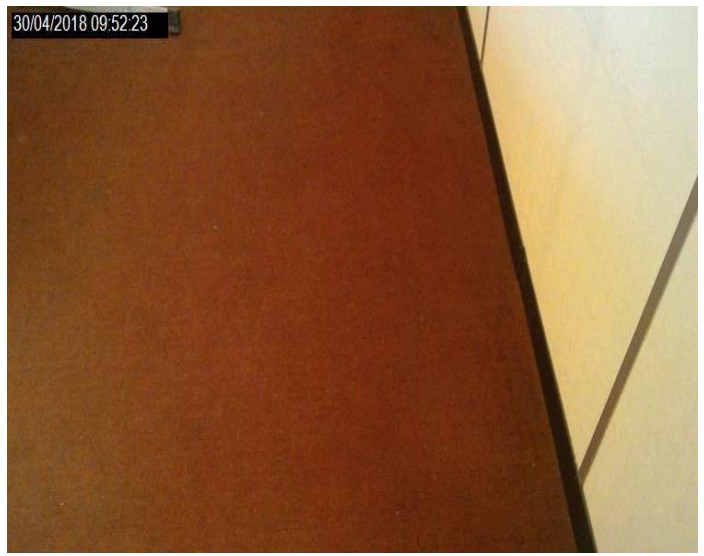
Item:	Asbestos Thermoplastic floor tiles with bitumen adhesive			
Asbestos Content:	Result Based on:			
Chrysotile in adhesive only	Analysis of sample using PLM			
Sample Analysed By: Reg 13(1)	Extent:	14 m ²		
Comments: Beneath carpet

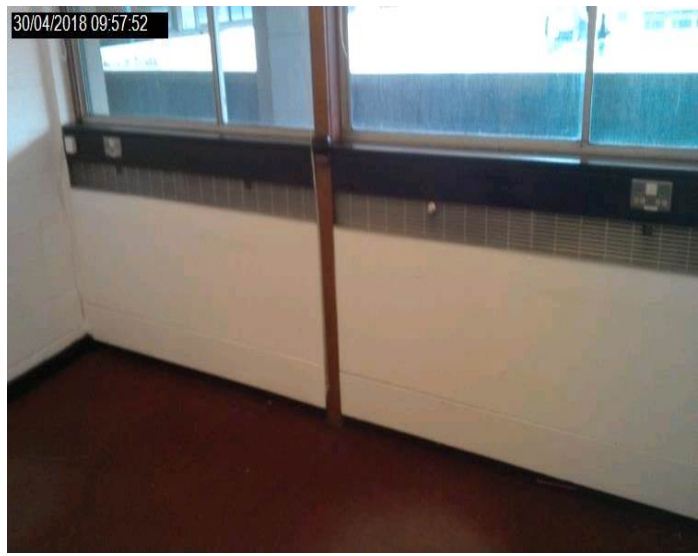
Item:	Asbestos Cement window sill			
Asbestos Content:	Result Based on:			
Chrysotile	Strongly presumed			
Sample Analysed By:	Not applicable	Extent:	4 linear metres	
Comments:

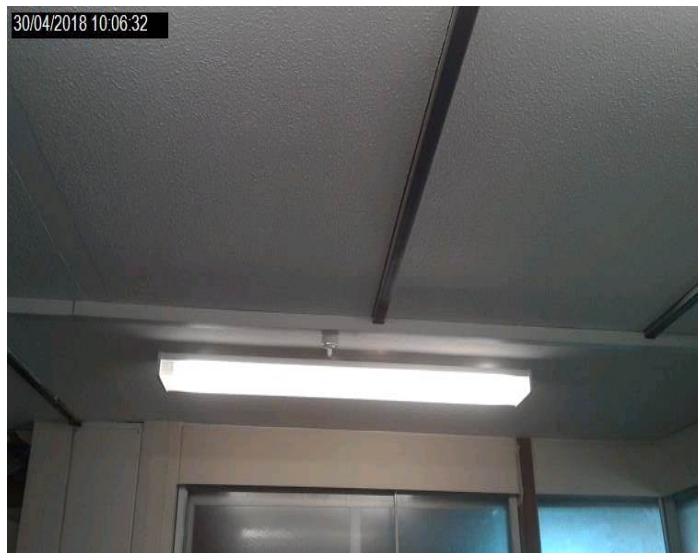
Item:	Asbestos Textured coating to concrete ceiling			
Asbestos Content:	Result Based on:			
Chrysotile	Strongly presumed			
Sample Analysed By:	Not applicable	Extent:	28 m ²	
Comments:

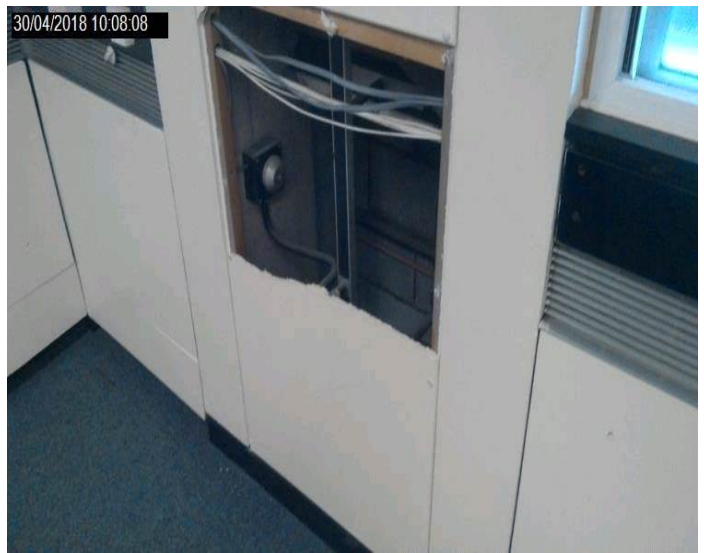
Item:	Insulating board panels to riser			
Asbestos Content:		Result Based on:		
No Asbestos Detected		Strongly presumed		
Sample Analysed By:	Not applicable	Extent:	5 m ²	
Comments: 2 x risers

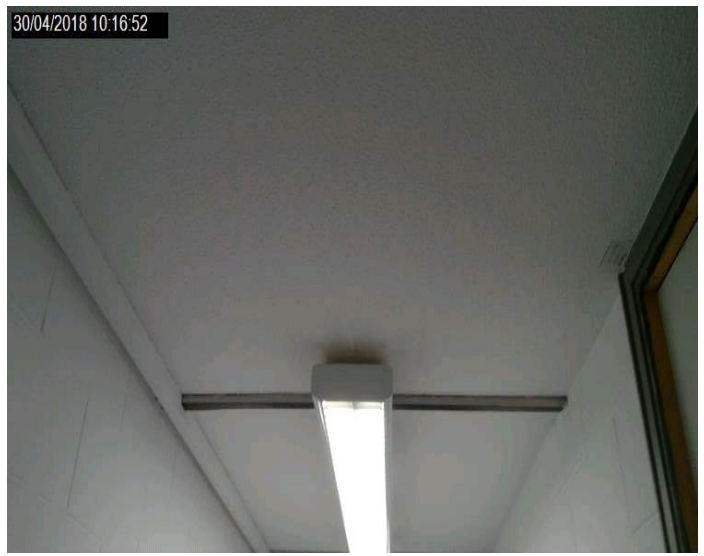
Item:	Asbestos Textured coating to concrete ceiling			
Asbestos Content:	Result Based on:			
Chrysotile	Strongly presumed			
Sample Analysed By:	Not applicable	Extent:	9 m ²	
Comments: To recess sections of main corridor only

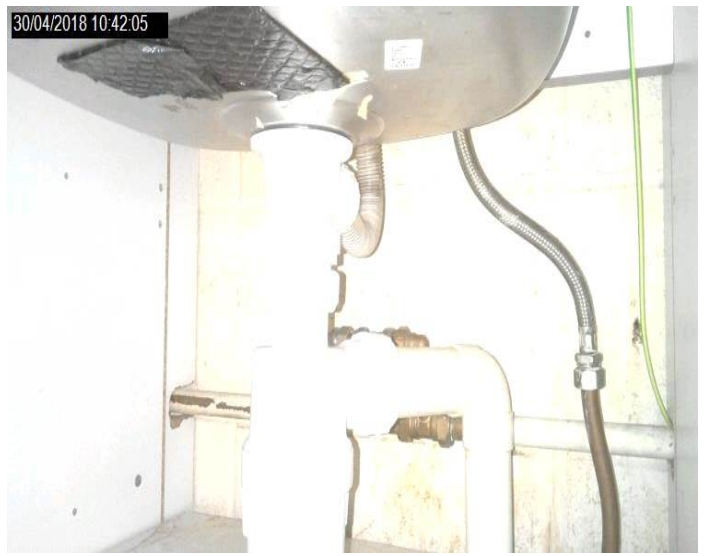
Item:	Bitumen sink pad			
Asbestos Content:		Result Based on:		
No Asbestos Detected		Analysis of sample using PLM		
Sample Analysed By:	Reg 13(1)	Extent:	2 units	
Comments:

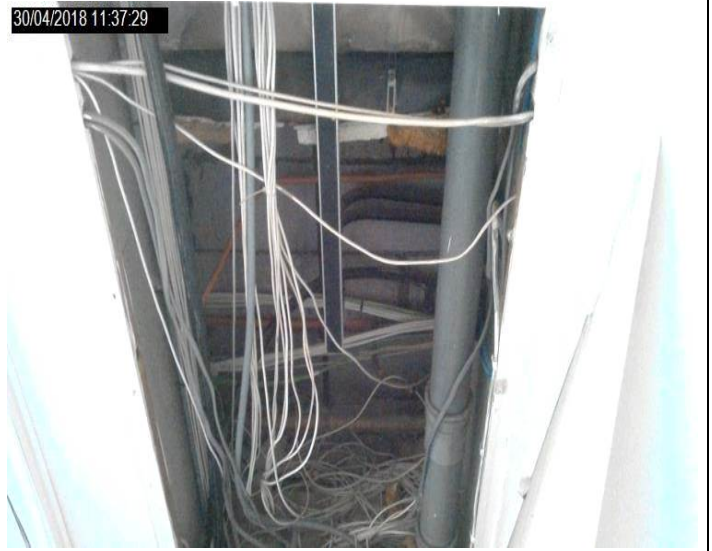
Item:	Asbestos Cement shuttering			
Asbestos Content:	Result Based on:			
Chrysotile Amosite	Strongly presumed			
Sample Analysed By:	Not applicable	Extent:	6 m ²	
Comments: To ceiling of wall void behind polystyrene sheets

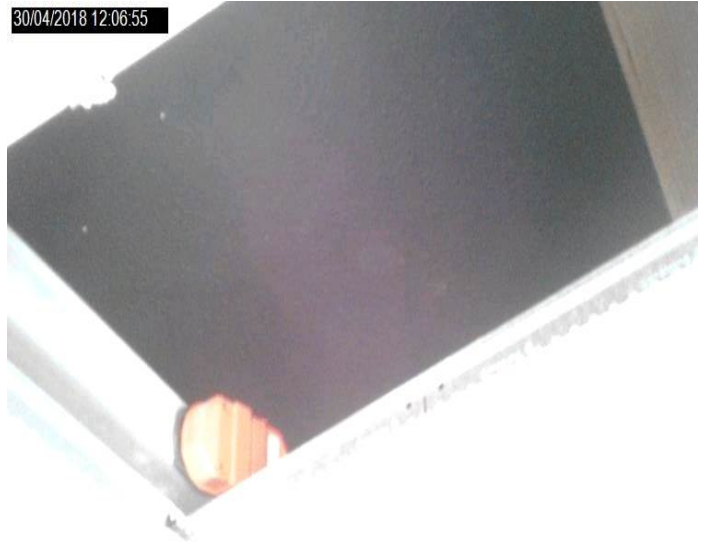
Item:	Asbestos Textured coating to concrete ceiling			
Asbestos Content:	Result Based on:			
Chrysotile	Strongly presumed			
Sample Analysed By:	Not applicable	Extent:	60 m ²	
Comments: Above ceiling tiles painted black

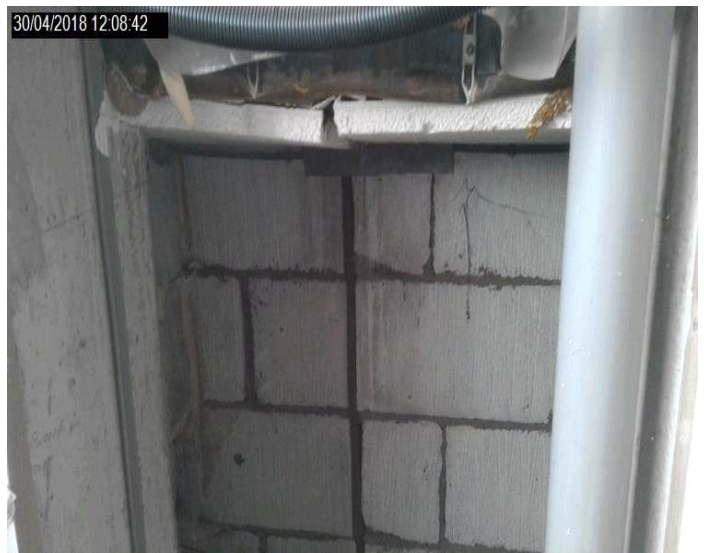
Item:	Asbestos Cement shuttering			
Asbestos Content:	Result Based on:			
Chrysotile Amosite	Strongly presumed			
Sample Analysed By:	Not applicable	Extent:	16 m ²	
Comments: To ceiling of wall void behind polystyrene sheets

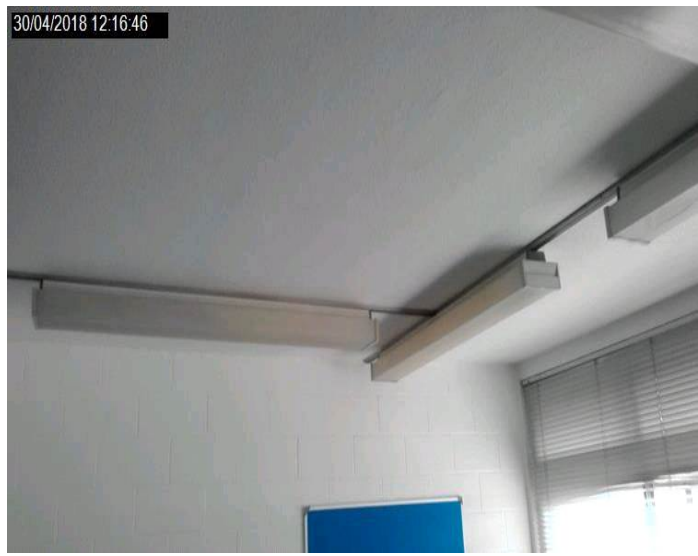
Item:	Asbestos Textured coating to concrete ceiling			
Asbestos Content:	Result Based on:			
Chrysotile	Strongly presumed			
Sample Analysed By:	Not applicable	Extent:	24 m ²	
Comments:

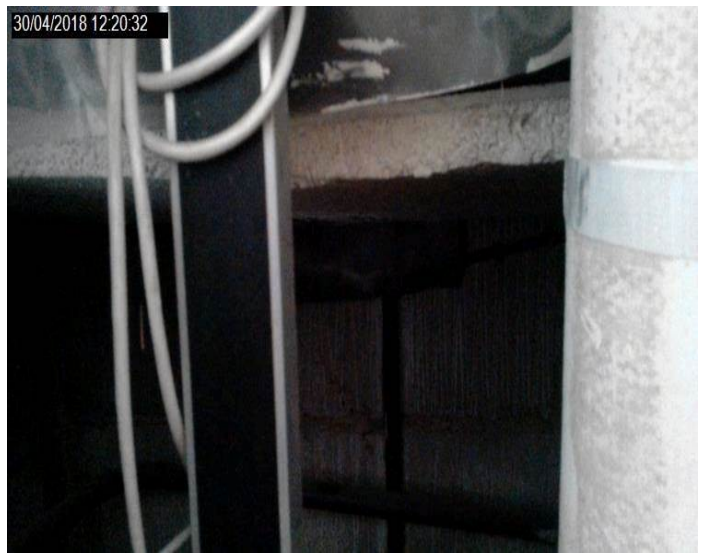
Item:	Asbestos Cement shuttering			
Asbestos Content:	Result Based on:			
Chrysotile Amosite	Strongly presumed			
Sample Analysed By:	Not applicable	Extent:	4 m ²	
Comments: To ceiling of wall void behind polystyrene sheets

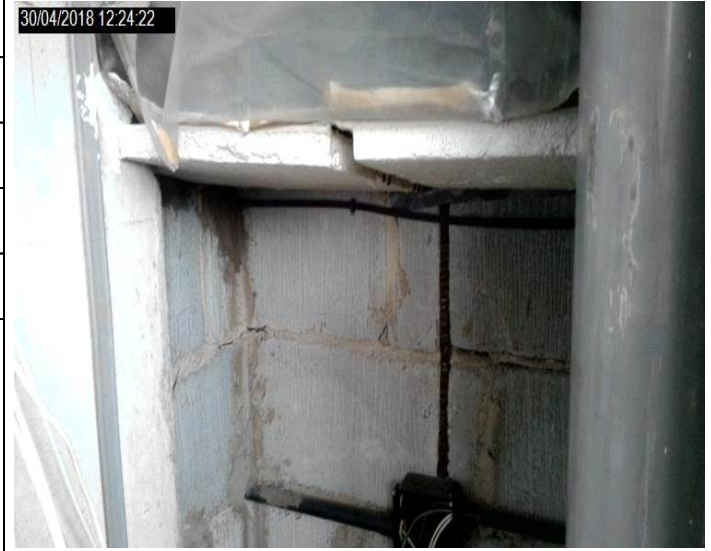
Item:	Asbestos Cement shuttering			
Asbestos Content:	Result Based on:			
Chrysotile Amosite	Strongly presumed			
Sample Analysed By:	Not applicable	Extent:	10 m ²	
Comments: To ceiling of wall void behind polystyrene sheets
