Report No.: J094099
Nature of Work: Demolition Survey
Issue Date: 11/06/2018
Client Name: WYG Engineering Ltd
Geneva Building, Lake View Drive, Sherwood Business Park,
Annesley, Nottingham, NG15 0ED
Site Address: Dawson building, Former City North Campus, Birmingham City
University, Perry Barr, B42 2US

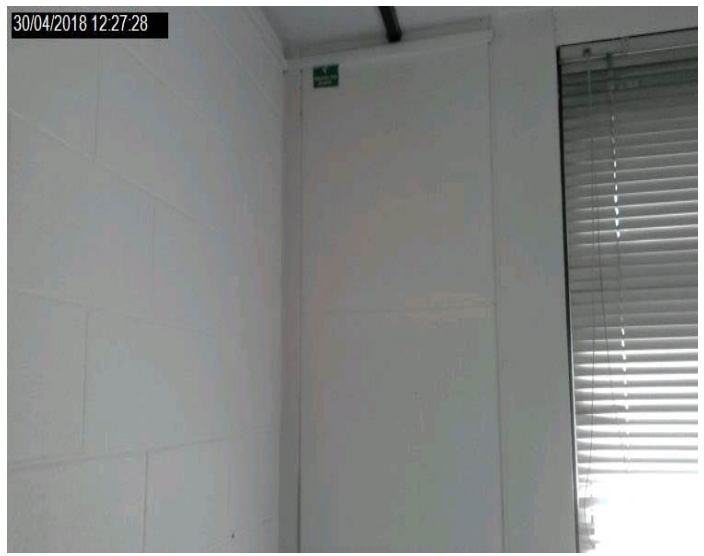
Item:	Insulating board panels to riser			
Asbestos Content:		Result Based on:		
No Asbestos Detected		Strongly presumed		
Sample Analysed By:	Not applicable	Extent:	2 m ²	
Comments: top 2 panels

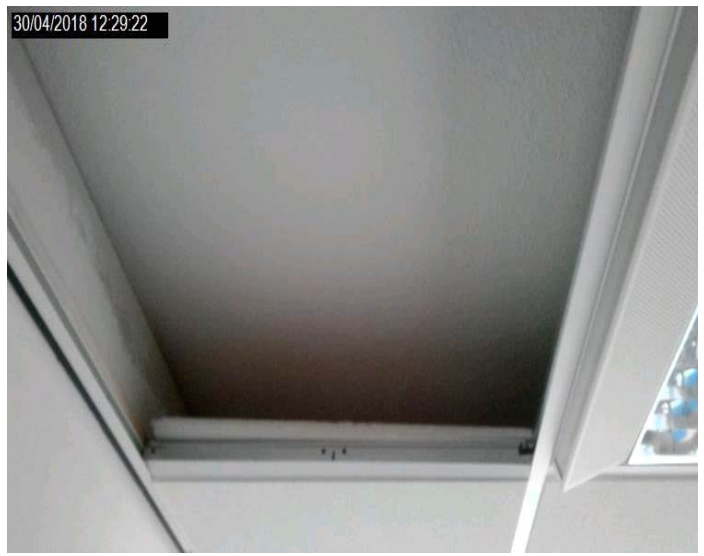
Item:	Asbestos Textured coating to concrete ceiling			
Asbestos Content:	Result Based on:			
Chrysotile	Strongly presumed			
Sample Analysed By:	Not applicable	Extent:	12 m ²	
Comments:

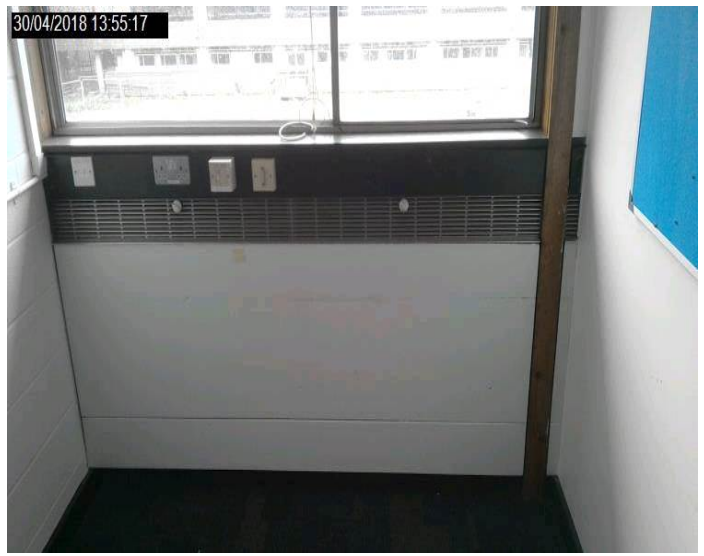
Item:	Asbestos Cement window sill			
Asbestos Content:	Result Based on:			
Chrysotile	Strongly presumed			
Sample Analysed By:	Not applicable	Extent:	2 linear metres	
Comments:

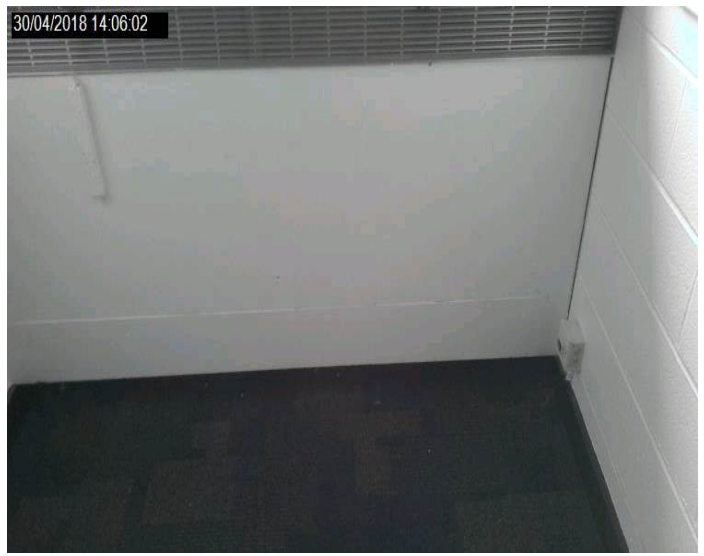
Item:	Asbestos Cement shuttering			
Asbestos Content:	Result Based on:			
Chrysotile Amosite	Strongly presumed			
Sample Analysed By:	Not applicable	Extent:	2 m ²	
Comments: To ceiling of wall void behind polystyrene sheets

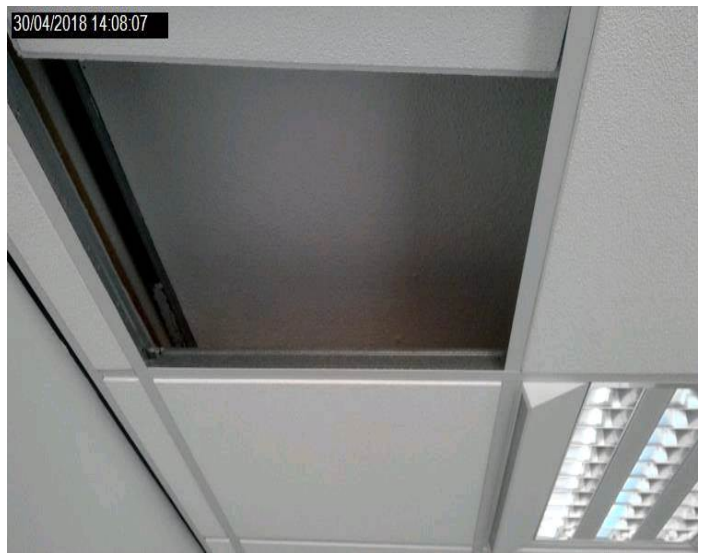
Item:	Asbestos Textured coating to concrete ceiling			
Asbestos Content:	Result Based on:			
Chrysotile	Strongly presumed			
Sample Analysed By:	Not applicable	Extent:	12 m ²	
Comments: Present above suspended ceiling

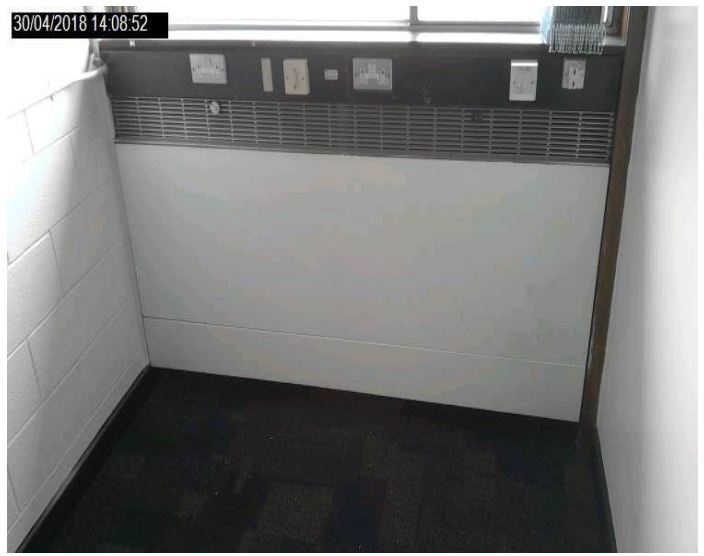
Item:	Asbestos Cement shuttering			
Asbestos Content:	Result Based on:			
Chrysotile Amosite	Strongly presumed			
Sample Analysed By:	Not applicable	Extent:	2 m ²	
Comments: To ceiling of wall void behind polystyrene sheets

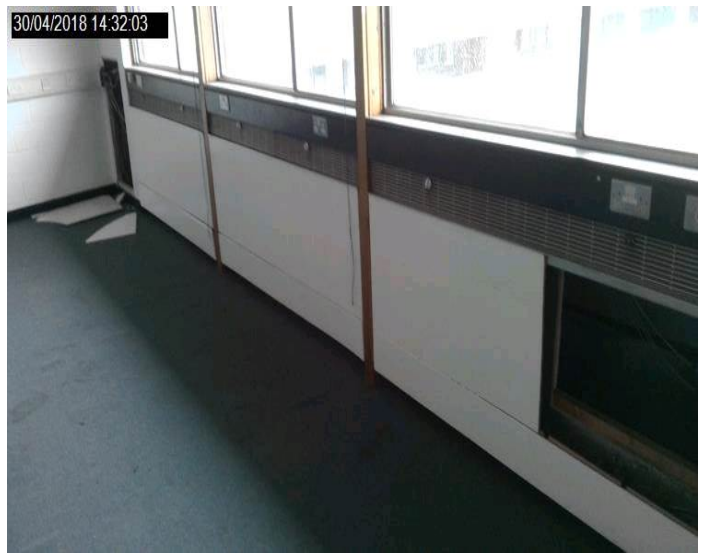
Item:	Asbestos Cement window sill			
Asbestos Content:	Result Based on:			
Chrysotile	Analysis of sample using PLM			
Sample Analysed By:	Reg 13(1)	Extent:	6 linear metres	
Comments:

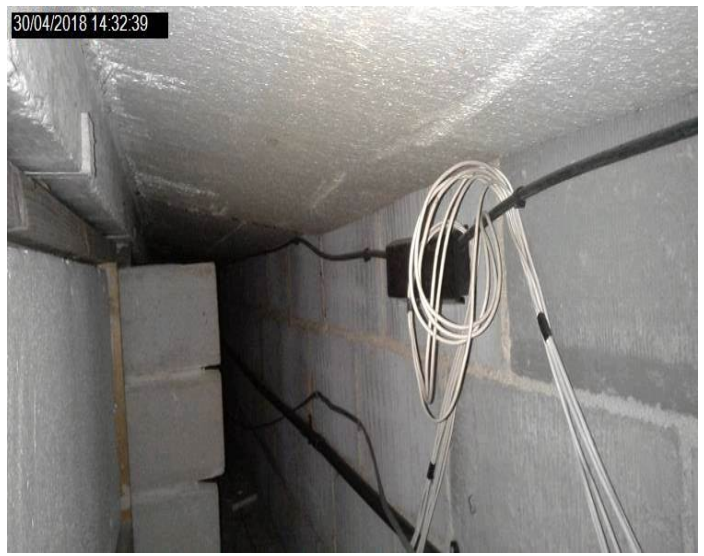
Item:	Asbestos Cement shuttering			
Asbestos Content:	Result Based on:			
Chrysotile Amosite	Analysis of sample using PLM			
Sample Analysed By: Reg 13(1)	Extent:	6 m ²		
Comments: To ceiling of wall void behind polystyrene sheets

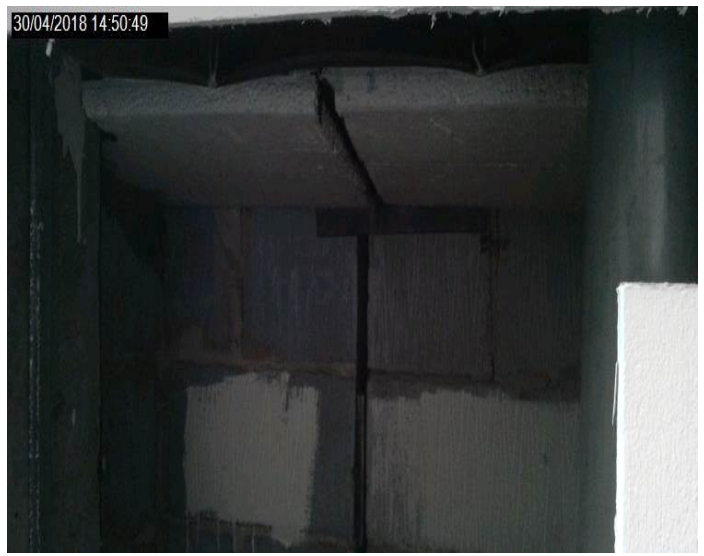
Item:	Asbestos Cement shuttering			
Asbestos Content:	Result Based on:			
Chrysotile Amosite	Strongly presumed			
Sample Analysed By:	Not applicable	Extent:	12 m ²	
Comments: To ceiling of wall void behind polystyrene sheets

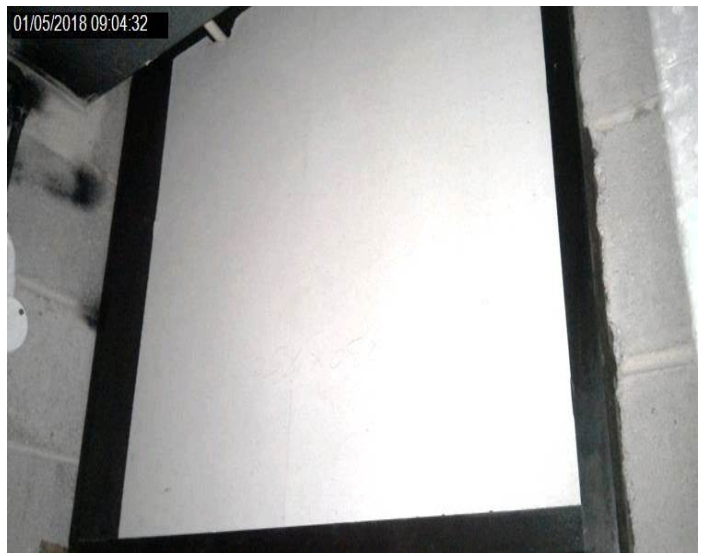
Item:	Asbestos Insulating board door header panel			
Asbestos Content:	Result Based on:			
Chrysotile Amosite	Analysis of sample using PLM			
Sample Analysed By: Reg 13(1)	Extent:	1 m ²		
Comments:
