Report No.: J102322
Nature of Work: Demolition Survey
Issue Date: 31/07/2018
Client Name: WYG Engineering Ltd
Geneva Building, Lake View Drive, Sherwood Business Park,
Annesley, Nottingham, NG15 0ED
Site Address: Kenrick Building, Former City North Campus, Birmingham City
University, Perry Barr, B42 2US

A demolition survey in line with HSG264 Asbestos: The Survey Guide was carried out internally and externally to the outbuildings adjacent to Kenrick building.

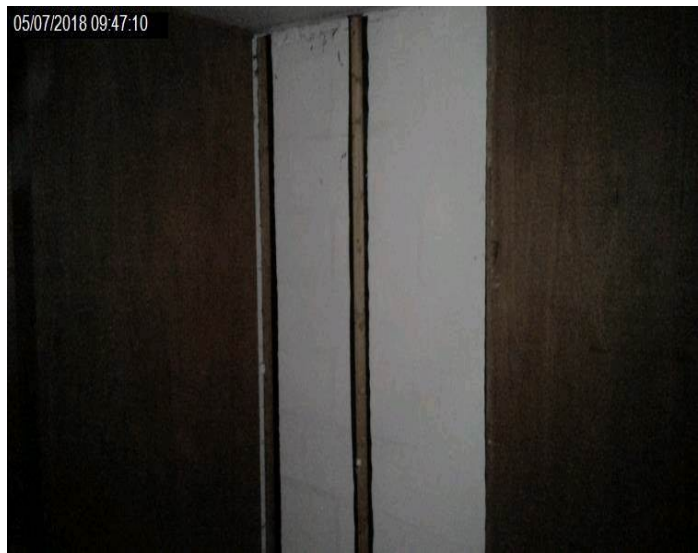
Location:	01 - Outside store	Block:	Commercial	Floor Level: Ground Floor
Sample No.:	DU001944	Portal Ref No.:	4

Item:	Bitumen damp proof course			
Asbestos Content:		Result Based on:		
No Asbestos Detected		Analysis of sample using PLM		
Sample Analysed By:	Reg 13(1)	Extent:	120 linear metres	
Comments: To rear of vertical timber battens to walls, battens every 400mm

Material Assessment Total Score: 0		Likelihood of Disturbance Assessment Total Score: 0		Management Assessment Licensable: No Recommendations: Not Applicable Reinspection Interval: Not Applicable Overall Risk Category: E0
Product Type:	0 Not Applicable	Location:	0 Not Applicable	
Condition:	0 Not Applicable	Accessibility:	0 Not Applicable	
Surface Treatment:	0 Not Applicable			
Asbestos Type:	0 Not Applicable	Extent Score:	0 Not Applicable

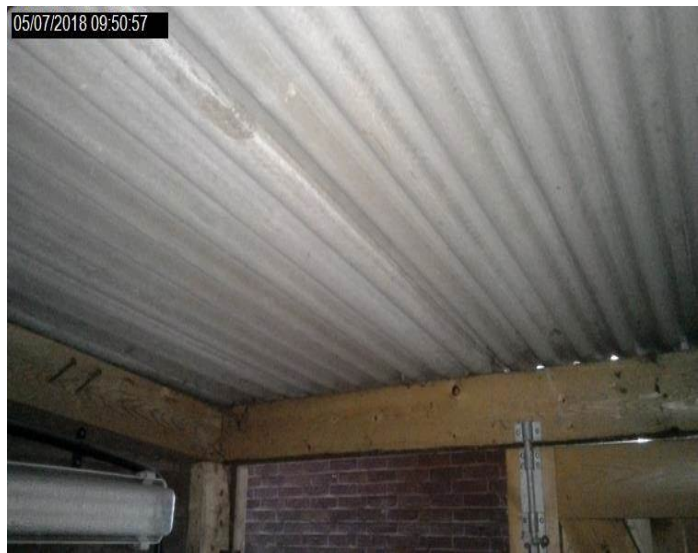
Location:	02 - Store	Block:	Commercial	Floor Level: Ground Floor
Sample No.:	DU001946	Portal Ref No.:	8

Item:	Corrugated cement			
Asbestos Content:		Result Based on:		
No Asbestos Detected		Analysis of sample using PLM		
Sample Analysed By:	Reg 13(1)	Extent:	4 m ²	
Comments: Sampled internally

Material Assessment Total Score: 0		Likelihood of Disturbance Assessment Total Score: 0		Management Assessment Licensable: No Recommendations: Not Applicable Reinspection Interval: Not Applicable Overall Risk Category: E0
Product Type:	0 Not Applicable	Location:	0 Not Applicable	
Condition:	0 Not Applicable	Accessibility:	0 Not Applicable	
Surface Treatment:	0 Not Applicable			
Asbestos Type:	0 Not Applicable	Extent Score:	0 Not Applicable

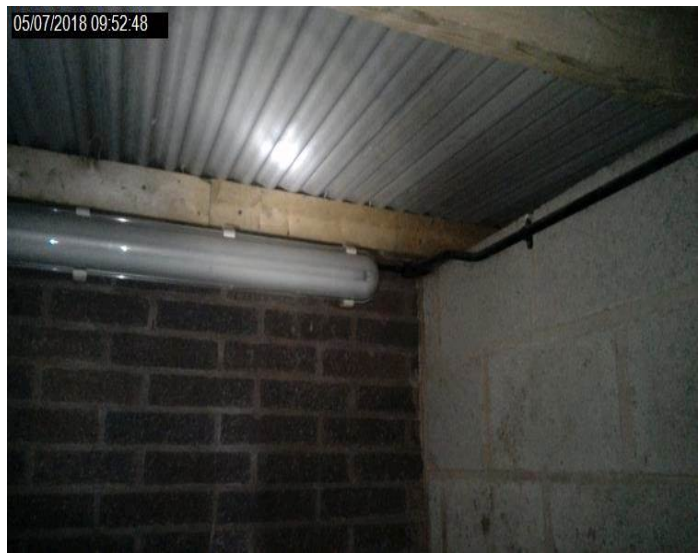
Location:	03 - Store	Block:	Commercial	Floor Level: Ground Floor
Sample No.:	As DU001946	Portal Ref No.:	9

Item:	Corrugated cement			
Asbestos Content:		Result Based on:		
No Asbestos Detected		Strongly presumed		
Sample Analysed By:	Not applicable	Extent:	5 m ²	
Comments: Sampled internally

Material Assessment Total Score: 0		Likelihood of Disturbance Assessment Total Score: 0		Management Assessment Licensable: No Recommendations: Not Applicable Reinspection Interval: Not Applicable Overall Risk Category: E0
Product Type:	0 Not Applicable	Location:	0 Not Applicable	
Condition:	0 Not Applicable	Accessibility:	0 Not Applicable	
Surface Treatment:	0 Not Applicable			
Asbestos Type:	0 Not Applicable	Extent Score:	0 Not Applicable

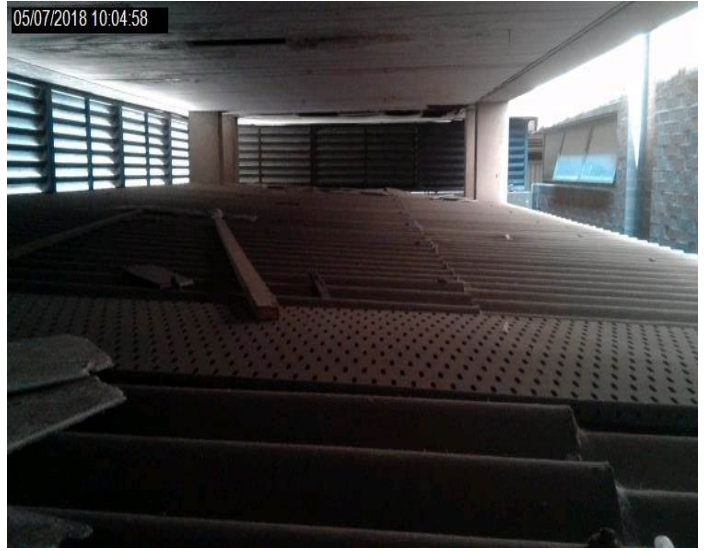
Location:	04 - External of 01	Block:	Commercial	Floor Level: E - External
Sample No.:	DU001947	Portal Ref No.:	10

Item:	Corrugated cement roof covering			
Asbestos Content:		Result Based on:		
No Asbestos Detected		Analysis of sample using PLM		
Sample Analysed By:	Reg 13(1)	Extent:	30 m ²	
Comments:

Material Assessment Total Score: 0		Likelihood of Disturbance Assessment Total Score: 0		Management Assessment Licensable: No Recommendations: Not Applicable Reinspection Interval: Not Applicable Overall Risk Category: E0
Product Type:	0 Not Applicable	Location:	0 Not Applicable	
Condition:	0 Not Applicable	Accessibility:	0 Not Applicable	
Surface Treatment:	0 Not Applicable			
Asbestos Type:	0 Not Applicable	Extent Score:	0 Not Applicable

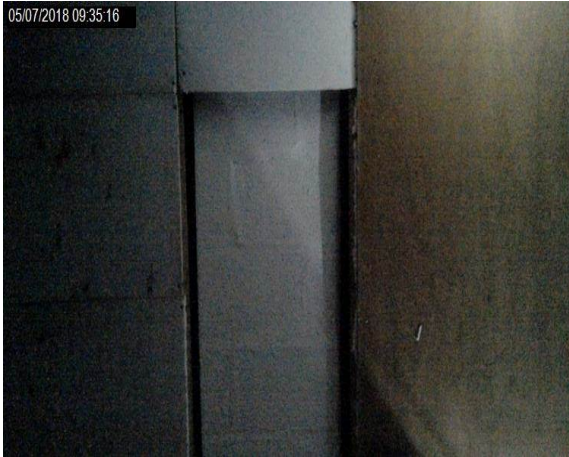
Intrusion 01 - Ply wood lining to polystyrene to block

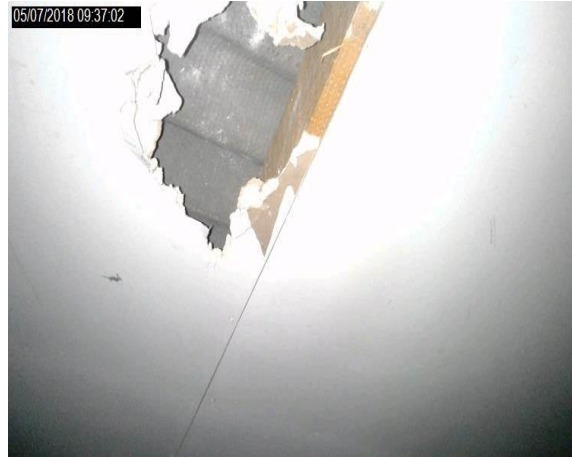
Intrusion 02 - Plasterboard to corrugate cement

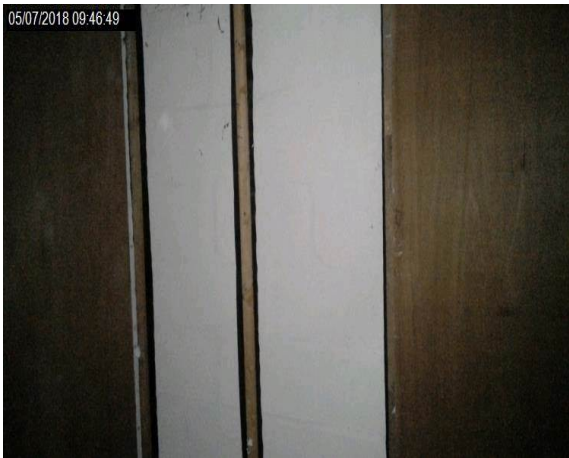
Intrusion 03 - Ply lining to polystyrene to block
