Report No.: J102752
Nature of Work: Demolition Survey
Issue Date: 26/09/2018
Client Name: WYG Engineering Ltd
Geneva Building, Lake View Drive, Sherwood Business Park,
Annesley, Nottingham, NG15 0ED
Site Address: Howes Building, Former City North Campus, Birmingham City
University, Perry Barr, B42 2US

A demolition survey in line with HSG264 Asbestos: The Survey Guide was carried out internally and externally to the property.

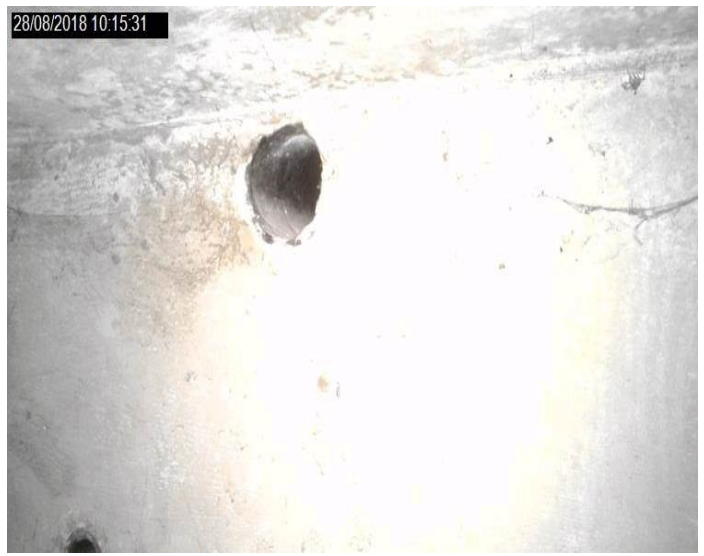
Location:	NHOG15 Playroom	Block:	Birmingham City University	Floor Level: Ground Floor
Sample No.:	DU002174	Portal Ref No.:	1

Item:	Asbestos Reinforced plastic sleeve			
Asbestos Content:	Result Based on:			
Chrysotile	Analysis of sample using PLM			
Sample Analysed By: Reg 13(1)	Extent:	10 units		
Comments: To metal conduit within ceiling void, various penetrations throughout the concrete structural sections within the ceiling void

Material Assessment Total Score: 3		Likelihood of Disturbance Assessment Average Score: 1		Management Assessment Licensable: No Recommendations: Program removal Reinspection Interval: Not Applicable Overall Risk Score: 5
Product Type:	1 (Asbestos reinforced plastic)	Location:	2 (Rooms up to 100 sq m)	
Condition:	1 (Minor scratches)	Accessibility:	0 (Usually inaccessible or unlikely to be disturbed)	
Surface Treatment:	0 (Composite material)	Extent Score:	1 (<10 sq m or 10m pipe run)	
Asbestos Type:	1 (Chrysotile)	Maintenance Activity Average Score: 1		
Human Exposure Potential Average Score: 0		Type of Maintenance Activity:	0 (Minor disturbance)	
Number of Occupants:	0 (None)	Frequency of Use:	1 (<1 per year)	
Average Time in Use:	0 (<1 hour)	Normal Occupancy Activity: 0		
		Main Type of Activity in Area:	0 (Rare disturbance)

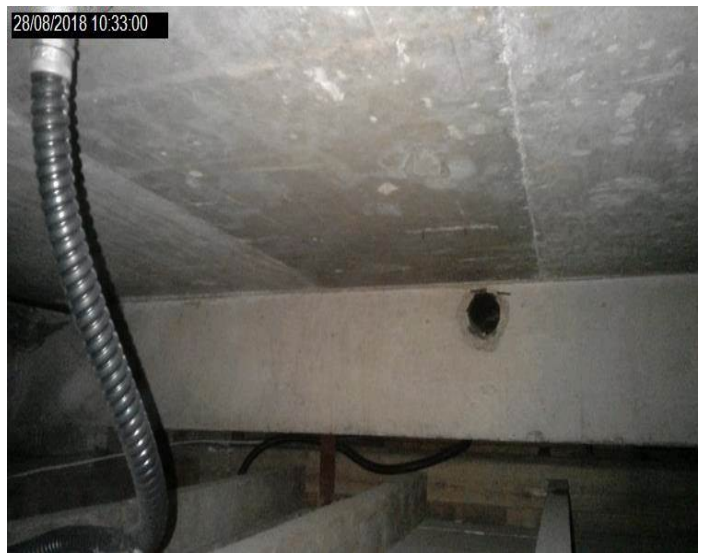
Location:	NHOG14 Playroom	Block:	Birmingham City University	Floor Level: Ground Floor
Sample No.:	As DU002174	Portal Ref No.:	6

Item:	Asbestos Reinforced plastic sleeve			
Asbestos Content:	Result Based on:			
Chrysotile	Strongly presumed			
Sample Analysed By:	Not applicable	Extent:	10 units	
Comments: To metal conduit within ceiling void, various penetrations throughout the concrete structural sections within the ceiling void

Material Assessment Total Score: 3		Likelihood of Disturbance Assessment Average Score: 1		Management Assessment Licensable: No Recommendations: Program removal Reinspection Interval: Not Applicable Overall Risk Score: 5
Product Type:	1 (Asbestos reinforced plastic)	Location:	2 (Rooms up to 100 sq m)	
Condition:	1 (Minor scratches)	Accessibility:	0 (Usually inaccessible or unlikely to be disturbed)	
Surface Treatment:	0 (Composite material)	Extent Score:	1 (<10 sq m or 10m pipe run)	
Asbestos Type:	1 (Chrysotile)	Maintenance Activity Average Score: 1		
Human Exposure Potential Average Score: 0		Type of Maintenance Activity:	0 (Minor disturbance)	
Number of Occupants:	0 (None)	Frequency of Use:	1 (<1 per year)	
Average Time in Use:	0 (<1 hour)	Normal Occupancy Activity: 0		
		Main Type of Activity in Area:	0 (Rare disturbance)

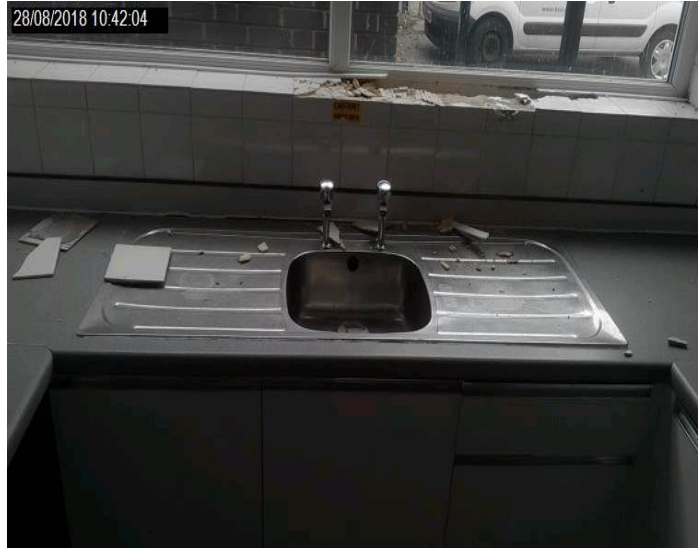
Location:	NHOG13 Kitchen	Block:	Birmingham City University	Floor Level: Ground Floor
Sample No.:	DU002177	Portal Ref No.:	11

Item:	Bitumen sink pad			
Asbestos Content:		Result Based on:		
No Asbestos Detected		Analysis of sample using PLM		
Sample Analysed By:	Reg 13(1)	Extent:	2 units	
Comments: Present to basin and drainer

Material Assessment Total Score: 0		Likelihood of Disturbance Assessment Average Score: 0		Management Assessment Licensable: No Recommendations: Not Applicable Reinspection Interval: Not Applicable Overall Risk Score: 0
Product Type:	0 Not Applicable	Location:	0 Not Applicable	
Condition:	0 Not Applicable	Accessibility:	0 Not Applicable	
Surface Treatment:	0 Not Applicable	Extent Score:	0 Not Applicable	
Asbestos Type:	0 Not Applicable	Maintenance Activity Average Score: 0		
Human Exposure Potential Average Score: 0		Type of Maintenance Activity:	0 Not Applicable	
Number of Occupants:	0 Not Applicable	Frequency of Use:	0 Not Applicable	
Average Time in Use:	0 Not Applicable	Normal Occupancy Activity: 0		
		Main Type of Activity in Area:	0 Not Applicable

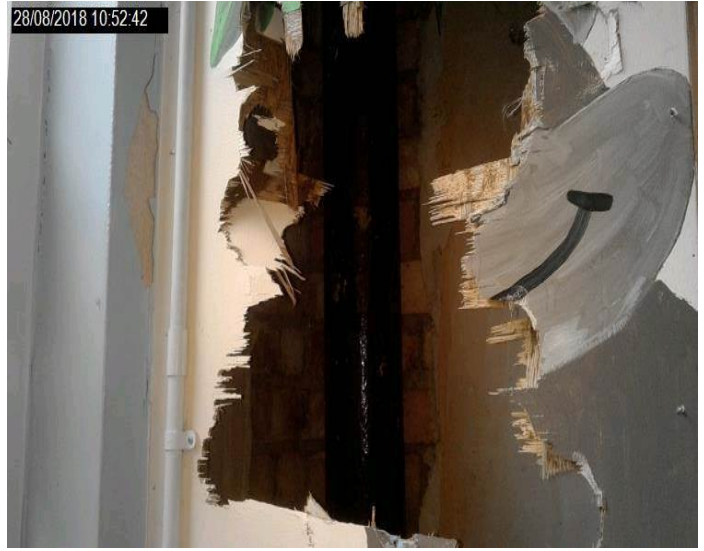
Location:	NHOG14 Playroom	Block:	Birmingham City University	Floor Level: Ground Floor
Sample No.:	DU002178	Portal Ref No.:	14

Item:	Asbestos Reinforced plastic soil pipe			
Asbestos Content:	Result Based on:			
Chrysotile	Analysis of sample using PLM			
Sample Analysed By: Reg 13(1)	Extent:	4 linear metres		
Comments: Adjacent to sink unit within boxing

Material Assessment Total Score: 3		Likelihood of Disturbance Assessment Average Score: 1		Management Assessment Licensable: No Recommendations: Program removal Reinspection Interval: Not Applicable Overall Risk Score: 8
Product Type:	1 (Asbestos reinforced plastic)	Location:	2 (Rooms up to 100 sq m)	
Condition:	1 (Minor scratches)	Accessibility:	0 (Usually inaccessible or unlikely to be disturbed)	
Surface Treatment:	0 (Composite material)	Extent Score:	1 (<10 sq m or 10m pipe run)	
Asbestos Type:	1 (Chrysotile)	Maintenance Activity Average Score: 1		
Human Exposure Potential Average Score: 2		Type of Maintenance Activity:	1 (Low disturbance)	
Number of Occupants:	1 (1 to 3)	Frequency of Use:	1 (<1 per year)	
Average Time in Use:	1 (1 to 3 hours)	Normal Occupancy Activity: 1		
		Main Type of Activity in Area:	1 (Low disturbance)

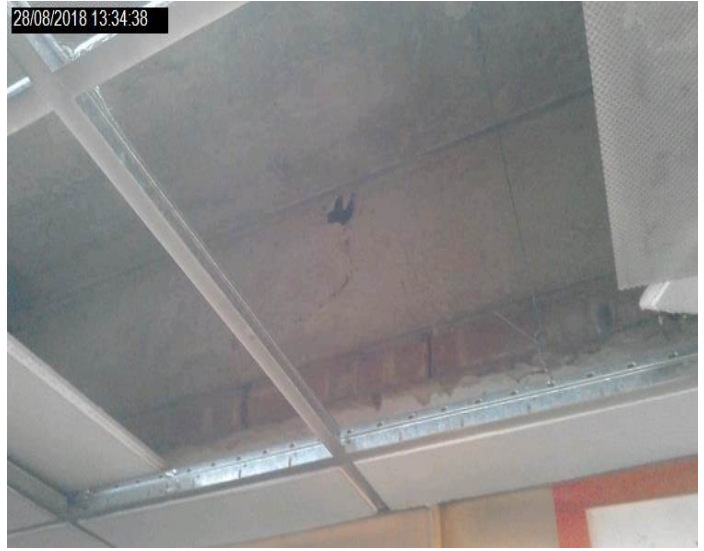
Location:	NHOG02 WC	Block:	Birmingham City University	Floor Level: Ground Floor
Sample No.:	As DU002174	Portal Ref No.:	22

Item:	Asbestos Reinforced plastic sleeves			
Asbestos Content:	Result Based on:			
Chrysotile	Strongly presumed			
Sample Analysed By:	Not applicable	Extent:	10 units	
Comments: Various areas within the structural concrete within the ceiling void

Material Assessment Total Score: 3		Likelihood of Disturbance Assessment Average Score: 1		Management Assessment Licensable: No Recommendations: Program removal Reinspection Interval: Not Applicable Overall Risk Score: 8
Product Type:	1 (Asbestos reinforced plastic)	Location:	2 (Rooms up to 100 sq m)	
Condition:	1 (Minor scratches)	Accessibility:	0 (Usually inaccessible or unlikely to be disturbed)	
Surface Treatment:	0 (Composite material)			
Asbestos Type:	1 (Chrysotile)	Extent Score:	1 (<10 sq m or 10m pipe run)	
Human Exposure Potential Average Score: 2		Maintenance Activity Average Score: 1		
Number of Occupants:	1 (1 to 3)	Type of Maintenance Activity:	1 (Low disturbance)	
Frequency of Use:	3 (Daily)	Frequency of Use:	1 (<1 per year)	
Average Time in Use:	1 (1 to 3 hours)	Normal Occupancy Activity: 1		
		Main Type of Activity in Area:	1 (Low disturbance)

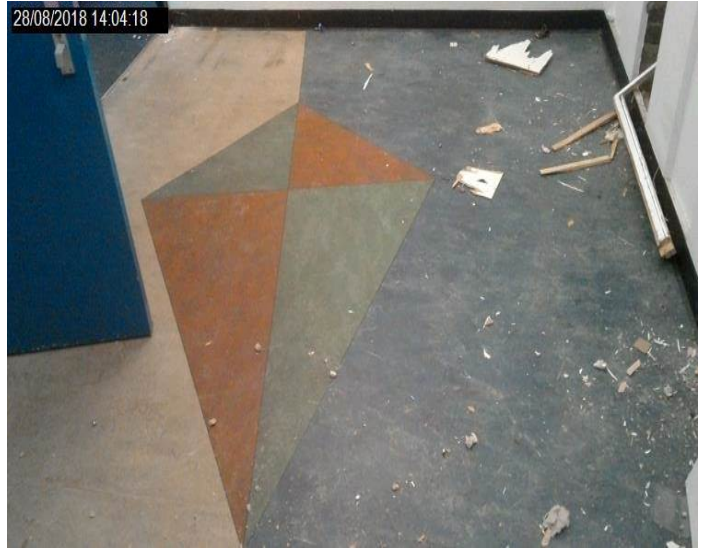
Location:	NHOG99A	Block:	Birmingham City University	Floor Level: Ground Floor
Sample No.:	DU002180	Portal Ref No.:	24

Item:	Vinyl			
Asbestos Content:		Result Based on:		
No Asbestos Detected		Analysis of sample using PLM		
Sample Analysed By:	Reg 13(1)	Extent:	35 m ²	
Comments:

Material Assessment Total Score: 0		Likelihood of Disturbance Assessment Average Score: 0		Management Assessment Licensable: No Recommendations: Not Applicable Reinspection Interval: Not Applicable Overall Risk Score: 0
Product Type:	0 Not Applicable	Location:	0 Not Applicable	
Condition:	0 Not Applicable	Accessibility:	0 Not Applicable	
Surface Treatment:	0 Not Applicable	Extent Score:	0 Not Applicable	
Asbestos Type:	0 Not Applicable	Maintenance Activity Average Score: 0		
Human Exposure Potential Average Score: 0		Type of Maintenance Activity:	0 Not Applicable	
Number of Occupants:	0 Not Applicable	Frequency of Use:	0 Not Applicable	
Average Time in Use:	0 Not Applicable	Normal Occupancy Activity: 0		
		Main Type of Activity in Area:	0 Not Applicable

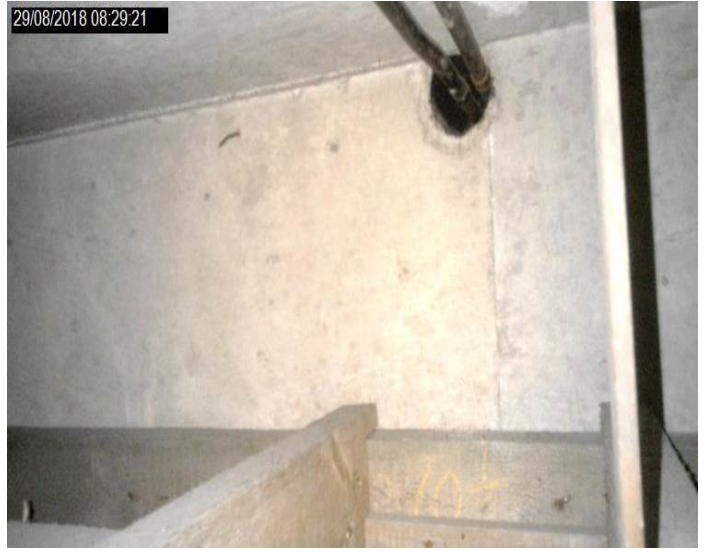
Location:	NHOG28 Office	Block:	Birmingham City University	Floor Level: Ground Floor
Sample No.:	DU002182	Portal Ref No.:	30

Item:	Asbestos Reinforced plastic sleeve			
Asbestos Content:	Result Based on:			
Chrysotile	Analysis of sample using PLM			
Sample Analysed By: Reg 13(1)	Extent:	12 units		
Comments: To metal conduit within ceiling void, various penetrations throughout the concrete structural sections within the ceiling void

Material Assessment Total Score: 3		Likelihood of Disturbance Assessment Average Score: 1		Management Assessment Licensable: No Recommendations: Program removal Reinspection Interval: Not Applicable Overall Risk Score: 5
Product Type:	1 (Asbestos reinforced plastic)	Location:	2 (Rooms up to 100 sq m)	
Condition:	1 (Minor scratches)	Accessibility:	0 (Usually inaccessible or unlikely to be disturbed)	
Surface Treatment:	0 (Composite material)	Extent Score:	1 (<10 sq m or 10m pipe run)	
Asbestos Type:	1 (Chrysotile)	Maintenance Activity Average Score: 1		
Human Exposure Potential Average Score: 0		Type of Maintenance Activity:	0 (Minor disturbance)	
Number of Occupants:	0 (None)	Frequency of Use:	1 (<1 per year)	
Average Time in Use:	0 (<1 hour)	Normal Occupancy Activity: 0		
		Main Type of Activity in Area:	0 (Rare disturbance)

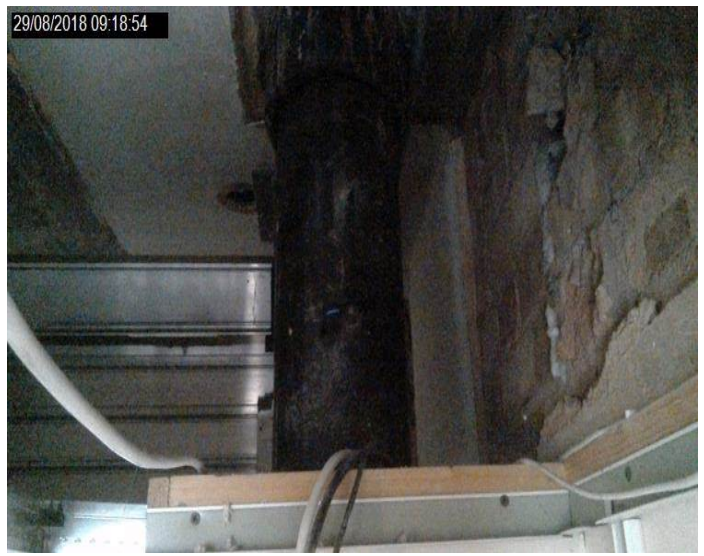
Location:	NHOG21 Childcare office	Block:	Birmingham City University	Floor Level: Ground Floor
Sample No.:	DU002184	Portal Ref No.:	33

Item:	Asbestos Reinforced plastic cistern			
Asbestos Content:	Result Based on:			
Chrysotile	Analysis of sample using PLM			
Sample Analysed By: Reg 13(1)	Extent:	4 linear metres		
Comments: Adjacent to reception desk

Material Assessment Total Score: 3		Likelihood of Disturbance Assessment Average Score: 1		Management Assessment Licensable: No Recommendations: Program removal Reinspection Interval: Not Applicable Overall Risk Score: 8
Product Type:	1 (Asbestos reinforced plastic)	Location:	2 (Rooms up to 100 sq m)	
Condition:	1 (Minor scratches)	Accessibility:	0 (Usually inaccessible or unlikely to be disturbed)	
Surface Treatment:	0 (Composite material)	Extent Score:	1 (<10 sq m or 10m pipe run)	
Asbestos Type:	1 (Chrysotile)	Maintenance Activity Average Score: 1		
Human Exposure Potential Average Score: 2		Type of Maintenance Activity:	1 (Low disturbance)	
Number of Occupants:	1 (1 to 3)	Frequency of Use:	1 (<1 per year)	
Average Time in Use:	1 (1 to 3 hours)	Normal Occupancy Activity: 1		
		Main Type of Activity in Area:	1 (Low disturbance)

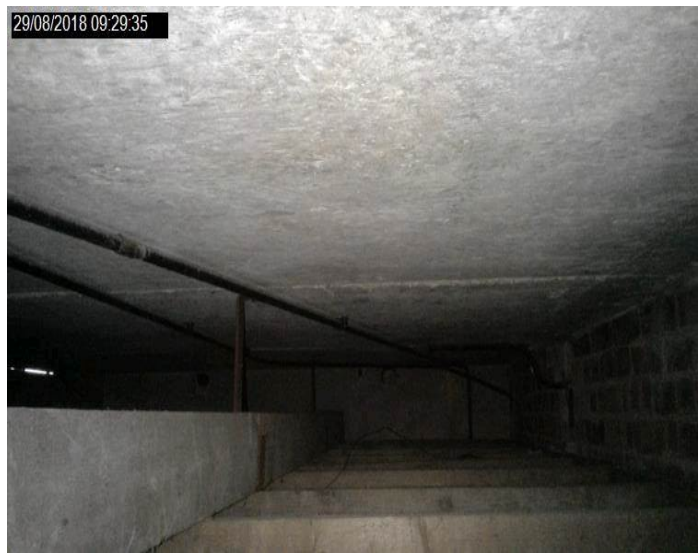
Location:	NHOG25 Office	Block:	Birmingham City University	Floor Level: Ground Floor
Sample No.:	As DU002182	Portal Ref No.:	35

Item:	Asbestos Reinforced plastic sleeve			
Asbestos Content:	Result Based on:			
Chrysotile	Strongly presumed			
Sample Analysed By:	Not applicable	Extent:	2 units	
Comments: To metal conduit within ceiling void, various penetrations throughout the concrete structural sections within the ceiling void

Material Assessment Total Score: 3		Likelihood of Disturbance Assessment Average Score: 1		Management Assessment Licensable: No Recommendations: Program removal Reinspection Interval: Not Applicable Overall Risk Score: 7
Product Type:	1 (Asbestos reinforced plastic)	Location:	2 (Rooms up to 100 sq m)	
Condition:	1 (Minor scratches)	Accessibility:	0 (Usually inaccessible or unlikely to be disturbed)	
Surface Treatment:	0 (Composite material)	Extent Score:	1 (<10 sq m or 10m pipe run)	
Asbestos Type:	1 (Chrysotile)	Maintenance Activity Average Score: 1		
Human Exposure Potential Average Score: 1		Type of Maintenance Activity:	1 (Low disturbance)	
Number of Occupants:	1 (1 to 3)	Frequency of Use:	1 (<1 per year)	
Average Time in Use:	0 (<1 hour)	Normal Occupancy Activity: 1		
		Main Type of Activity in Area:	1 (Low disturbance)

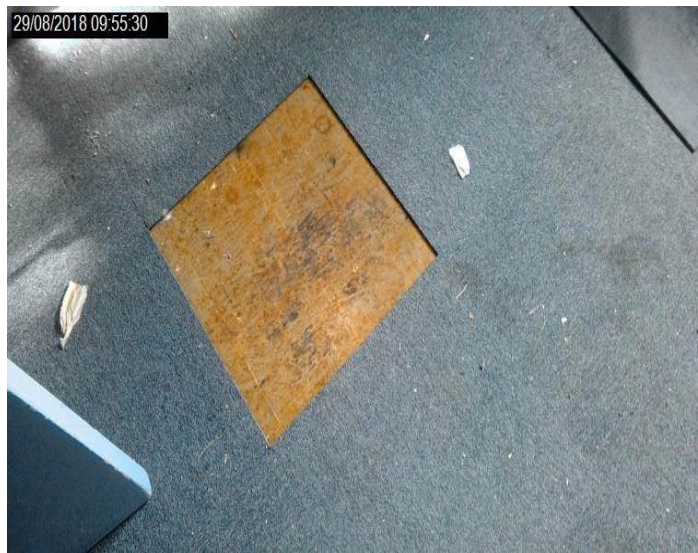
Location:	NHOG23 Office	Block:	Birmingham City University	Floor Level: Ground Floor
Sample No.:	As DU002185	Portal Ref No.:	38

Item:	Asbestos Vinyl			
Asbestos Content:	Result Based on:			
Chrysotile in vinyl only	Strongly presumed			
Sample Analysed By:	Not applicable	Extent:	12 m ²	
Comments:

Material Assessment Total Score: 3		Likelihood of Disturbance Assessment Average Score: 2		Management Assessment Licensable: No Recommendations: Program removal Reinspection Interval: Not Applicable Overall Risk Score: 9
Product Type:	1 (Asbestos vinyl)	Location:	2 (Rooms up to 100 sq m)	
Condition:	1 (Minor scratches)	Accessibility:	1 (Occasionally likely to be disturbed)	
Surface Treatment:	0 (Composite material)	Extent Score:	2 (>10 - <50 sq m or >10m - <50m pipe run)	
Asbestos Type:	1 (Chrysotile)	Maintenance Activity Average Score: 1		
Human Exposure Potential Average Score: 2		Type of Maintenance Activity:	1 (Low disturbance)	
Number of Occupants:	1 (1 to 3)	Frequency of Use:	1 (<1 per year)	
Average Time in Use:	1 (1 to 3 hours)	Normal Occupancy Activity: 1		
		Main Type of Activity in Area:	1 (Low disturbance)

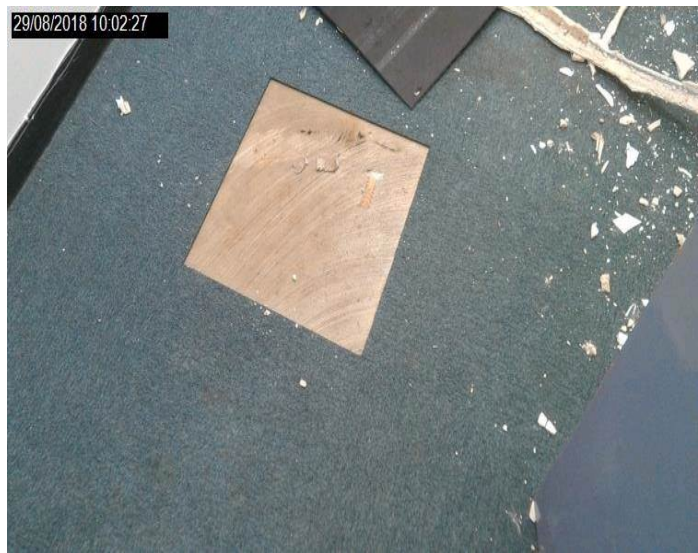
Location:	NHOG18 Kitchen	Block:	Birmingham City University	Floor Level: Ground Floor
Sample No.:	As DU002186	Portal Ref No.:	42

Item:	Asbestos Vinyl			
Asbestos Content:	Result Based on:			
Chrysotile in vinyl only	Strongly presumed			
Sample Analysed By:	Not applicable	Extent:	16 m ²	
Comments:

Material Assessment Total Score: 3		Likelihood of Disturbance Assessment Average Score: 2		Management Assessment Licensable: No Recommendations: Program removal Reinspection Interval: Not Applicable Overall Risk Score: 9
Product Type:	1 (Asbestos vinyl)	Location:	2 (Rooms up to 100 sq m)	
Condition:	1 (Minor scratches)	Accessibility:	1 (Occasionally likely to be disturbed)	
Surface Treatment:	0 (Composite material)	Extent Score:	2 (>10 - <50 sq m or >10m - <50m pipe run)	
Asbestos Type:	1 (Chrysotile)	Maintenance Activity Average Score: 1		
Human Exposure Potential Average Score: 2		Type of Maintenance Activity:	1 (Low disturbance)	
Number of Occupants:	1 (1 to 3)	Frequency of Use:	1 (<1 per year)	
Average Time in Use:	1 (1 to 3 hours)	Normal Occupancy Activity: 1		
		Main Type of Activity in Area:	1 (Low disturbance)

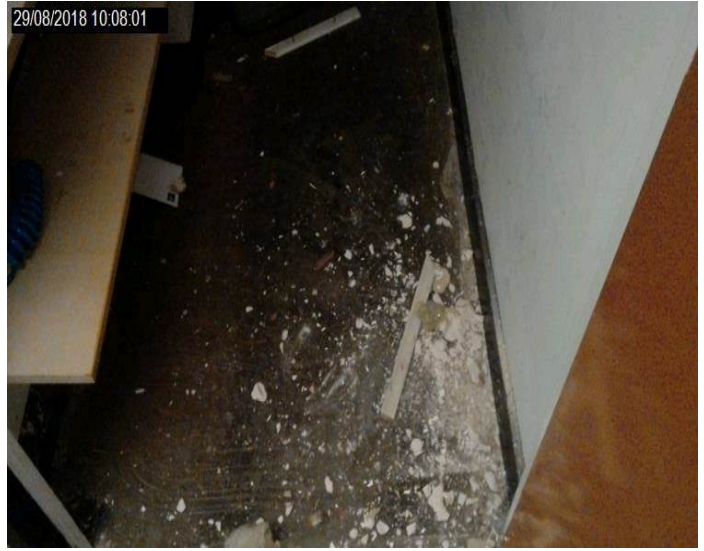
Location:	NHOG31 Store	Block:	Birmingham City University	Floor Level: Ground Floor
Sample No.:	As DU002186	Portal Ref No.:	46

Item:	Asbestos Vinyl			
Asbestos Content:	Result Based on:			
Chrysotile in vinyl only	Strongly presumed			
Sample Analysed By:	Not applicable	Extent:	2 m ²	
Comments:

Material Assessment Total Score: 3		Likelihood of Disturbance Assessment Average Score: 2		Management Assessment Licensable: No Recommendations: Program removal Reinspection Interval: Not Applicable Overall Risk Score: 8
Product Type:	1 (Asbestos vinyl)	Location:	2 (Rooms up to 100 sq m)	
Condition:	1 (Minor scratches)	Accessibility:	3 (Routinely disturbed)	
Surface Treatment:	0 (Composite material)	Extent Score:	1 (<10 sq m or 10m pipe run)	
Asbestos Type:	1 (Chrysotile)	Maintenance Activity Average Score: 1		
Human Exposure Potential Average Score: 1		Type of Maintenance Activity:	0 (Minor disturbance)	
Number of Occupants:	1 (1 to 3)	Frequency of Use:	1 (<1 per year)	
Average Time in Use:	0 (<1 hour)	Normal Occupancy Activity: 1		
		Main Type of Activity in Area:	1 (Low disturbance)

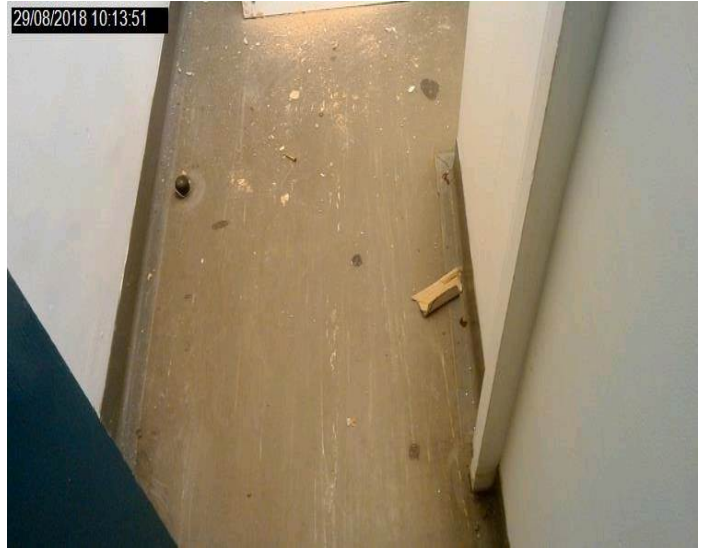
Location:	NHOG12 Gallery	Block:	Birmingham City University	Floor Level: Ground Floor
Sample No.:	As DU002187	Portal Ref No.:	49

Item:	Asbestos Vinyl			
Asbestos Content:	Result Based on:			
Chrysotile in vinyl only	Strongly presumed			
Sample Analysed By:	Not applicable	Extent:	12 m ²	
Comments:

Material Assessment Total Score: 3		Likelihood of Disturbance Assessment Average Score: 2		Management Assessment Licensable: No Recommendations: Program removal Reinspection Interval: Not Applicable Overall Risk Score: 8
Product Type:	1 (Asbestos vinyl)	Location:	2 (Rooms up to 100 sq m)	
Condition:	1 (Minor scratches)	Accessibility:	3 (Routinely disturbed)	
Surface Treatment:	0 (Composite material)	Extent Score:	2 (>10 - <50 sq m or >10m - <50m pipe run)	
Asbestos Type:	1 (Chrysotile)	Maintenance Activity Average Score: 1		
Human Exposure Potential Average Score: 1		Type of Maintenance Activity:	1 (Low disturbance)	
Number of Occupants:	1 (1 to 3)	Frequency of Use:	1 (<1 per year)	
Average Time in Use:	0 (<1 hour)	Normal Occupancy Activity: 1		
		Main Type of Activity in Area:	1 (Low disturbance)

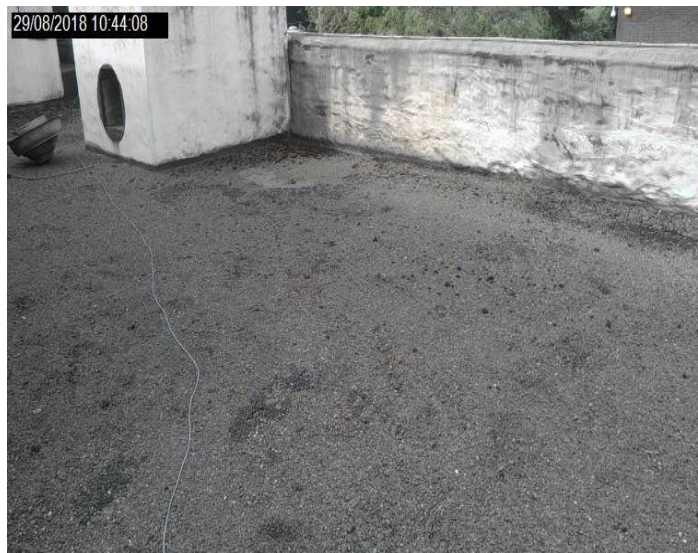
Location:	External	Block:	Birmingham City University	Floor Level: E - External
Sample No.:	DU002188	Portal Ref No.:	52

Item:	Butumen roof felt			
Asbestos Content:	Result Based on:			
No Asbestos Detected	Analysis of sample using PLM			
Sample Analysed By:	Reg 13(1)	Extent:	200 m ²	
Comments:

Material Assessment Total Score: 0		Likelihood of Disturbance Assessment Average Score: 0		Management Assessment Licensable: No Recommendations: Not Applicable Reinspection Interval: Not Applicable Overall Risk Score: 0
Product Type:	0 Not Applicable	Location:	0 Not Applicable	
Condition:	0 Not Applicable	Accessibility:	0 Not Applicable	
Surface Treatment:	0 Not Applicable	Extent Score:	0 Not Applicable	
Asbestos Type:	0 Not Applicable	Maintenance Activity Average Score: 0		
Human Exposure Potential Average Score: 0		Type of Maintenance Activity:	0 Not Applicable	
Number of Occupants:	0 Not Applicable	Frequency of Use:	0 Not Applicable	
Average Time in Use:	0 Not Applicable	Normal Occupancy Activity: 0		
		Main Type of Activity in Area:	0 Not Applicable

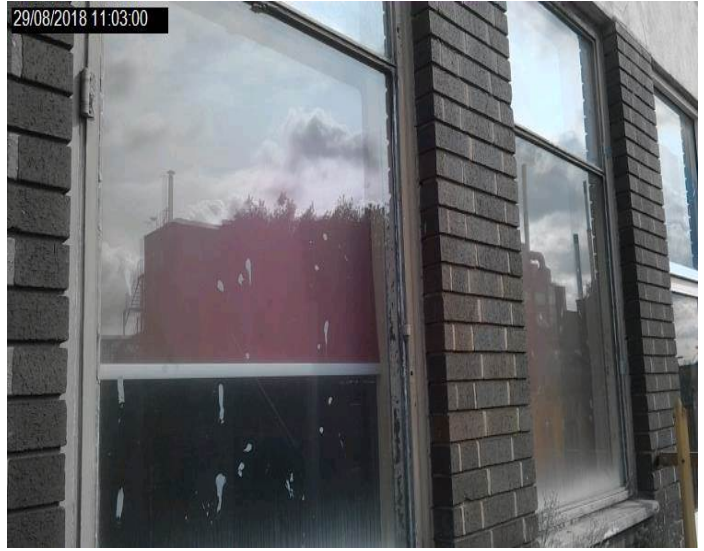
Location:	External	Block:	Birmingham City University	Floor Level: E - External
Sample No.:	DU002189	Portal Ref No.:	53

Item:	Putty seal to metal window frames only			
Asbestos Content:		Result Based on:		
No Asbestos Detected		Analysis of sample using PLM		
Sample Analysed By:	Reg 13(1)	Extent:	28 linear metres	
Comments: 3 to the rear and 2 on side elevation

Material Assessment Total Score: 0		Likelihood of Disturbance Assessment Average Score: 0		Management Assessment Licensable: No Recommendations: Not Applicable Reinspection Interval: Not Applicable Overall Risk Score: 0
Product Type:	0 Not Applicable	Location:	0 Not Applicable	
Condition:	0 Not Applicable	Accessibility:	0 Not Applicable	
Surface Treatment:	0 Not Applicable	Extent Score:	0 Not Applicable	
Asbestos Type:	0 Not Applicable	Maintenance Activity Average Score: 0		
Human Exposure Potential Average Score: 0		Type of Maintenance Activity:	0 Not Applicable	
Number of Occupants:	0 Not Applicable	Frequency of Use:	0 Not Applicable	
Average Time in Use:	0 Not Applicable	Normal Occupancy Activity: 0		
		Main Type of Activity in Area:	0 Not Applicable
