**Report No.:** J102747  
**Nature of Work:** Demolition Survey  
**Issue Date:** 26/09/2018  
**Client Name:** WYG Engineering Ltd  
Geneva Building, Lake View Drive, Sherwood Business Park,  
Annesley, Nottingham, NG15 0ED  
**Site Address:** Kenrick Building, Former City North Campus, Birmingham City  
University, Perry Barr, B42 2US

**Order Placed By:** Reg 13(1)  
**Site Contact:** Reg 13(1)  
**Date(s) of Work:** 20/08/2018 to 23/08/2018  
**Technical Manager:** Reg 13(1) (Asbestos)  
**Assistant Surveyor(s):** Reg 13(1)

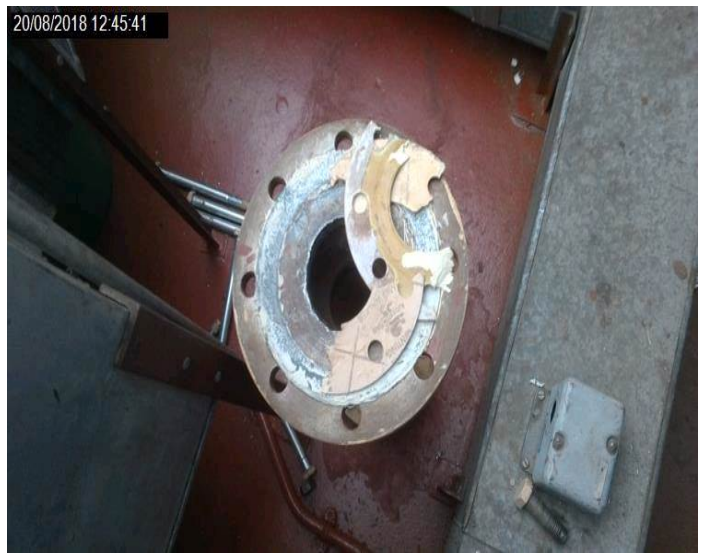
<b>Item:</b>	Compressed fibre gasket			
<b>Asbestos Content:</b>		<b>Result Based on:</b>		
No Asbestos Detected		Analysis of sample using PLM		
<b>Sample Analysed By:</b>	Reg 13(1)	<b>Extent:</b>	1 unit	
<b>Comments:</b> To redundant yellow gas pipe

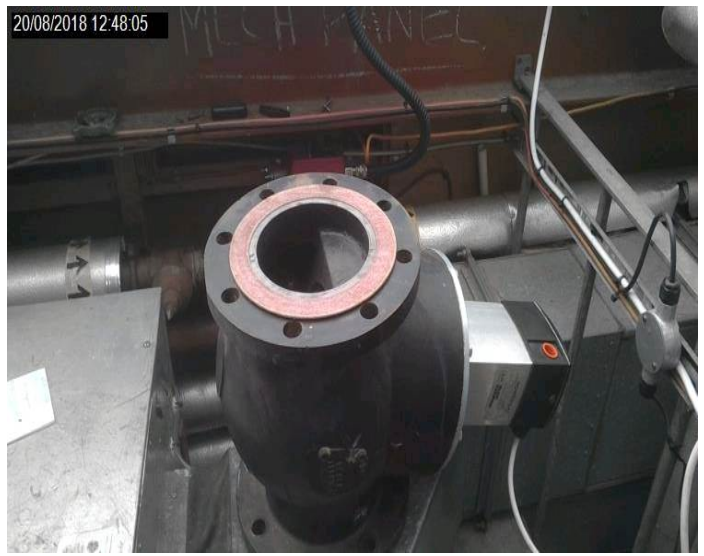
<b>Item:</b>	Asbestos Compressed fibre gasket			
<b>Asbestos Content:</b>	Chrysotile			
<b>Result Based on:</b>	Analysis of sample using PLM			
<b>Sample Analysed By:</b>	Reg 13(1)	<b>Extent:</b>	1 unit	
<b>Comments:</b> To redundant black pipework section

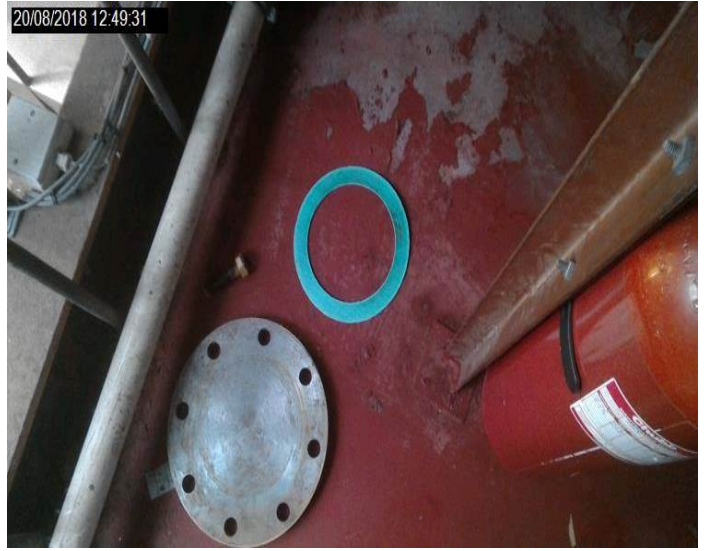
<b>Item:</b>	Compressed fibre gasket debris			
<b>Asbestos Content:</b>		<b>Result Based on:</b>		
No Asbestos Detected		Analysis of sample using PLM		
<b>Sample Analysed By:</b>	Reg 13(1)	<b>Extent:</b>	1 unit	
<b>Comments:</b> To floor top of stairs

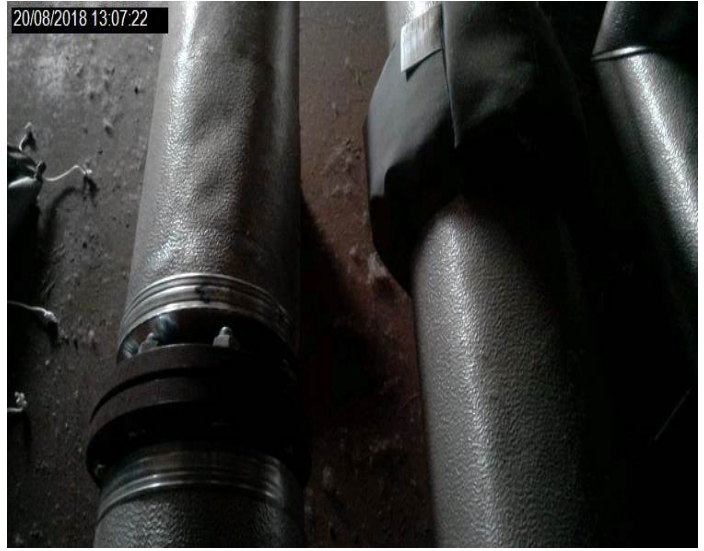
<b>Item:</b>	Compressed fibre gasket			
<b>Asbestos Content:</b>		<b>Result Based on:</b>		
No Asbestos Detected		Analysis of sample using PLM		
<b>Sample Analysed By:</b>	Reg 13(1)	<b>Extent:</b>	20 units	
<b>Comments:</b> To the majority of the pipework

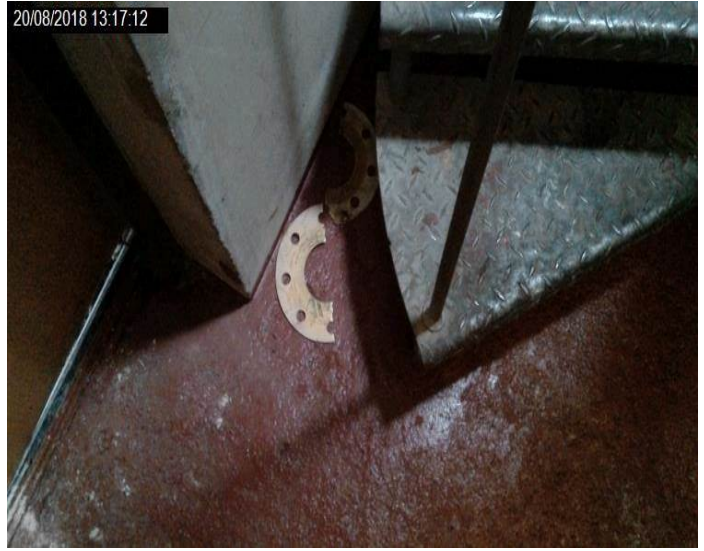
<b>Item:</b>	Compressed fibre gasket debris			
<b>Asbestos Content:</b>	<b>Result Based on:</b>			
No Asbestos Detected	Analysis of sample using PLM			
<b>Sample Analysed By:</b> Reg 13(1)	<b>Extent:</b>	1 unit		
<b>Comments:</b> To floor bottom of the stairs

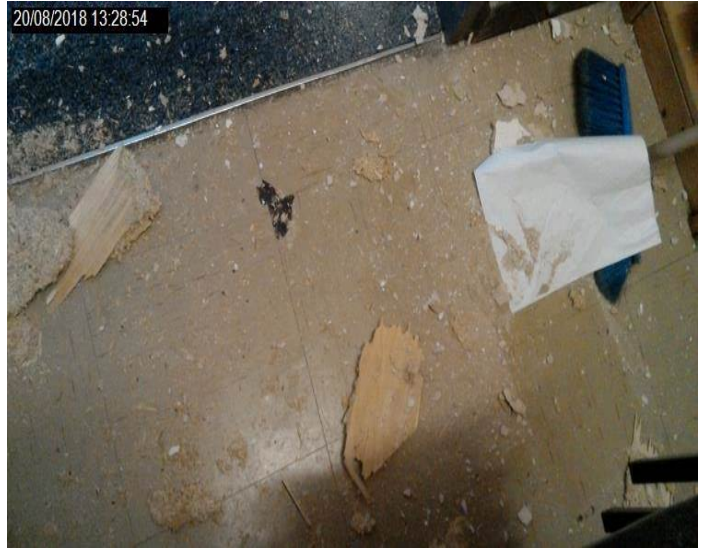
<b>Item:</b>	Thermoplastic floor tiles with bitumen adhesive			
<b>Asbestos Content:</b>	<b>Result Based on:</b>			
No Asbestos Detected in tile or adhesive		Analysis of sample using PLM		
<b>Sample Analysed By:</b>	Reg 13(1)	<b>Extent:</b>	3 m <sup>2</sup>	
<b>Comments:</b>

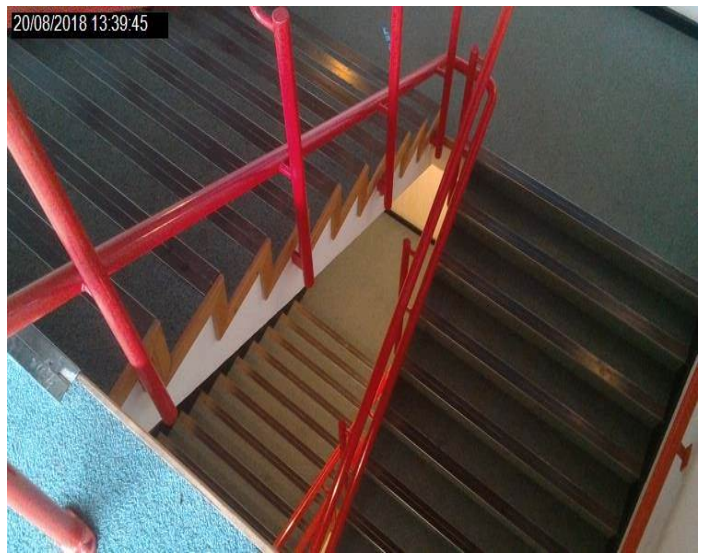
<b>Item:</b>	Reinforced plastic stair treads			
<b>Asbestos Content:</b>		<b>Result Based on:</b>		
No Asbestos Detected		Analysis of sample using PLM		
<b>Sample Analysed By:</b>	Reg 13(1)	<b>Extent:</b>	44 m <sup>2</sup>	
<b>Comments:</b> Both flights to the next floor level

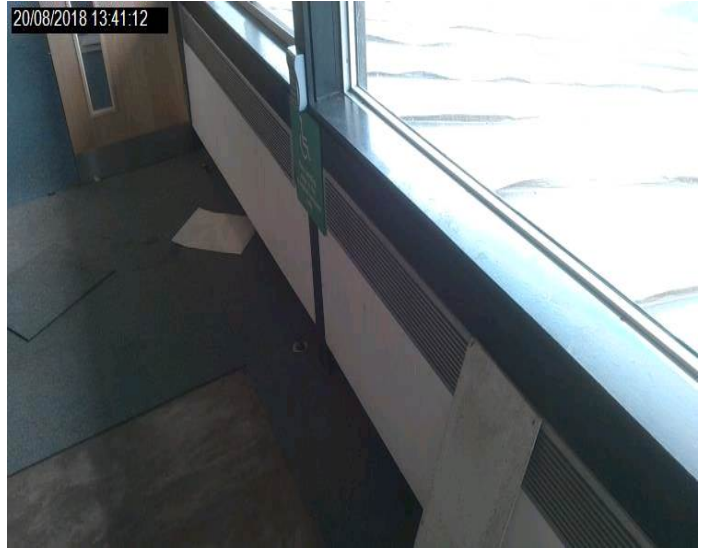
<b>Item:</b>	Asbestos Cement window sill			
<b>Asbestos Content:</b>	Result Based on:			
Chrysotile	Analysis of sample using PLM			
<b>Sample Analysed By:</b>	Reg 13(1)	<b>Extent:</b>	4 linear metres	
<b>Comments:</b>

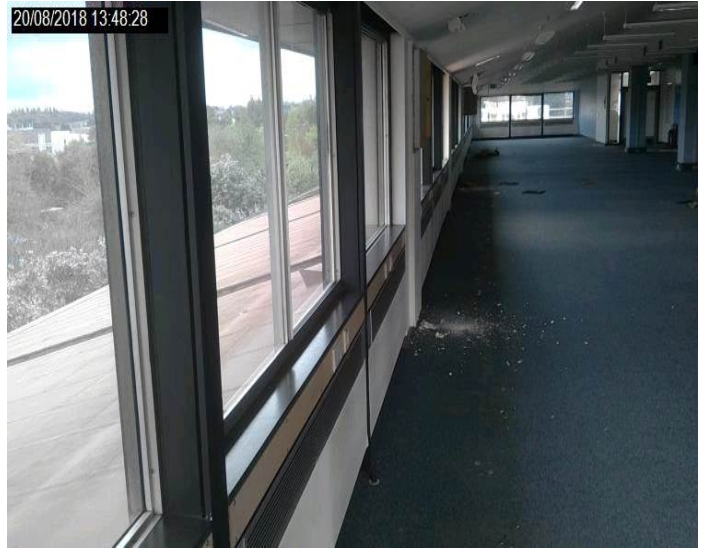
<b>Item:</b>	Asbestos Cement window sill				
<b>Asbestos Content:</b>	Result Based on:				
Chrysotile	Analysis of sample using PLM				
<b>Sample Analysed By:</b>	Reg 13(1)	<b>Extent:</b>	100 linear metres		
<b>Comments:</b>

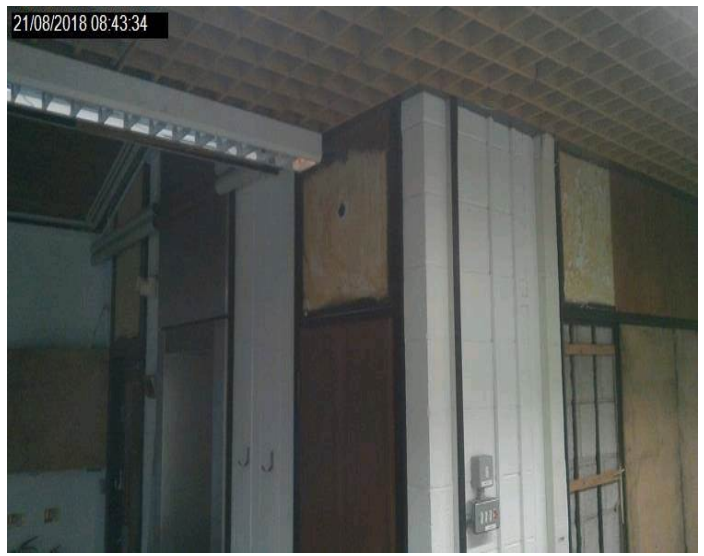
<b>Item:</b>	Insulating board door headers			
<b>Asbestos Content:</b>		<b>Result Based on:</b>		
No Asbestos Detected		Analysis of sample using PLM		
<b>Sample Analysed By:</b>	Reg 13(1)	<b>Extent:</b>	4 m <sup>2</sup>	
<b>Comments:</b> To electric cupboard, rear of lift and stairwell

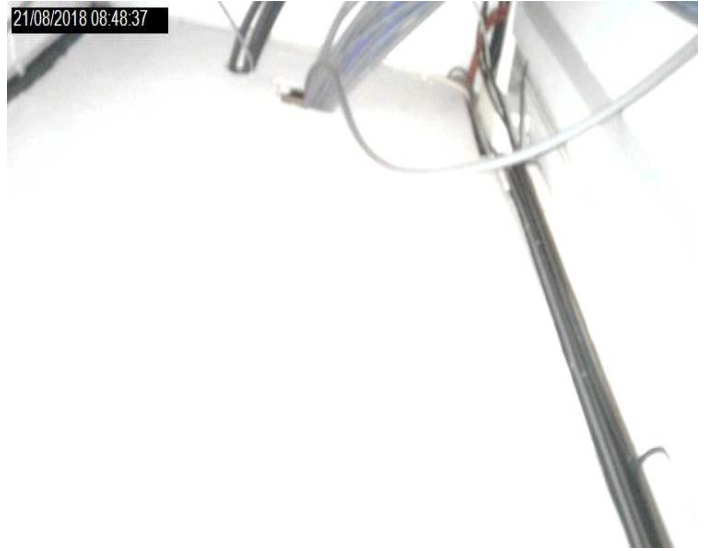
<b>Item:</b>	Insulating board door header panel			
<b>Asbestos Content:</b>		<b>Result Based on:</b>		
No Asbestos Detected		Analysis of sample using PLM		
<b>Sample Analysed By:</b>	Reg 13(1)	<b>Extent:</b>	1 m <sup>2</sup>	
<b>Comments:</b> Double skin sampled within office external facing side

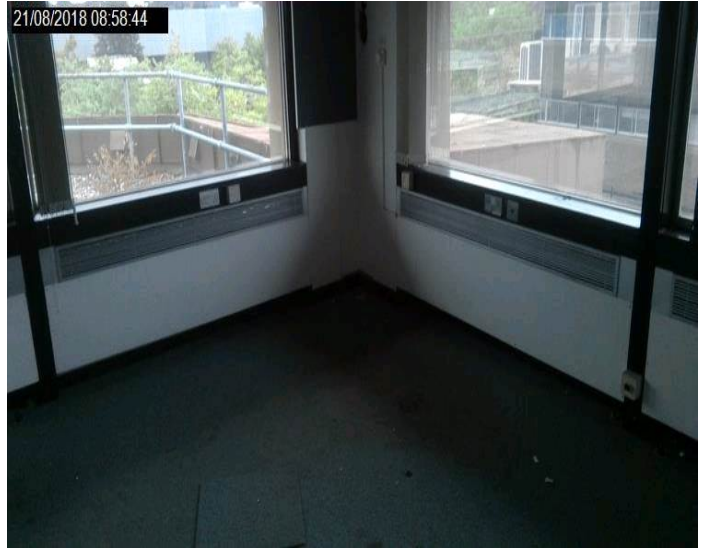
<b>Item:</b>	Asbestos Cement window sill			
<b>Asbestos Content:</b>	<b>Result Based on:</b>			
Chrysotile	Strongly presumed			
<b>Sample Analysed By:</b>	Not applicable	<b>Extent:</b>	8 linear metres	
<b>Comments:</b>

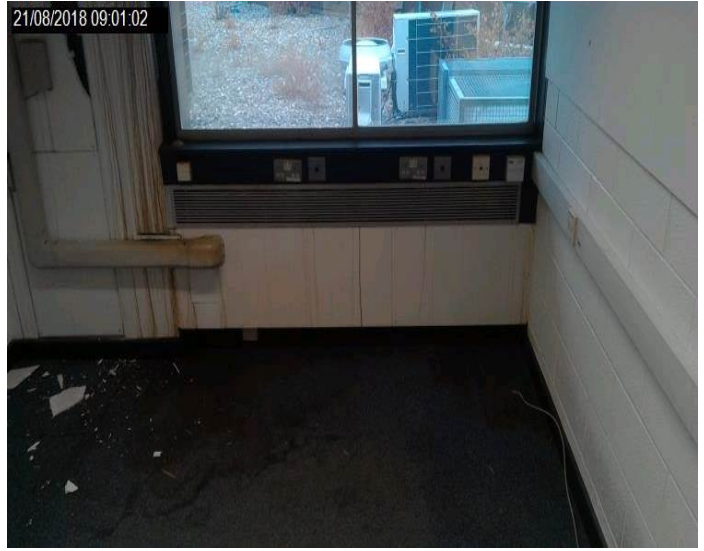
<b>Item:</b>	Asbestos Cement window sill			
<b>Asbestos Content:</b>	<b>Result Based on:</b>			
Chrysotile	Strongly presumed			
<b>Sample Analysed By:</b>	Not applicable	<b>Extent:</b>	2 linear metres	
<b>Comments:</b>

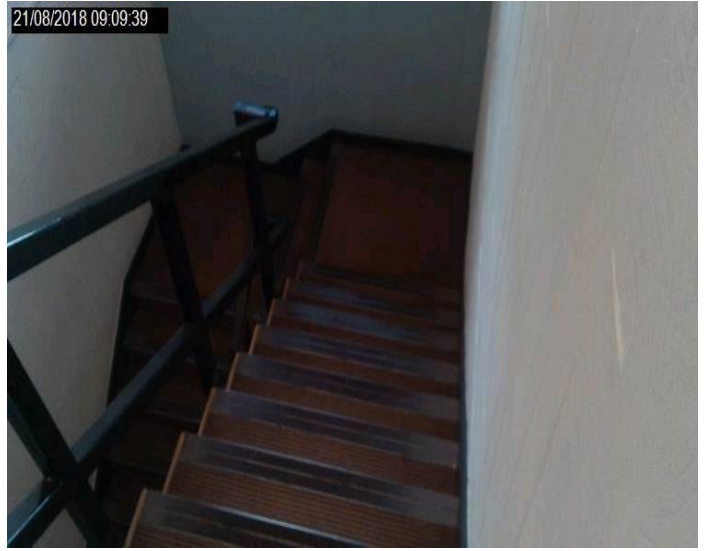
<b>Item:</b>	Reinforced plastic stair nosing			
<b>Asbestos Content:</b>		<b>Result Based on:</b>		
No Asbestos Detected		Analysis of sample using PLM		
<b>Sample Analysed By:</b>	Reg 13(1)	<b>Extent:</b>	22 linear metres	
<b>Comments:</b>

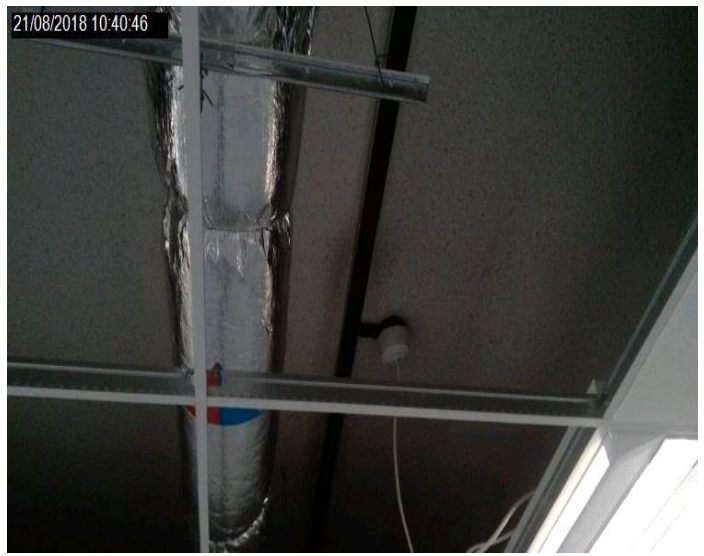
<b>Item:</b>	Textured coating to concrete			
<b>Asbestos Content:</b>		<b>Result Based on:</b>		
No Asbestos Detected		Analysis of sample using PLM		
<b>Sample Analysed By:</b>	Reg 13(1)	<b>Extent:</b>	560 m <sup>2</sup>	
<b>Comments:</b> Above compressed fibre suspended ceiling tiles only

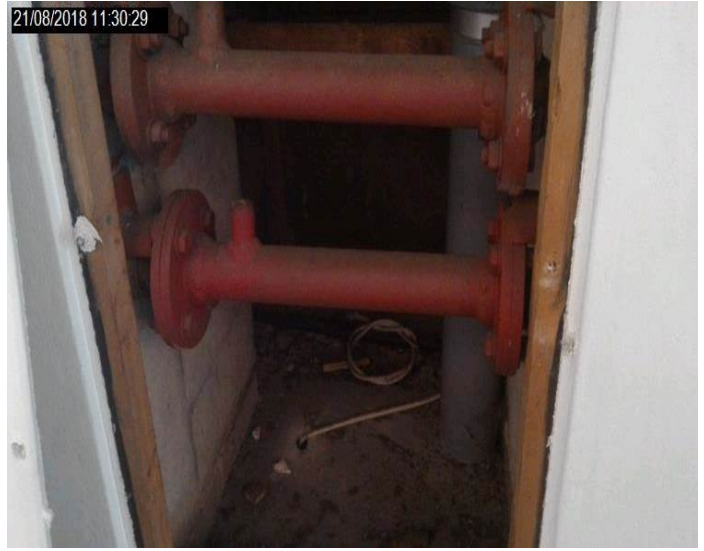
<b>Item:</b>	Asbestos Compressed fibre gasket			
<b>Asbestos Content:</b>	Result Based on:			
Chrysotile	Analysis of sample using PLM			
<b>Sample Analysed By:</b> Reg 13(1)	<b>Extent:</b>	6 units		
<b>Comments:</b> Within the wall void

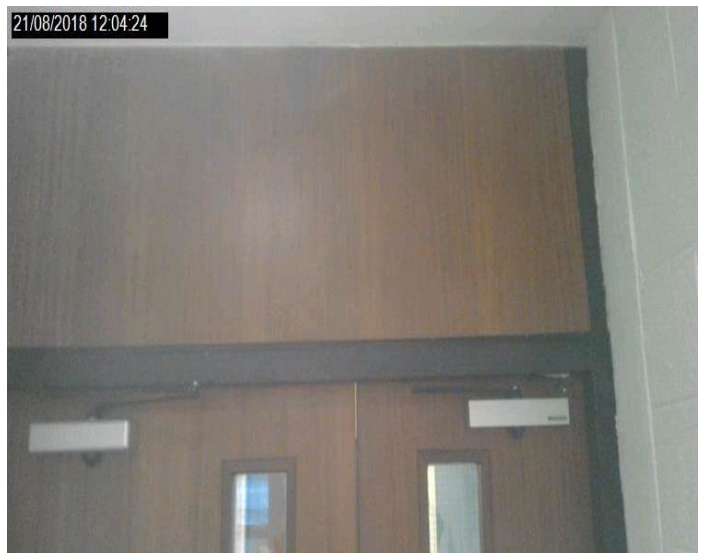
<b>Item:</b>	Insulating board door header			
<b>Asbestos Content:</b>		<b>Result Based on:</b>		
No Asbestos Detected		Analysis of sample using PLM		
<b>Sample Analysed By:</b>	Reg 13(1)	<b>Extent:</b>	4 m <sup>2</sup>	
<b>Comments:</b> Double skin to stairwell

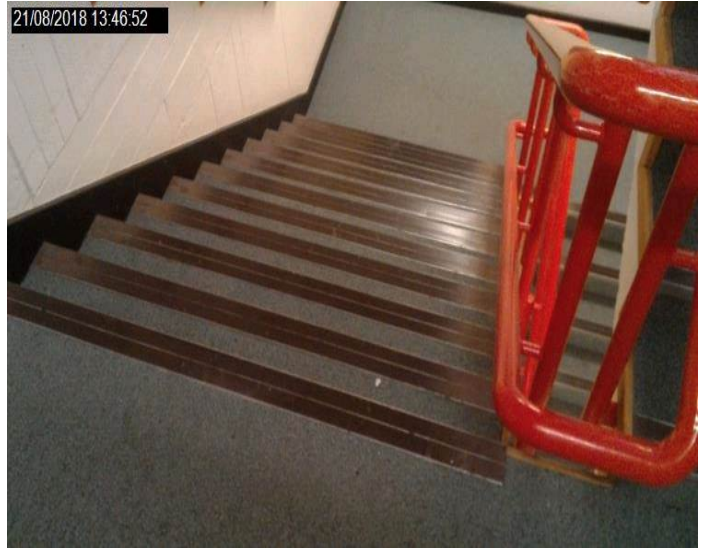
<b>Item:</b>	Reinforced plastic stair nosing			
<b>Asbestos Content:</b>		<b>Result Based on:</b>		
No Asbestos Detected		Analysis of sample using PLM		
<b>Sample Analysed By:</b>	Reg 13(1)	<b>Extent:</b>	44 linear metres	
<b>Comments:</b>

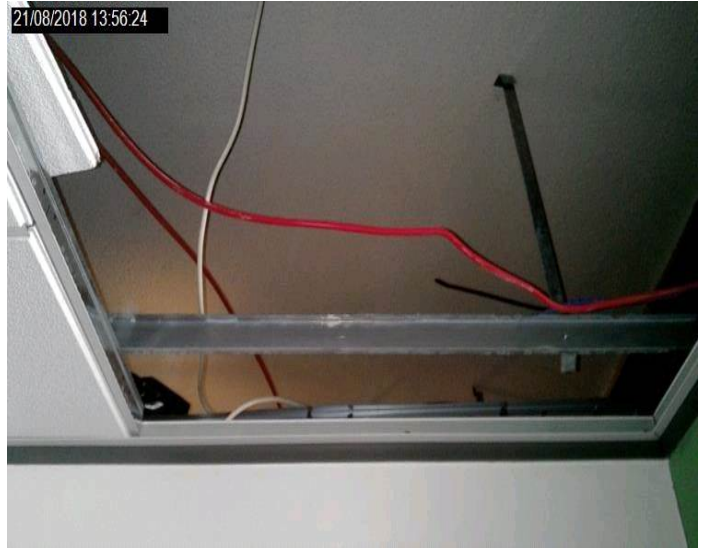
<b>Item:</b>	Textured coating to concrete			
<b>Asbestos Content:</b>		<b>Result Based on:</b>		
No Asbestos Detected		Strongly presumed		
<b>Sample Analysed By:</b>	Not applicable	<b>Extent:</b>	6 m <sup>2</sup>	
<b>Comments:</b> Above plasterboard ceiling

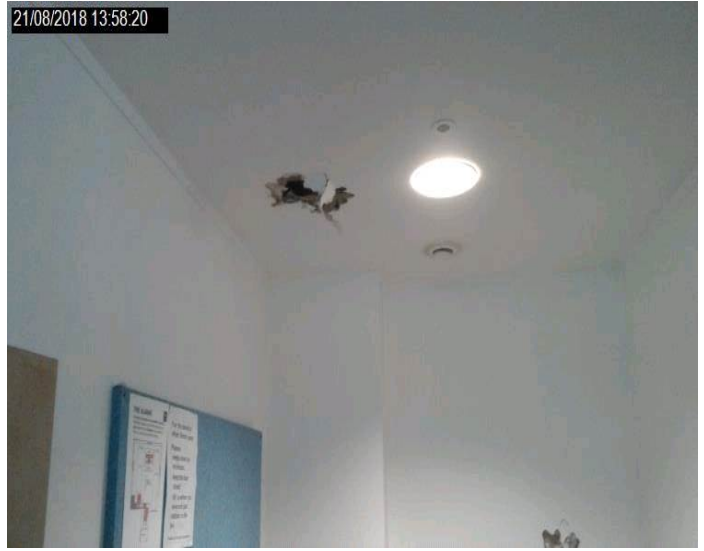
<b>Item:</b>	Textured coating to concrete			
<b>Asbestos Content:</b>		<b>Result Based on:</b>		
No Asbestos Detected		Strongly presumed		
<b>Sample Analysed By:</b>	Not applicable	<b>Extent:</b>	6 m <sup>2</sup>	
<b>Comments:</b> Above plasterboard ceiling

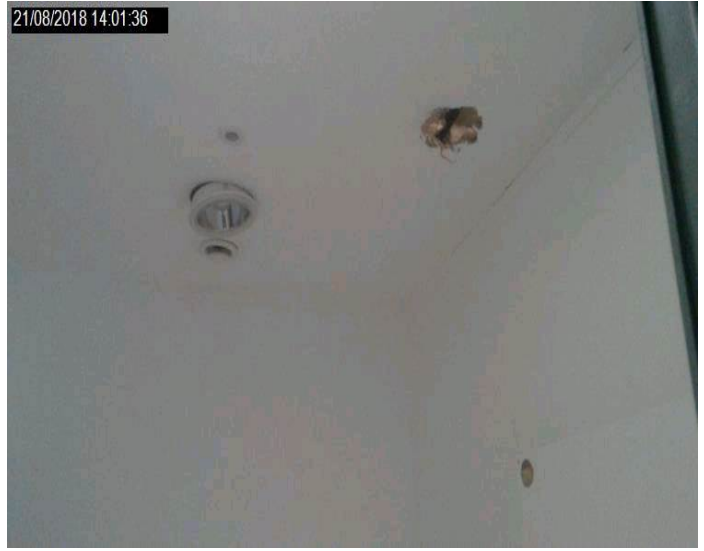
<b>Item:</b>	Textured coating to concrete			
<b>Asbestos Content:</b>		<b>Result Based on:</b>		
No Asbestos Detected		Strongly presumed		
<b>Sample Analysed By:</b>	Not applicable	<b>Extent:</b>	6 m <sup>2</sup>	
<b>Comments:</b> Above plasterboard ceiling

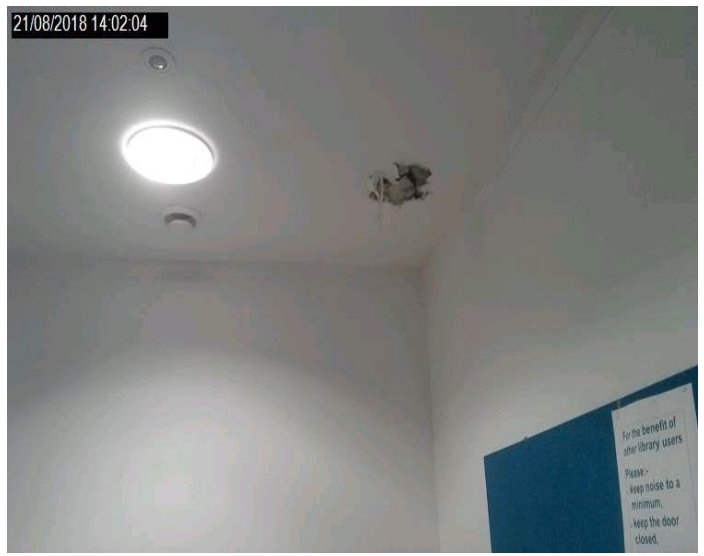
<b>Item:</b>	Textured coating to concrete			
<b>Asbestos Content:</b>		<b>Result Based on:</b>		
No Asbestos Detected		Strongly presumed		
<b>Sample Analysed By:</b>	Not applicable	<b>Extent:</b>	3 m <sup>2</sup>	
<b>Comments:</b> Above plasterboard ceiling, half of ceiling area

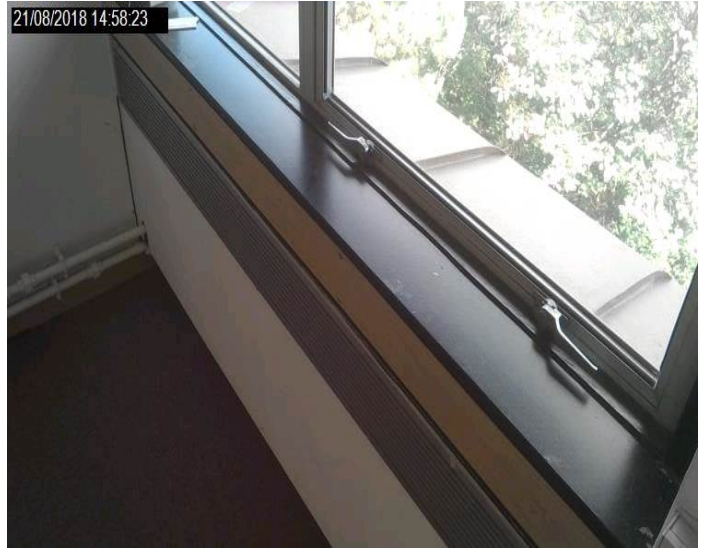
<b>Item:</b>	Asbestos Cement window sills			
<b>Asbestos Content:</b>	Result Based on:			
Chrysotile	Analysis of sample using PLM			
<b>Sample Analysed By:</b>	Reg 13(1)	<b>Extent:</b>	8 linear metres	
<b>Comments:</b>

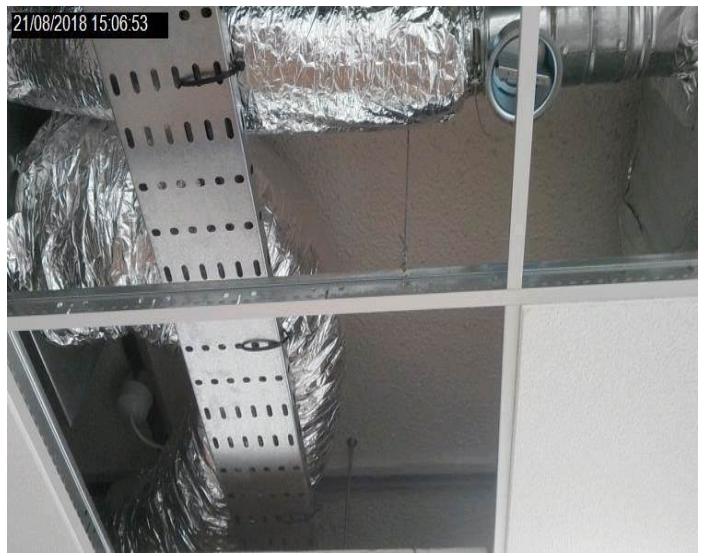
<b>Item:</b>	Textured coating to concrete ceiling			
<b>Asbestos Content:</b>		<b>Result Based on:</b>		
No Asbestos Detected		Strongly presumed		
<b>Sample Analysed By:</b>	Not applicable	<b>Extent:</b>	16 m <sup>2</sup>	
<b>Comments:</b> Above suspended tiles

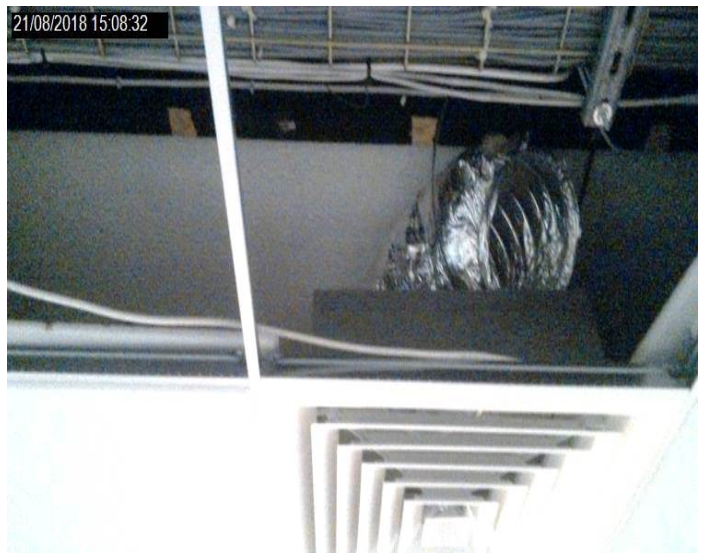
<b>Item:</b>	Textured coating to concrete ceiling			
<b>Asbestos Content:</b>		<b>Result Based on:</b>		
No Asbestos Detected		Strongly presumed		
<b>Sample Analysed By:</b>	Not applicable	<b>Extent:</b>	12 m <sup>2</sup>	
<b>Comments:</b> Above suspended tiles, not to entire ceiling

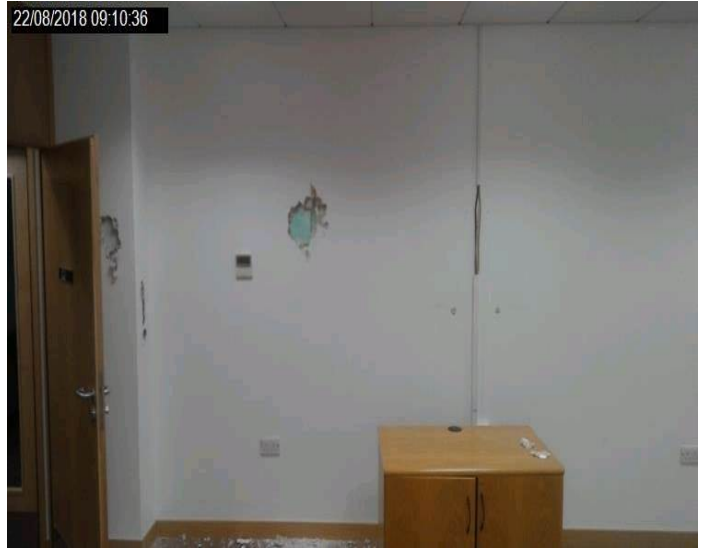
<b>Item:</b>	Textured coating to block			
<b>Asbestos Content:</b>		<b>Result Based on:</b>		
No Asbestos Detected		Analysis of sample using PLM		
<b>Sample Analysed By:</b>	Reg 13(1)	<b>Extent:</b>	35 m <sup>2</sup>	
<b>Comments:</b> To two walls only

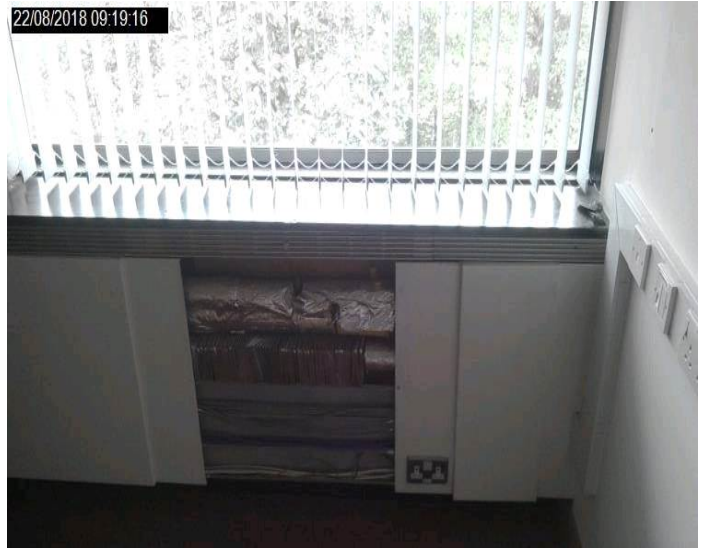
<b>Item:</b>	Asbestos Cement window sill			
<b>Asbestos Content:</b>	<b>Result Based on:</b>			
Chrysotile	Strongly presumed			
<b>Sample Analysed By:</b>	Not applicable	<b>Extent:</b>	4 linear metres	
<b>Comments:</b>

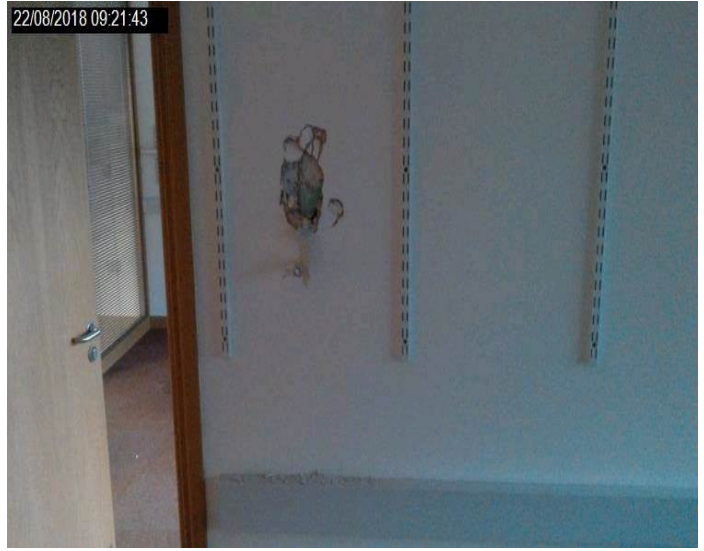
<b>Item:</b>	Textured coating to block			
<b>Asbestos Content:</b>		<b>Result Based on:</b>		
No Asbestos Detected		Strongly presumed		
<b>Sample Analysed By:</b>	Not applicable	<b>Extent:</b>	30 m <sup>2</sup>	
<b>Comments:</b> To both walls

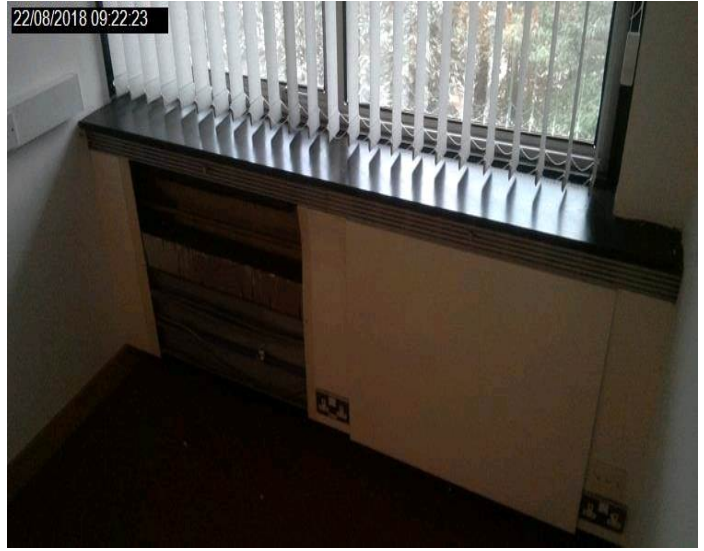
<b>Item:</b>	Asbestos Cement window sill			
<b>Asbestos Content:</b>	<b>Result Based on:</b>			
Chrysotile	Strongly presumed			
<b>Sample Analysed By:</b>	Not applicable	<b>Extent:</b>	2 linear metres	
<b>Comments:</b>

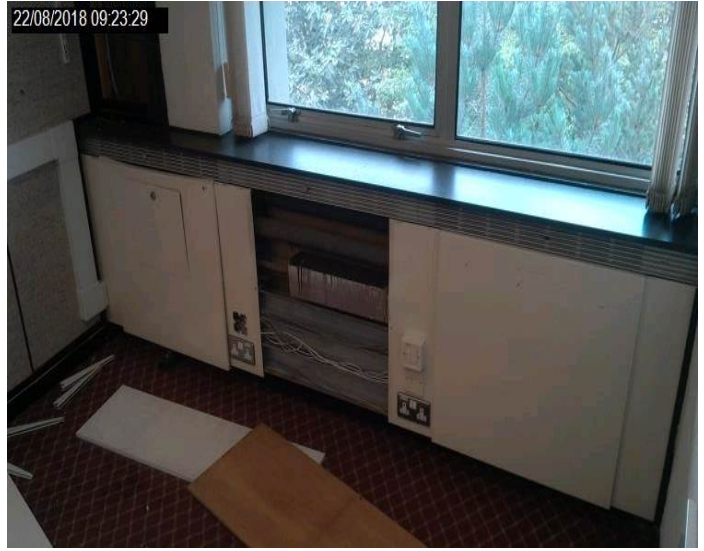
<b>Item:</b>	Asbestos Cement window sill			
<b>Asbestos Content:</b>	<b>Result Based on:</b>			
Chrysotile	Strongly presumed			
<b>Sample Analysed By:</b>	Not applicable	<b>Extent:</b>	3 linear metres	
<b>Comments:</b>

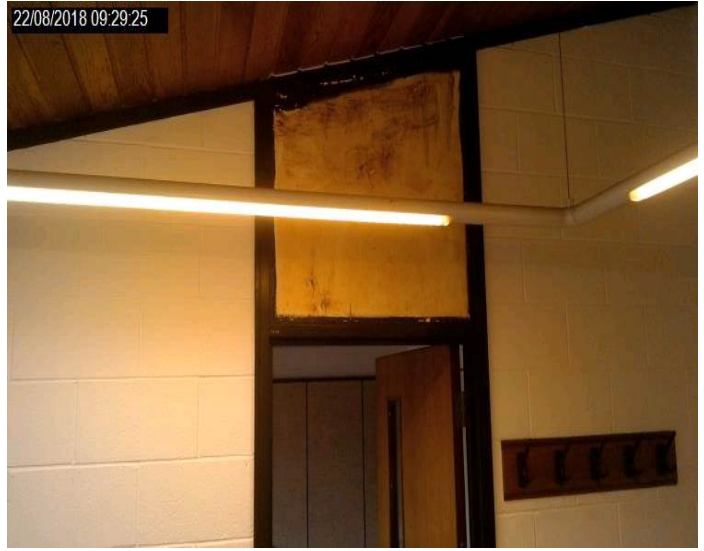
<b>Item:</b>	Insulating board door header			
<b>Asbestos Content:</b>		<b>Result Based on:</b>		
No Asbestos Detected		Analysis of sample using PLM		
<b>Sample Analysed By:</b>	Reg 13(1)	<b>Extent:</b>	2 m <sup>2</sup>	
<b>Comments:</b> Double skin

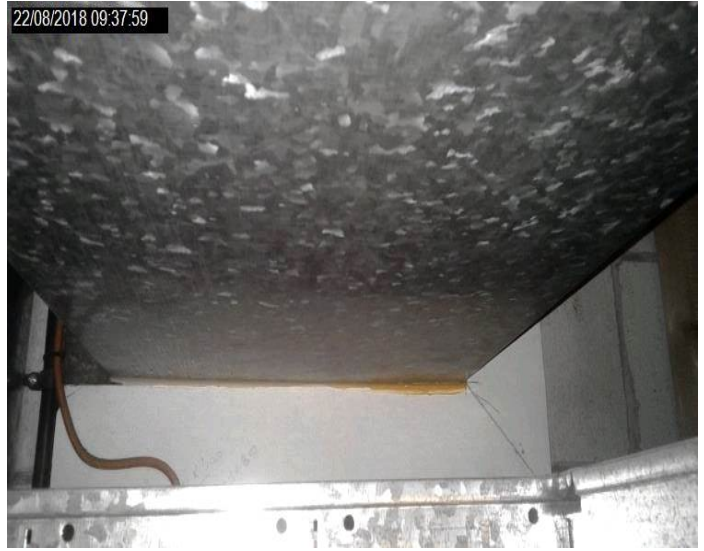
<b>Item:</b>	Insulating board fire protection			
<b>Asbestos Content:</b>		<b>Result Based on:</b>		
No Asbestos Detected		Analysis of sample using PLM		
<b>Sample Analysed By:</b>	Reg 13(1)	<b>Extent:</b>	2 m <sup>2</sup>	
<b>Comments:</b> Above ceiling tiles where metal ducting passes through the wall

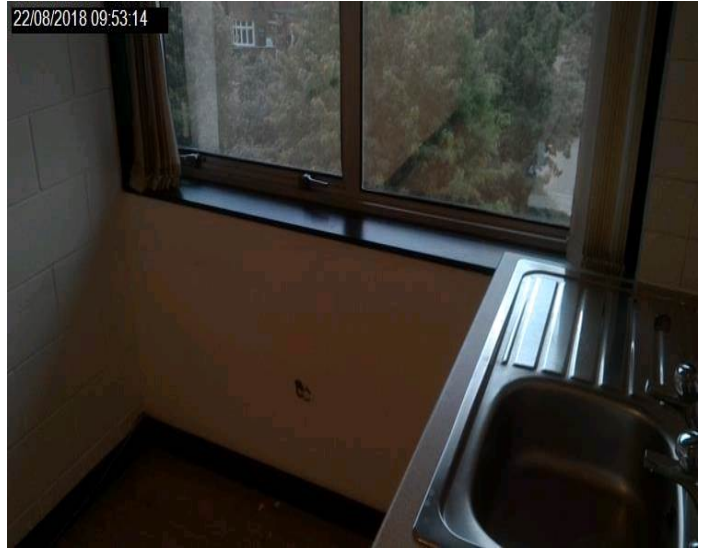
<b>Item:</b>	Asbestos Cement window sill			
<b>Asbestos Content:</b>	<b>Result Based on:</b>			
Chrysotile	Strongly presumed			
<b>Sample Analysed By:</b>	Not applicable	<b>Extent:</b>	3 linear metres	
<b>Comments:</b>

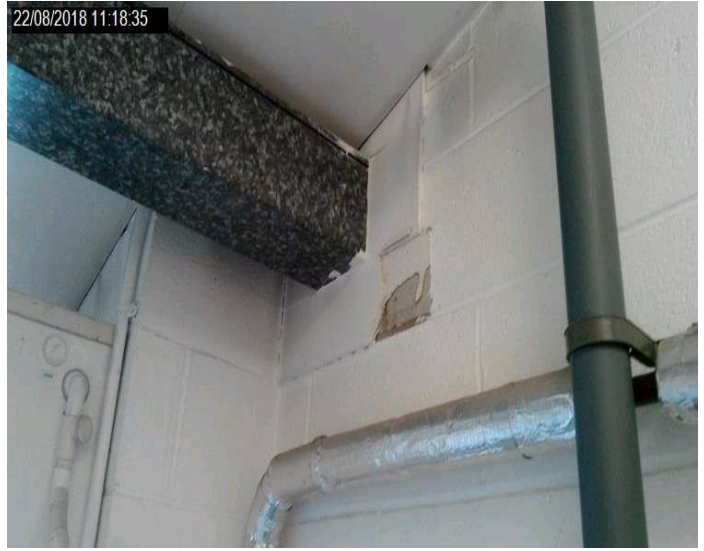
<b>Item:</b>	Insulating board firebreak			
<b>Asbestos Content:</b>		<b>Result Based on:</b>		
No Asbestos Detected		Analysis of sample using PLM		
<b>Sample Analysed By:</b>	Reg 13(1)	<b>Extent:</b>	2 m <sup>2</sup>	
<b>Comments:</b> Both sides of room

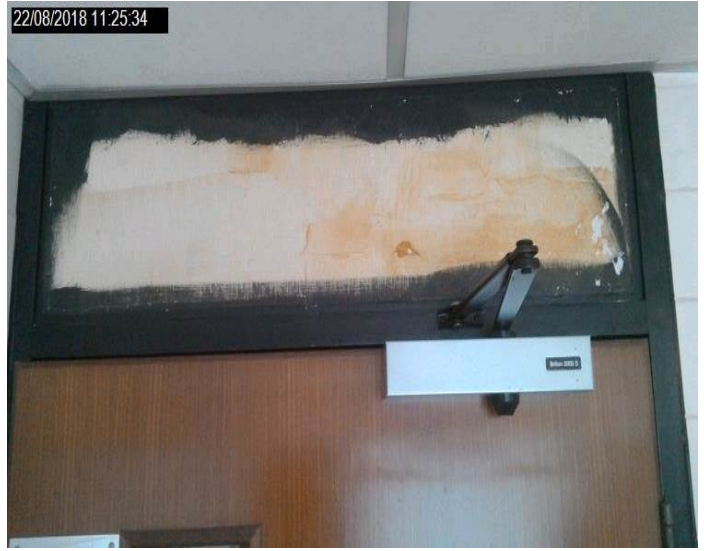
<b>Item:</b>	Insulating board door header			
<b>Asbestos Content:</b>		<b>Result Based on:</b>		
No Asbestos Detected		Analysis of sample using PLM		
<b>Sample Analysed By:</b>	Reg 13(1)	<b>Extent:</b>	1 m <sup>2</sup>	
<b>Comments:</b> Double skin

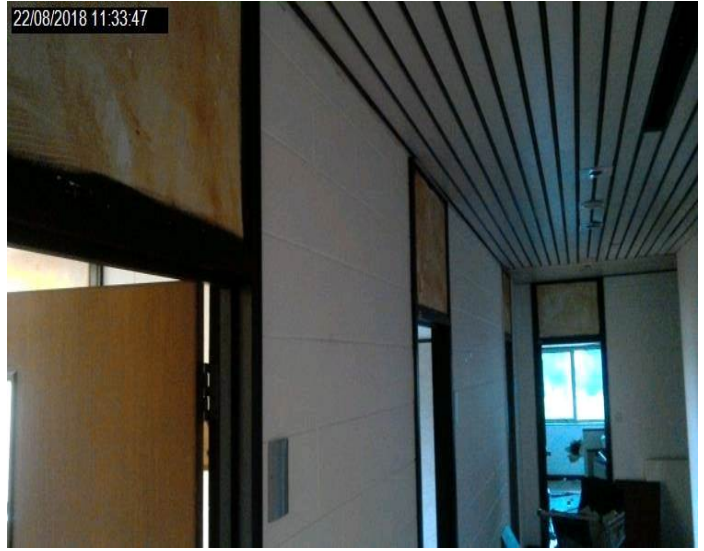
<b>Item:</b>	Insulating board door headers double skin			
<b>Asbestos Content:</b>	<b>Result Based on:</b>			
No Asbestos Detected	Analysis of sample using PLM			
<b>Sample Analysed By:</b> Reg 13(1)	<b>Extent:</b>	26 m <sup>2</sup>		
<b>Comments:</b> Above doors to 3.40, 3.27, 3,28, 3.29, 3.30, 3.39, 3.31, 3.32, 3.33, 3.34 and 3.38

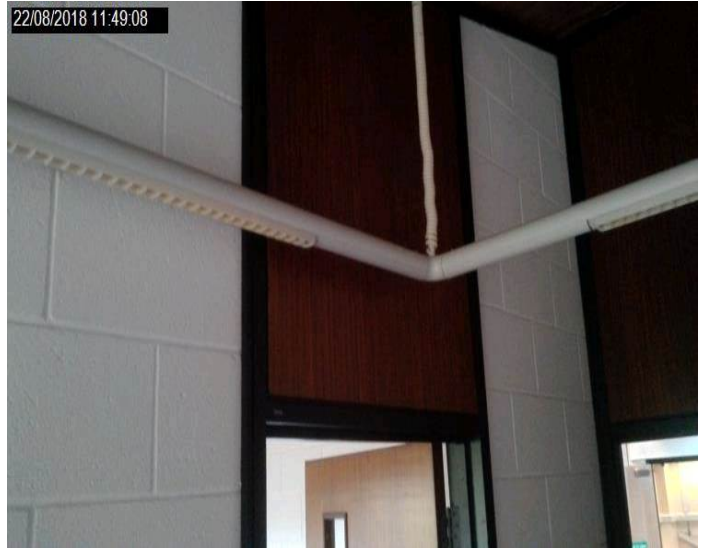
<b>Item:</b>	Insulating board door header			
<b>Asbestos Content:</b>		<b>Result Based on:</b>		
No Asbestos Detected		Analysis of sample using PLM		
<b>Sample Analysed By:</b>	Reg 13(1)	<b>Extent:</b>	2 m <sup>2</sup>	
<b>Comments:</b> Double skin

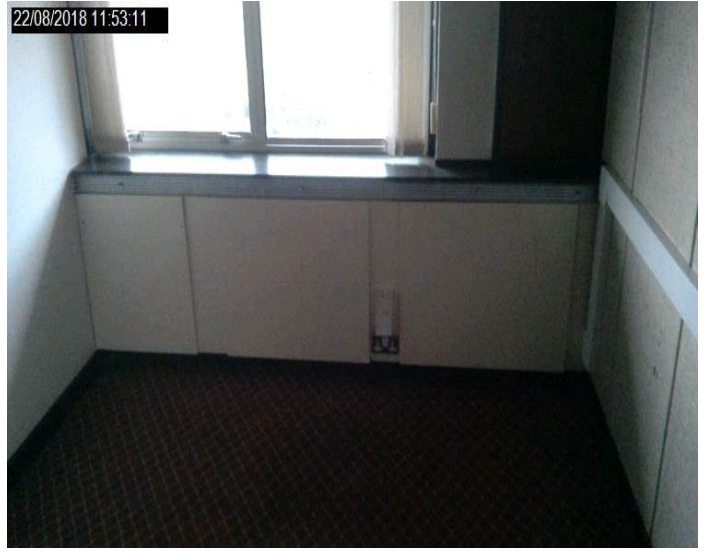
<b>Item:</b>	Asbestos Cement window sill			
<b>Asbestos Content:</b>	<b>Result Based on:</b>			
Chrysotile	Strongly presumed			
<b>Sample Analysed By:</b>	Not applicable	<b>Extent:</b>	4 linear metres	
<b>Comments:</b>

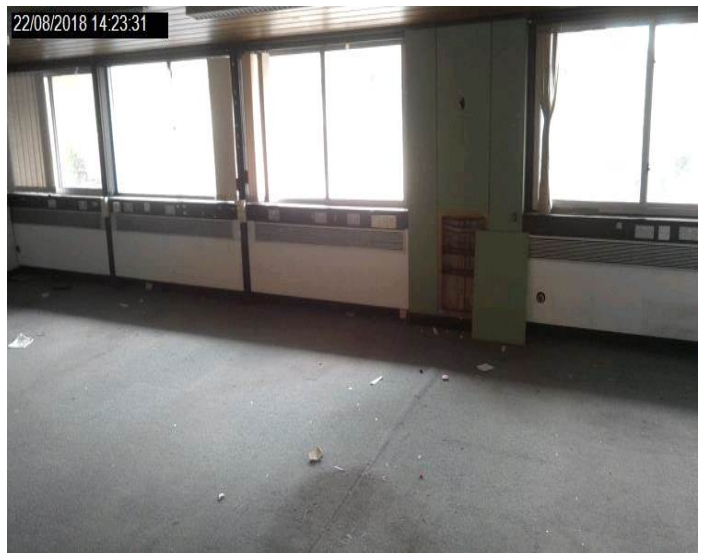
<b>Item:</b>	Asbestos Cement window sill			
<b>Asbestos Content:</b>	<b>Result Based on:</b>			
Chrysotile	Strongly presumed			
<b>Sample Analysed By:</b>	Not applicable	<b>Extent:</b>	8 linear metres	
<b>Comments:</b>

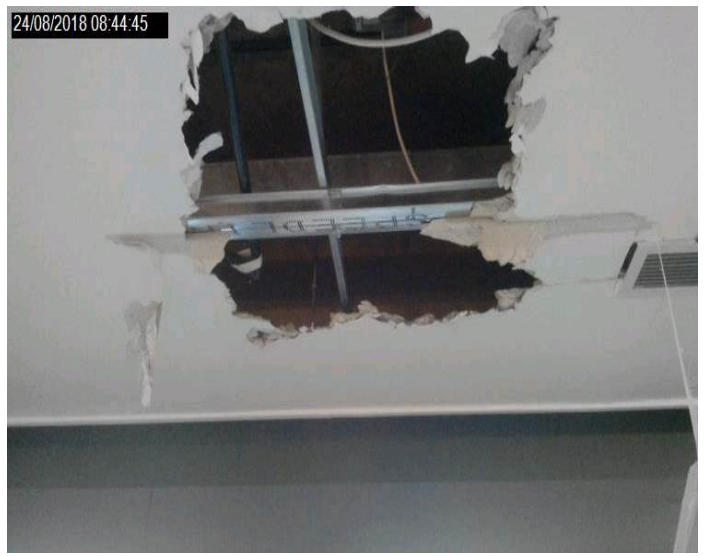
<b>Item:</b>	Insulating board upstand			
<b>Asbestos Content:</b>		<b>Result Based on:</b>		
No Asbestos Detected		Analysis of sample using PLM		
<b>Sample Analysed By:</b>	Reg 13(1)	<b>Extent:</b>	10 linear metres	
<b>Comments:</b> To sliding doors internal entrance

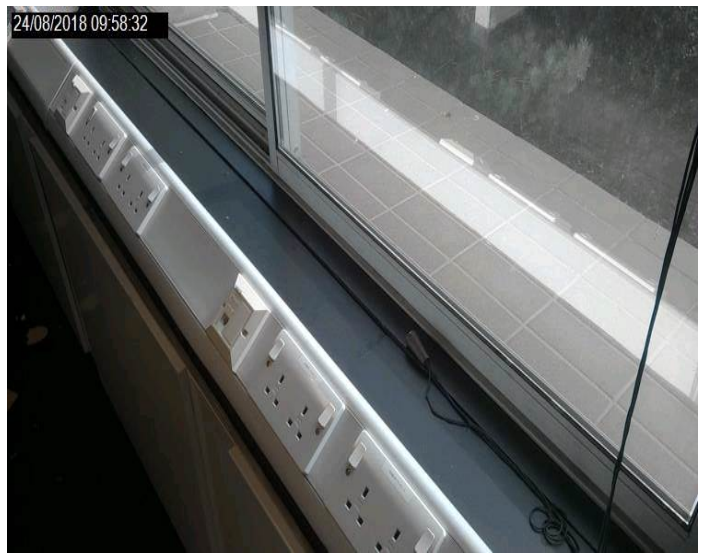
<b>Item:</b>	Asbestos Cement window sill			
<b>Asbestos Content:</b>	Result Based on:			
Chrysotile	Analysis of sample using PLM			
<b>Sample Analysed By:</b>	Reg 13(1)	<b>Extent:</b>	17 linear metres	
<b>Comments:</b>

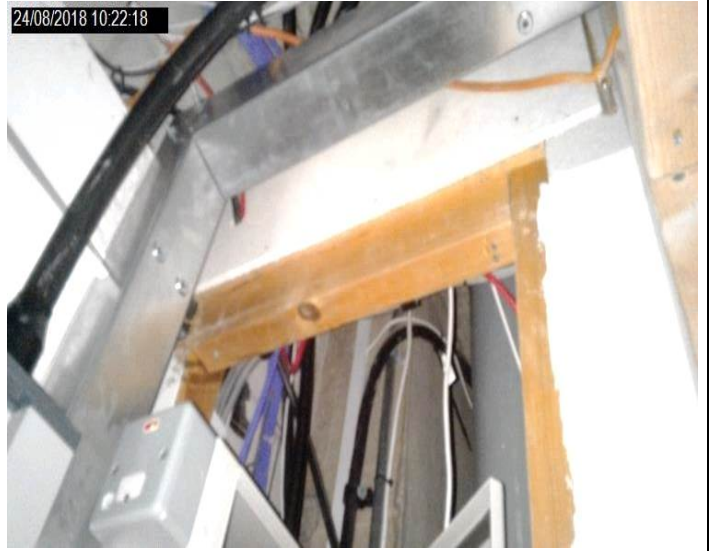
<b>Item:</b>	Insulating board panel			
<b>Asbestos Content:</b>		<b>Result Based on:</b>		
No Asbestos Detected		Analysis of sample using PLM		
<b>Sample Analysed By:</b>	Reg 13(1)	<b>Extent:</b>	1 m <sup>2</sup>	
<b>Comments:</b> High level right handside

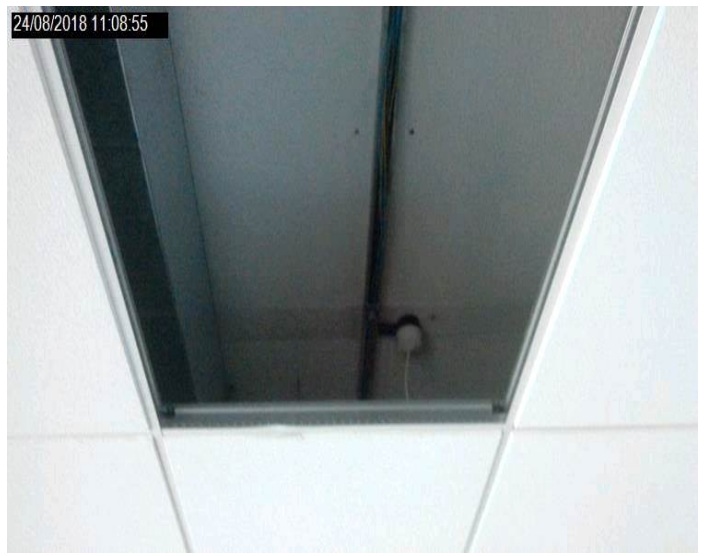
<b>Item:</b>	Textured coating to concrete			
<b>Asbestos Content:</b>		<b>Result Based on:</b>		
No Asbestos Detected		Strongly presumed		
<b>Sample Analysed By:</b>	Not applicable	<b>Extent:</b>	35 m <sup>2</sup>	
<b>Comments:</b>

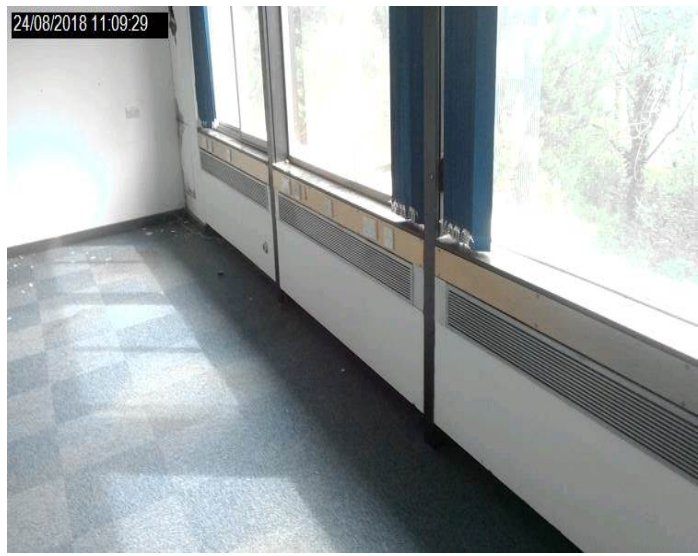
<b>Item:</b>	Asbestos Cement window sill			
<b>Asbestos Content:</b>	<b>Result Based on:</b>			
Chrysotile	Strongly presumed			
<b>Sample Analysed By:</b>	Not applicable	<b>Extent:</b>	6 linear metres	
<b>Comments:</b>

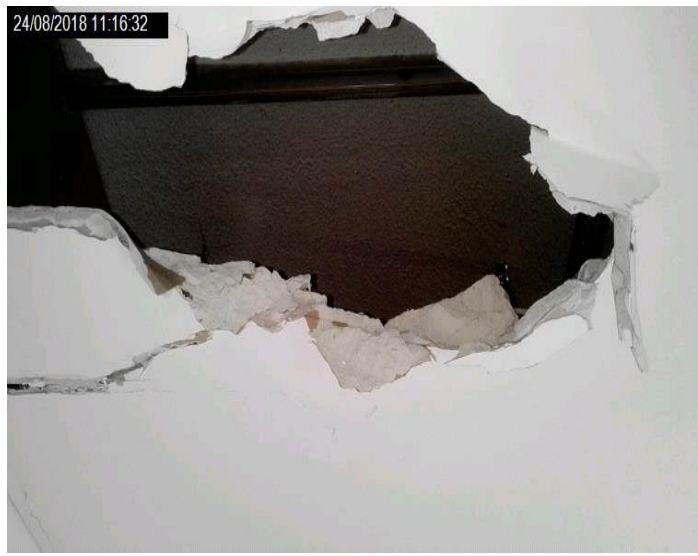
<b>Item:</b>	Textured coating to concrete			
<b>Asbestos Content:</b>	<b>Result Based on:</b>			
No Asbestos Detected	Analysis of sample using PLM			
<b>Sample Analysed By:</b> Reg 13(1)	<b>Extent:</b>	8 m <sup>2</sup>		
<b>Comments:</b> Above plasterboard

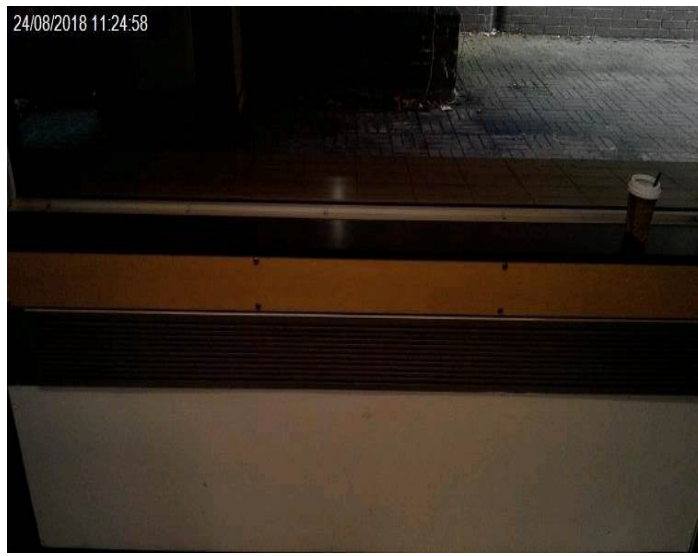
<b>Item:</b>	Asbestos Cement window sill			
<b>Asbestos Content:</b>	<b>Result Based on:</b>			
Chrysotile	Strongly presumed			
<b>Sample Analysed By:</b>	Not applicable	<b>Extent:</b>	2 linear metres	
<b>Comments:</b>

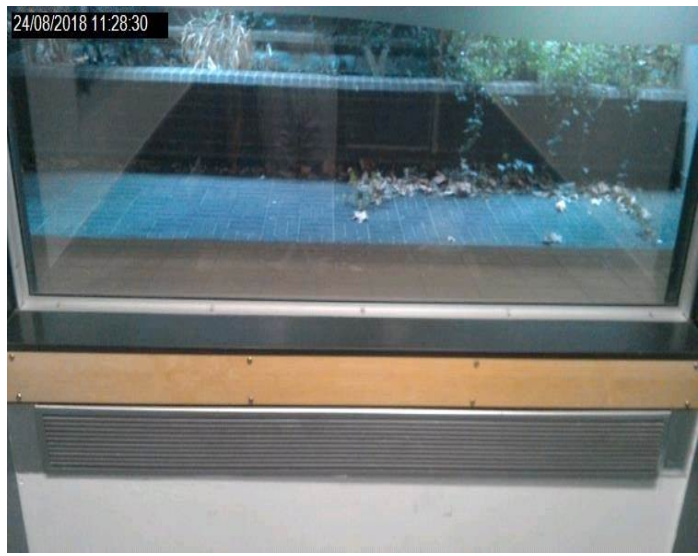
<b>Item:</b>	Asbestos Cement window sill			
<b>Asbestos Content:</b>	<b>Result Based on:</b>			
Chrysotile	Strongly presumed			
<b>Sample Analysed By:</b>	Not applicable	<b>Extent:</b>	2 linear metres	
<b>Comments:</b>

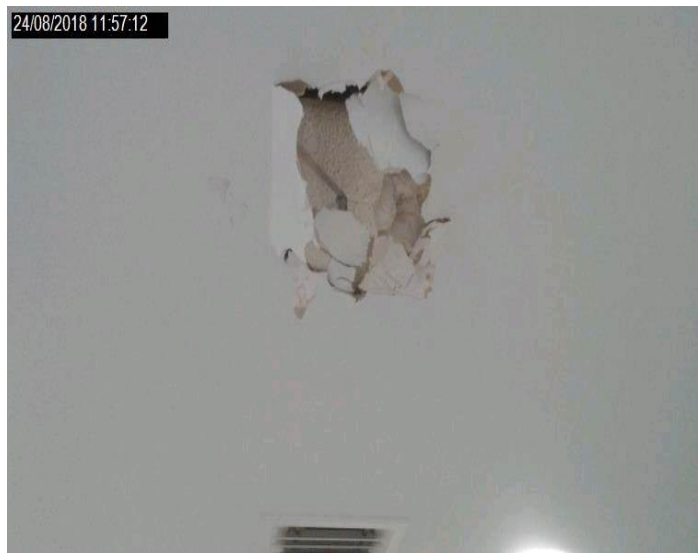
<b>Item:</b>	Textured coating to concrete			
<b>Asbestos Content:</b>		<b>Result Based on:</b>		
No Asbestos Detected		Strongly presumed		
<b>Sample Analysed By:</b>	Not applicable	<b>Extent:</b>	18 m <sup>2</sup>	
<b>Comments:</b> Above plasterboard

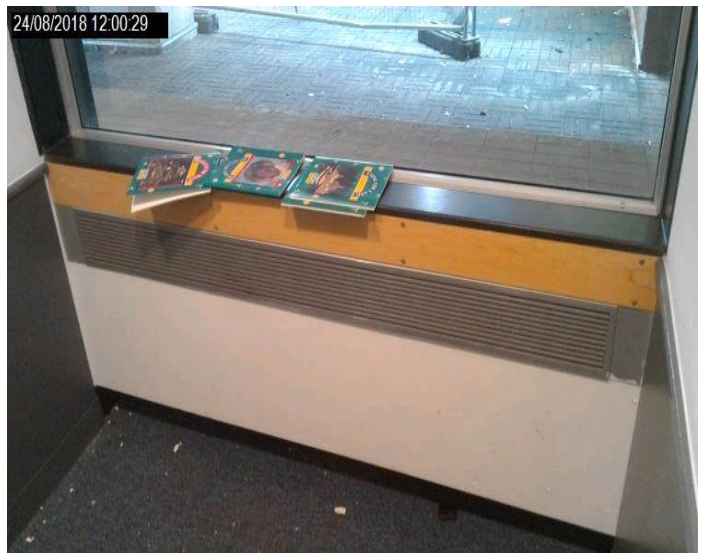
<b>Item:</b>	Asbestos Cement window sill			
<b>Asbestos Content:</b>	<b>Result Based on:</b>			
Chrysotile	Strongly presumed			
<b>Sample Analysed By:</b>	Not applicable	<b>Extent:</b>	2 linear metres	
<b>Comments:</b>
