**Report No.:** J102747  
**Nature of Work:** Demolition Survey  
**Issue Date:** 26/09/2018  
**Client Name:** WYG Engineering Ltd  
Geneva Building, Lake View Drive, Sherwood Business Park,  
Annesley, Nottingham, NG15 0ED  
**Site Address:** Kenrick Building, Former City North Campus, Birmingham City  
University, Perry Barr, B42 2US

**Order Placed By:** Reg 13(1)  
**Site Contact:** Reg 13(1)  
**Date(s) of Work:** 20/08/2018 to 23/08/2018  
**Technical Manager:** Reg 13(1) (Asbestos)  
**Assistant Surveyor(s):** Reg 13(1)

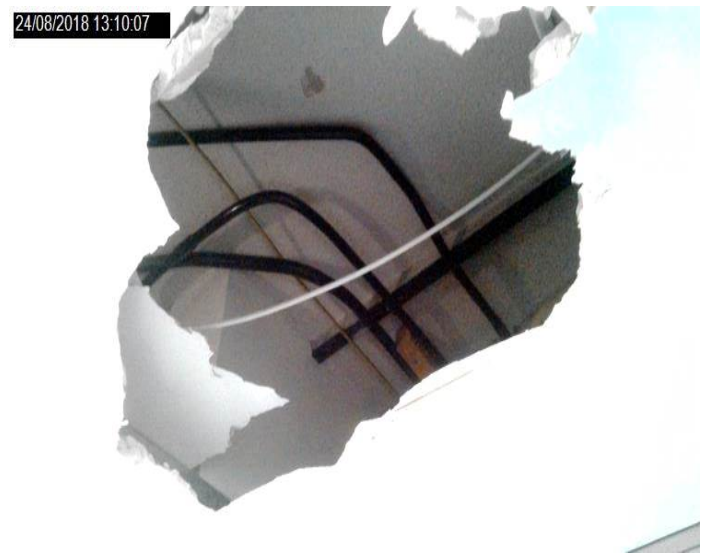
<b>Item:</b>	Textured coating to concrete			
<b>Asbestos Content:</b>		<b>Result Based on:</b>		
No Asbestos Detected		Analysis of sample using PLM		
<b>Sample Analysed By:</b>	Reg 13(1)	<b>Extent:</b>	20 m <sup>2</sup>	
<b>Comments:</b> Above plasterboard

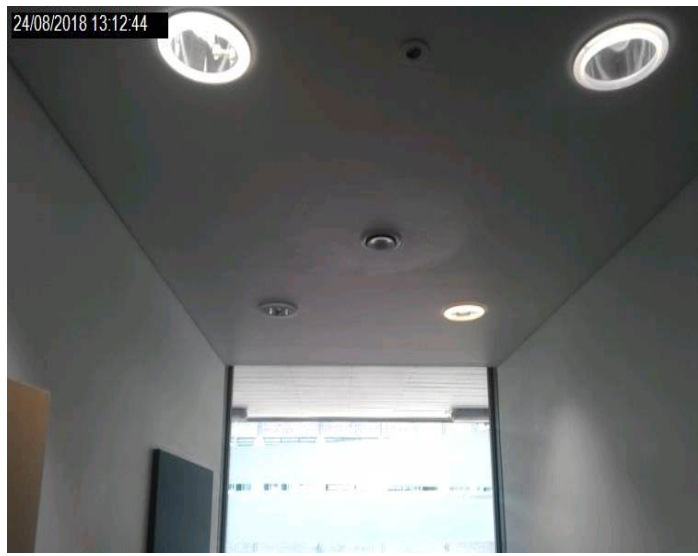
<b>Item:</b>	Textured coating to concrete			
<b>Asbestos Content:</b>		<b>Result Based on:</b>		
No Asbestos Detected		Strongly presumed		
<b>Sample Analysed By:</b>	Not applicable	<b>Extent:</b>	8 m <sup>2</sup>	
<b>Comments:</b> Above plasterboard
