Report No.: J102751 V2
Nature of Work: Demolition Survey
Issue Date: 25/10/2018
Client Name: WYG Engineering Ltd
Geneva Building, Lake View Drive, Sherwood Business Park,
Annesley, Nottingham, NG15 0ED
Site Address: Murdoch & Jackson Buildings, Former City North Campus,
Birmingham City University, Perry Barr, B42 2US

A demolition survey in line with HSG264 Asbestos: The Survey Guide was carried out internally and externally to both Murdoch and Jackson Buildings.

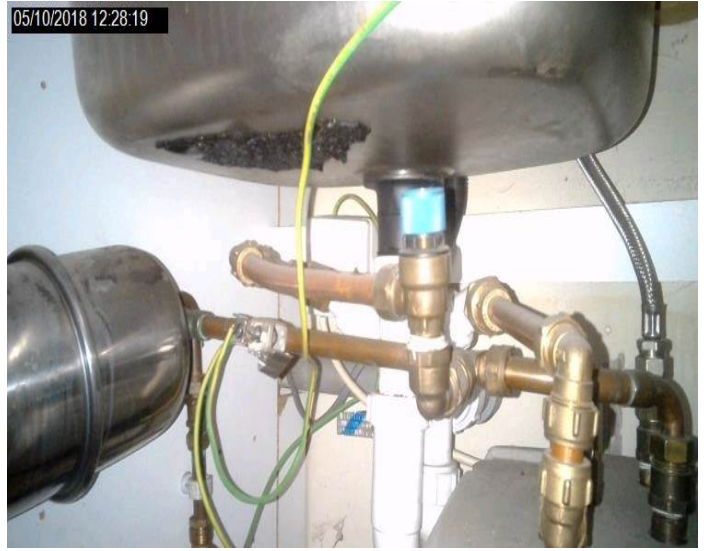
Location:	NMU104	Block:	Birmingham City University	Floor Level: 1st Floor
Sample No.:	DU002590	Portal Ref No.:	1

Item:	Bitumen sink pad			
Asbestos Content:	Result Based on:			
No Asbestos Detected	Analysis of sample using PLM			
Sample Analysed By: Reg 13(1)	Extent:	1 unit		
Comments:

Material Assessment Total Score: 0		Likelihood of Disturbance Assessment Total Score: 0		Management Assessment Licensable: No Recommendations: Not Applicable Reinspection Interval: Not Applicable Overall Risk Category: E0
Product Type:	0 Not Applicable	Location:	0 Not Applicable	
Condition:	0 Not Applicable	Accessibility:	0 Not Applicable	
Surface Treatment:	0 Not Applicable			
Asbestos Type:	0 Not Applicable	Extent Score:	0 Not Applicable

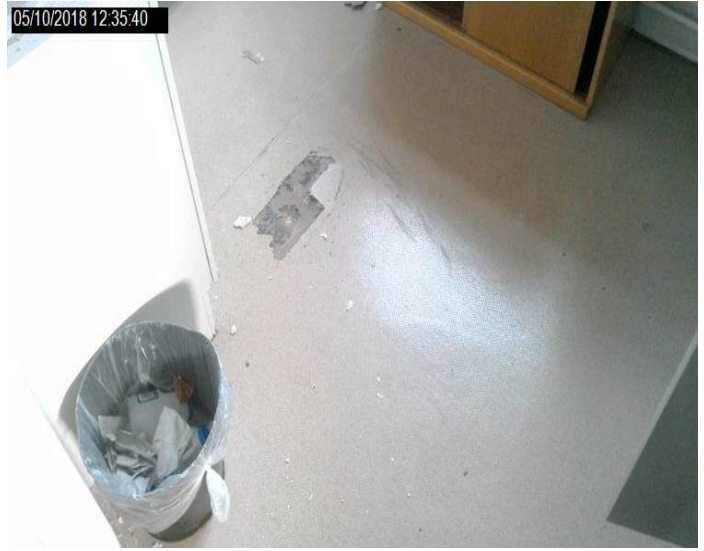
Location:	NMU101	Block:	Birmingham City University	Floor Level: 1st Floor
Sample No.:	DU002591	Portal Ref No.:	5

Item:	Asbestos Bitumen adhesive			
Asbestos Content:	Result Based on:			
Chrysotile	Analysis of sample using PLM			
Sample Analysed By:	Reg 13(1)	Extent:	12 m ²	
Comments:

Material Assessment Total Score: 3		Likelihood of Disturbance Assessment Total Score: 4		Management Assessment Licensable: No Recommendations: Program removal Reinspection Interval: Not Applicable Overall Risk Category: C7
Product Type:	1 (Asbestos bitumen)	Location:	2 (Rooms up to 100 sq m)	
Condition:	1 (Minor scratches)	Accessibility:	0 (Usually inaccessible or unlikely to be disturbed)	
Surface Treatment:	0 (Composite material)			
Asbestos Type:	1 (Chrysotile)	Extent Score:	2 (>10 - <50 sq m or >10m - <50m pipe run)

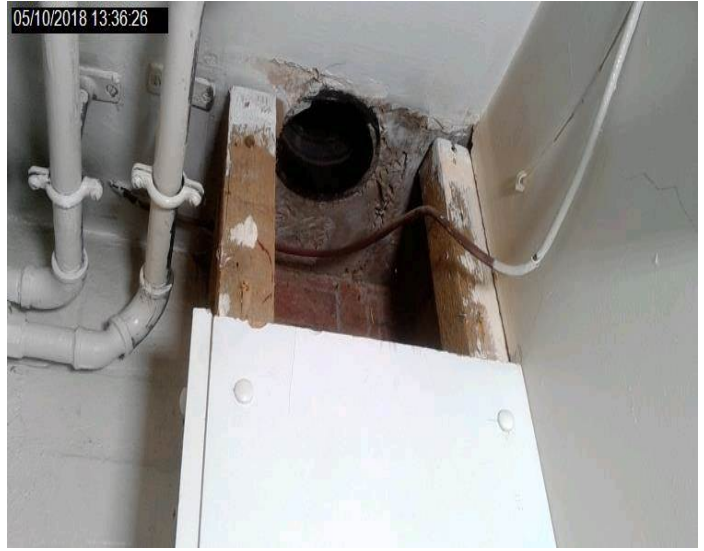
Location:	NMUG13	Block:	Birmingham City University	Floor Level: Ground Floor
Sample No.:	DU002592	Portal Ref No.:	11

Item:	Asbestos Reinforced plastic downpipe			
Asbestos Content:	Result Based on:			
Chrysotile	Analysis of sample using PLM			
Sample Analysed By: Reg 13(1)	Extent:	1 linear metres		
Comments:

Material Assessment Total Score: 3		Likelihood of Disturbance Assessment Total Score: 4		Management Assessment Licensable: No Recommendations: Program removal Reinspection Interval: Not Applicable Overall Risk Category: C7
Product Type:	1 (Asbestos reinforced plastic)	Location:	2 (Rooms up to 100 sq m)	
Condition:	1 (Minor scratches)	Accessibility:	1 (Occasionally likely to be disturbed)	
Surface Treatment:	0 (Composite material)			
Asbestos Type:	1 (Chrysotile)	Extent Score:	1 (<10 sq m or 10m pipe run)

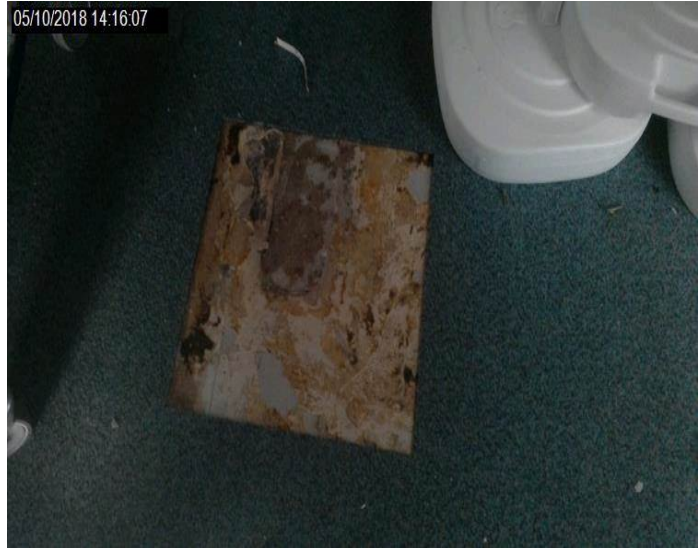
Location:	NMUG05	Block:	Birmingham City University	Floor Level: Ground Floor
Sample No.:	As DU002593	Portal Ref No.:	19

Item:	Asbestos Bitumen adhesive			
Asbestos Content:	Result Based on:			
Chrysotile	Strongly presumed			
Sample Analysed By:	Not applicable	Extent:	10 m ²	
Comments:

Material Assessment Total Score: 3		Likelihood of Disturbance Assessment Total Score: 4		Management Assessment Licensable: No Recommendations: Program removal Reinspection Interval: Not Applicable Overall Risk Category: C7
Product Type:	1 (Asbestos bitumen)	Location:	2 (Rooms up to 100 sq m)	
Condition:	1 (Minor scratches)	Accessibility:	0 (Usually inaccessible or unlikely to be disturbed)	
Surface Treatment:	0 (Composite material)			
Asbestos Type:	1 (Chrysotile)	Extent Score:	2 (>10 - <50 sq m or >10m - <50m pipe run)

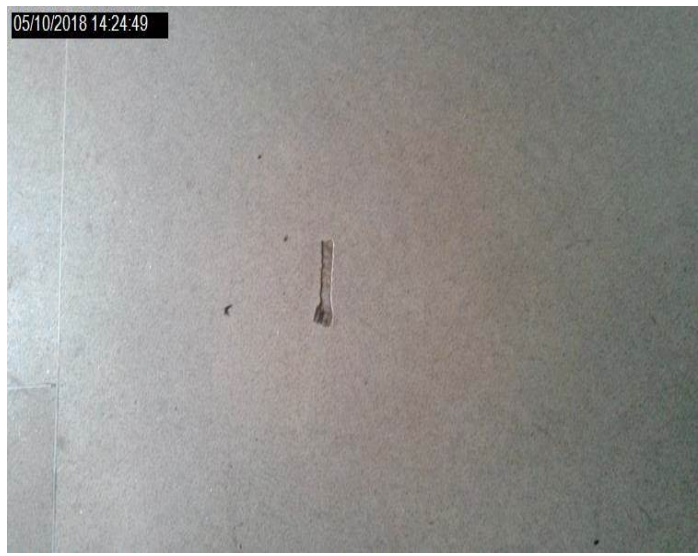
Location:	NMUG08	Block:	Birmingham City University	Floor Level: Ground Floor
Sample No.:	As DU002593	Portal Ref No.:	21

Item:	Asbestos Bitumen adhesive			
Asbestos Content:	Result Based on:			
Chrysotile	Strongly presumed			
Sample Analysed By:	Not applicable	Extent:	8 m ²	
Comments:

Material Assessment Total Score: 3		Likelihood of Disturbance Assessment Total Score: 3		Management Assessment Licensable: No Recommendations: Program removal Reinspection Interval: Not Applicable Overall Risk Category: D6
Product Type:	1 (Asbestos bitumen)	Location:	2 (Rooms up to 100 sq m)	
Condition:	1 (Minor scratches)	Accessibility:	0 (Usually inaccessible or unlikely to be disturbed)	
Surface Treatment:	0 (Composite material)			
Asbestos Type:	1 (Chrysotile)	Extent Score:	1 (<10 sq m or 10m pipe run)

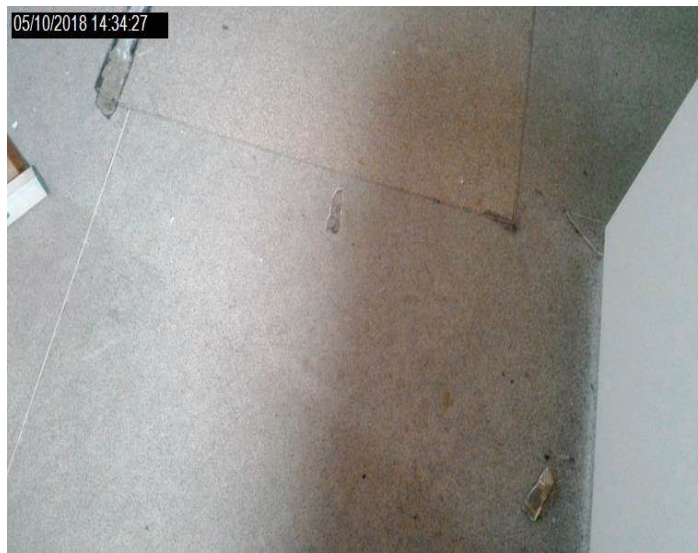
Location:	NMUG09	Block:	Birmingham City University	Floor Level: Ground Floor
Sample No.:	As DU002593	Portal Ref No.:	22

Item:	Asbestos Bitumen adhesive			
Asbestos Content:	Result Based on:			
Chrysotile	Strongly presumed			
Sample Analysed By:	Not applicable	Extent:	8 m ²	
Comments:

Material Assessment Total Score: 3		Likelihood of Disturbance Assessment Total Score: 3		Management Assessment Licensable: No Recommendations: Program removal Reinspection Interval: Not Applicable Overall Risk Category: D6
Product Type:	1 (Asbestos bitumen)	Location:	2 (Rooms up to 100 sq m)	
Condition:	1 (Minor scratches)	Accessibility:	0 (Usually inaccessible or unlikely to be disturbed)	
Surface Treatment:	0 (Composite material)			
Asbestos Type:	1 (Chrysotile)	Extent Score:	1 (<10 sq m or 10m pipe run)

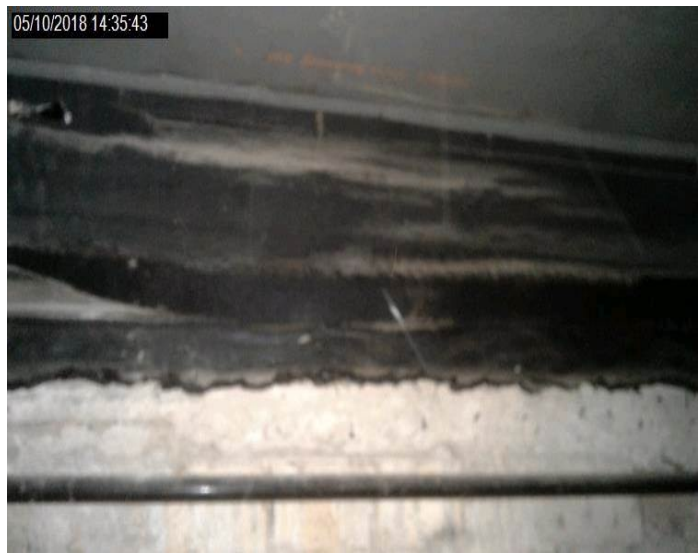
Location:	NMUG09	Block:	Birmingham City University	Floor Level: Ground Floor
Sample No.:	DU002594	Portal Ref No.:	23

Item:	Asbestos Bitumen flat roof covering			
Asbestos Content:	Result Based on:			
Chrysotile	Analysis of sample using PLM			
Sample Analysed By: Reg 13(1)	Extent:	50 m ²		
Comments: Former roof covering, now built on top of.

Material Assessment Total Score: 3		Likelihood of Disturbance Assessment Total Score: 5		Management Assessment Licensable: No Recommendations: Program removal Reinspection Interval: Not Applicable Overall Risk Category: C8
Product Type:	1 (Asbestos bitumen)	Location:	2 (Rooms up to 100 sq m)	
Condition:	1 (Minor scratches)	Accessibility:	0 (Usually inaccessible or unlikely to be disturbed)	
Surface Treatment:	0 (Composite material)			
Asbestos Type:	1 (Chrysotile)	Extent Score:	3 (>50 sq m or >50m pipe run)

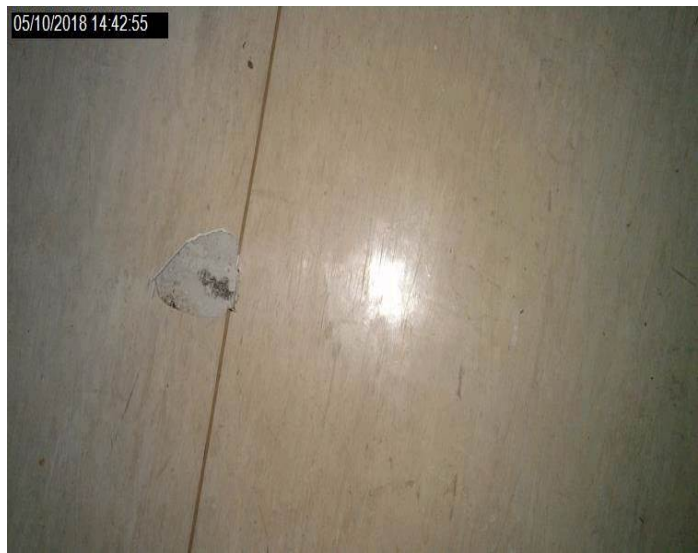
Location:	NMUG99B	Block:	Birmingham City University	Floor Level: Ground Floor
Sample No.:	DU002595	Portal Ref No.:	24

Item:	Bitumen adhesive			
Asbestos Content:	Result Based on:			
No Asbestos Detected	Analysis of sample using PLM			
Sample Analysed By:	Reg 13(1)	Extent:	16 m ²	
Comments:

Material Assessment Total Score: 0		Likelihood of Disturbance Assessment Total Score: 0		Management Assessment Licensable: No Recommendations: Not Applicable Reinspection Interval: Not Applicable Overall Risk Category: E0
Product Type:	0 Not Applicable	Location:	0 Not Applicable	
Condition:	0 Not Applicable	Accessibility:	0 Not Applicable	
Surface Treatment:	0 Not Applicable			
Asbestos Type:	0 Not Applicable	Extent Score:	0 Not Applicable

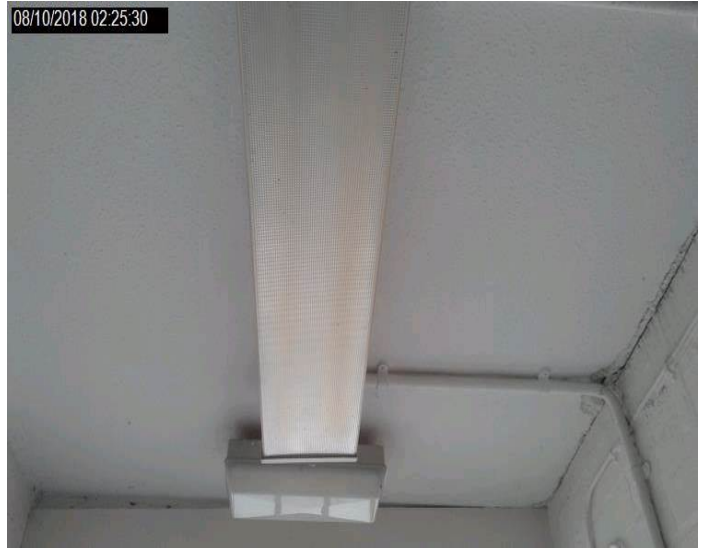
Location:	JACK G01	Block:	Birmingham City University	Floor Level: Ground Floor
Sample No.:	DU002596	Portal Ref No.:	25

Item:	Textured coating to plasterboard ceiling			
Asbestos Content:	Result Based on:			
No Asbestos Detected	Analysis of sample using PLM			
Sample Analysed By: Reg 13(1)	Extent:	3 m ²		
Comments:

Material Assessment Total Score: 0		Likelihood of Disturbance Assessment Total Score: 0		Management Assessment Licensable: No Recommendations: Not Applicable Reinspection Interval: Not Applicable Overall Risk Category: E0
Product Type:	0 Not Applicable	Location:	0 Not Applicable	
Condition:	0 Not Applicable	Accessibility:	0 Not Applicable	
Surface Treatment:	0 Not Applicable			
Asbestos Type:	0 Not Applicable	Extent Score:	0 Not Applicable

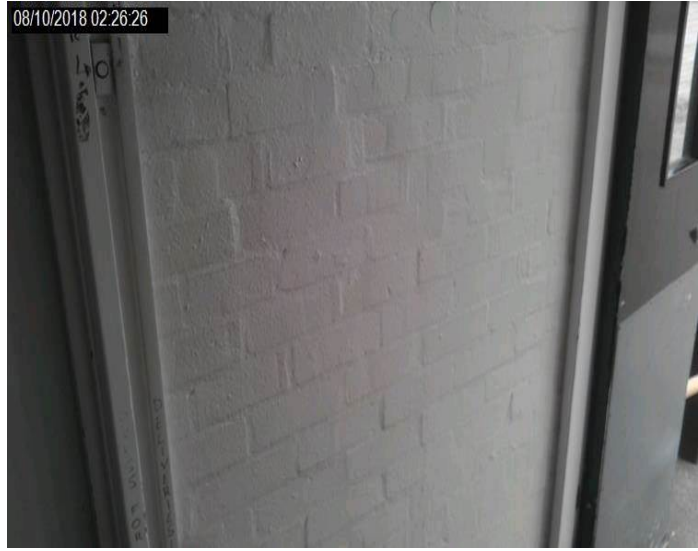
Location:	JACK G01	Block:	Birmingham City University	Floor Level: Ground Floor
Sample No.:	DU002597	Portal Ref No.:	26

Item:	Textured coating to brickwork wall			
Asbestos Content:	Result Based on:			
No Asbestos Detected	Analysis of sample using PLM			
Sample Analysed By: Reg 13(1)	Extent:	8 m ²		
Comments:

Material Assessment Total Score: 0		Likelihood of Disturbance Assessment Total Score: 0		Management Assessment Licensable: No Recommendations: Not Applicable Reinspection Interval: Not Applicable Overall Risk Category: E0
Product Type:	0 Not Applicable	Location:	0 Not Applicable	
Condition:	0 Not Applicable	Accessibility:	0 Not Applicable	
Surface Treatment:	0 Not Applicable			
Asbestos Type:	0 Not Applicable	Extent Score:	0 Not Applicable

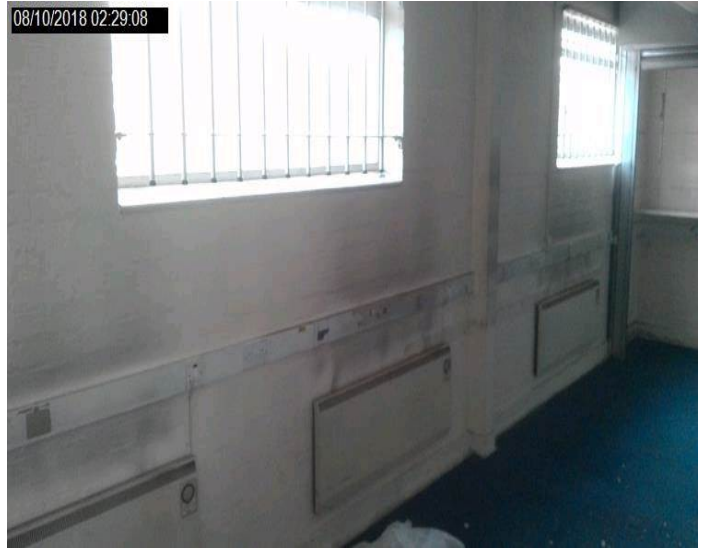
Location:	JACK G02	Block:	Birmingham City University	Floor Level: Ground Floor
Sample No.:	As DU002597	Portal Ref No.:	28

Item:	Textured coating to brickwork wall			
Asbestos Content:		Result Based on:		
No Asbestos Detected		Strongly presumed		
Sample Analysed By:	Not applicable	Extent:	45 m ²	
Comments:

Material Assessment Total Score: 0		Likelihood of Disturbance Assessment Total Score: 0		Management Assessment Licensable: No Recommendations: Not Applicable Reinspection Interval: Not Applicable Overall Risk Category: E0
Product Type:	0 Not Applicable	Location:	0 Not Applicable	
Condition:	0 Not Applicable	Accessibility:	0 Not Applicable	
Surface Treatment:	0 Not Applicable			
Asbestos Type:	0 Not Applicable	Extent Score:	0 Not Applicable

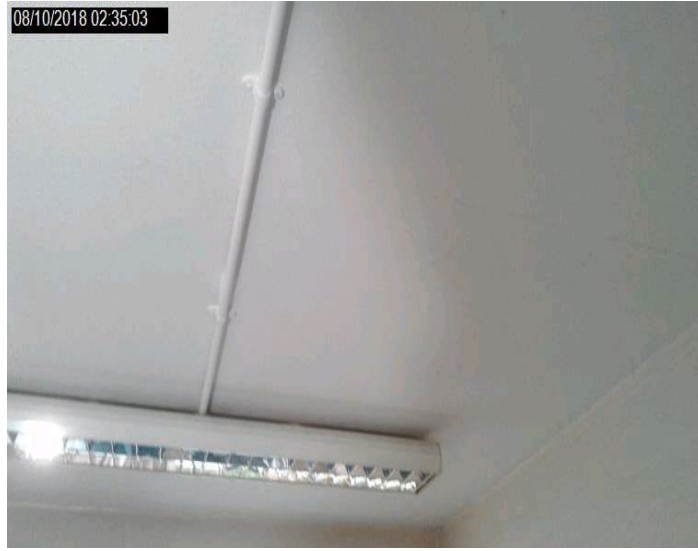
Location:	JACK G03	Block:	Birmingham City University	Floor Level: Ground Floor
Sample No.:	As DU002596	Portal Ref No.:	30

Item:	Textured coating to plasterboard ceiling			
Asbestos Content:		Result Based on:		
No Asbestos Detected		Strongly presumed		
Sample Analysed By:	Not applicable	Extent:	6 m ²	
Comments:

Material Assessment Total Score: 0		Likelihood of Disturbance Assessment Total Score: 0		Management Assessment Licensable: No Recommendations: Not Applicable Reinspection Interval: Not Applicable Overall Risk Category: E0
Product Type:	0 Not Applicable	Location:	0 Not Applicable	
Condition:	0 Not Applicable	Accessibility:	0 Not Applicable	
Surface Treatment:	0 Not Applicable			
Asbestos Type:	0 Not Applicable	Extent Score:	0 Not Applicable

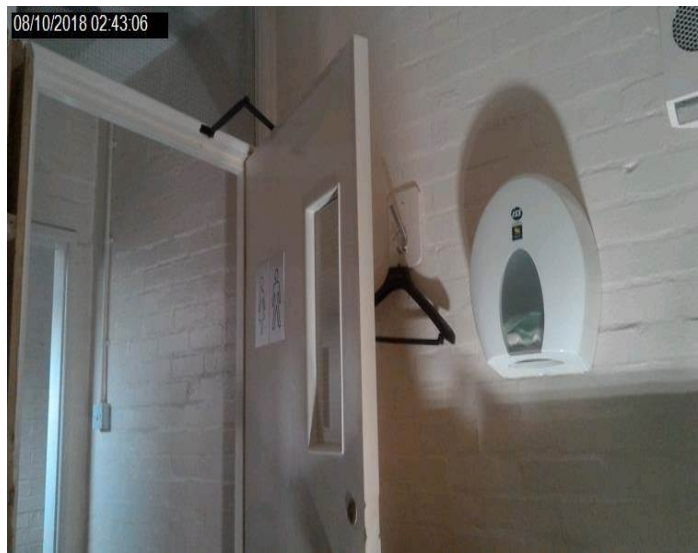
Location:	JACK G04	Block:	Birmingham City University	Floor Level: Ground Floor
Sample No.:	As DU002597	Portal Ref No.:	34

Item:	Textured coating to brickwork wall			
Asbestos Content:		Result Based on:		
No Asbestos Detected		Strongly presumed		
Sample Analysed By:	Not applicable	Extent:	25 m ²	
Comments:

Material Assessment Total Score: 0		Likelihood of Disturbance Assessment Total Score: 0		Management Assessment Licensable: No Recommendations: Not Applicable Reinspection Interval: Not Applicable Overall Risk Category: E0
Product Type:	0 Not Applicable	Location:	0 Not Applicable	
Condition:	0 Not Applicable	Accessibility:	0 Not Applicable	
Surface Treatment:	0 Not Applicable			
Asbestos Type:	0 Not Applicable	Extent Score:	0 Not Applicable

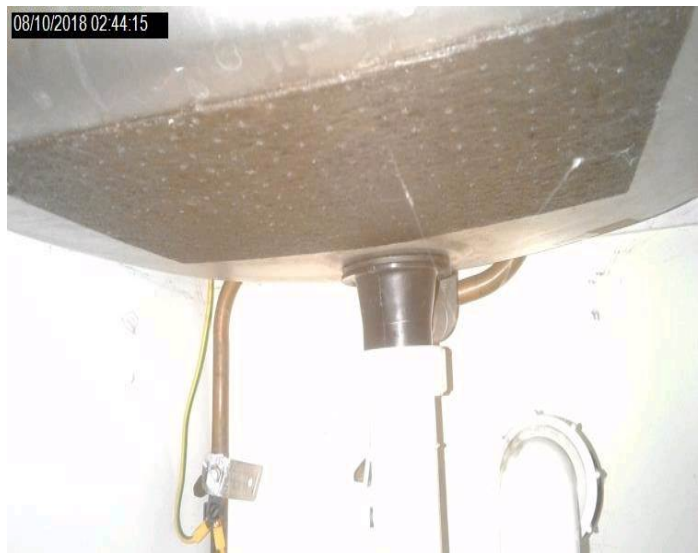
Location:	JACK G04	Block:	Birmingham City University	Floor Level: Ground Floor
Sample No.:	DU002598	Portal Ref No.:	36

Item:	Bitumen sink pad			
Asbestos Content:		Result Based on:		
No Asbestos Detected		Analysis of sample using PLM		
Sample Analysed By:	Reg 13(1)	Extent:	2 units	
Comments:

Material Assessment Total Score: 0		Likelihood of Disturbance Assessment Total Score: 0		Management Assessment Licensable: No Recommendations: Not Applicable Reinspection Interval: Not Applicable Overall Risk Category: E0
Product Type:	0 Not Applicable	Location:	0 Not Applicable	
Condition:	0 Not Applicable	Accessibility:	0 Not Applicable	
Surface Treatment:	0 Not Applicable			
Asbestos Type:	0 Not Applicable	Extent Score:	0 Not Applicable

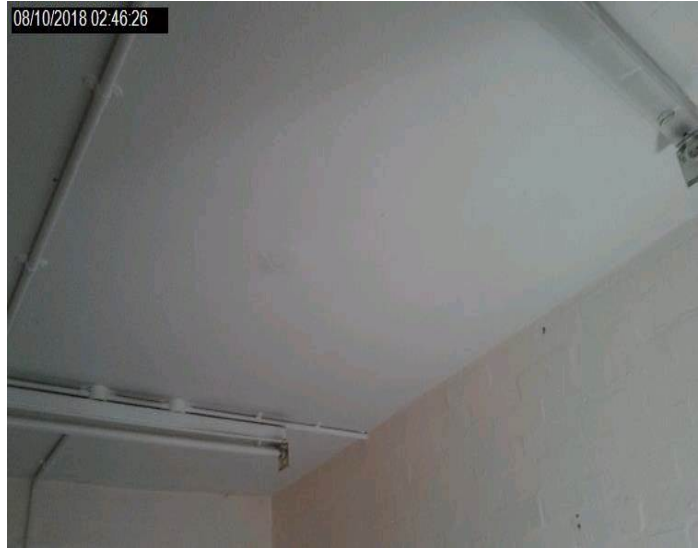
Location:	JACK G05	Block:	Birmingham City University	Floor Level: Ground Floor
Sample No.:	DU002599	Portal Ref No.:	38

Item:	Textured coating to plasterboard ceiling			
Asbestos Content:	Result Based on:			
No Asbestos Detected	Analysis of sample using PLM			
Sample Analysed By: Reg 13(1)	Extent:	8 m ²		
Comments:

Material Assessment Total Score: 0		Likelihood of Disturbance Assessment Total Score: 0		Management Assessment Licensable: No Recommendations: Not Applicable Reinspection Interval: Not Applicable Overall Risk Category: E0
Product Type:	0 Not Applicable	Location:	0 Not Applicable	
Condition:	0 Not Applicable	Accessibility:	0 Not Applicable	
Surface Treatment:	0 Not Applicable			
Asbestos Type:	0 Not Applicable	Extent Score:	0 Not Applicable

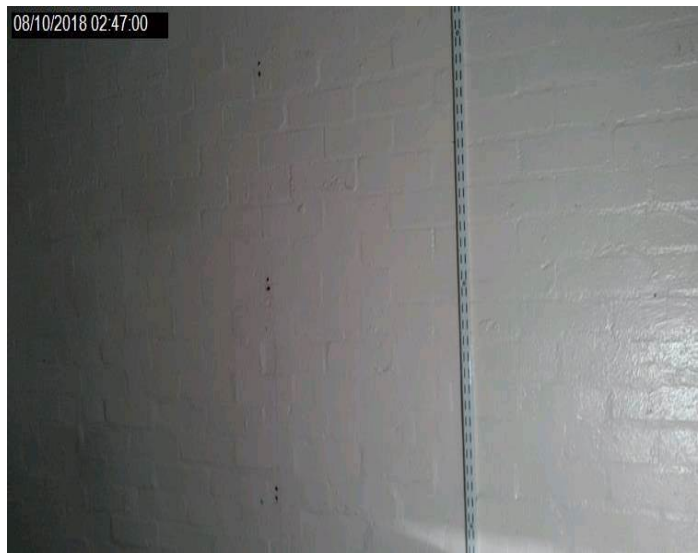
Location:	JACK G05	Block:	Birmingham City University	Floor Level: Ground Floor
Sample No.:	DU002600	Portal Ref No.:	39

Item:	Textured coating to brickwork wall			
Asbestos Content:		Result Based on:		
No Asbestos Detected		Analysis of sample using PLM		
Sample Analysed By:	Reg 13(1)	Extent:	28 m ²	
Comments:

Material Assessment Total Score: 0		Likelihood of Disturbance Assessment Total Score: 0		Management Assessment Licensable: No Recommendations: Not Applicable Reinspection Interval: Not Applicable Overall Risk Category: E0
Product Type:	0 Not Applicable	Location:	0 Not Applicable	
Condition:	0 Not Applicable	Accessibility:	0 Not Applicable	
Surface Treatment:	0 Not Applicable			
Asbestos Type:	0 Not Applicable	Extent Score:	0 Not Applicable

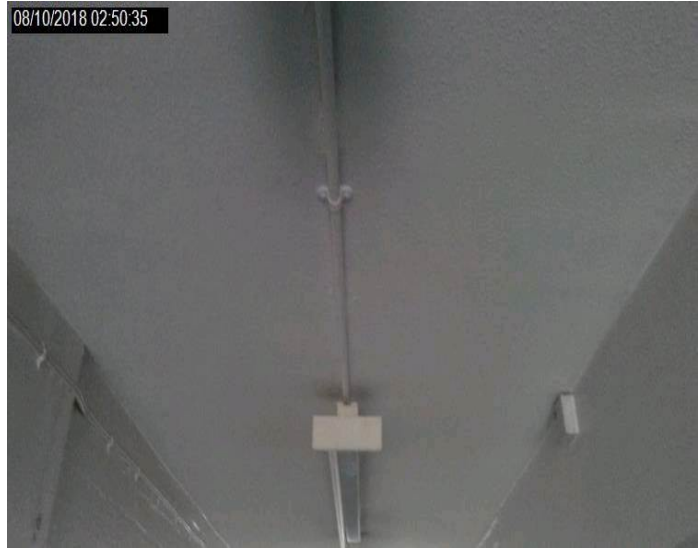
Location:	JACK G06	Block:	Birmingham City University	Floor Level: Ground Floor
Sample No.:	As DU002599	Portal Ref No.:	40

Item:	Textured coating to plasterboard ceiling			
Asbestos Content:			Result Based on:	
No Asbestos Detected		Strongly presumed		
Sample Analysed By:	Not applicable	Extent:	8 m ²	
Comments:

Material Assessment Total Score: 0		Likelihood of Disturbance Assessment Total Score: 0		Management Assessment Licensable: No Recommendations: Not Applicable Reinspection Interval: Not Applicable Overall Risk Category: E0
Product Type:	0 Not Applicable	Location:	0 Not Applicable	
Condition:	0 Not Applicable	Accessibility:	0 Not Applicable	
Surface Treatment:	0 Not Applicable			
Asbestos Type:	0 Not Applicable	Extent Score:	0 Not Applicable

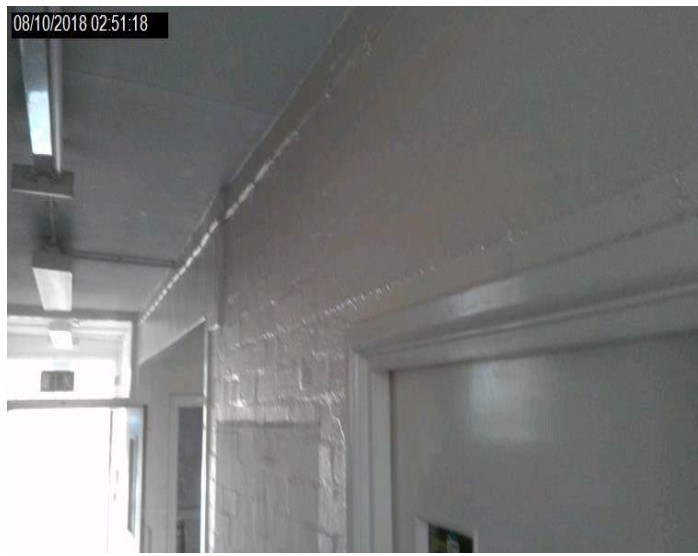
Location:	JACK G06	Block:	Birmingham City University	Floor Level: Ground Floor
Sample No.:	As DU002600	Portal Ref No.:	41

Item:	Textured coating to brickwork wall			
Asbestos Content:		Result Based on:		
No Asbestos Detected		Strongly presumed		
Sample Analysed By:	Not applicable	Extent:	20 m ²	
Comments:

Material Assessment Total Score: 0		Likelihood of Disturbance Assessment Total Score: 0		Management Assessment Licensable: No Recommendations: Not Applicable Reinspection Interval: Not Applicable Overall Risk Category: E0
Product Type:	0 Not Applicable	Location:	0 Not Applicable	
Condition:	0 Not Applicable	Accessibility:	0 Not Applicable	
Surface Treatment:	0 Not Applicable			
Asbestos Type:	0 Not Applicable	Extent Score:	0 Not Applicable

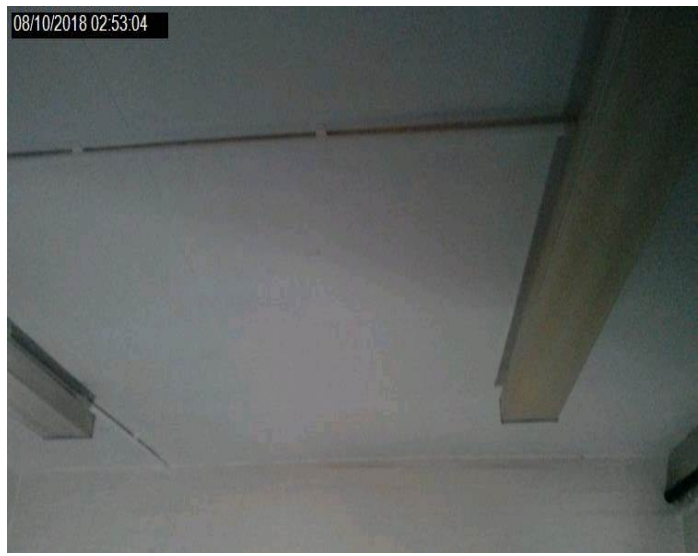
Location:	JACK G07	Block:	Birmingham City University	Floor Level: Ground Floor
Sample No.:	As DU002599	Portal Ref No.:	42

Item:	Textured coating to plasterboard ceiling			
Asbestos Content:		Result Based on:		
No Asbestos Detected		Strongly presumed		
Sample Analysed By:	Not applicable	Extent:	9 m ²	
Comments:

Material Assessment Total Score: 0		Likelihood of Disturbance Assessment Total Score: 0		Management Assessment Licensable: No Recommendations: Not Applicable Reinspection Interval: Not Applicable Overall Risk Category: E0
Product Type:	0 Not Applicable	Location:	0 Not Applicable	
Condition:	0 Not Applicable	Accessibility:	0 Not Applicable	
Surface Treatment:	0 Not Applicable			
Asbestos Type:	0 Not Applicable	Extent Score:	0 Not Applicable

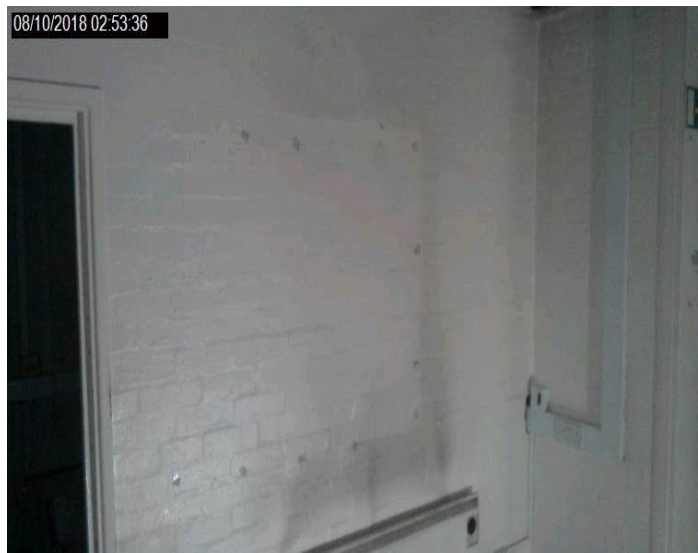
Location:	JACK G07	Block:	Birmingham City University	Floor Level: Ground Floor
Sample No.:	As DU002600	Portal Ref No.:	43

Item:	Textured coating to brickwork wall			
Asbestos Content:		Result Based on:		
No Asbestos Detected		Strongly presumed		
Sample Analysed By:	Not applicable	Extent:	15 m ²	
Comments:

Material Assessment Total Score: 0		Likelihood of Disturbance Assessment Total Score: 0		Management Assessment Licensable: No Recommendations: Not Applicable Reinspection Interval: Not Applicable Overall Risk Category: E0
Product Type:	0 Not Applicable	Location:	0 Not Applicable	
Condition:	0 Not Applicable	Accessibility:	0 Not Applicable	
Surface Treatment:	0 Not Applicable			
Asbestos Type:	0 Not Applicable	Extent Score:	0 Not Applicable

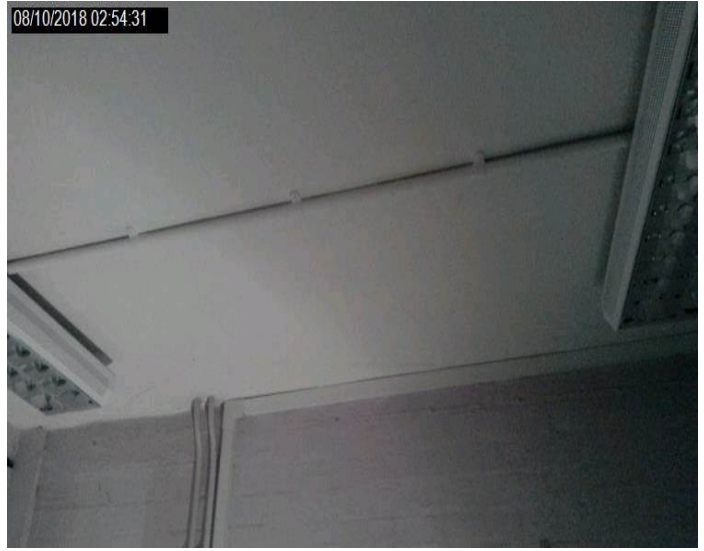
Location:	JACK G08	Block:	Birmingham City University	Floor Level: Ground Floor
Sample No.:	As DU002599	Portal Ref No.:	44

Item:	Textured coating to plasterboard ceiling			
Asbestos Content:	Result Based on:			
No Asbestos Detected	Strongly presumed			
Sample Analysed By:	Not applicable	Extent:	6 m ²	
Comments:

Material Assessment Total Score: 0		Likelihood of Disturbance Assessment Total Score: 0		Management Assessment Licensable: No Recommendations: Not Applicable Reinspection Interval: Not Applicable Overall Risk Category: E0
Product Type:	0 Not Applicable	Location:	0 Not Applicable	
Condition:	0 Not Applicable	Accessibility:	0 Not Applicable	
Surface Treatment:	0 Not Applicable			
Asbestos Type:	0 Not Applicable	Extent Score:	0 Not Applicable

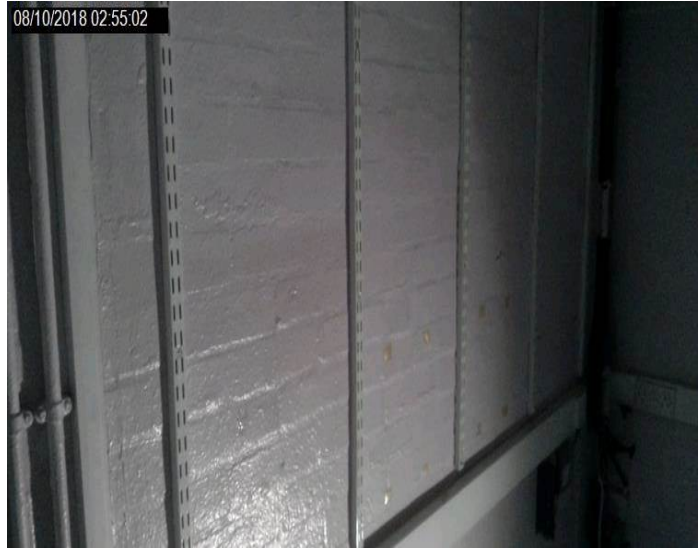
Location:	JACK G08	Block:	Birmingham City University	Floor Level: Ground Floor
Sample No.:	As DU002600	Portal Ref No.:	45

Item:	Textured coating to brickwork wall			
Asbestos Content:		Result Based on:		
No Asbestos Detected		Strongly presumed		
Sample Analysed By:	Not applicable	Extent:	18 m ²	
Comments:

Material Assessment Total Score: 0		Likelihood of Disturbance Assessment Total Score: 0		Management Assessment Licensable: No Recommendations: Not Applicable Reinspection Interval: Not Applicable Overall Risk Category: E0
Product Type:	0 Not Applicable	Location:	0 Not Applicable	
Condition:	0 Not Applicable	Accessibility:	0 Not Applicable	
Surface Treatment:	0 Not Applicable			
Asbestos Type:	0 Not Applicable	Extent Score:	0 Not Applicable

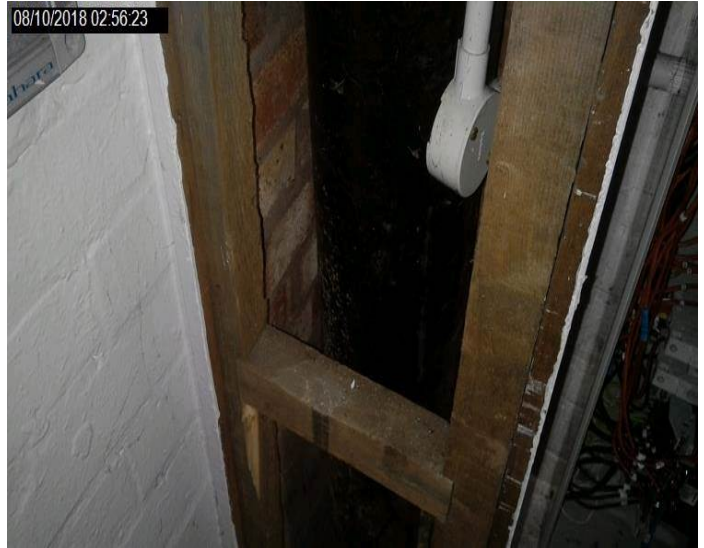
Location:	JACK G08	Block:	Birmingham City University	Floor Level: Ground Floor
Sample No.:	DU002601	Portal Ref No.:	46

Item:	Asbestos Reinforced plastic downpipe			
Asbestos Content:	Chrysotile			
Result Based on:	Analysis of sample using PLM			
Sample Analysed By:	Reg 13(1)	Extent:	3 linear metres	
Comments:

Material Assessment Total Score: 3		Likelihood of Disturbance Assessment Total Score: 4		Management Assessment Licensable: No Recommendations: Program removal Reinspection Interval: Not Applicable Overall Risk Category: C7
Product Type:	1 (Asbestos reinforced plastic)	Location:	2 (Rooms up to 100 sq m)	
Condition:	1 (Minor scratches)	Accessibility:	1 (Occasionally likely to be disturbed)	
Surface Treatment:	0 (Composite material)			
Asbestos Type:	1 (Chrysotile)	Extent Score:	1 (<10 sq m or 10m pipe run)

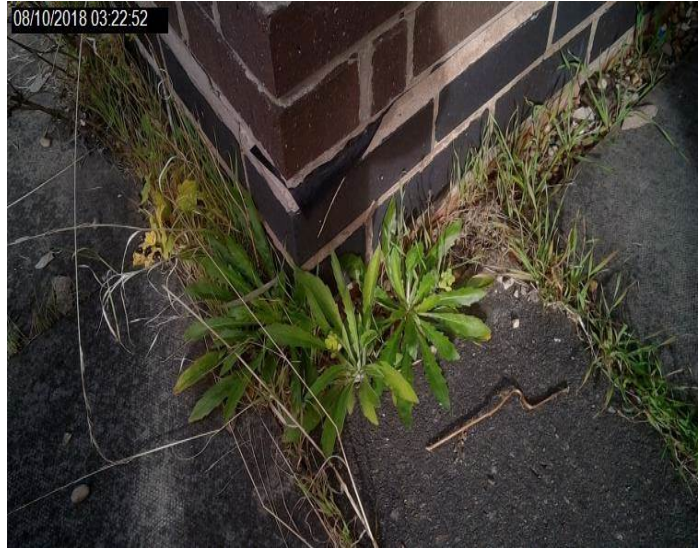
Location:	JACK EXT	Block:	Birmingham City University	Floor Level: E - External
Sample No.:	DU002602	Portal Ref No.:	52

Item:	Bitumen damp proof course			
Asbestos Content:		Result Based on:		
No Asbestos Detected		Analysis of sample using PLM		
Sample Analysed By:	Reg 13(1)	Extent:	48 linear metres	
Comments:

Material Assessment Total Score: 0		Likelihood of Disturbance Assessment Total Score: 0		Management Assessment Licensable: No Recommendations: Not Applicable Reinspection Interval: Not Applicable Overall Risk Category: E0
Product Type:	0 Not Applicable	Location:	0 Not Applicable	
Condition:	0 Not Applicable	Accessibility:	0 Not Applicable	
Surface Treatment:	0 Not Applicable			
Asbestos Type:	0 Not Applicable	Extent Score:	0 Not Applicable
