Report No.: J102748
Nature of Work: Demolition Survey
Issue Date: 31/10/2018
Client Name: WYG Engineering Ltd
Geneva Building, Lake View Drive, Sherwood Business Park,
Annesley, Nottingham, NG15 0ED
Site Address: Baker Building, Former City North Campus, Birmingham City
University, Perry Barr, B42 2US

A demolition survey in line with HSG264 Asbestos: The Survey Guide was carried out internally and externally to the property.

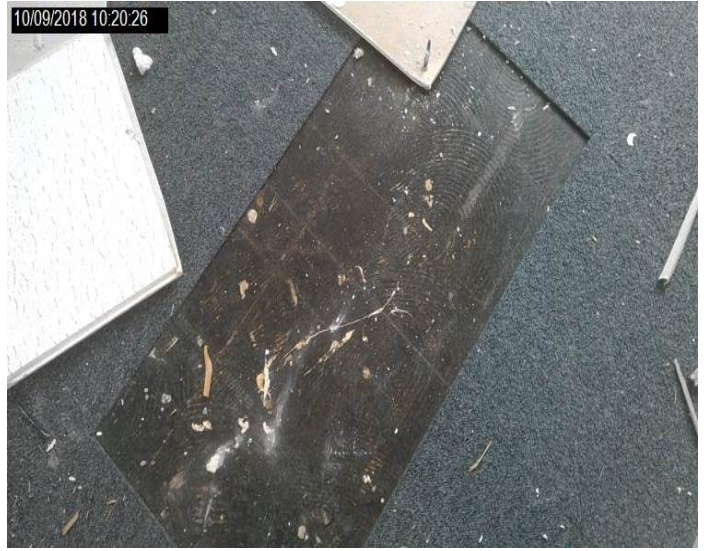
Item:	Asbestos Bitumen adhesive			
Asbestos Content:	Result Based on:			
Chrysotile	Strongly presumed			
Sample Analysed By:	Not applicable	Extent:	10 m ²	
Comments:

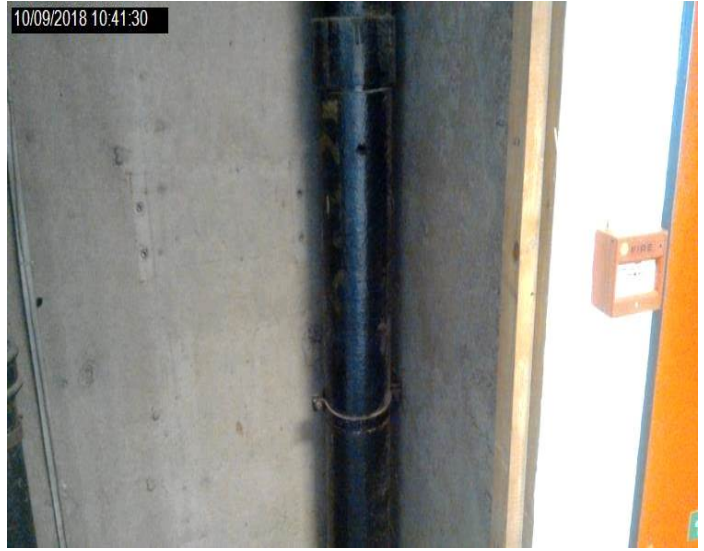
Item:	Asbestos Reinforced plastic downpipe			
Asbestos Content:	Result Based on:			
Chrysotile	Analysis of sample using PLM			
Sample Analysed By:	Reg 13(1)	Extent:	3 linear metres	
Comments:

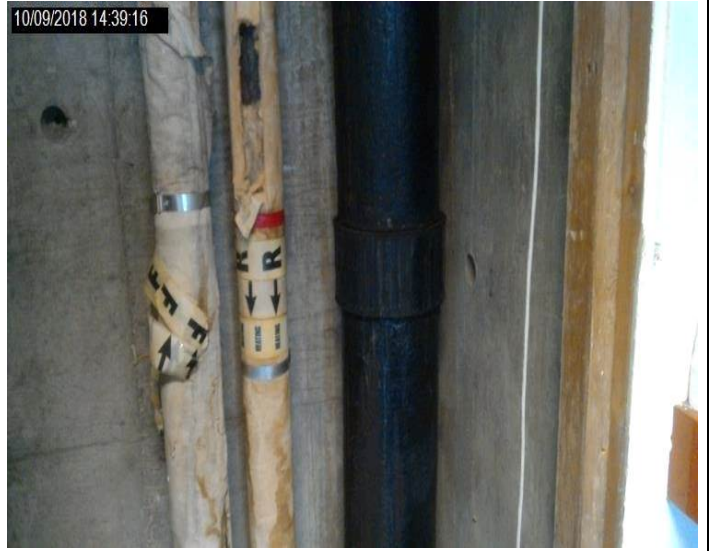
Item:	Asbestos Reinforced plastic downpipe			
Asbestos Content:	Result Based on:			
Chrysotile	Strongly presumed			
Sample Analysed By:	Not applicable	Extent:	3 linear metres	
Comments:

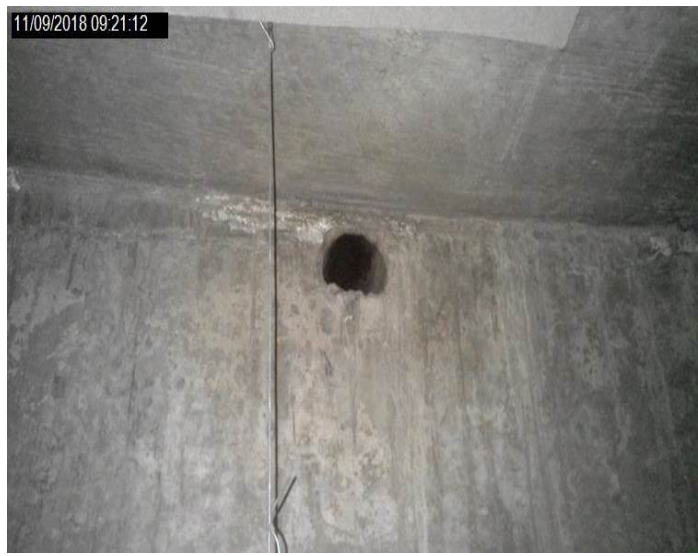
Item:	Asbestos Reinforced plastic sleeve			
Asbestos Content:	Result Based on:			
Chrysotile	Strongly presumed			
Sample Analysed By:	Not applicable	Extent:	5 units	
Comments: Within concrete structure, beams across room within ceiling

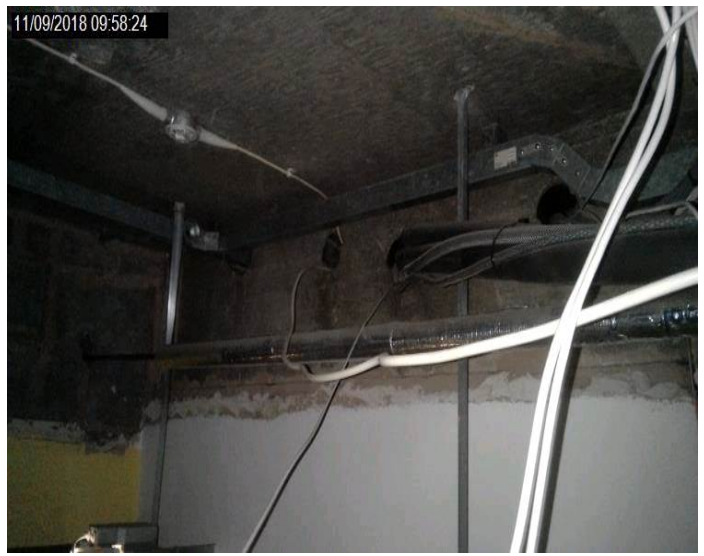
Item:	Asbestos Reinforced plastic sleeve			
Asbestos Content:	Result Based on:			
Chrysotile	Strongly presumed			
Sample Analysed By:	Not applicable	Extent:	8 units	
Comments: Within concrete structure, beams across room within ceiling

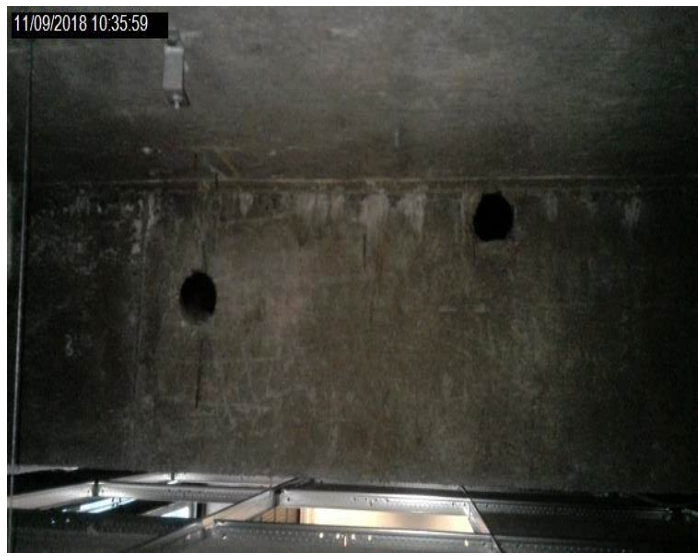
Item:	Asbestos Reinforced plastic pipe sleeve			
Asbestos Content:	Result Based on:			
Chrysotile	Analysis of sample using PLM			
Sample Analysed By: Reg 13(1)	Extent:	16 units		
Comments: Structural columns

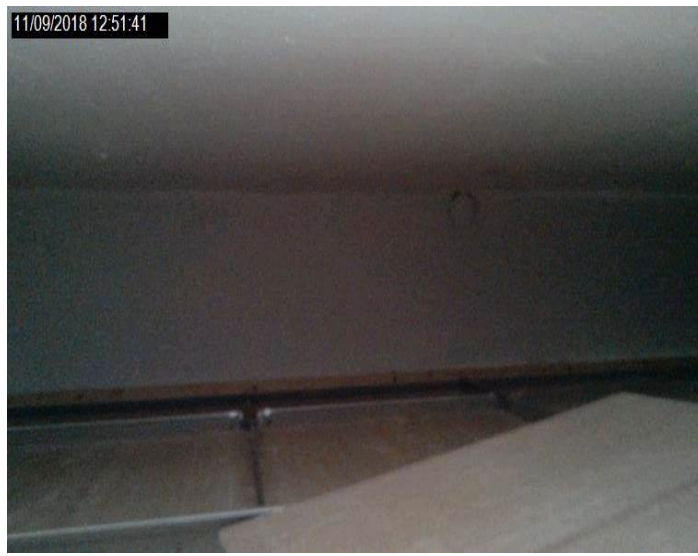
Item:	Asbestos Reinforced plastic pipe sleeve			
Asbestos Content:	Result Based on:			
Chrysotile	Strongly presumed			
Sample Analysed By:	Not applicable	Extent:	3 units	
Comments: Structural columns

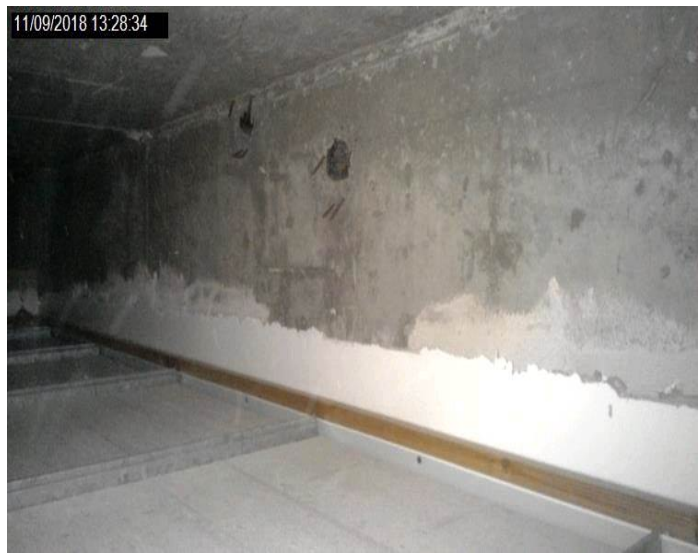
Item:	Asbestos Reinforced plastic pipe sleeve			
Asbestos Content:	Result Based on:			
Chrysotile	Analysis of sample using PLM			
Sample Analysed By:	Reg 13(1)	Extent:	8 units	
Comments: Structural columns

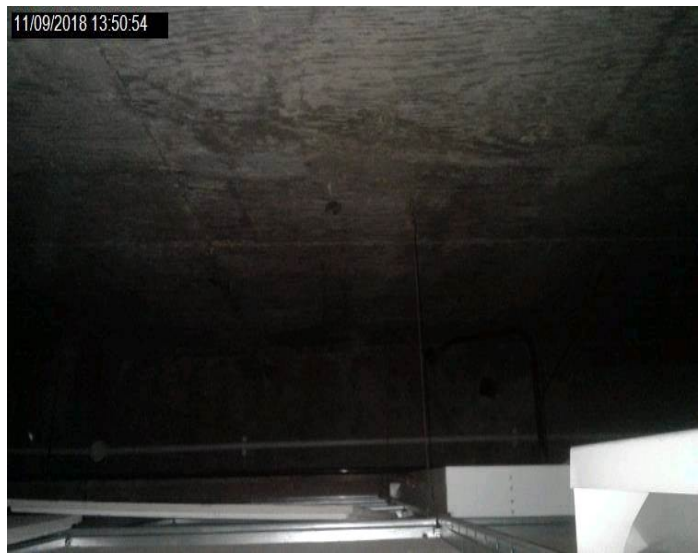
Item:	Asbestos Reinforced plastic sleeve			
Asbestos Content:	Result Based on:			
Chrysotile	Strongly presumed			
Sample Analysed By:	Not applicable	Extent:	4 units	
Comments: Structural columns

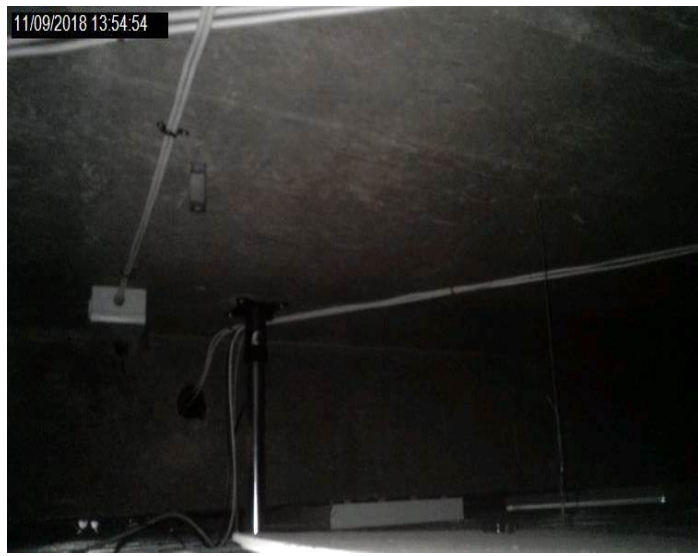
Item:	Asbestos Reinforced plastic pipe sleeve			
Asbestos Content:	Result Based on:			
Chrysotile	Strongly presumed			
Sample Analysed By:	Not applicable	Extent:	16 units	
Comments: Structural columns

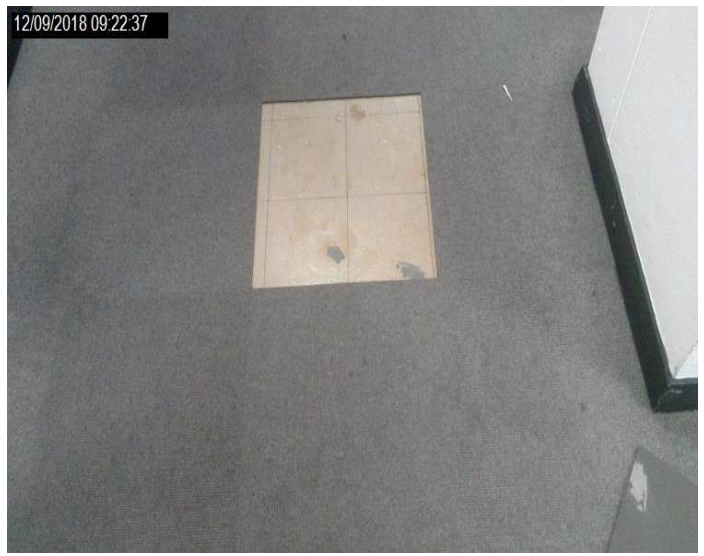
Item:	Asbestos Thermoplastic floor tiles with bitumen adhesive			
Asbestos Content:			Result Based on:	
Chrysotile in tile and adhesive		Strongly presumed		
Sample Analysed By:	Not applicable	Extent:	40 m ²	
Comments:

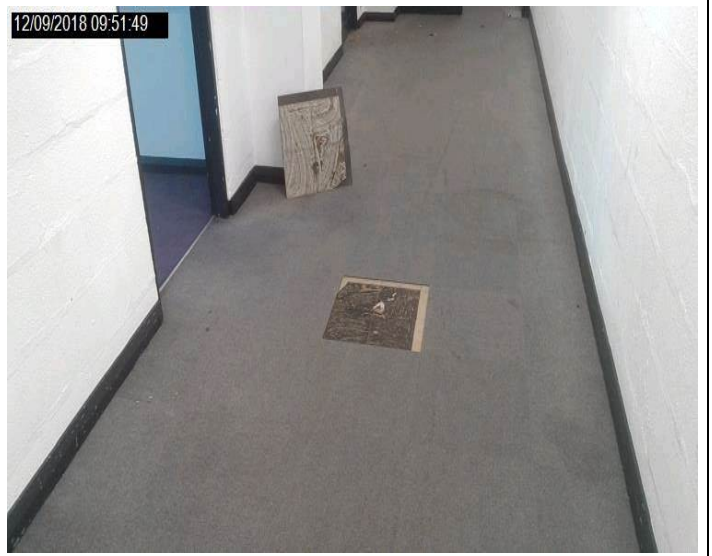
Item:	Asbestos Thermoplastic floor tiles with bitumen adhesive			
Asbestos Content:	Result Based on:			
Chrysotile in tile and adhesive	Strongly presumed			
Sample Analysed By:	Not applicable	Extent:	60 m ²	
Comments:

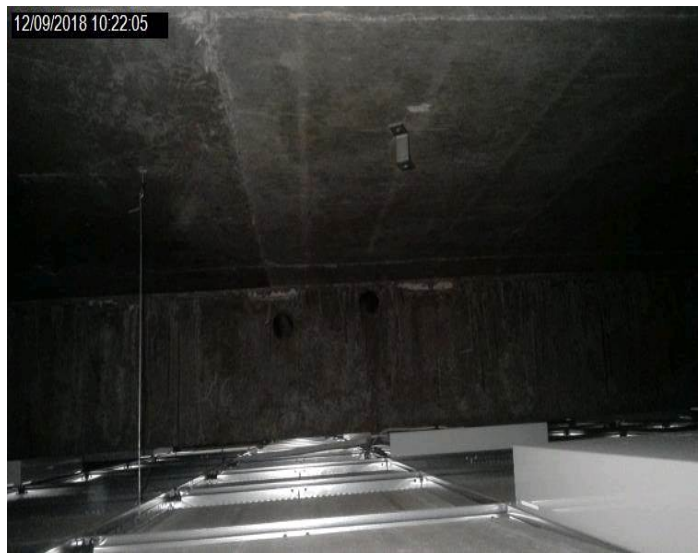
Item:	Asbestos Reinforced plastic sleeve			
Asbestos Content:	Result Based on:			
Chrysotile	Strongly presumed			
Sample Analysed By:	Not applicable	Extent:	18 units	
Comments:

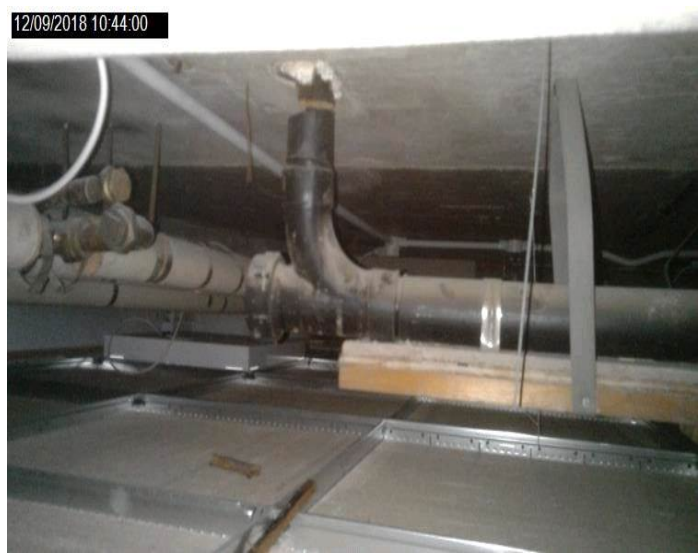
Item:	Asbestos Reinforced plastic sleeve			
Asbestos Content:	Result Based on:			
Chrysotile	Strongly presumed			
Sample Analysed By:	Not applicable	Extent:	4 units	
Comments:

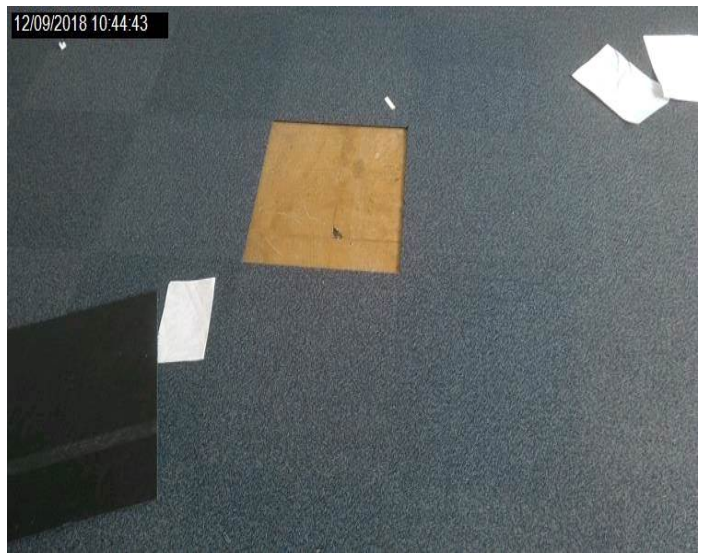
Item:	Asbestos Thermoplastic floor tiles with bitumen adhesive			
Asbestos Content:	Result Based on:			
Chrysotile in tile and adhesive		Analysis of sample using PLM		
Sample Analysed By:	Reg 13(1)	Extent:	18 m ²	
Comments:

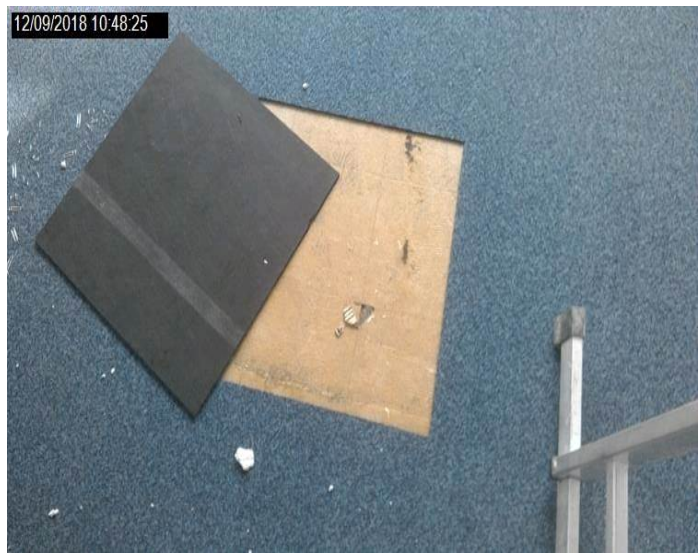
Item:	Asbestos Thermoplastic floor tiles with bitumen adhesive			
Asbestos Content:	Result Based on:			
Chrysotile in tile and adhesive	Strongly presumed			
Sample Analysed By:	Not applicable	Extent:	22 m ²	
Comments:

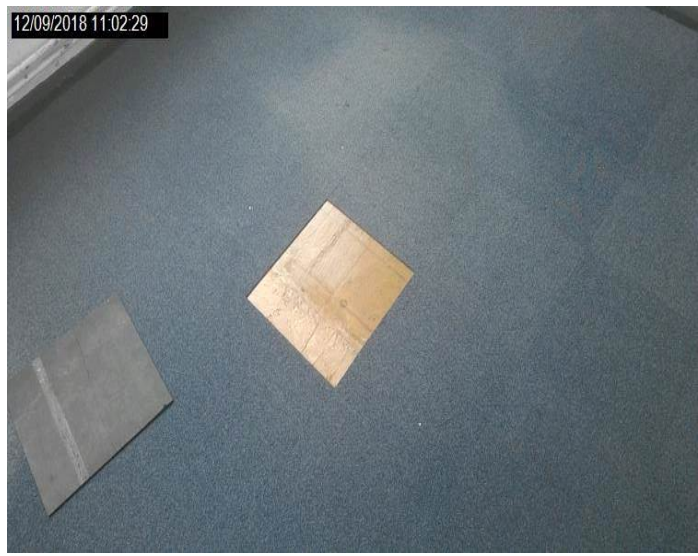
Item:	Asbestos Thermoplastic floor tiles with bitumen adhesive			
Asbestos Content:	Result Based on:			
Chrysotile in tile and adhesive		Strongly presumed		
Sample Analysed By:	Not applicable	Extent:	20 m ²	
Comments:

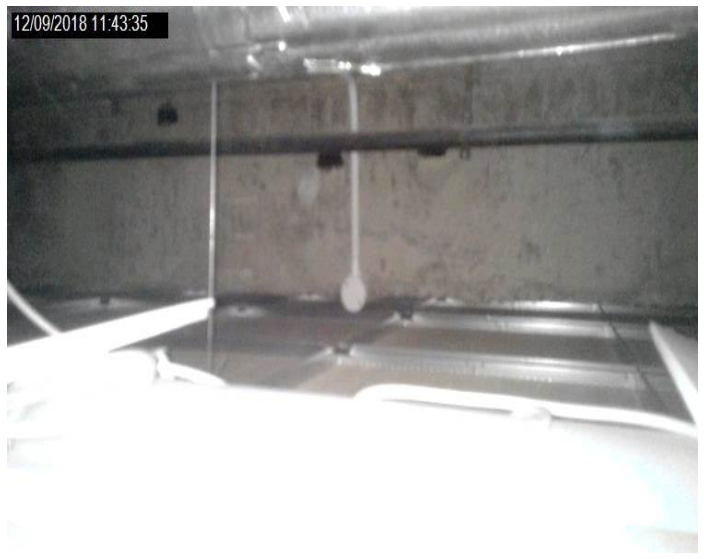
Item:	Asbestos Reinforced plastic sleeve			
Asbestos Content:	Result Based on:			
Chrysotile	Analysis of sample using PLM			
Sample Analysed By:	Reg 13(1)	Extent:	12 units	
Comments:

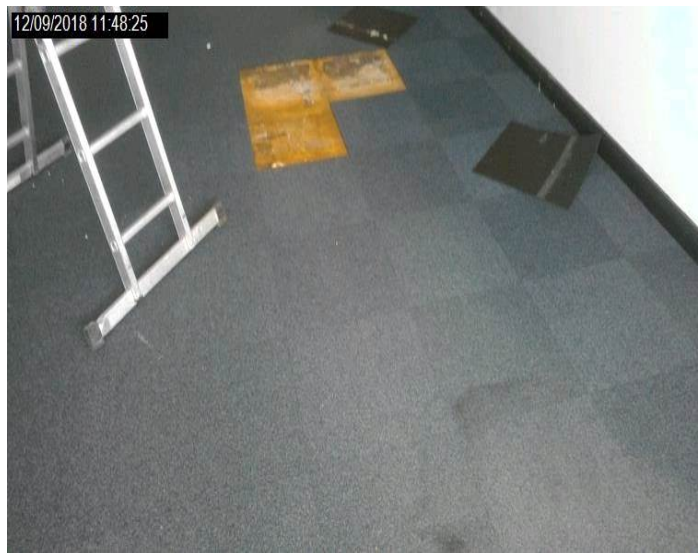
Item:	Asbestos Bitumen adhesive			
Asbestos Content:	Result Based on:			
Chrysotile	Analysis of sample using PLM			
Sample Analysed By:	Reg 13(1)	Extent:	20 m ²	
Comments:

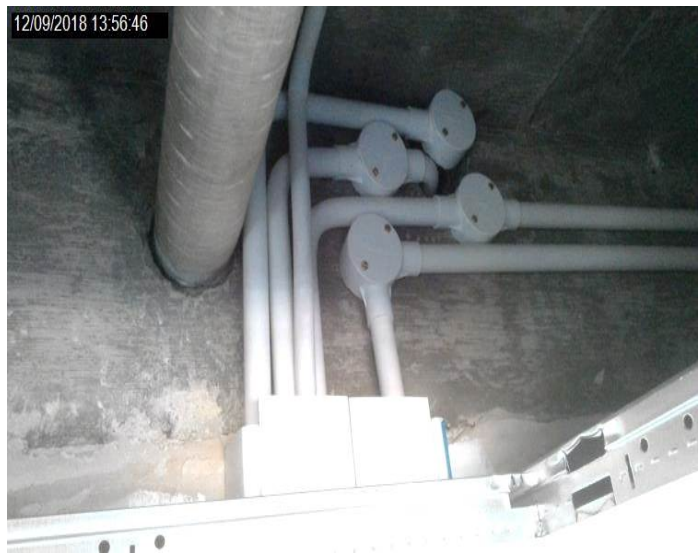
Item:	Asbestos Reinforced plastic sleeve			
Asbestos Content:	Result Based on:			
Chrysotile	Strongly presumed			
Sample Analysed By:	Not applicable	Extent:	2 units	
Comments: Passes through the wall

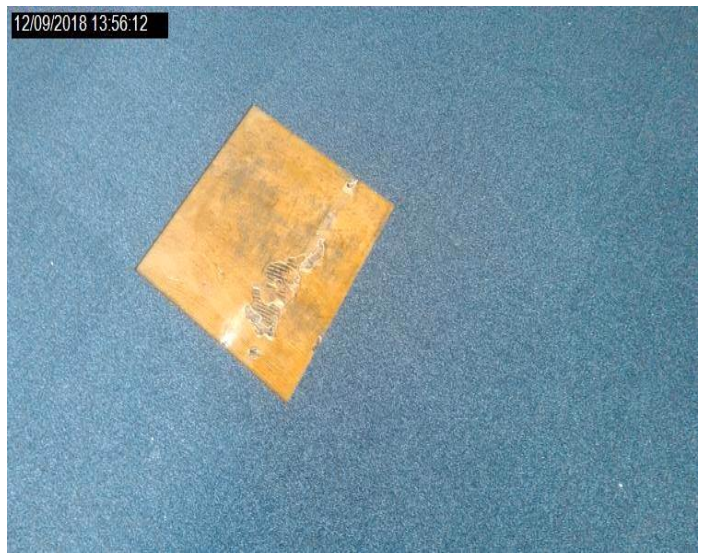
Item:	Asbestos Bitumen adhesive			
Asbestos Content:	Result Based on:			
Chrysotile	Analysis of sample using PLM			
Sample Analysed By:	Reg 13(1)	Extent:	20 m ²	
Comments:

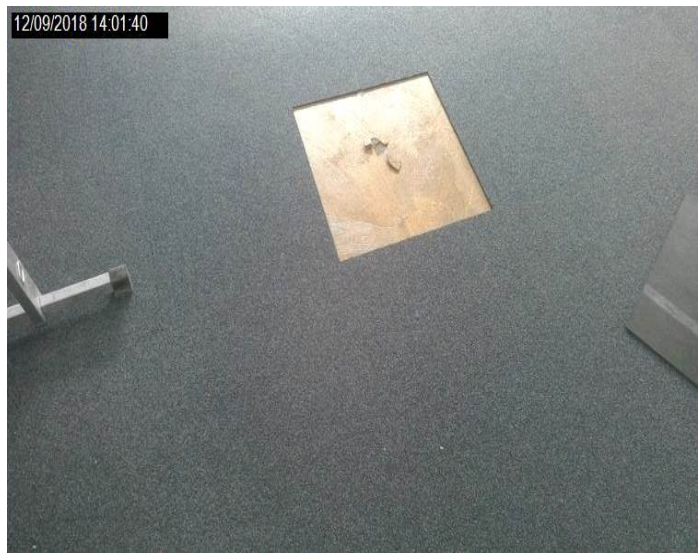
Item:	Asbestos Thermoplastic floor tiles with bitumen adhesive			
Asbestos Content:	Result Based on:			
Chrysotile in tile and adhesive	Strongly presumed			
Sample Analysed By:	Not applicable	Extent:	16 m ²	
Comments:

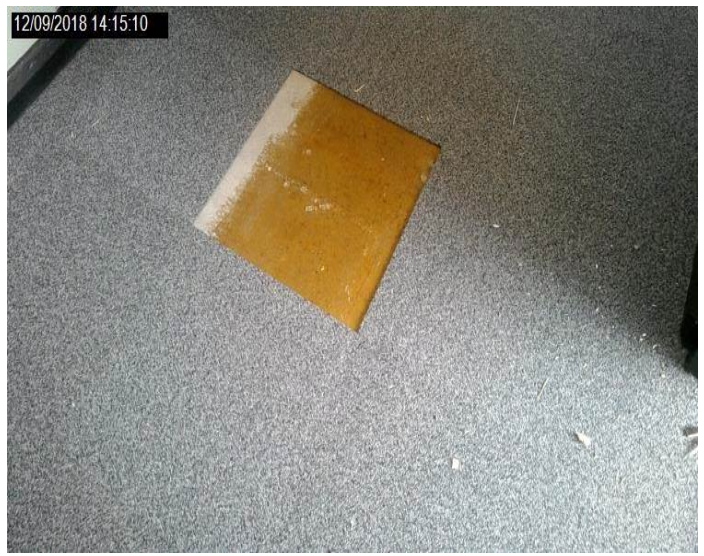
Item:	Asbestos Bitumen adhesive			
Asbestos Content:	Result Based on:			
Chrysotile	Analysis of sample using PLM			
Sample Analysed By:	Reg 13(1)	Extent:	50 m ²	
Comments:

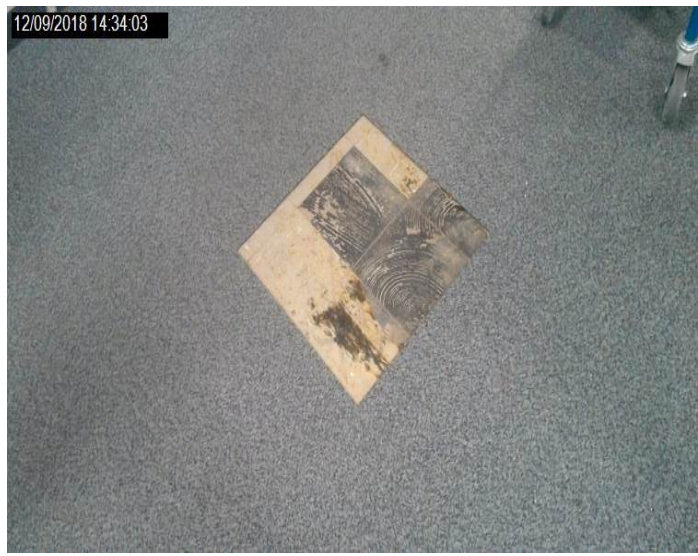
Item:	Asbestos Thermoplastic floor tiles			
Asbestos Content:	Result Based on:			
Chrysotile in tile and adhesive	Analysis of sample using PLM			
Sample Analysed By: Reg 13(1)	Extent:	50 m ²		
Comments:

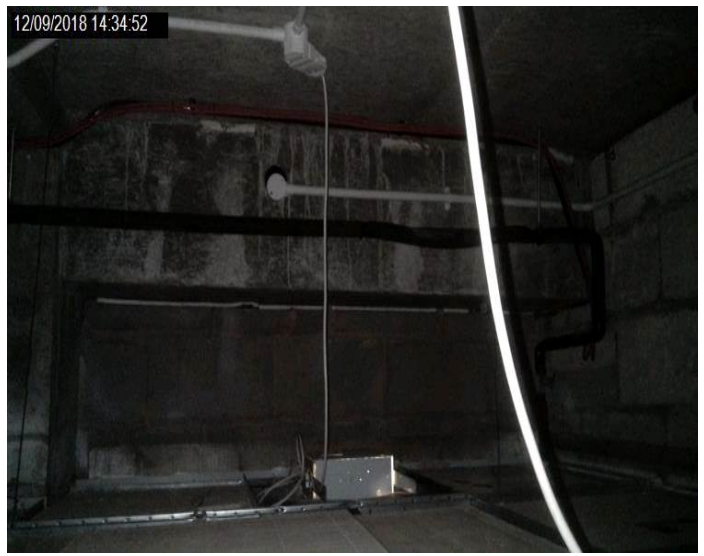
Item:	Asbestos Reinforced plastic sleeve			
Asbestos Content:	Result Based on:			
Chrysotile	Strongly presumed			
Sample Analysed By:	Not applicable	Extent:	16 units	
Comments: Structural columns

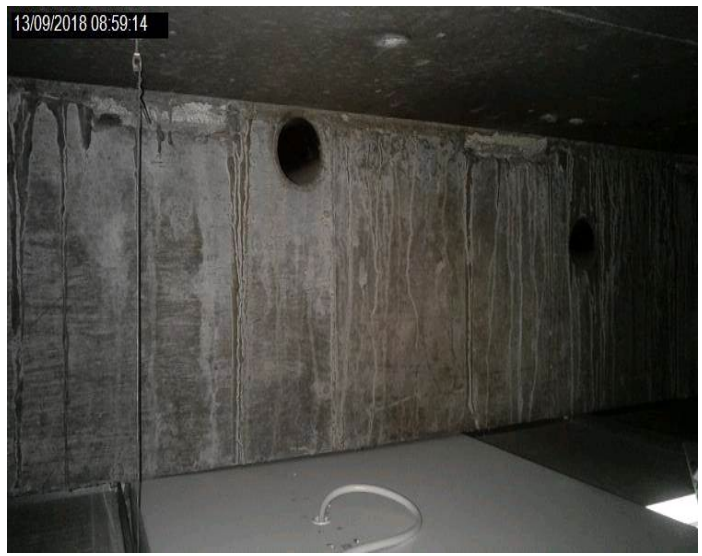
Item:	Asbestos Reinforced plastic sleeve			
Asbestos Content:	Result Based on:			
Chrysotile	Strongly presumed			
Sample Analysed By:	Not applicable	Extent:	6 units	
Comments:

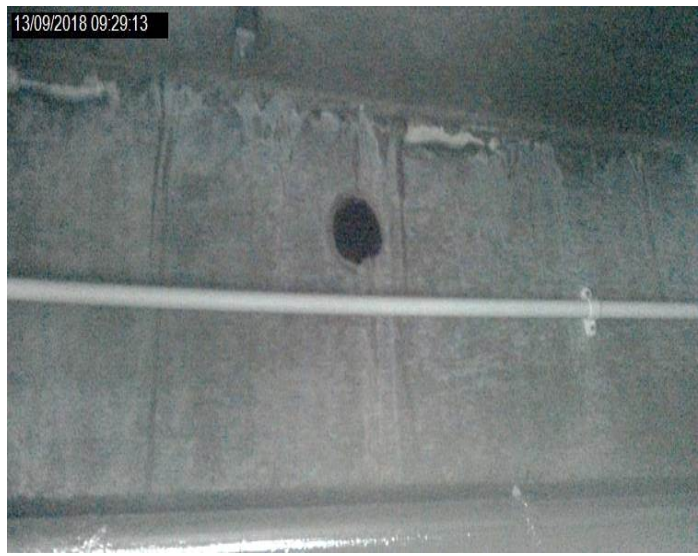
Item:	Asbestos Reinforced plastic sleeve			
Asbestos Content:	Result Based on:			
Chrysotile	Strongly presumed			
Sample Analysed By:	Not applicable	Extent:	16 units	
Comments:

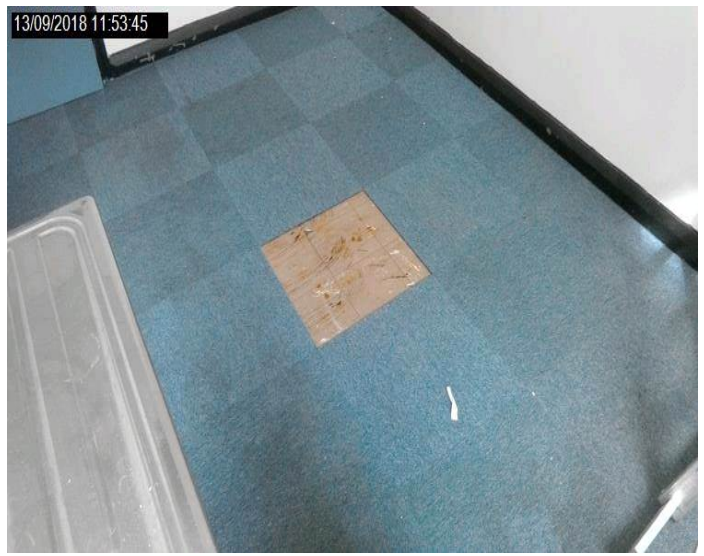
Item:	Asbestos Thermoplastic floor tiles with bitumen adhesive			
Asbestos Content:	Result Based on:			
Chrysotile in tile and adhesive	Analysis of sample using PLM			
Sample Analysed By: Reg 13(1)	Extent:	12 m ²		
Comments:

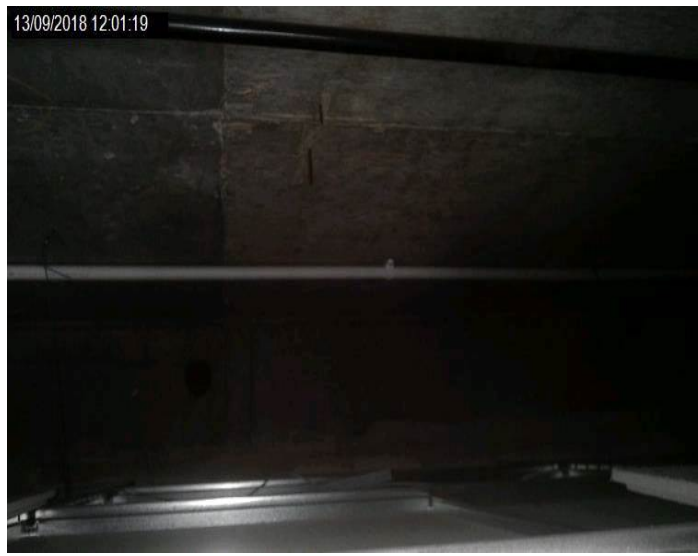
Item:	Asbestos Reinforced plastic sleeve			
Asbestos Content:	Result Based on:			
Chrysotile	Strongly presumed			
Sample Analysed By:	Not applicable	Extent:	8 units	
Comments: To wall which runs alongside the corridor

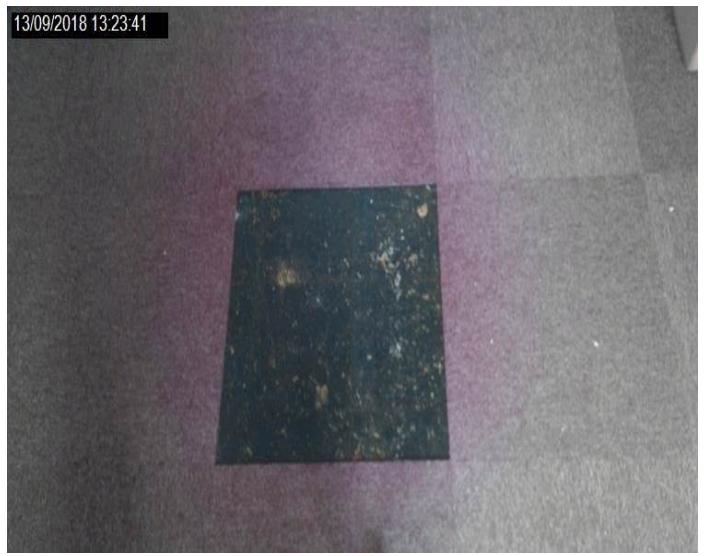
Item:	Asbestos Bitumen adhesive			
Asbestos Content:	Result Based on:			
Chrysotile	Strongly presumed			
Sample Analysed By:	Not applicable	Extent:	12 m ²	
Comments:

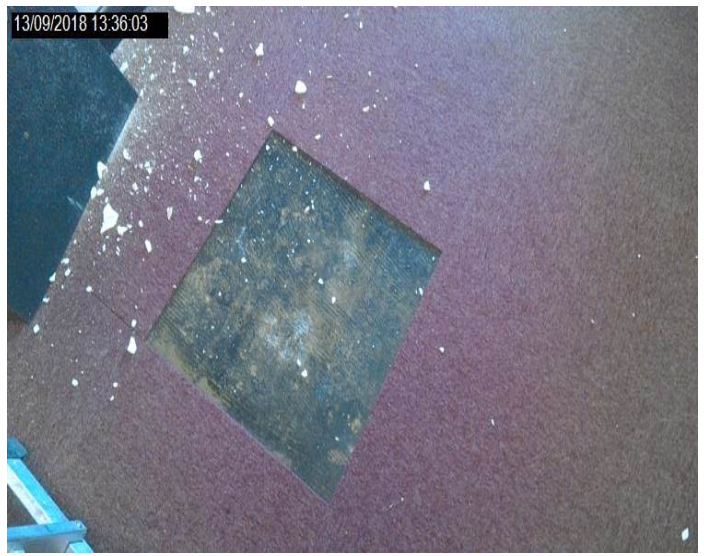
Item:	Asbestos Bitumen adhesive			
Asbestos Content:	Result Based on:			
Chrysotile	Strongly presumed			
Sample Analysed By:	Not applicable	Extent:	10 m ²	
Comments: Floor area outside rooms 15, 14 13 and 12

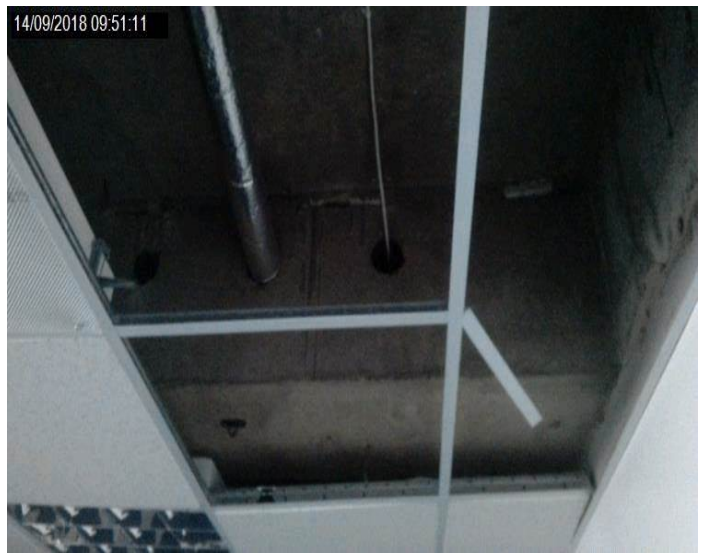
Item:	Asbestos Reinforced plastic sleeve			
Asbestos Content:	Result Based on:			
Chrysotile	Strongly presumed			
Sample Analysed By:	Not applicable	Extent:	3 units	
Comments:

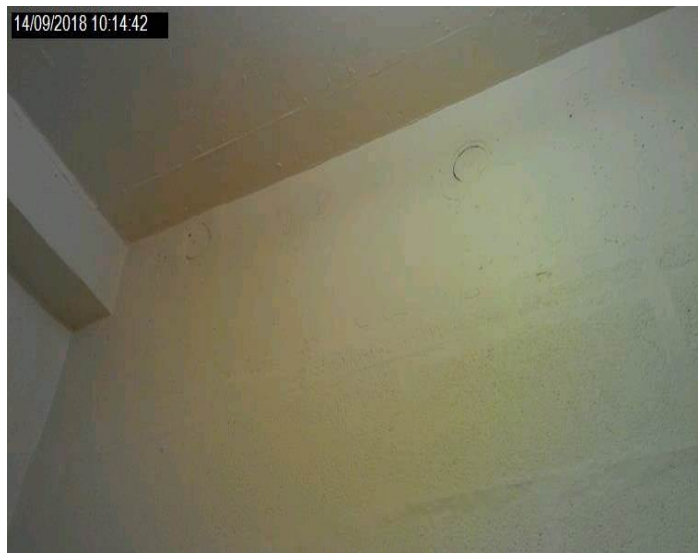
Item:	Asbestos Reinforced plastic sleeve			
Asbestos Content:	Result Based on:			
Chrysotile	Strongly presumed			
Sample Analysed By:	Not applicable	Extent:	2 units	
Comments:

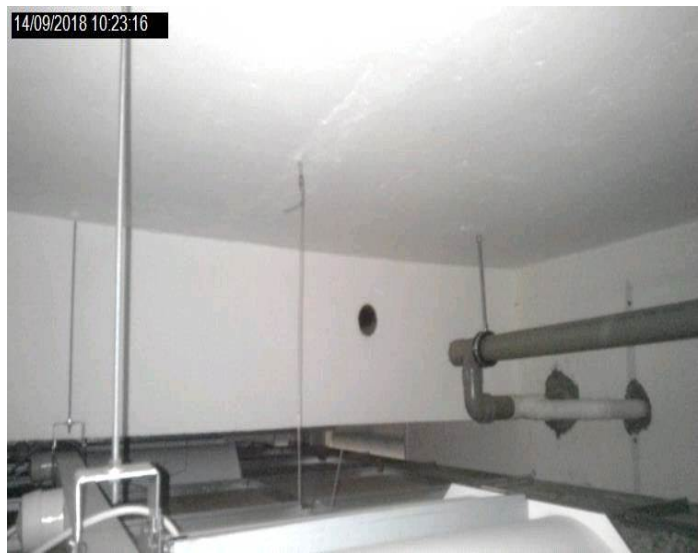
Item:	Asbestos Reinforced plastic sleeve			
Asbestos Content:	Result Based on:			
Chrysotile	Strongly presumed			
Sample Analysed By:	Not applicable	Extent:	5 units	
Comments:

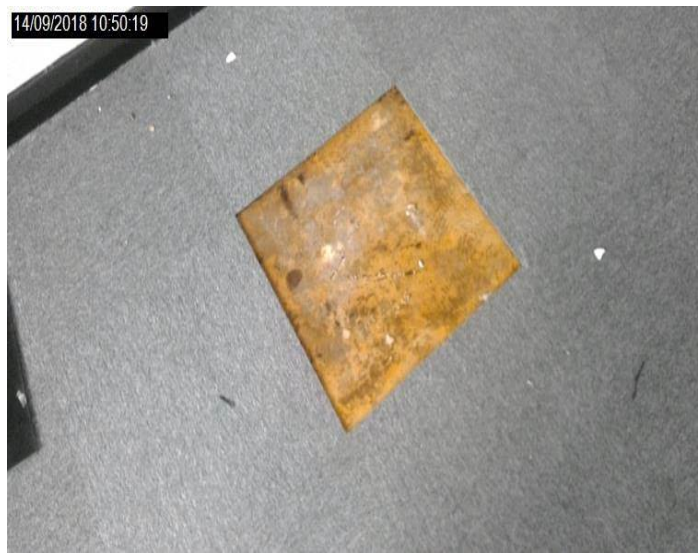
Item:	Asbestos Bitumen adhesive			
Asbestos Content:	Result Based on:			
Chrysotile	Strongly presumed			
Sample Analysed By:	Not applicable	Extent:	25 m ²	
Comments:

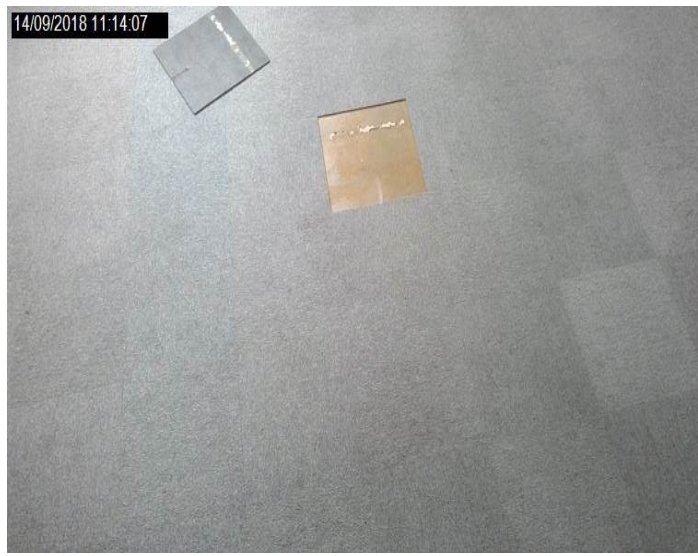
Item:	Asbestos Bitumen adhesive			
Asbestos Content:	Result Based on:			
Chrysotile	Strongly presumed			
Sample Analysed By:	Not applicable	Extent:	30 m ²	
Comments:

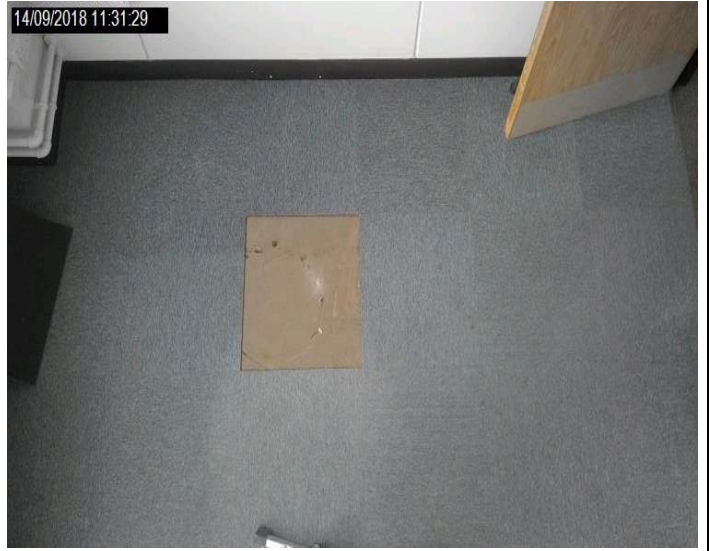
Item:	Asbestos Bitumen adhesive			
Asbestos Content:	Result Based on:			
Chrysotile	Strongly presumed			
Sample Analysed By:	Not applicable	Extent:	12 m ²	
Comments:

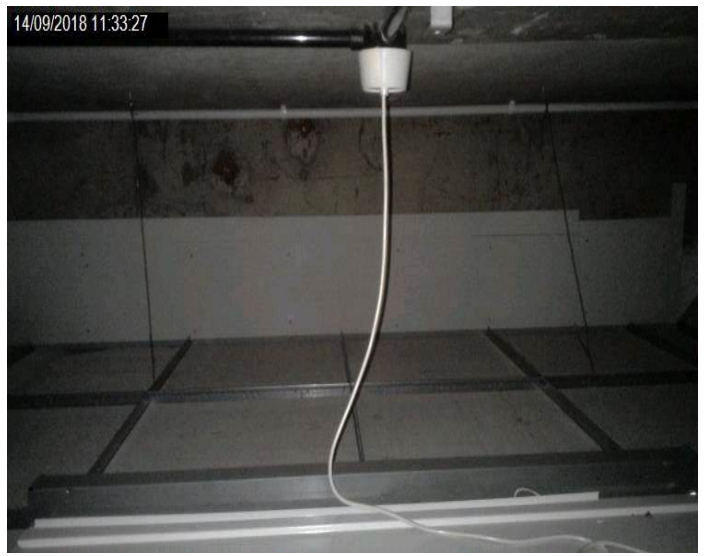
Item:	Asbestos Reinforced plastic sleeve			
Asbestos Content:	Result Based on:			
Chrysotile	Strongly presumed			
Sample Analysed By:	Not applicable	Extent:	2 units	
Comments:

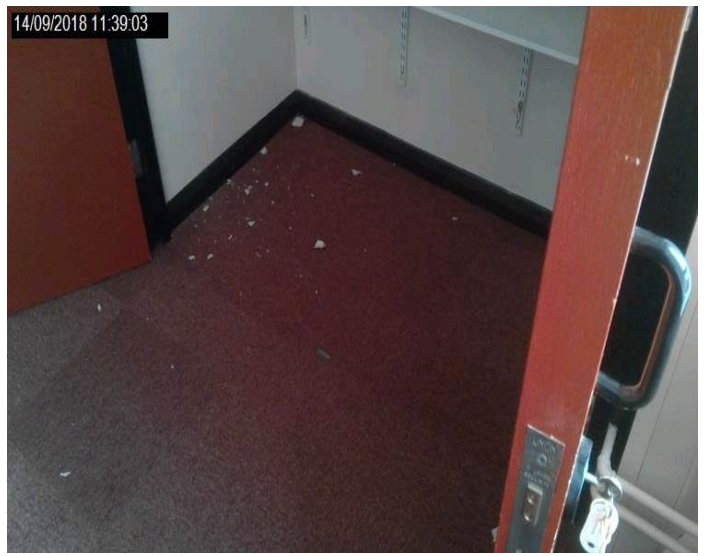
Item:	Asbestos Bitumen adhesive			
Asbestos Content:	Result Based on:			
Chrysotile	Strongly presumed			
Sample Analysed By:	Not applicable	Extent:	8 m ²	
Comments: 3 x storage cupboards completed as one room

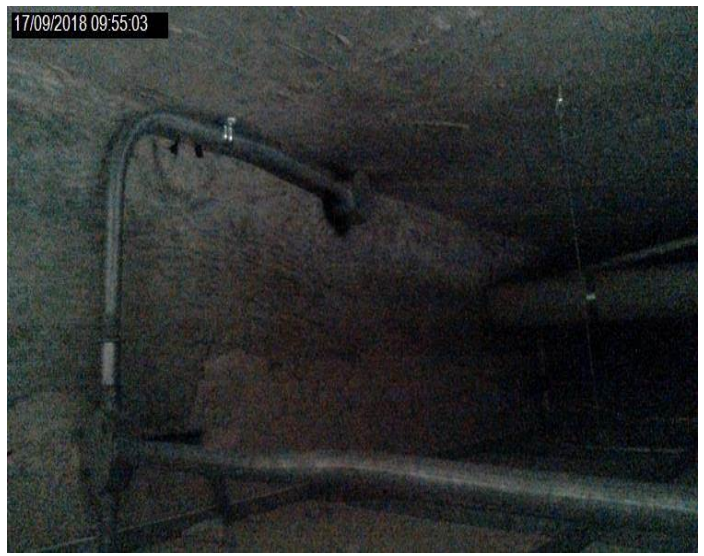
Item:	Asbestos Reinforced plastic sleeve			
Asbestos Content:	Result Based on:			
Chrysotile	Strongly presumed			
Sample Analysed By:	Not applicable	Extent:	3 units	
Comments:

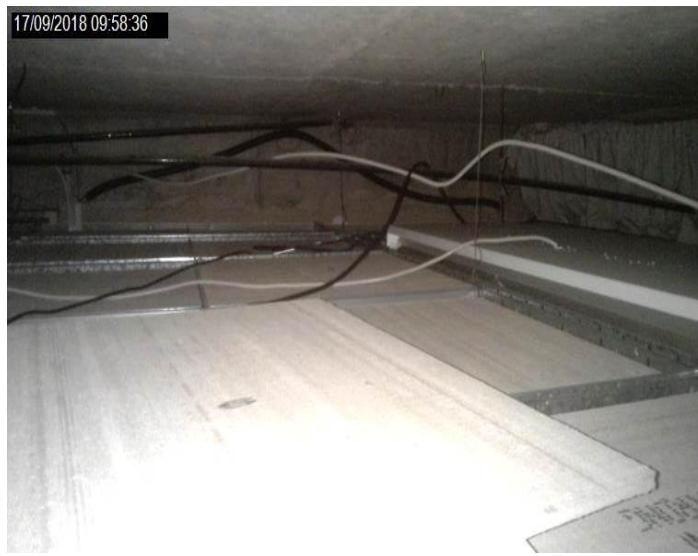
Item:	Asbestos Reinforced plastic sleeve			
Asbestos Content:	Result Based on:			
Chrysotile	Strongly presumed			
Sample Analysed By:	Not applicable	Extent:	3 units	
Comments:

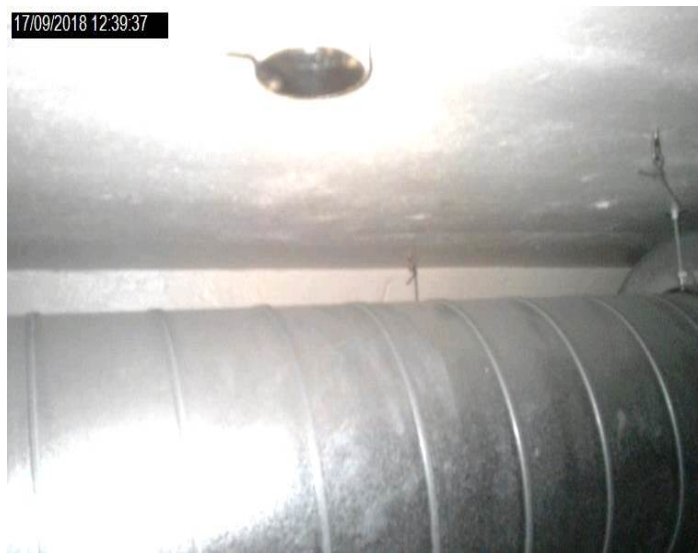
Item:	Asbestos Reinforced plastic sleeve			
Asbestos Content:	Result Based on:			
Chrysotile	Strongly presumed			
Sample Analysed By:	Not applicable	Extent:	2 units	
Comments: Through the structural concrete

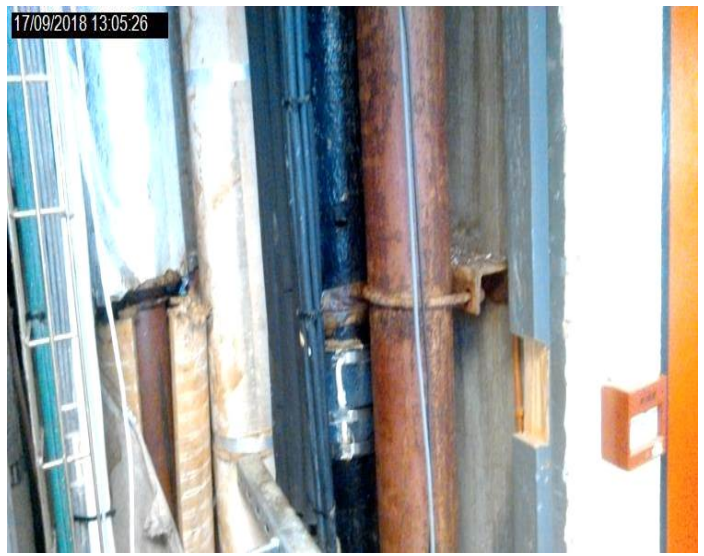
Item:	Asbestos Reinforced plastic downpipe			
Asbestos Content:	Result Based on:			
Chrysotile	Analysis of sample using PLM			
Sample Analysed By: Reg 13(1)	Extent:	3 linear metres		
Comments:

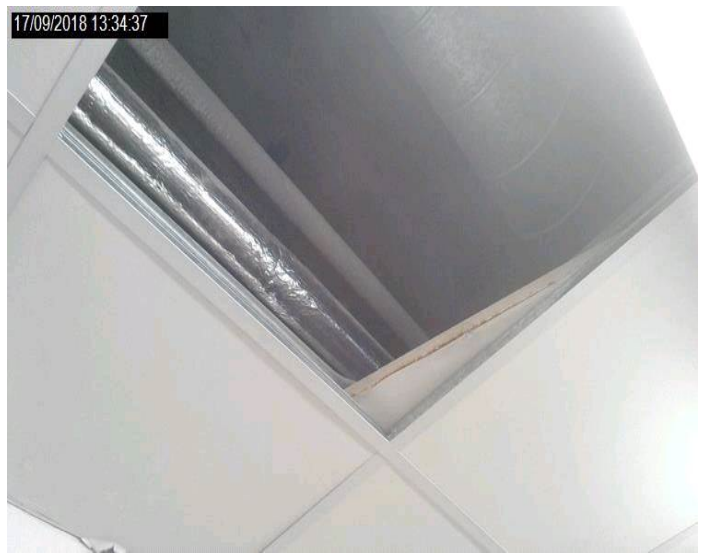
Item:	Asbestos Reinforced plastic sleeve			
Asbestos Content:	Result Based on:			
Chrysotile	Strongly presumed			
Sample Analysed By:	Not applicable	Extent:	2 units	
Comments: Through the structural concrete

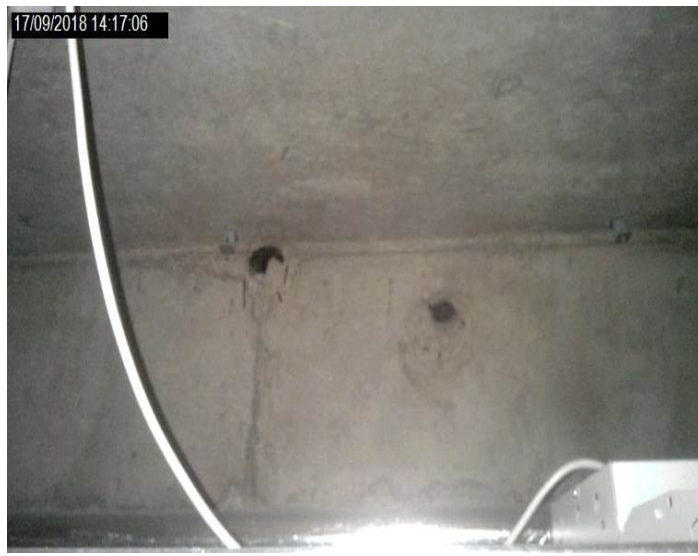
Item:	Asbestos Reinforced plastic sleeve			
Asbestos Content:	Result Based on:			
Chrysotile	Strongly presumed			
Sample Analysed By:	Not applicable	Extent:	2 units	
Comments: Through the structural concrete

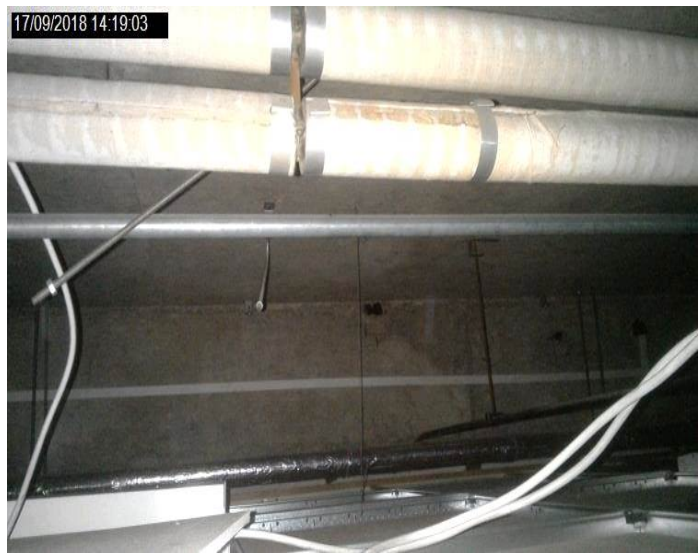
Item:	Asbestos Reinforced plastic sleeve			
Asbestos Content:	Result Based on:			
Chrysotile	Strongly presumed			
Sample Analysed By:	Not applicable	Extent:	5 units	
Comments: Through the structural concrete

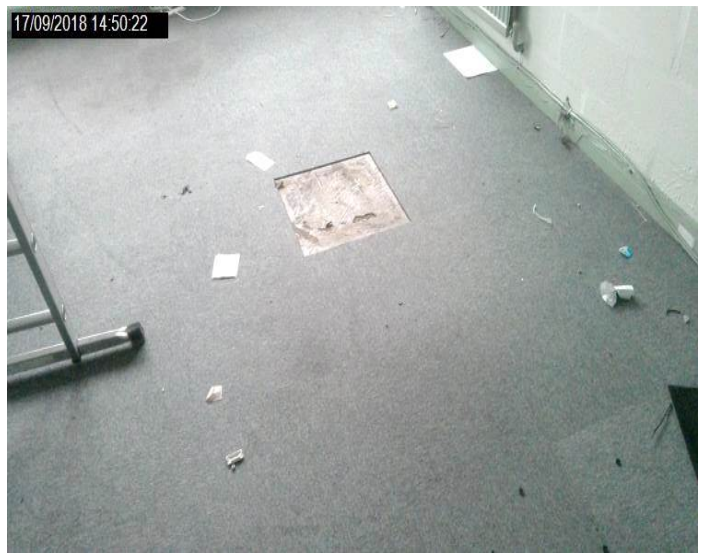
Item:	Asbestos Bitumen adhesive			
Asbestos Content:	Result Based on:			
Chrysotile	Strongly presumed			
Sample Analysed By:	Not applicable	Extent:	16 m ²	
Comments:

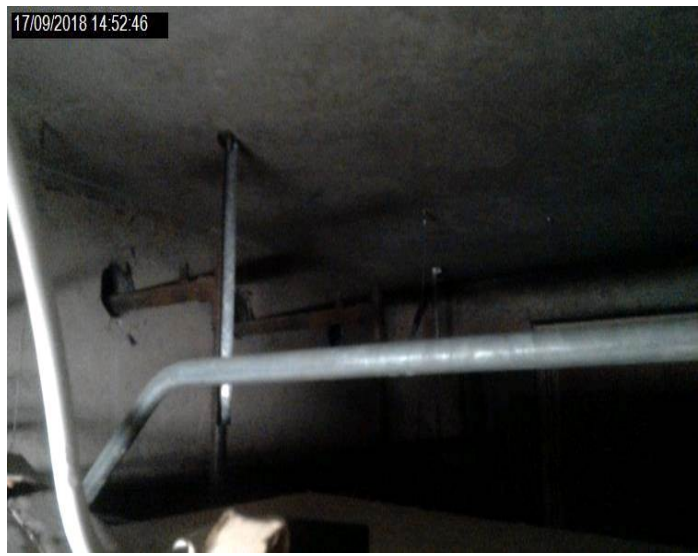
Item:	Asbestos Reinforced plastic sleeve			
Asbestos Content:	Result Based on:			
Chrysotile	Strongly presumed			
Sample Analysed By:	Not applicable	Extent:	4 units	
Comments: Through the structural concrete
