Location:	NBA201A	Block:	Birmingham City University	Floor Level: 2nd Floor
Sample No.:	DU002474	Portal Ref No.:	492

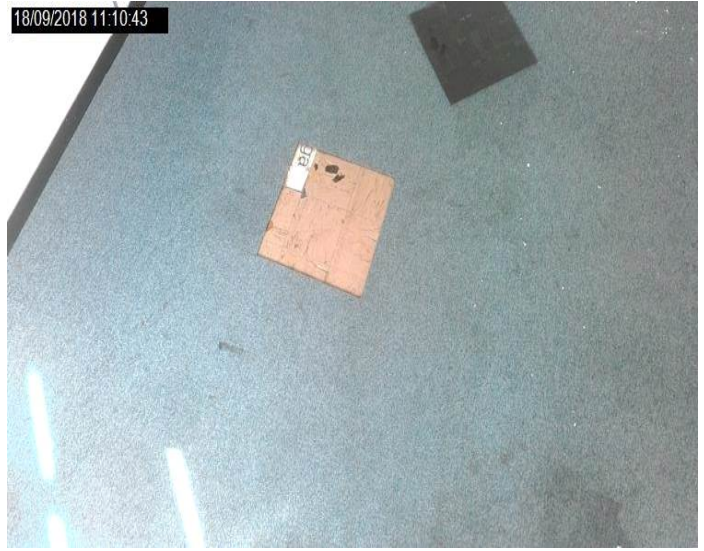
Item:	Asbestos Thermoplastic floor tiles with bitumen adhesive			
Asbestos Content:	Result Based on:			
Chrysotile in tile and adhesive	Analysis of sample using PLM			
Sample Analysed By:	Reg 13(1)	Extent:	18 m ²	
Comments:

Material Assessment Total Score: 3		Likelihood of Disturbance Assessment Total Score: 4		Management Assessment Licensable: No Recommendations: Program removal Reinspection Interval: Not Applicable Overall Risk Category: C7
Product Type:	1 (Asbestos thermoplastic)	Location:	2 (Rooms up to 100 sq m)	
Condition:	1 (Minor scratches)	Accessibility:	0 (Usually inaccessible or unlikely to be disturbed)	
Surface Treatment:	0 (Composite material)			
Asbestos Type:	1 (Chrysotile)	Extent Score:	2 (>10 - <50 sq m or >10m - <50m pipe run)

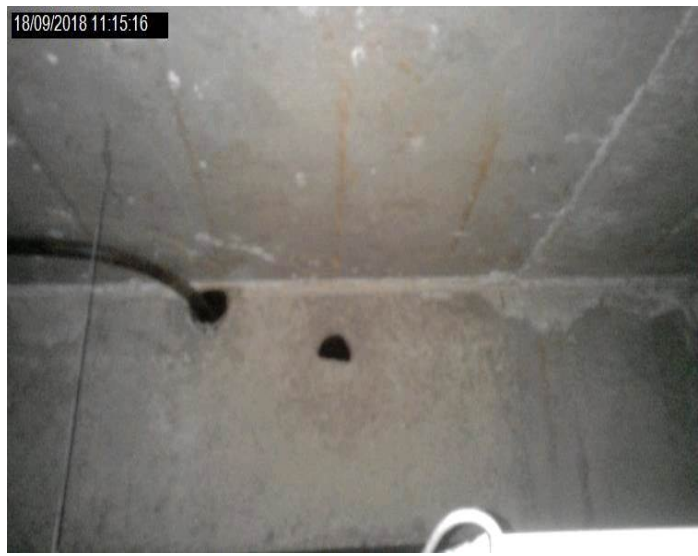
Location:	NBA201C	Block:	Birmingham City University	Floor Level: 2nd Floor
Sample No.:	As DU002472	Portal Ref No.:	493

Item:	Asbestos Reinforced plastic sleeve			
Asbestos Content:	Result Based on:			
Chrysotile	Strongly presumed			
Sample Analysed By:	Not applicable	Extent:	5 units	
Comments: To structural columns

Material Assessment Total Score: 3		Likelihood of Disturbance Assessment Total Score: 4		Management Assessment Licensable: No Recommendations: Program removal Reinspection Interval: Not Applicable Overall Risk Category: C7
Product Type:	1 (Asbestos reinforced plastic)	Location:	2 (Rooms up to 100 sq m)	
Condition:	1 (Minor scratches)	Accessibility:	1 (Occasionally likely to be disturbed)	
Surface Treatment:	0 (Composite material)			
Asbestos Type:	1 (Chrysotile)	Extent Score:	1 (<10 sq m or 10m pipe run)

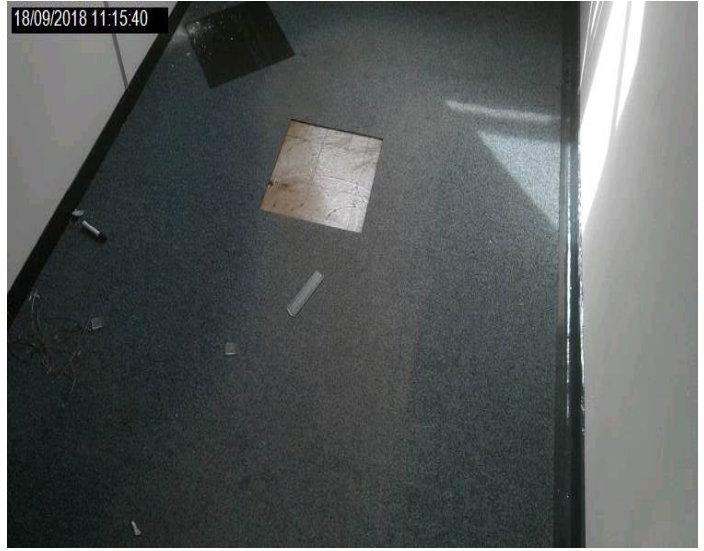
Location:	NBA201C	Block:	Birmingham City University	Floor Level: 2nd Floor
Sample No.:	As DU002474	Portal Ref No.:	494

Item:	Asbestos Thermoplastic floor tiles with bitumen adhesive			
Asbestos Content:	Result Based on:			
Chrysotile in tile and adhesive	Strongly presumed			
Sample Analysed By:	Not applicable	Extent:	10 m ²	
Comments:

Material Assessment Total Score: 3		Likelihood of Disturbance Assessment Total Score: 3		Management Assessment Licensable: No Recommendations: Program removal Reinspection Interval: Not Applicable Overall Risk Category: D6
Product Type:	1 (Asbestos thermoplastic)	Location:	2 (Rooms up to 100 sq m)	
Condition:	1 (Minor scratches)	Accessibility:	0 (Usually inaccessible or unlikely to be disturbed)	
Surface Treatment:	0 (Composite material)			
Asbestos Type:	1 (Chrysotile)	Extent Score:	1 (<10 sq m or 10m pipe run)

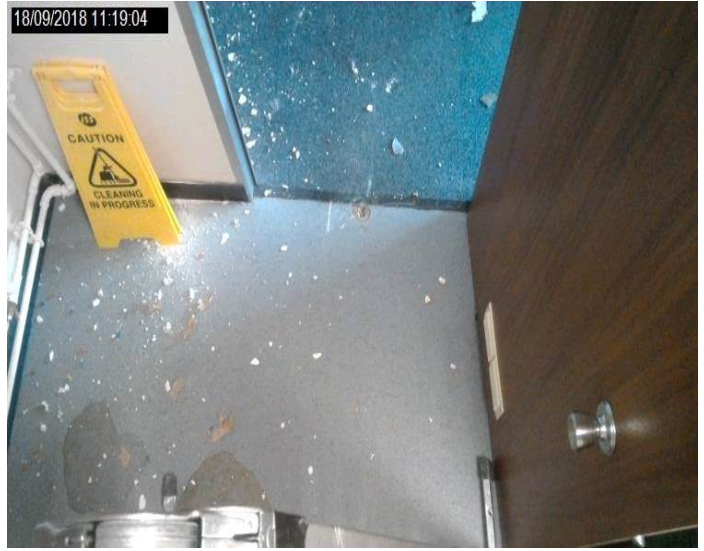
Location:	NBA201B	Block:	Birmingham City University	Floor Level: 2nd Floor
Sample No.:	As DU002474	Portal Ref No.:	496

Item:	Asbestos Thermoplastic floor tiles with bitumen adhesive			
Asbestos Content:	Result Based on:			
Chrysotile in tile and adhesive	Strongly presumed			
Sample Analysed By:	Not applicable	Extent:	4 m ²	
Comments:

Material Assessment Total Score: 3		Likelihood of Disturbance Assessment Total Score: 3		Management Assessment Licensable: No Recommendations: Program removal Reinspection Interval: Not Applicable Overall Risk Category: D6
Product Type:	1 (Asbestos thermoplastic)	Location:	2 (Rooms up to 100 sq m)	
Condition:	1 (Minor scratches)	Accessibility:	0 (Usually inaccessible or unlikely to be disturbed)	
Surface Treatment:	0 (Composite material)			
Asbestos Type:	1 (Chrysotile)	Extent Score:	1 (<10 sq m or 10m pipe run)

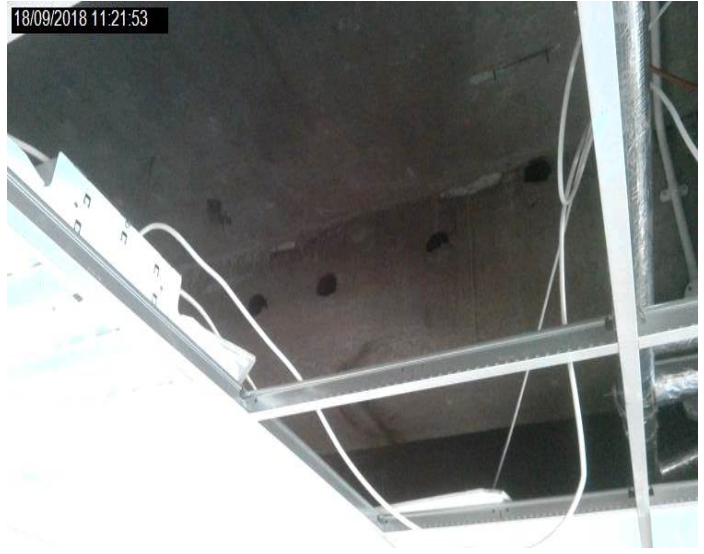
Item:	Asbestos Reinforced plastic sleeve			
Asbestos Content:	Result Based on:			
Chrysotile	Strongly presumed			
Sample Analysed By:	Not applicable	Extent:	12 units	
Comments: To structural columns

Material Assessment Total Score: 3		Likelihood of Disturbance Assessment Total Score: 4		Management Assessment Licensable: No Recommendations: Program removal Reinspection Interval: Not Applicable Overall Risk Category: C7
Product Type:	1 (Asbestos reinforced plastic)	Location:	2 (Rooms up to 100 sq m)	
Condition:	1 (Minor scratches)	Accessibility:	1 (Occasionally likely to be disturbed)	
Surface Treatment:	0 (Composite material)			
Asbestos Type:	1 (Chrysotile)	Extent Score:	1 (<10 sq m or 10m pipe run)

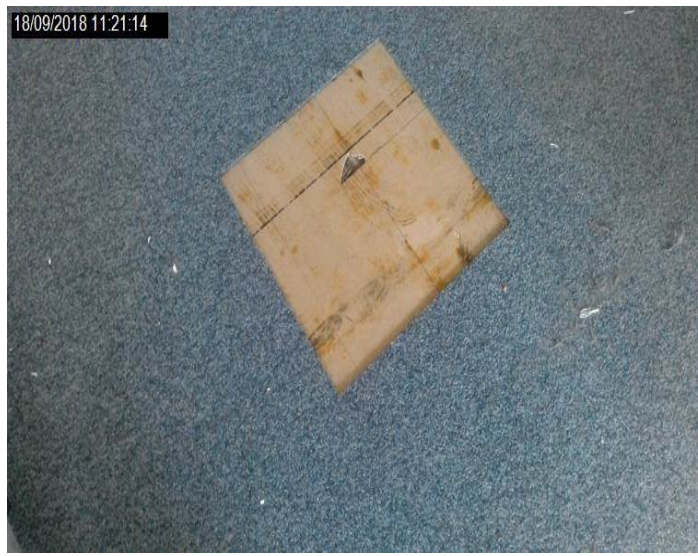
Item:	Asbestos Thermoplastic floor tiles with bitumen adhesive			
Asbestos Content:	Result Based on:			
Chrysotile in tile and adhesive	Analysis of sample using PLM			
Sample Analysed By:	Reg 13(1)	Extent:	38 m ²	
Comments:

Material Assessment Total Score: 3		Likelihood of Disturbance Assessment Total Score: 4		Management Assessment Licensable: No Recommendations: Program removal Reinspection Interval: Not Applicable Overall Risk Category: C7
Product Type:	1 (Asbestos thermoplastic)	Location:	2 (Rooms up to 100 sq m)	
Condition:	1 (Minor scratches)	Accessibility:	0 (Usually inaccessible or unlikely to be disturbed)	
Surface Treatment:	0 (Composite material)			
Asbestos Type:	1 (Chrysotile)	Extent Score:	2 (>10 - <50 sq m or >10m - <50m pipe run)

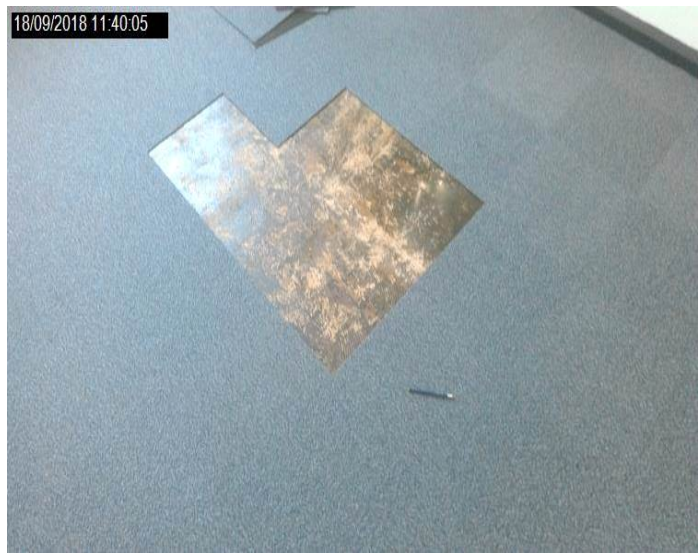
Item:	Asbestos Bitumen adhesive			
Asbestos Content:	Result Based on:			
Chrysotile	Analysis of sample using PLM			
Sample Analysed By:	Reg 13(1)	Extent:	18 m ²	
Comments:

Material Assessment Total Score: 3		Likelihood of Disturbance Assessment Total Score: 4		Management Assessment Licensable: No Recommendations: Program removal Reinspection Interval: Not Applicable Overall Risk Category: C7
Product Type:	1 (Asbestos bitumen)	Location:	2 (Rooms up to 100 sq m)	
Condition:	1 (Minor scratches)	Accessibility:	0 (Usually inaccessible or unlikely to be disturbed)	
Surface Treatment:	0 (Composite material)			
Asbestos Type:	1 (Chrysotile)	Extent Score:	2 (>10 - <50 sq m or >10m - <50m pipe run)

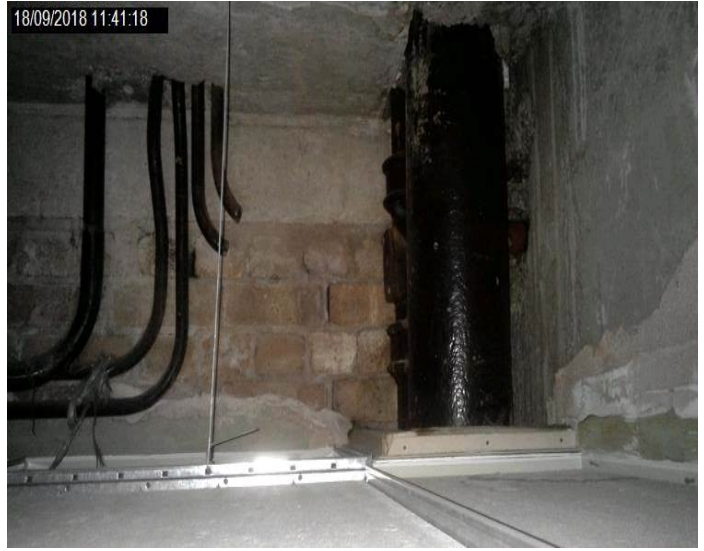
Item:	Asbestos Reinforced plastic downpipe			
Asbestos Content:	Result Based on:			
Chrysotile	Strongly presumed			
Sample Analysed By:	Not applicable	Extent:	3 linear metres	
Comments:

Material Assessment Total Score: 3		Likelihood of Disturbance Assessment Total Score: 4		Management Assessment Licensable: No Recommendations: Program removal Reinspection Interval: Not Applicable Overall Risk Category: C7
Product Type:	1 (Asbestos reinforced plastic)	Location:	2 (Rooms up to 100 sq m)	
Condition:	1 (Minor scratches)	Accessibility:	1 (Occasionally likely to be disturbed)	
Surface Treatment:	0 (Composite material)			
Asbestos Type:	1 (Chrysotile)	Extent Score:	1 (<10 sq m or 10m pipe run)

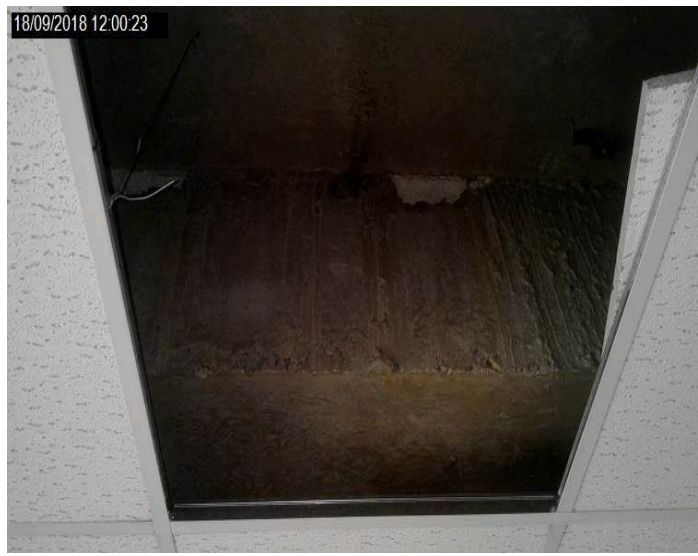
Item:	Asbestos Reinforced plastic sleeve			
Asbestos Content:	Result Based on:			
Chrysotile	Strongly presumed			
Sample Analysed By:	Not applicable	Extent:	6 units	
Comments: To structural concrete

Material Assessment Total Score: 3		Likelihood of Disturbance Assessment Total Score: 4		Management Assessment Licensable: No Recommendations: Program removal Reinspection Interval: Not Applicable Overall Risk Category: C7
Product Type:	1 (Asbestos reinforced plastic)	Location:	2 (Rooms up to 100 sq m)	
Condition:	1 (Minor scratches)	Accessibility:	1 (Occasionally likely to be disturbed)	
Surface Treatment:	0 (Composite material)			
Asbestos Type:	1 (Chrysotile)	Extent Score:	1 (<10 sq m or 10m pipe run)

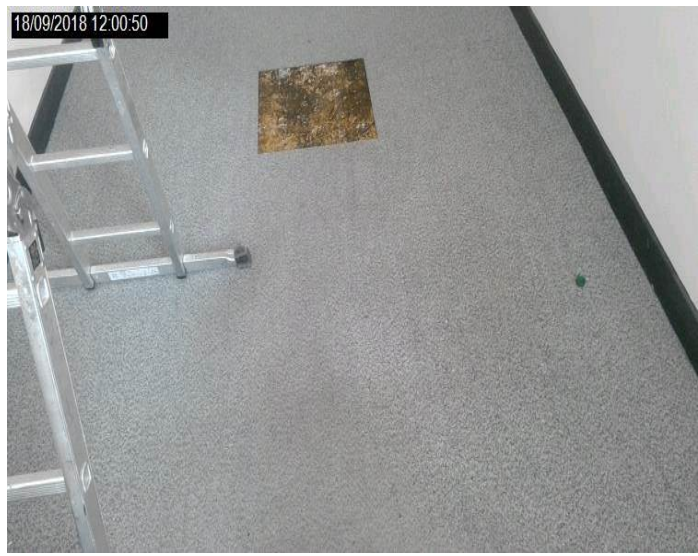
Item:	Asbestos Bitumen adhesive			
Asbestos Content:	Result Based on:			
Chrysotile	Strongly presumed			
Sample Analysed By:	Not applicable	Extent:	12 m ²	
Comments:

Material Assessment Total Score: 3		Likelihood of Disturbance Assessment Total Score: 4		Management Assessment Licensable: No Recommendations: Program removal Reinspection Interval: Not Applicable Overall Risk Category: C7
Product Type:	1 (Asbestos bitumen)	Location:	2 (Rooms up to 100 sq m)	
Condition:	1 (Minor scratches)	Accessibility:	0 (Usually inaccessible or unlikely to be disturbed)	
Surface Treatment:	0 (Composite material)			
Asbestos Type:	1 (Chrysotile)	Extent Score:	2 (>10 - <50 sq m or >10m - <50m pipe run)

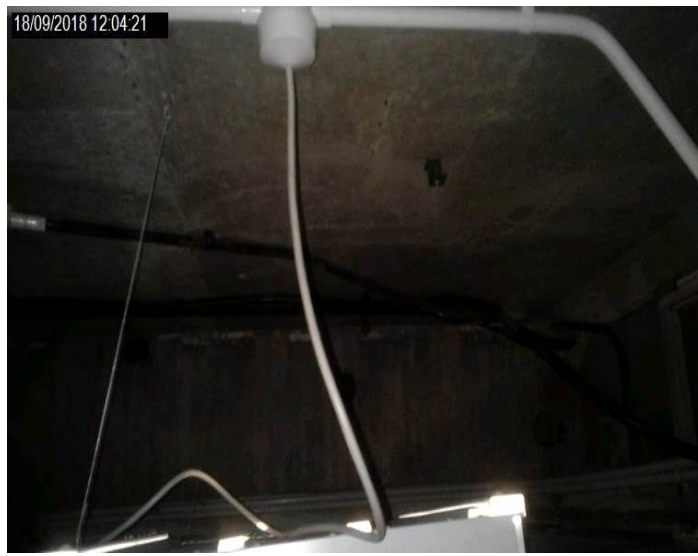
Item:	Asbestos Reinforced plastic sleeve			
Asbestos Content:	Result Based on:			
Chrysotile	Strongly presumed			
Sample Analysed By:	Not applicable	Extent:	4 units	
Comments: To structural concrete

Material Assessment Total Score: 3		Likelihood of Disturbance Assessment Total Score: 4		Management Assessment Licensable: No Recommendations: Program removal Reinspection Interval: Not Applicable Overall Risk Category: C7
Product Type:	1 (Asbestos reinforced plastic)	Location:	2 (Rooms up to 100 sq m)	
Condition:	1 (Minor scratches)	Accessibility:	1 (Occasionally likely to be disturbed)	
Surface Treatment:	0 (Composite material)			
Asbestos Type:	1 (Chrysotile)	Extent Score:	1 (<10 sq m or 10m pipe run)

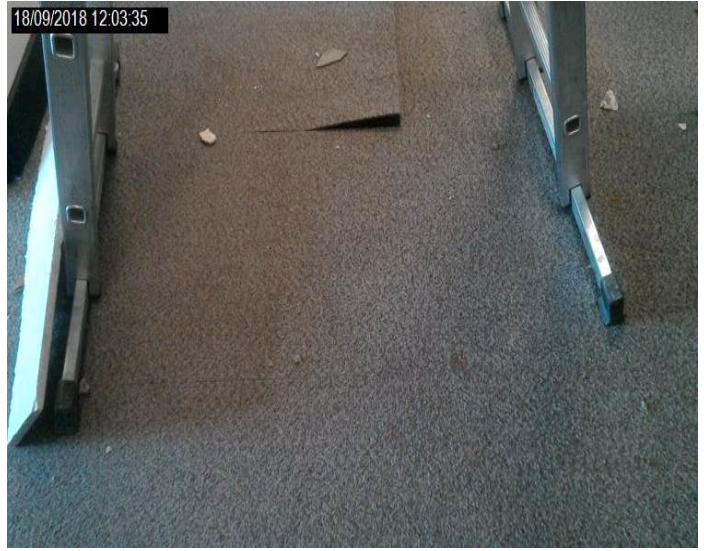
Item:	Asbestos Bitumen adhesive			
Asbestos Content:	Result Based on:			
Chrysotile	Strongly presumed			
Sample Analysed By:	Not applicable	Extent:	6 m ²	
Comments:

Material Assessment Total Score: 3		Likelihood of Disturbance Assessment Total Score: 3		Management Assessment Licensable: No Recommendations: Program removal Reinspection Interval: Not Applicable Overall Risk Category: D6
Product Type:	1 (Asbestos bitumen)	Location:	2 (Rooms up to 100 sq m)	
Condition:	1 (Minor scratches)	Accessibility:	0 (Usually inaccessible or unlikely to be disturbed)	
Surface Treatment:	0 (Composite material)			
Asbestos Type:	1 (Chrysotile)	Extent Score:	1 (<10 sq m or 10m pipe run)

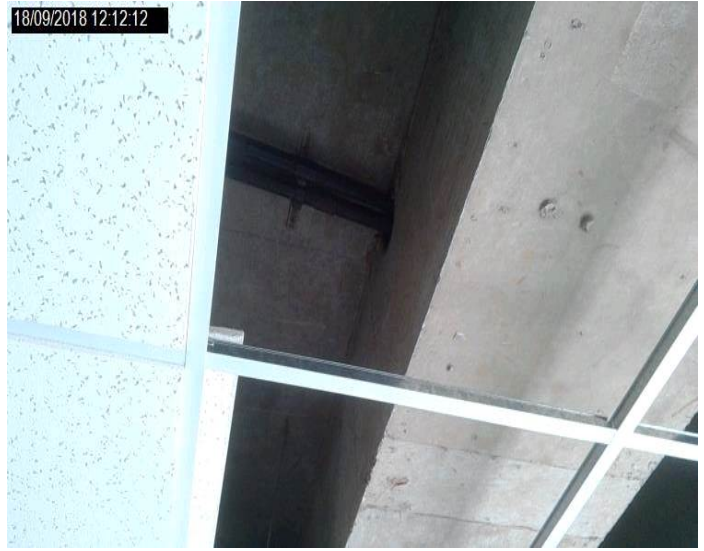
Item:	Asbestos Reinforced plastic sleeve			
Asbestos Content:	Result Based on:			
Chrysotile	Strongly presumed			
Sample Analysed By:	Not applicable	Extent:	4 units	
Comments:

Material Assessment Total Score: 3		Likelihood of Disturbance Assessment Total Score: 4		Management Assessment Licensable: No Recommendations: Program removal Reinspection Interval: Not Applicable Overall Risk Category: C7
Product Type:	1 (Asbestos reinforced plastic)	Location:	2 (Rooms up to 100 sq m)	
Condition:	1 (Minor scratches)	Accessibility:	1 (Occasionally likely to be disturbed)	
Surface Treatment:	0 (Composite material)			
Asbestos Type:	1 (Chrysotile)	Extent Score:	1 (<10 sq m or 10m pipe run)

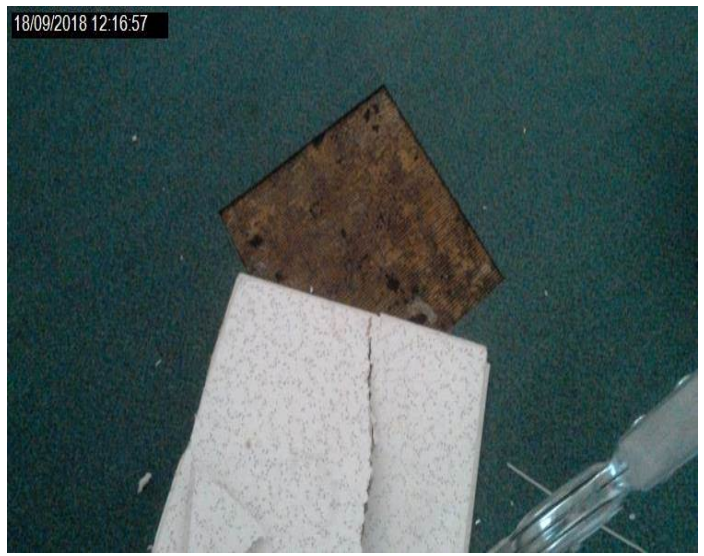
Item:	Asbestos Bitumen adhesive			
Asbestos Content:	Result Based on:			
Chrysotile	Strongly presumed			
Sample Analysed By:	Not applicable	Extent:	6 m ²	
Comments:

Material Assessment Total Score: 3		Likelihood of Disturbance Assessment Total Score: 3		Management Assessment Licensable: No Recommendations: Program removal Reinspection Interval: Not Applicable Overall Risk Category: D6
Product Type:	1 (Asbestos bitumen)	Location:	2 (Rooms up to 100 sq m)	
Condition:	1 (Minor scratches)	Accessibility:	0 (Usually inaccessible or unlikely to be disturbed)	
Surface Treatment:	0 (Composite material)			
Asbestos Type:	1 (Chrysotile)	Extent Score:	1 (<10 sq m or 10m pipe run)

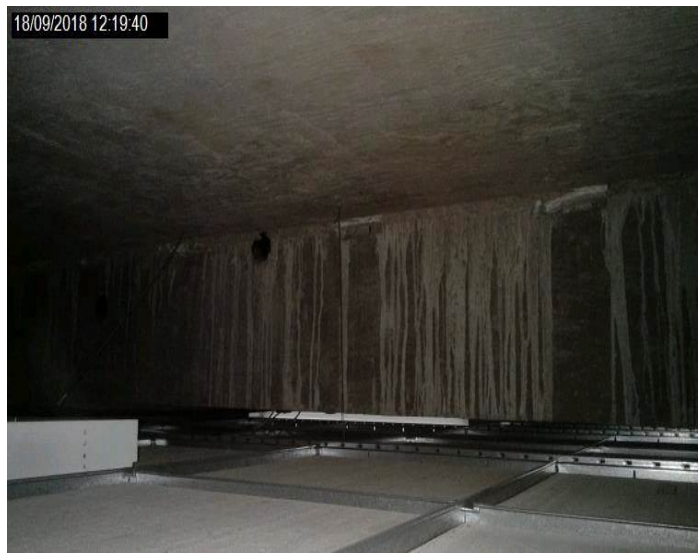
Item:	Asbestos Reinforced plastic sleeve			
Asbestos Content:	Result Based on:			
Chrysotile	Strongly presumed			
Sample Analysed By:	Not applicable	Extent:	10 units	
Comments: To structural columns

Material Assessment Total Score: 3		Likelihood of Disturbance Assessment Total Score: 4		Management Assessment Licensable: No Recommendations: Program removal Reinspection Interval: Not Applicable Overall Risk Category: C7
Product Type:	1 (Asbestos reinforced plastic)	Location:	2 (Rooms up to 100 sq m)	
Condition:	1 (Minor scratches)	Accessibility:	1 (Occasionally likely to be disturbed)	
Surface Treatment:	0 (Composite material)			
Asbestos Type:	1 (Chrysotile)	Extent Score:	1 (<10 sq m or 10m pipe run)

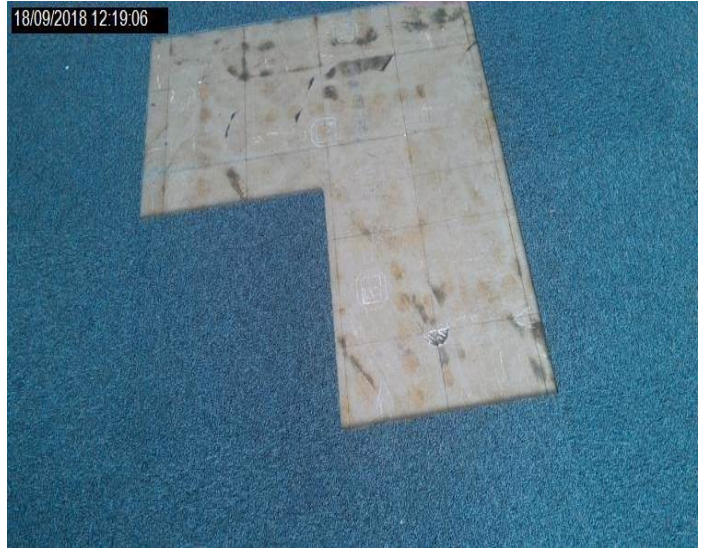
Item:	Asbestos Thermoplastic floor tiles with bitumen adhesive			
Asbestos Content:	Result Based on:			
Chrysotile in tile and adhesive	Analysis of sample using PLM			
Sample Analysed By: Reg 13(1)	Extent:	50 m ²		
Comments:

Material Assessment Total Score: 3		Likelihood of Disturbance Assessment Total Score: 5		Management Assessment Licensable: No Recommendations: Program removal Reinspection Interval: Not Applicable Overall Risk Category: C8
Product Type:	1 (Asbestos thermoplastic)	Location:	2 (Rooms up to 100 sq m)	
Condition:	1 (Minor scratches)	Accessibility:	0 (Usually inaccessible or unlikely to be disturbed)	
Surface Treatment:	0 (Composite material)			
Asbestos Type:	1 (Chrysotile)	Extent Score:	3 (>50 sq m or >50m pipe run)

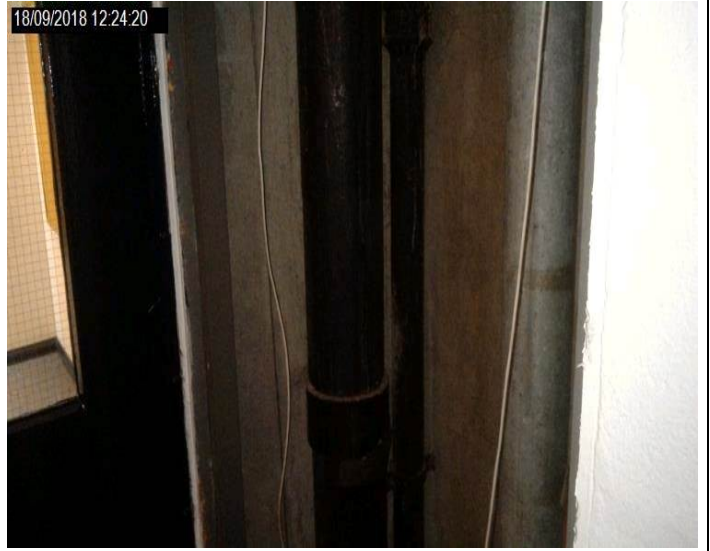
Item:	Asbestos Reinforced plastic downpipe			
Asbestos Content:	Result Based on:			
Chrysotile	Strongly presumed			
Sample Analysed By:	Not applicable	Extent:	3 linear metres	
Comments:

Material Assessment Total Score: 3		Likelihood of Disturbance Assessment Total Score: 4		Management Assessment Licensable: No Recommendations: Program removal Reinspection Interval: Not Applicable Overall Risk Category: C7
Product Type:	1 (Asbestos reinforced plastic)	Location:	2 (Rooms up to 100 sq m)	
Condition:	1 (Minor scratches)	Accessibility:	1 (Occasionally likely to be disturbed)	
Surface Treatment:	0 (Composite material)			
Asbestos Type:	1 (Chrysotile)	Extent Score:	1 (<10 sq m or 10m pipe run)

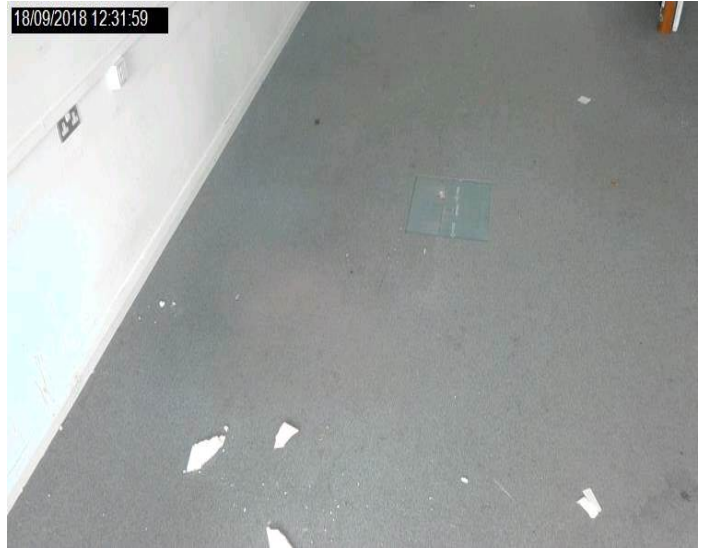
Item:	Asbestos Thermoplastic floor tiles with bitumen adhesive			
Asbestos Content:	Result Based on:			
Chrysotile in tile and adhesive	Analysis of sample using PLM			
Sample Analysed By: Reg 13(1)	Extent:	25 m ²		
Comments:

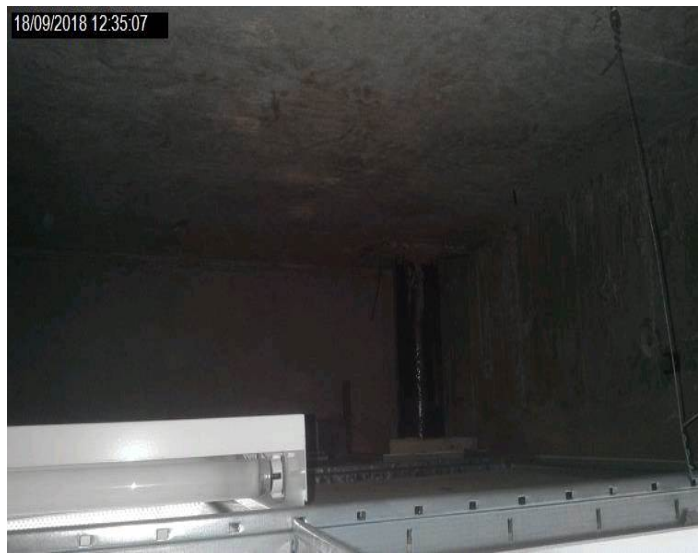
Item:	Asbestos Reinforced plastic downpipe			
Asbestos Content:	Result Based on:			
Chrysotile	Strongly presumed			
Sample Analysed By:	Not applicable	Extent:	3 linear metres	
Comments: To timber boxing

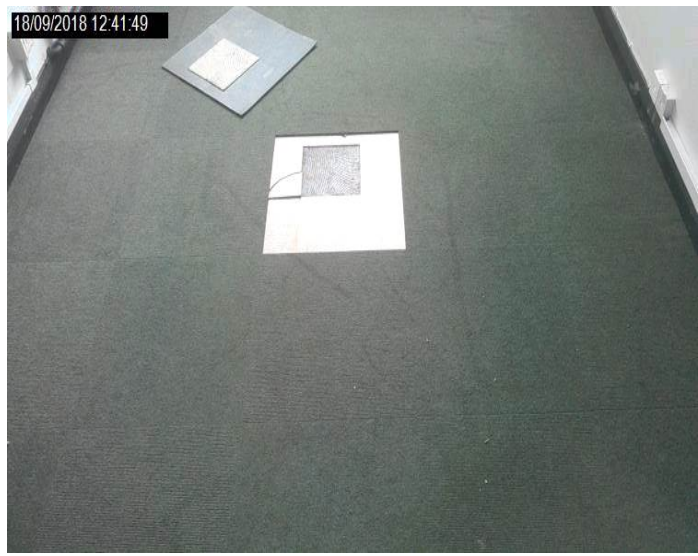
Item:	Asbestos Thermoplastic floor tiles with bitumen adhesive			
Asbestos Content:	Result Based on:			
Chrysotile in tile and adhesive	Strongly presumed			
Sample Analysed By:	Not applicable	Extent:	12 m ²	
Comments:

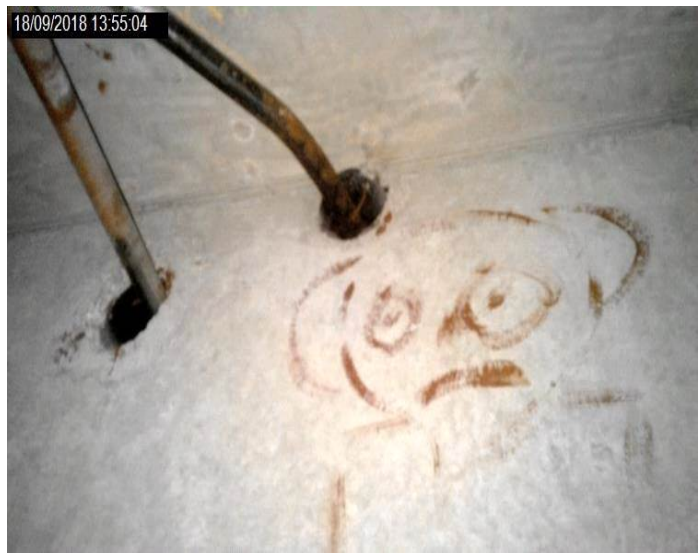
Item:	Asbestos Reinforced plastic sleeve			
Asbestos Content:	Result Based on:			
Chrysotile	Analysis of sample using PLM			
Sample Analysed By: Reg 13(1)	Extent:	12 units		
Comments:

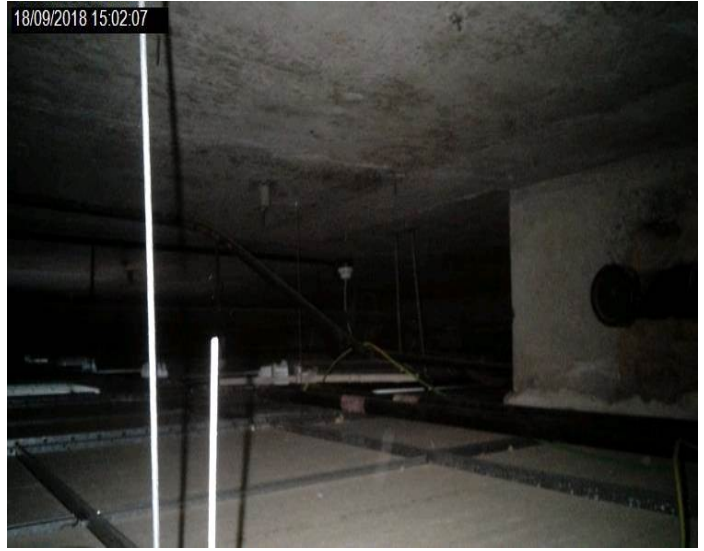
Item:	Asbestos Reinforced plastic sleeve			
Asbestos Content:	Result Based on:			
Chrysotile	Strongly presumed			
Sample Analysed By:	Not applicable	Extent:	5 units	
Comments: To the corridor wall

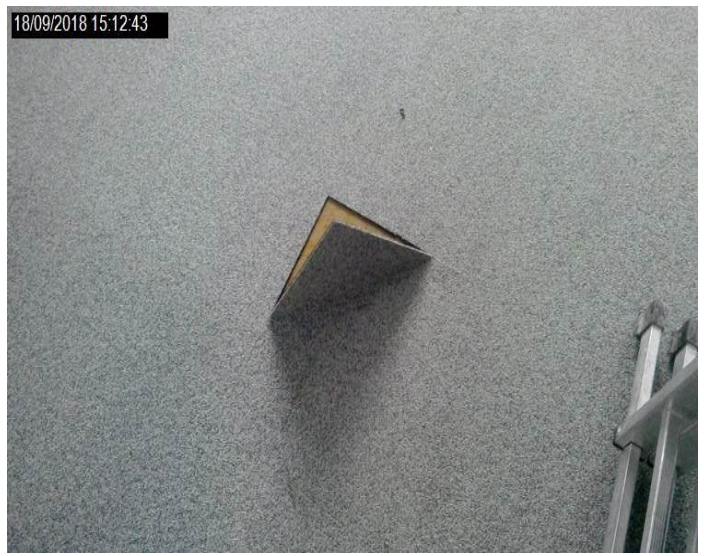
Item:	Asbestos Thermoplastic floor tiles with bitumen adhesive			
Asbestos Content:	Result Based on:			
Chrysotile in tile and adhesive	Strongly presumed			
Sample Analysed By:	Not applicable	Extent:	16 m ²	
Comments:

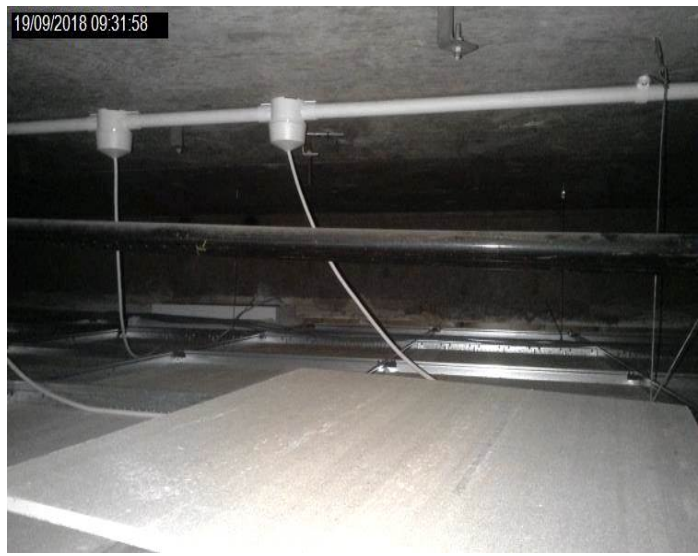
Item:	Asbestos Reinforced plastic sleeve			
Asbestos Content:	Result Based on:			
Chrysotile	Strongly presumed			
Sample Analysed By:	Not applicable	Extent:	6 units	
Comments: To corridor wall

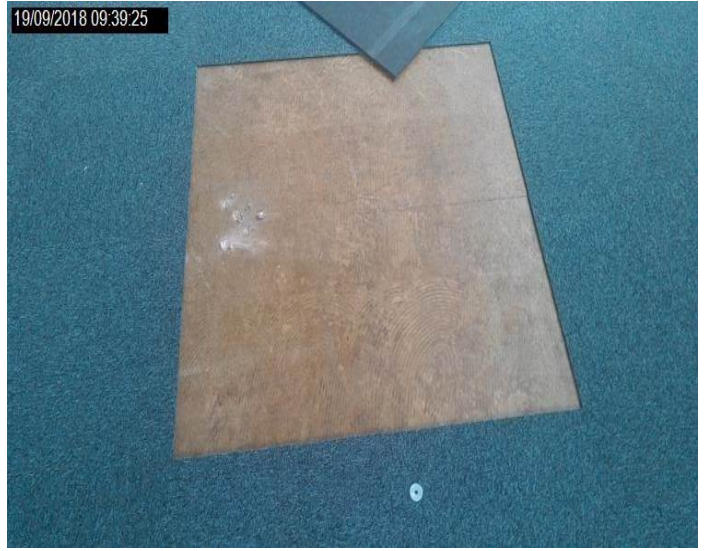
Item:	Asbestos Bitumen adhesive			
Asbestos Content:	Result Based on:			
Chrysotile	Strongly presumed			
Sample Analysed By:	Not applicable	Extent:	25 m ²	
Comments:

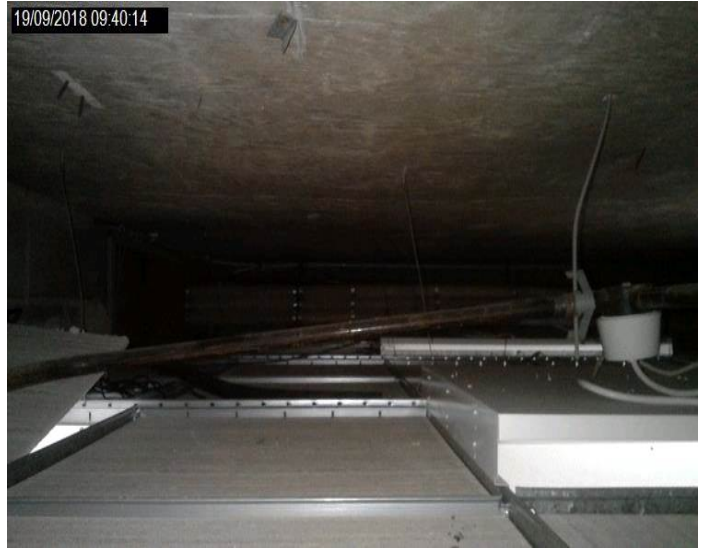
Item:	Asbestos Reinforced plastic sleeve			
Asbestos Content:	Result Based on:			
Chrysotile	Strongly presumed			
Sample Analysed By:	Not applicable	Extent:	6 units	
Comments: To adjoining room

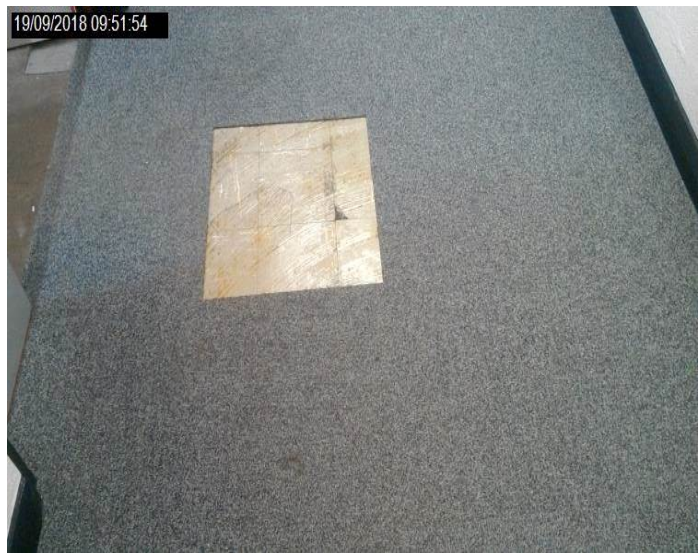
Item:	Asbestos Thermoplastic floor tiles with bitumen adhesive			
Asbestos Content:	Result Based on:			
Chrysotile in tile and adhesive	Analysis of sample using PLM			
Sample Analysed By: Reg 13(1)	Extent:	50 m ²		
Comments:

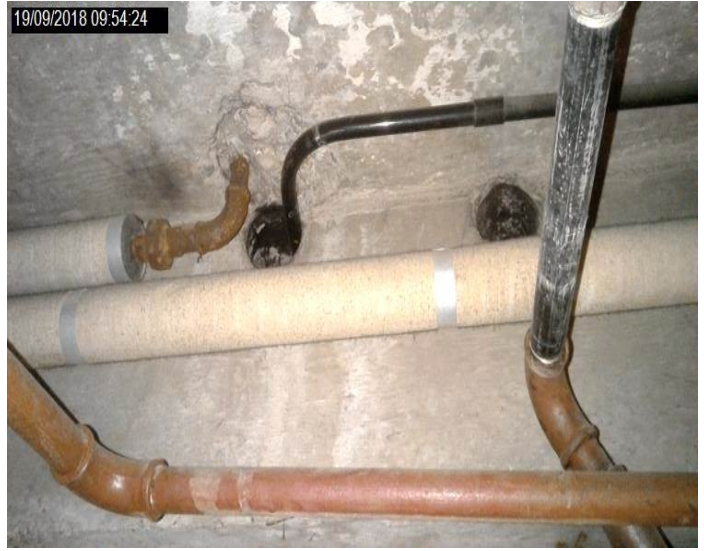
Item:	Asbestos Reinforced plastic sleeve			
Asbestos Content:	Result Based on:			
Chrysotile	Strongly presumed			
Sample Analysed By:	Not applicable	Extent:	16 units	
Comments: Passes through wall section separating the rooms and the corridor

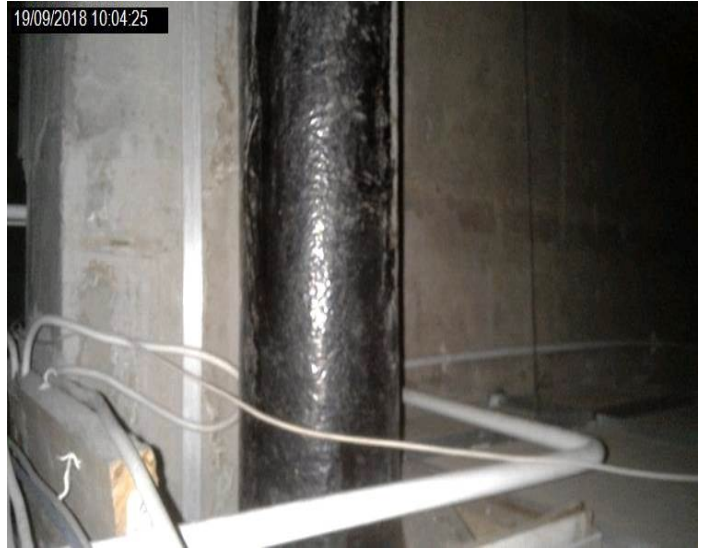
Item:	Asbestos Reinforced plastic downpipe			
Asbestos Content:	Result Based on:			
Chrysotile	Strongly presumed			
Sample Analysed By:	Not applicable	Extent:	3 linear metres	
Comments: Internally to timber boxing

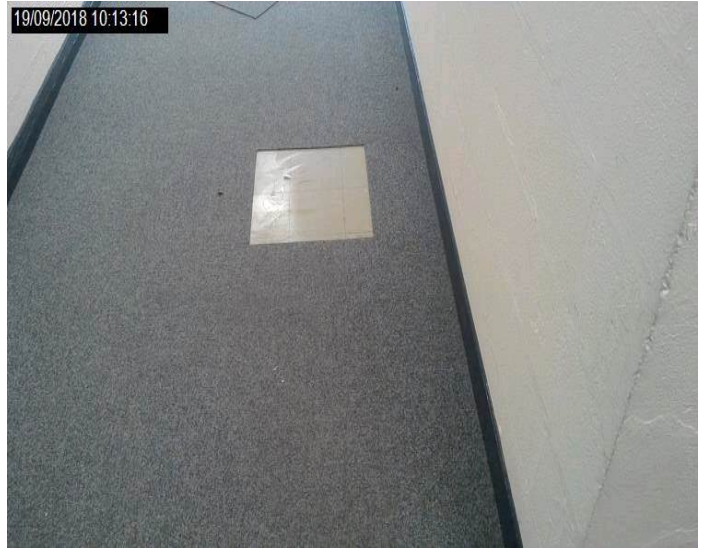
Item:	Asbestos Thermoplastic floor tiles with bitumen adhesive			
Asbestos Content:	Result Based on:			
Chrysotile in tile and adhesive	Strongly presumed			
Sample Analysed By:	Not applicable	Extent:	50 m ²	
Comments:

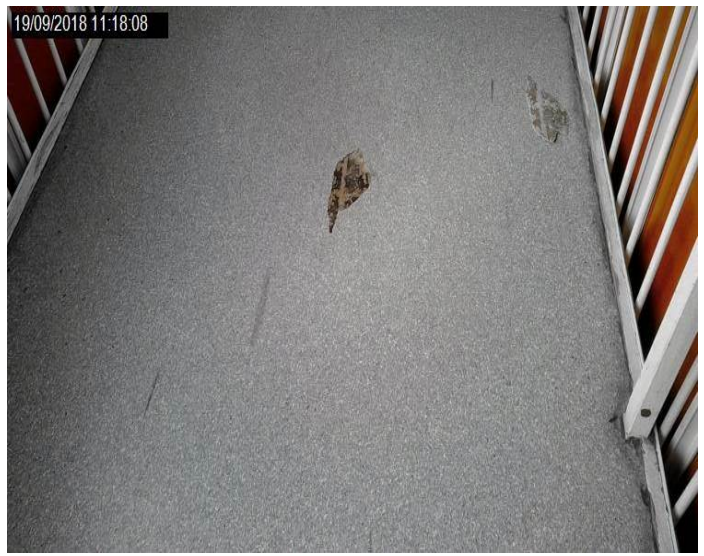
Item:	Asbestos Modern vinyl with adhesive			
Asbestos Content:	Result Based on:			
Chrysotile in adhesive only	Analysis of sample using PLM			
Sample Analysed By: Reg 13(1)	Extent:	16 m ²		
Comments: Sample taken of modern vinyl with bitumen adhesive to the rear

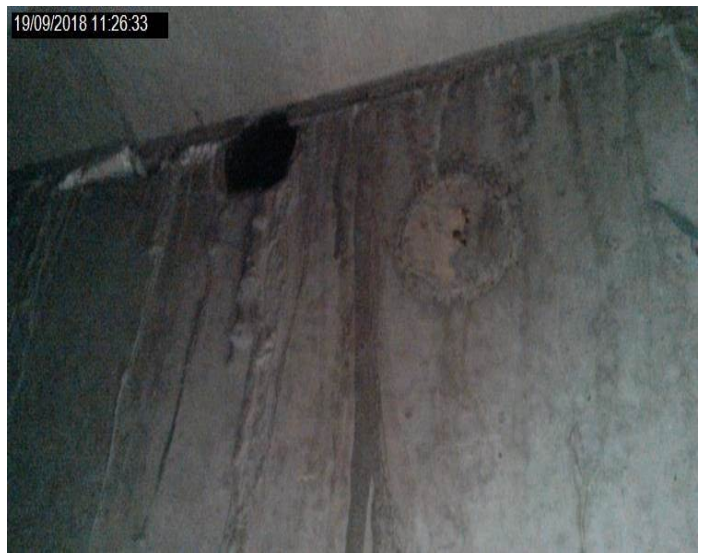
Item:	Asbestos Reinforced plastic sleeve			
Asbestos Content:	Result Based on:			
Chrysotile	Analysis of sample using PLM			
Sample Analysed By:	Reg 13(1)	Extent:	4 units	
Comments:

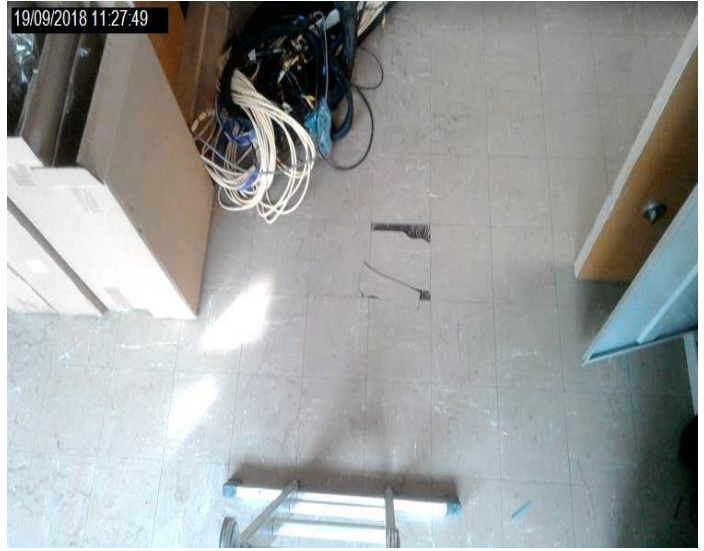
Item:	Asbestos Thermoplastic floor tiles			
Asbestos Content:	Result Based on:			
Chrysotile in tile and adhesive	Analysis of sample using PLM			
Sample Analysed By: Reg 13(1)	Extent:	14 m ²		
Comments:

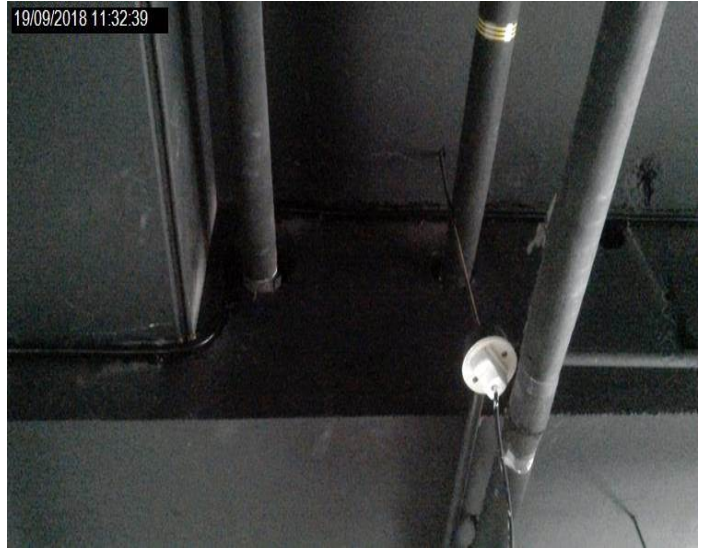
Item:	Asbestos Reinforced plastic sleeve			
Asbestos Content:	Result Based on:			
Chrysotile	Strongly presumed			
Sample Analysed By:	Not applicable	Extent:	12 units	
Comments: To the structural columns

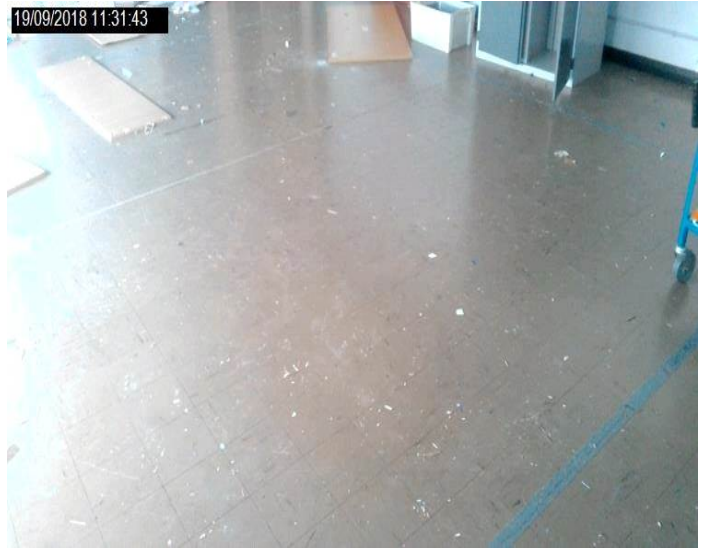
Item:	Asbestos Thermoplastic floor tiles			
Asbestos Content:	Result Based on:			
Chrysotile in tile and adhesive	Strongly presumed			
Sample Analysed By:	Not applicable	Extent:	64 m ²	
Comments:

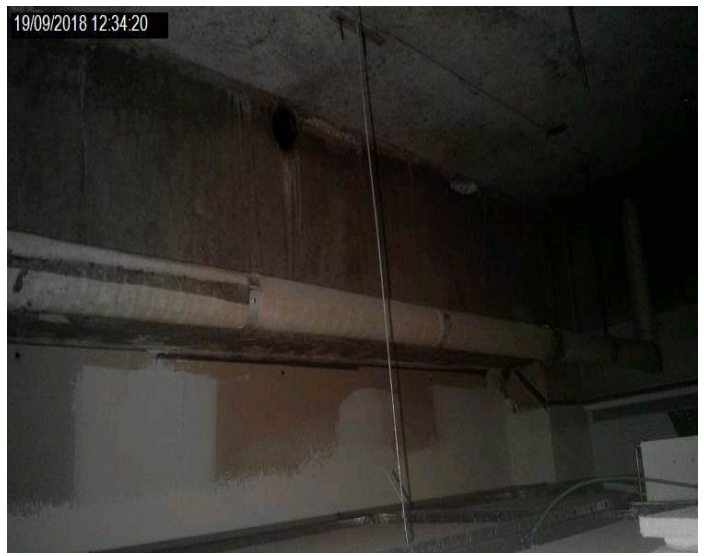
Item:	Asbestos Reinforced plastic sleeve			
Asbestos Content:	Result Based on:			
Chrysotile	Strongly presumed			
Sample Analysed By:	Not applicable	Extent:	3 units	
Comments:

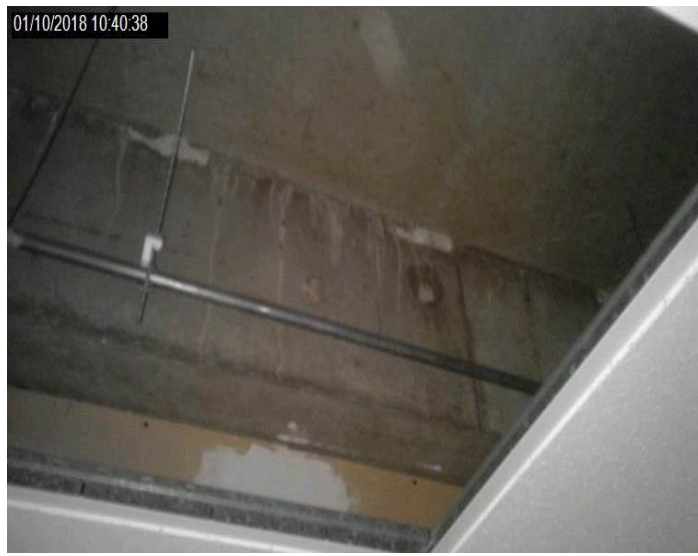
Item:	Asbestos Reinforced plastic sleeve			
Asbestos Content:	Result Based on:			
Chrysotile	Strongly presumed			
Sample Analysed By:	Not applicable	Extent:	2 units	
Comments: From room 107

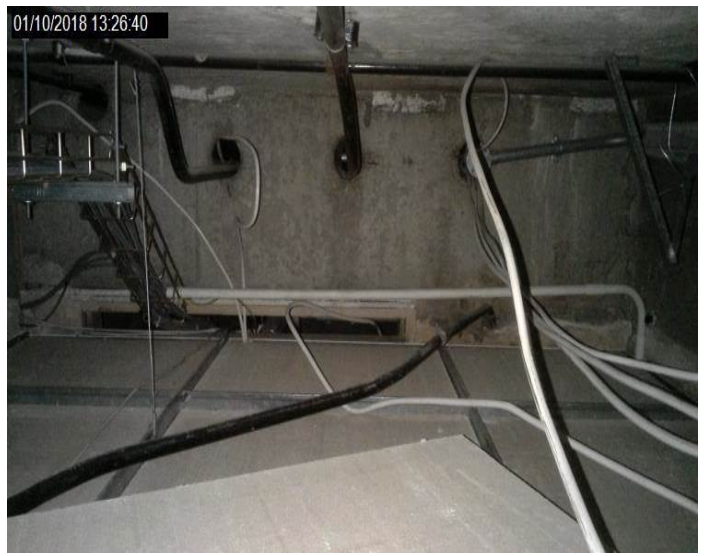
Item:	Asbestos Reinforced plastic sleeve			
Asbestos Content:	Result Based on:			
Chrysotile	Strongly presumed			
Sample Analysed By:	Not applicable	Extent:	6 units	
Comments: To the structural columns

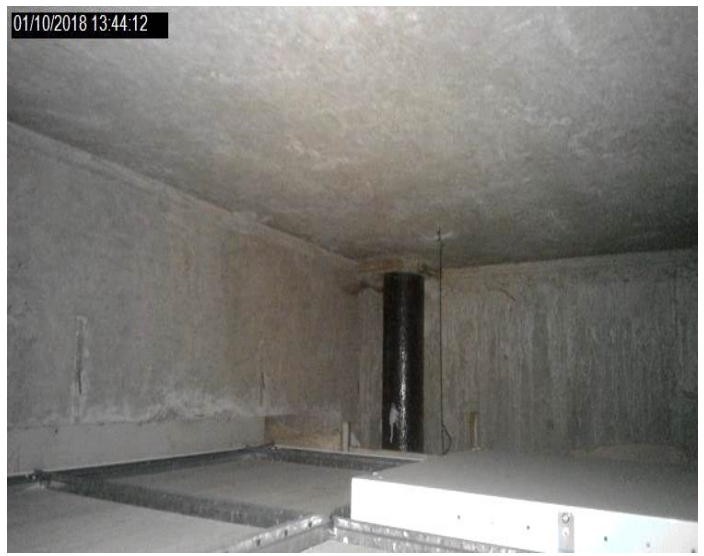
Item:	Asbestos Reinforced plastic downpipe			
Asbestos Content:	Result Based on:			
Chrysotile	Strongly presumed			
Sample Analysed By:	Not applicable	Extent:	3 linear metres	
Comments: Within timber boxing

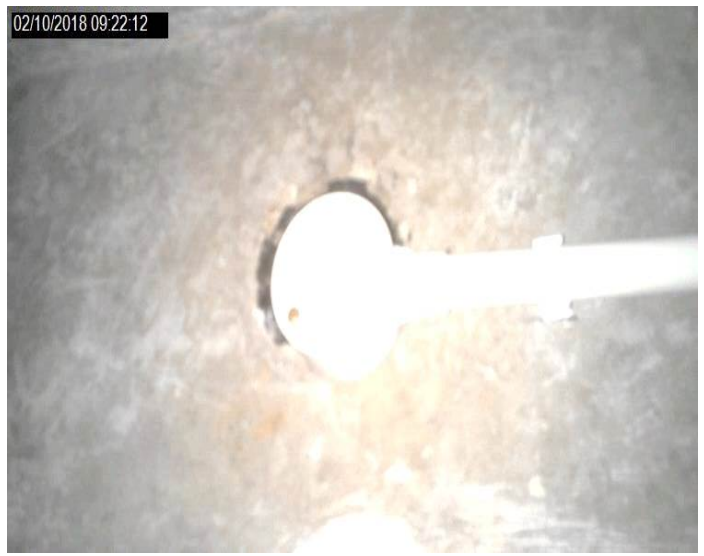
Item:	Asbestos Reinforced plastic sleeve			
Asbestos Content:	Result Based on:			
Chrysotile	Analysis of sample using PLM			
Sample Analysed By: Reg 13(1)	Extent:	2 units		
Comments:

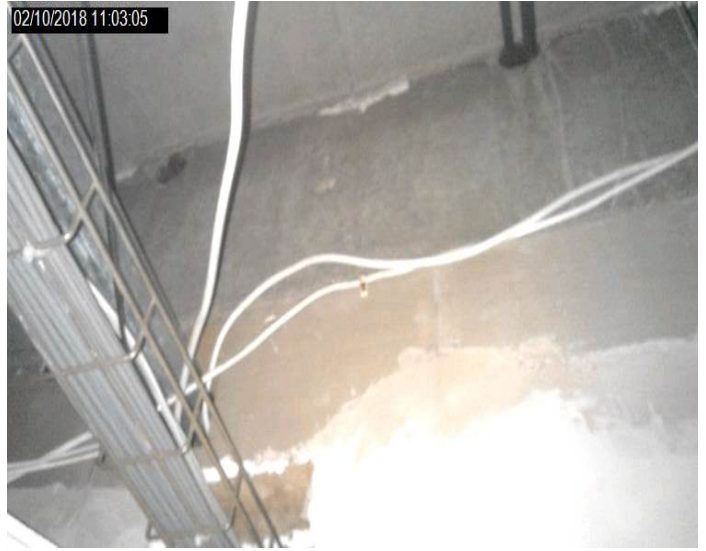
Item:	Asbestos Reinforced plastic sleeve			
Asbestos Content:	Result Based on:			
Chrysotile	Strongly presumed			
Sample Analysed By:	Not applicable	Extent:	10 units	
Comments:

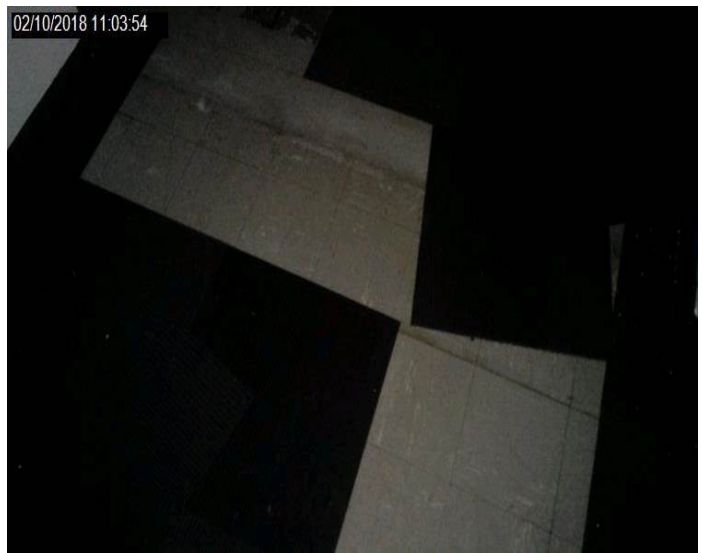
Item:	Asbestos Thermoplastic floor tiles			
Asbestos Content:	Result Based on:			
Chrysotile in tile and adhesive	Analysis of sample using PLM			
Sample Analysed By: Reg 13(1)	Extent:	30 m ²		
Comments: Section of floor leading up to Attwood walkway

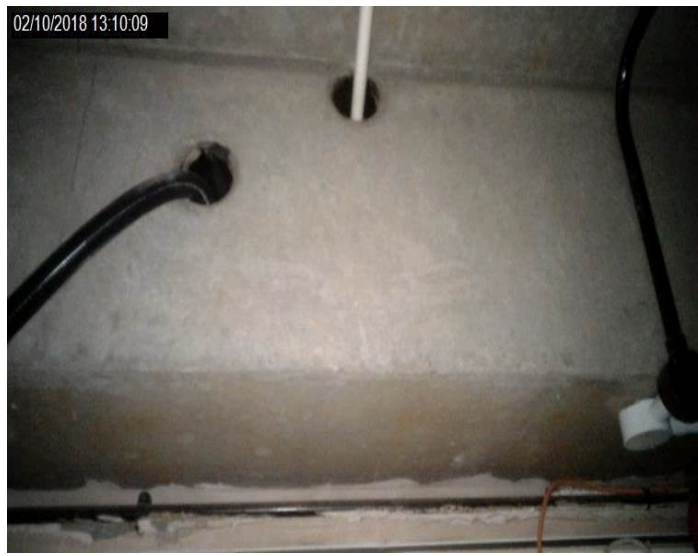
Item:	Asbestos Reinforced plastic sleeve			
Asbestos Content:	Result Based on:			
Chrysotile	Analysis of sample using PLM			
Sample Analysed By: Reg 13(1)	Extent:	8 units		
Comments: Through structural concrete

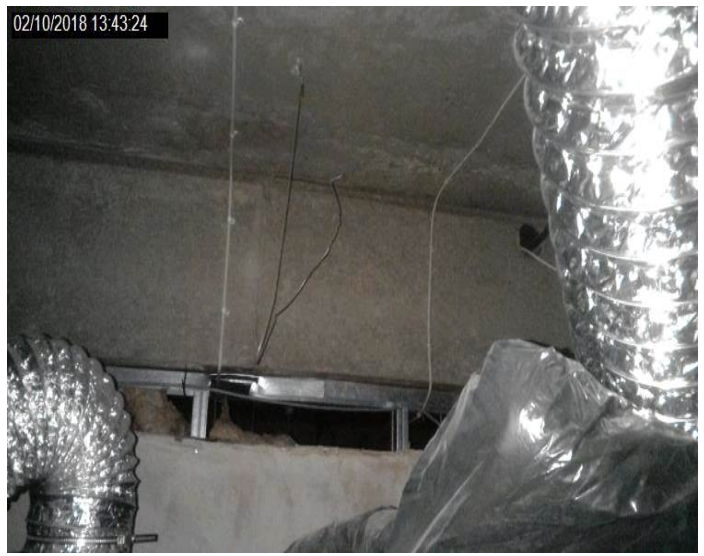
Item:	Asbestos Reinforced plastic sleeve			
Asbestos Content:	Result Based on:			
Chrysotile	Strongly presumed			
Sample Analysed By:	Not applicable	Extent:	2 units	
Comments: Through structural concrete

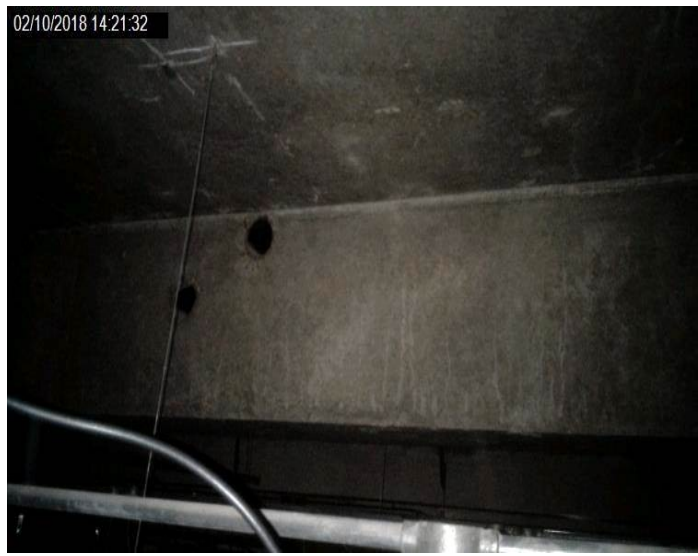
Item:	Asbestos Reinforced plastic sleeve			
Asbestos Content:	Result Based on:			
Chrysotile	Strongly presumed			
Sample Analysed By:	Not applicable	Extent:	12 units	
Comments: To the structural column
