Location:	NBA201A	Block:	Birmingham City University	Floor Level: 2nd Floor
Sample No.:	DU002474	Portal Ref No.:	492

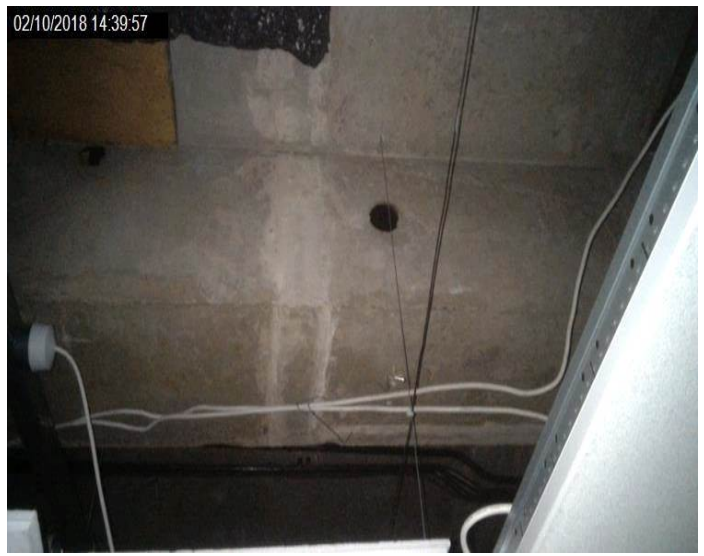
Item:	Asbestos Reinforced plastic sleeve			
Asbestos Content:	Result Based on:			
Chrysotile	Strongly presumed			
Sample Analysed By:	Not applicable	Extent:	15 units	
Comments: To the structural column

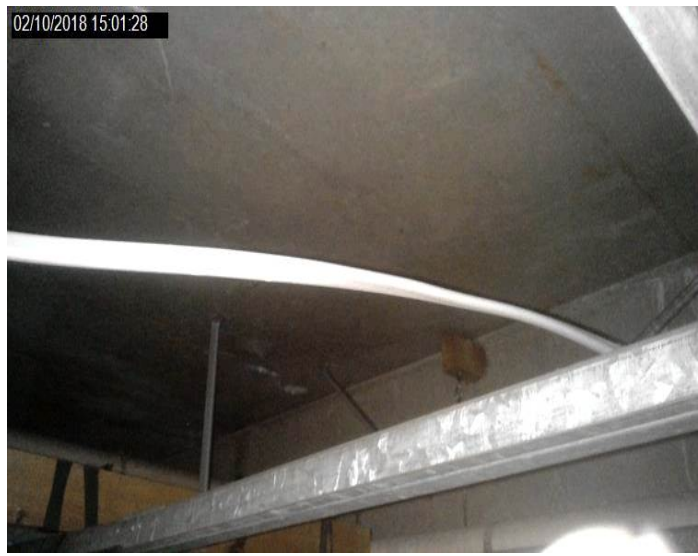
Item:	Asbestos Reinforced plastic sleeve			
Asbestos Content:	Result Based on:			
Chrysotile	Strongly presumed			
Sample Analysed By:	Not applicable	Extent:	6 units	
Comments: Through structural concrete

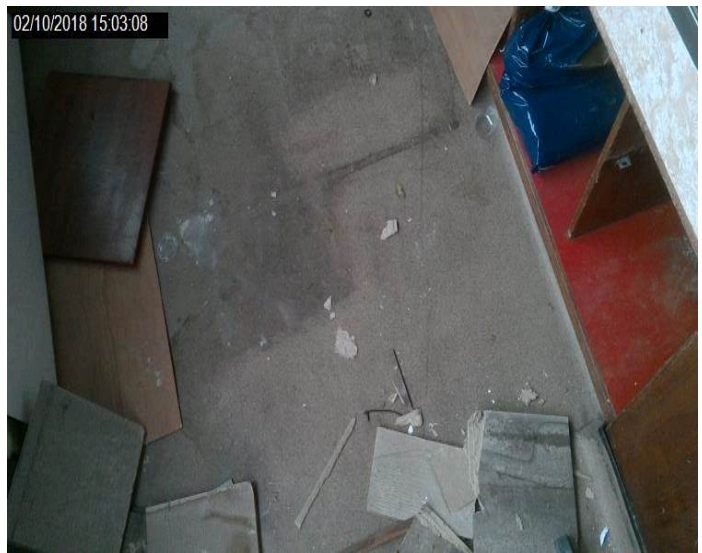
Item:	Asbestos Vinyl			
Asbestos Content:	Result Based on:			
Chrysotile in adhesive only	Analysis of sample using PLM			
Sample Analysed By: Reg 13(1)	Extent:	16 m ²		
Comments:

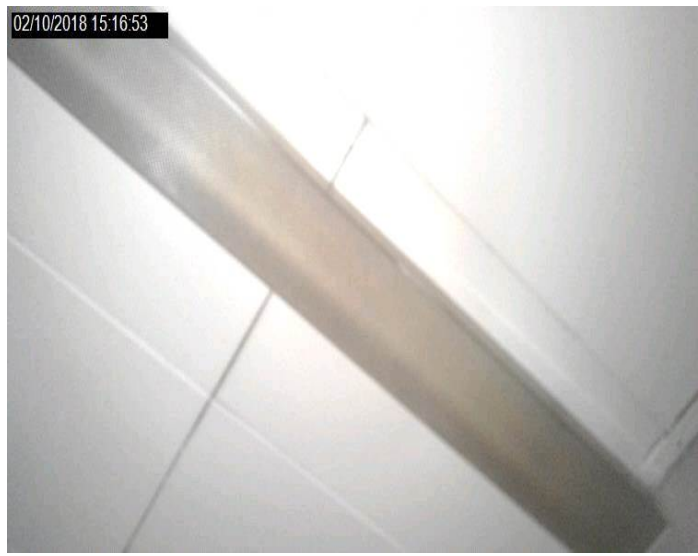
Item:	Asbestos Reinforced plastic sleeve			
Asbestos Content:	Result Based on:			
Chrysotile	Strongly presumed			
Sample Analysed By:	Not applicable	Extent:	2 units	
Comments: Through structural concrete

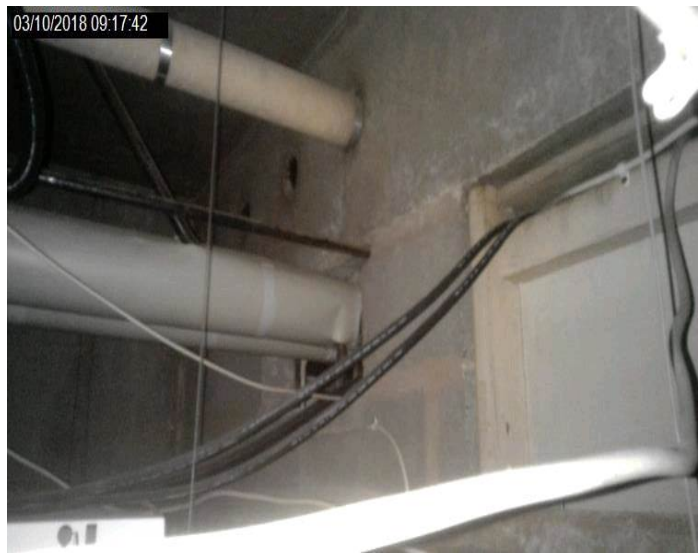
Item:	Asbestos Reinforced plastic sleeve			
Asbestos Content:	Result Based on:			
Chrysotile	Strongly presumed			
Sample Analysed By:	Not applicable	Extent:	6 units	
Comments: Through structural concrete

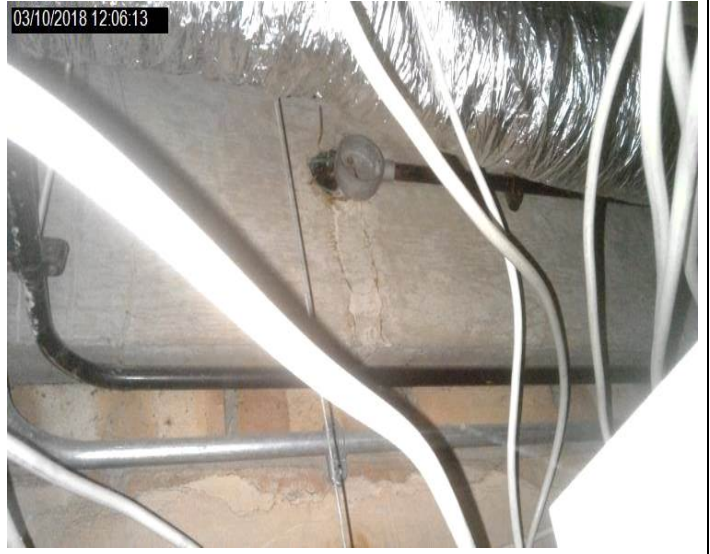
Item:	Asbestos Reinforced plastic sleeve			
Asbestos Content:	Result Based on:			
Chrysotile	Strongly presumed			
Sample Analysed By:	Not applicable	Extent:	3 units	
Comments: To structural concrete

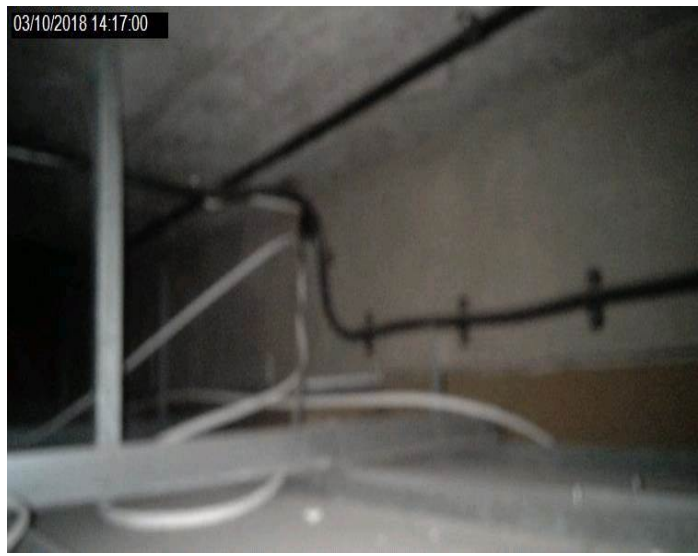
Item:	Asbestos Reinforced plastic sleeve			
Asbestos Content:	Result Based on:			
Chrysotile	Strongly presumed			
Sample Analysed By:	Not applicable	Extent:	12 units	
Comments: To structural concrete

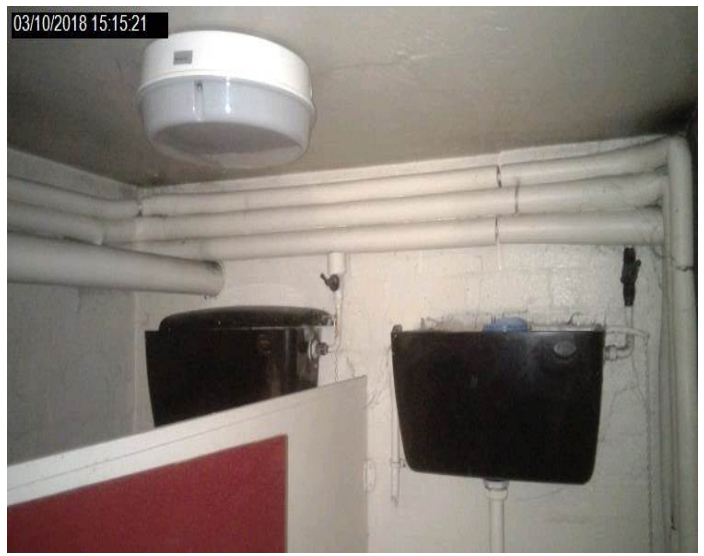
Item:	Asbestos Reinforced plastic cisterns			
Asbestos Content:	Result Based on:			
Amosite	Analysis of sample using PLM			
Sample Analysed By:	Reg 13(1)	Extent:	2 units	
Comments: Composite sample
