Report No.: J102749
Nature of Work: Demolition Survey
Issue Date: 02/11/2018
Client Name: WYG Engineering Ltd
 Geneva Building, Lake View Drive, Sherwood Business Park,
 Annesley, Nottingham, NG15 0ED
Site Address: Attwood Building, Former City North Campus, Birmingham City
 University, Perry Barr, B42 2US

1.0 Introduction & Scope of Work

A demolition survey in line with HSG264 Asbestos: The Survey Guide was carried out internally and externally to the property.

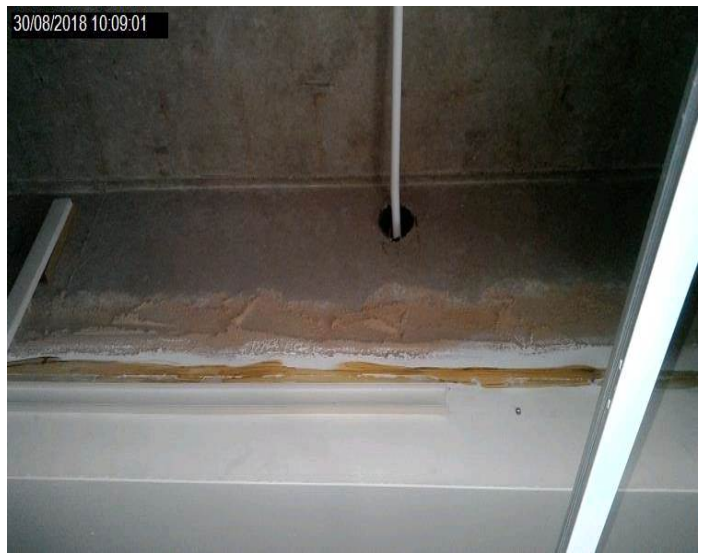
Item:	Asbestos Reinforced plastic sleeve			
Asbestos Content:	Chrysotile			
Result Based on:	Analysis of sample using PLM			
Sample Analysed By:	Reg 13(1)	Extent:	9 units	
Comments: Through structural concrete various points within ceiling void items run parallel generally throughout the ceiling void

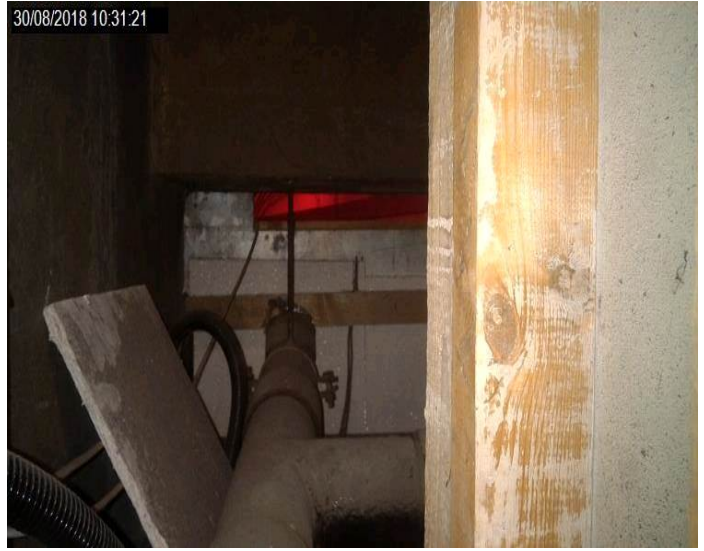
Item:	Insulating board door header			
Asbestos Content:		Result Based on:		
No Asbestos Detected		Analysis of sample using PLM		
Sample Analysed By:	Reg 13(1)	Extent:	2 m ²	
Comments: To link corridor to Baker building, including debris panel

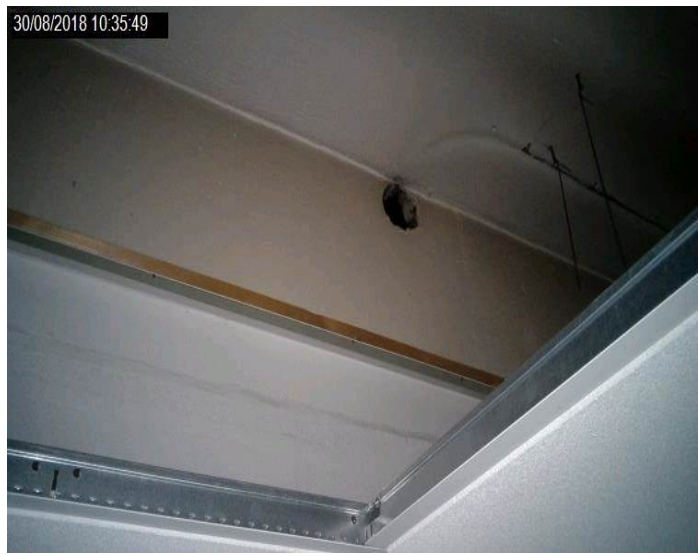
Item:	Asbestos Reinforced plastic sleeve			
Asbestos Content:	Result Based on:			
Chrysotile	Strongly presumed			
Sample Analysed By:	Not applicable	Extent:	7 units	
Comments: Through structural concrete various points within ceiling void items run parallel generally throughout the ceiling void

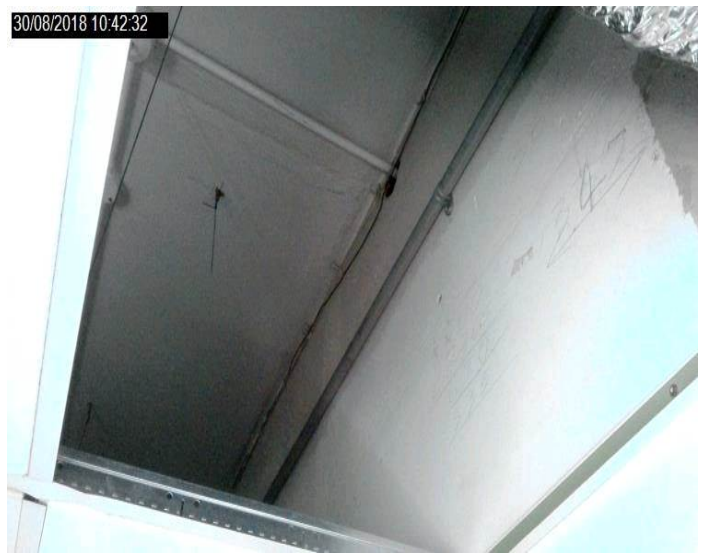
Item:	Asbestos Reinforced plastic sleeve			
Asbestos Content:	Result Based on:			
Chrysotile	Strongly presumed			
Sample Analysed By:	Not applicable	Extent:	1 unit	
Comments: Through structural concrete various points within ceiling void items run parallel generally throughout the ceiling void

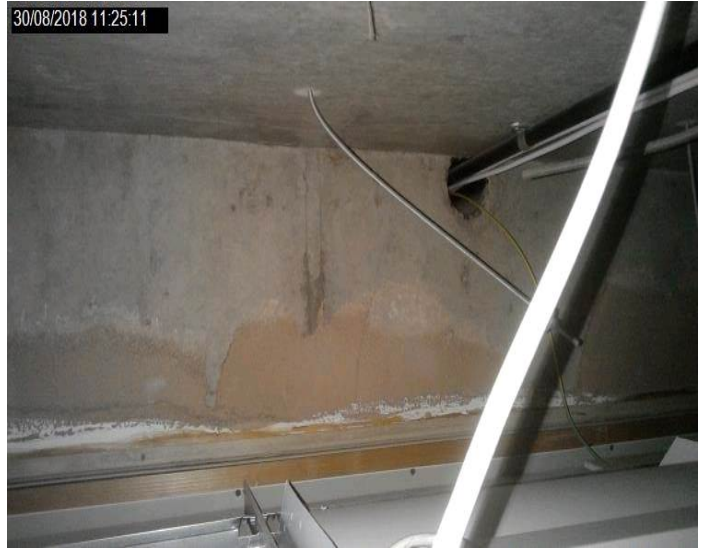
Item:	Asbestos Reinforced plastic sleeve			
Asbestos Content:	Result Based on:			
Chrysotile	Strongly presumed			
Sample Analysed By:	Not applicable	Extent:	12 units	
Comments: Through structural concrete various points within ceiling void items run parallel generally throughout the ceiling void

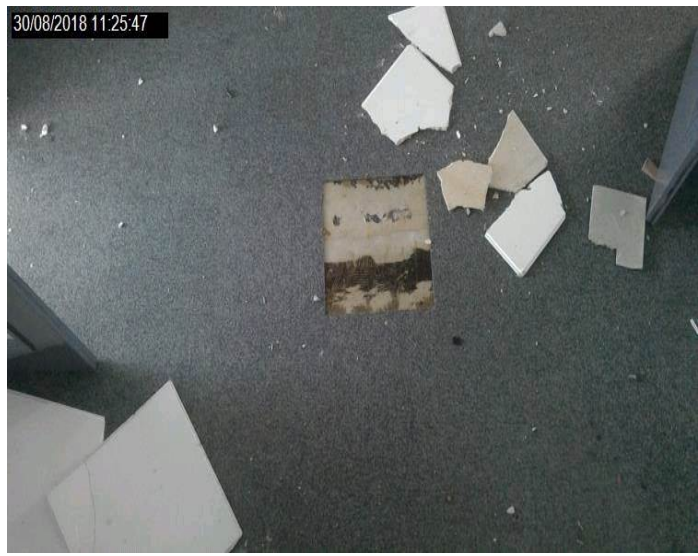
Item:	Asbestos Bitumen adhesive			
Asbestos Content:	Result Based on:			
Chrysotile	Analysis of sample using PLM			
Sample Analysed By:	Reg 13(1)	Extent:	25 m ²	
Comments:

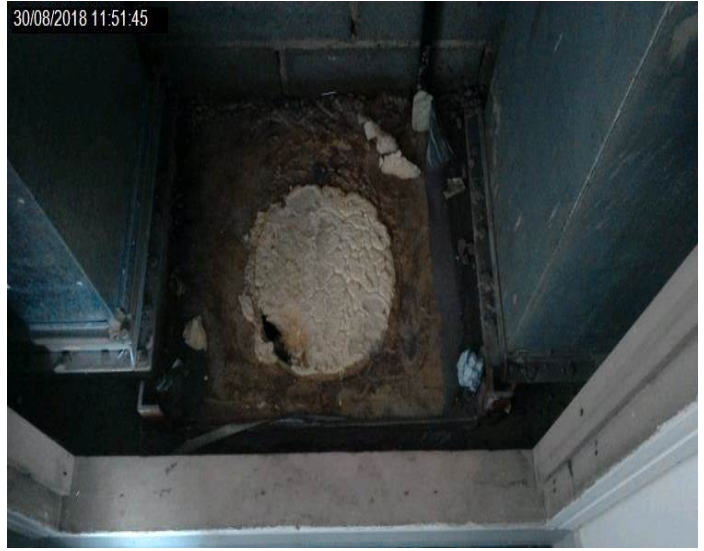
Item:	Asbestos Cement flue pipe			
Asbestos Content:	Result Based on:			
Chrysotile	Analysis of sample using PLM			
Sample Analysed By: Reg 13(1)	Extent:	1 linear metres		
Comments: Embedded within concrete floor

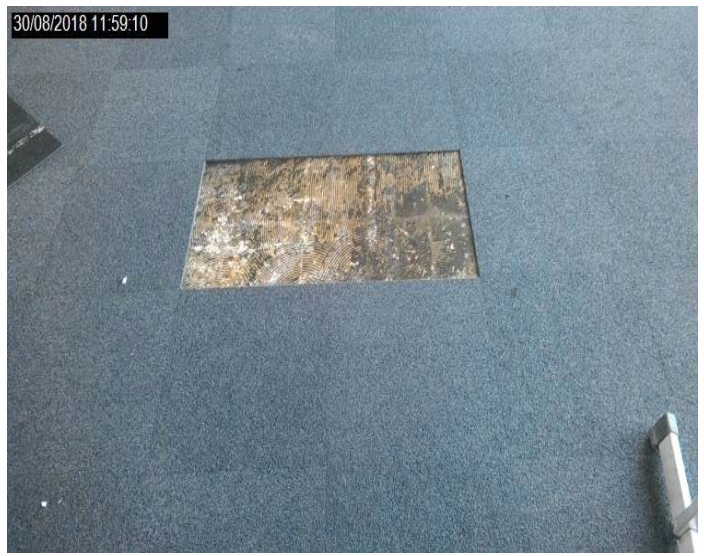
Item:	Asbestos Bitumen adhesive			
Asbestos Content:	Result Based on:			
Chrysotile	Strongly presumed			
Sample Analysed By:	Not applicable	Extent:	84 m ²	
Comments:

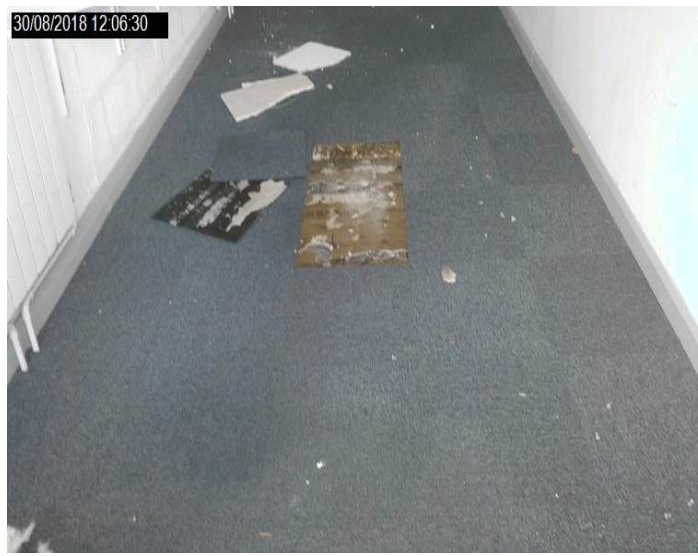
Item:	Asbestos Bitumen adhesive			
Asbestos Content:	Result Based on:			
Chrysotile	Strongly presumed			
Sample Analysed By:	Not applicable	Extent:	20 m ²	
Comments:

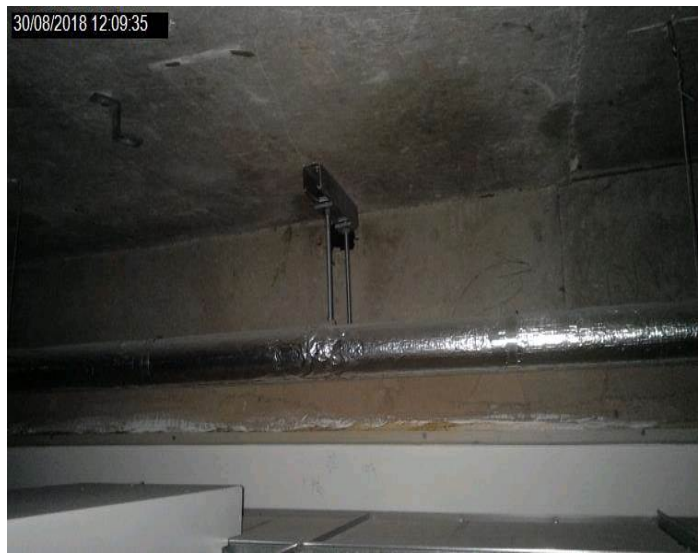
Item:	Asbestos Reinforced plastic sleeve			
Asbestos Content:	Result Based on:			
Chrysotile	Strongly presumed			
Sample Analysed By:	Not applicable	Extent:	12 units	
Comments: Through structural concrete various points within ceiling void items run parallel generally throughout the ceiling void

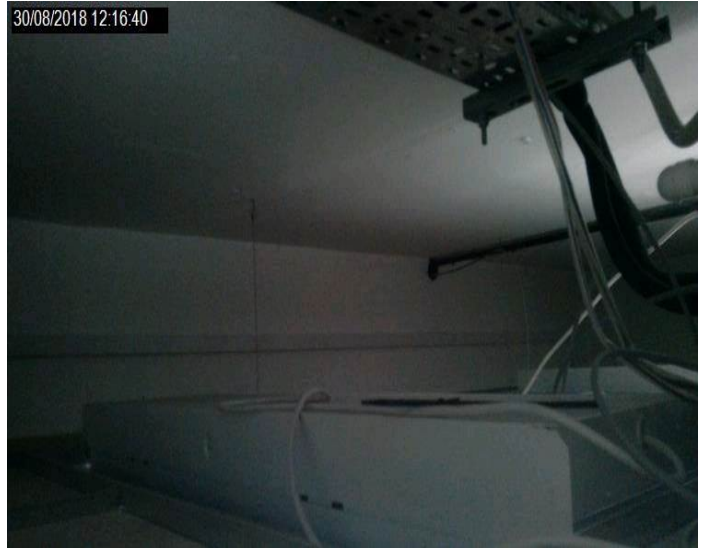
Item:	Asbestos Reinforced plastic sleeve			
Asbestos Content:	Result Based on:			
Chrysotile	Strongly presumed			
Sample Analysed By:	Not applicable	Extent:	1 unit	
Comments: Through structural concrete various points within ceiling void items run parallel generally throughout the ceiling void

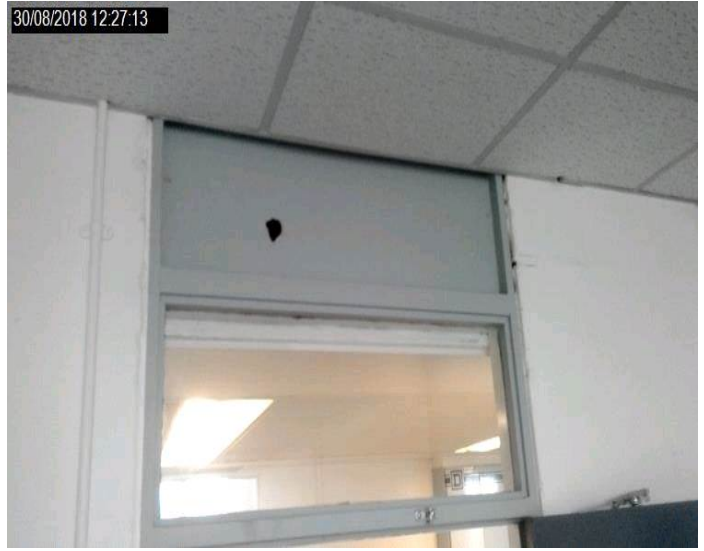
Item:	Insulating board door header			
Asbestos Content:		Result Based on:		
No Asbestos Detected		Analysis of sample using PLM		
Sample Analysed By:	Reg 13(1)	Extent:	1 m ²	
Comments:

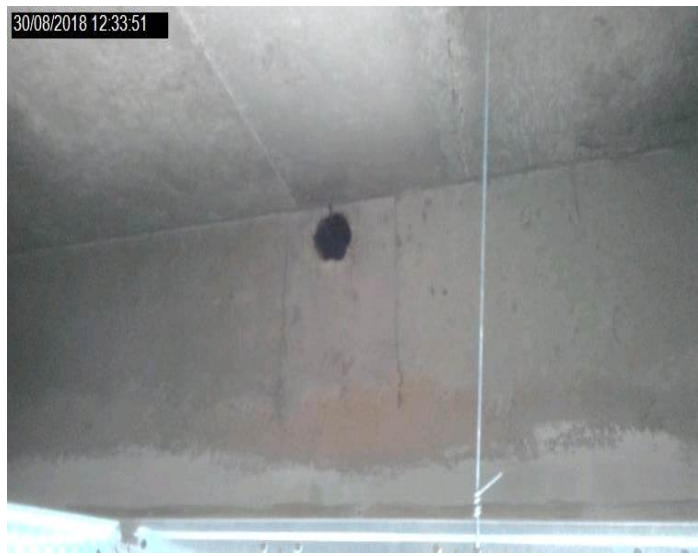
Item:	Asbestos Reinforced plastic sleeve			
Asbestos Content:	Result Based on:			
Chrysotile	Strongly presumed			
Sample Analysed By:	Not applicable	Extent:	2 units	
Comments: Through structural concrete various points within ceiling void items run parallel generally throughout the ceiling void

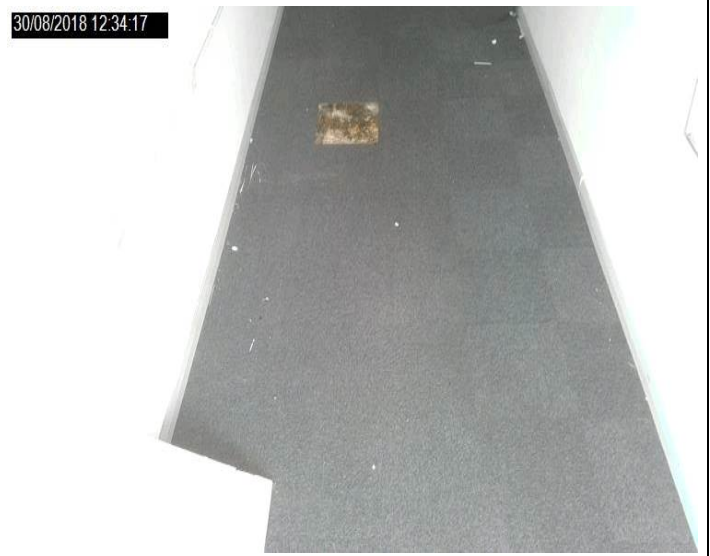
Item:	Asbestos Bitumen adhesive			
Asbestos Content:	Result Based on:			
Chrysotile	Strongly presumed			
Sample Analysed By:	Not applicable	Extent:	18 m ²	
Comments:

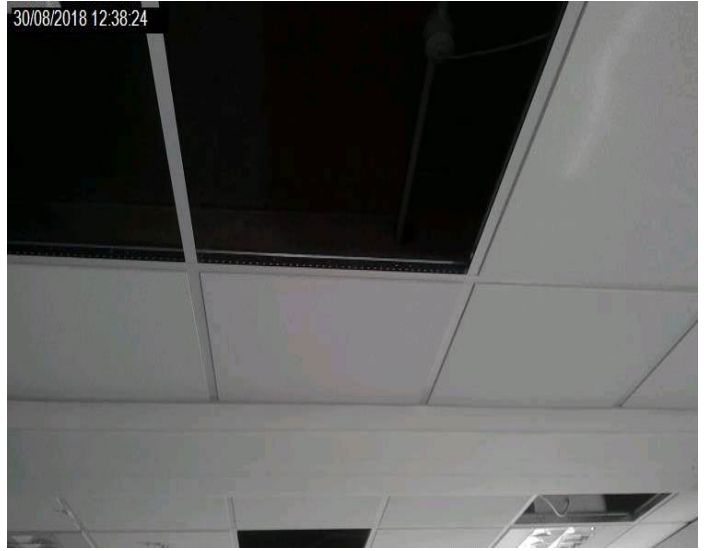
Item:	Asbestos Reinforced plastic sleeve			
Asbestos Content:	Result Based on:			
Chrysotile	Strongly presumed			
Sample Analysed By:	Not applicable	Extent:	8 units	
Comments: Through structural concrete various points within ceiling void items run parallel generally throughout the ceiling void

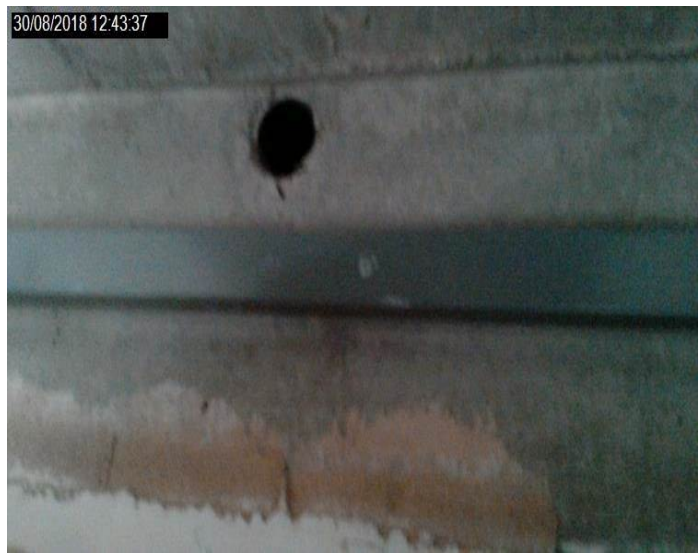
Item:	Asbestos Reinforced plastic sleeve			
Asbestos Content:	Result Based on:			
Chrysotile	Analysis of sample using PLM			
Sample Analysed By:	Reg 13(1)	Extent:	12 units	
Comments: Through structural concrete various points within ceiling void items run parallel generally throughout the ceiling void

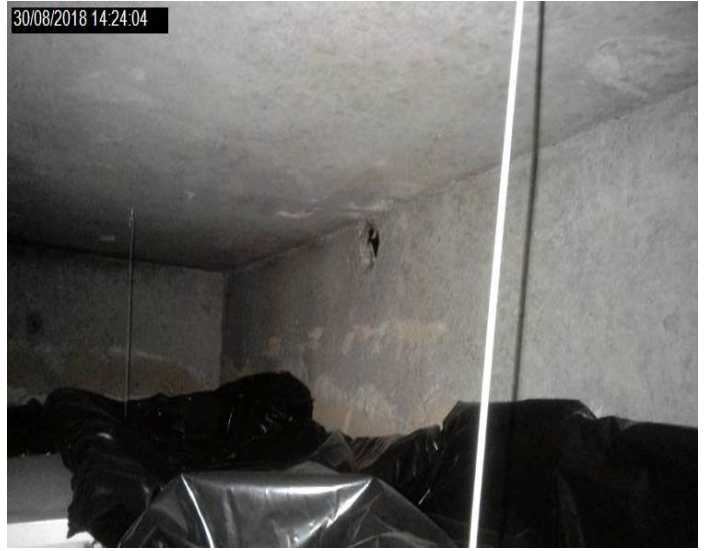
Item:	Asbestos Reinforced plastic sleeve			
Asbestos Content:	Result Based on:			
Chrysotile	Strongly presumed			
Sample Analysed By:	Not applicable	Extent:	9 units	
Comments: Through structural concrete various points within ceiling void items run parallel generally throughout the ceiling void

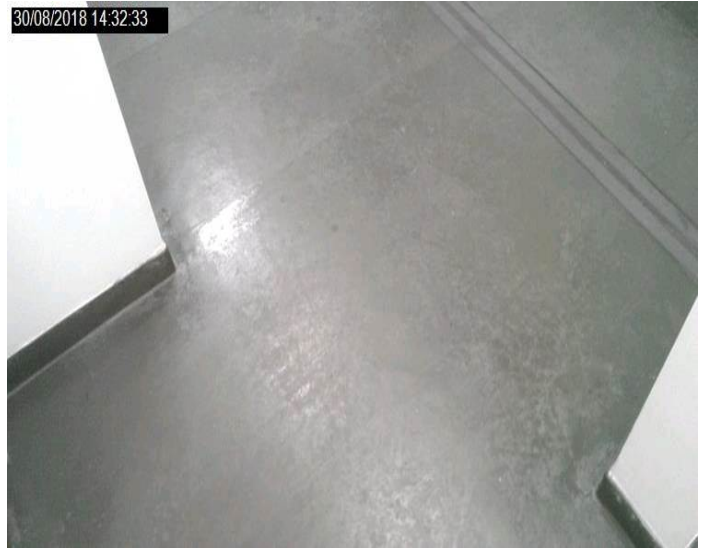
Item:	Asbestos Vinyl			
Asbestos Content:	Result Based on:			
Chrysotile in bitumen adhesive only	Strongly presumed			
Sample Analysed By:	Not applicable	Extent:	18 m ²	
Comments:

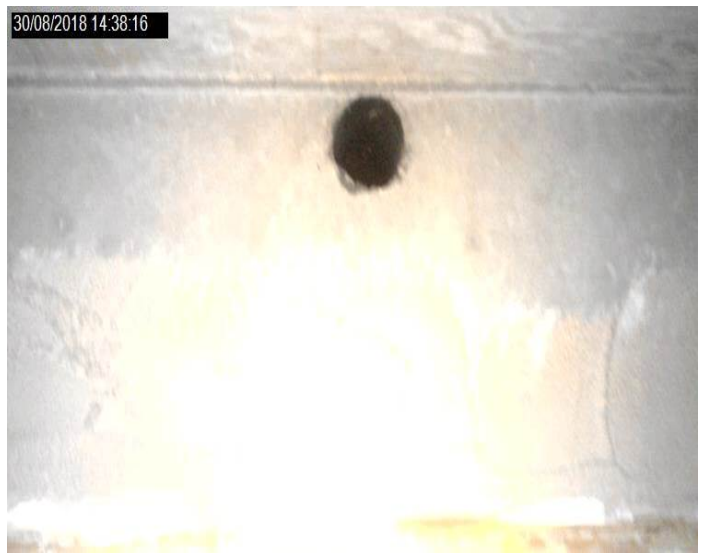
Item:	Asbestos Reinforced plastic sleeve			
Asbestos Content:	Result Based on:			
Chrysotile	Strongly presumed			
Sample Analysed By:	Not applicable	Extent:	8 units	
Comments: Through structural concrete various points within ceiling void items run parallel generally throughout the ceiling void

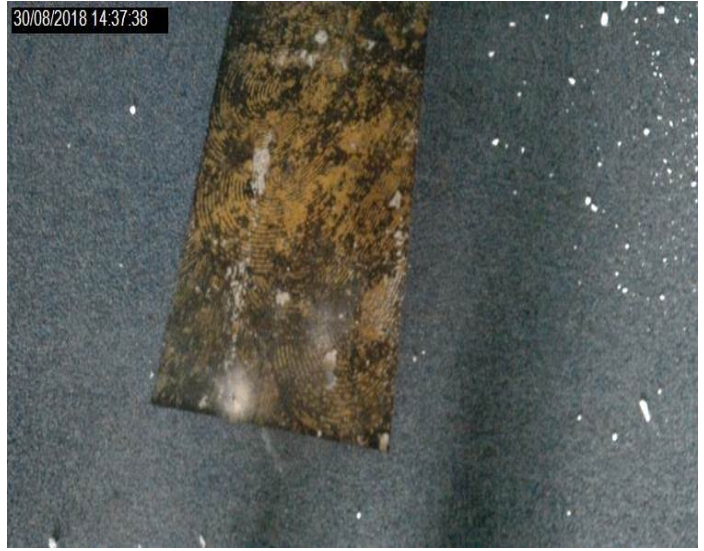
Item:	Asbestos Bitumen adhesive			
Asbestos Content:	Result Based on:			
Chrysotile	Strongly presumed			
Sample Analysed By:	Not applicable	Extent:	16 m ²	
Comments:

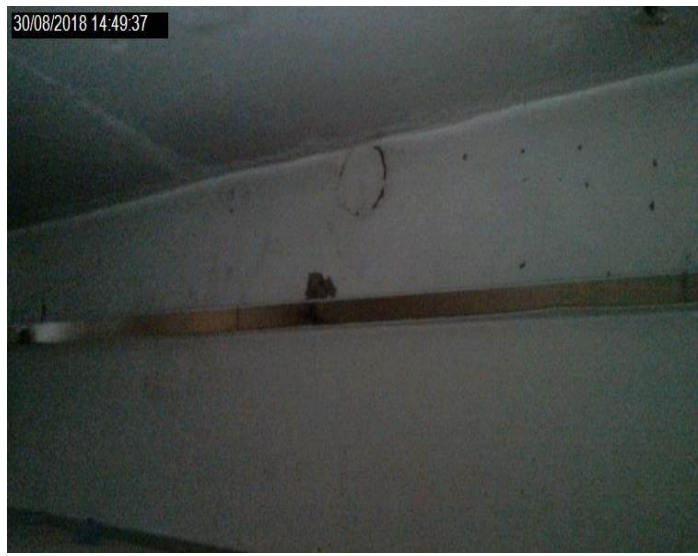
Item:	Asbestos Reinforced plastic sleeve			
Asbestos Content:	Result Based on:			
Chrysotile	Strongly presumed			
Sample Analysed By:	Not applicable	Extent:	8 units	
Comments: Through structural concrete various points within ceiling void items run parallel generally throughout the ceiling void

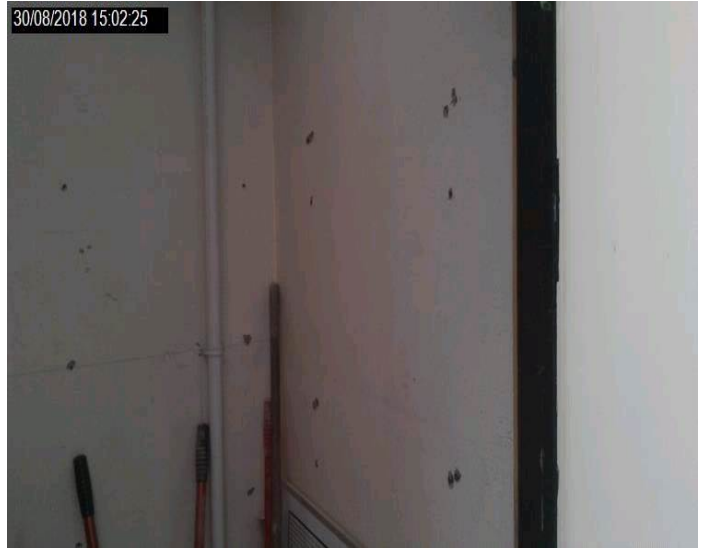
Item:	Textured coating to door wall			
Asbestos Content:		Result Based on:		
No Asbestos Detected		Analysis of sample using PLM		
Sample Analysed By:	Reg 13(1)	Extent:	12 m ²	
Comments:

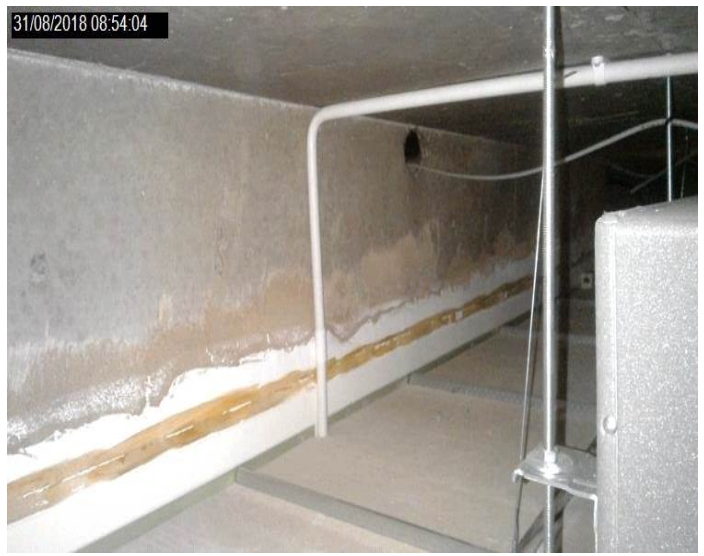
Item:	Asbestos Reinforced plastic sleeve			
Asbestos Content:	Result Based on:			
Chrysotile	Strongly presumed			
Sample Analysed By:	Not applicable	Extent:	4 units	
Comments: Through structural concrete various points within ceiling void items run parallel generally throughout the ceiling void

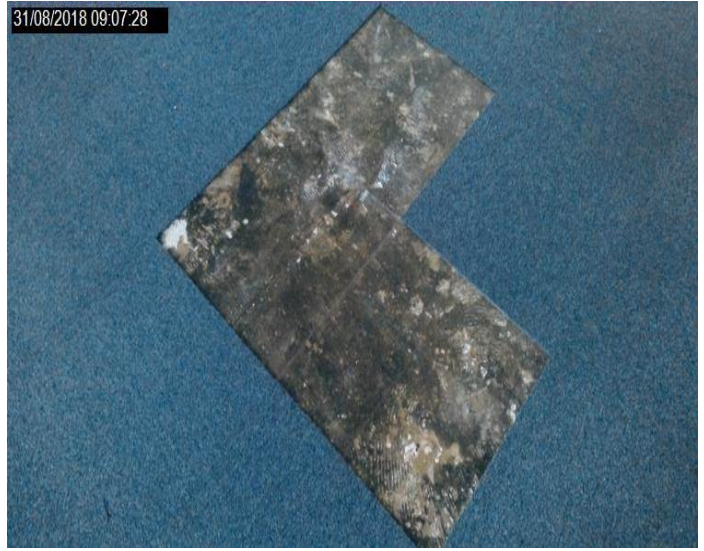
Item:	Asbestos Bitumen adhesive			
Asbestos Content:	Result Based on:			
Chrysotile	Strongly presumed			
Sample Analysed By:	Not applicable	Extent:	20 m ²	
Comments:

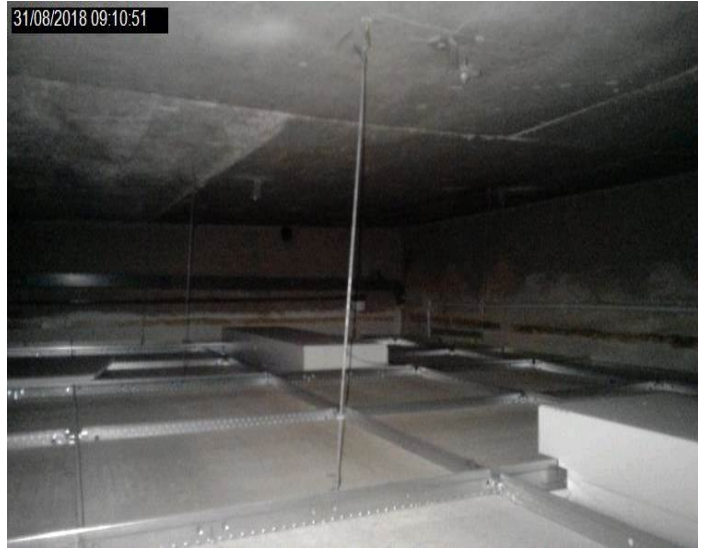
Item:	Asbestos Reinforced plastic pipe sleeve			
Asbestos Content:			Result Based on:	
Chrysotile			Strongly presumed	
Sample Analysed By:	Not applicable	Extent:	12 units	
Comments: Through structural concrete various points within ceiling void items run parallel generally throughout the ceiling void

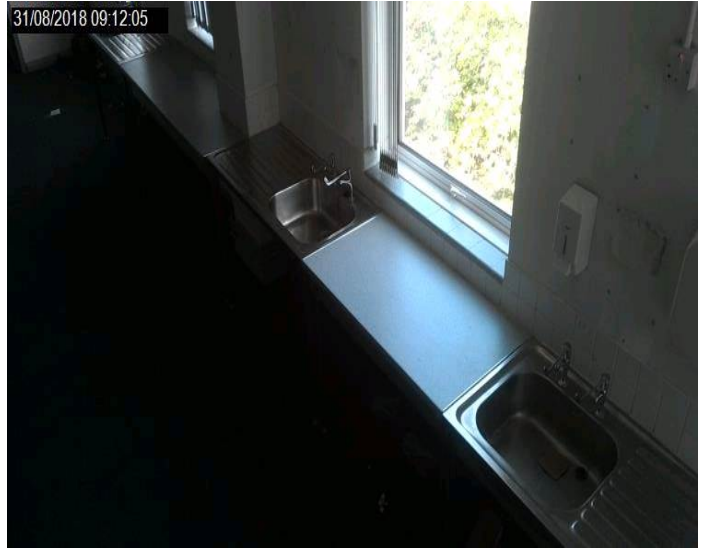
Item:	Bitumen sink pads			
Asbestos Content:		Result Based on:		
No Asbestos Detected		Analysis of sample using PLM		
Sample Analysed By:	Reg 13(1)	Extent:	6 units	
Comments:

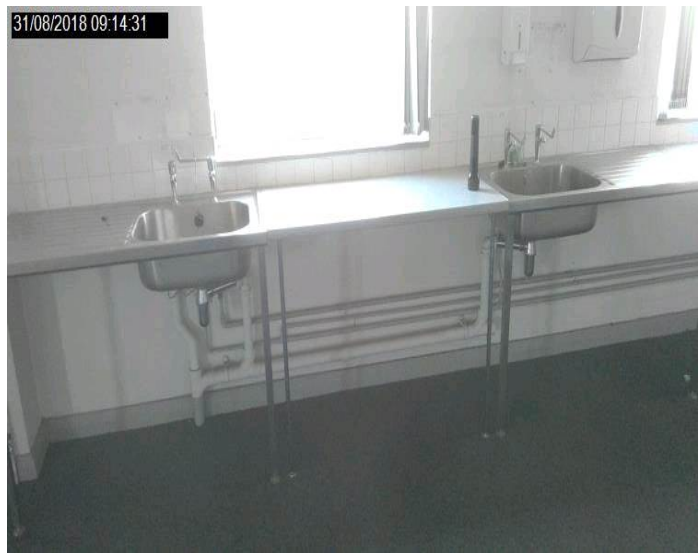
Item:	Bitumen sink pads			
Asbestos Content:		Result Based on:		
No Asbestos Detected		Strongly presumed		
Sample Analysed By:	Not applicable	Extent:	6 units	
Comments:

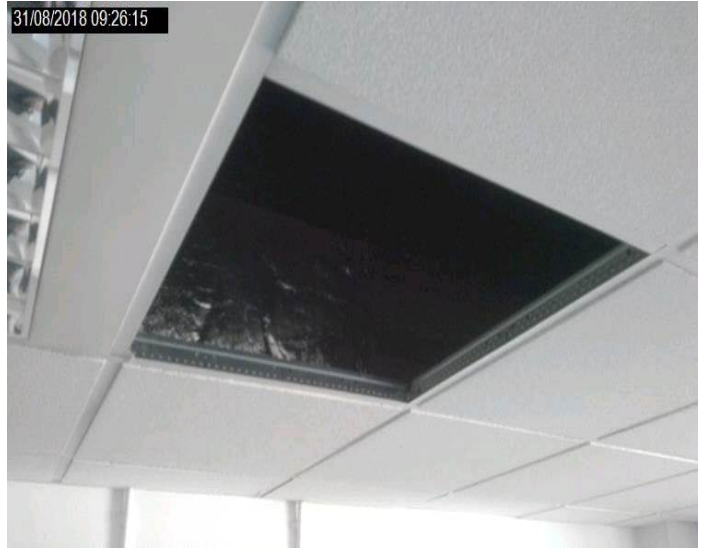
Item:	Asbestos Reinforced plastic pipe sleeve			
Asbestos Content:			Result Based on:	
Chrysotile			Strongly presumed	
Sample Analysed By:	Not applicable	Extent:	4 units	
Comments: Through structural concrete various points within ceiling void items run parallel generally throughout the ceiling void

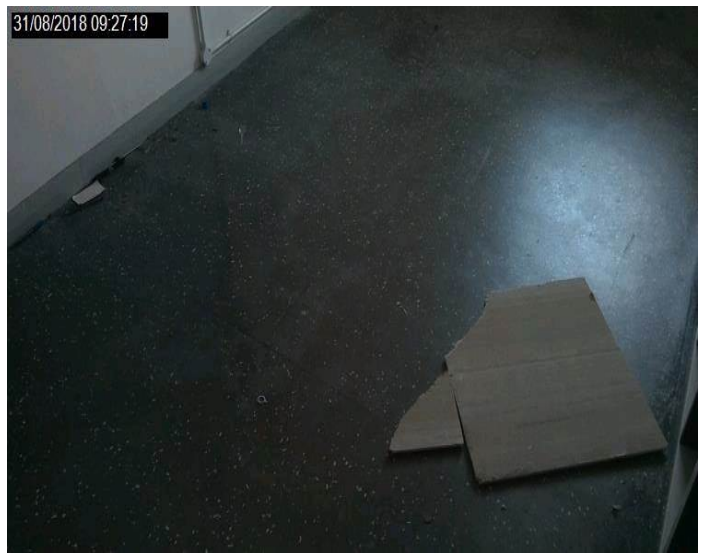
Item:	Asbestos Vinyl floor tiles			
Asbestos Content:	Result Based on:			
Chrysotile in bitumen adhesive only	Strongly presumed			
Sample Analysed By:	Not applicable	Extent:	16 m ²	
Comments:

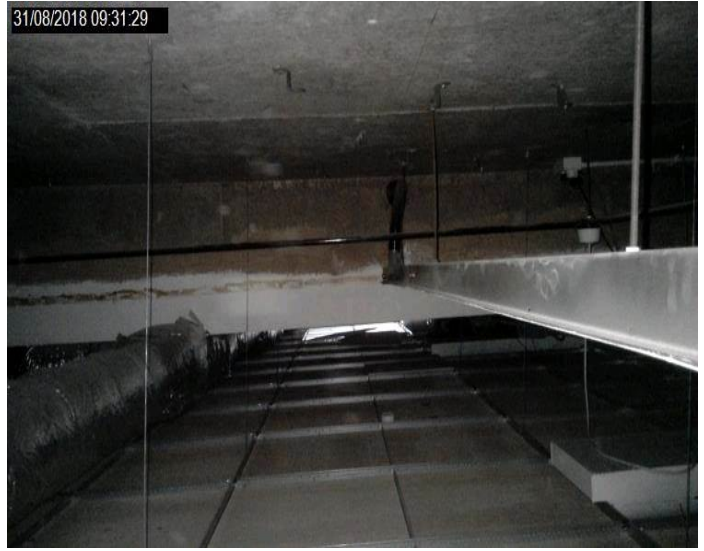
Item:	Asbestos Reinforced plastic pipe sleeve			
Asbestos Content:			Result Based on:	
Chrysotile			Strongly presumed	
Sample Analysed By:	Not applicable	Extent:	8 units	
Comments: Through structural concrete various points within ceiling void items run parallel generally throughout the ceiling void

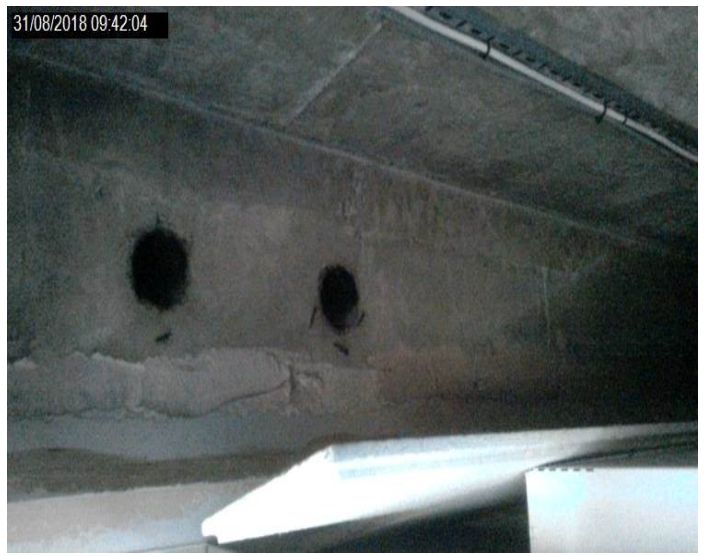
Item:	Asbestos Reinforced plastic pipe sleeve			
Asbestos Content:			Result Based on:	
Chrysotile			Strongly presumed	
Sample Analysed By:	Not applicable	Extent:	8 units	
Comments: Through structural concrete various points within ceiling void items run parallel generally throughout the ceiling void

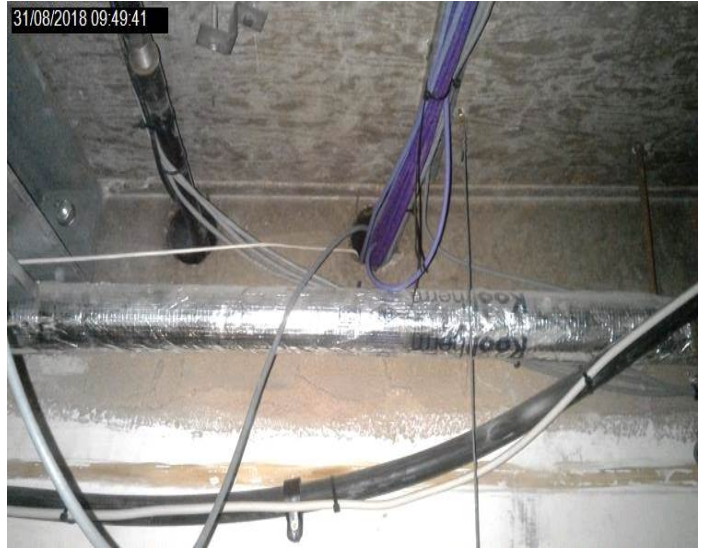
Item:	Asbestos Reinforced plastic sleeve			
Asbestos Content:	Result Based on:			
Chrysotile	Strongly presumed			
Sample Analysed By:	Not applicable	Extent:	25 units	
Comments: Top section of corridor within ceiling void, then again throughout the corridor through the structural concrete

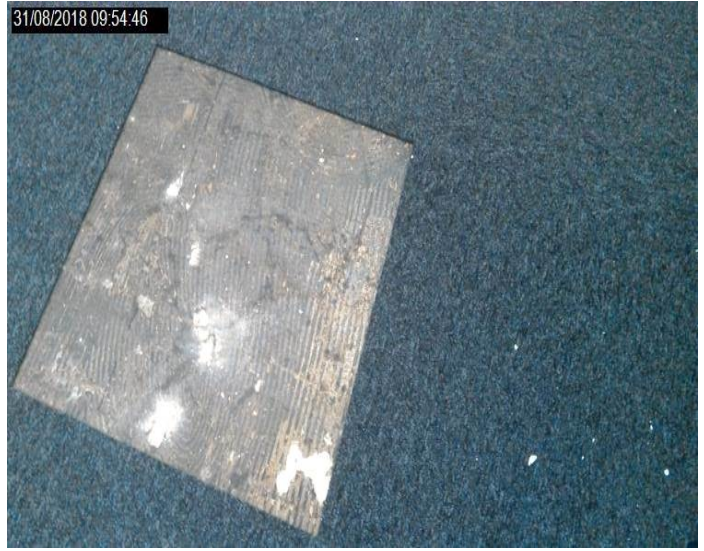
Item:	Asbestos Bitumen adhesive			
Asbestos Content:	Result Based on:			
Chrysotile	Analysis of sample using PLM			
Sample Analysed By:	Reg 13(1)	Extent:	100 m ²	
Comments:

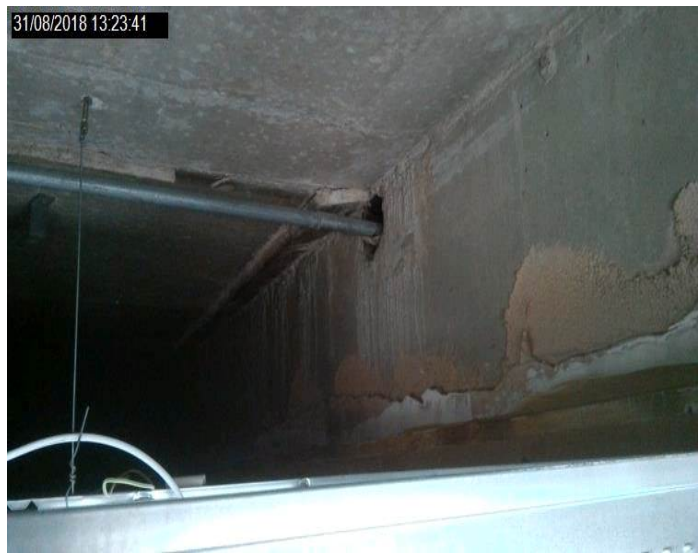
Item:	Asbestos Reinforced plastic sleeve			
Asbestos Content:	Result Based on:			
Chrysotile	Strongly presumed			
Sample Analysed By:	Not applicable	Extent:	6 units	
Comments:

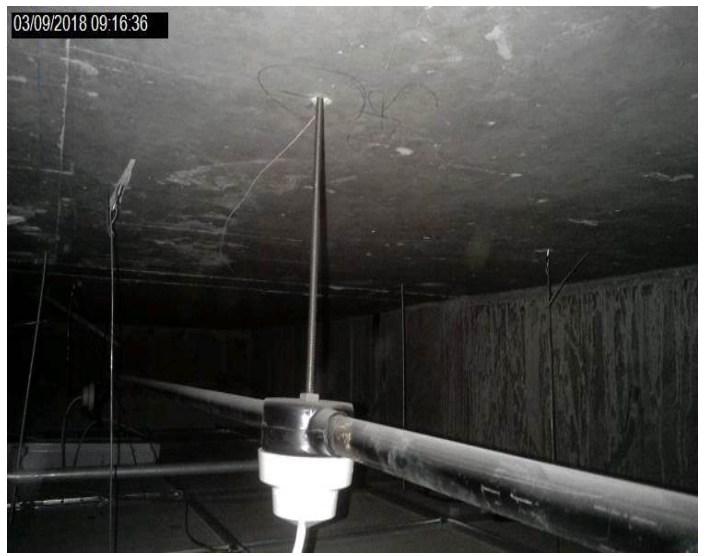
Item:	Asbestos Reinforced plastic sleeve			
Asbestos Content:	Result Based on:			
Chrysotile	Strongly presumed			
Sample Analysed By:	Not applicable	Extent:	2 units	
Comments:

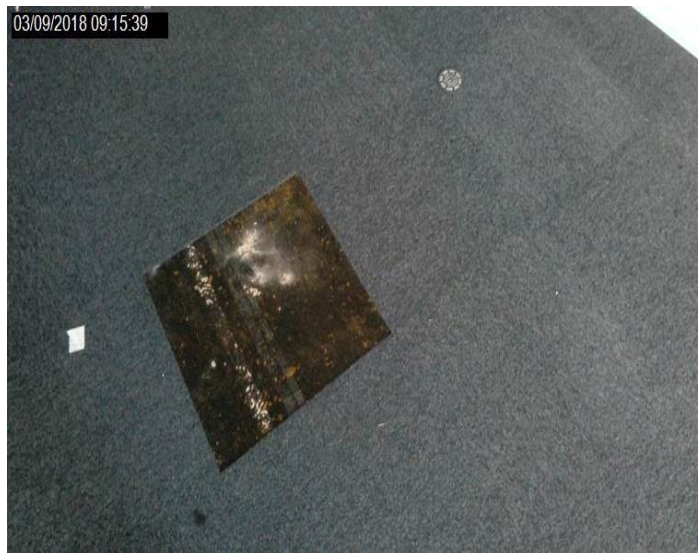
Item:	Asbestos Bitumen adhesive			
Asbestos Content:	Result Based on:			
Chrysotile	Analysis of sample using PLM			
Sample Analysed By: Reg 13(1)	Extent:	21 m ²		
Comments:

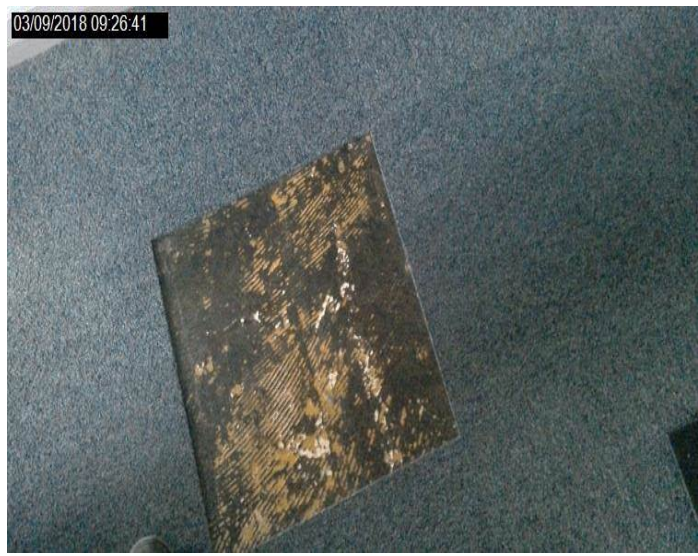
Item:	Asbestos Bitumen adhesive			
Asbestos Content:	Result Based on:			
Chrysotile	Strongly presumed			
Sample Analysed By:	Not applicable	Extent:	14 m ²	
Comments:

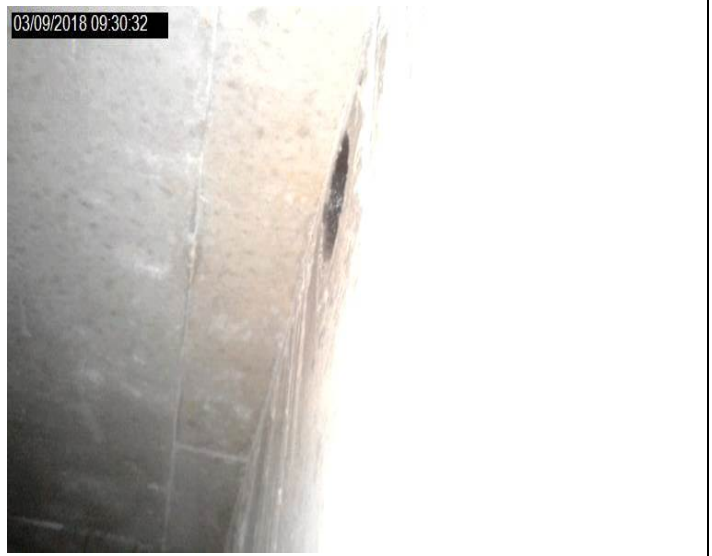
Item:	Asbestos Reinforced plastic sleeve			
Asbestos Content:	Result Based on:			
Chrysotile	Strongly presumed			
Sample Analysed By:	Not applicable	Extent:	3 units	
Comments:

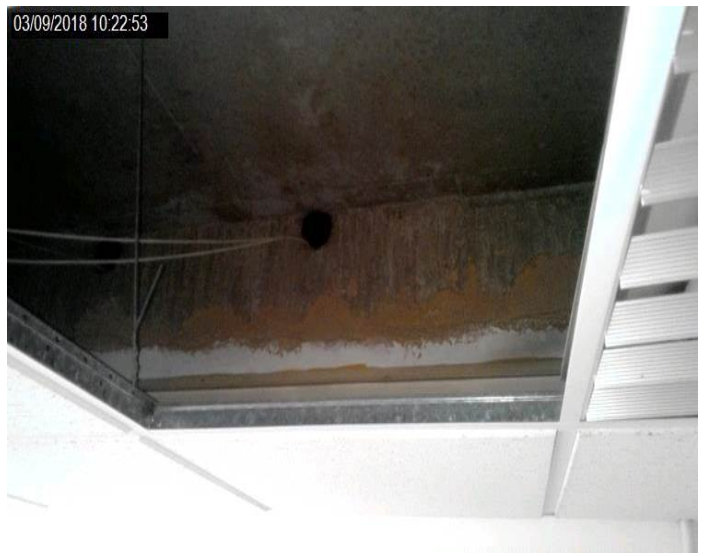
Item:	Asbestos Reinforced plastic sleeve			
Asbestos Content:	Result Based on:			
Chrysotile	Strongly presumed			
Sample Analysed By:	Not applicable	Extent:	3 units	
Comments:

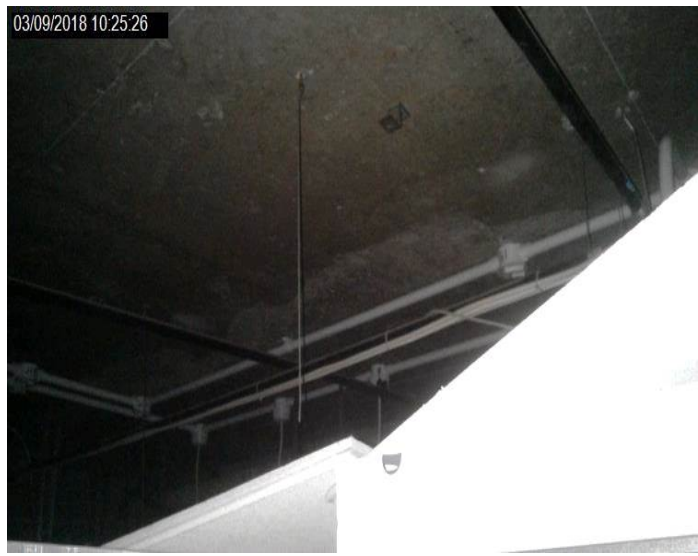
Item:	Asbestos Reinforced plastic sleeve			
Asbestos Content:	Result Based on:			
Chrysotile	Strongly presumed			
Sample Analysed By:	Not applicable	Extent:	12 units	
Comments:

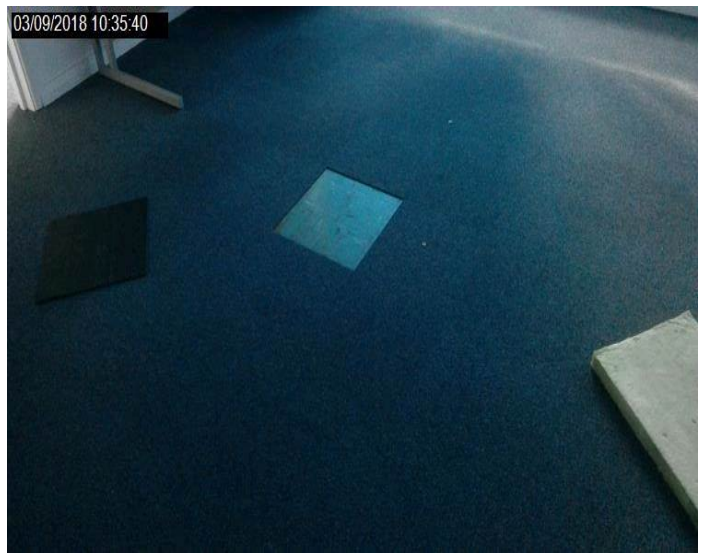
Item:	Asbestos Thermoplastic floor tiles			
Asbestos Content:	Result Based on:			
Chrysotile in tile and adhesive	Strongly presumed			
Sample Analysed By:	Not applicable	Extent:	22 m ²	
Comments:

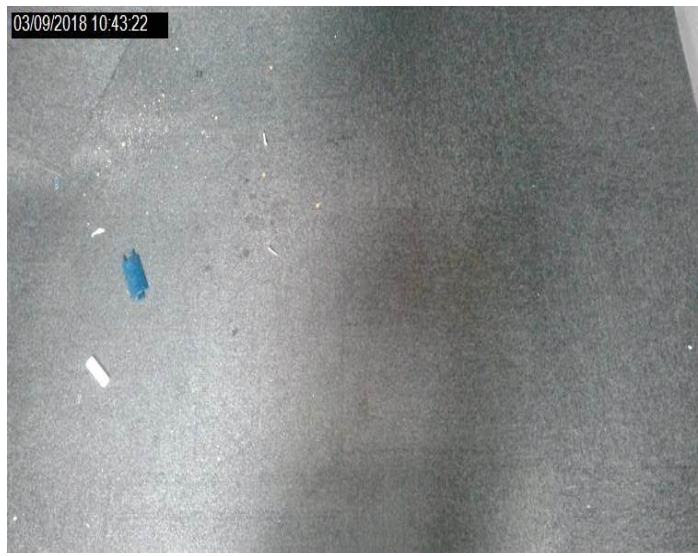
Item:	Asbestos Bitumen adhesive			
Asbestos Content:	Result Based on:			
Chrysotile	Strongly presumed			
Sample Analysed By:	Not applicable	Extent:	14 m ²	
Comments: Lifted elsewhere

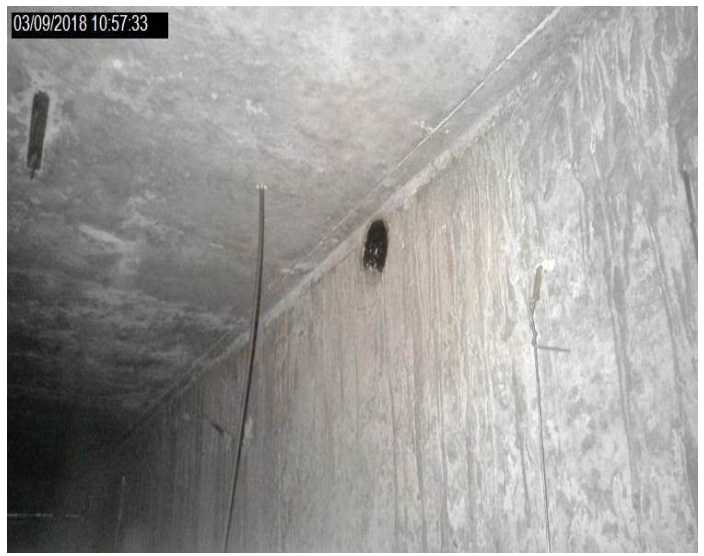
Item:	Asbestos Reinforced plastic sleeve			
Asbestos Content:	Result Based on:			
Chrysotile	Strongly presumed			
Sample Analysed By:	Not applicable	Extent:	4 units	
Comments:

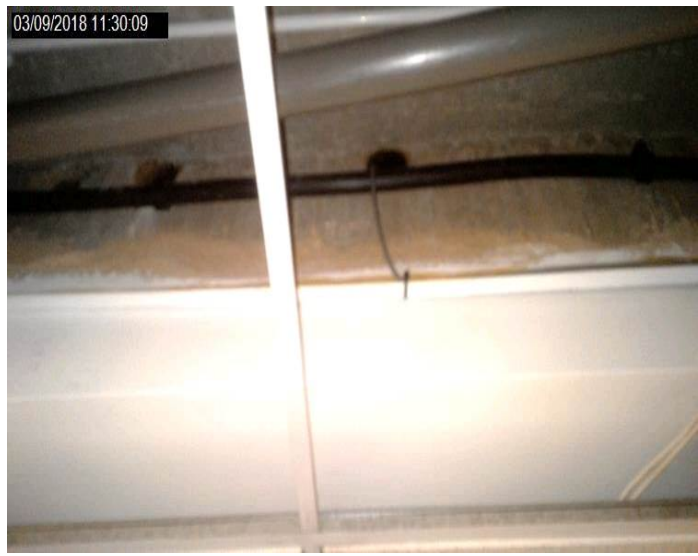
Item:	Asbestos Reinforced plastic sleeve			
Asbestos Content:	Result Based on:			
Chrysotile	Strongly presumed			
Sample Analysed By:	Not applicable	Extent:	8 units	
Comments: Passes through the ceiling

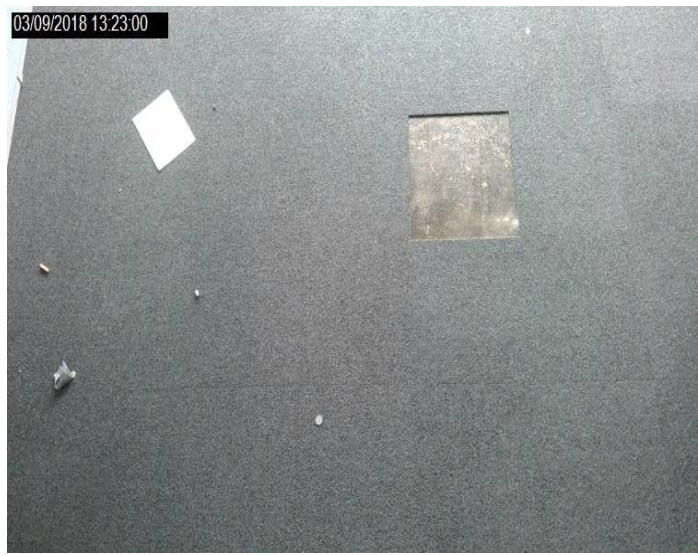
Item:	Asbestos Bitumen adhesive			
Asbestos Content:	Result Based on:			
Chrysotile	Strongly presumed			
Sample Analysed By:	Not applicable	Extent:	45 m ²	
Comments:

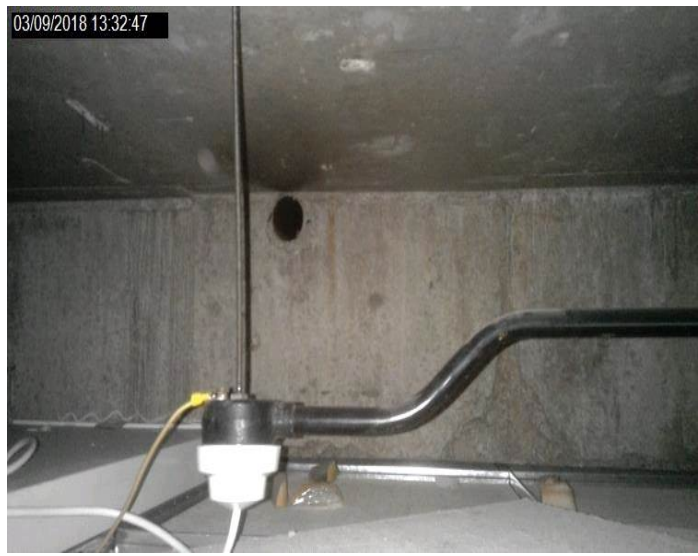
Item:	Asbestos Reinforced plastic sleeve			
Asbestos Content:	Result Based on:			
Chrysotile	Strongly presumed			
Sample Analysed By:	Not applicable	Extent:	6 units	
Comments: Through ceiling also where rooms join

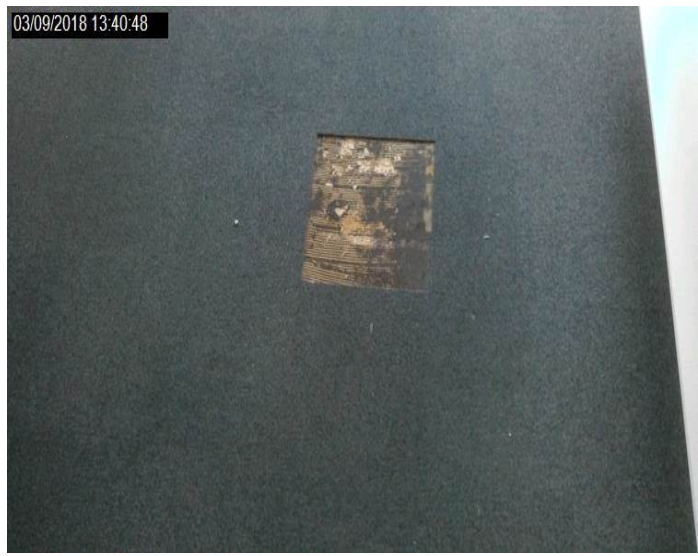
Item:	Asbestos Bitumen adhesive			
Asbestos Content:	Result Based on:			
Chrysotile	Strongly presumed			
Sample Analysed By:	Not applicable	Extent:	21 m ²	
Comments:

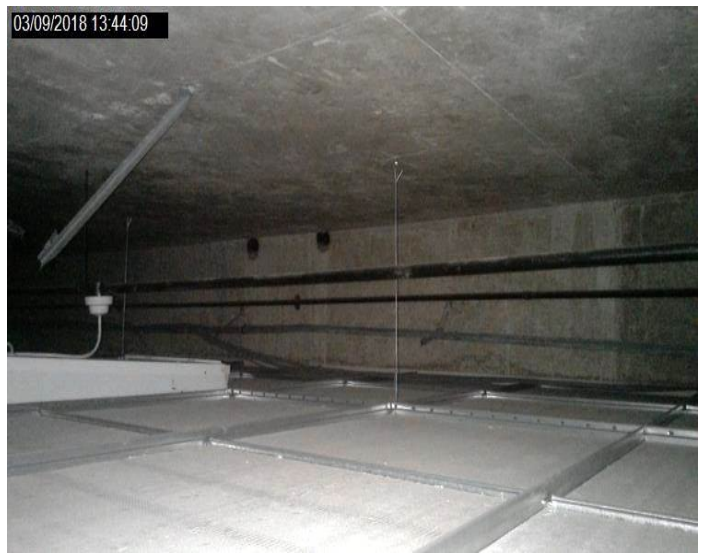
Item:	Asbestos Reinforced plastic sleeve			
Asbestos Content:	Result Based on:			
Chrysotile	Strongly presumed			
Sample Analysed By:	Not applicable	Extent:	6 units	
Comments:

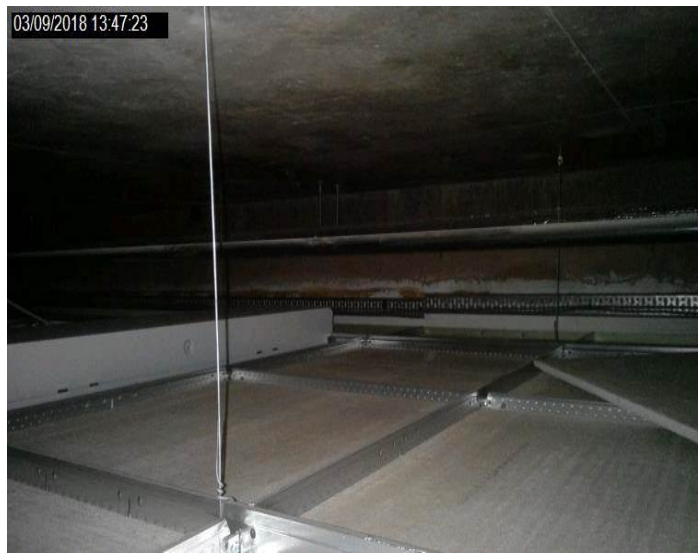
Item:	Asbestos Reinforced plastic sleeve			
Asbestos Content:	Result Based on:			
Chrysotile	Strongly presumed			
Sample Analysed By:	Not applicable	Extent:	8 units	
Comments:

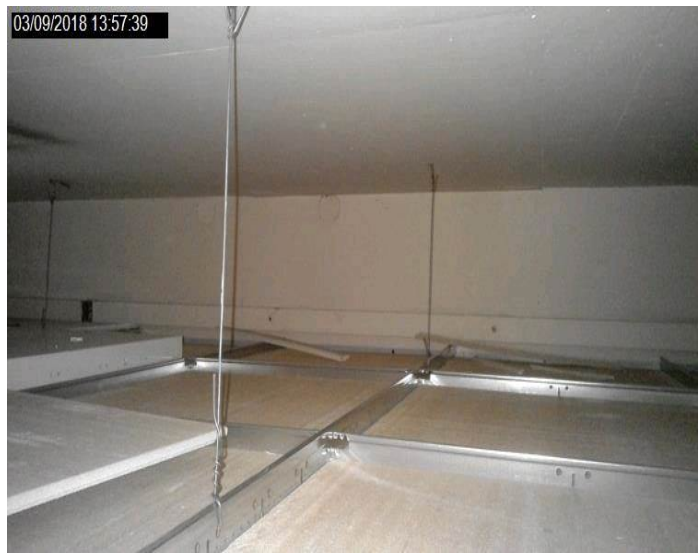
Item:	Asbestos Reinforced plastic sleeve			
Asbestos Content:	Result Based on:			
Chrysotile	Strongly presumed			
Sample Analysed By:	Not applicable	Extent:	3 units	
Comments:
