Report No.: J102749
Nature of Work: Demolition Survey
Issue Date: 02/11/2018
Client Name: WYG Engineering Ltd
 Geneva Building, Lake View Drive, Sherwood Business Park,
 Annesley, Nottingham, NG15 0ED
Site Address: Attwood Building, Former City North Campus, Birmingham City
 University, Perry Barr, B42 2US

1.0 Introduction & Scope of Work

A demolition survey in line with HSG264 Asbestos: The Survey Guide was carried out internally and externally to the property.

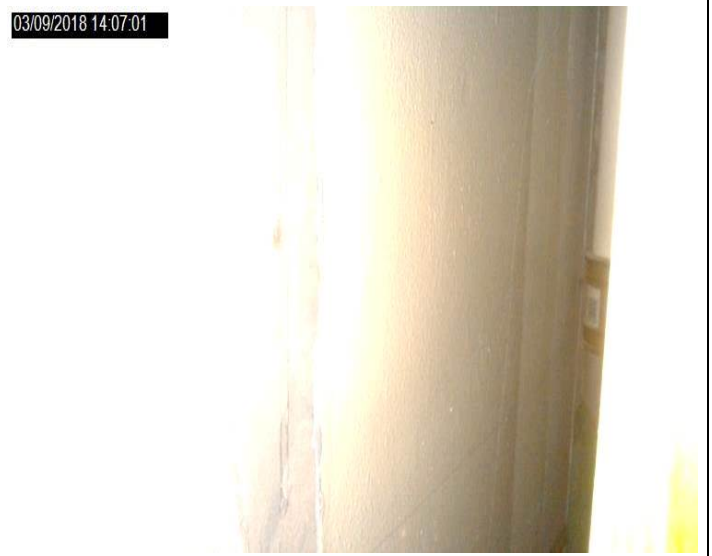
Item:	Textured coating to blockwork			
Asbestos Content:		Result Based on:		
No Asbestos Detected		Analysis of sample using PLM		
Sample Analysed By:	Reg 13(1)	Extent:	20 m ²	
Comments:

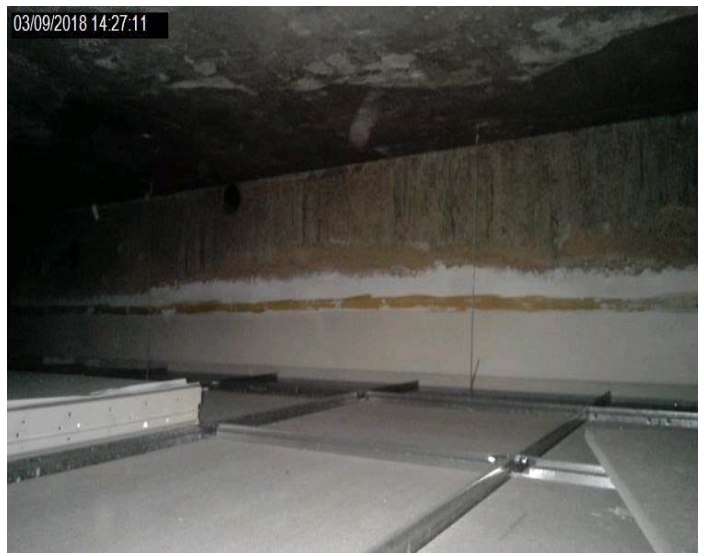
Item:	Asbestos Reinforced plastic sleeve			
Asbestos Content:	Result Based on:			
Chrysotile	Strongly presumed			
Sample Analysed By:	Not applicable	Extent:	8 units	
Comments:

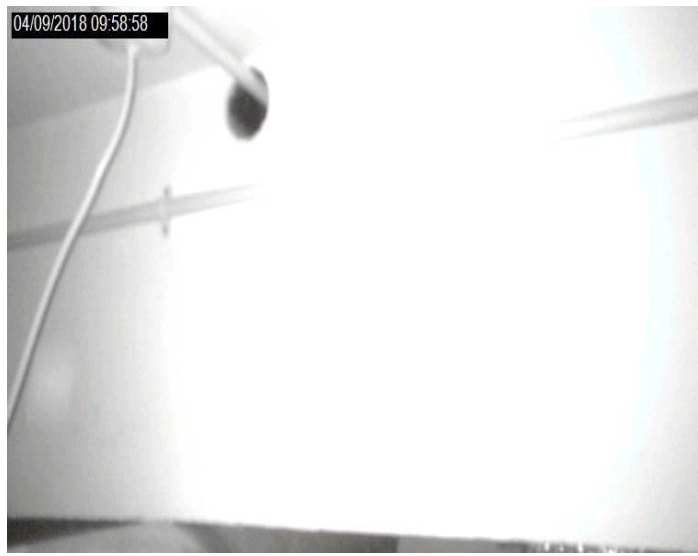
Item:	Asbestos Reinforced plastic sleeve			
Asbestos Content:	Result Based on:			
Chrysotile	Strongly presumed			
Sample Analysed By:	Not applicable	Extent:	1 unit	
Comments:

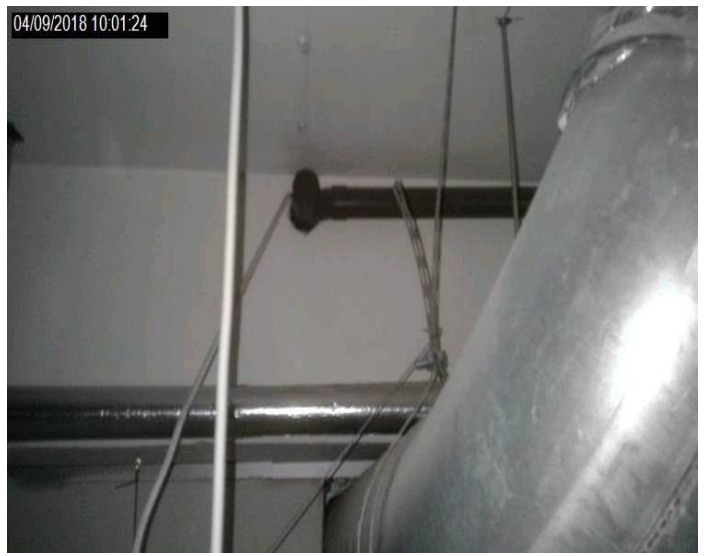
Item:	Asbestos Reinforced plastic sleeve			
Asbestos Content:	Result Based on:			
Chrysotile	Strongly presumed			
Sample Analysed By:	Not applicable	Extent:	1 unit	
Comments:

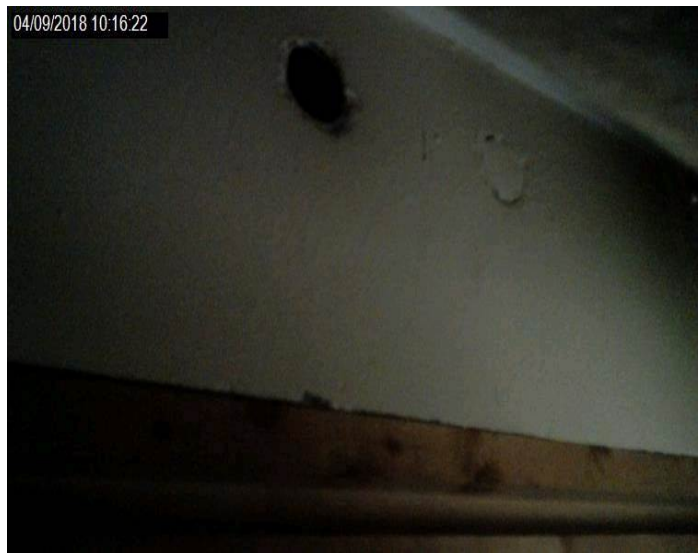
Item:	Asbestos Reinforced plastic sleeve			
Asbestos Content:	Result Based on:			
Chrysotile	Strongly presumed			
Sample Analysed By:	Not applicable	Extent:	2 units	
Comments:

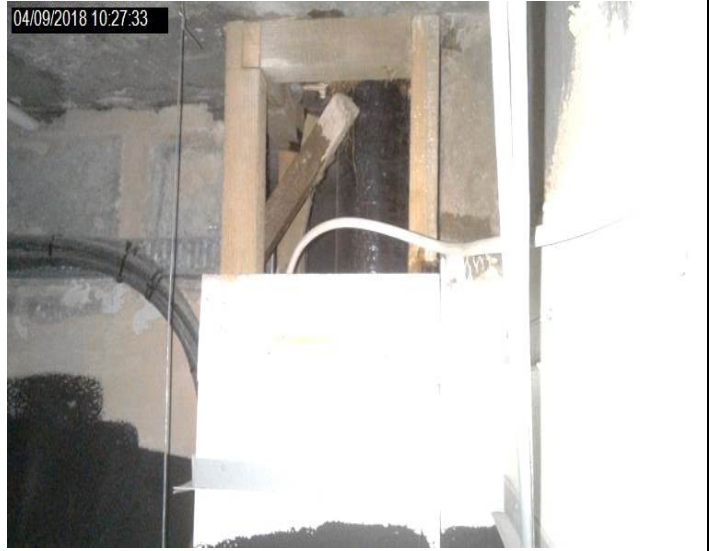
Item:	Asbestos Reinforced plastic downpipe			
Asbestos Content:	Result Based on:			
Chrysotile	Strongly presumed			
Sample Analysed By:	Not applicable	Extent:	4 linear metres	
Comments: Black pipe within timber boxing

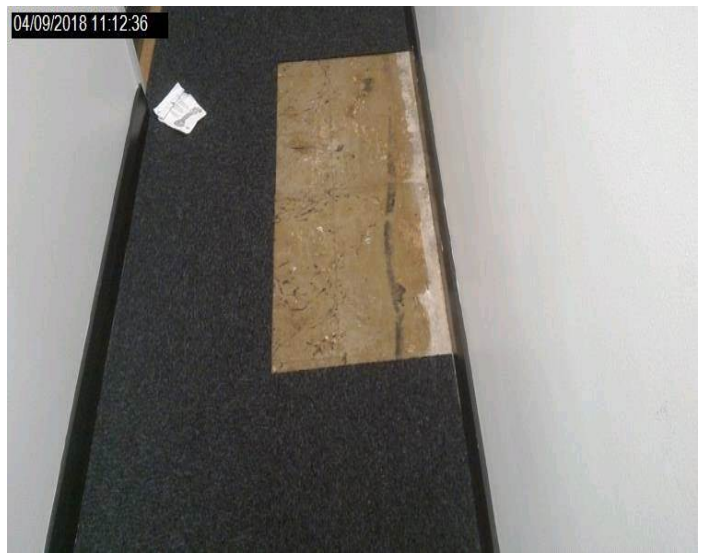
Item:	Asbestos Thermoplastic floor tiles			
Asbestos Content:	Result Based on:			
Chrysotile in tile and adhesive	Strongly presumed			
Sample Analysed By:	Not applicable	Extent:	5 m ²	
Comments: Corridor section outside room NAT113

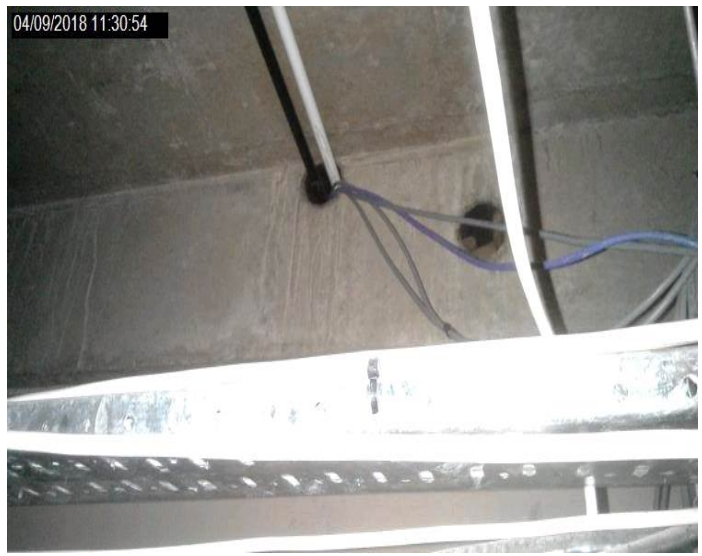
Item:	Asbestos Reinforced plastic sleeve			
Asbestos Content:	Result Based on:			
Chrysotile	Strongly presumed			
Sample Analysed By:	Not applicable	Extent:	16 units	
Comments: Estimated amount of sleeves
