Near miss with track workers near Kirtlebridge, Dumfries and Galloway, 14 November 2019

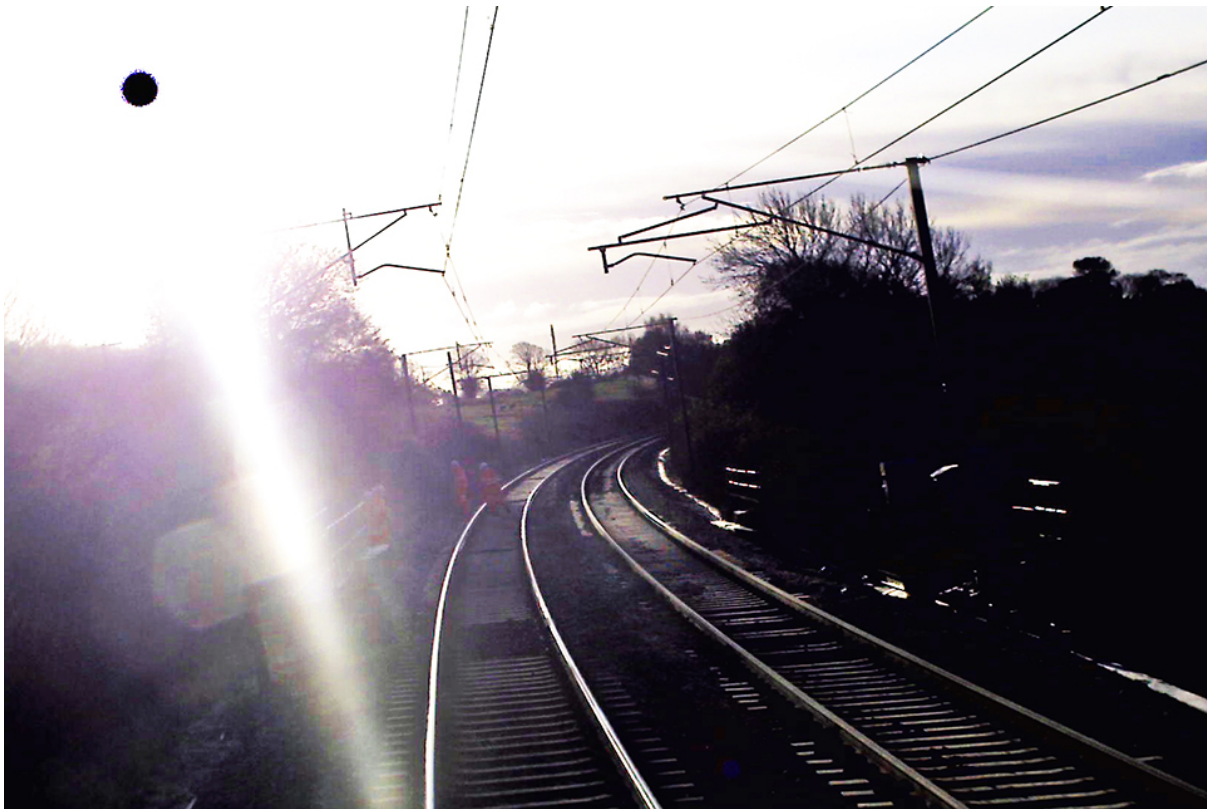
- 09:00:38 hrs First opportunity for train driver to see inspection team, although the train driver's view may have been restricted by sun glare.
- 09:00:40 hrs Train driver sounds horn.

- 09:00:41.5 hrs Inspection team clear of path of train.
- 09:00:42 hrs Train passes inspection team.

Forward-facing CCTV image from front of train approximately one second before it passed the inspection team (Virgin Trains). This image is affected by bright sunlight and has been enhanced to improve its clarity.
