General Inspection Report for Claydon I/C North (/A14//181.10//)

Summary

Structure Key	9942	Agent Name	Kier Highways - Area 6
Commissioned	01/01/1975	O.S. Grid Ref East/North	612890 / 249610
Bridge Type	Highway Underbridge	Number of Spans	3
Length	32.30	Overall Condition	Good
Date Inspected	04/12/2018		
Weather	Bright and dry		
Inspected by	██████████		
Authorised by	██████████		
Authorisation date	22/01/2019		
Method of Inspection	Visual		
Equipment Used	Camera		
Parts of Structure Not Inspected	Buried foundations, waterproofing and parts at height

Inspection Summary

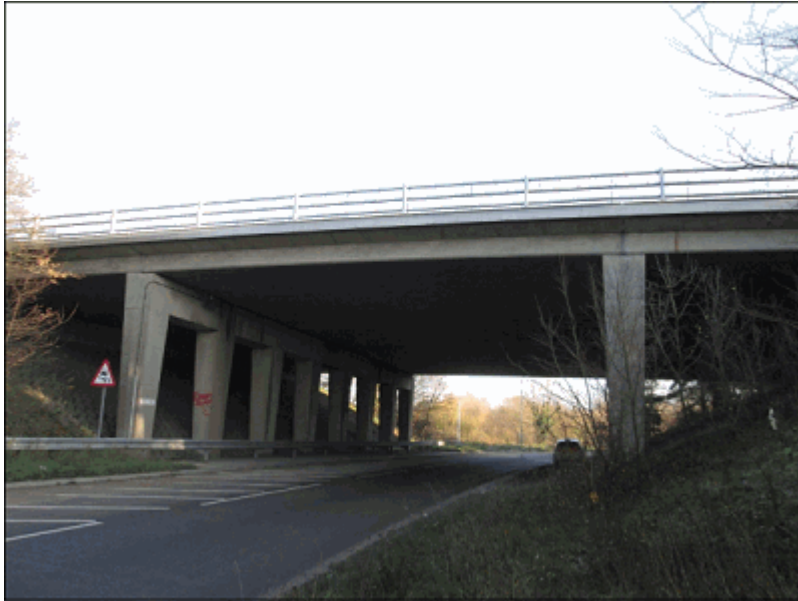
01 - West elevation

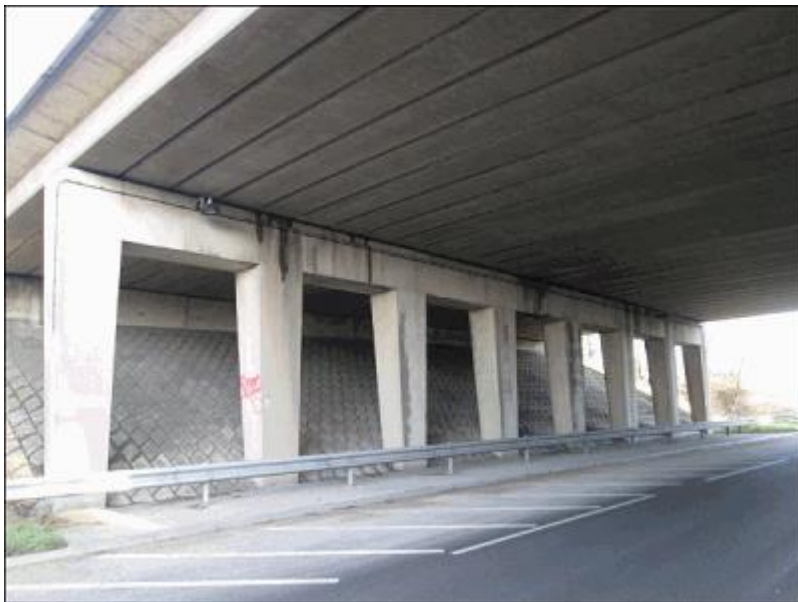
02 - North piers

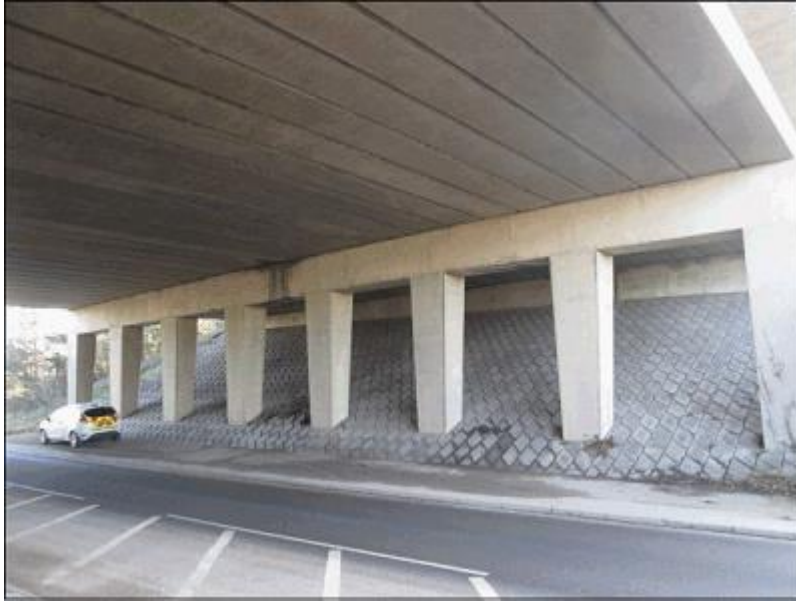
03 - South piers

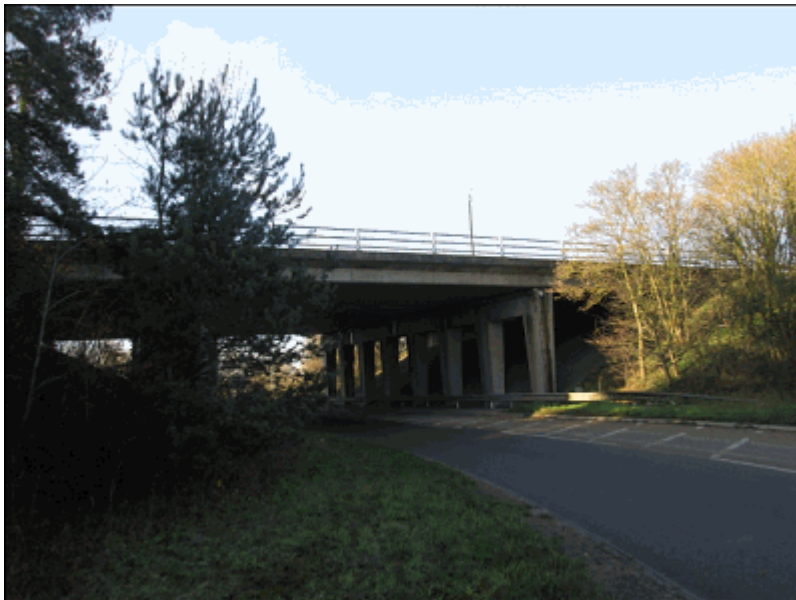
04 - East elevation

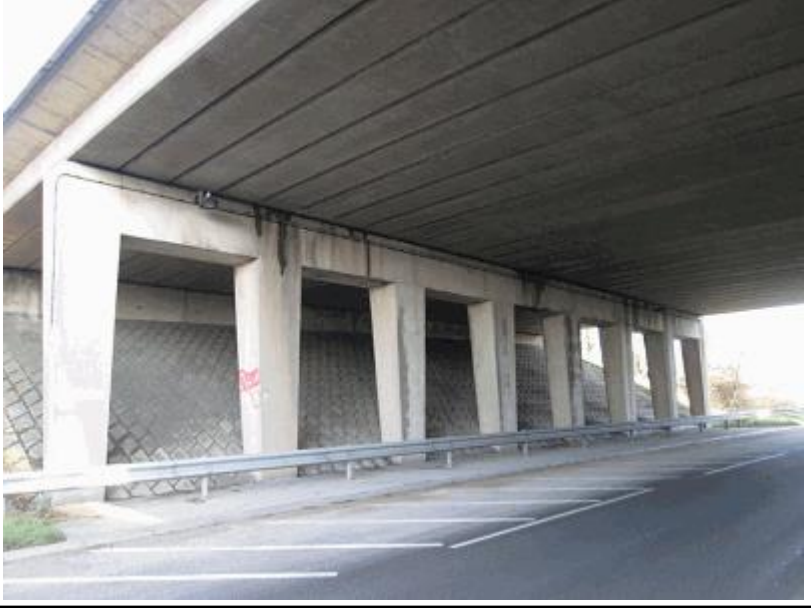
Components	North Pier - Cross head (north), South Pier - Cross head (south), North Abutment - Abutment Wall for North Abutment, South Abutment - Abutment Wall for South Abutment		
Defect Type	AI - Algal growth

Extent	SC - Defect present in 5% to not more than 20% of area or length of element		
Severity	D3 - Moderate: Defect is probably causing damage to element or structure, or is likely to do so in the near future		
Priority	Medium		
Comments	The portal piers are heavily stained with algal deposit and scaling. Water seepage is evident on the pier cross beam.		
Cause	Fixings Failure	Certainty	Medium

Comment on Cause	Joint failure above supports.		
Cause	The central reserve drainage gully may also have failed.		
	Staining to the north pier portals

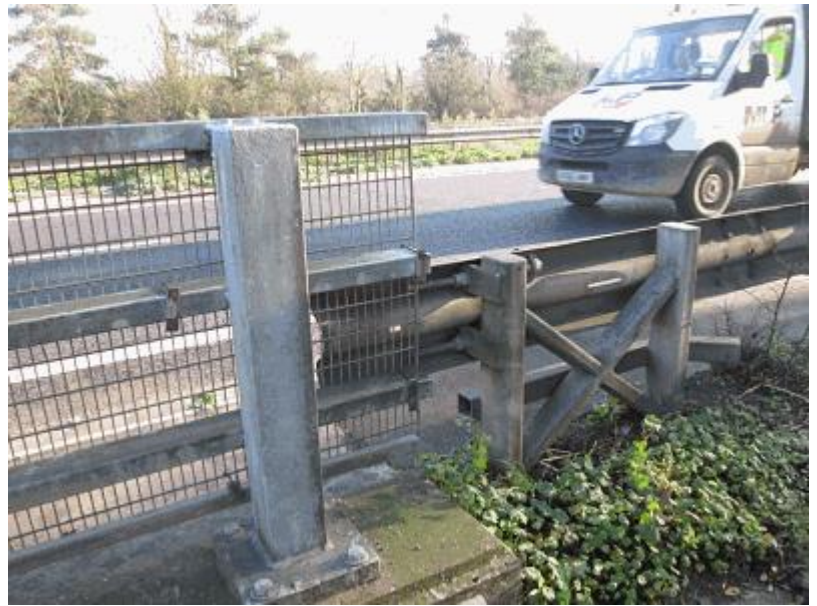
Components	North Pier - tensioned corrugated beam safety fencing (B1113)		
Defect Type	MissCo - Missing		
Extent	SB - Defect present in not more than 5% of area or length of element		
Severity	D2 - Minor: Defect is unlikely to be causing damage to the element or structure now or unlikely to do so in the near future		
Priority	Medium		
Comments	There are no connections between the safety fence and the parapets. Presence of full height anchor instead.		
Cause	Construction Issue	Certainty	High

Full height anchor block

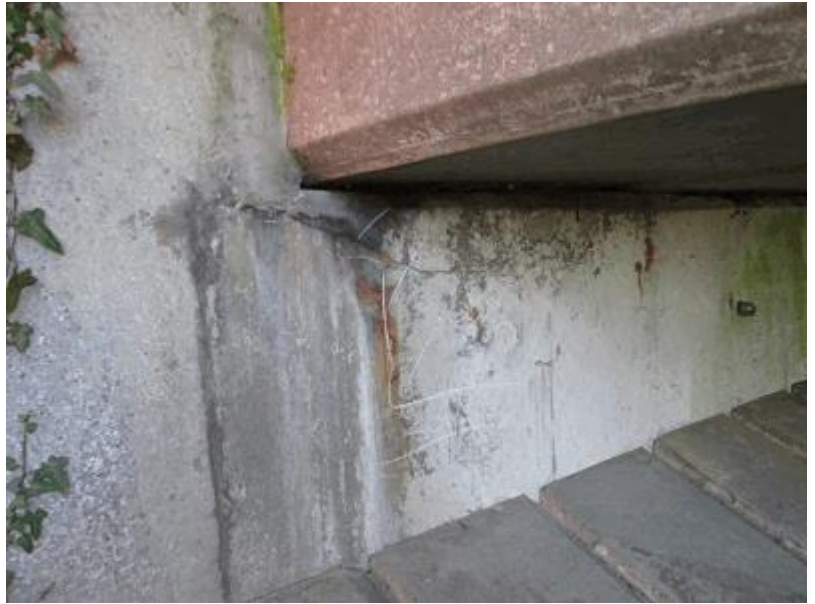
Cracking to the south abutment

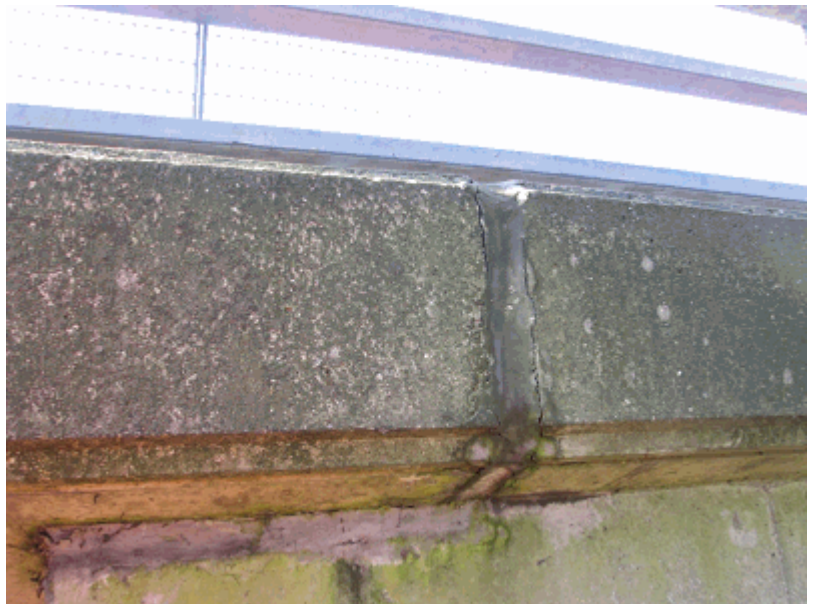
Defect Type Debo - Debonding

Severity D2 - Minor: Defect is unlikely to be causing damage to the element or structure now or unlikely to do so in the near future

Comments The polysulphide joints sealant have degraded and are debonding.

Typical deterioration of the polysulphide sealant

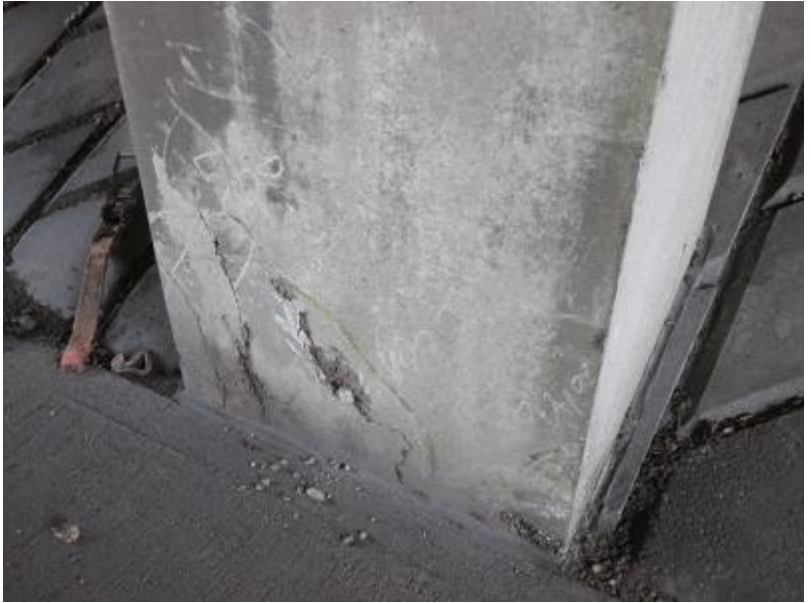
Components	North Pier - Piers / Columns for North Pier	
Defect Type	Sp - Spalled area

Extent	SB - Defect present in not more than 5% of area or length of element	
Severity	D2 - Minor: Defect is unlikely to be causing damage to the element or structure now or unlikely to do so in the near future	
Priority	Low	
Comments	North piers, at the base of the fifth column from the west, two areas of spalling (approx 300m long x 100mm wide and 20mm deep) and a crack 400mm long and 0.55mm wide. There is corrosive staining in the vicinity of the spall. Delamination now extends to 600x500mm. Other areas of delaminated concrete were noted to pier bases.	
	Spalling to the north pier leg

Maintenance Object	Pier/Column	Maintenance Action	Repair
Estimated Cost	£1,000	Recomm. Action Date	01/04/2016
Priority Category	3	Risk Score	41
Comments	Undertake minor concrete repair to areas of spalling.		
Maintenance Object	Concrete Deck	Maintenance Action	Repair
Estimated Cost	£1,000	Recomm. Action Date	01/04/2016
Priority Category	3	Risk Score	25
Comments	Remove corroding objects and repair spalling on the west deck cantiliver soffit.		
Maintenance Object	Revetment	Maintenance Action	Repair
Estimated Cost	£500	Recomm. Action Date	01/04/2016
Priority Category	3	Risk Score	25
Comments	Replace missing slab on the north revetment.		
Maintenance Object	Parapet	Maintenance Action	Paint
Estimated Cost	£6,000	Recomm. Action Date	01/04/2016
Priority Category	3	Risk Score	25
Comments	Localised paint repairs to parapet		
Maintenance Object	Parapet	Maintenance Action	Repair
Estimated Cost	£2,000	Recomm. Action Date	01/04/2016

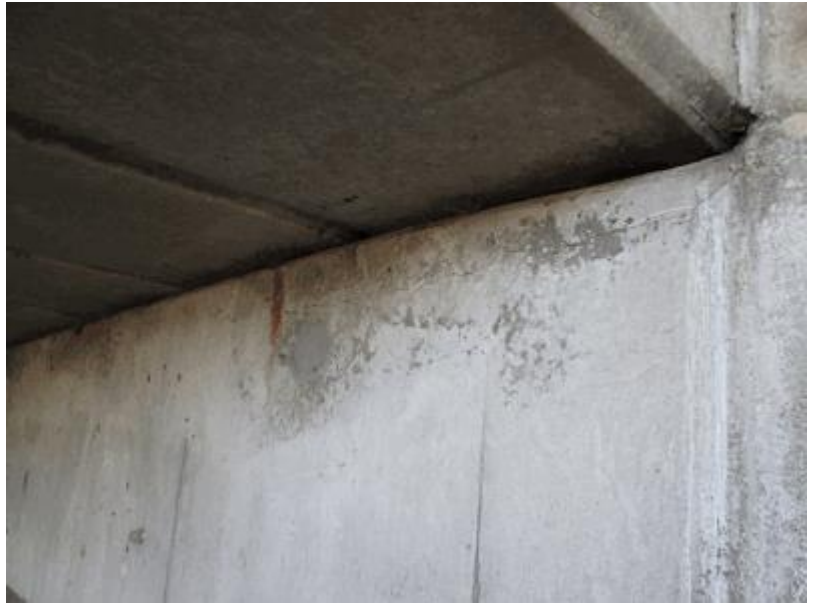
Components	South Abutment - Abutment Wall for South Abutment	
Defect Type	Cr - Crack of uncertain origin or a combination of causes	
Extent	SC - Defect present in 5% to not more than 20% of area or length of element	
Severity	D1 - Defect is definitely not causing damage to element or structure

Priority	Medium	
Comments	Longitudinal crack (approx 6m) at the West end of the South abutment. There is a rusty leak at the East end of that crack.

Cracking to the south abutment

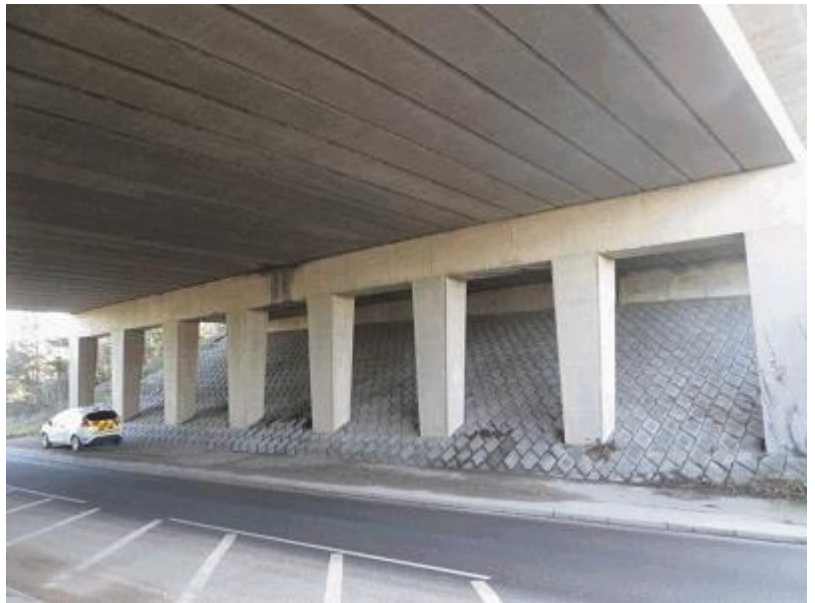
Defect Type MissCo - Missing

Priority High

Comments There is no safety fence protection to the south pier portal.

No safety fence protection to the south pier portal

Maintenance Object	Safety Fence	Maintenance Action	Install
Estimated Cost	£20,000	Recomm. Action Date	30/09/2014
Priority Category	2	Risk Score	92
Comments	Provide safety fence protection to the south pier portal		
Maintenance Object	Concrete	Maintenance Action	Repair
Estimated Cost	£30,000	Recomm. Action Date	01/08/2017
Priority Category	3	Risk Score	72
Comments	Repair areas of delaminated concrete caused by reinforcement corrosion.		
Maintenance Object	Expansion Joint	Maintenance Action	Replace
Estimated Cost	£25,000	Recomm. Action Date	30/09/2014
Priority Category	3	Risk Score	65
Comments	Investigate cause of water seepage. If joints are found to leak repair joints. Note the defect is likely to occur at the interface of the phased joint replacement works near the central reserve. In addition, the longitudinal joint between the two bridge decks may be the cause of water seepage. In addition to the above joint repairs will be required as a consequence of resurfacing works.

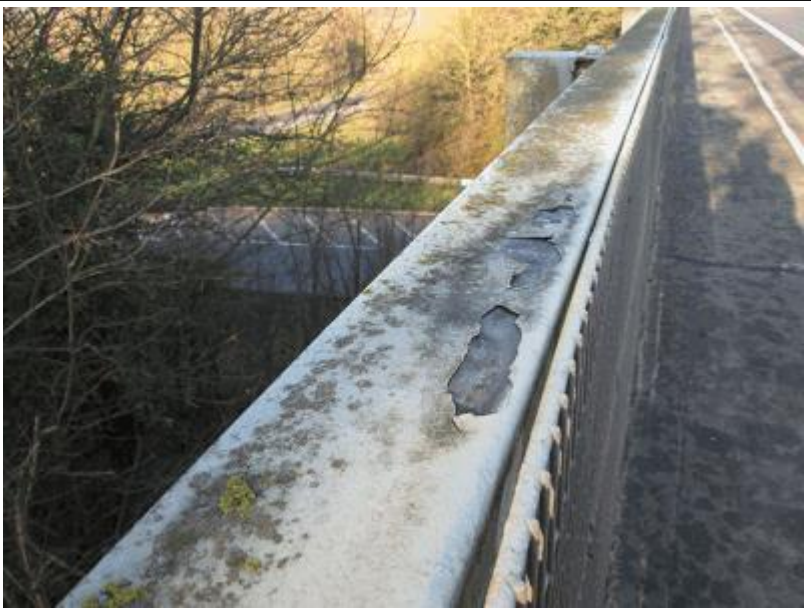
Components	West Deck (north side span - west) - West Parapet, East Deck (north side span - east) - East Parapet, West Deck (south side span - west) - West Parapet, West Deck(main span - west) - West Parapet, East Deck (main span - east) - East Parapet, East Deck(south side span - east) - East Parapet		
Defect Type	PDeg - Other degradation or breakdown

Extent	SC - Defect present in 5% to not more than 20% of area or length of element		
Severity	P2 - Minor loss of protection likely in the near future		
Priority	Low		
Comments	The parapet rails and posts are subject to loss and general deterioration of the paint system. The infill mesh fixings are suffering from corrosion.		
Cause	Corrosion	Certainty	High

Comment on Cause			
	Deterioration of the parapet paint system

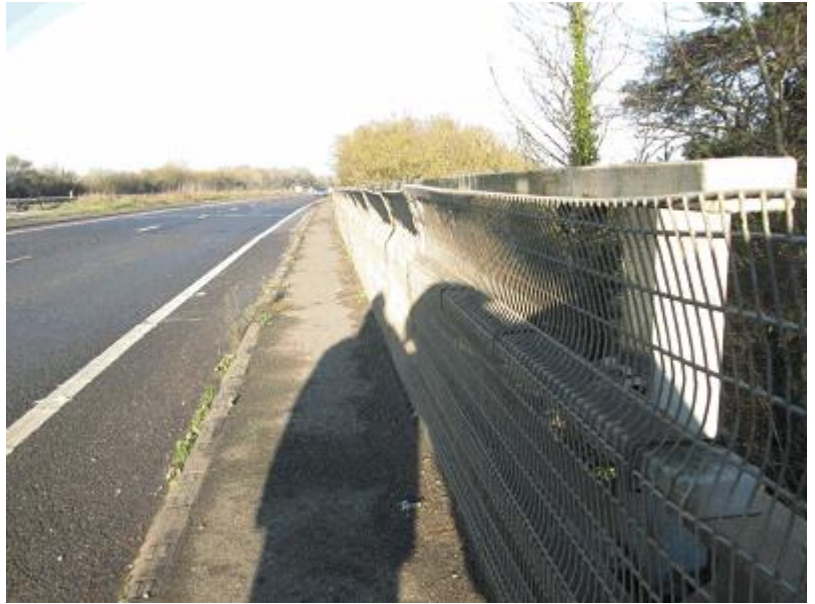
Components	East Deck(south side span - east) - East Parapet		
Defect Type	AD - Impact (accident) damage other

Extent	SC - Defect present in 5% to not more than 20% of area or length of element		
Severity	D2 - Minor: Defect is unlikely to be causing damage to the element or structure now or unlikely to do so in the near future		
Priority	Low		
Comments	The mesh infill to the east parapet has minor impact damage approximately 15m long.		
Cause	Accident Damage	Certainty	High

Mesh infill to the east parapet has minor impact damage

Priority Category	3	Risk Score	25
Comments	Replace deformed mesh infill east parapet.

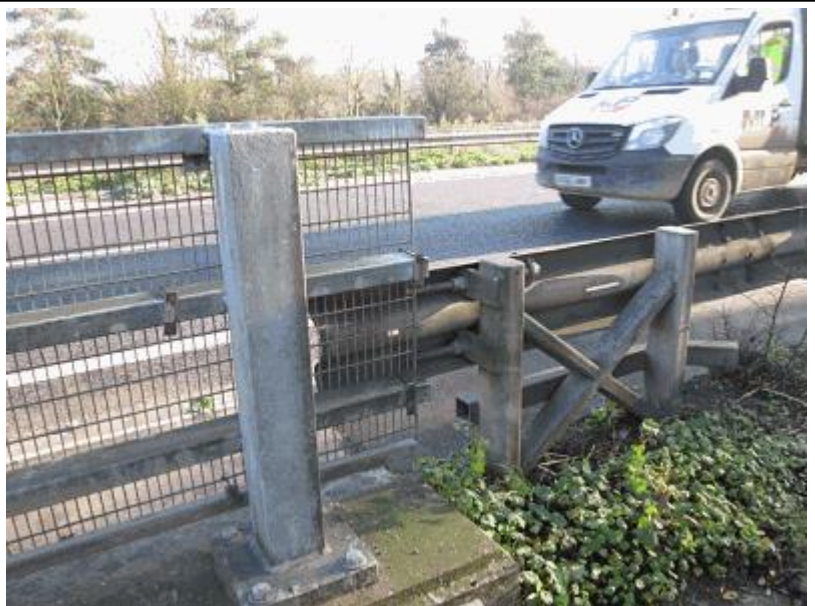
Components	East Deck (north side span - east) - East Parapet, East Deck(south side span - east) - East Parapet		
Defect Type	MissCo - Missing		
Extent	SB - Defect present in not more than 5% of area or length of element		
Severity	D2 - Minor: Defect is unlikely to be causing damage to the element or structure now or unlikely to do so in the near future		
Priority	Medium		
Comments	There are no connections between the safety fence and the parapets. Presence of full height anchor instead.		
Cause	Construction Issue	Certainty	High
Comment on Cause	Full height anchor block

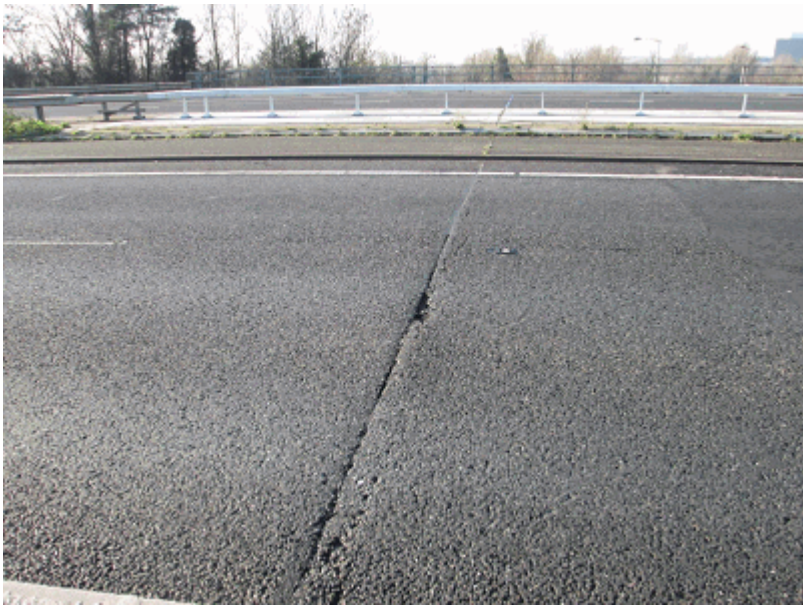
Components	East Deck (main span - east) - Joint 2 east (north verge piers), East Deck (main span - east) - Joint 3 east (south verge piers), West Deck(main span - west) - Joint 3 west (south verge piers), East Deck(south side span - east) - Joint 4 east (south abutment), West Deck (south side span - west) - Joint 4 west (south abutment), West Deck (north side span - west) - Joint 1 (north abutment - west bound), East Deck (north side span - east) - Joint 1 (north abutment - east bound), West Deck(main span - west) - Joint 2 west (north verge piers)		
Defect Type	CrCo - Cracked		
Extent	SC - Defect present in 5% to not more than 20% of area or length of element		
Severity	D3 - Moderate: Defect is probably causing damage to element or structure, or is likely to do so in the near future		
Priority	High		
Comments	There is no sealant across portions of the saw cuts in the carriageway surfacing above deck joints which may be a point of entrance for water damaging elements below.

Cause	Maintenance Issue	Certainty	Medium
Comment on Cause			
	Southbound south joint

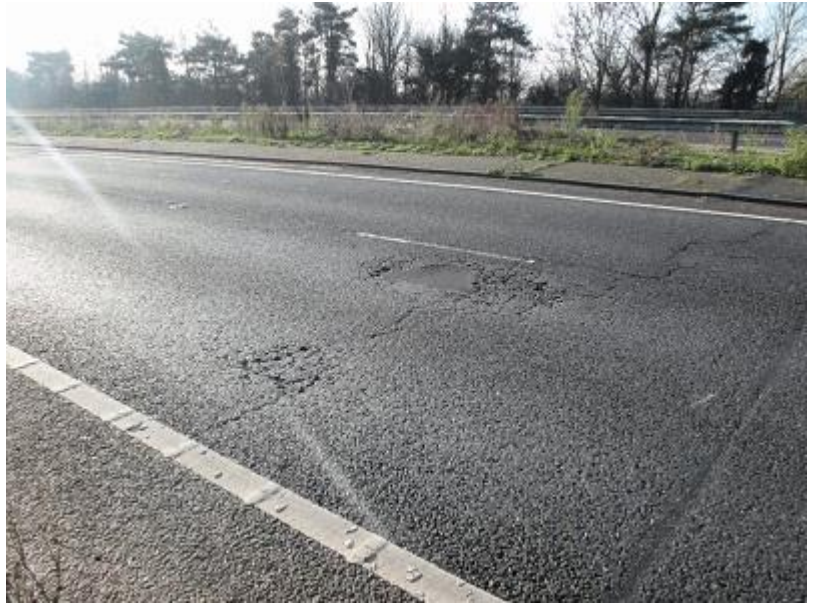
Components	East Deck (north side span - east) - A14 east bound surfacing (replaced Nov 07)		
Defect Type	CrCo - Cracked		
Extent	SB - Defect present in not more than 5% of area or length of element		
Severity	D3 - Moderate: Defect is probably causing damage to element or structure, or is likely to do so in the near future		
Priority	Medium		
Comments	There was cracking in the carriageway on the departure to the Eastbound carriageway behind the abutment.		
Cause	Unable to Determine	Certainty	Medium

Deterioration of the eastbound carriageway departure

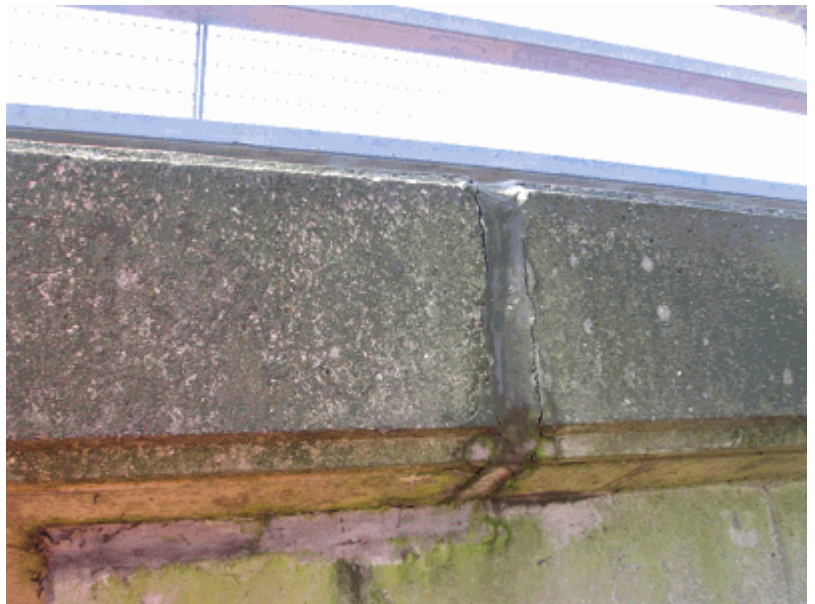
Defect Type Debo - Debonding

Severity D2 - Minor: Defect is unlikely to be causing damage to the element or structure now or unlikely to do so in the near future

Comments The polysulphide joints sealant have degraded and are debonding.

Typical deterioration of the polysulphide sealant

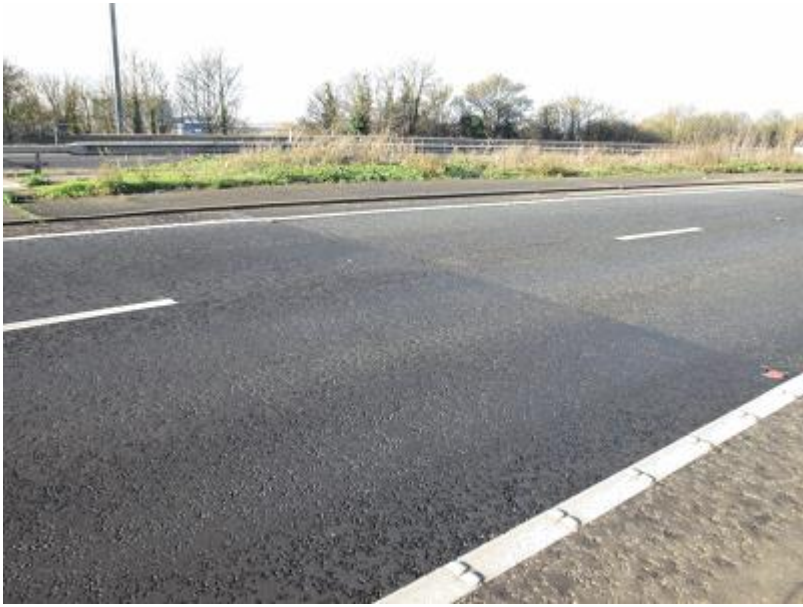
Components	West Deck(main span - west) - A14 westbound surfacing (replaced Sept 09), West Deck (north side span - west) - A14 westbound surfacing (replaced Sept 09), East Deck (north side span - east) - Joint 1 (north abutment - east bound), East Deck (main span - east) - Joint 2 east (north verge piers)		
Defect Type	PH - Pothole

Extent	SB - Defect present in not more than 5% of area or length of element		
Severity	D1 - Defect is definitely not causing damage to element or structure		
Priority	Low		
Comments	RESURFACED Potholing and surfacing deterioration is present to the eastbound carriageway at North pier and over abutment. Pothole has been reported to NCC for repair in 24HRS ref.51023525-51023760. 50-2016 G.I.		
Cause	Age Expired	Certainty	High

Comment on Cause	Lack of binding agent to the aggregate leading to movement of material and breakup of the surfacing.		
	Resurfaced carriageway

Maintenance Object	Surfacing	Maintenance Action	Replace
Estimated Cost	£80,000	Recomm. Action Date	30/09/2014
Comments	Resurfacing of westbound lane 1 over the entire structure. Repairs/replacement of burried joint and waterproofing will also be required.

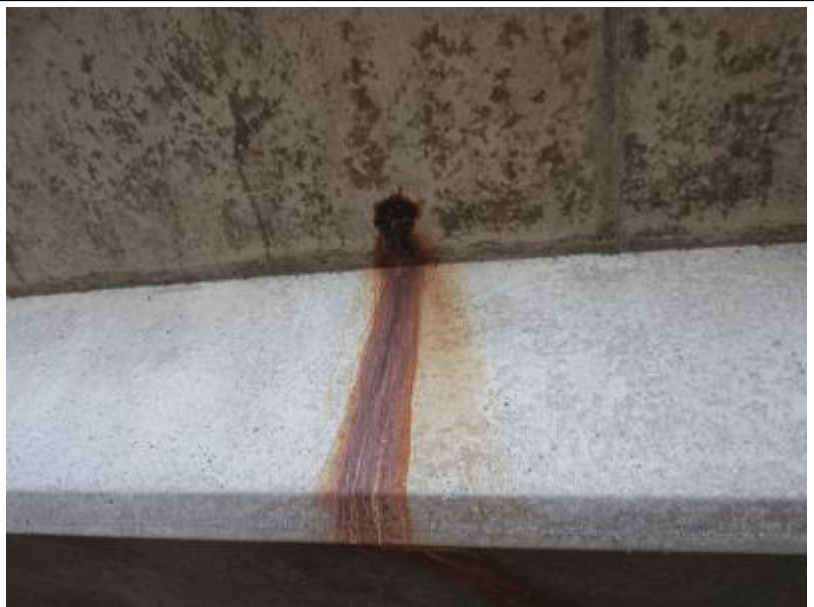
Components	West Deck (south side span - west) - parapet cantilever, North Abutment - north abutment bearings
Defect Type	FO - Foreign object

Extent	SB - Defect present in not more than 5% of area or length of element
Severity	D2 - Minor: Defect is unlikely to be causing damage to the element or structure now or unlikely to do so in the near future
Priority	Low
Comments	In the west cantilever at the south end there is an area of corroding ferrous material with a spall, approx 60mm diameter. Similar defect in the same area approximately 1m south of the south pier. Also, a small area of exposed corroding steel on the north abutment east end.

Corroding ferrous material with a spall
