General Inspection Report for Claydon I/C North (/A14//181.10//)

The structure is a simply supported three span underbridge and carries the A14, two lane, dual carriageway all purpose trunk road and two verges over the B1113 interchange through the centre span.

A14 Claydon I/C North was found to be in fair condition. Potholes to both carriageways have been reported to the NCC for temporary repair within 24 HRS. 05-2016.No new defects added.

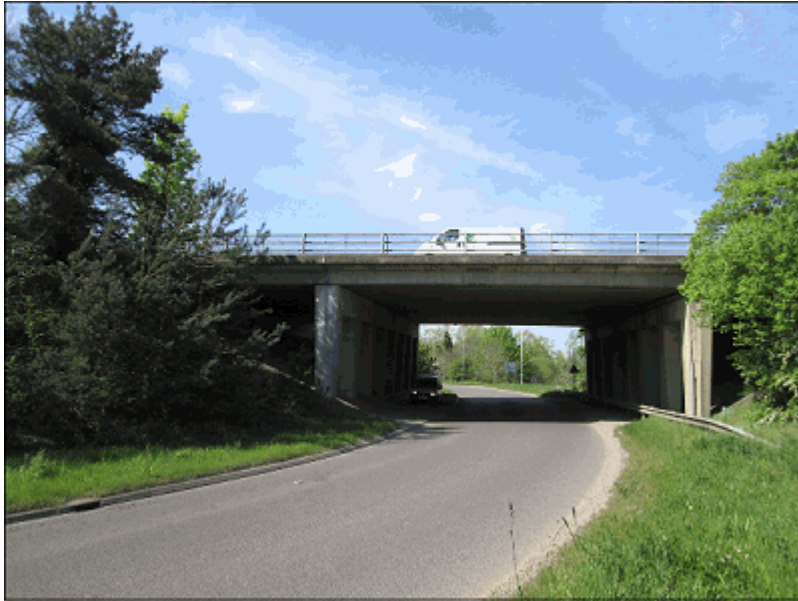
East elevation.

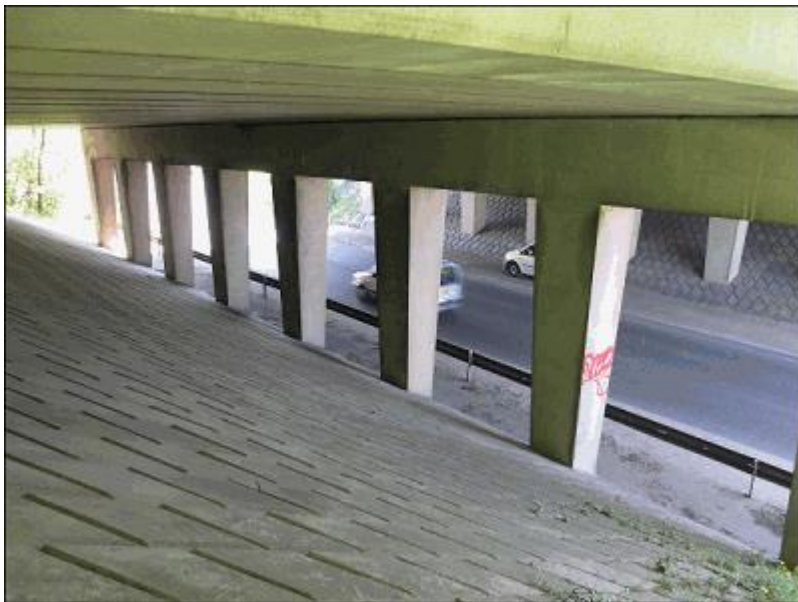
North piers.

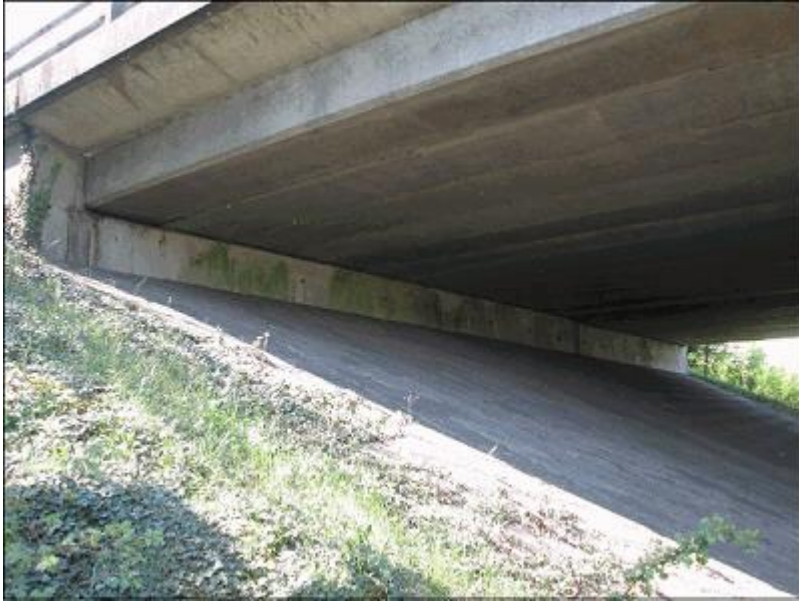
South abutment/revetment.

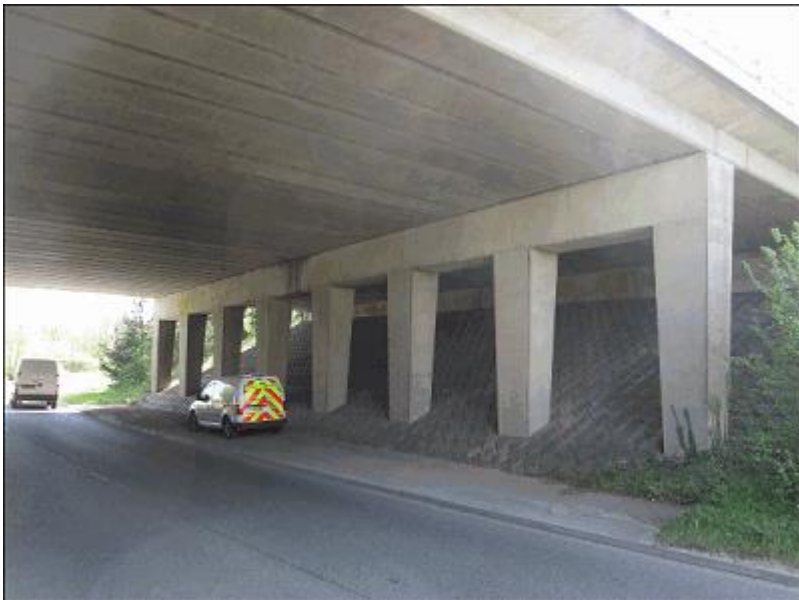
South piers.

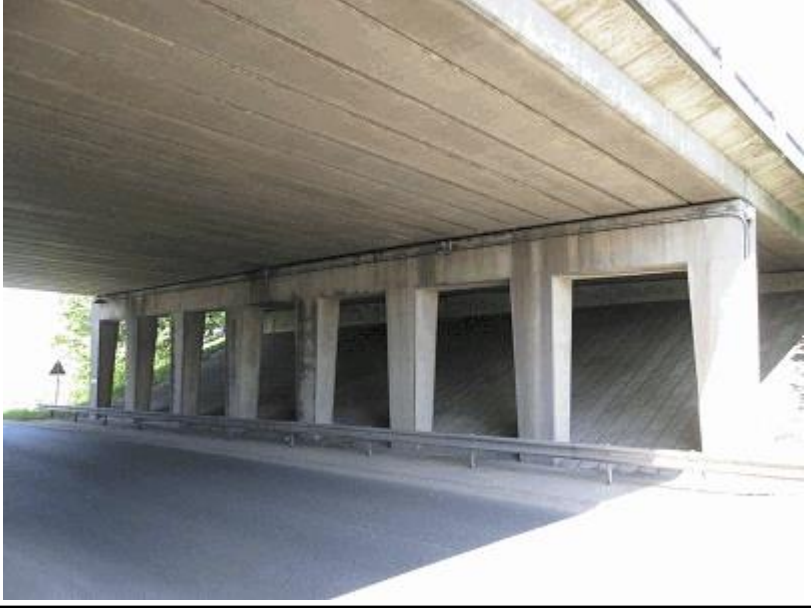
Components	North Pier - Cross head (north), South Pier - Cross head (south), North Abutment - Abutment Wall for North Abutment, South Abutment - Abutment Wall for South Abutment		
Defect Type	AI - Algal growth

Extent	SC - Defect present in 5% to not more than 20% of area or length of element		
Severity	D3 - Moderate: Defect is probably causing damage to element or structure, or is likely to do so in the near future		
Priority	Medium		
Comments	The portal piers are heavily stained with algal deposit and scaling. Water seepage is evident on the pier cross beam.		
Cause	Fixings Failure	Certainty	Medium

Comment on Cause	Joint failure above supports.		
Cause	The central reserve drainage gully may also have failed.		
	<p>North portal piers are heavily stained.</p>

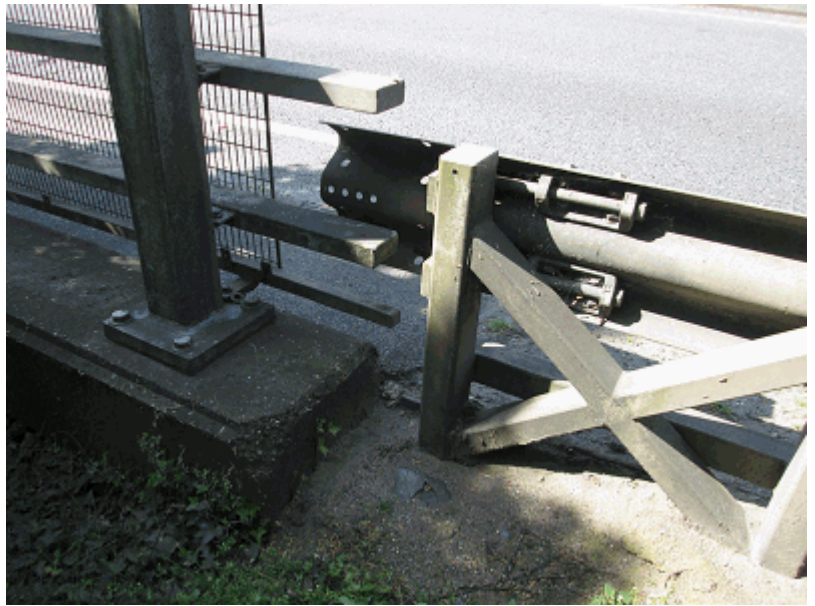
Components	North Pier - tensioned corrugated beam safety fencing (B1113)		
Defect Type	MissCo - Missing		
Extent	SB - Defect present in not more than 5% of area or length of element		
Severity	D2 - Minor: Defect is unlikely to be causing damage to the element or structure now or unlikely to do so in the near future		
Priority	Medium		
Comments	There are no connections between the safety fence and the parapets. Presence of full height anchor instead.		
Cause	Construction Issue	Certainty	High

No connections to NE parapet.

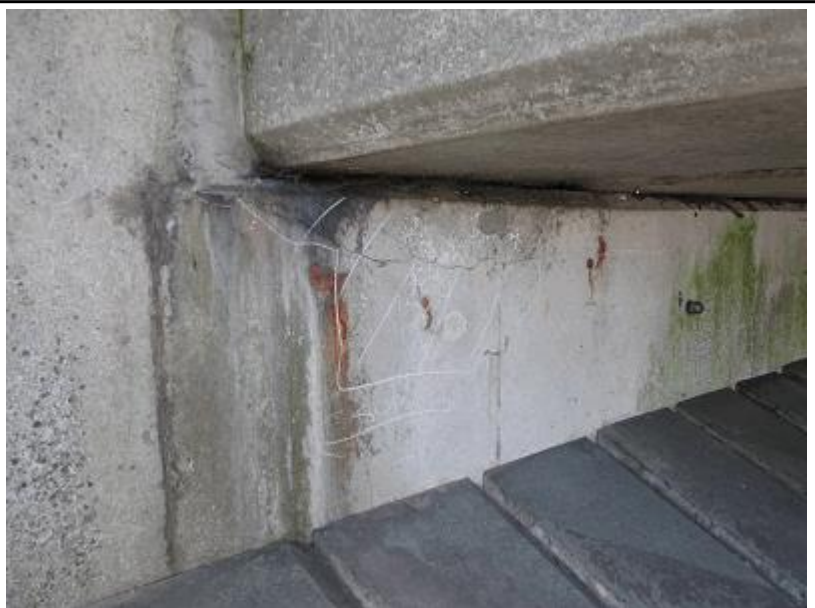
Defect Type Cr - Crack of uncertain origin or a combination of causes

Comments The South abutment, a number of cracks were noted which are showing damp and rust staining. Delaminated concrete is common adjacent to these cracks. Cracking also noted in the North bankseat wall.

South abutment cracking SE corner.

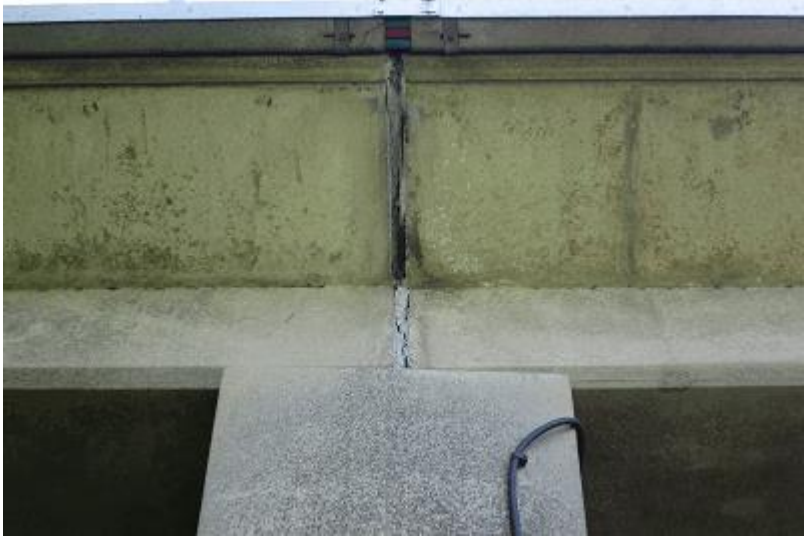
Components	South Pier - Piers / Columns for South Pier	
Defect Type	Debo - Debonding	
Extent	SB - Defect present in not more than 5% of area or length of element	
Severity	D2 - Minor: Defect is unlikely to be causing damage to the element or structure now or unlikely to do so in the near future	
Priority	Low	
Comments	The polysulphide joints sealant have degraded and are debonding.	
	NW polysulphide joint debonding.

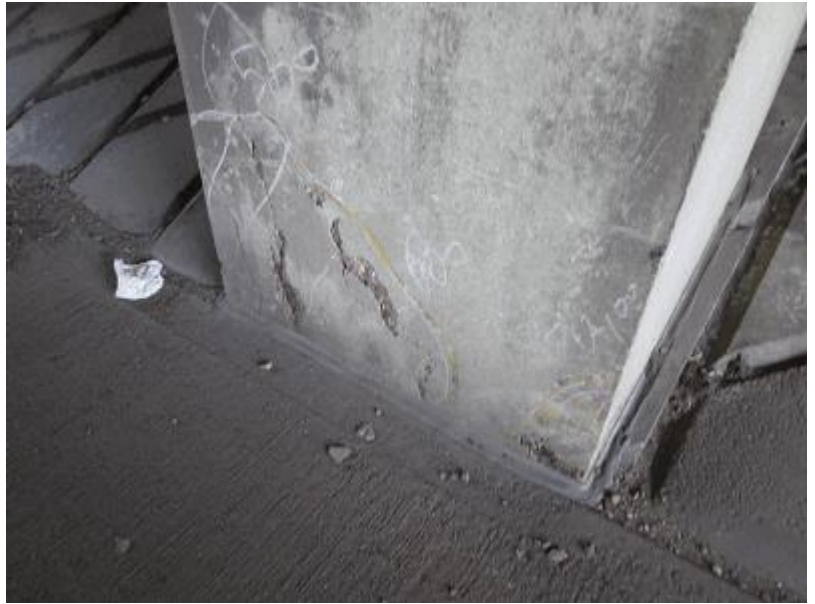
Components	North Pier - Piers / Columns for North Pier	
Defect Type	Sp - Spalled area

Extent	SB - Defect present in not more than 5% of area or length of element	
Severity	D2 - Minor: Defect is unlikely to be causing damage to the element or structure now or unlikely to do so in the near future	
Priority	Low	
Comments	North piers, at the base of the fifth column from the west, two areas of spalling (approx 300mm long x 100mm wide and 20mm deep) and a crack 400mm long and 0.55mm wide. There is corrosive staining in the vicinity of the spall. Delamination now extends to 600x500mm. Other areas of delaminated concrete were noted to pier bases.

North piers, fifth pier from west, two areas of spalling.

Maintenance Object	Pier/Column	Maintenance Action	Repair
Estimated Cost	£1,000	Recomm. Action Date	01/04/2016
Priority Category	3	Risk Score	41
Comments	Undertake minor concrete repair to areas of spalling.		
Maintenance Object	Revetment	Maintenance Action	Repair
Estimated Cost	£500	Recomm. Action Date	01/04/2016
Priority Category	3	Risk Score	25
Comments	Replace missing slab on the north revetment.		
Maintenance Object	Parapet	Maintenance Action	Paint
Estimated Cost	£6,000	Recomm. Action Date	01/04/2016
Priority Category	3	Risk Score	25
Comments	Localised paint repairs to parapet		
Maintenance Object	Parapet	Maintenance Action	Repair
Estimated Cost	£2,000	Recomm. Action Date	01/04/2016
Priority Category	3	Risk Score	25
Comments	Replace deformed mesh infill east parapet.		
Maintenance Object	Concrete Deck	Maintenance Action	Repair
Estimated Cost	£1,000	Recomm. Action Date	01/04/2016
Priority Category	3	Risk Score	25

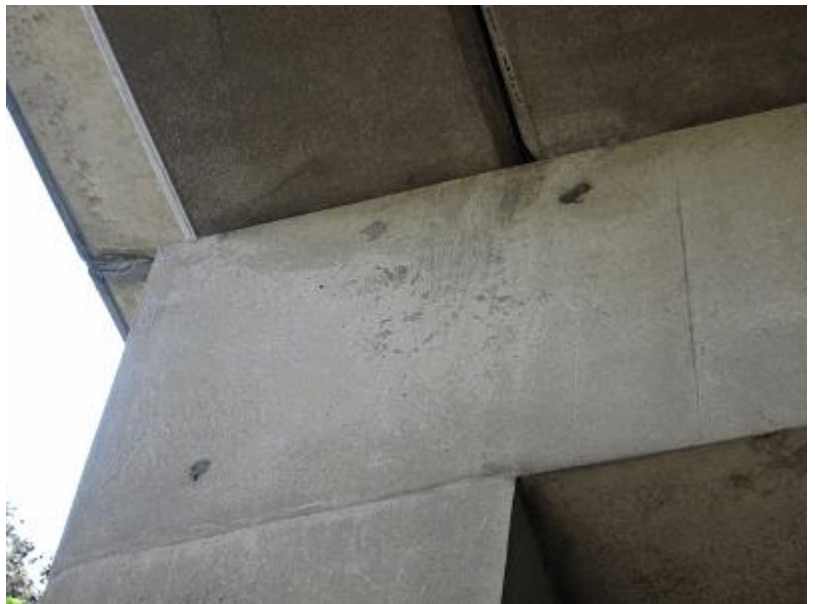
Defect Type FRep - Failed repair

Comments A number of repairs at core hole testing locations to pier crossheads have failed.

Repairs to testing holes pier have failed.

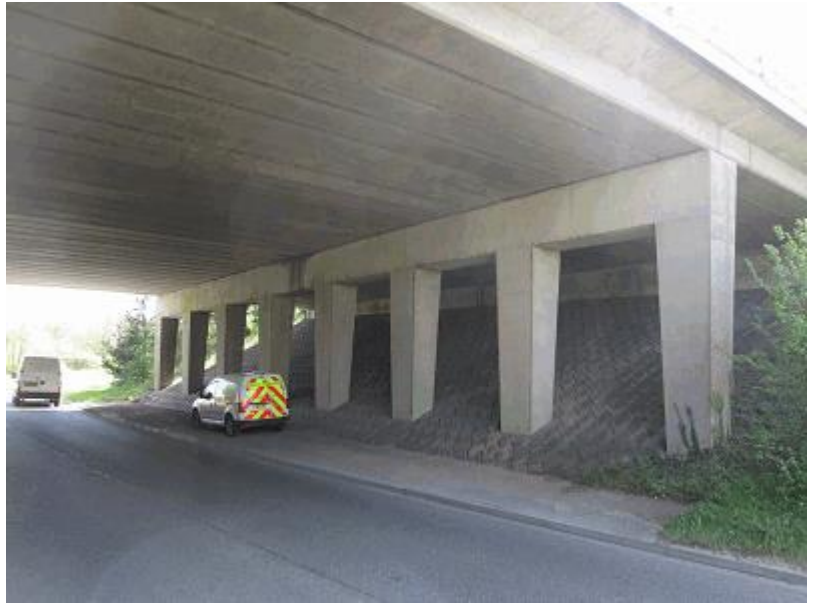
Comments There is no safety fence protection to the south pier portal.

No safety fence protection to south pier portal.

Maintenance Object	Safety Fence	Maintenance Action	Install
Estimated Cost	£20,000	Recomm. Action Date	30/09/2014
Priority Category	2	Risk Score	92
Comments	Provide safety fence protection to the south pier portal		
Maintenance Object	Concrete	Maintenance Action	Repair
Estimated Cost	£30,000	Recomm. Action Date	01/08/2017
Priority Category	3	Risk Score	72
Comments	Repair areas of delaminated concrete caused by reinforcement corrosion.		
Maintenance Object	Surfacing	Maintenance Action	Replace
Estimated Cost	£80,000	Recomm. Action Date	30/09/2014
Priority Category	3	Risk Score	70
Comments	Resurfacing of westbound lane 1 over the entire structure. Repairs/replacement of buried joint and waterproofing will also be required.		
Maintenance Object	Expansion Joint	Maintenance Action	Replace
Estimated Cost	£25,000	Recomm. Action Date	30/09/2014
Priority Category	3	Risk Score	65
Comments	Investigate cause of water seepage. If joints are found to leak repair joints. Note the defect is likely to occur at the interface of the phased joint replacement works near the central reserve. In addition, the longitudinal joint between the two bridge decks may be the cause of water seepage. In addition to the above joint repairs will be required as a consequence of resurfacing works.

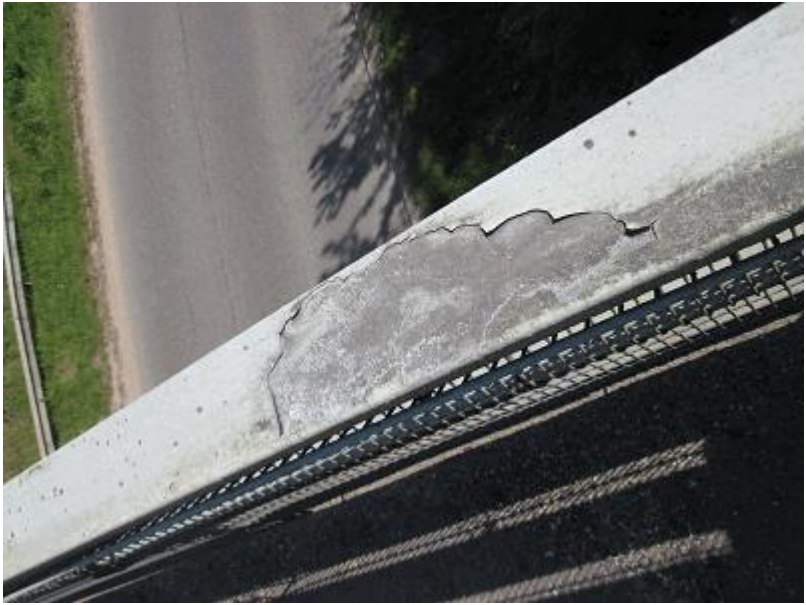
Components	West Deck (north side span - west) - West Parapet, East Deck (north side span - east) - East Parapet, West Deck (south side span - west) - West Parapet, West Deck(main span - west) - West Parapet, East Deck (main span - east) - East Parapet, East Deck(south side span - east) - East Parapet		
Defect Type	PDeg - Other degradation or breakdown		
Extent	SC - Defect present in 5% to not more than 20% of area or length of element		
Severity	P2 - Minor loss of protection likely in the near future		
Priority	Low		
Comments	The parapet rails and posts are subject to loss and general deterioration of the paint system. The infill mesh fixings are suffering from corrosion.		
Cause	Corrosion	Certainty	High

Comment on Cause			
	Parapet rails have deterioration of paint system.

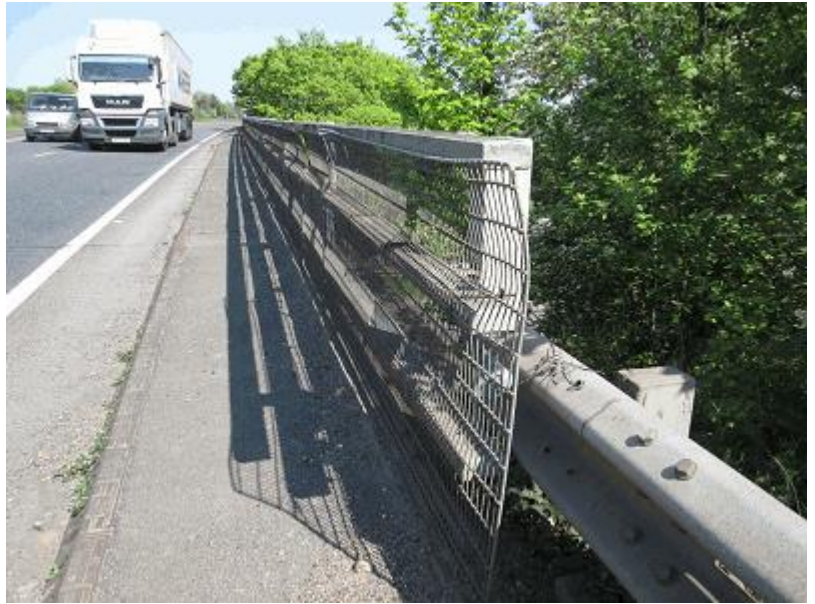
Components	East Deck(south side span - east) - East Parapet		
Defect Type	AD - Impact (accident) damage other		
Extent	SC - Defect present in 5% to not more than 20% of area or length of element		
Severity	D2 - Minor: Defect is unlikely to be causing damage to the element or structure now or unlikely to do so in the near future		
Priority	Medium		
Comments	The mesh infill to the east parapet has minor impact damage approximately 15m long.		
Cause	Accident Damage	Certainty	High

East parapet is damage approximately 15m long.

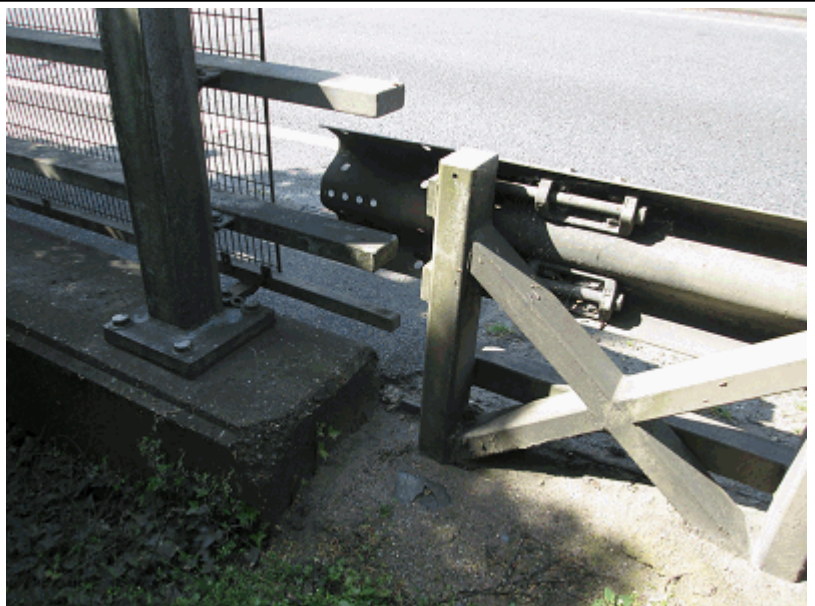
Components	East Deck (north side span - east) - East Parapet, East Deck(south side span - east) - East Parapet		
Defect Type	MissCo - Missing		
Extent	SB - Defect present in not more than 5% of area or length of element		
Severity	D2 - Minor: Defect is unlikely to be causing damage to the element or structure now or unlikely to do so in the near future		
Priority	Medium		
Comments	There are no connections between the safety fence and the parapets. Presence of full height anchor instead.		
Cause	Construction Issue	Certainty	High
Comment on Cause

No connections to NE parapet.

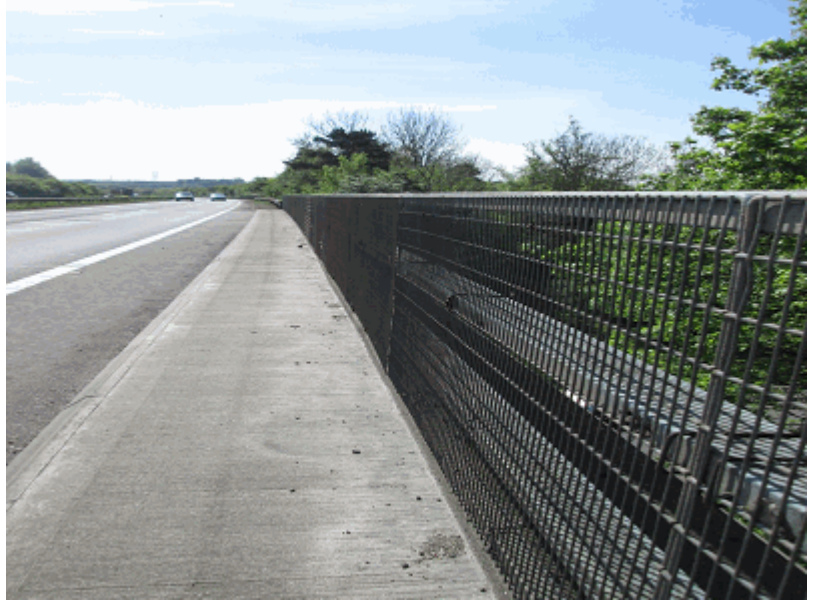
Components	West Deck (south side span - west) - West Parapet, East Deck(south side span - east) - East Parapet, West Deck(main span - west) - West Parapet, East Deck (north side span - east) - East Parapet, East Deck (main span - east) - East Parapet, West Deck (north side span - west) - West Parapet		
Defect Type	Deg - Degraded		
Extent	SB - Defect present in not more than 5% of area or length of element		
Severity	D2 - Minor: Defect is unlikely to be causing damage to the element or structure now or unlikely to do so in the near future		
Priority	Low		
Comments	IAN 97/07 Assessment - Monitor parapet condition in future PI/GI inspections.		
Cause	Design Issue	Certainty	High
Comment on Cause	IAN 97/07 Assessment: Risk - Very low; Result - Monitor only.

West parapet.

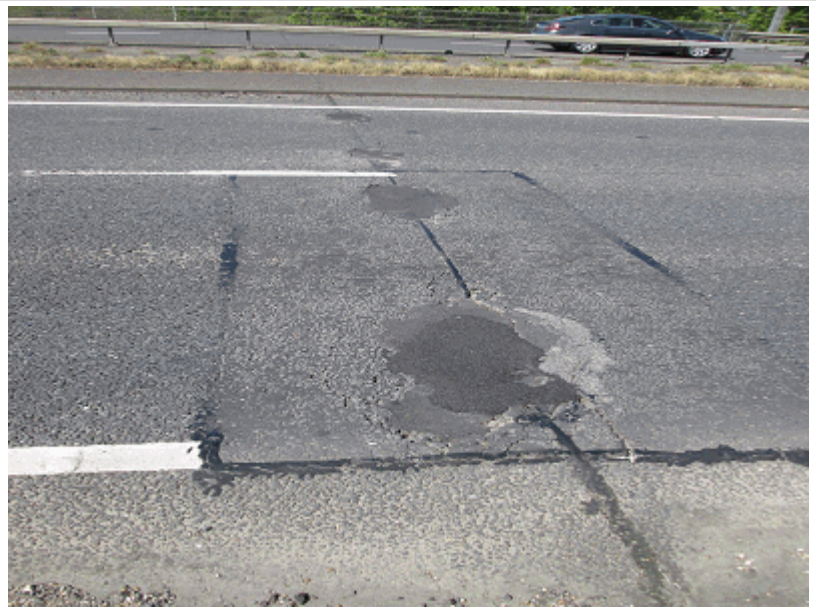
Extent	SB - Defect present in not more than 5% of area or length of element
Severity	D3S - Moderate: Defect may present a danger to the public in the near future
Priority	High
Comments	Potholing and surfacing deterioration is present to the eastbound carriageway at North pier and over abutment. Pothole has been reported to NCC for repair in 24HRS ref.51023525-51023760. 50-2016 G.I.
Cause	Age Expired Certainty High
Comment on Cause	Lack of binding agent to the aggregate leading to movement of material and breakup of the surfacing.

Pothole to eastbound carriageway at North pier.

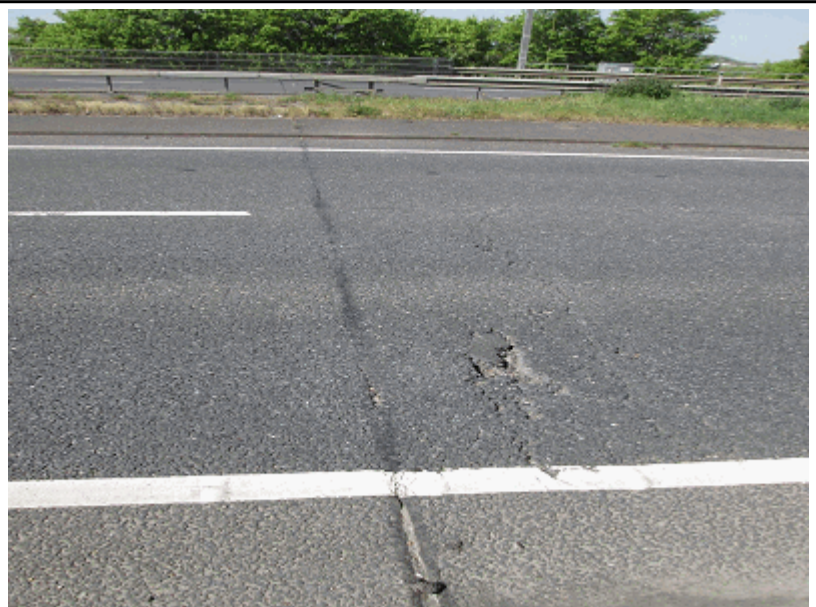
Pothole to eastbound carriageway at North abutment.

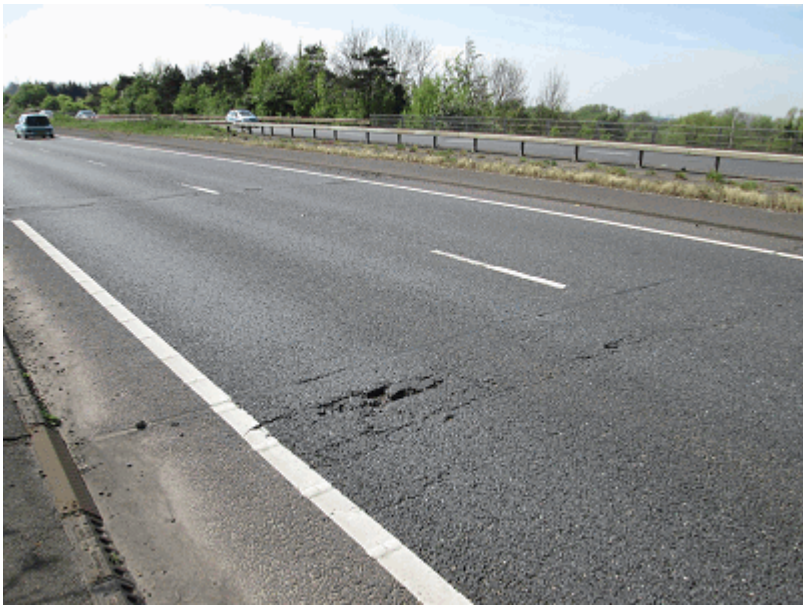
Components	East Deck (north side span - east) - A14 east bound surfacing (replaced Nov 07)		
Defect Type	CrCo - Cracked		
Extent	SB - Defect present in not more than 5% of area or length of element		
Severity	D3 - Moderate: Defect is probably causing damage to element or structure, or is likely to do so in the near future		
Priority	Medium		
Comments	There was cracking in the carriageway on the approach to the North joint (Eastbound).		
Cause	Unable to Determine	Certainty	Medium

Comment on Cause	Cracking to eastbound carriageway.

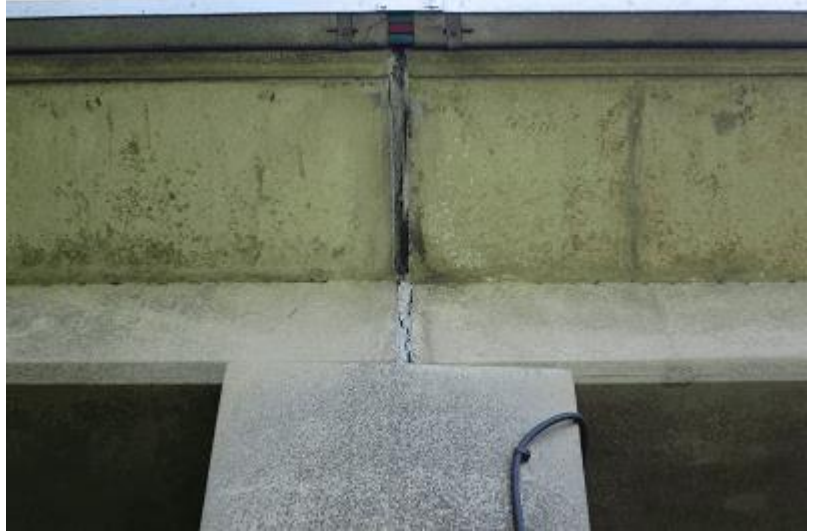
Components	West Deck(main span - west) - Joint 2 west (north verge piers)		
Defect Type	Debo - Debonding		
Extent	SB - Defect present in not more than 5% of area or length of element		
Severity	D2 - Minor: Defect is unlikely to be causing damage to the element or structure now or unlikely to do so in the near future		
Priority	Low		
Comments	The polysulphide joints sealant have degraded and are debonding.

NW polysulphide joint debonding.

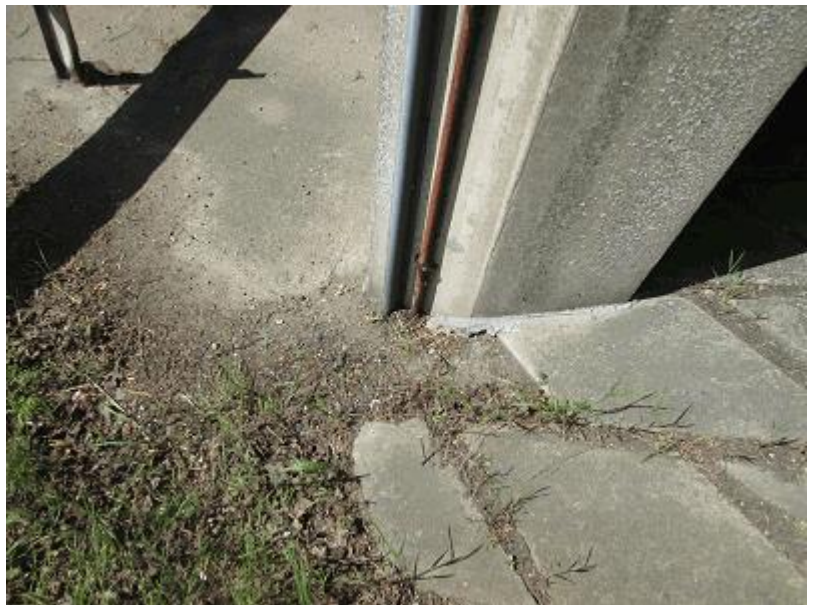
Comments The north revetment has a slab missing at the base of the north east pier.

Slab missing at the base of NE pier.

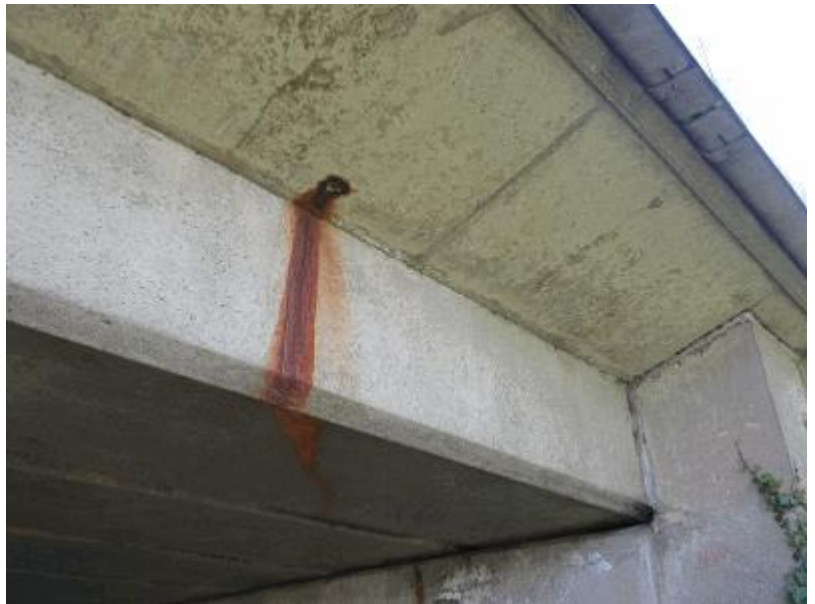
Components	West Deck (south side span - west) - parapet cantilever, North Abutment - north abutment bearings
Defect Type	FO - Foreign object

Extent	SB - Defect present in not more than 5% of area or length of element
Severity	D2 - Minor: Defect is unlikely to be causing damage to the element or structure now or unlikely to do so in the near future
Priority	Low
Comments	In the west cantillever at the south end there is an area of corroding ferrous material with a spall, approx 60mm diameter. Similar defect in the same area approximately 1m south of the south pier. Also, a small area of exposed corroding steel on the north abutment east end.

West cantillever at south end corroding metal.

Comments	Remove corroding objects and repair spalling on the west deck cantilever soffit.
